CASE STUDIES OF BUILDING BEHAVIOR IN RESPONSE TO ADJACENT EXCAVATION

FINAL REPORT

1. Report No. UMTA-IL-06-0043-78-2	2. Government Accession No.	3. Recipient's Catalog No.	
4. Title and Subtitle Case Studies of Building Behavior in Response to Adjacent Excavation		5. Report Date October, 1978

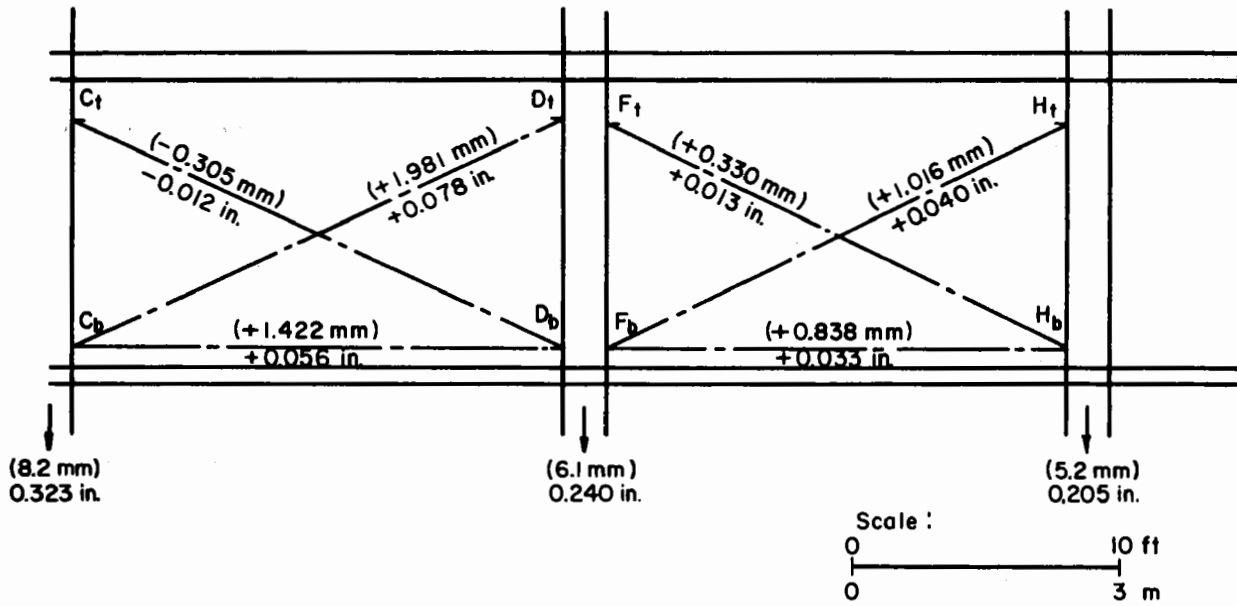
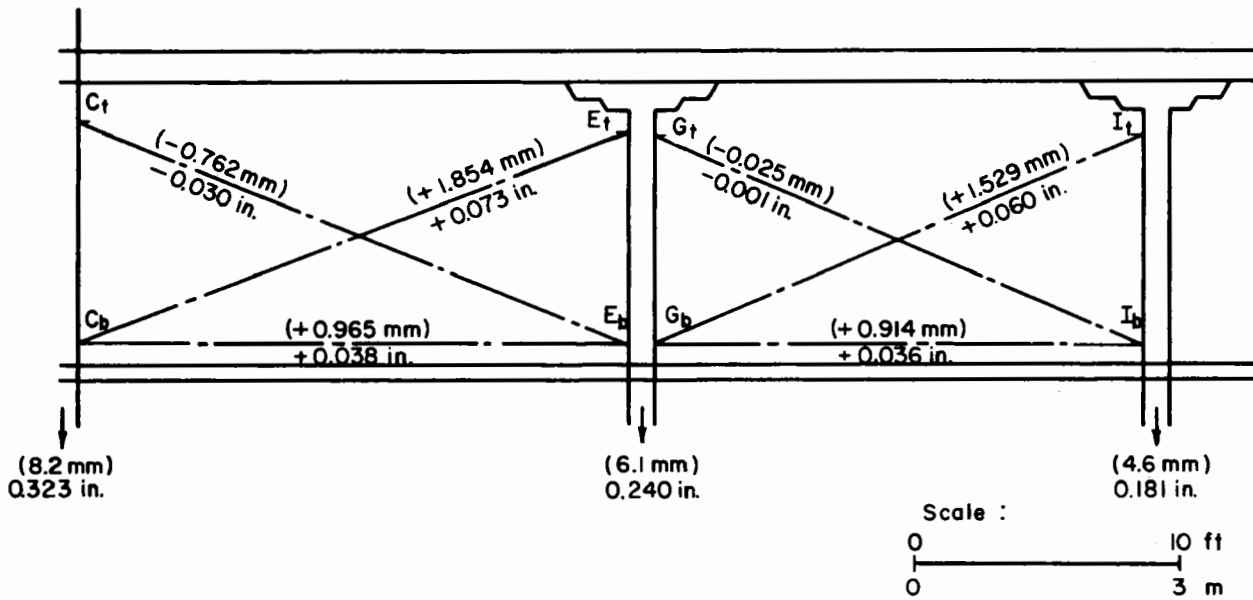
FIGURE 2.8 SECTIONS ILLUSTRATING TAPE EXTENSOMETER POINTS AND CUMULATIVE DISTORTION FROM 18 DEC 75 TO 2 DEC 76

Figure 2.8 shows the changes in the tape extensometer measurements that occurred from the time of the initial readings to the time corresponding to a partially backfilled condition and the removal of most B-level braces. The external building temperature and internal temperature of the structural bay under scrutiny were similar for the two sets of readings. Differential lateral extension at the bases of the columns was approximately 1/32 in. (1 mm). This horizontal extension correlates with diagonal extension and diagonal compression directed downward and upward, respectively, toward the columns nearest the excavation.

The crack survey revealed that only minor cracking occurred during excavation and construction. Construction joints in the basement slab and at the basement slab-wall junction opened 1/64 to 1/32 in. (0.4 to 1.0 mm). This is in agreement with the lateral movements recorded in Figure 2.8. The observed cracking was concentrated in the area where the north basement wall and the north stairwell meet. The stairwell is much stiffer than the basement wall and it is integrally connected with the superstructure. Under such conditions, the area of the intersection of the wall and the stairwell would be quite susceptible to

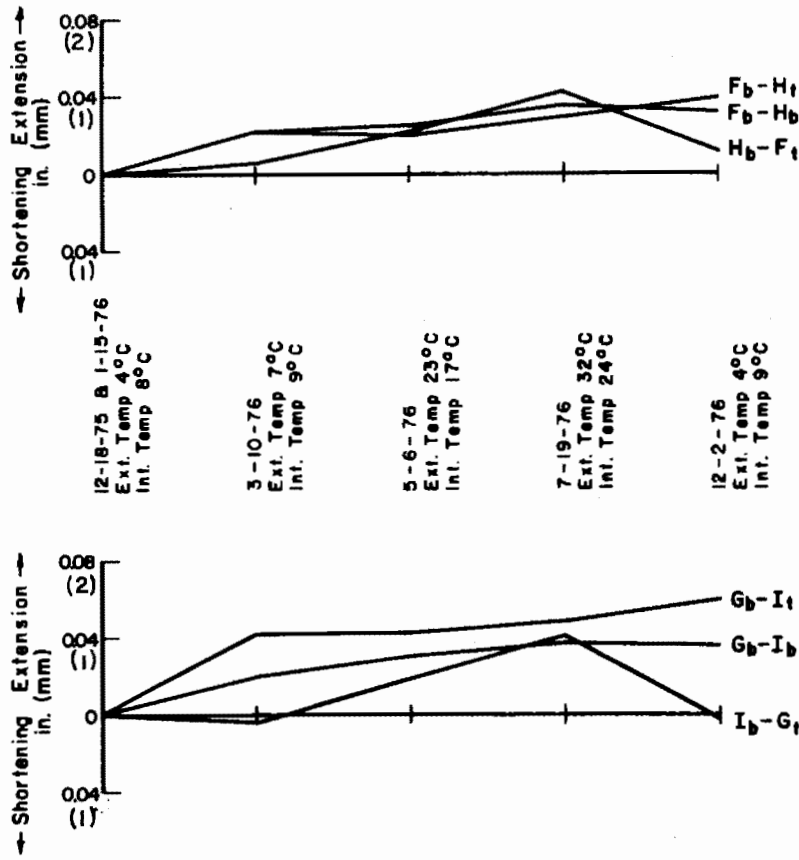
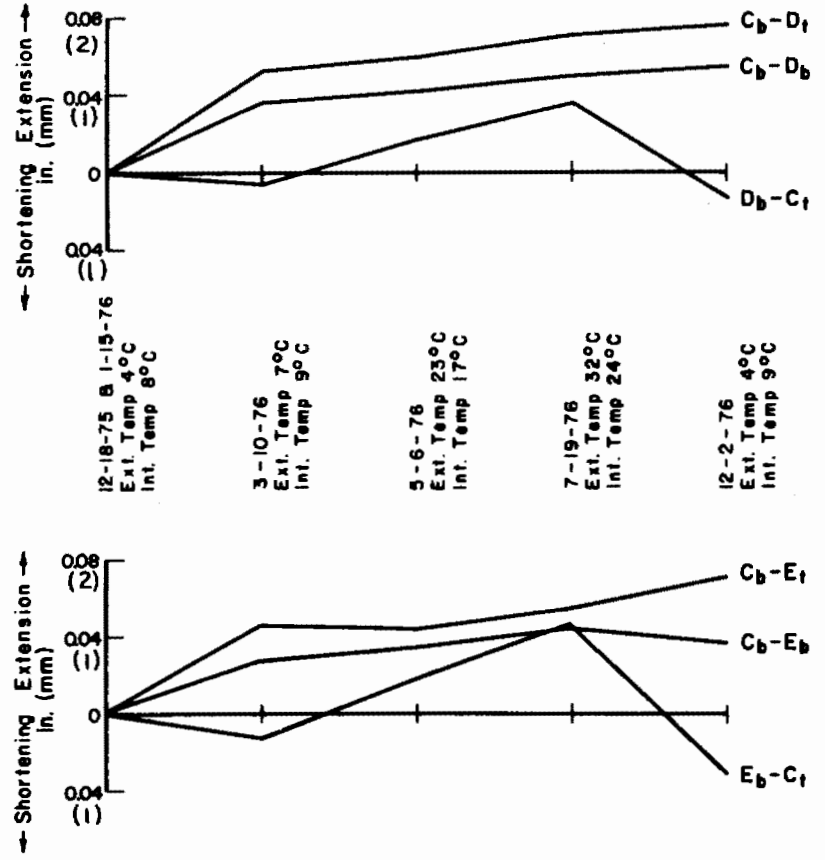
FIGURE 2.10 TAPE EXTENSOMETER MEASUREMENTS OF STRUCTURAL BAY DISTORTION AS A FUNCTION OF TEMPERATURE

The data from the tape extensometer measurements are presented in Figure 2.10. Figures 2.2 and 2.8 illustrate the locations of these measurements. Figure 2.10 is a plot of the total change in the distances between reference points for the various dates of observation. Exterior and interior temperatures are noted.

In each bay, the diagonals directed upward toward the columns closest to the excavation (lines $D_b - D_t$, $E_b - C_t$, $H_b - F_t$, and $I_b - G_t$) show a significant extension during the summer months and a compression during the winter months and, in particular, to the movement determined from the final set of readings. Moreover, as the summer temperature increased, the extension of these diagonals increased significantly, whereas the measurements at the other extensometer lines showed only minor alterations. Clearly, the distortion of the building frame was influenced by temperature.

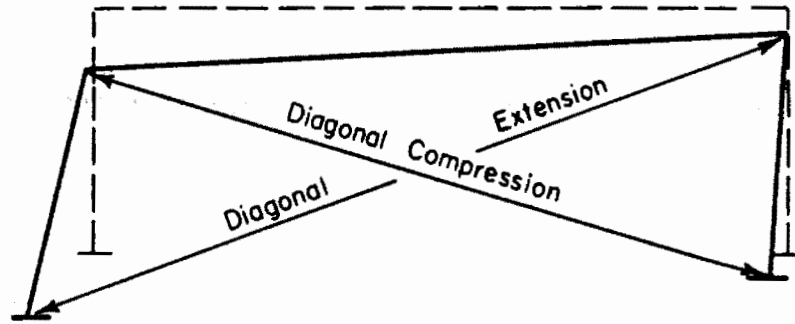
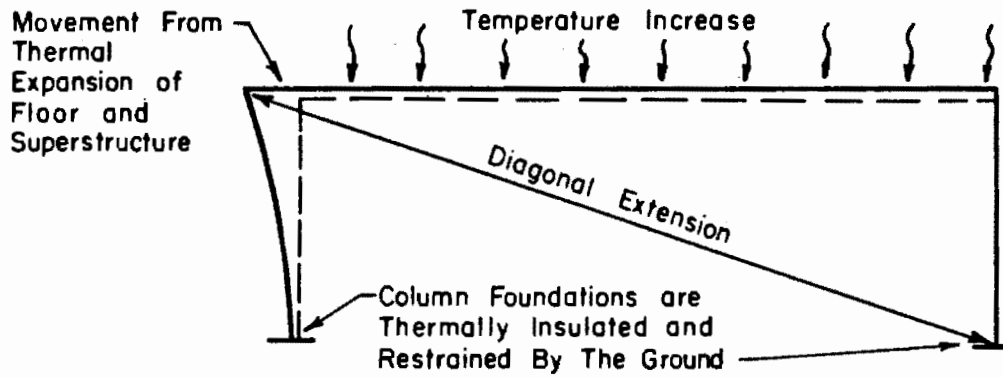
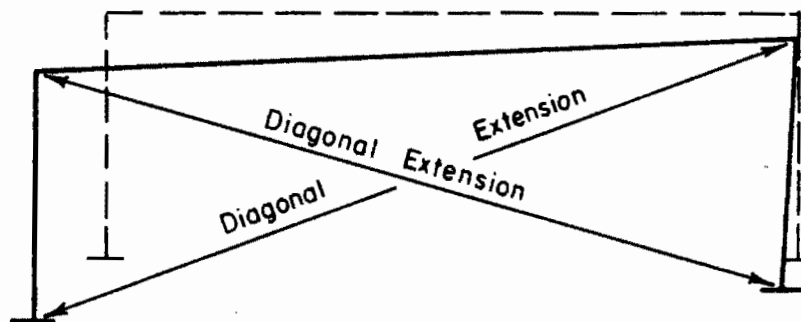
FIGURE 2.11 FACTORS CONTRIBUTING TO FRAME DISTORTION

The influence of temperature is illustrated in Figure 2.11. For simplicity a single bay is shown and its distortions due to both

differential ground movement and thermal expansion are indicated separately. Thermal expansion of the first floor and superstructure causes additional separation at the tops of the columns, thus, extending the diagonal directed upward from the base of the interior column. Because the foundations of the columns are thermally insulated and restrained by the ground, the horizontal separation at the base of the frame remains constant. The average temperature change from the time of the zero readings until 19 July 1976 was approximately 72°F (22°C). If this increase of temperature caused a widening along the first floor line that was related to the coefficient of thermal expansion for concrete (6 micro-strains per F° or 9 micro-strains per C°), then the diagonal extension should have been approximately 0.04 in. (1 mm). This calculated value agrees with the measured increase. When the distortions caused by differential ground movements and thermal expansion are combined, the resulting deformation shows an extension of both diagonals.

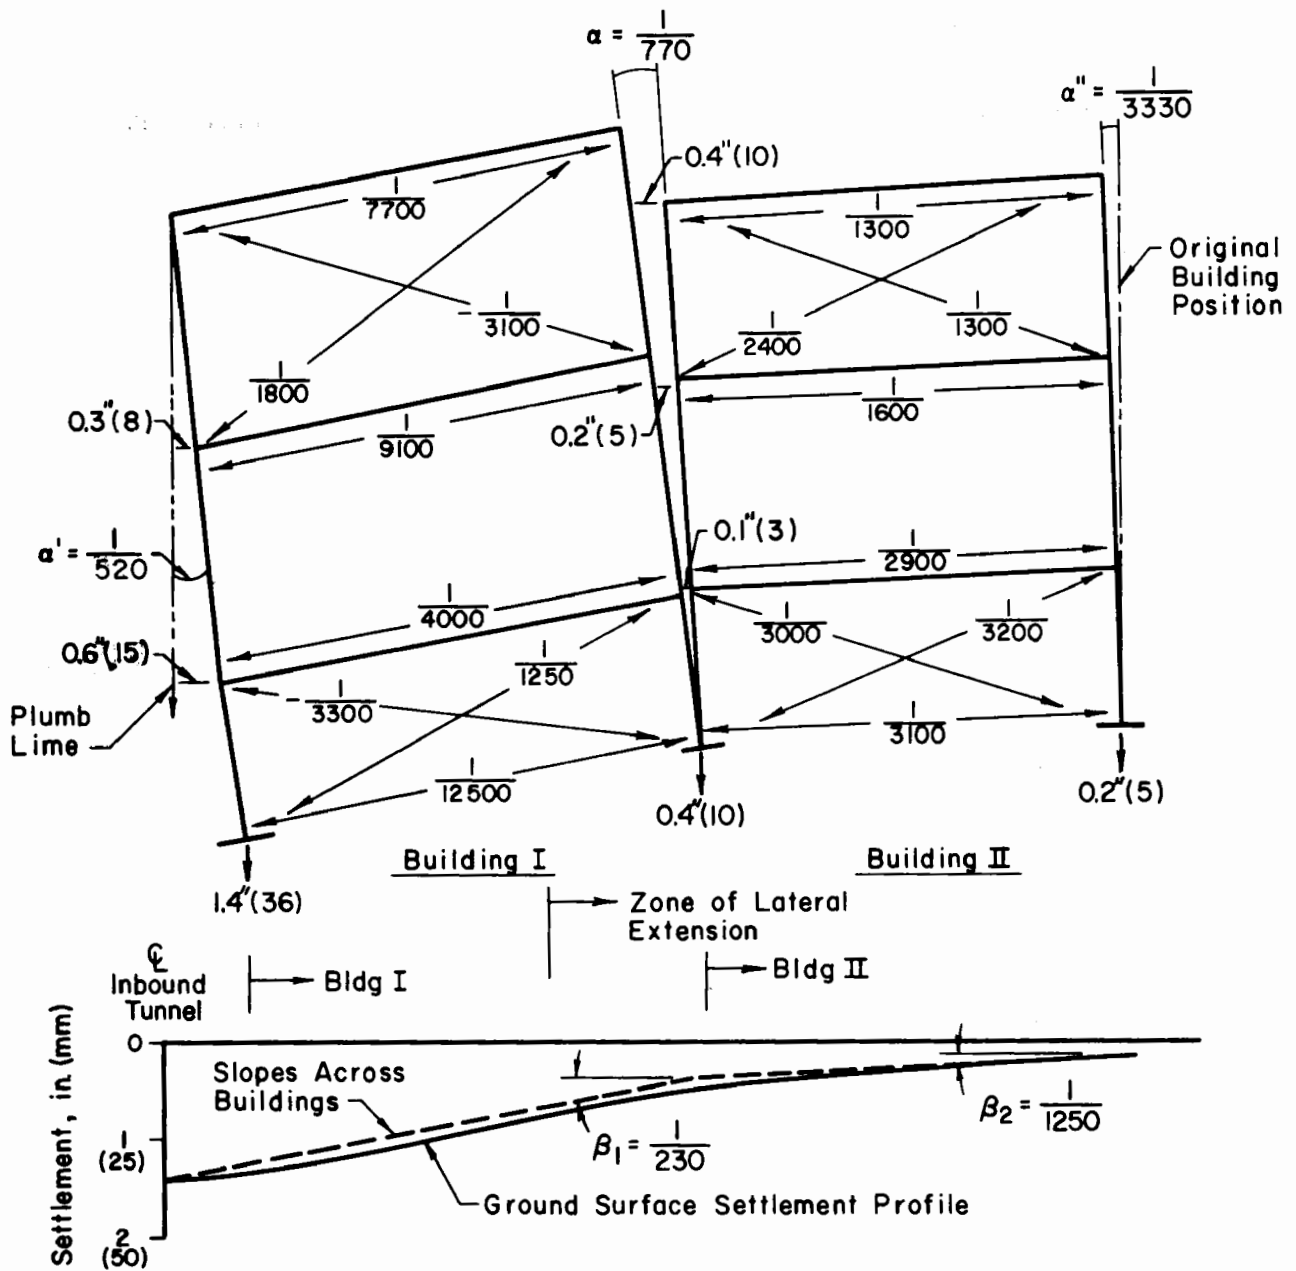
FIGURE 3.13. FINAL DISTORTED SHAPES OF THE FRONTS OF BUILDINGS I AND II

Building I
 $\beta_1 = 1/230$ (4.4×10^{-3})
 $\alpha' = 1/520$ (1.4×10^{-3})
 $\delta_{a1} = 1/410$ (2.4×10^{-3})

The final distortions of Building II, shown in Fig. 3.13, illustrates the behavior of a structure in the zone of lateral extension. The differential settlement between the bearing walls is 0.2 in. (5 mm), causing of the building settlement curve to have a slope of 1/1250. The rigid body rotation of Building II is on the order of 1/3300 or less. Thus the differential settlements and the rigid body rotations of Building II are less than those of Building I. The final true angular distortion, δ_a , of Building II is about 1/2000. The horizontal tape extensometer measurements show lateral strains between the bearing walls ranging from 1/3100 in the basement to 1/1300 at the roof. Both diagonals of each set shown extension, the extension strains range from 1/3000 to 1/1300 for the basement and second story tape extensometer lines, respectively. The greater extension measured along the horizontal and diagonal tape extensometer lines higher up in the structure are caused by a relative rotation of the bearing walls. The bearing wall nearer the center of the settlement trough is on a steeper portion of the ground surface settlement curve and thus rotates more than the farther bearing wall. Again, the torsion about the longitudinal axis did not appear to have caused any distress in this building.

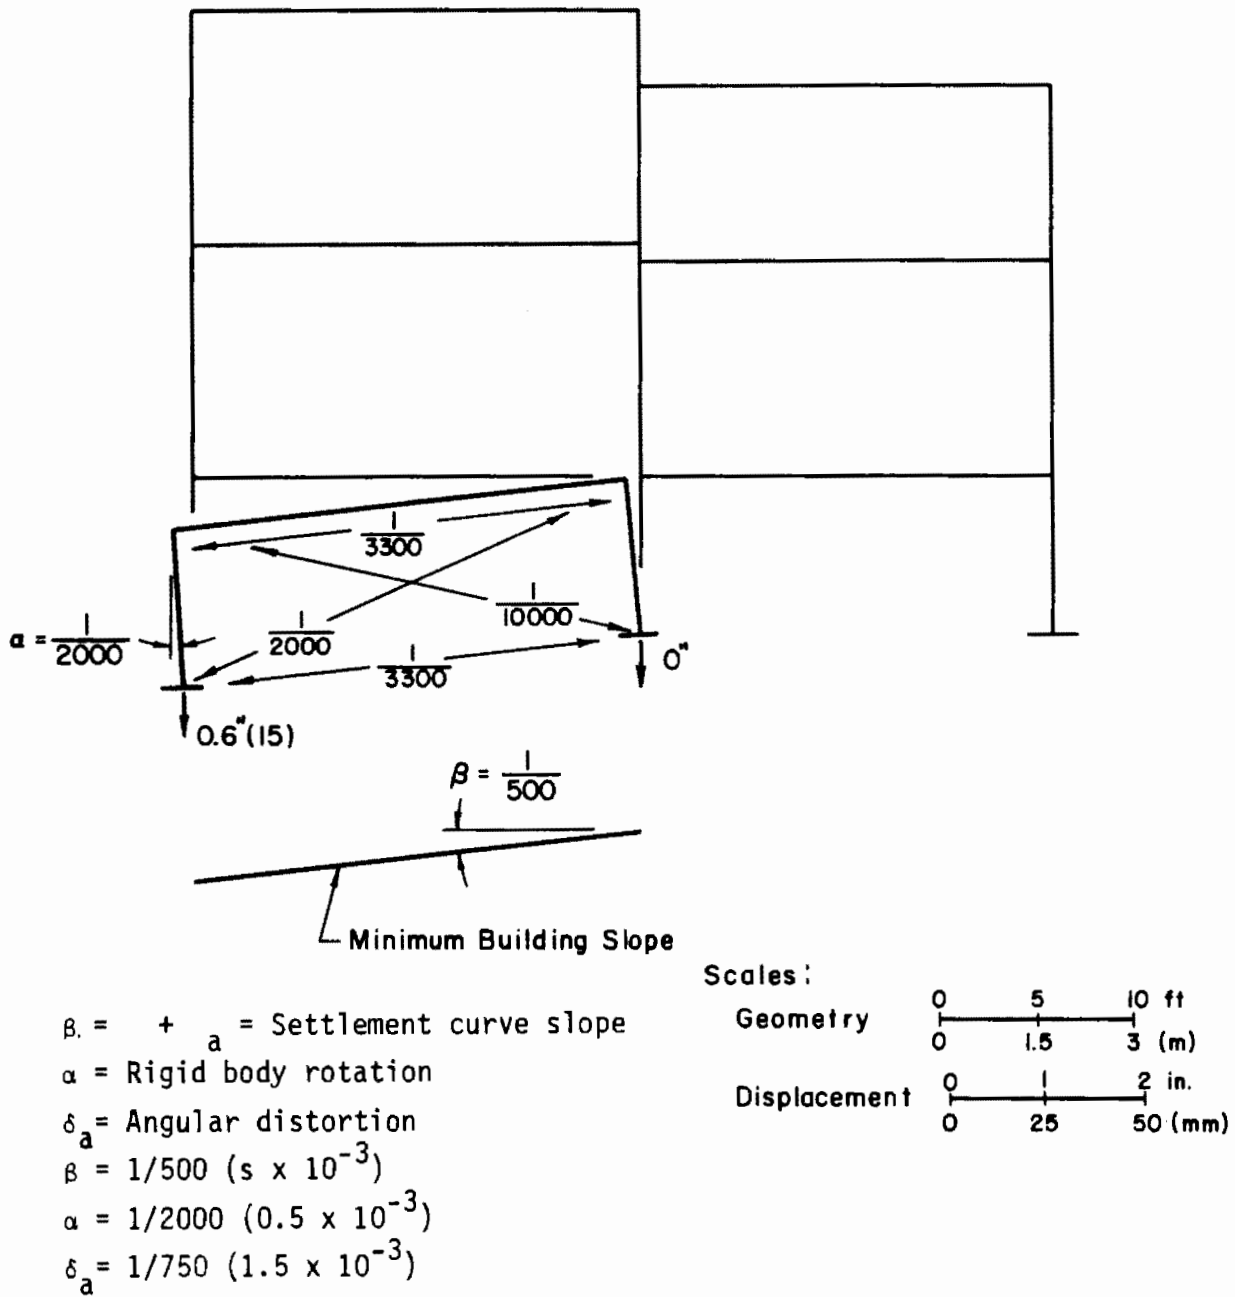
FIGURE 3.15 DISTORTED SHAPE OF THE BASEMENT NEAR THE FRONT OF BUILDING I, TUNNEL HEADING AT STA. 308 + 50

During the early stages of the development of the settlement trough Building I was in the zone of lateral extension. Fig. 3.15 shows a distorted

sketch of the basement of Building I along 308 + 50 cross-section at an early stage of development of the settlement trough when the face of the tunnel was approximately at Station 308 + 50. Settlement contours would be similar to those shown in Fig. 3.14a, but displaced about 25 ft (7 m) in the direction of tunnel advance. The differential settlement between the bearing walls was 0.6 in (15 mm) and the horizontal extension strain was 1/3300. Both diagonals were in extension as a result of the lateral extension of the ground, but the shear strains, derived from the differential settlements, caused a greater extension in one diagonal than the other. The rigid body rotation was about 1/2000, the slope of the building settlement profile, equivalent to the angular distortion plus rigid body rotation, equaled 2.0×10^{-3} (1/500), and the true angular distortion was 1.5×10^{-3} (1/750). Thus, during the early stages of the development of the settlement trough, the distortion of the structure had both horizontal and shear strain components, whereas, the final distortion of the structure appears dominated by the shear strain caused by differential settlement.

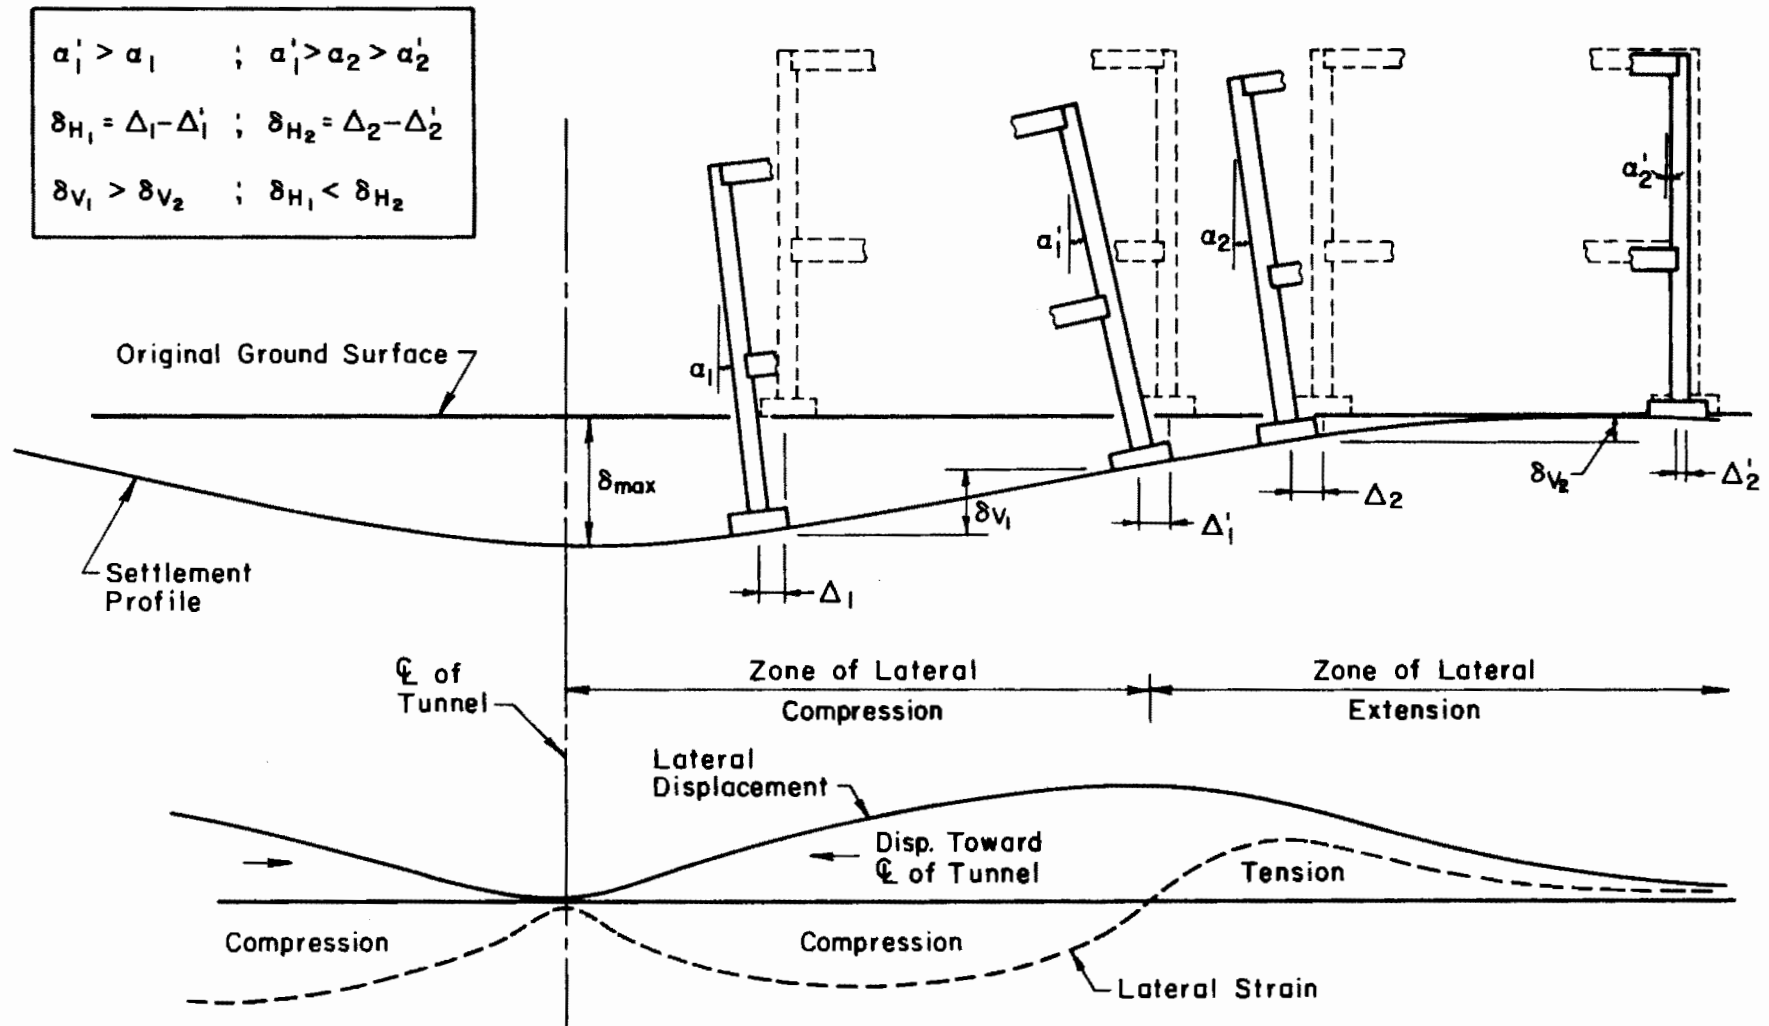
FIGURE 3.16 PATTERN OF DIFFERENTIAL MOVEMENTS OF STRUCTURES IN DIFFERENT ZONES OF THE SETTLEMENT TROUGH CAUSED BY TUNNELING

The above summary illustrates the general behavior of two similar structures located in different portions of the final settlement trough and the manner in which a developing settlement trough can distort a structure more and differently than the final measurements would indicate. Overall building response to settlement caused by an excavation involves three components; rigid body rotation, true angular distortion, and horizontal strain or distortion. The relative importance of each component varies depending on the position of the structure in the settlement trough and the stage of development of the settlement trough, as illustrated by Fig. 3.16.

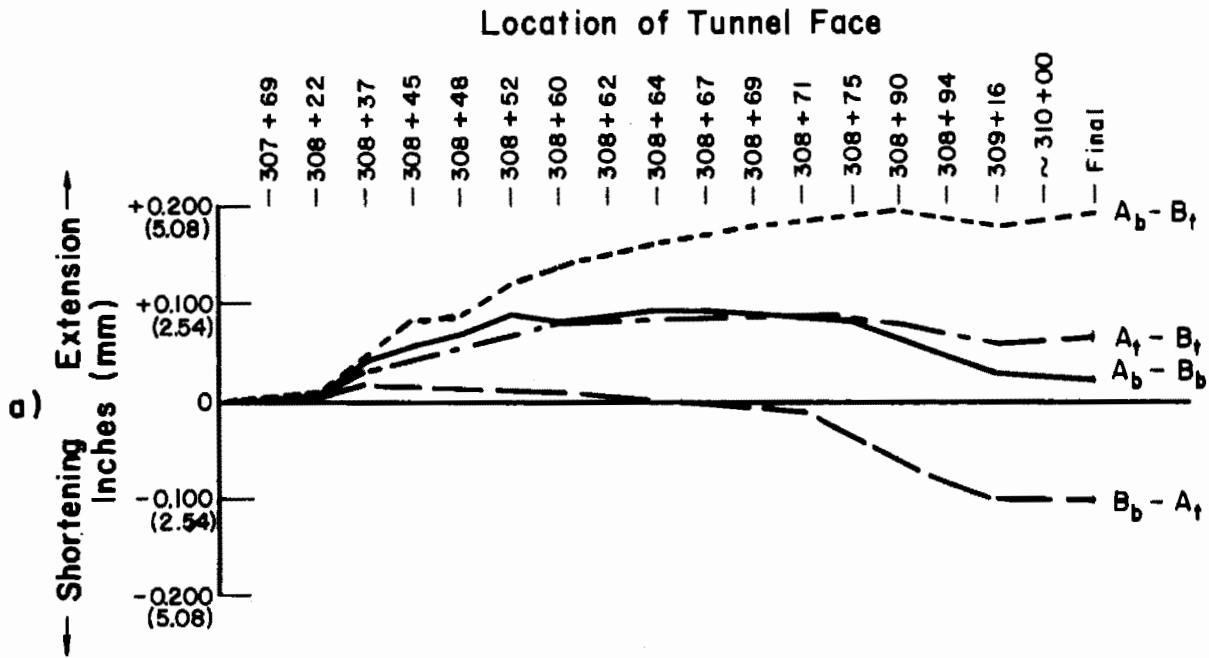
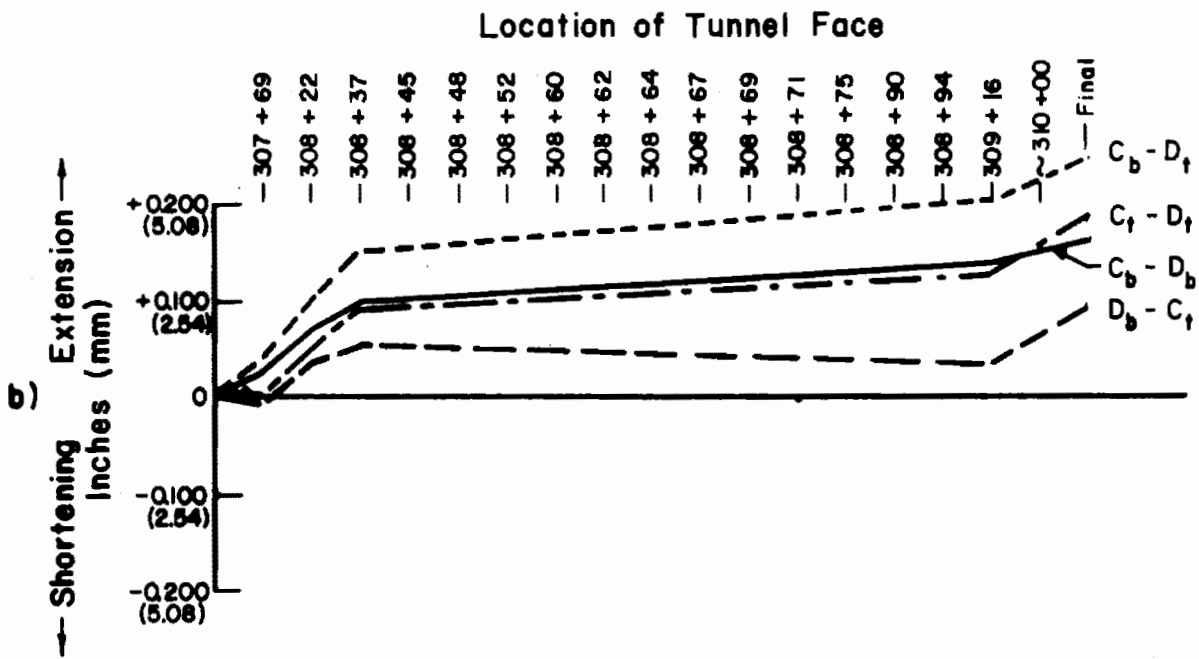
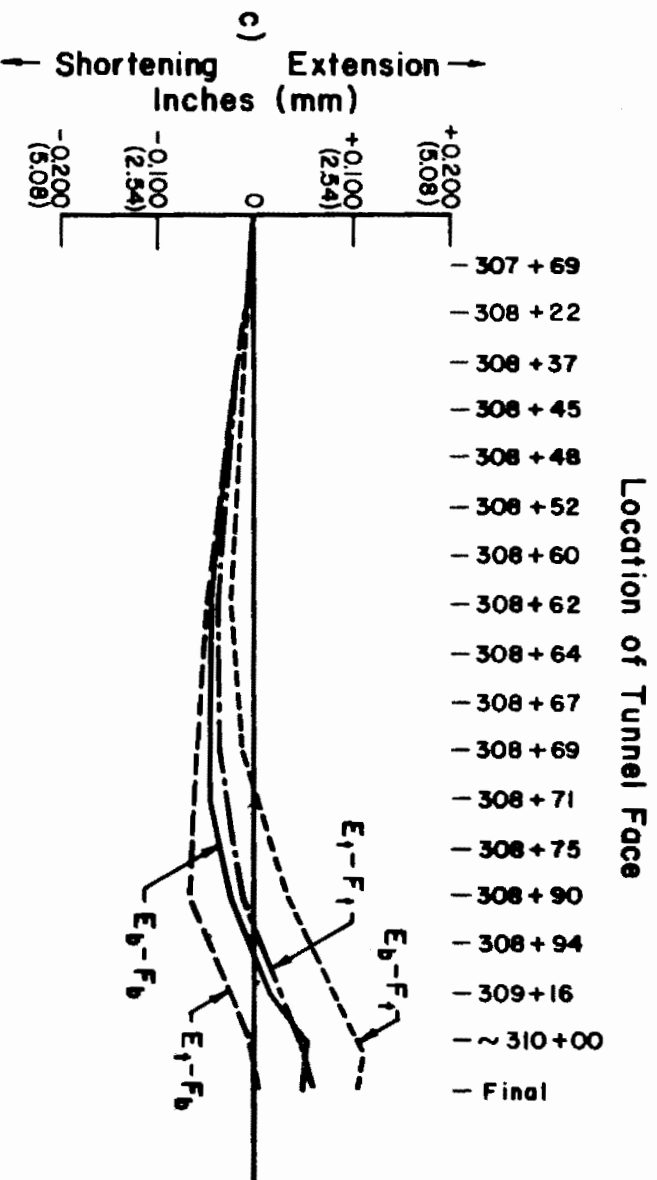
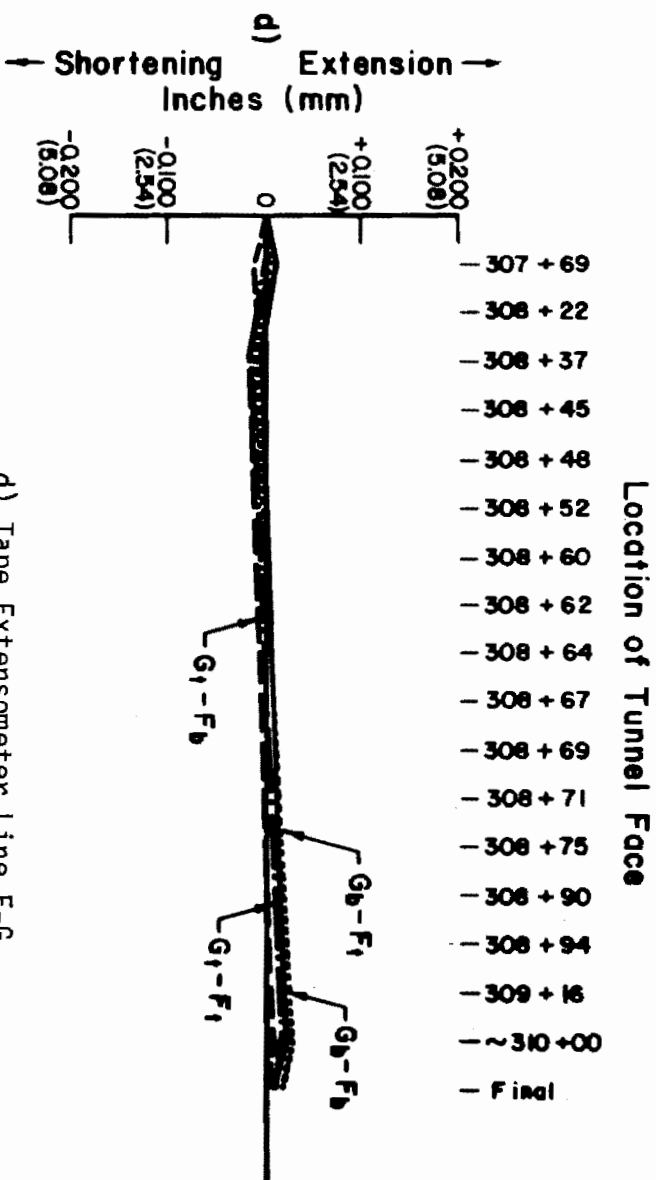
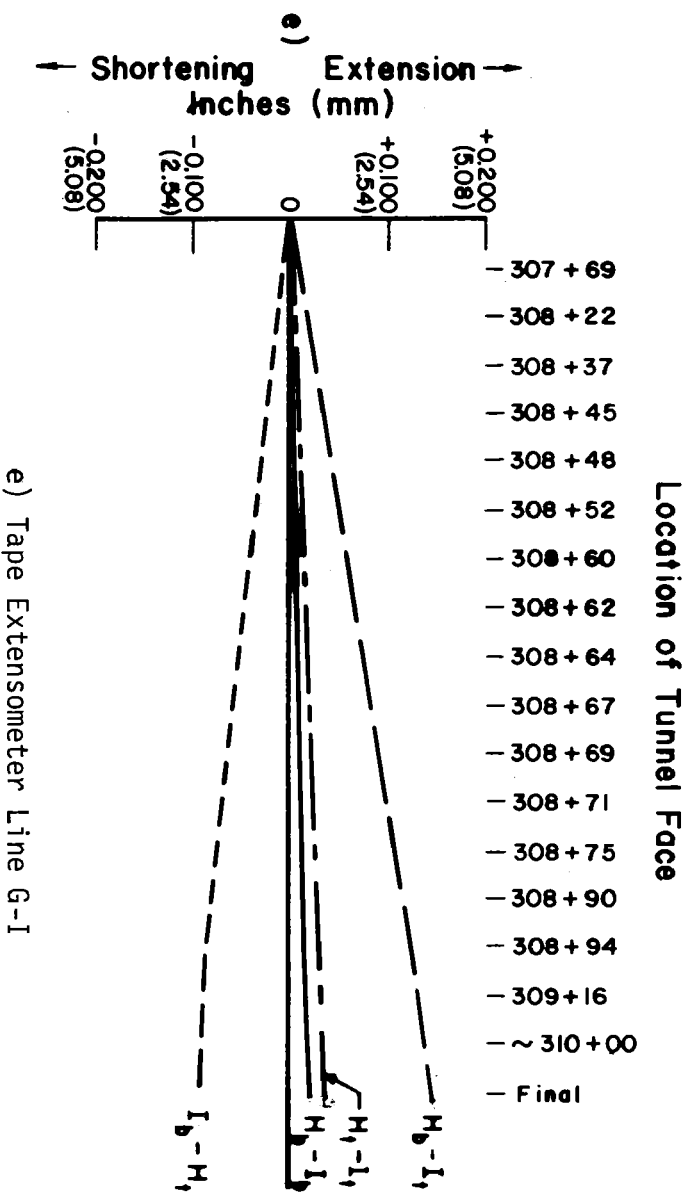
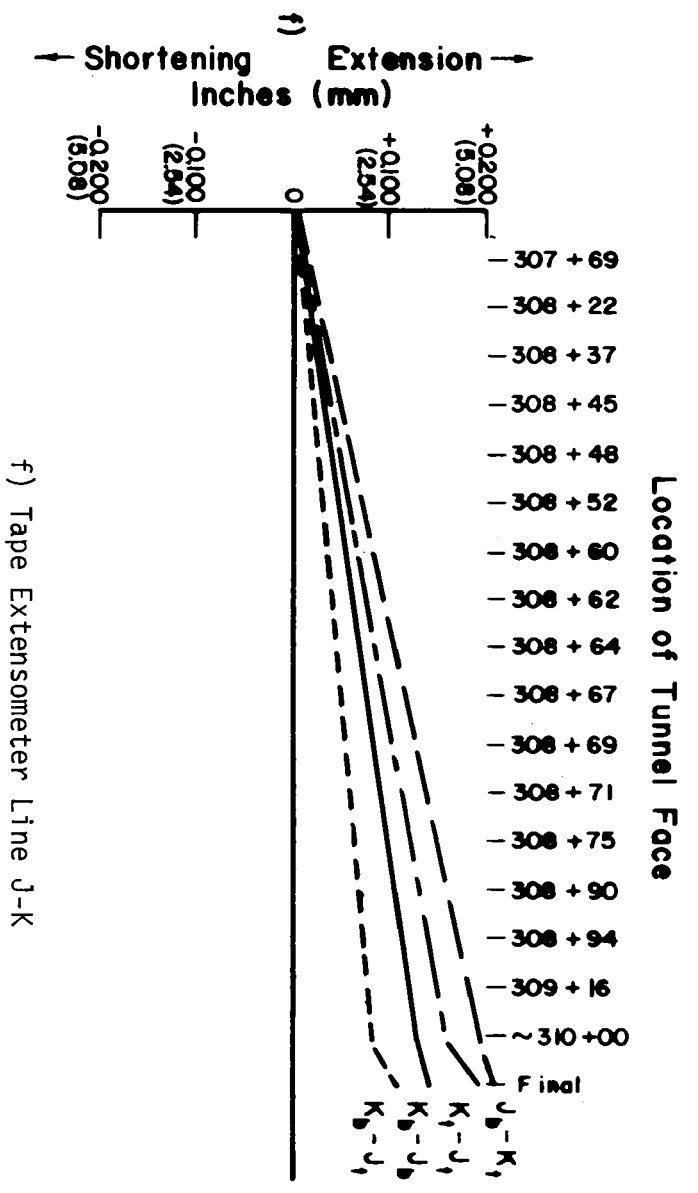
FIGURE 3.25 SUMMARY OF TAPE EXTENSOMETER MEASUREMENTS FOR VARIOUS LOCATIONS OF THE TUNNEL FACE

Tape extensometer lines A-B and H-I clearly demonstrate the extension of one diagonal and compression of the other, as well as the small relative horizontal displacement between the bearing walls of Building I in response to the tunnel excavation (Fig. 3.4 and 3.25).

The extension and compression diagonals are less obvious in tape extensometer cross-section C-D also located in Building I (Fig. 3.25). Since the axes of the building are skewed at an angle of 22° with respect to the tunnel axis, cross-section C-D is located farther from the centerline of the tunnel, in a zone where significant horizontal extension strain of the ground occurs. This results in a similar lateral extension of the building and extensions of both diagonals in cross-section C-D. However, one diagonal has a greater extension than the other as result of the differential settlement.

Cross-section J-K and L-M in Building II exhibit a different behavior than observed in Building I (Fig. 3.4 and 3.25). The magnitude of the horizontal strain is large and the differential settlements are small. Therefore, the lateral strains tend to dominate the relative displacements measured by the extensometers so that both extensometers undergo extension. The relative rotation of the bearing walls in Building II is apparent when the relative horizontal displacements between the walls at various levels are compared. As shown by Fig. 3.4, greater relative horizontal displacements occur at higher levels in the structure. Based upon the location of the various tape extensometer lines

Correlations may also be made with the tape extensometer measurements and the development of the settlement trough. For example, the plot in Fig. 3.25a of the tape extensometer measured displacements vs. location of the tunnel face illustrates the behavior of the structure at various stages of development of the settlement trough. Initially as the tunnel heading approaches the station of the cross-section being monitored, only the wall nearer the tunnel displaces to cause an increase in the distance between the bearing walls. During this early phase of the trough development the wall is in the zone of horizontal extension. The wall tilts, moves horizontally towards the tunnel, and settles slightly. As the tunnel heading passes by the station of the cross-section, the settlement trough widens and the wall is no longer in the zone of extension, but in the zone of compression. The horizontal movements are slight yet, the vertical move-

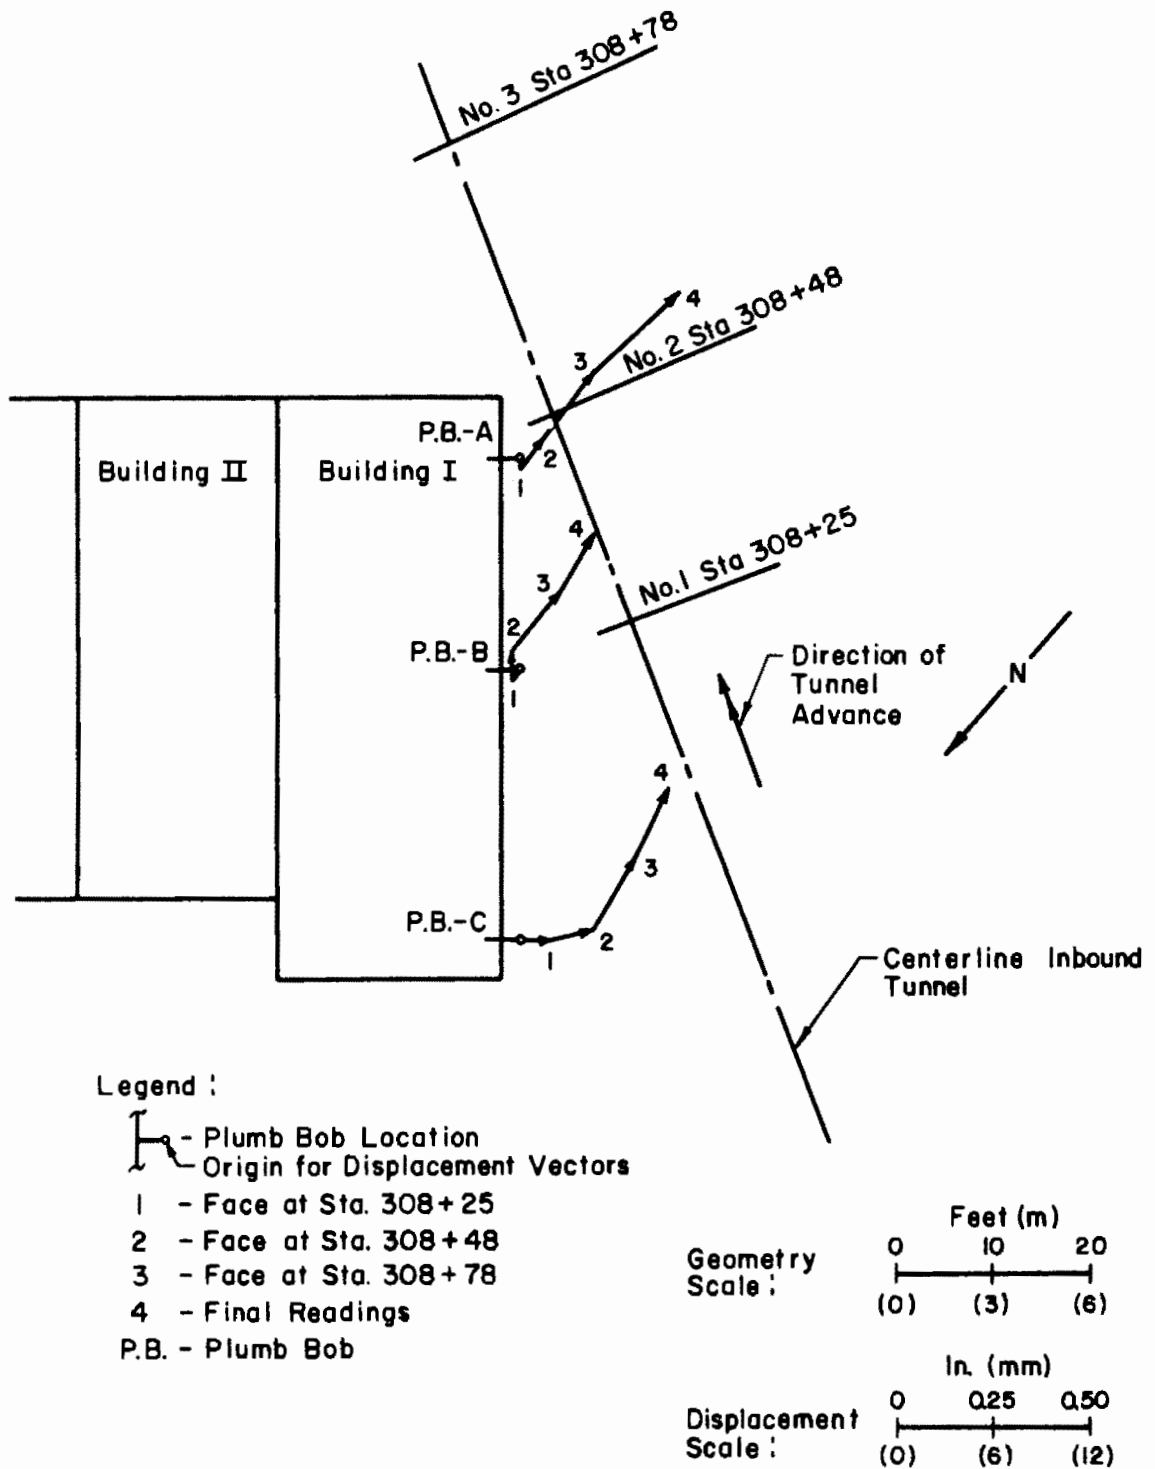
FIGURE 3.26 PLUMB BOB DATA SUMMARY
 (Vectors indicate the relative movement of the top of the wall with respect to the bottom for various stages of tunnel progress.)

The data from the plumb bob survey are summarized in Fig. 3.26. The resultant displacements of the top of the wall relative to its bottom at each of the plumb bob locations are shown as vectors for various stages of tunnel progress through the site. Both the distance of the wall from the centerline of the tunnel and the orientation of the wall with respect to the tunnel axis influences the tilt and its pattern of development. In this case the wall is oriented such that it cuts across the settlement trough so that the final tilt occurs both towards the tunnel axis and in a direction along the building wall towards the point where the wall is closest to the tunnel centerline (in this case in the direction of tunnel advance). The values of tilt perpendicular to the wall (almost perpendicular to the tunnel axis) are 1.4×10^{-3} , 0.6×10^{-3} , and 1.3×10^{-3} radians for plumb bobs A, B, and C, respectively. Slopes calculated from settlements along cross section perpendicular to the wall are 5.0×10^{-3} , 4.0×10^{-3} , and 3.2×10^{-3} and near plumb bobs A, B, and C, respectively, (Fig. 3.23). Thus, the inclination of the wall toward the tunnel is 1/3 to 1/4 of the slope of transverse building settlement profiles. The inclinations parallel to the wall (approximately in the direction of tunnel advance) are 1.4×10^{-3} , 1.2×10^{-3} and 1.3×10^{-3} for A, B, and C, respectively. The slope of the settlement profile along the wall is about 1.5×10^{-3} , Fig. 3.22. The inclination parallel to the plane of the wall is approximately the same as the slope of the building settlement profile along the wall.

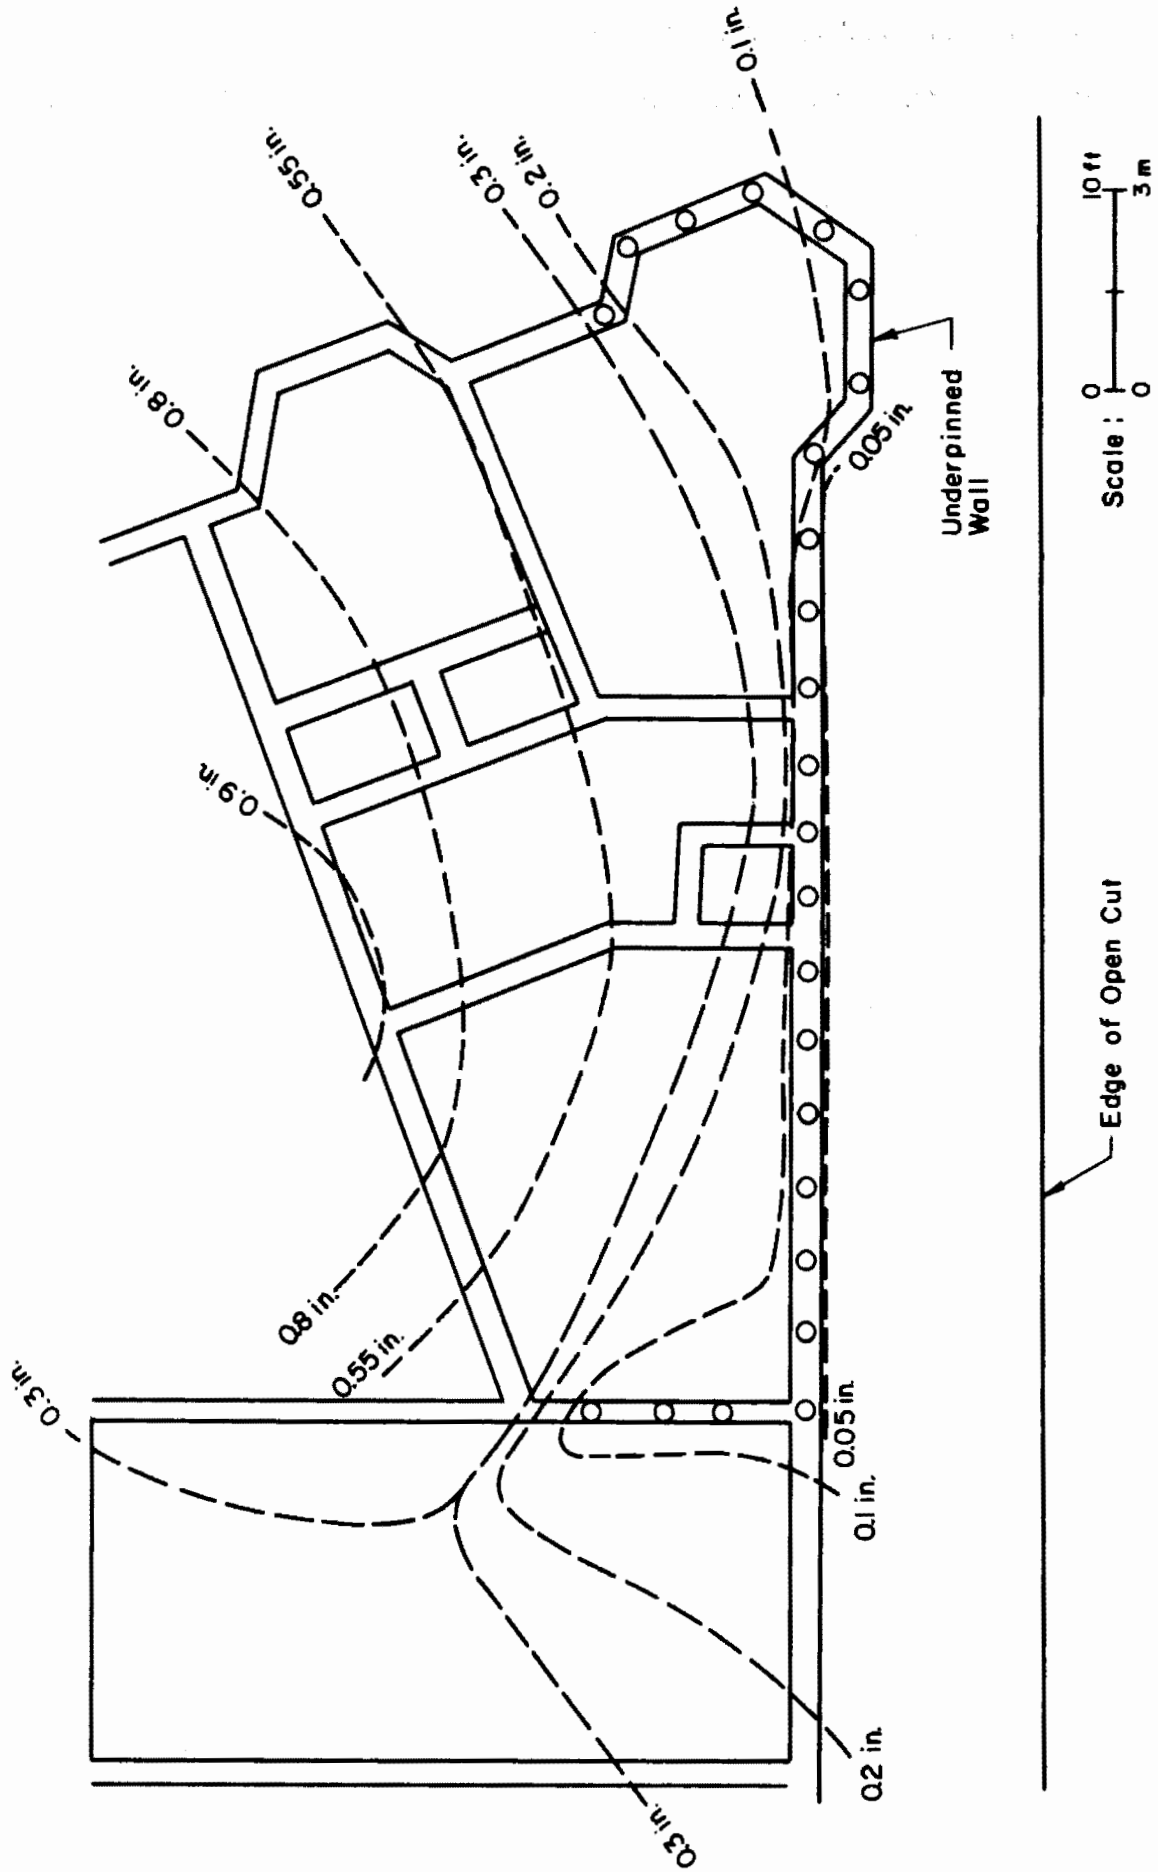
FIGURE 4.1 SETTLEMENT CONTOURS FOR CASE A

completion of all construction operations. Extensive cracking was noted on all floors; cracks ranged up to 1 and 2 in. (25 to 50 mm) in width. Door and window frames were severely distorted and repair was required to return the doors and windows to a functional state. The most severe damage occurred at the north end of the structure where steel channels were required to strap together and reinforce the 3rd, 4th, and 5th floors.

Settlement measurements taken on the building are shown in Figures 4.1, 4.2, and 4.3. It is evident that the underpinning supported the front wall of the building while the rear of the building, that was not underpinned, settled considerably as a result of the excavation. The underpinning acted to create large differential settlements over small distances, thus caused severe distortions in the structure. The angular distortions sustained by the building, based on settlement measurements at 8-to 15-ft (2.4-to 4.6-m)-intervals, are presented in Figure 4.4. There were many observations of angular distortion in the structure that exceeded 1×10^{-3} (1/1000), the limiting angular distortion for architectural damage to load bearing wall structures suggested by O'Rourke et al. (1976). Angular distortions of 1.8×10^{-3} (1/555) and 5.2×10^{-3} (1/190) were calculated for the north end of the structure along a line parallel to the edge of the excavation. Angular distortions ranging up to 8.0×10^{-3} (1/125) were calculated for the north end of the structure along a line perpendicular to the edge of the excavation.

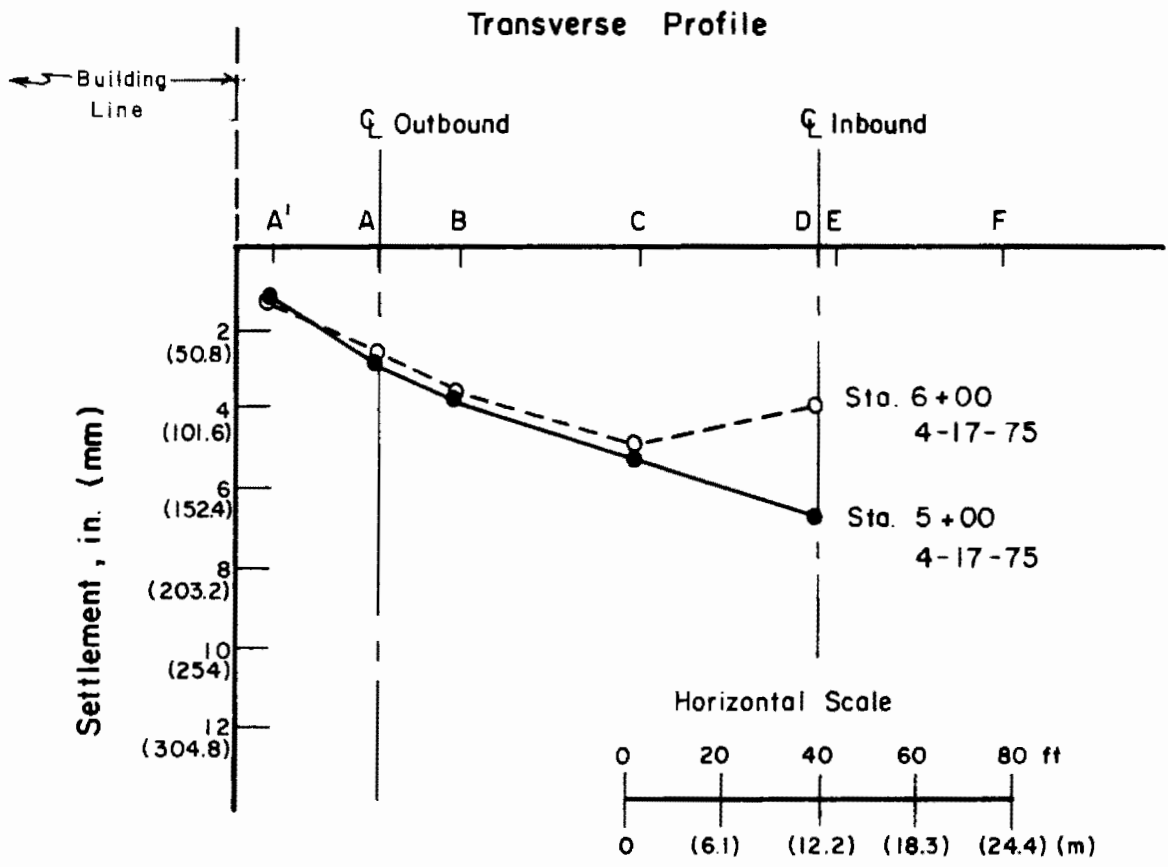
FIGURE 4.5 SETTLEMENT PROFILE PERPENDICULAR TO TUNNEL AXES, CASE C

Measurements of the settlement of both the ground surface and the structure appear in Figs. 4.5 and 4.6. Street settlements in excess of 6 in. (152 mm) and building settlements ranging up to 1 in. (25 mm) developed. An angular distortion of 1.1×10^{-3} (1/910), was calculated for the north end of the structure. At the south end of the structure, where most of the damage was observed, angular distortions of 3.6×10^{-3} (1/280) and 7.2×10^{-3} (1/140) were calculated from building settlement data. The settlement points used in the angular distortion calculations were located at 10-ft (3-m)-intervals. In addition to building damage related to angular distortion, the structure appeared to have suffered distress from horizontal extension. The inflection point of the settlement profile, where horizontal extension strains are at a maximum, occurred just inside the front wall of the structure.
