CASE STUDIES OF BUILDING BEHAVIOR IN RESPONSE TO ADJACENT EXCAVATION

FINAL REPORT

1. Report No. UMTA-IL-06-0043-78-2	2. Government Accession No.	3. Recipient's Catalog No.	
4. Title and Subtitle Case Studies of Building Behavior in Response to Adjacent Excavation		5. Report Date October, 1978

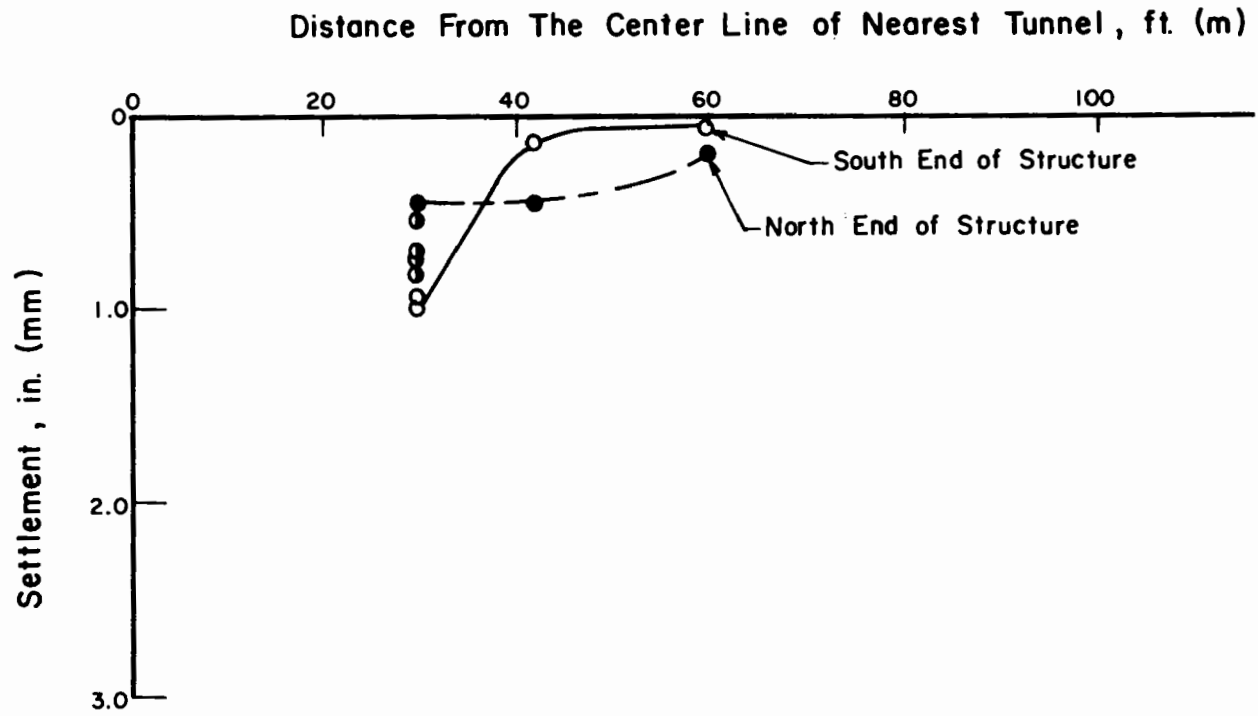
FIGURE 4.6 BUILDING SETTLEMENT, CASE C

The building sustained extensive damage, the south end of the structure more so than the north end. Cracking appeared on all floors levels in both walls and ceilings and require major repairs. Large continuous cracks appeared in the crowns of the corridor barrel vaults due to horizontal extension on all three floors. Cracks in excess of 1/4 in. (6 mm) appeared and shoring to provide additional support for the barrel vaults was required. Cracking also occurred in the groined vaults and in the walls causing plaster

to spall from the masonry surfaces and rendering the entire side of the building nearest the tunnel unusable. The construction files indicated that problems with dewatering were encountered and many runs occurred in the sandy soil. This resulted in large local ground losses and erratic settlement patterns.

Measurements of the settlement of both the ground surface and the structure appear in Figs. 4.5 and 4.6. Street settlements in excess of 6 in. (152 mm) and building settlements ranging up to 1 in. (25 mm) developed. An angular distortion of 1.1×10^{-3} (1/910), was calculated for the north end of the structure. At the south end of the structure, where most of the damage was observed, angular distortions of 3.6×10^{-3} (1/280) and 7.2×10^{-3} (1/140) were calculated from building settlement data. The settlement points used in the angular distortion calculations were located at 10-ft (3-m)-intervals. In addition to building damage related to angular distortion, the structure appeared to have suffered distress from horizontal extension. The inflection point of the settlement profile, where horizontal extension strains are at a maximum, occurred just inside the front wall of the structure.
