WHEELCHAIR SECUREMENT
on
BUS AND PARATRANSIT VEHICLES

Interim Report No. 1

April 1981

Carl F. Stewart
Herbert G. Reinl

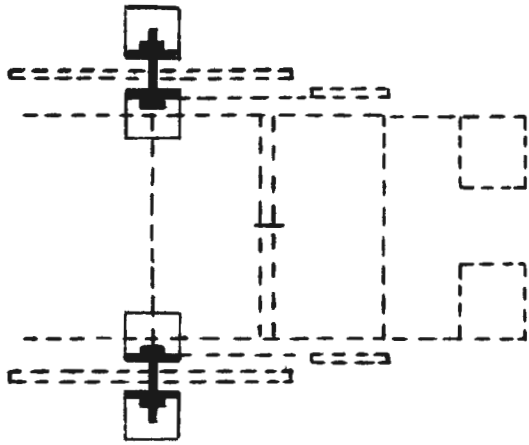
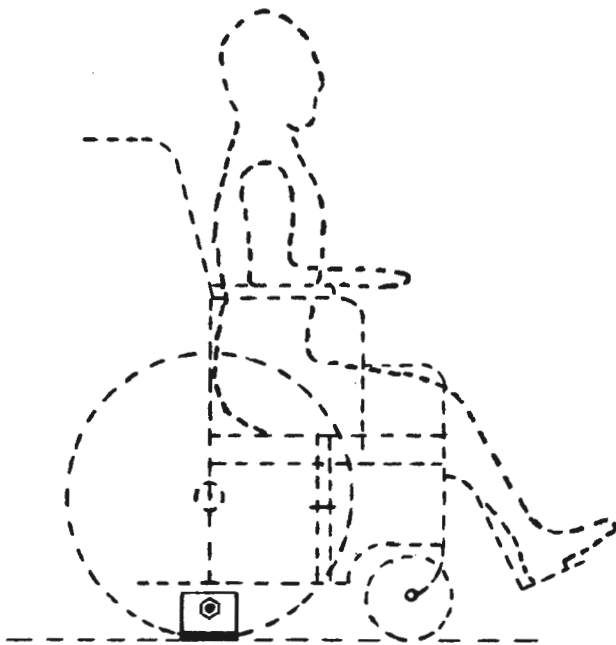
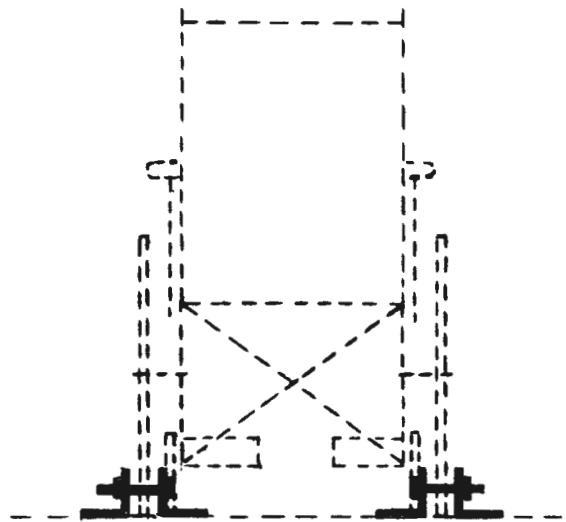
FLOOR RIM PIN

Floor rim pin/forward facing. Two tests were conducted in the forward facing mode, both at approximately 19 mph and 12 g's. In both tests the chair sustained moderate damage. In the first test the dummy was secured to the chair with a belt about its midsection and around the back of the chair. Upon impact the belt rode up the back of the chair to the handgrips, breaking the left back post tube just above the axle mount, and bending both tubes forward and inwards. The dummy came close to becoming free of the chair. The position of the dummy's waistband--high on the stomach area--caused the dummy to remain in a sitting position, and to experience pressures on the soft stomach area as opposed to pressures on the more preferable hip area.

In the other test, the regular lap belt method of anchoring to the axles was used. The primary damage to this chair was badly bent wheels.

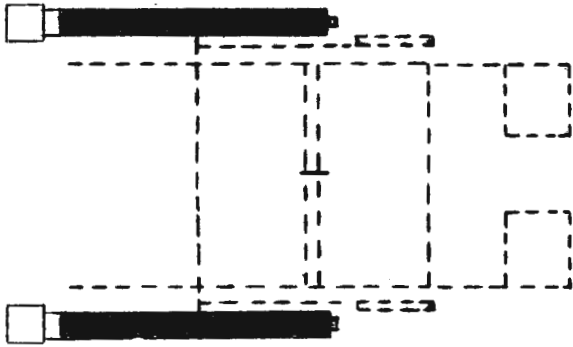
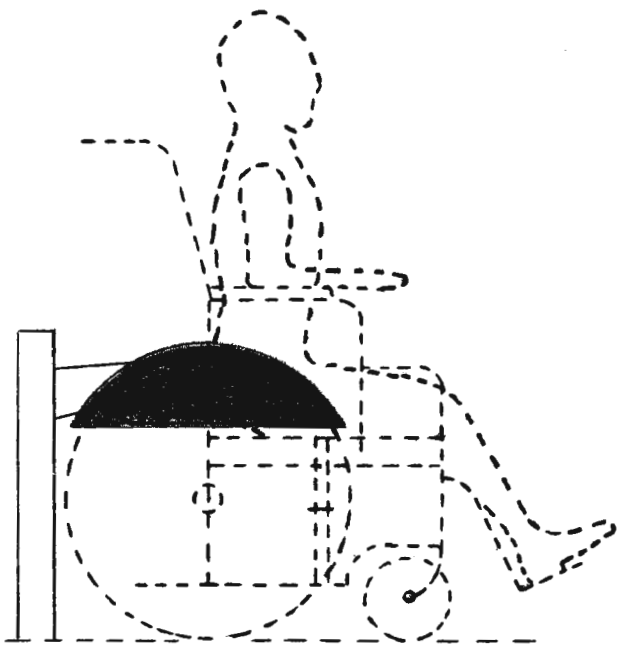
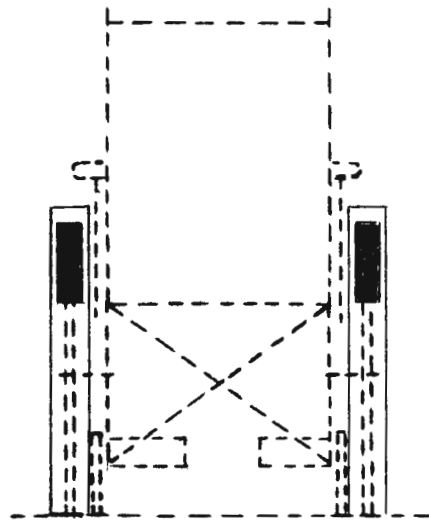
FENDER

During the forward facing test, damage to the wheelchair was moderate and no unusual loads were imposed upon the dummy.

In the side facing test, the support bracket for the fender system provided some support for the chair, with a result of minor chair damage. This helps to support the assumption that less chair damage will

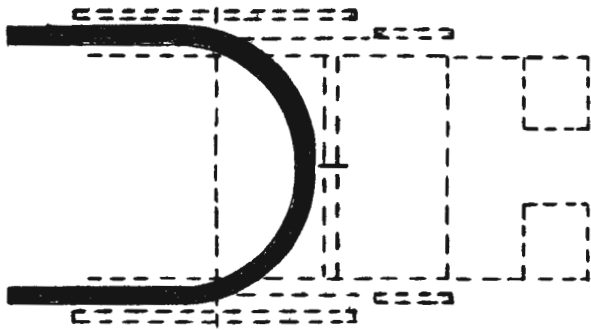
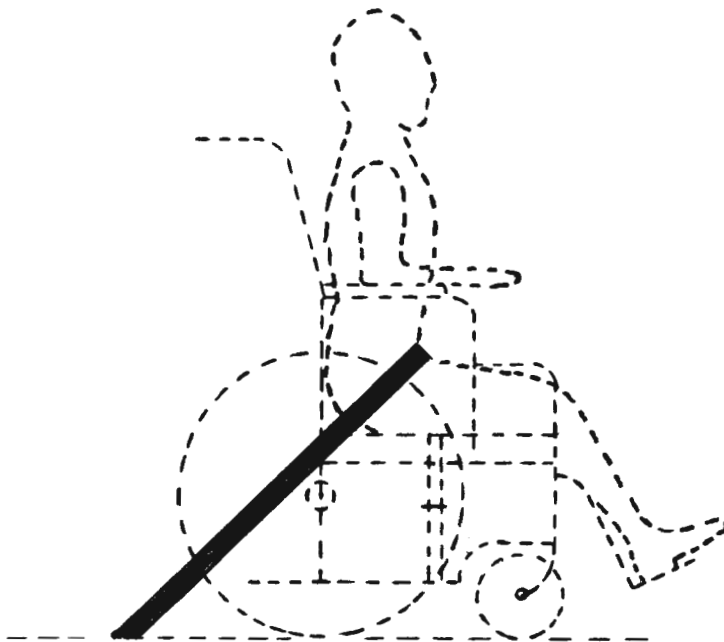
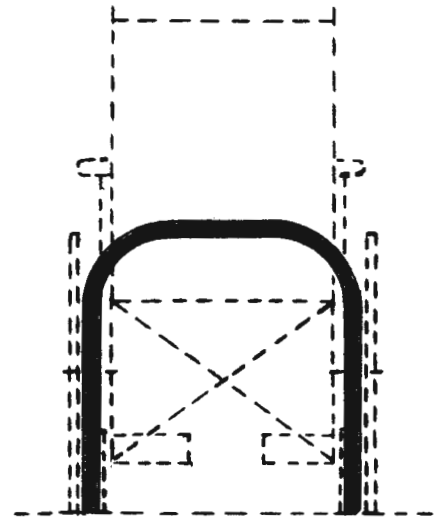
USER AND CHAIR BELT

User and chair belt/side facing. Two tests were conducted with the dummy and wheelchair facing sideways with respect to the direction of travel. The sled velocity in both tests was approximately 11 mph. The deceleration rate was 10 g's in the first test and 12 in the second.

In the first test there was no wall on the sled to simulate the side of a vehicle. This allowed the wheelchair to rotate about the belt anchorage points, causing the chair to tip onto its side and contact the nearby wall of the test building. In practice, the wheelchair is usually placed with the rear wheels against the vehicle sidewall when this system is used in the side facing position. Therefore, in the second test a wall was installed on the sled and the rotation of the wheelchair during impact was reduced to about 20°. Damage to the wheelchair in the second test was minor and the dummy experienced no unusual deceleration.

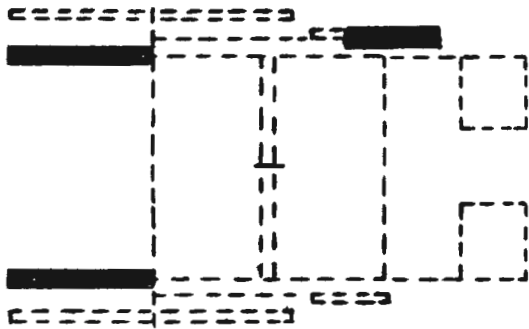
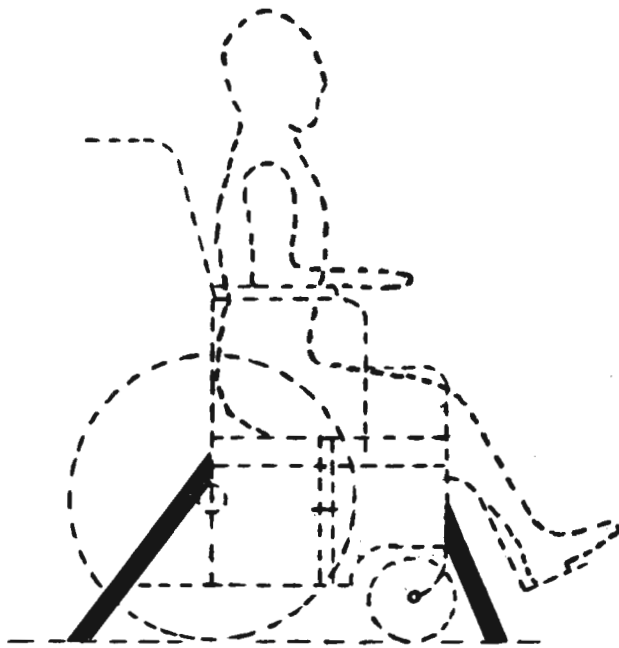
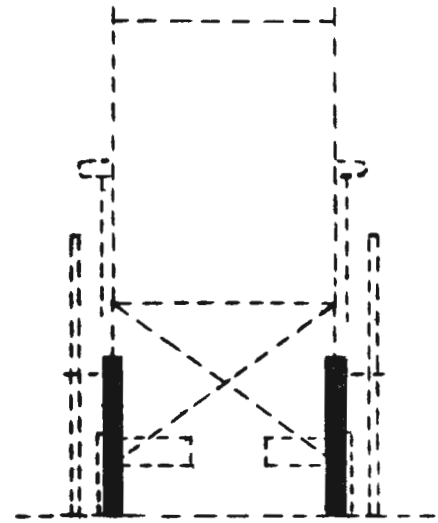
Figure 29

A three-point belt securement system is one that uses automotive-type seat belt equipment to secure the wheelchair to the floor (Figure 29). Two of the three belts are attached to the frame of the chair near the large wheel axles, one on each side. The third belt is attached to the frame near one of the front casters. The anchorages of the axle and caster belts are positioned to create opposing forces to minimize longitudinal movement and prevent overturning of the chair.

In the forward facing test, the chair sustained minor damage and the dummy experienced no high loads. In the side facing test, the chair sustained major damage, the dummy's head struck the armrest of the simulated obstruction, and the dummy experienced a blow giving a HIC measurement indicating a fatal injury.

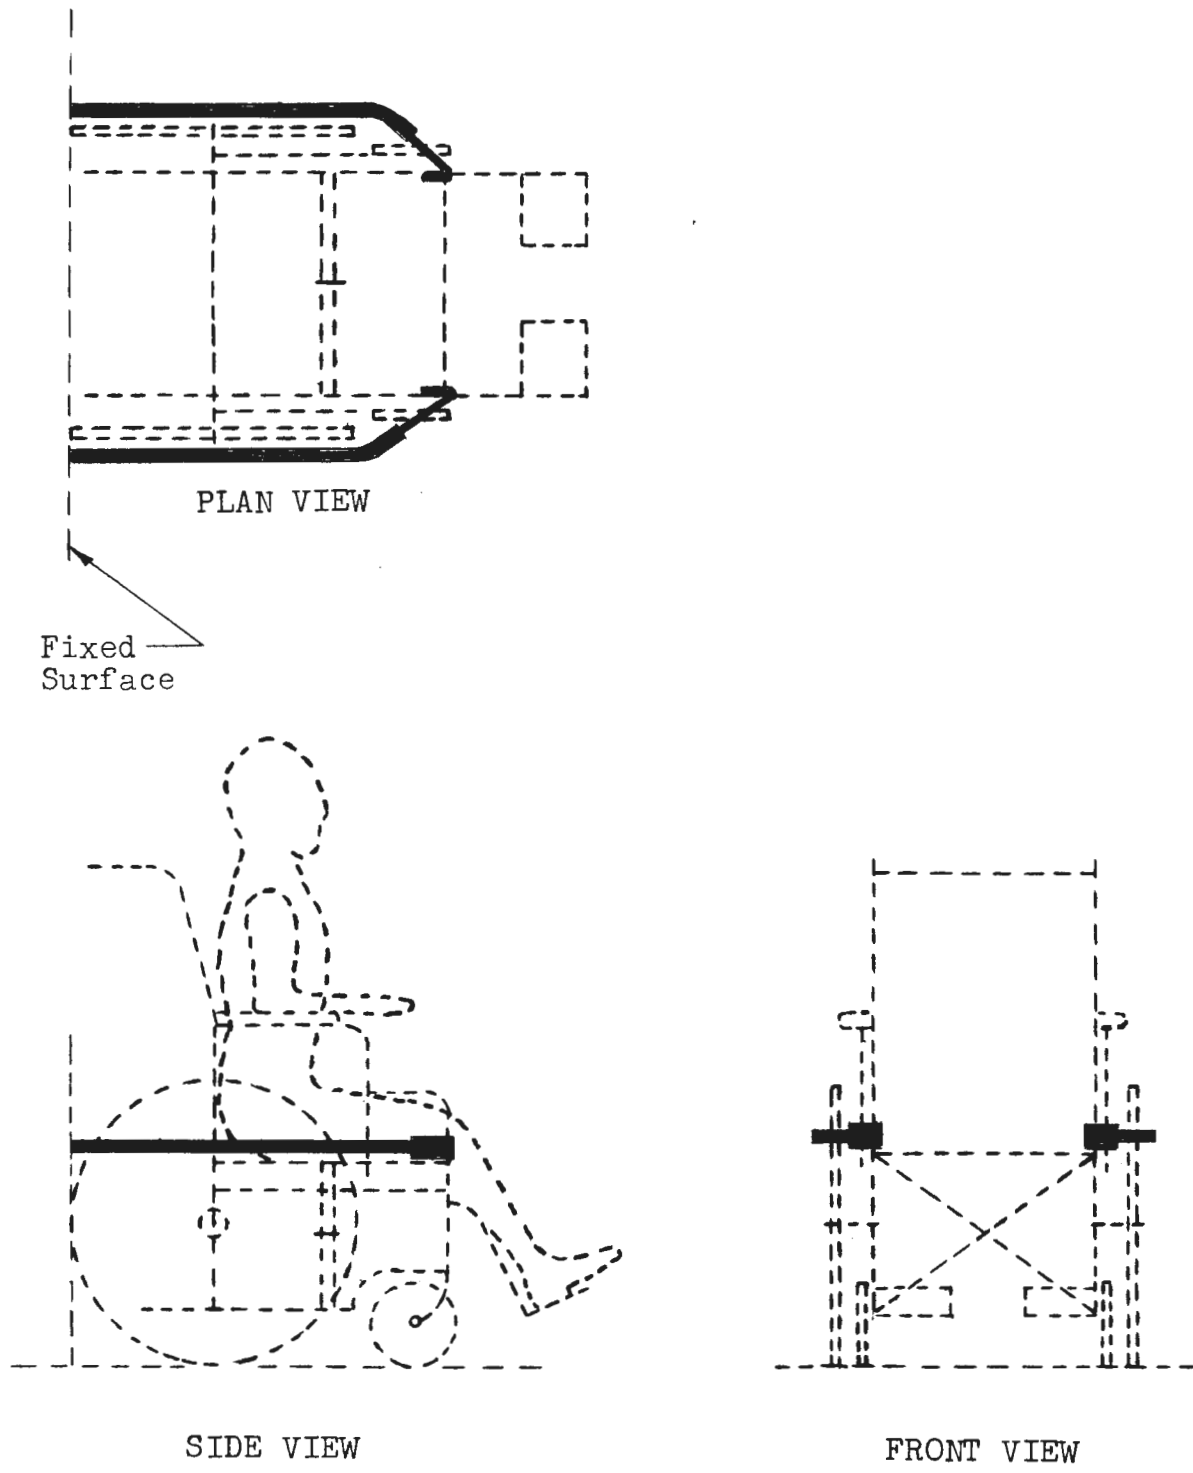
Figure.30

A horizontal bar securement system consists of an adjustable bar along each side of the wheelchair at its seat height. One end of the bar is attached to the vehicle at the rear of the chair and the other end has a hook that "grasps" a front vertical frame member of the chair. A tension method is provided to draw the chair's rear wheels against a fixture behind the chair (Figure 30).

The results of both tests are invalid because the securement system failed in both cases. During the forward facing test, the right-hand hook straightened out, thereby releasing the chair. During the side facing test the horizontal bars slid forward in their anchorage track far enough to allow a back-up tether to become taut and prevent further movement of the chair. Without the tether the bars would have slid free of their anchorage.

The securement system was modified to minimize the possibility of such failures and the tests were rerun. The results are reported next under "Modified Horizontal Bars."

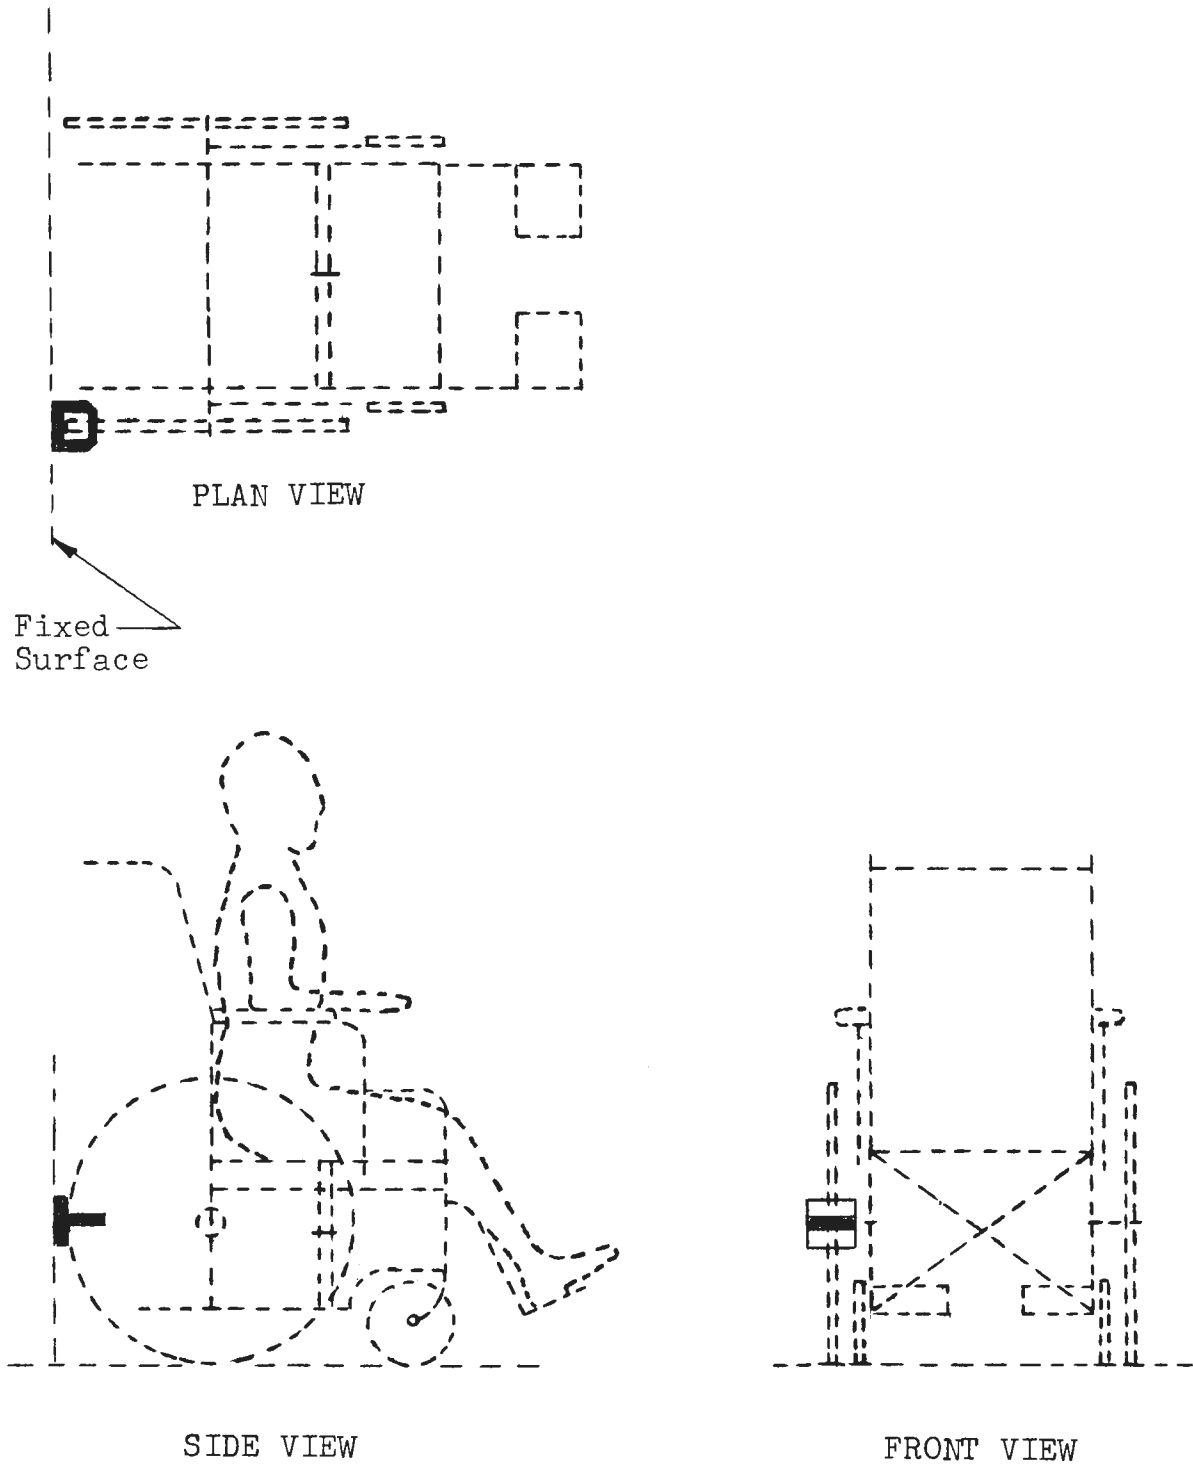
Figure 31

A single rim latch securement system is a device that grasps one of the large diameter wheels at about 13 inches above the floor level. The system tested was mounted on the bottom of a fold-down-seat (Figure 31).

In both tests the forward pull on the latch caused the bus seat to fold downward, forcing the securement to unlatch and release the wheelchair.

seat belt was attached to the axles of the chair).
The manually propelled wheelchair sustained major
damage to the secured wheel, resulting in a virtually
unsecured chair. The dummy's left shoulder and both
knees struck the simulated obstruction.

The latching device was modified to ensure that the latch could not open upon impact. One test was conducted at approximately the same velocity and deceleration as in the above two tests (the dummy's

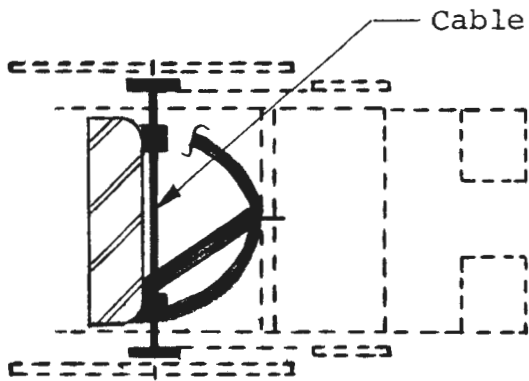
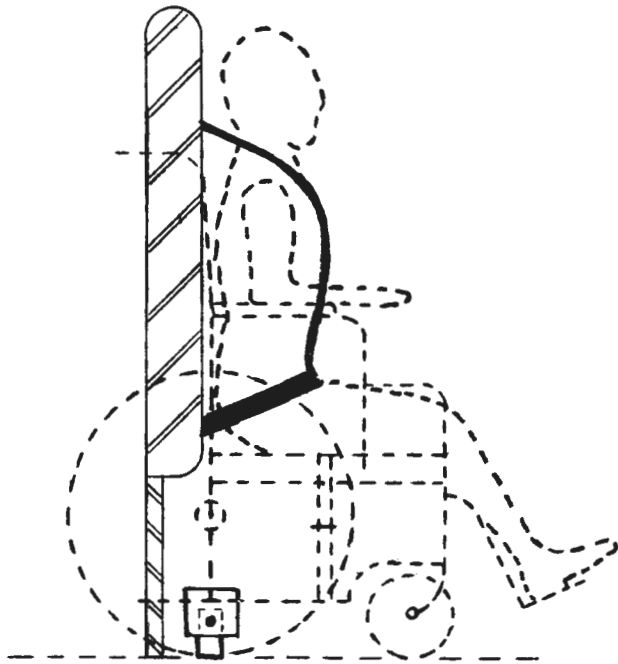
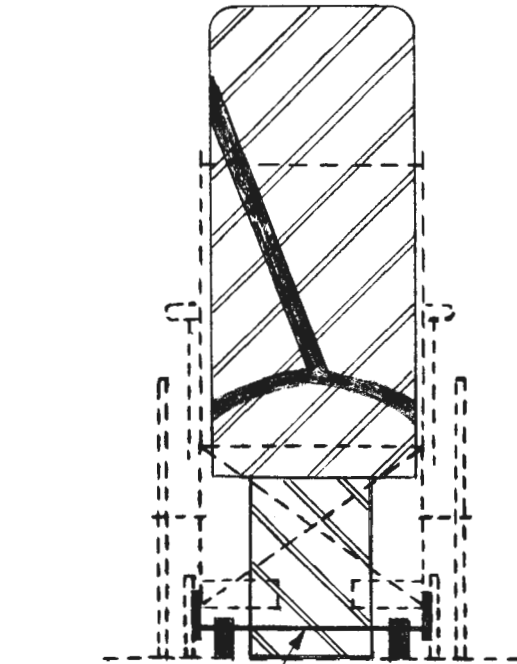
WAYNE STATE

In the rearward facing test, the wheelchair and dummy were restrained by the securement, but the dummy's head registered accelerations, producing a HIC of 144, which is low in the minor head injury range. The chair was undamaged.

In the forward facing test, the cable broke and securement for both the chair and dummy was transferred to the dummy's lap and upper torso harness. The wheelchair was undamaged except for a slight bending of the seat back frame.

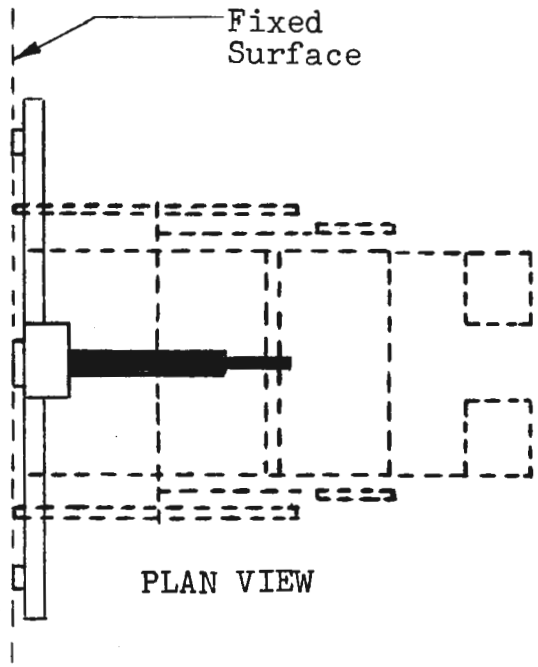
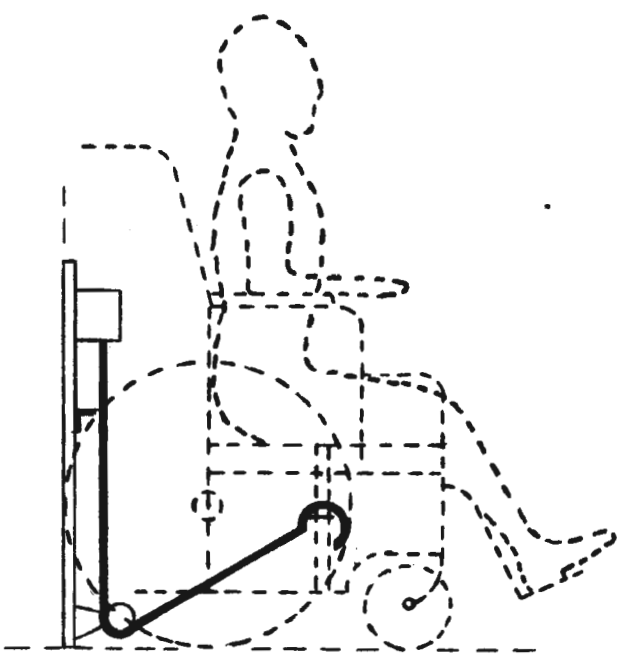
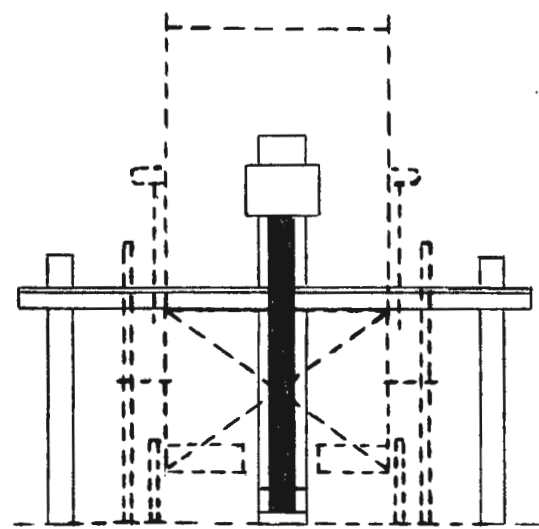
Figure 33

The cross brace belt securement system consists of a web belt that attaches to the wheelchair's cross brace. The belt is threaded through a roller that is mounted at the vehicle's side wall to floor intersection. From there the belt continues to a side wall mounted ratchet system that applies tension to the belt (Figure 33).

Upon impact, the chair and dummy slid in a downrange arc about the wall anchor point. The chair tilted approximately 45 degrees in the direction of travel allowing the dummy to strike the simulated obstruction in the area of its elbow. The wheelchair sustained major damage.

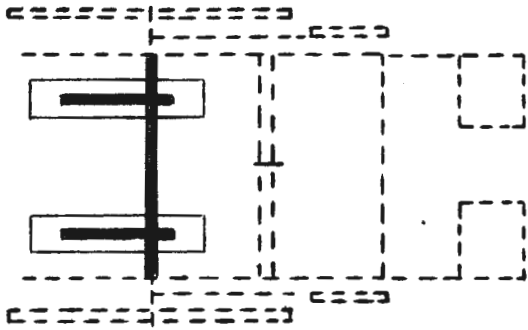
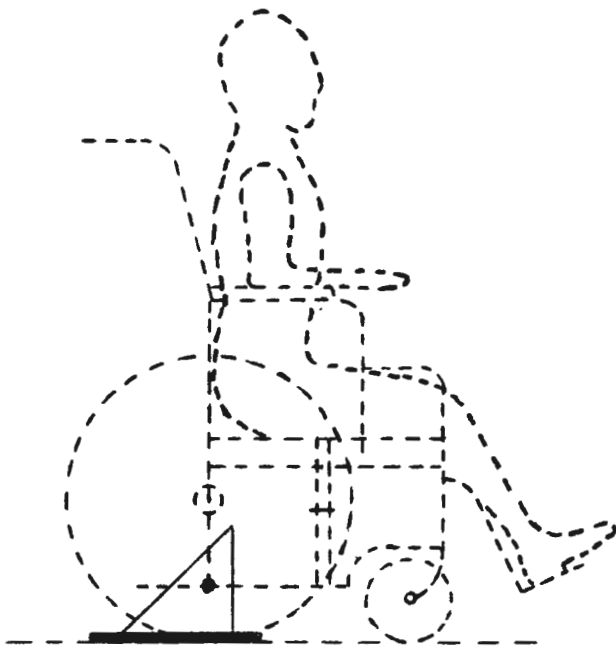
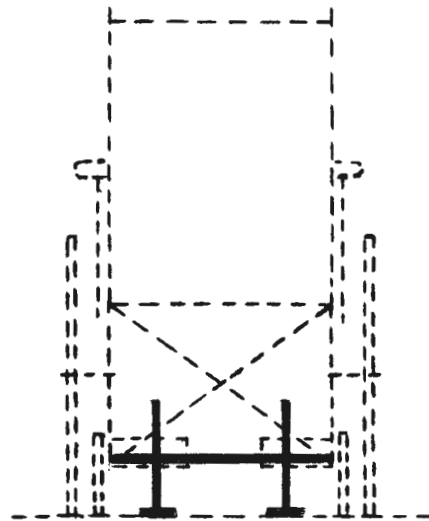
FRAME CABLE

Shortly after impact the cable failed (presumably in shear), allowing the dummy and wheelchair to continue forward without restraint.

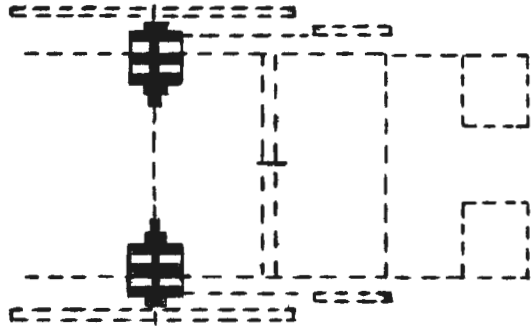
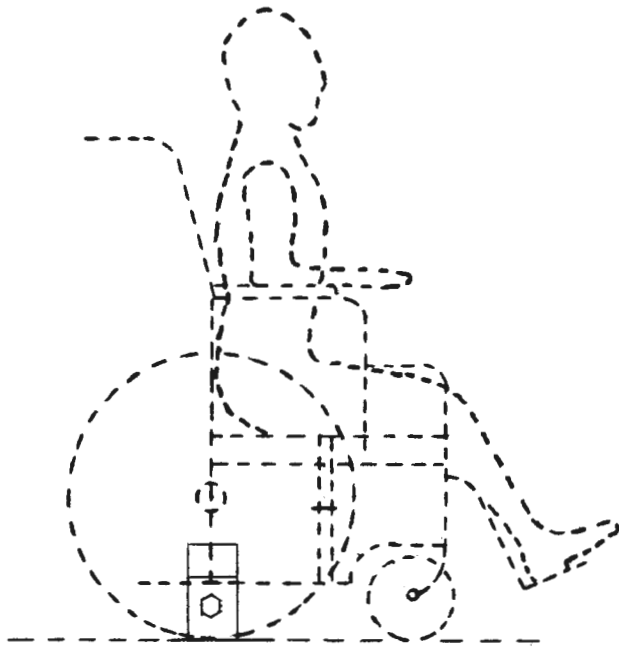
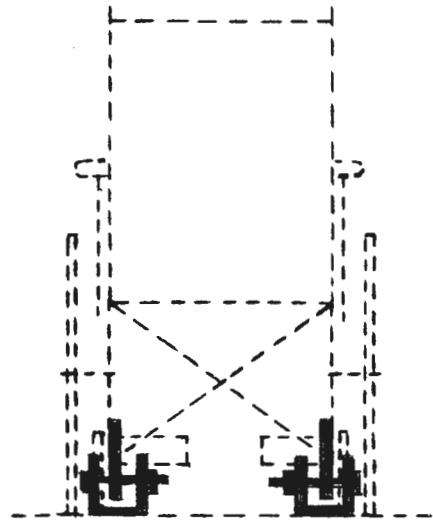
FRAME ANCHOR

During the test, the dummy's hands and feet struck the simulated obstruction. Its head did not contact the obstruction but did strike its right leg. The measured head accelerations indicated it could have sustained a minor injury. The wheelchair sustained minor bending of the frame.

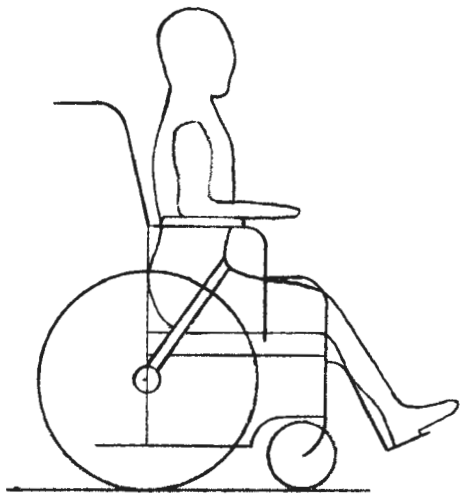
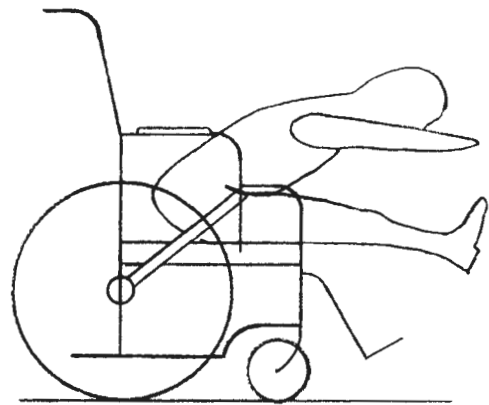
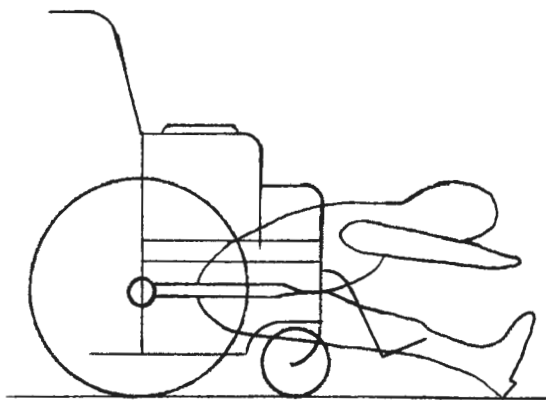
After Impact Excursion
Without Seat Failure

After Impact Excursion
With Total Seat Failure

Hence, improvement in the reinforcement to prevent edge tear-out of the seat would greatly improve the chairs' performance with respect to protection for the occupant by minimizing his excursion; consequently, this improvement is suggested.

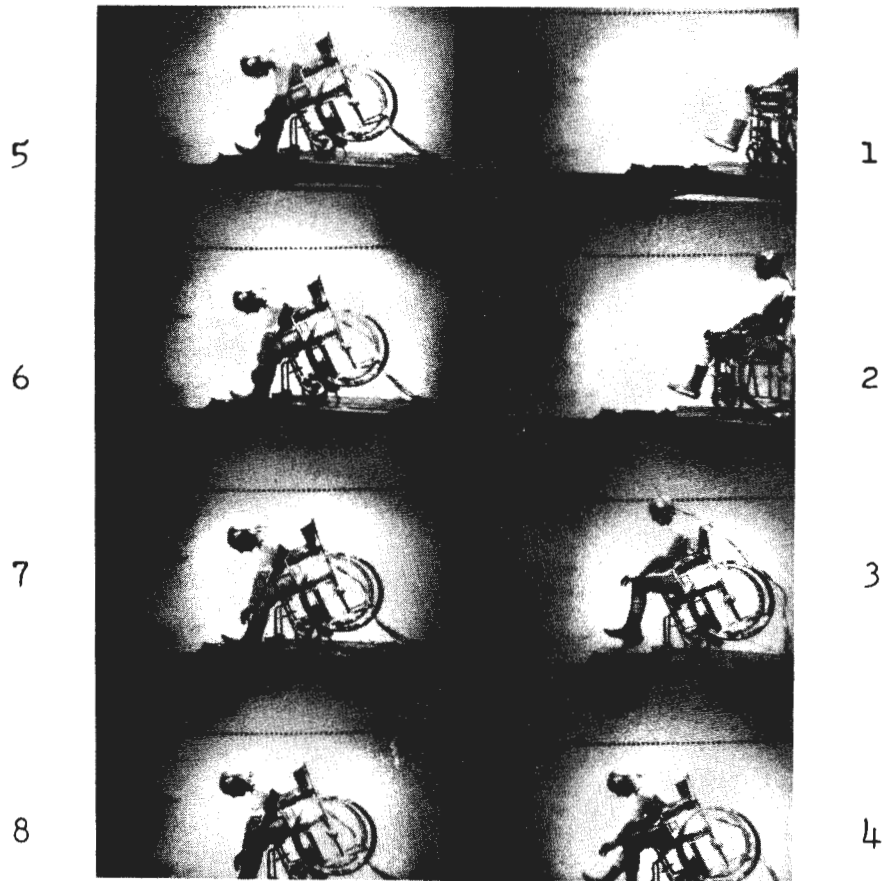
Figure A-3

The T-bar immediately slid off the caster arch and engaged the bottom rail just forward of the cross brace. The chair then tipped forward placing load on the rigid type footrests. While this was happening, the dummy slipped forward in the seat placing load on the waist belt. The load in the waist belt was taken by the backposts of the chair causing the chair to rotate forward off of the back wheels and onto the footrests. The waist belt load caused the backposts to deflect inward and forward a small amount. Both feet of the dummy came off the footrests, but the dummy did not go into a jackknife position (Figure A-3).

Test 1040--Sequence

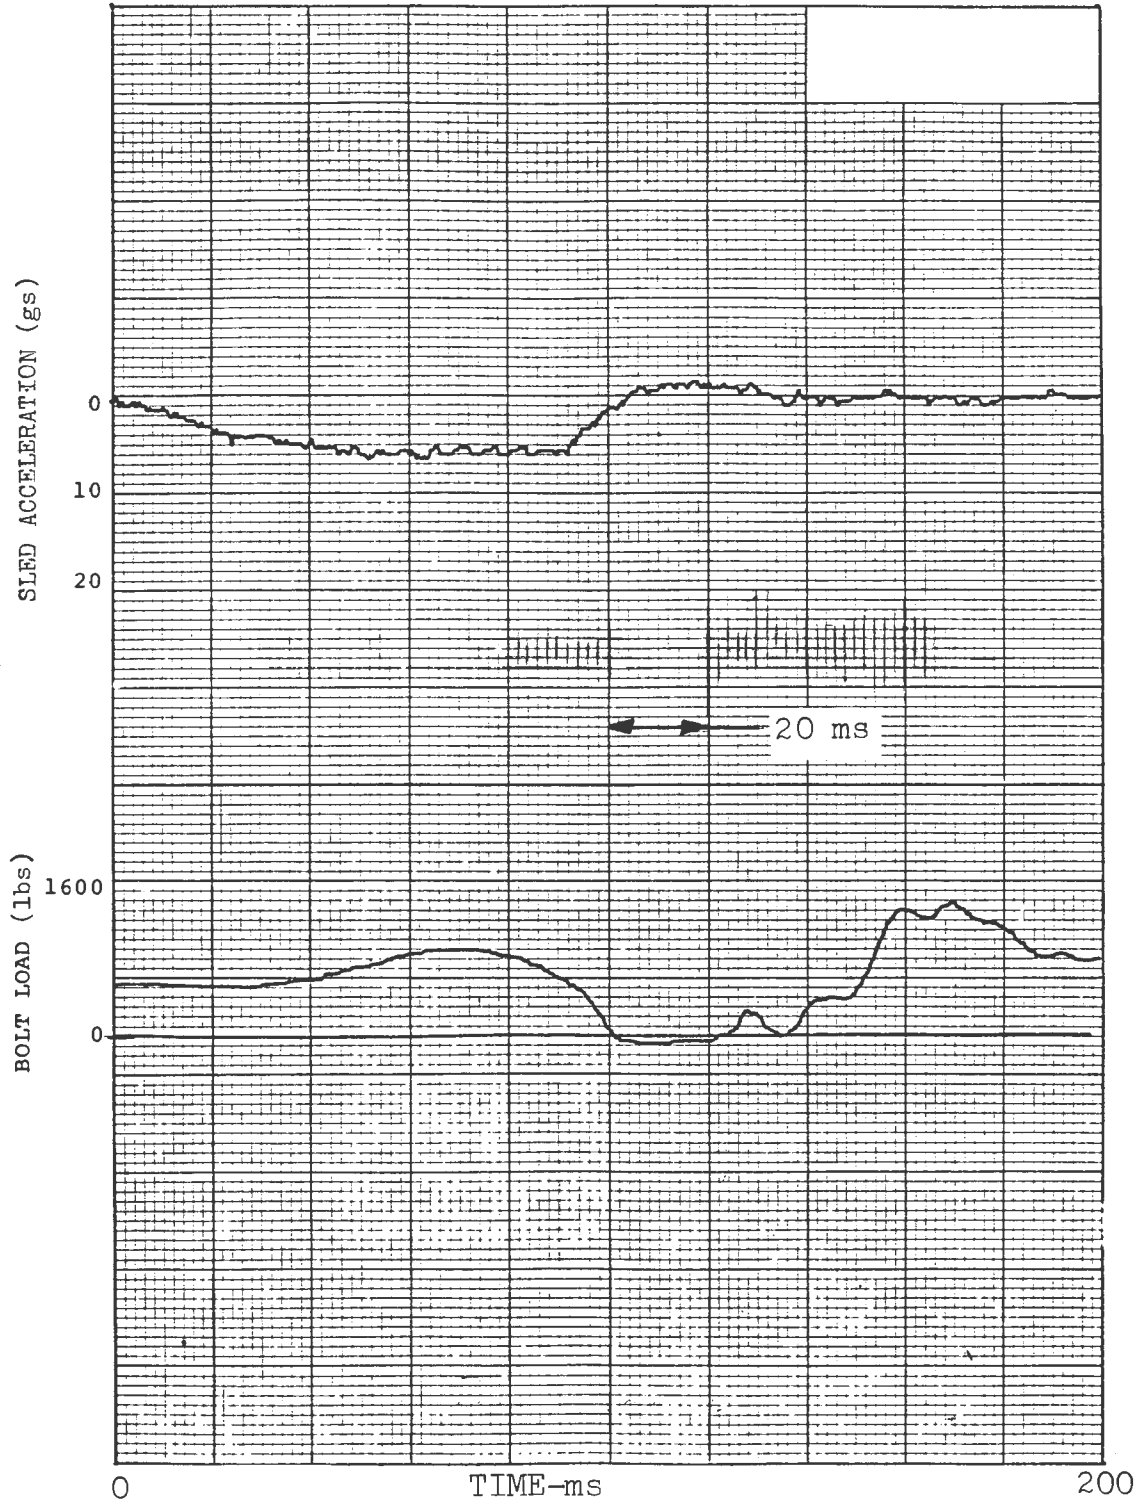
Test 1040

WHEELCHAIR: There was minor bending of the front casters, footrests and backposts. Maximum tension in the T-bar anchor bolt was recorded as 1300 lbs. (Figure A-4).

Bolt Load and Sled Acceleration

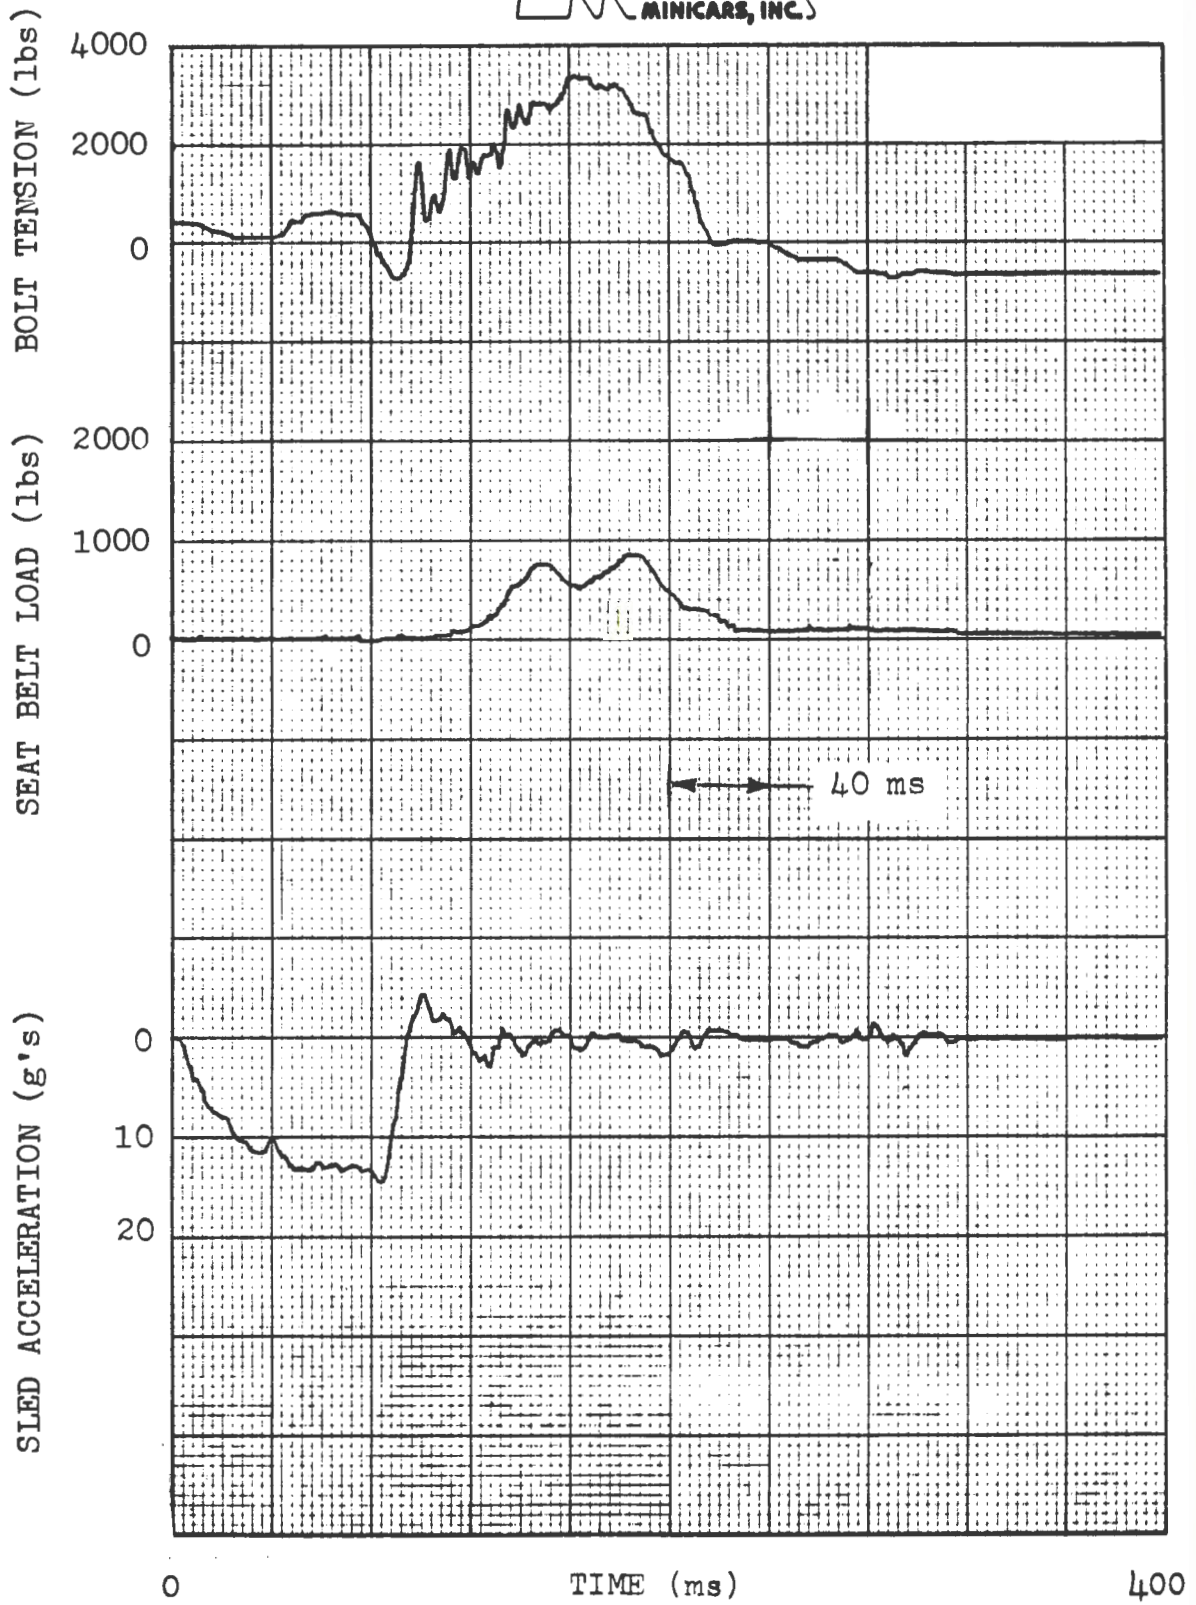
Figure A-6

WHEELCHAIR: The crash pulse, belt load, and T-bar tension bolt load histories are shown in Figure A-6. Minor damage to the front casters and frame were observed.

Sled Acceleration, Seat Belt Load and Belt Tension

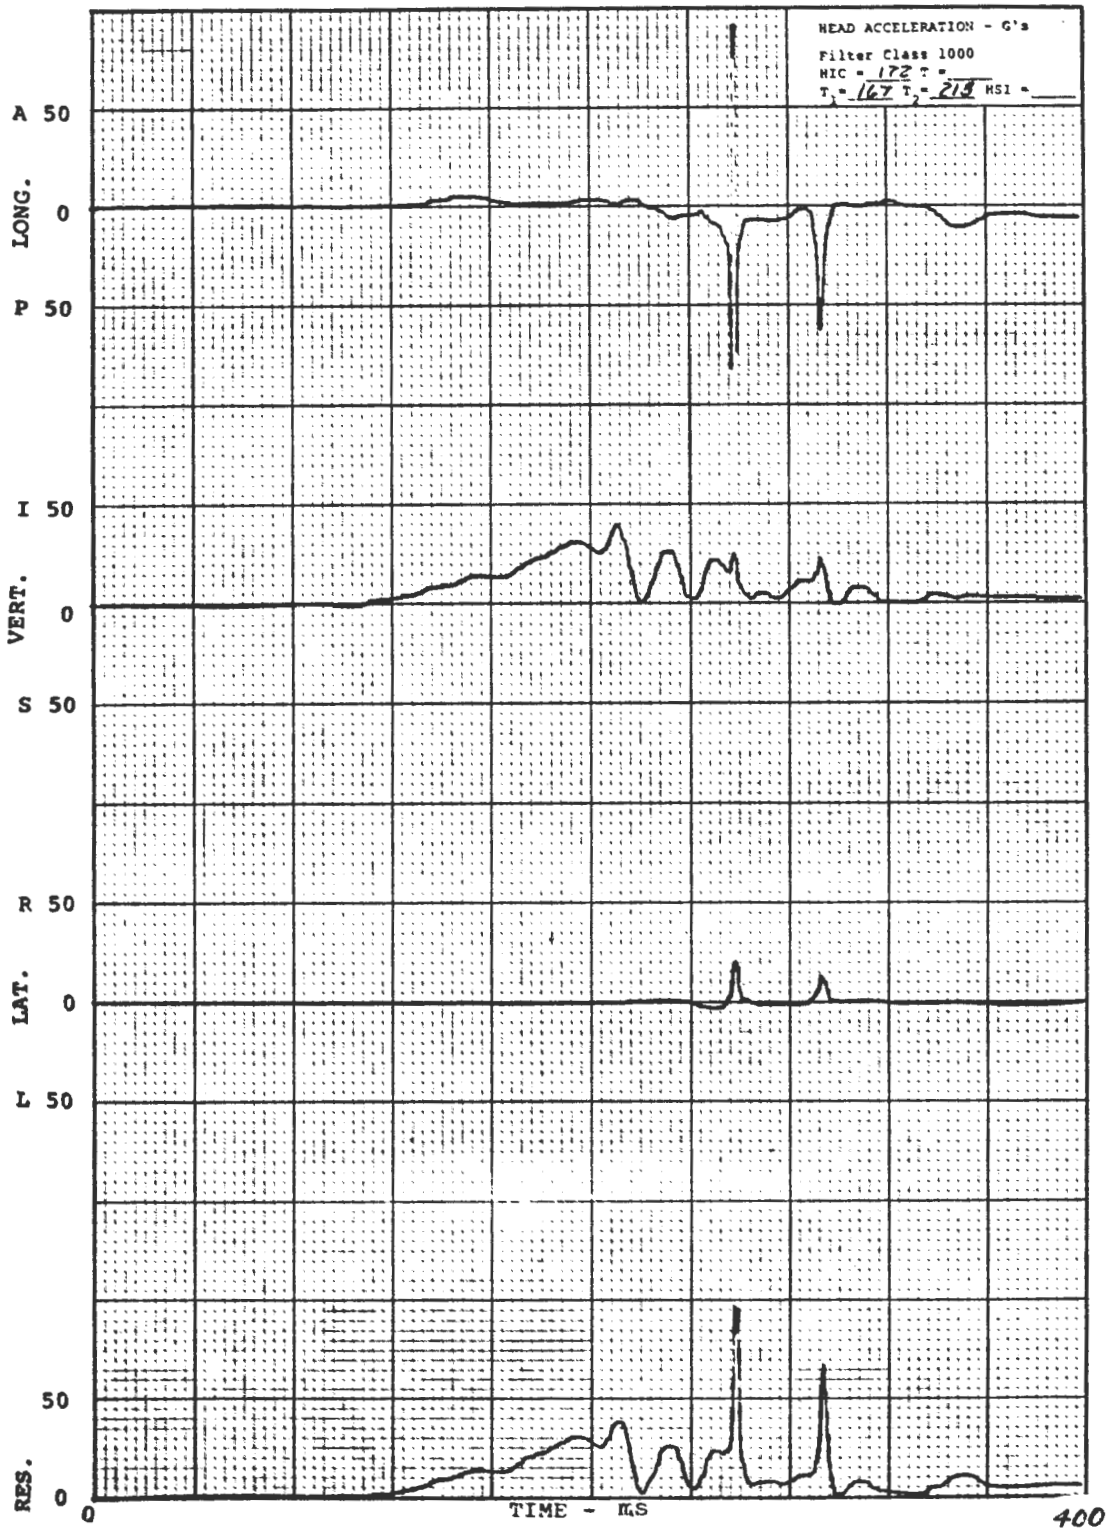
Figure A-7

DUMMY: The dummy head and chest accelerations are shown in Figures A-7 and A-8. The spikes in the head plots were caused by the dummy's head hitting the legs. The acceleration of the head striking the legs was judged to be minor from an injury standpoint. The head injury criteria (HIC) was calculated as 172, $T = 167$ ms, $T_2 = 218$ ms. Head excursion was 56 inches.

Head Acceleration Graphs

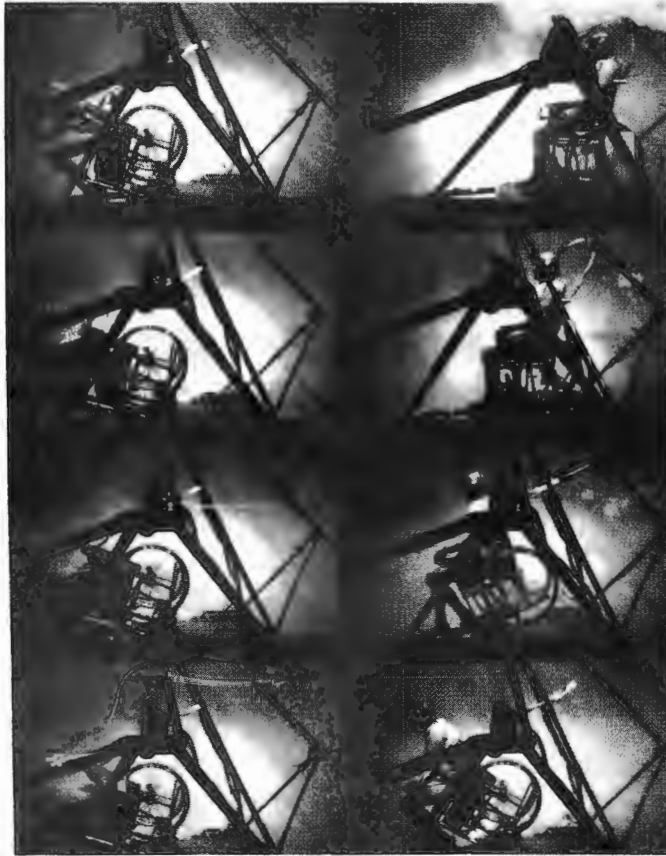
WHEELCHAIR: Chair damage was limited to caster crush back and some down bending of the bottom rail in the left side frame. Maximum load in the T-bar tension bolt was recorded as 2200 lbs.

Test 1095--
Sequence

Test 1095--
Post Test
Conditions

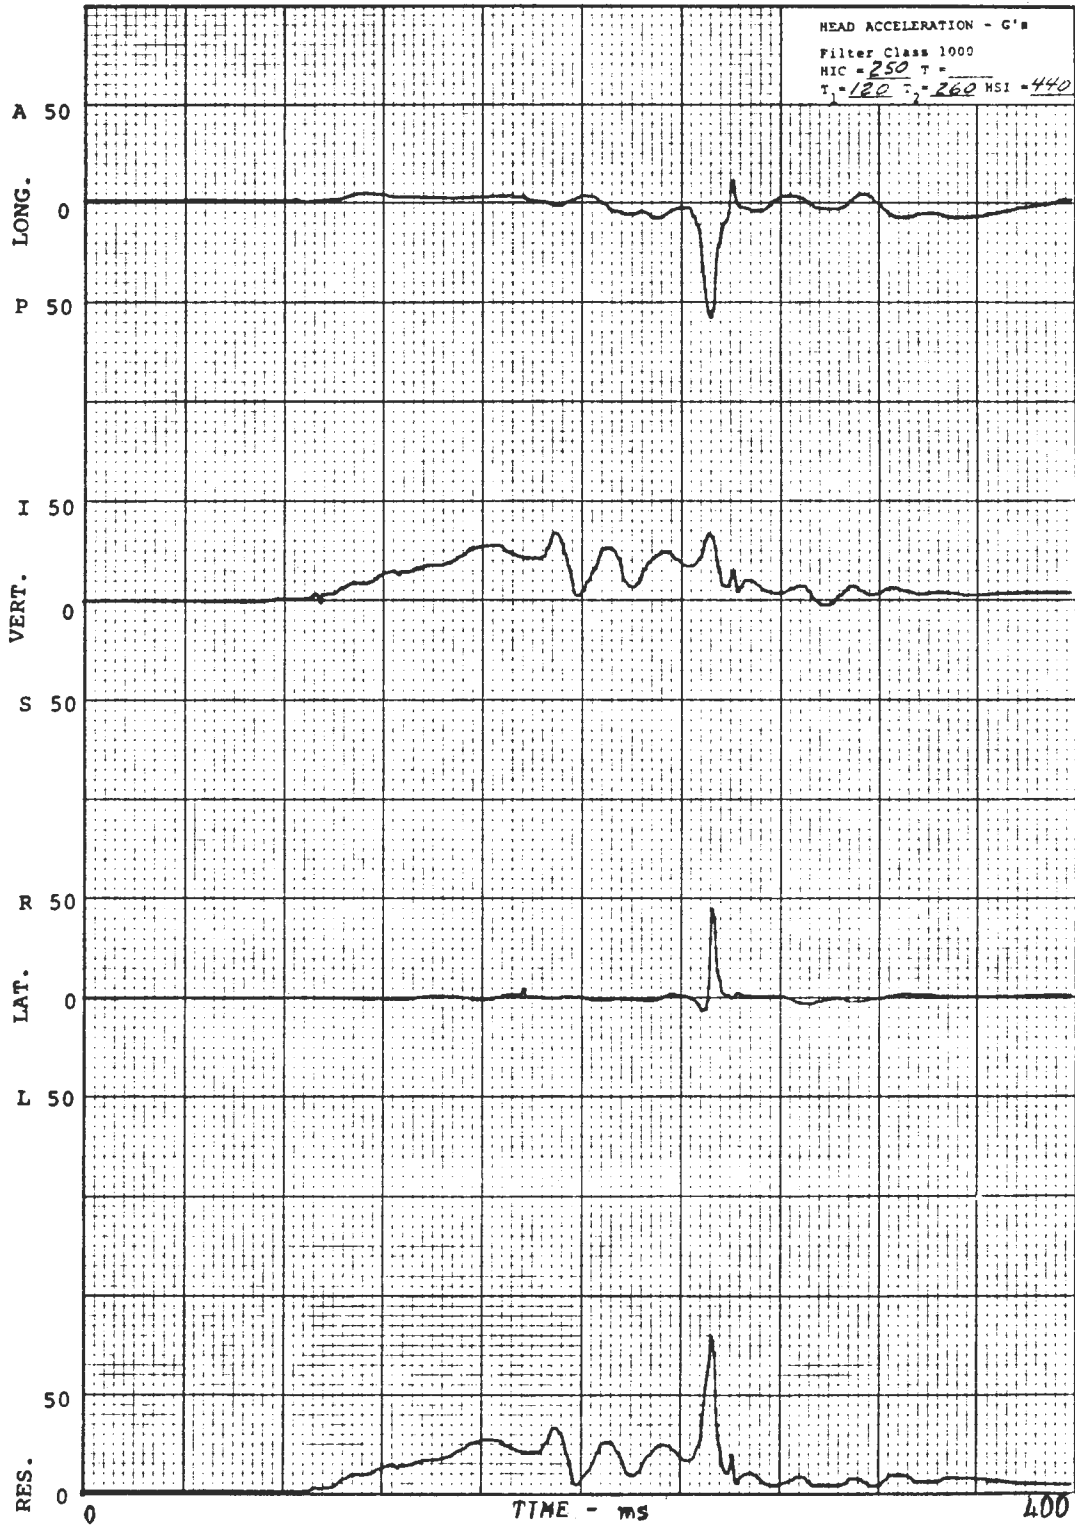
Test 1077

DUMMY: Head acceleration data (Figure A-14) indicated a minor head strike at 250 ms which was probably caused by the head striking the dummy's legs. The maximum head injury criteria (HIC) was calculated as 246 ($T_1 = 120$ ms, $T_2 = 259$ ms). Head excursion was 41 inches.

Head Acceleration Graphs

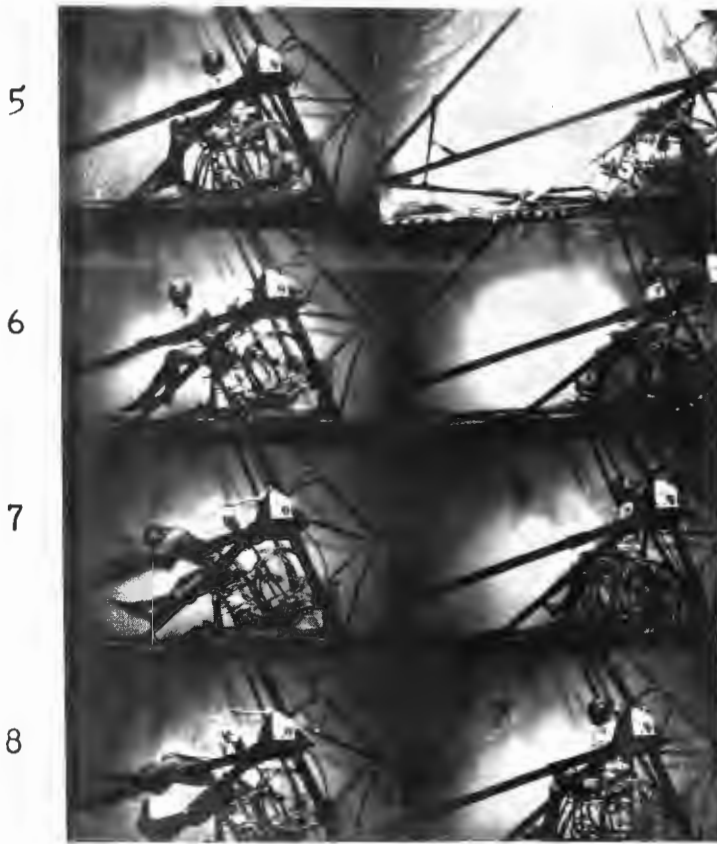
Test 1101--Sequence
