WHEELCHAIR SECUREMENT
on
BUS AND PARATRANSIT VEHICLES

Interim Report No. 1

April 1981

Carl F. Stewart
Herbert G. Reinl

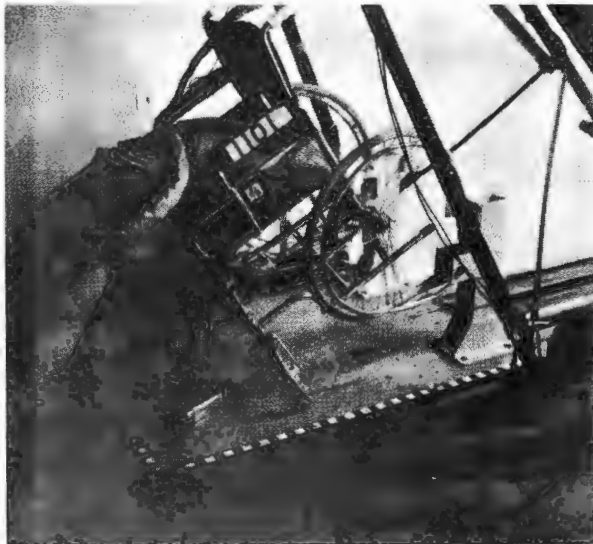
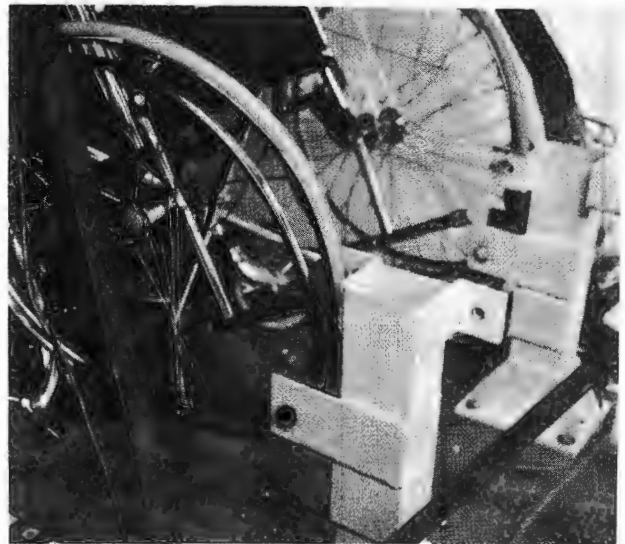
Test 1101

WHEELCHAIR: Both rear wheels suffered severe damage. Their rims were badly deformed with 9 broken spokes in the left wheel and 4 broken in the right (Figure A-23).

Post Test Conditions

Wheel Damage

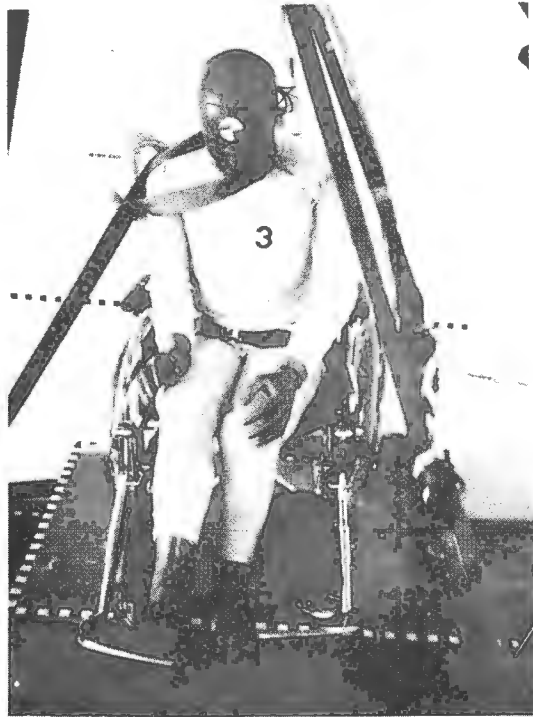
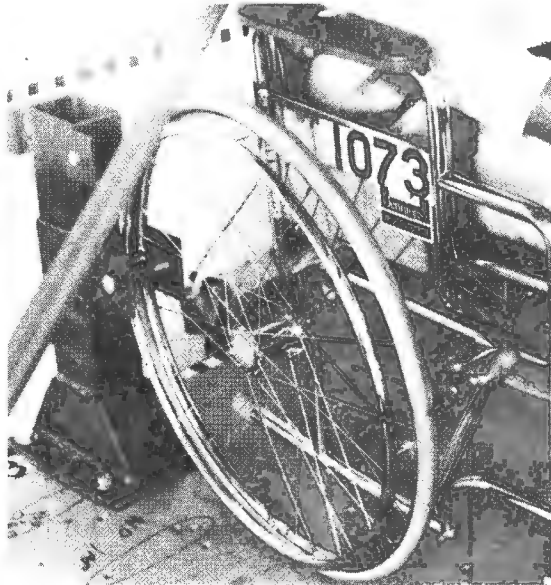
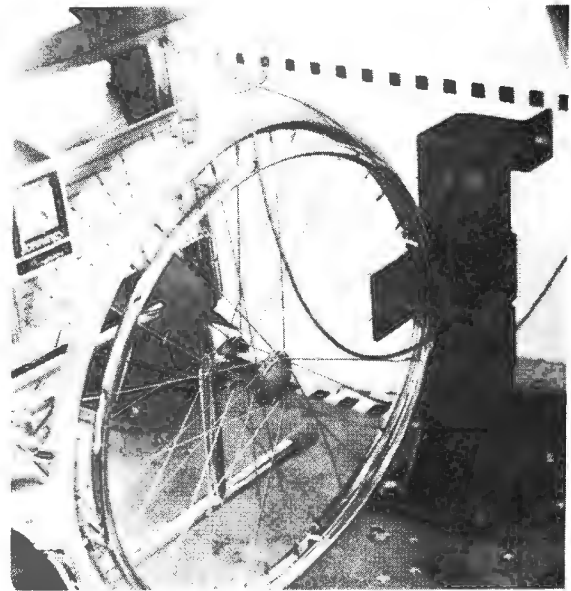
Test 1073--Post Test Conditions

WHEELCHAIR: There was no visible damage to the chair frame, armrests and leading wheel. The left (trailing) wheel suffered one broken spoke and the cross brace had suffered some distortion (Figure A-24). There was minor damage to the leading (right) caster.

Frontal
View

Left Wheel

Right Wheel

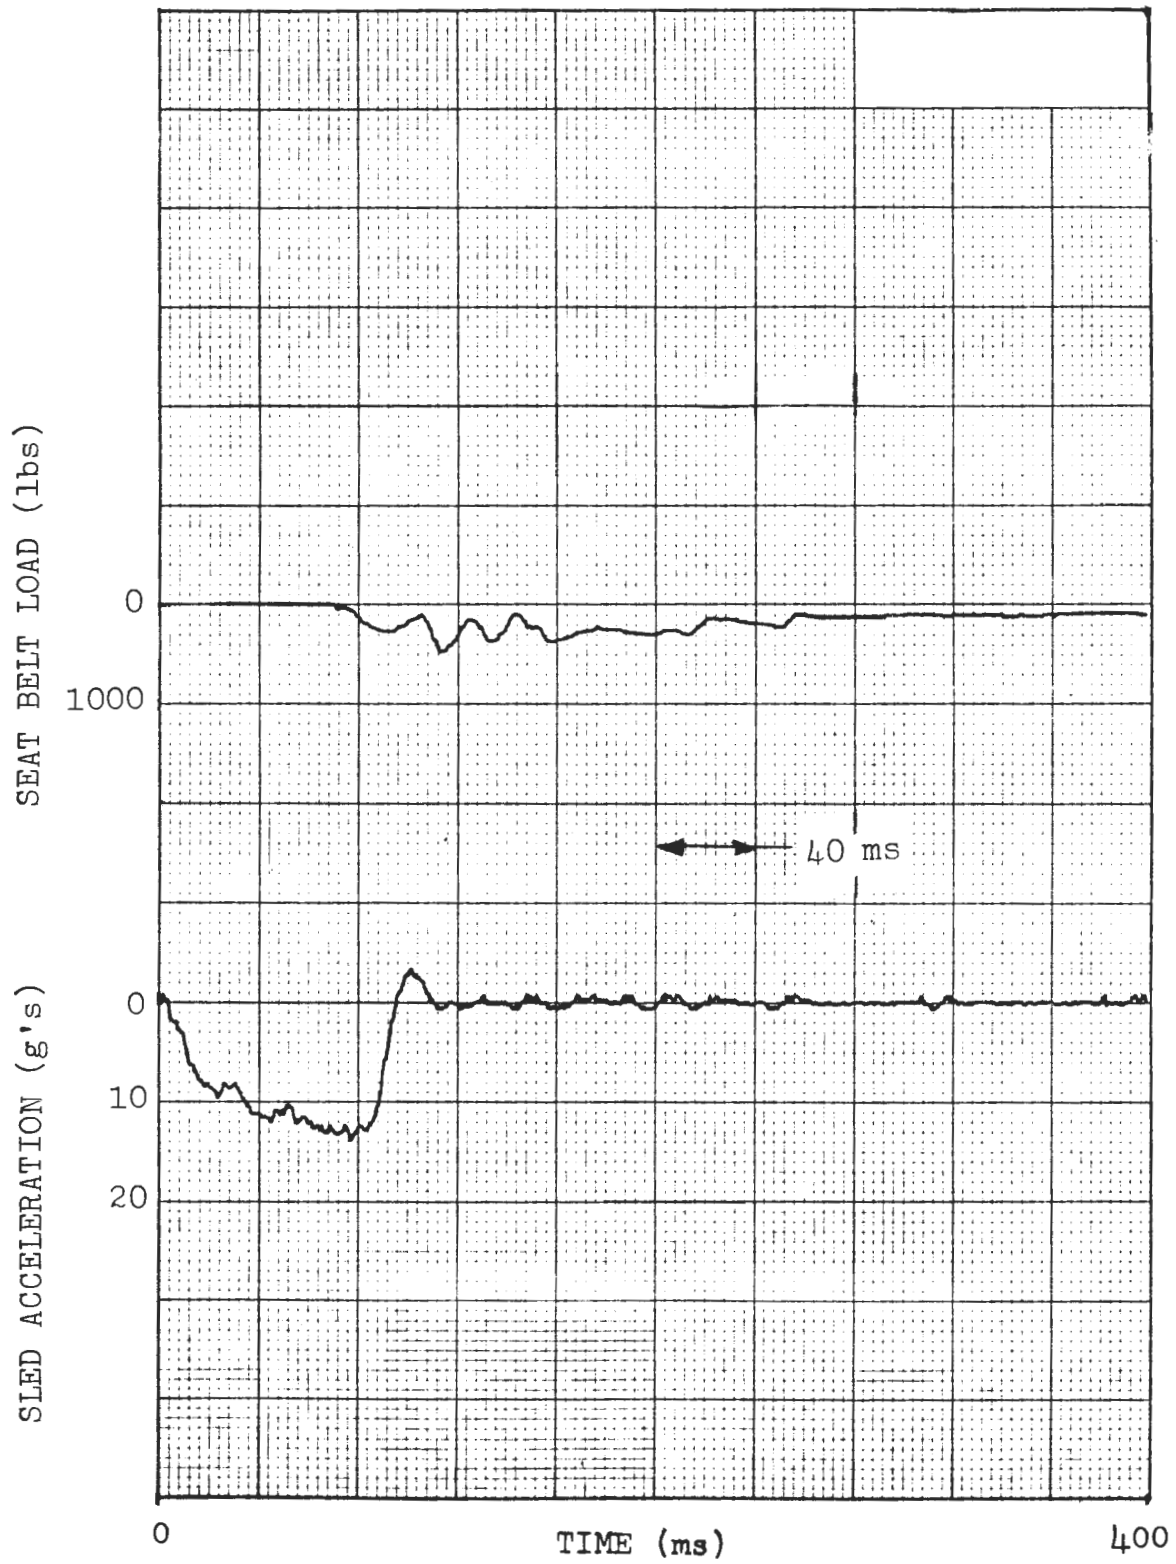
Test 1054

DUMMY: Belt force on the abdominal area of the dummy (Figure A-28) was 900 lbs (twice belt load). Forward excursion of the head was 53 inches. Securement of the dummy was judged inadequate due to the imminent loss of the waist belt attachment to the chair.

Sled Acceleration and Seat Belt Load

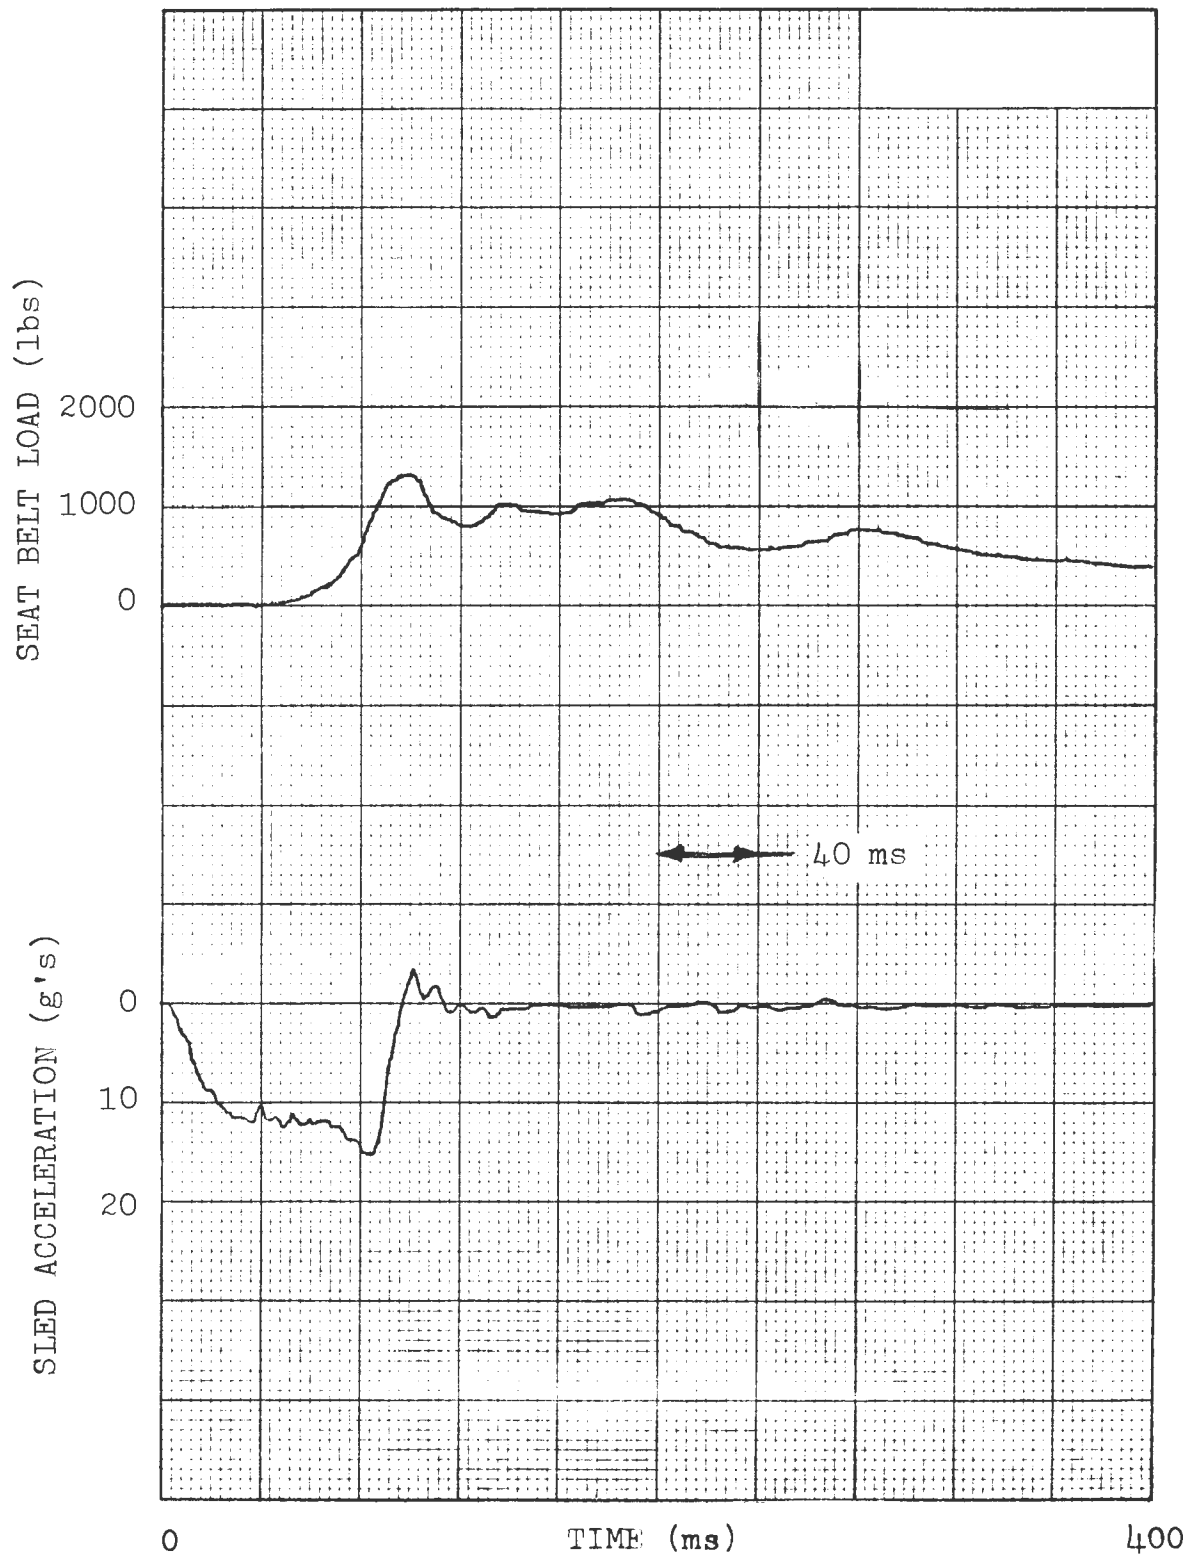
Figure A-30

WHEELCHAIR: Each rear wheel suffered three broken spokes and major distortion of their rims (Figure A-30). The casters were bent toward the rear about 3/4 inch.

Sled Acceleration and Seat Belt Load

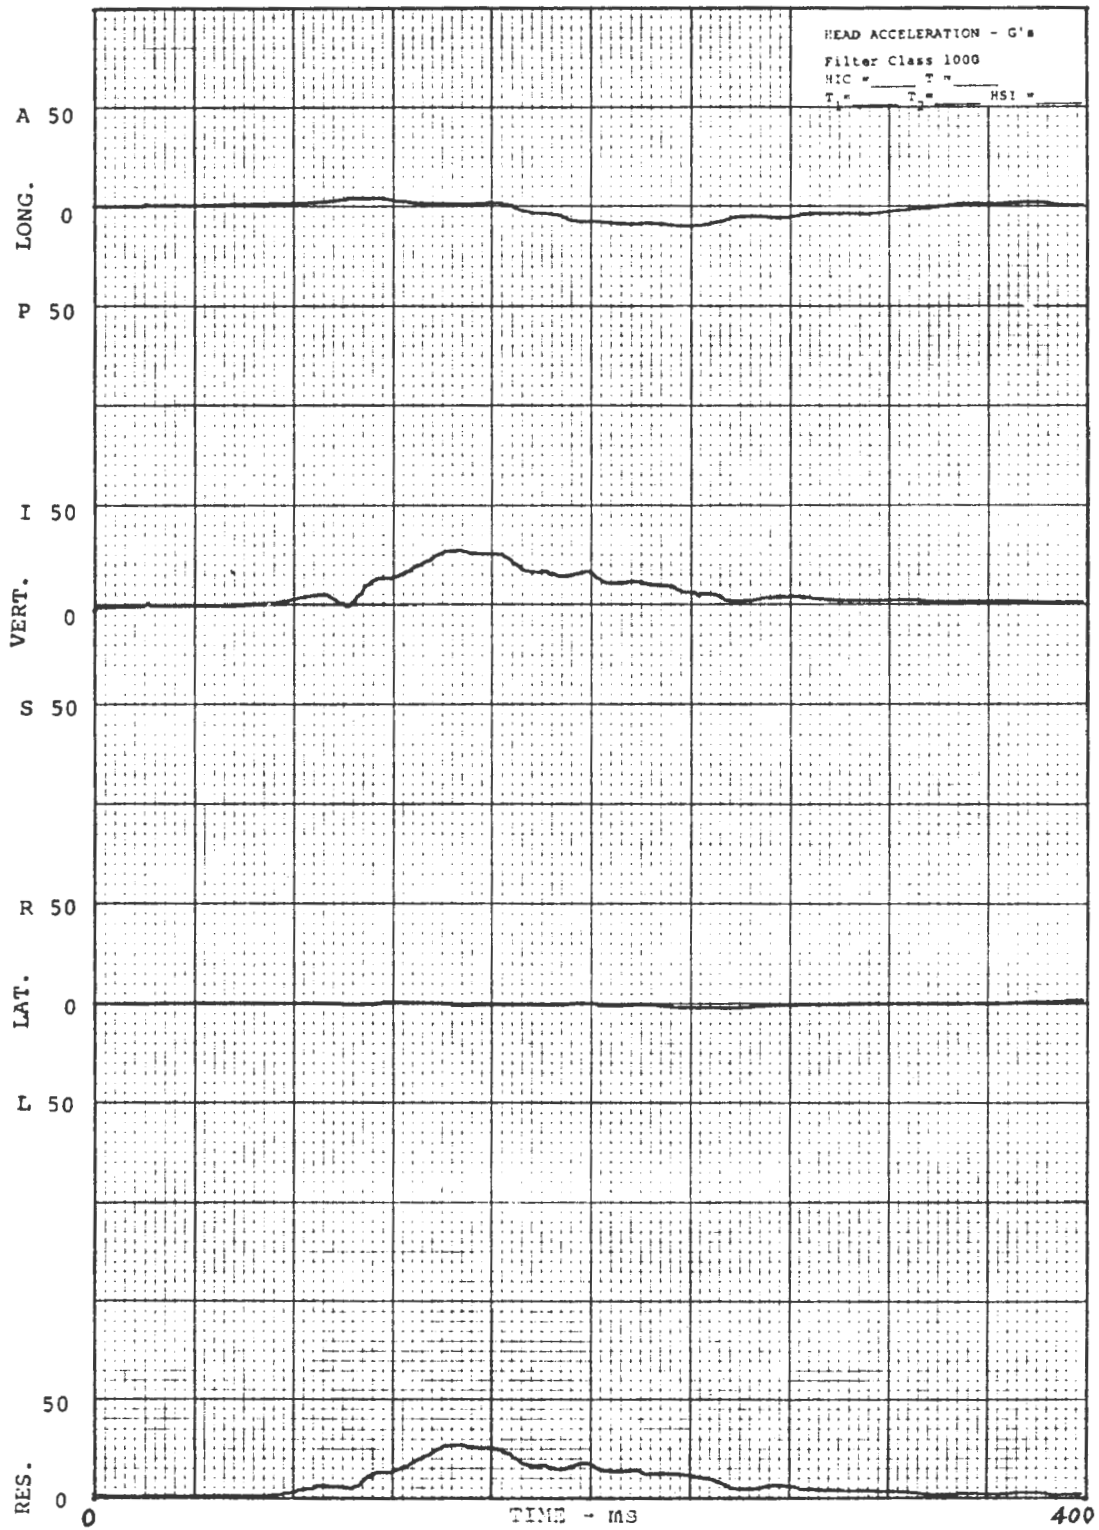
Figure A-31

Head Acceleration Graphs

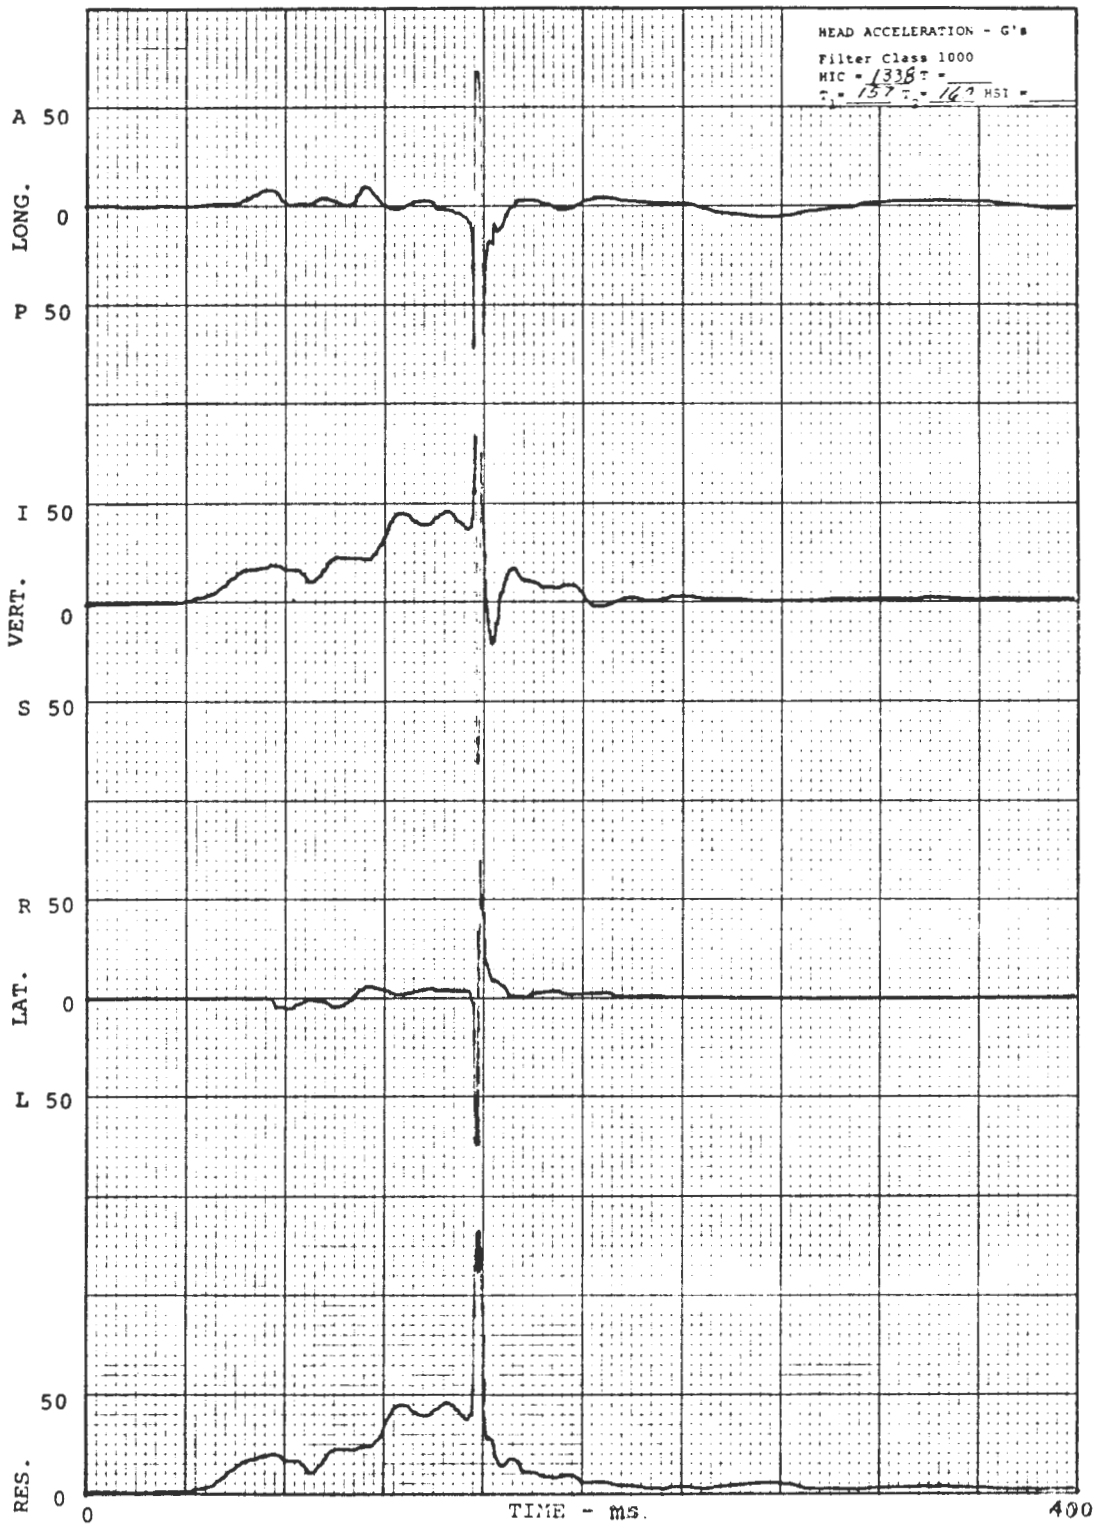
Figure A-46

DUMMY: Maximum floor belt load was measured at approximately 2400 lbs (4800 lbs on dummy). The occupant suffered a severe head strike (HIC = 1338, $T_1 = 157$, $T_2 = 160$) apparently from an impact on its legs (Figures A-46 and A-47). Forward head excursion was 50 inches.

Head Acceleration Graphs

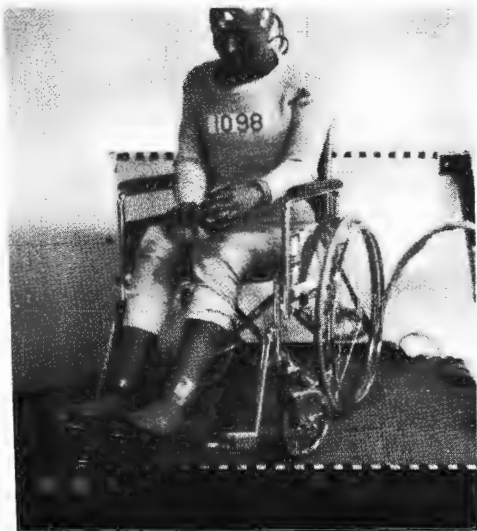
Figure A-51

Test 1098--Post Test Conditions

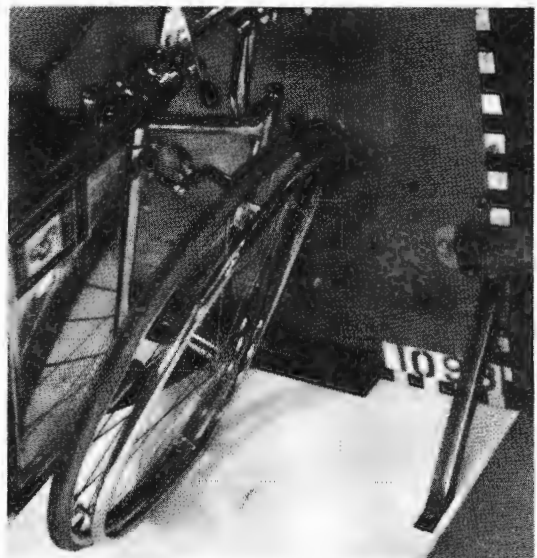
Figure A-52

WHEELCHAIR: The leading wheel of the chair was bent under about 2 inches at the floor (Figure A-52).

Test 1098--Wheel Damage

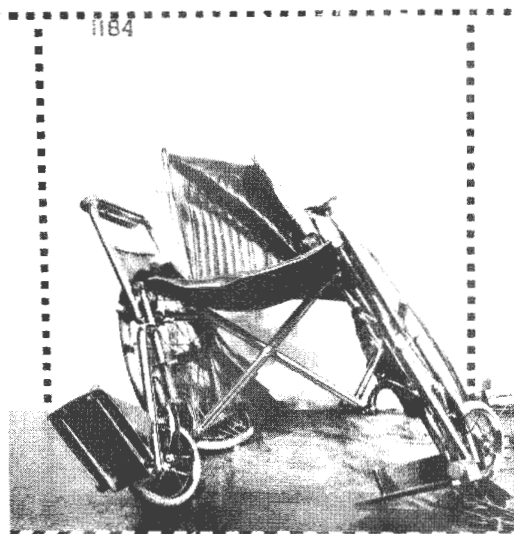
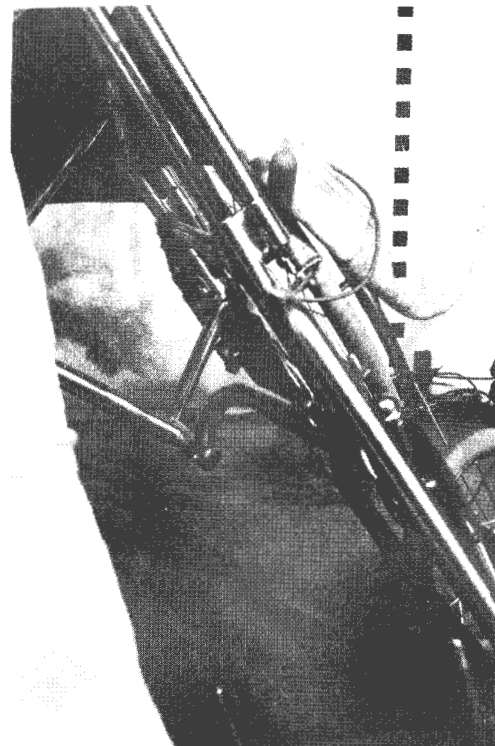
Figure A-55

WHEELCHAIR: The chair was severely distorted sideways, bending the bottom rail of the aft side frame inwards (Figure A-55). The large leading wheel was bent under the side frame. Load cells on the trailing floor belts registered maximum loads of 850 lbs in the left caster belt and 500 lbs in the right rear axle belt.

Test 1184--Post Test Conditions

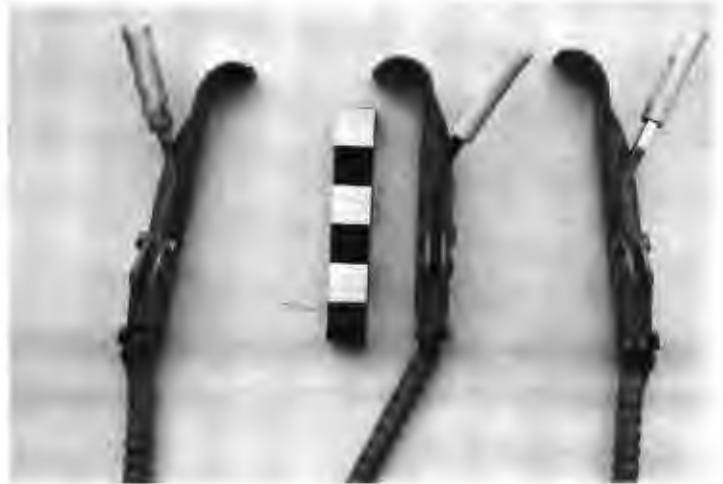
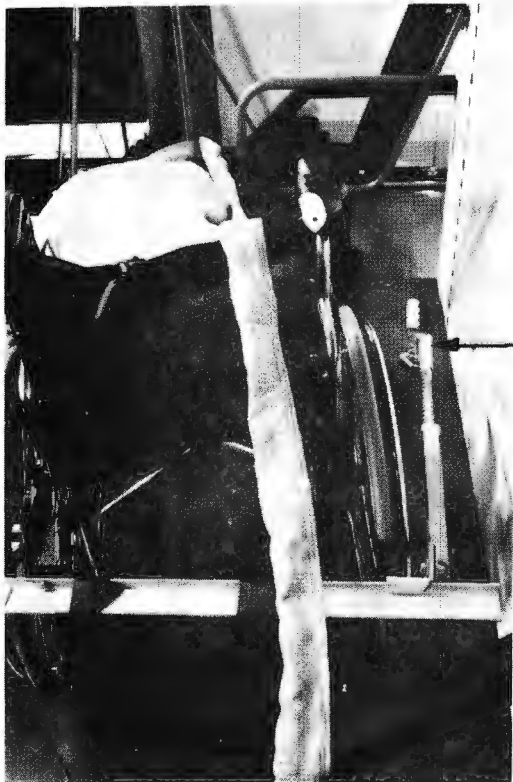
Figure A-58

As the sled began to decelerate, the dummy slid forward on the seat taking up slack in the seat belt. Loads in the seat belts were transferred through the chair frame to the horizontal bars. Application of load to the horizontal bars caused bending in both chair armrests. Bending in the armrests allowed the rear wheels to raise up (approximately 6 inches) off the sled until the wheels contacted the keeper bracket. As load was applied, the right horizontal bar anchor hook straightened out (Figure A-58) releasing the chair.

Note Disengaged
Arm

Test 1185--Anchor "Hook" Straightened

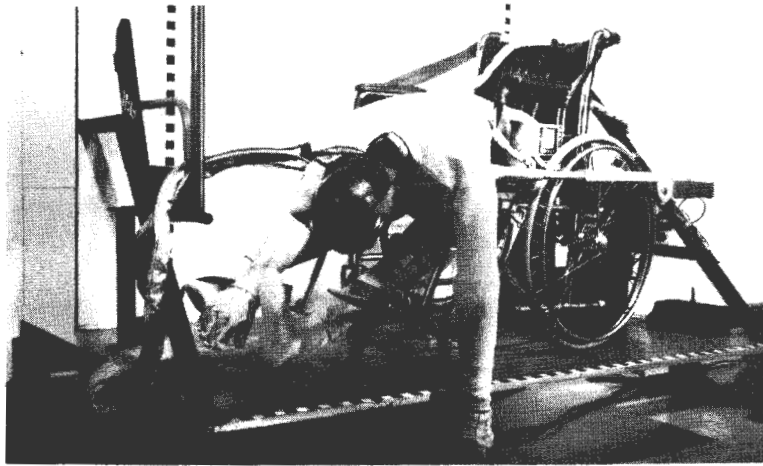
Figure A-59

WHEELCHAIR: Damage to the chair was minor (Figures A-59 and A-60). The left forward portion of the seat tore away from the anchorage to the top rail. The armrest suffered minor bending and crushing at the point of attachment of the horizontal bar.

Test 1185--Post Test Condition

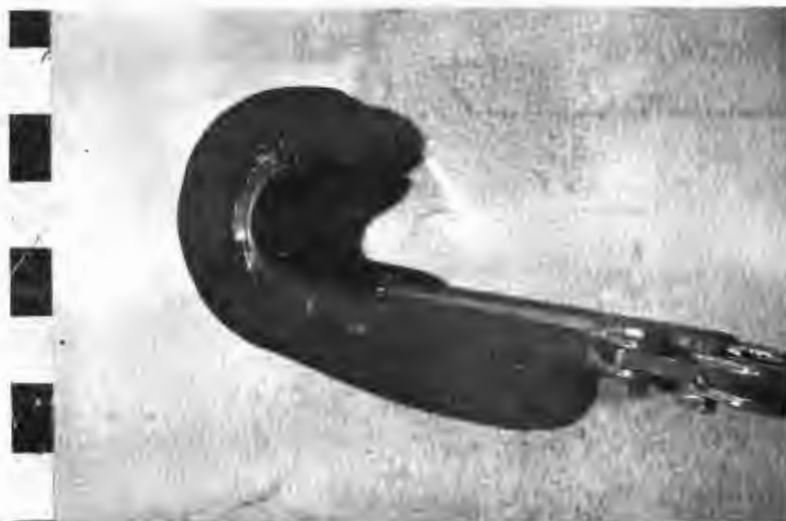
Figure A-63

Modified Horizontal Bar Hook

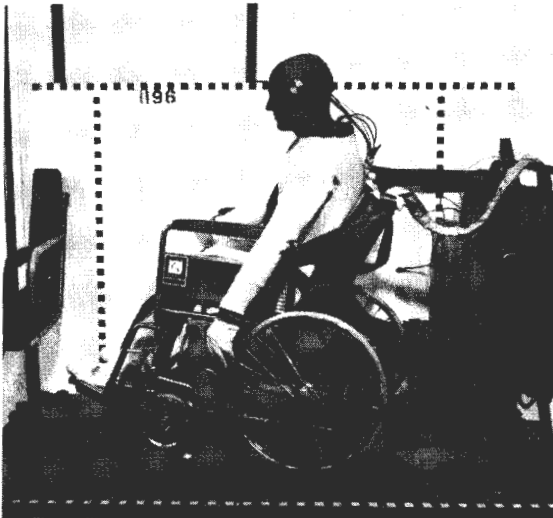
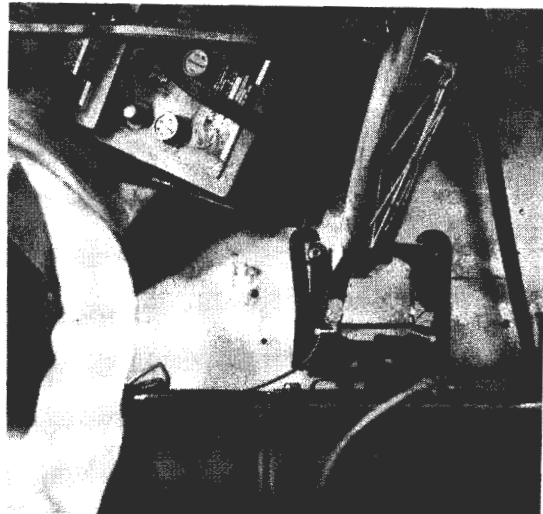
Figure A-74

WHEELCHAIR: The chair backposts were bent aft approximately 20 degrees, separating the seat slides from the backposts. Bending also occurred in the right rear wheel.

Test 1196-- Post Test Conditions

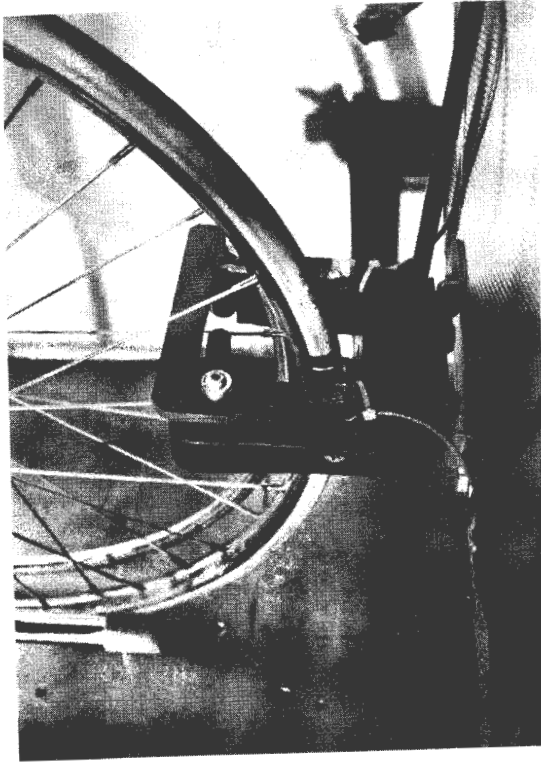
Figure A-75

Test 1197--Gripper
Modification
