# Vulnerability of Transportation Systems to Earthquakes--U.S.

Report No.  
FHWA/RD-81/128

Final Report  
October 1982

Federal Highway  
Administration

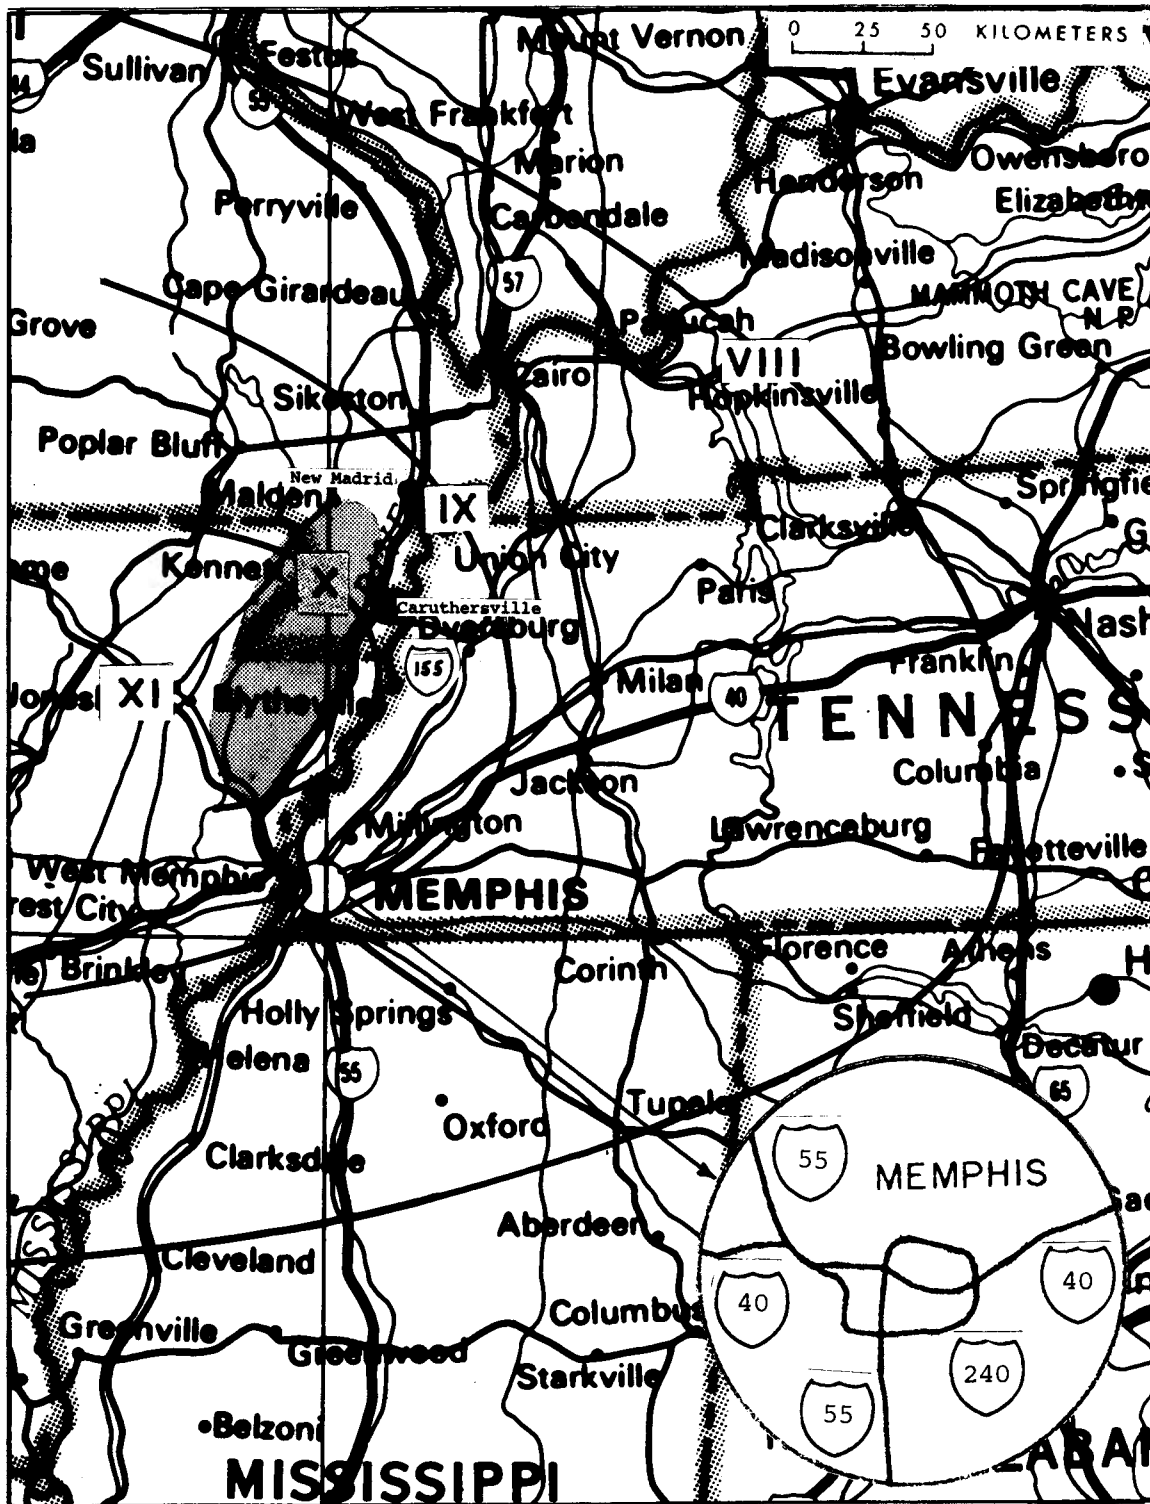
Figure 4. Epicentral area and generalized isoseismal M.M. contours for the New Madrid 1811-12 earthquakes. (Epicentral area (shaded) after Penick, Isoseismal contours after Nuttli)

Figure 4 shows the generalized isoseismal contours of intensity VIII through XI overprinted on a current highway map of the region. Note that U.S. Highway 55 goes right through the epicentral area with many bridge interchanges. U.S. Highway 155 joins U.S. Highway 55 at Caruthersville, an area of intensity X. (Later we shall look at what kind of damage has occurred in recent earthquakes with the same intensity.) At Memphis, U.S. Highways 40 and 55 intersect the beltway U.S. 240 in an intensity IX region. In the event of a repeat earthquake of the New Madrid type and intensity, U.S. Highways 40, 55, 155, and 240 are expected to be out of service following the quake because of bridge failures and severe highway cracking.

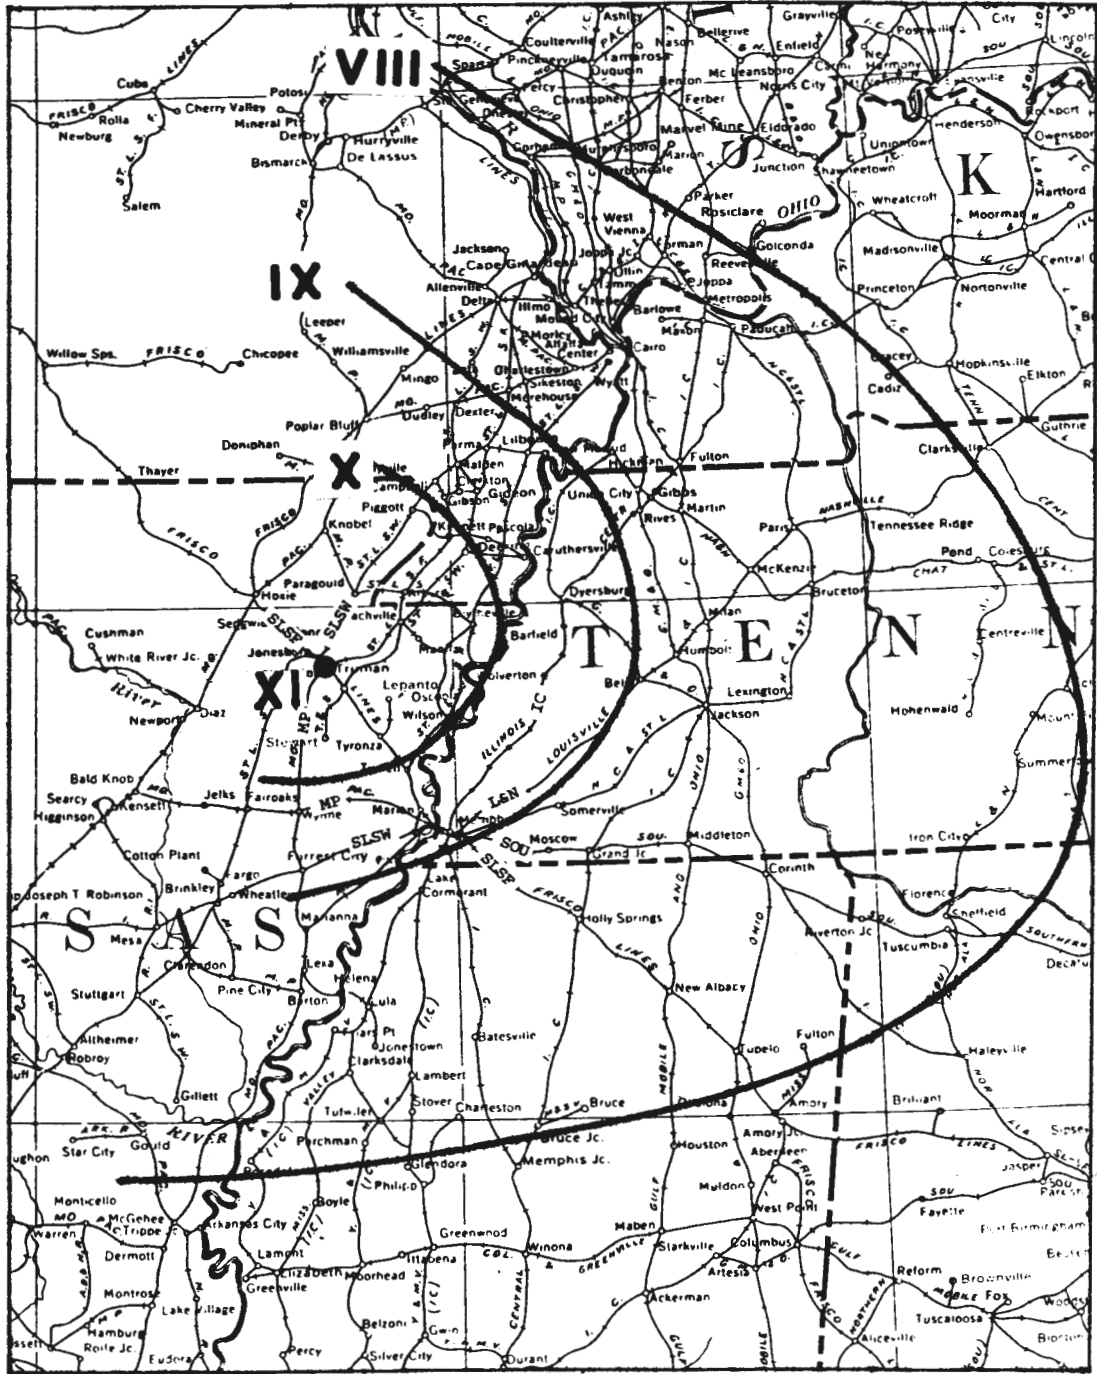
Figure 6. Generalized isoseismal contours for New Madrid earthquake overprinted on a base railroad map.

Figure 6 shows the extensive network of railroads that might suffer damage during a New Madrid type earthquake. The SLSF (St. Louis, San Francisco), MP (Missouri, Pacific), SLSW (St. Louis, Southwestern) railroads go right through the epicentral area and would be extensively damaged. Memphis with an expected intensity of IX serves as a transfer point between the SOU (Southern Pacific), SLSF, MP, L&N (Louisville and Nashville), IC (Illinois Central), and SLSW lines.

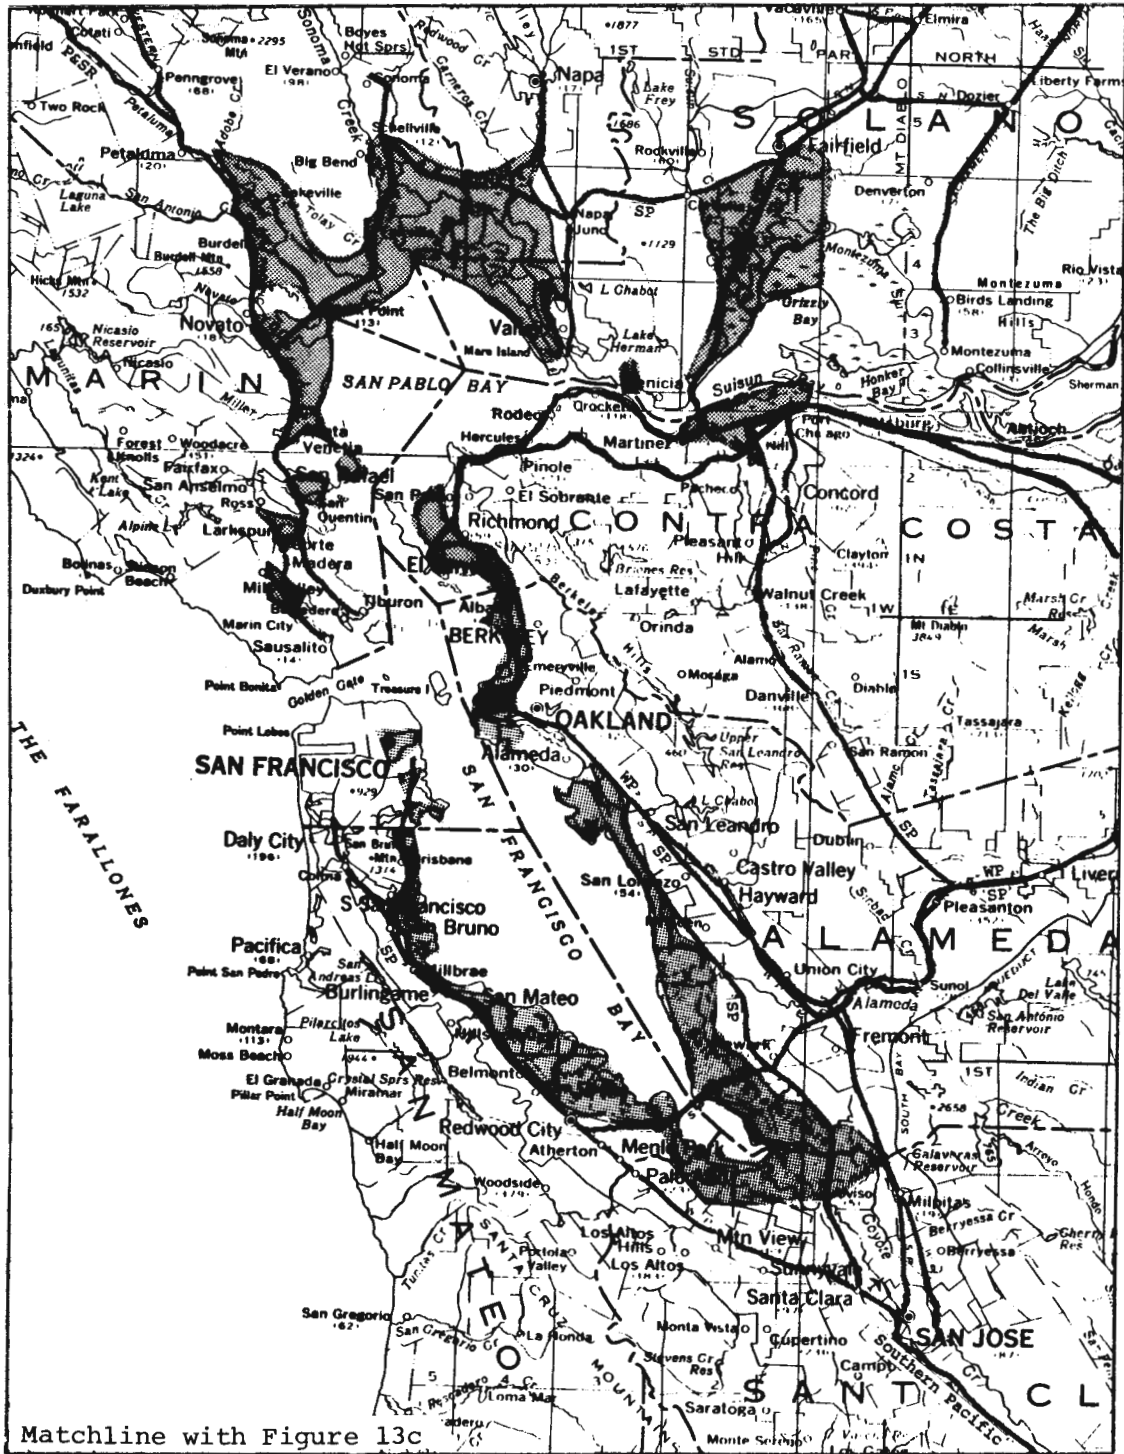
Figure 13b. Railroad network in the San Francisco area. Approximate location of marshlands (shaded area). (After Algermission & Steinbrugge)

The experience of the 1906 earthquake was used as a basis for estimating damage to the railroad system. For an earthquake activating the San Andreas fault, embankments will fail where the system crosses marsh land or earth underlain by soft strata. (Figure 13b) Damage to trestle bridges would be small; most of the damage would be confined to trestles on soft ground. Draw bridges might be vulnerable to damage if they were open at the time of the quake. For fixed span bridges there would be some movement of their piers or abutments. Tunnels would suffer little damage. The bridge of the Southern Pacific main coastal line to Los Angeles, crossing the San Andreas fault at Pajaro River near Watsonville is expected to fail. (Figure 13c) The previous bridge at this site failed in the 1906 quake. Also on structurally poor ground, the damage would be similar to that of the Alaska Railroad.\*

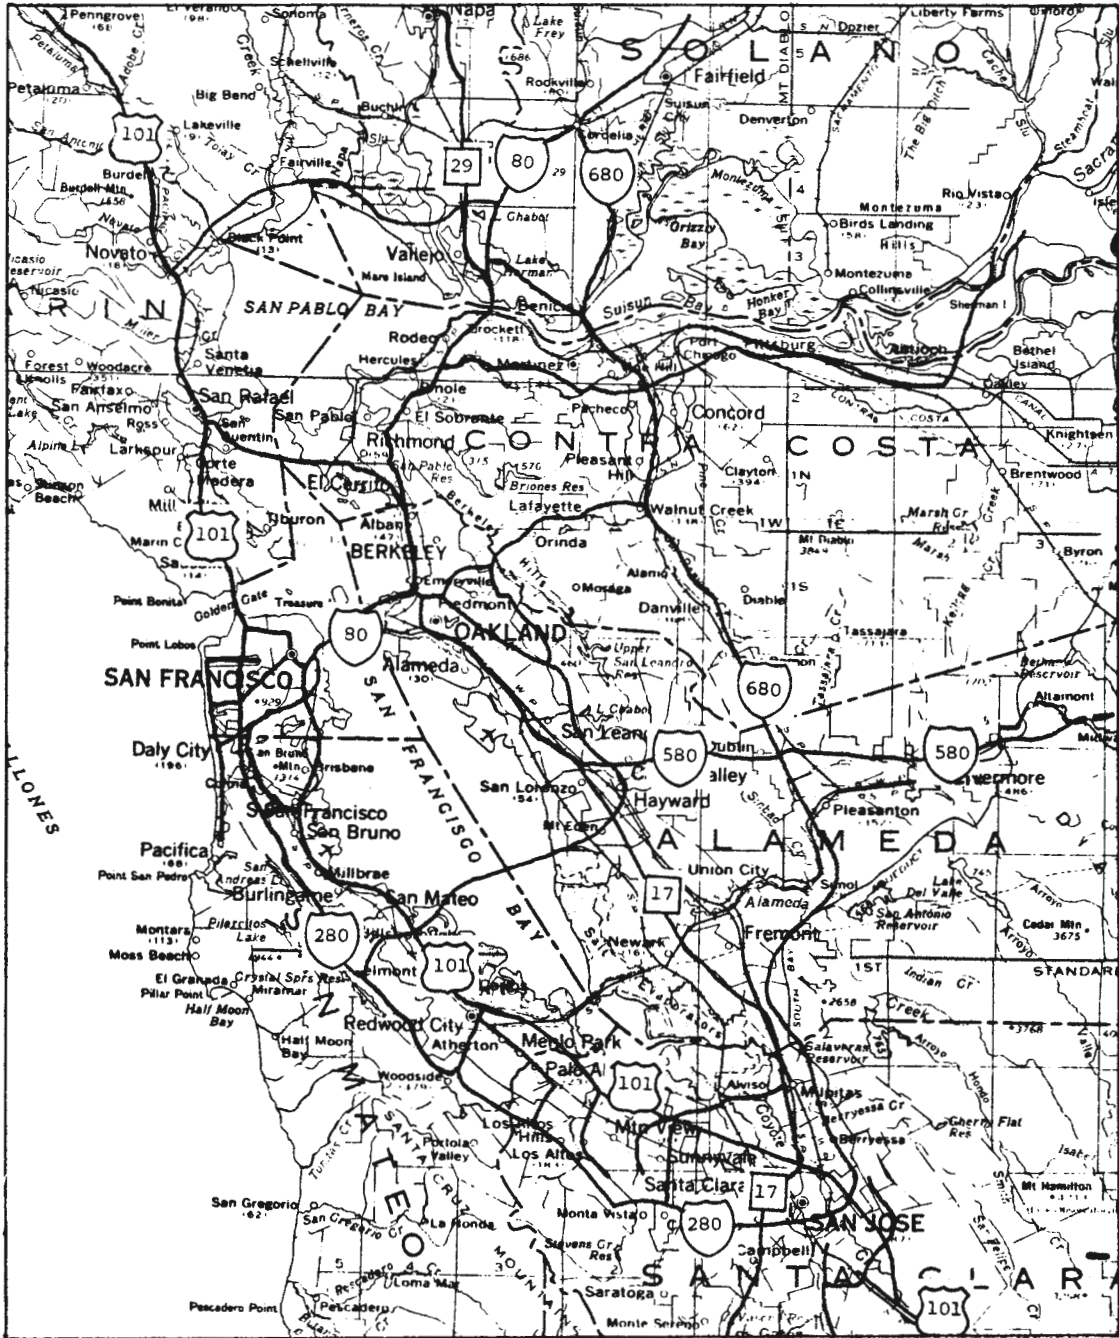
Figure 13d. Principle highways in the San Francisco Bay area.

...at approaches to bridges and overcrossings, the pavements on the well placed deep fills may settle in terms of inches as compared to the surface of the bridge deck...these problems will slow up traffic or stop it until repairs are made...

...problems which are much more serious from a long term standpoint relate to the potential stability of certain major engineered fills. For one example, the

miles of US 101 south of Candlestick Point in San Francisco to San Bruno may be cited; major land slips or movements are distinctly possible in heavy ground motion, and major stretches of this freeway can be under water or badly damaged due to soil movements. Additionally, the hydraulic fills used to construct miles of freeways along the east shore of the Bay in Alameda County may liquefy during heavy shaking, with long sections becoming totally impassable.

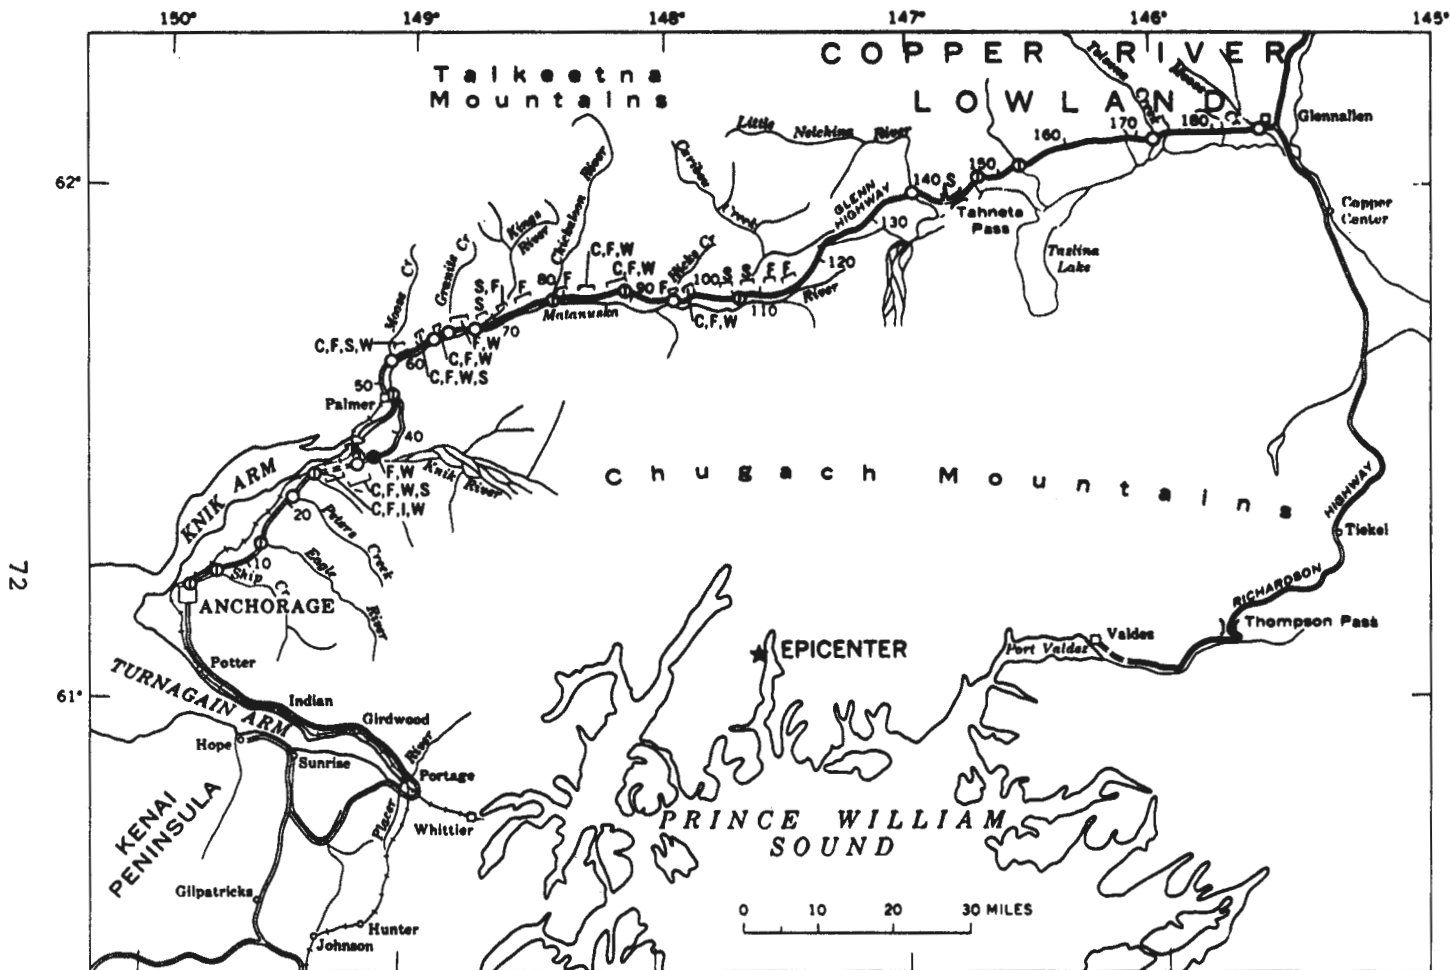
Figure 21. Damage to bridges on Glen Highway. (From Kachadoorian)

On the Sterling Highway (Figure 20) from Seward Highway to Homer - the primary bridge damage was the collapse of the bridge at Cooper Landing over the Kenai River. A temporary Bailey bridge was needed to restore traffic. On the Glen Highway - from Anchorage to the north (Figure 21) - very little damage to bridges was reported except at the Knik River Bridge located about 45 miles from Anchorage. Several piers were shifted out of line. On the 12 mile section of the Copper River Highway (Figure 22) between Cordova and the municipal airport, five of the twelve bridges needed reconstruction. Considerable damage was done to the bridges on the section of highway from the municipal airport to the Million Dollar Bridge (Figure 22). Several long spans of reconstructed railroad bridges were dropped into the river. Kachadoorian states that all the structures in this area were severely damaged and would require replacement. On the Richardson Highway (Figure 23) the bridges over Valdez glacial stream number 3 and the Little Tonsina River were severely damaged.

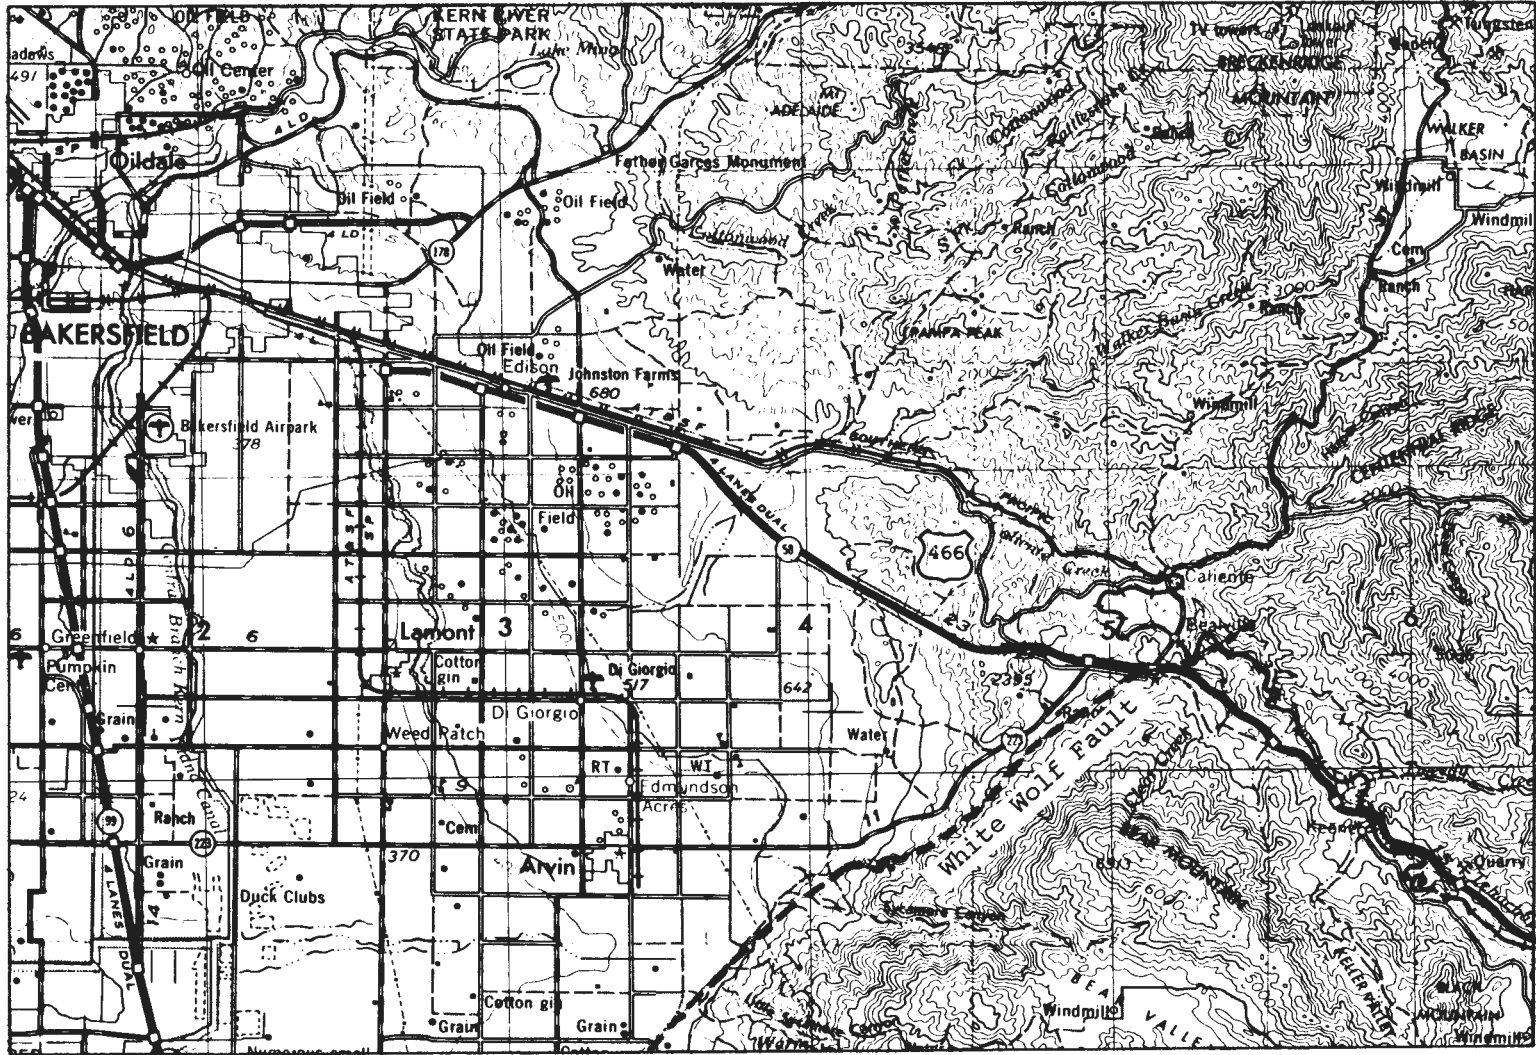
Figure 26. Route of Southern Pacific Railroad in Kern County, California.

At 4:52 a.m. the main shock (7.7 magnitude) of a series of shocks occurred in Kern County, California (Figure 26). The shock originated along the White Wolf fault, a relatively short fault at 90° to the San Andreas fault. This earthquake resulted in the partial collapse of several Southern Pacific Railroad tunnels near the town of Calienti. Landslides and rockfalls also blocked the roads to Tehachapi.
