PATH Car Motor Controller Unit Investigation

Port Authority Trans-Hudson Corporation and
Parsons, Brinckerhoff, Quade & Douglas, Inc.

February 1985

This report describes the tests and analyses conducted to determine possible cause(s) of the Motor Controller fire on PATH Car 725. In addition, tests were made to determine possible cause(s) of the Motor Controller bolt erosion.

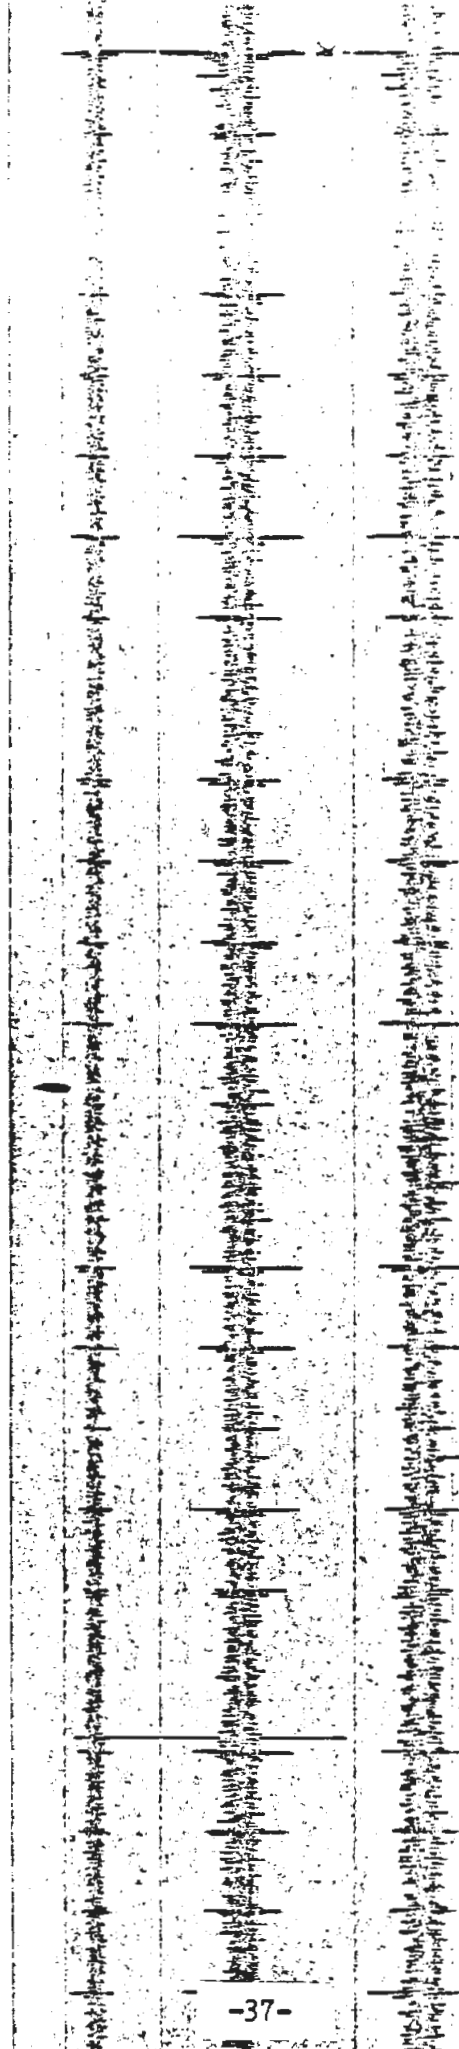
FIGURE 1 - GENERAL NOISE LEVEL OF BOLT CURRENTS

LEAVING JOURNAL SQUARE FOR NEWARK

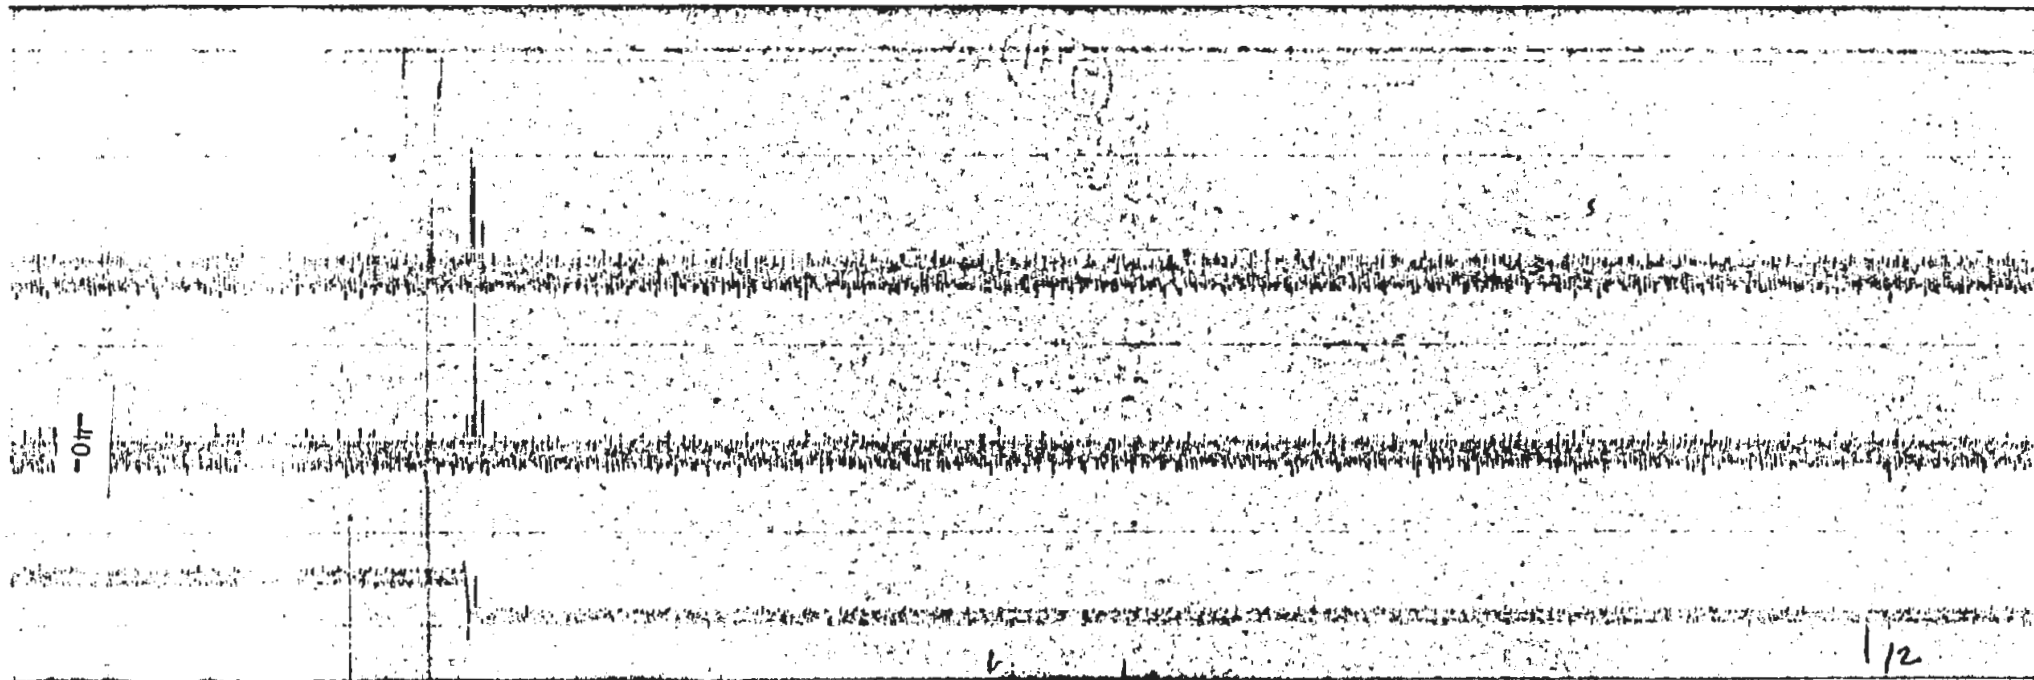
FIGURE 4 - 87 SECONDS OUT OF JOURNAL SQUARE

A TYPICAL POWER REDUCTION

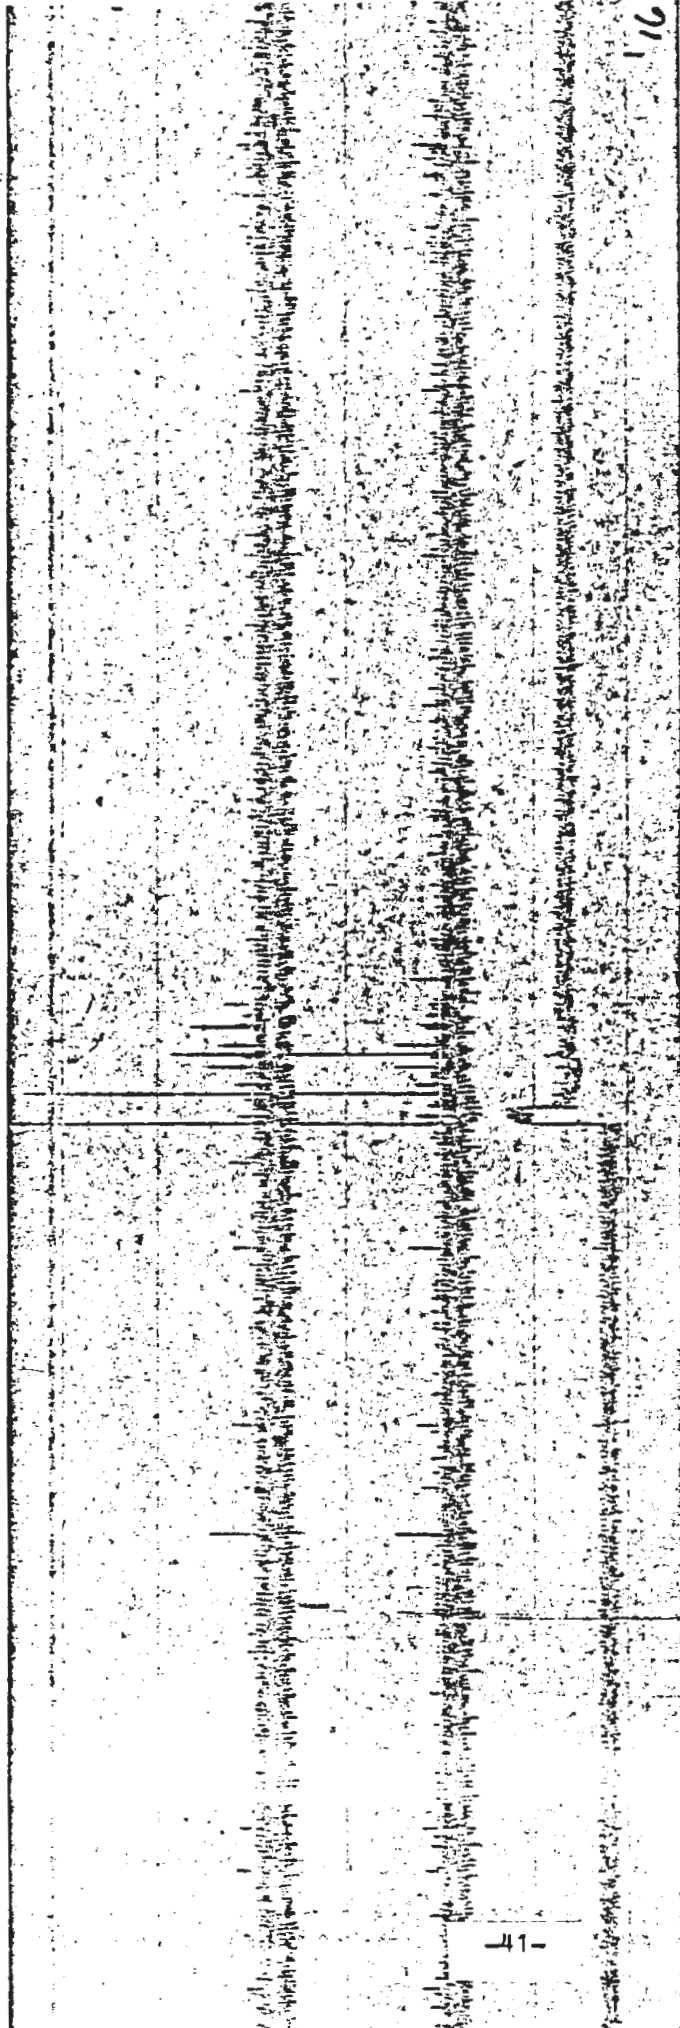
FIGURE 5 - 117 SECONDS OUT OF JOURNAL SQUARE

A TYPICAL POWER APPLICATION

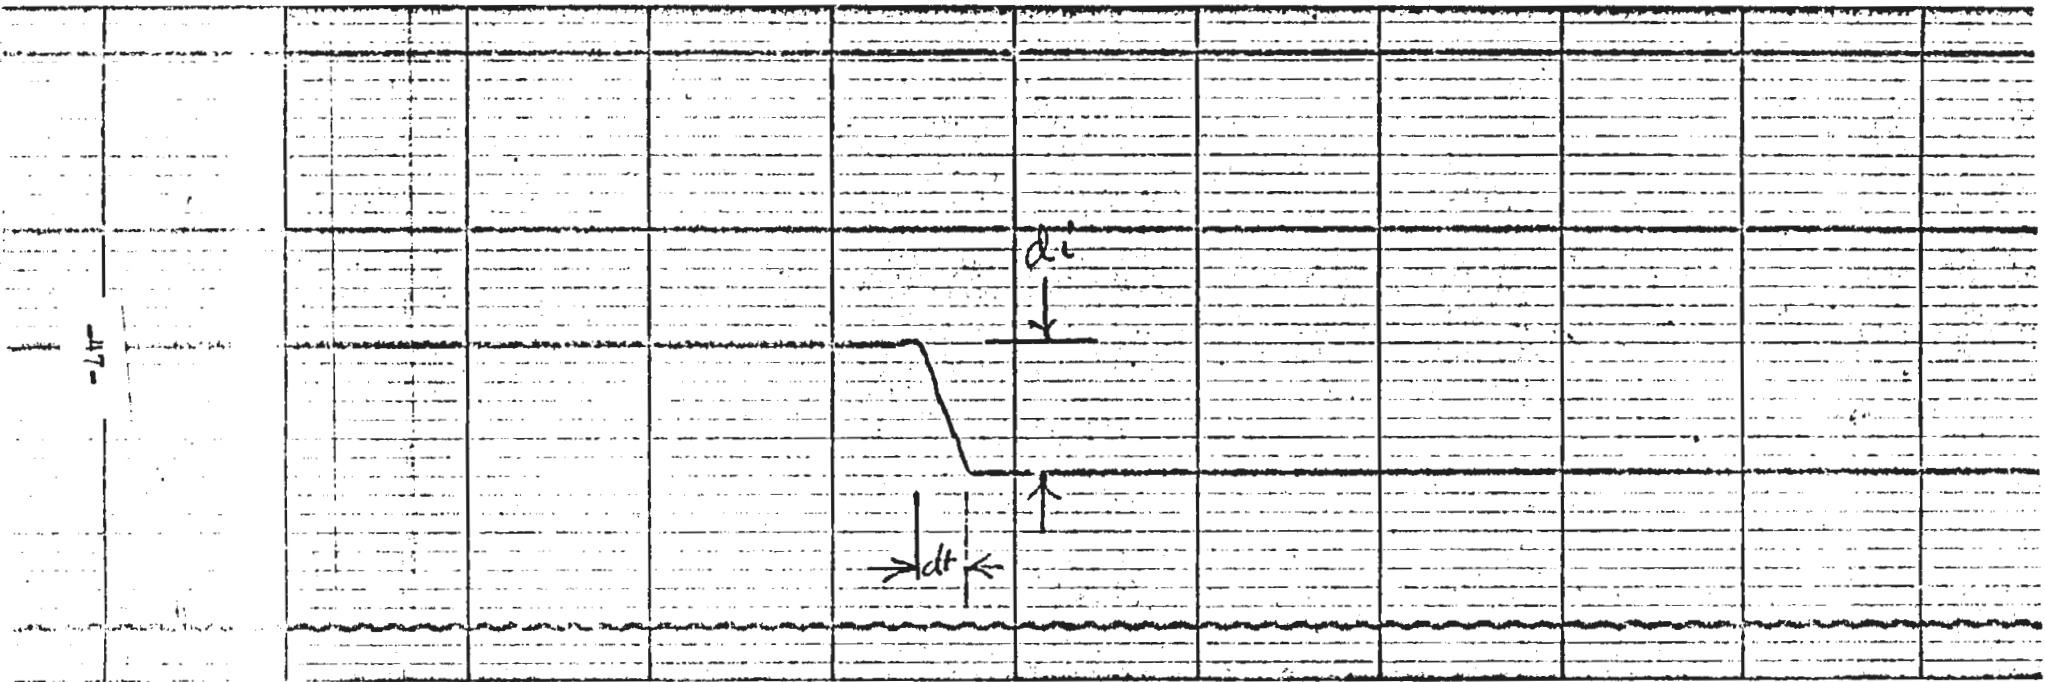
FIGURE 11 - MEASUREMENT OF AMPERES PER SECOND ON CURRENT DECAY

$$d_i = 280 \text{ amperes}$$

$$d_i/dt = 11200 \text{ amperes per second}$$

- This measurement made statically at Henderson Shops

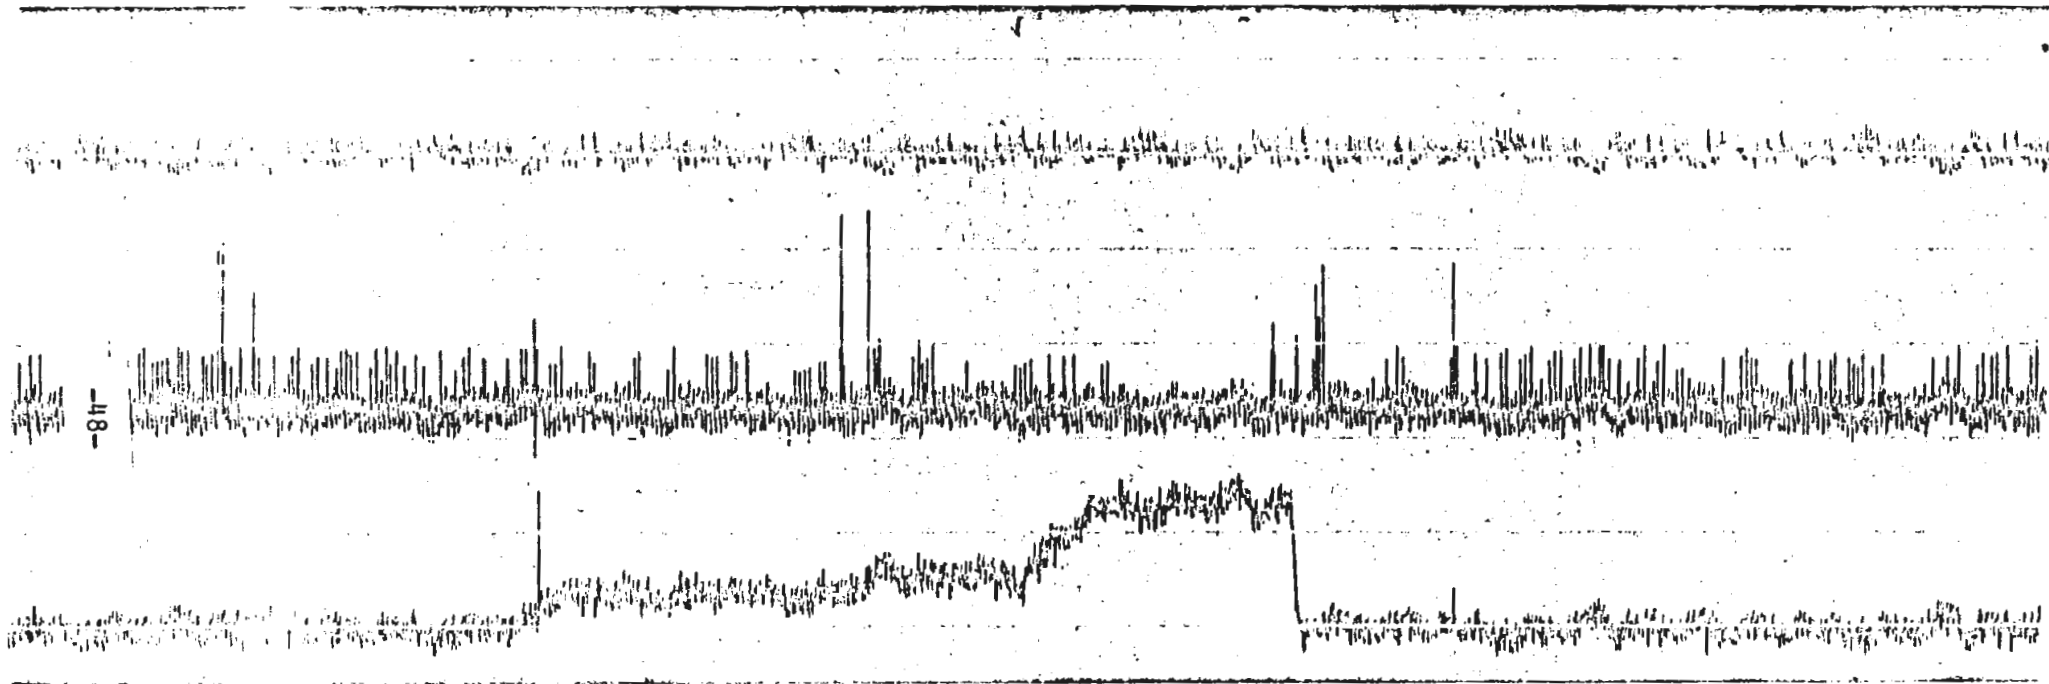
FIGURE 12 - INSTRUMENTATION CHECK

- Bolt 4 leads disconnected from shunt
- Bolt 1 leads connected
- This test made statically at Henderson Shops to show there was no pickup in leads

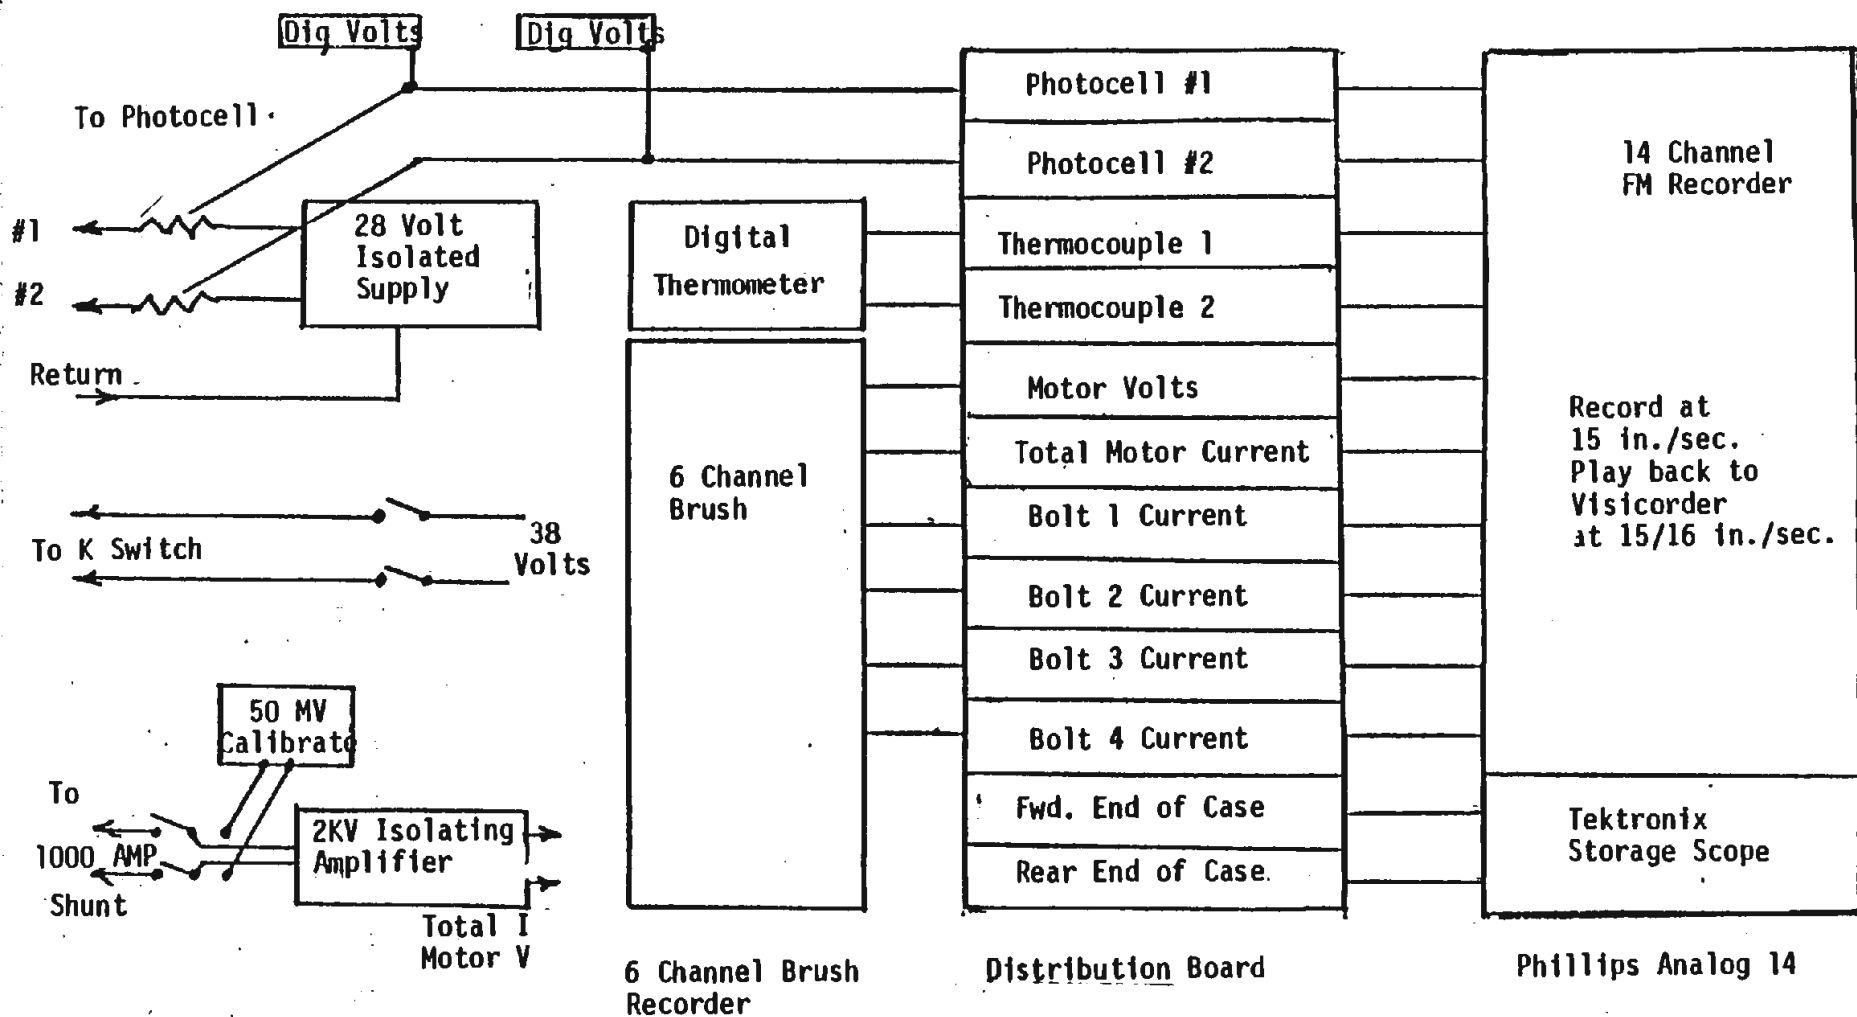
FIGURE 14. IN-CAR INSTRUMENTATION

Note: This is a one-line diagram. Actual wiring is more complex and generally in coaxial cable.

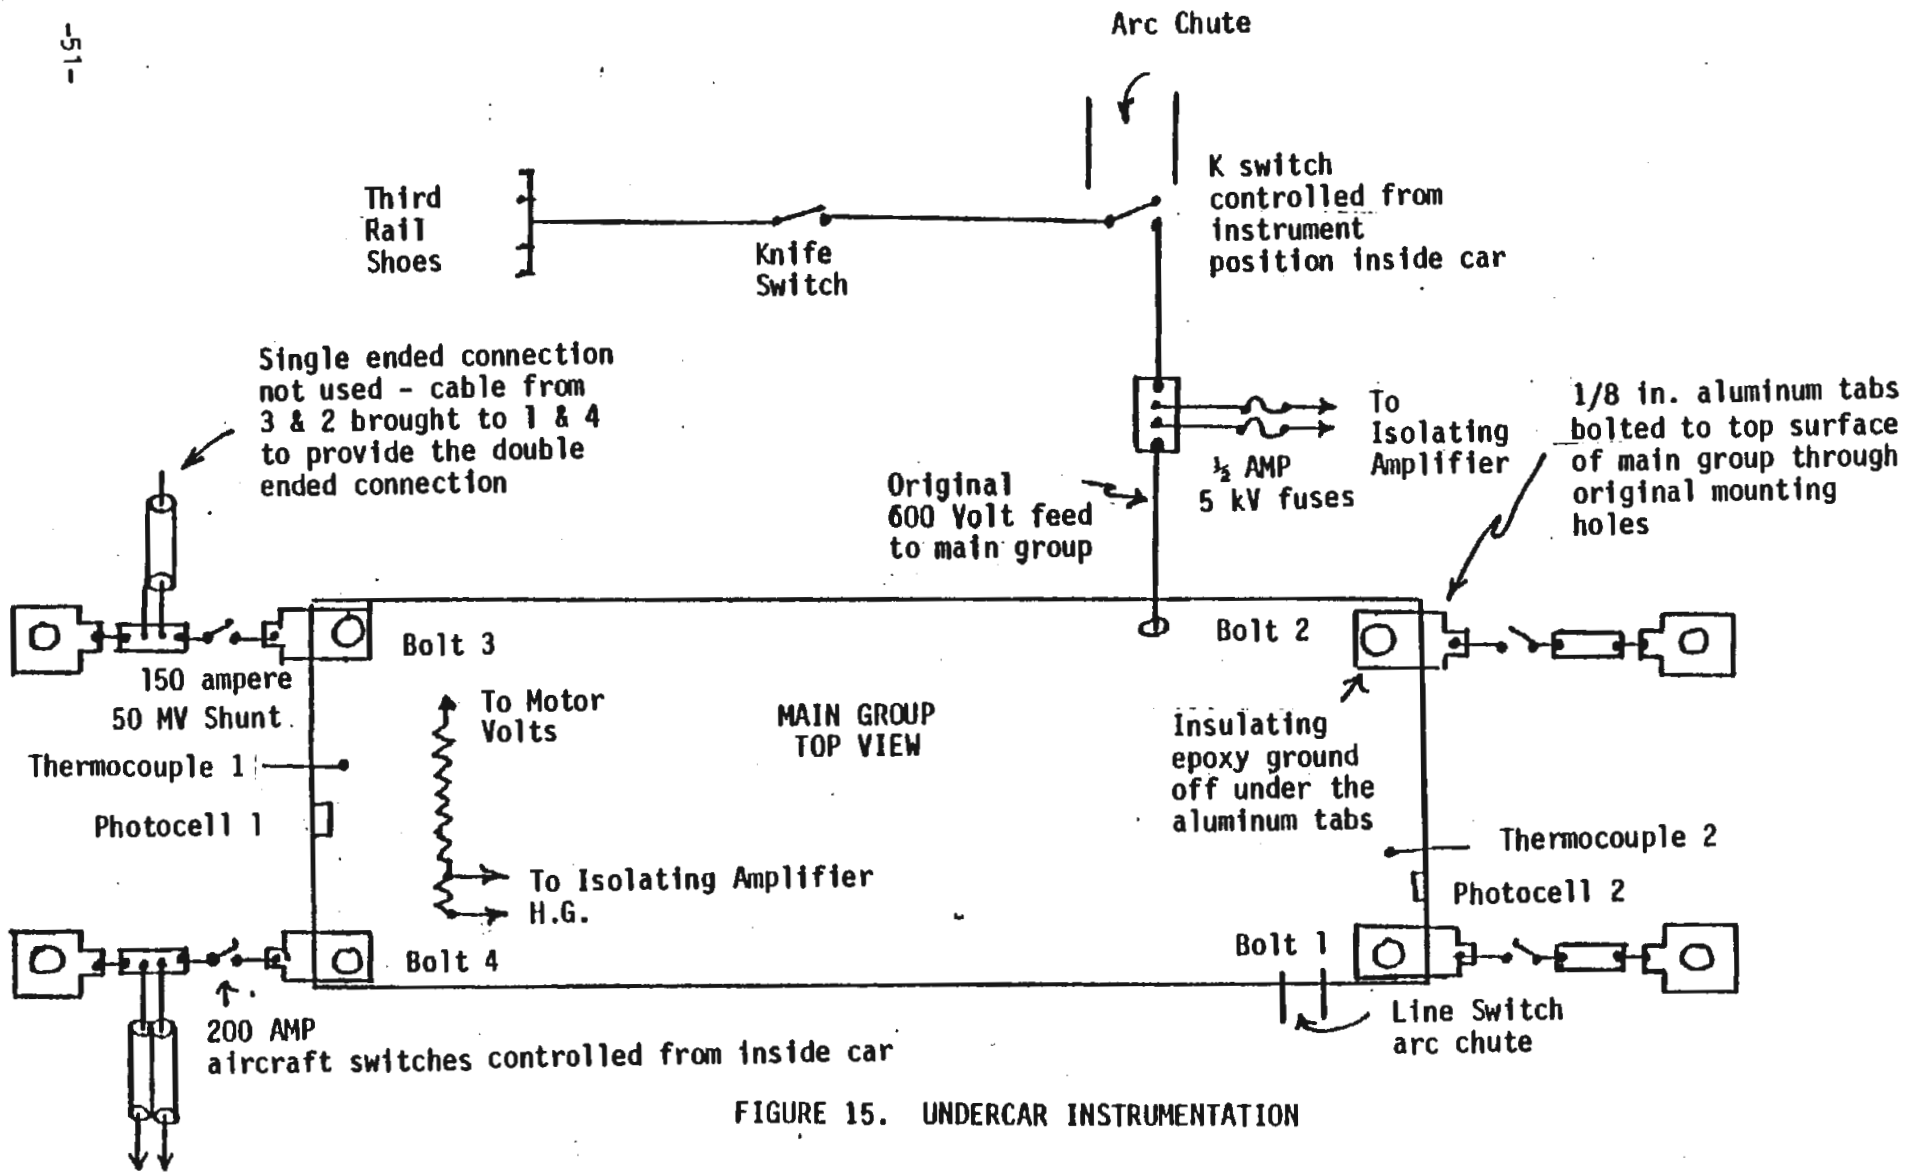
FIGURE 15. UNDERCAR INSTRUMENTATION

When these tests were begun, the control group case-to-ground resistance was measured as 300 megohms with the four bolt switches open (see Figure 15). This measurement was the leakage across the four pink support insulators. The resistance from +600 volts to control group case, essentially the leakage resistance within the main group, was 200 megohms. The high leakage resistance of a reasonably dirty control group was quite surprising. Even more surprising, after two days of rain, was that the resistance of the pink insulators dropped from 300 megohms to 30 megohms and the dirt within the control group maintained its value of 200 megohms, indicating that the inside of the main control group case stayed dry during the damp weather.

Note - Outboard aluminum tab folds over around the switch and shunt connection. Thus the same hole in car body is used for the ground connection.

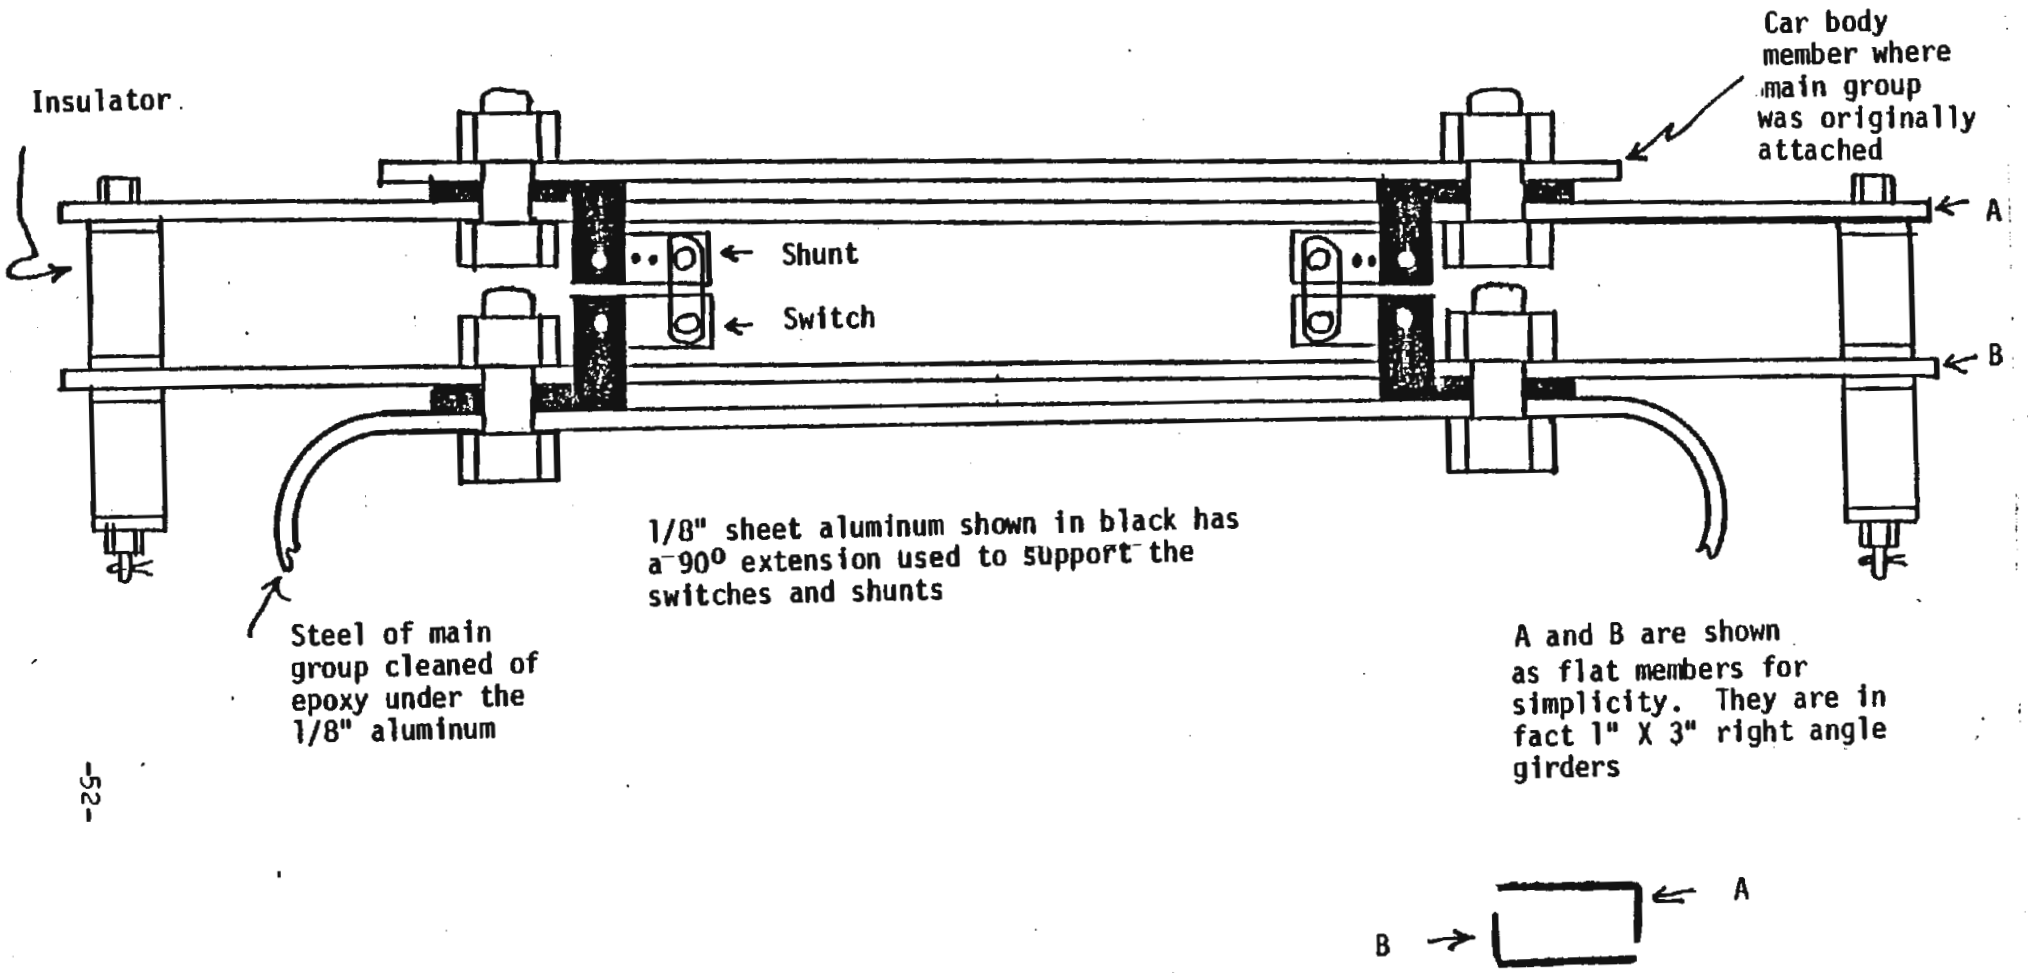
FIGURE 16. METHOD USED TO INSULATE THE MAIN GROUP OF CAR 159

The mechanical and electrical arrangement is shown in Figure 16. The electrical path is simple: currents through the shunt and switch flow in opposite directions to cancel inductive effects. To achieve this, the connections to, and the size of, the switch had to be as equal as possible to the size of the shunt. Figure 16 shows them to be equal. In fact, they were made very nearly equal through the use of a Cutler-Hammer solenoid-operated aircraft switch with the profile required.

To control both the Controller box fire problem and the Controller box bolt erosion problem, it is recommended that all PATH Controller boxes should be insulated from the car body. In addition, a ground fault protection device is recommended, so that in the event that excessive ground currents are present, they can be quickly detected and interrupted. Further, establishment of optimum maintenance standards for ensuring a non-contaminated environment within the Controller box is recommended.

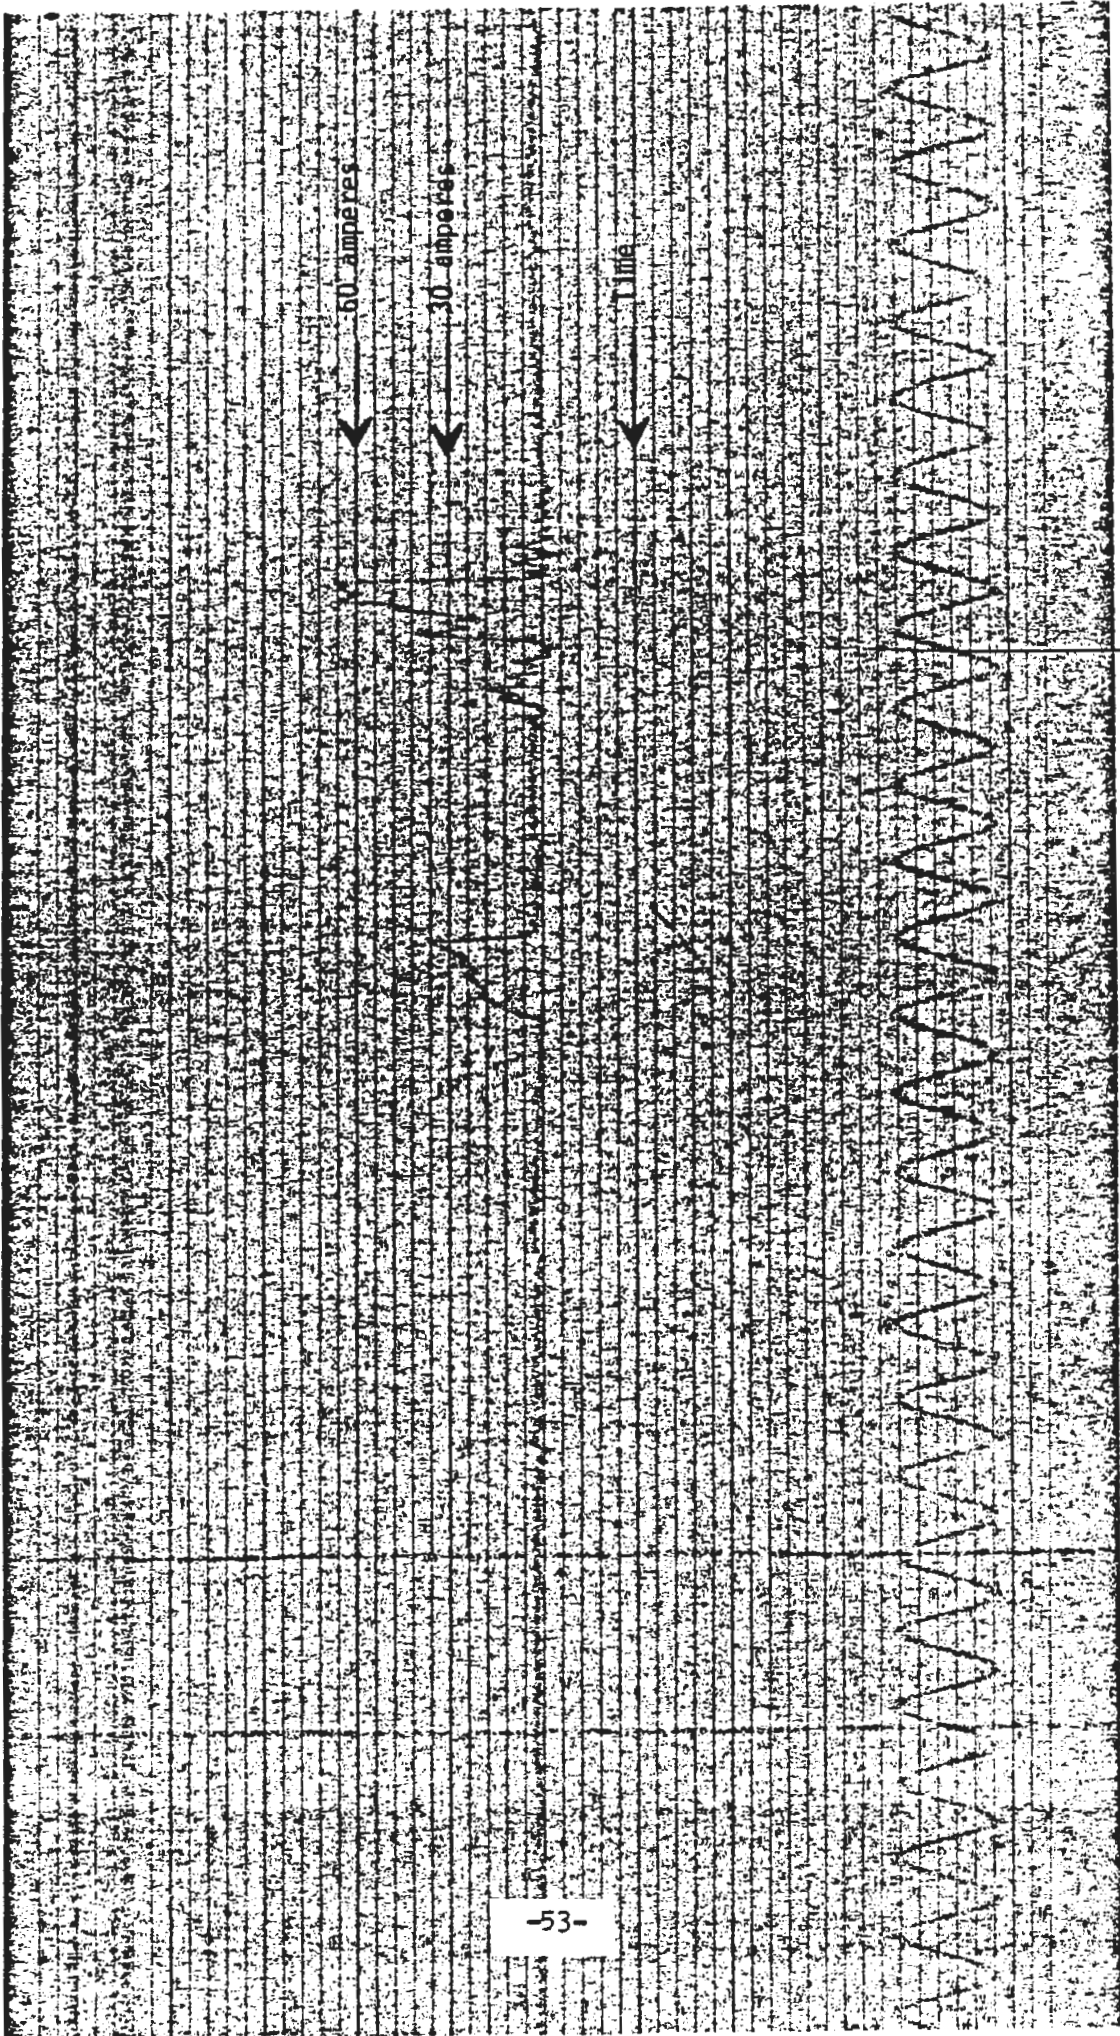
FIGURE 17
- Two bolt currents taken at random from magnetic tape
- Timing Wave 960 HZ

Figure 17, which shows two expansions of bolt currents, indicate that the assumption of a 1-millisecond interval and a square pulse is conservative.

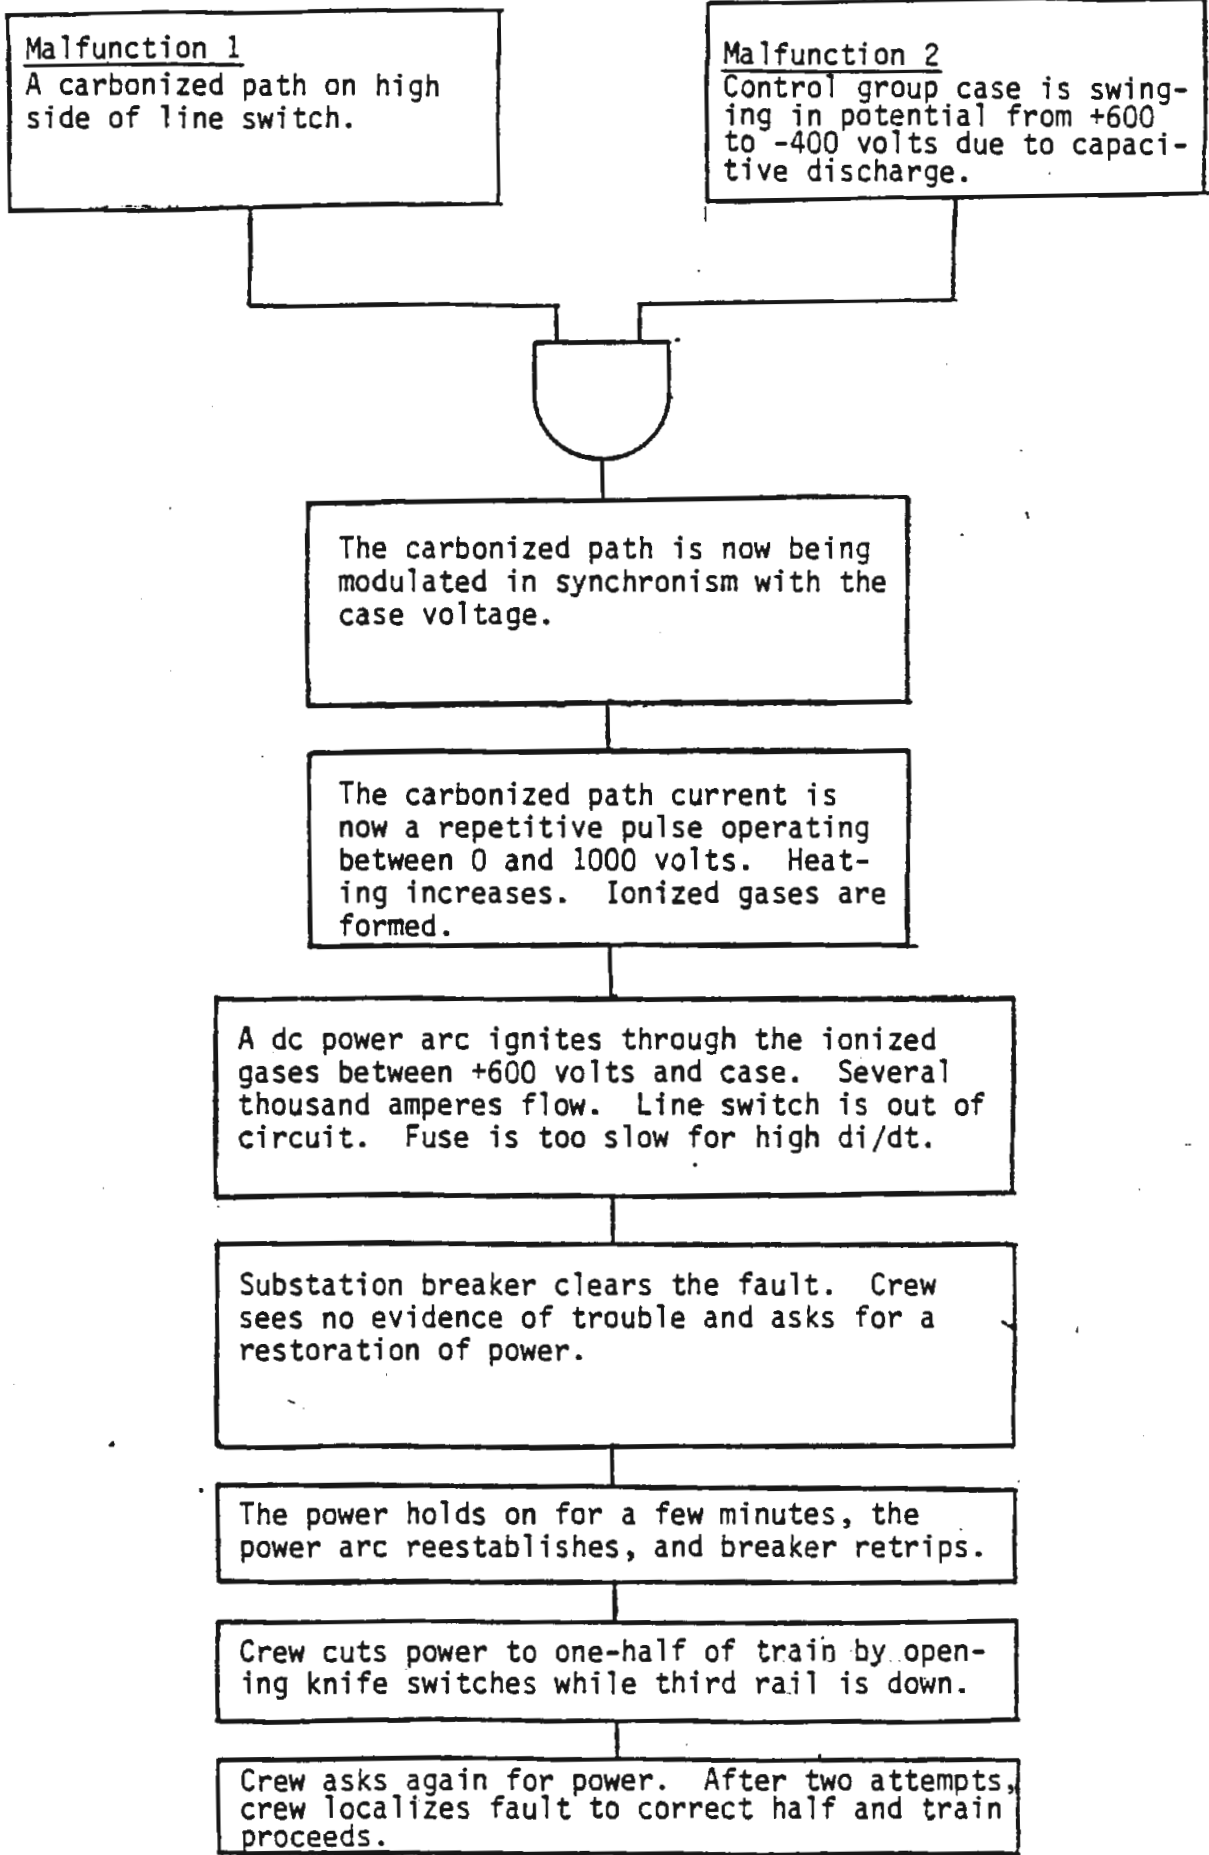
FIGURE 20. FAILURE MODE EFFECTS ANALYSIS (FMEA) - CARBONIZED PATH AND CAPACITIVE CHARGING AND DISCHARGING

The two months of testing on Car 159 provided an understanding of what is happening on PATH cars with regard to the bolt erosion problem as well as the possible various causes and events leading to the Controller fire. The fault trees in Appendix 4 describe a number of reasonable hypotheses. For example, Figure 20 in Appendix 4 draws on the experience reported by the University of Sherbrooke combined with the charge-discharge phenomenon to provide a scenario where the sub-station breaker clears the fault. A similar scenario with severe arcing would exist if the sub-station breaker did not immediately clear the fault. This would occur if the arc currents were comparable to ordinary line currents so that the sub-station breaker remained closed for some time. (See "POWER ARCS" in Appendix 4.)

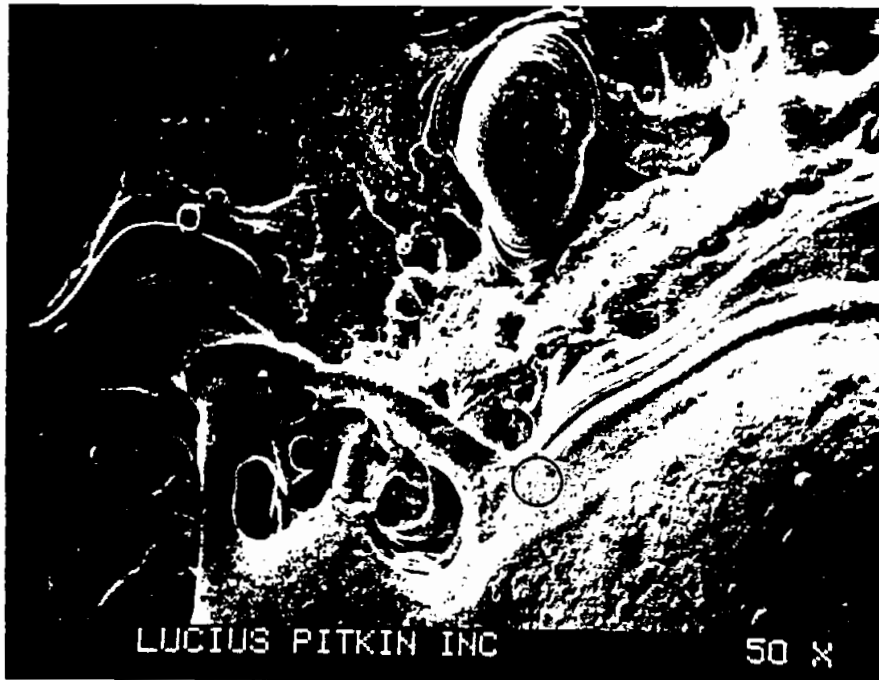
Fig. 2

A small section of the straw-colored wasted area of the bolt was prepared for scanning electron microscopy. Examination revealed the surface to contain numerous relatively small spheroids and contour markings characteristic of melting and rapid solidification as would occur from electrical arcing. The surface condition of the bolt in the straw-colored area showing the metal spheroids is shown in Fig. 2.

SCANNING ELECTRON MICROGRAPH

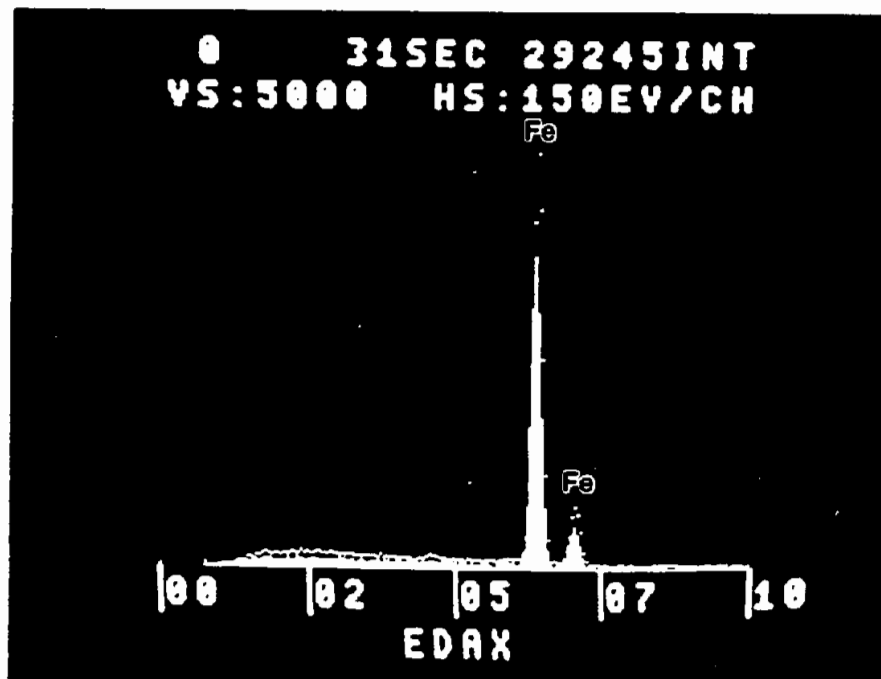
An energy dispersive X-ray analysis in the wasted area exhibiting the straw-colored melted and resolidified metal showed the element iron to be present, no other elements were detected. Fig. 4 is a energy dispersive X-ray spectrum of this area.

ENERGY DISPERSIVE X-RAY SPECTRUM

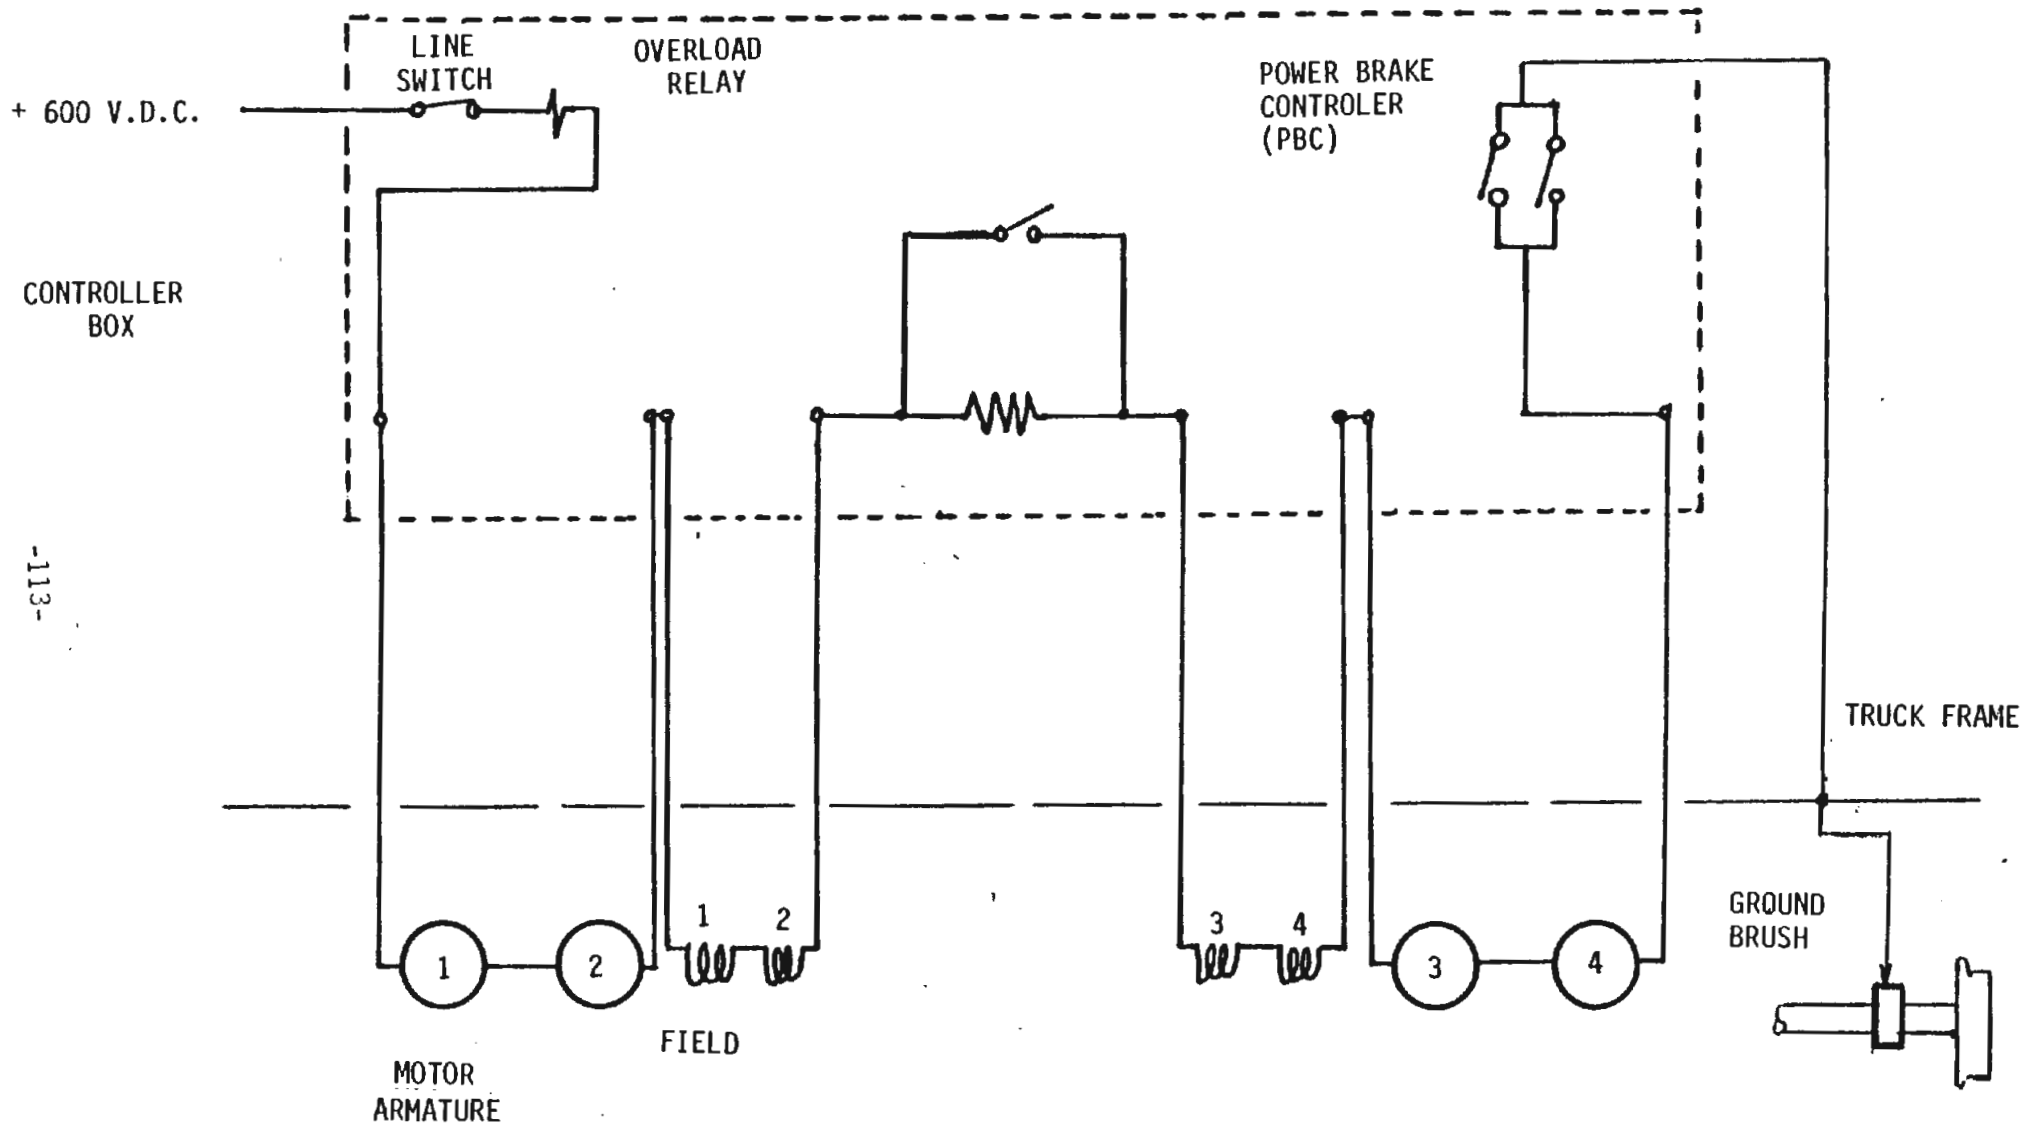
FIGURE 1

Figure 1 is a simplified diagram of the high current portions of the Controller box for the case where the car is starting up. All four motors and fields are connected in series, and maximum resistance is in the motor circuit. A similar diagram applies during

running, except that two motors of one truck are in series and these are connected in parallel with the two series-connected motors of the other truck. The Power Brake Controller (PBC) and Line Switch remain the same for both starting and running. Some arcing effects at the Controller box metal hinge (about 8" from the PBC) has been observed, possibly caused by inadvertent opening of the PBC contacts before the Line Switch opens.
