Guidelines for Detection, Analysis, and Treatment of Materials-Related Distress in Concrete Pavements Volume 3: Case Studies Using the Guidelines

PUBLICATION NO. FHWA-RD-01-165

AUGUST 2002

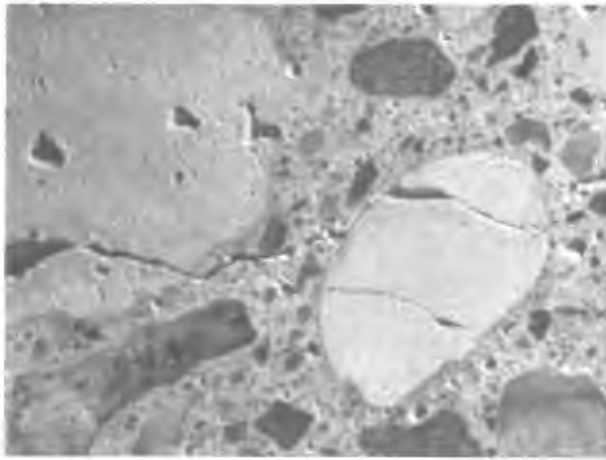
(a) Siltstone aggregate

The stereo optical microscope was used to first examine polished slabs cut from each core to assess the general condition of the concrete. Typical micrographs of interesting features are presented in figures 3-6 and 3-7. The aggregate type was determined to be a natural gravel with a varied lithology including limestone, siltstone, dolomite, and rhyolite as the main rock types for the coarse aggregate. Many of the rhyolite particles had small feldspar inclusions. The fine aggregates contained the same rock types seen in the coarse aggregate in addition to shale, sandstone quartzite, and granite. Cracks passing through the paste also passed through aggregates. Reaction rims were visible along with secondary infilling in cracks and air voids. A yellow to white “soft” crumbly siltstone constituent of the coarse aggregate natural gravel is frequently cracked, with the cracks extending into the surrounding cement paste, and occasional white deposits in cracks. Aggregate particles that were volcanics or rhyolites appear to be reactive.

Figure 3-6. Stereo optical micrographs of typical cracking pattern associated with porous siltstone aggregate SD-090-019.

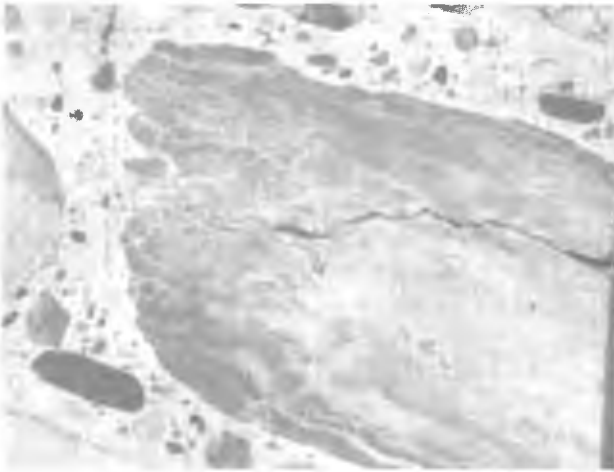
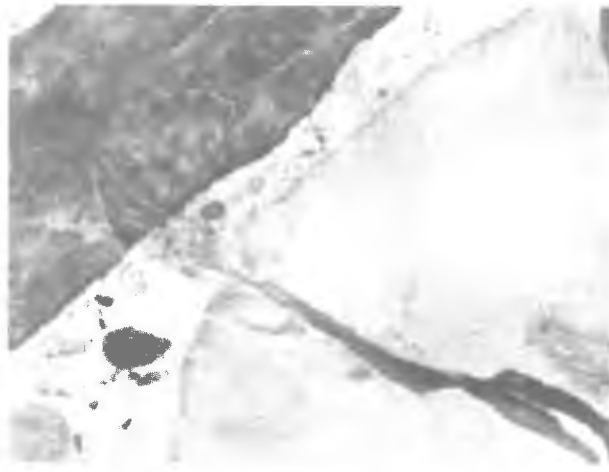
(a) Metamorphic aggregate

(b) Siltstone aggregate

Figure 3-7. Stereo optical micrograph showing gel deposits in SD-090-019 aggregates.

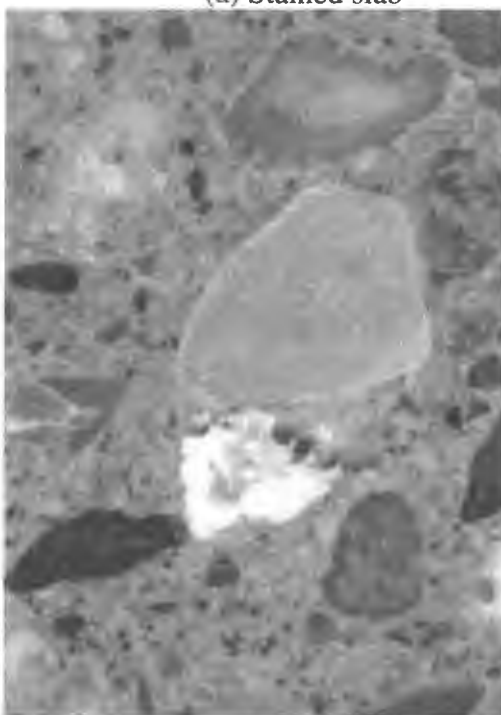
(c) ASR gel filled void

Figure 3-10. Slab 2B stained with sodium cobaltinitrite/rhodamine B from SD-090-019-002.

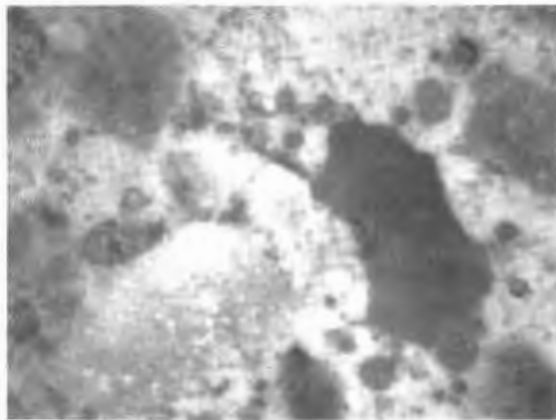
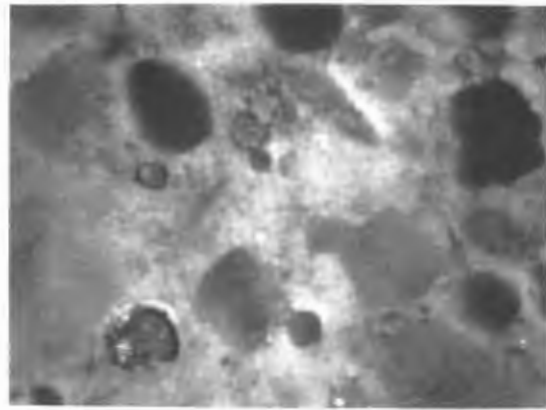
(a) Ettringite filled voids on polished surface

(b) Ettringite filled voids on polished surface

(c) Ettringite filled voids on unpolished surface

(d) Ettringite filled voids on unpolished surface

Figure 3-11. Stereo optical micrographs of air voids filled with sulfate minerals stained with potassium permanganate (note differences due to polishing).

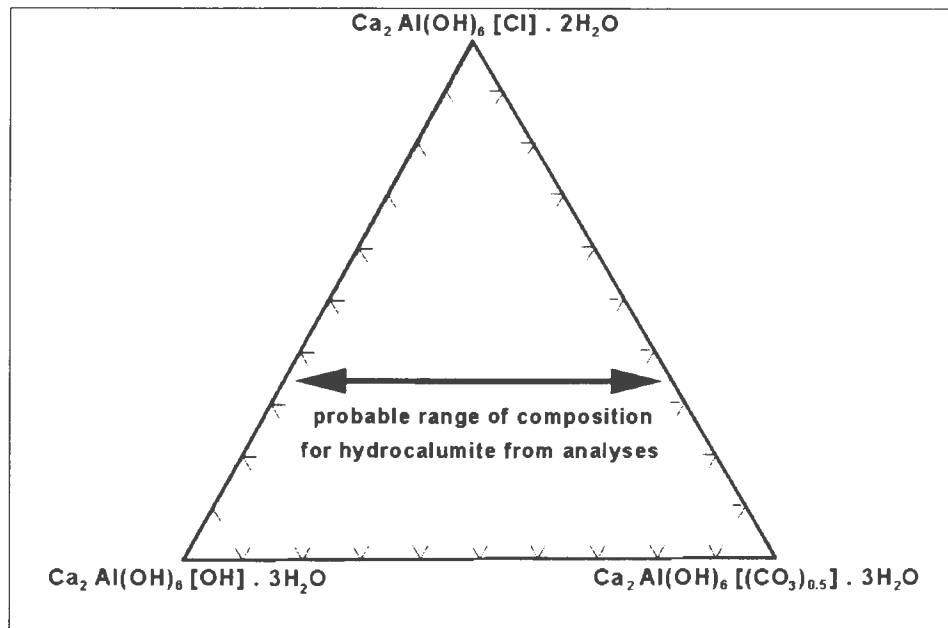
Figure 3-15. Ternary diagram showing the probable range of composition for the hydrocalumite deposits analyzed from SD-090-019.

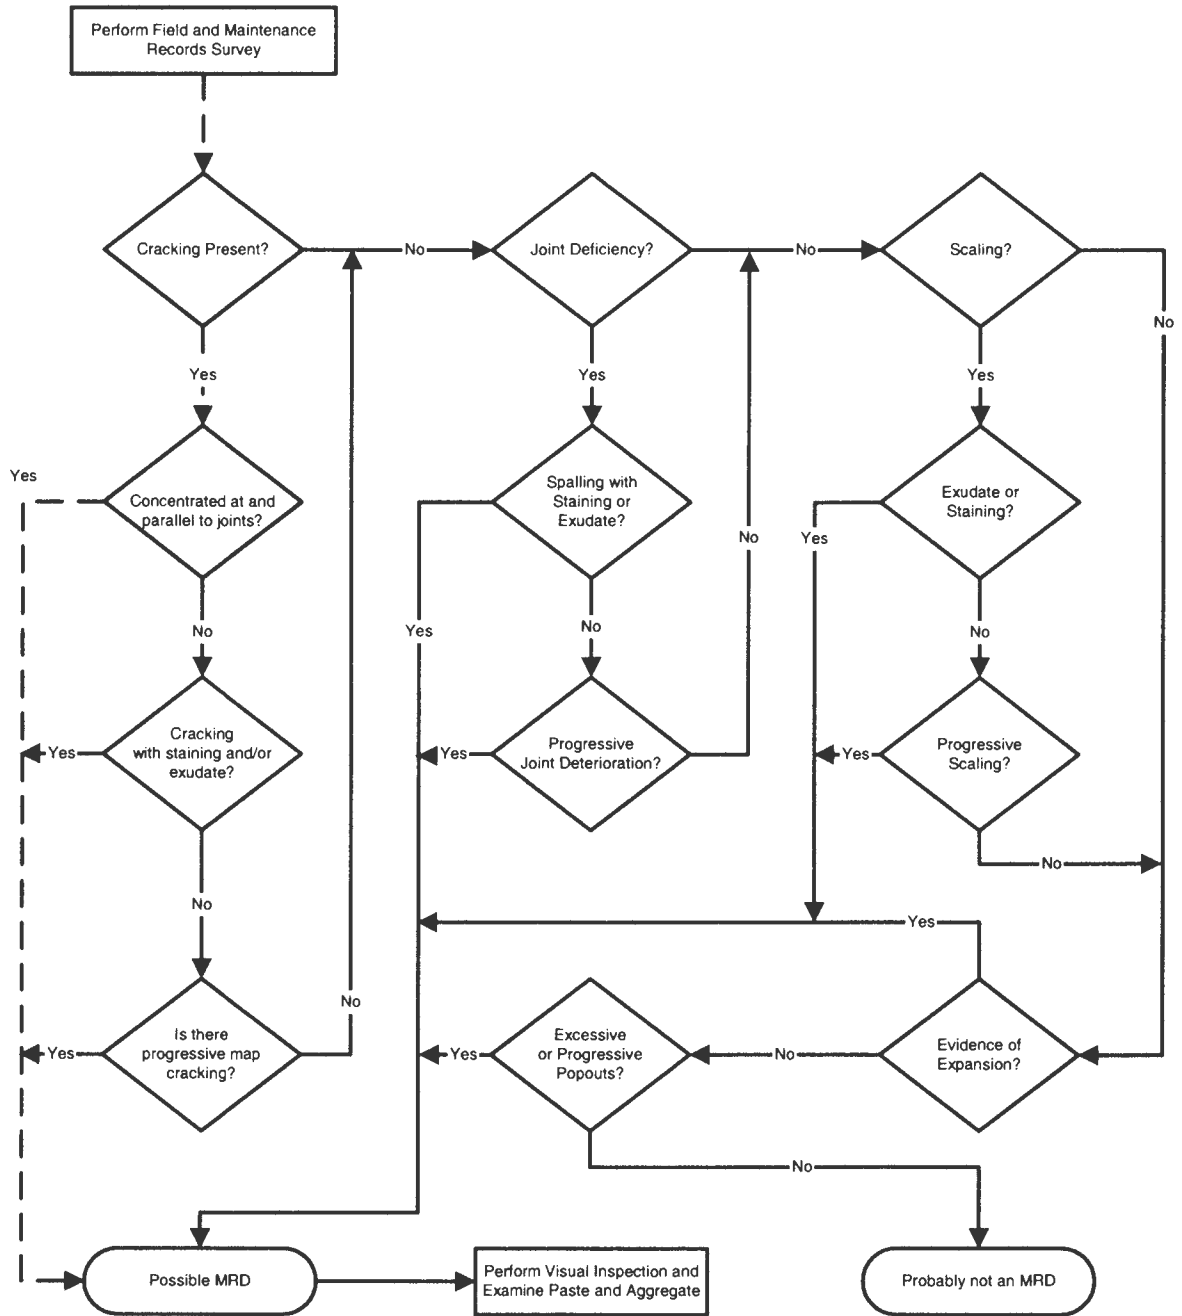
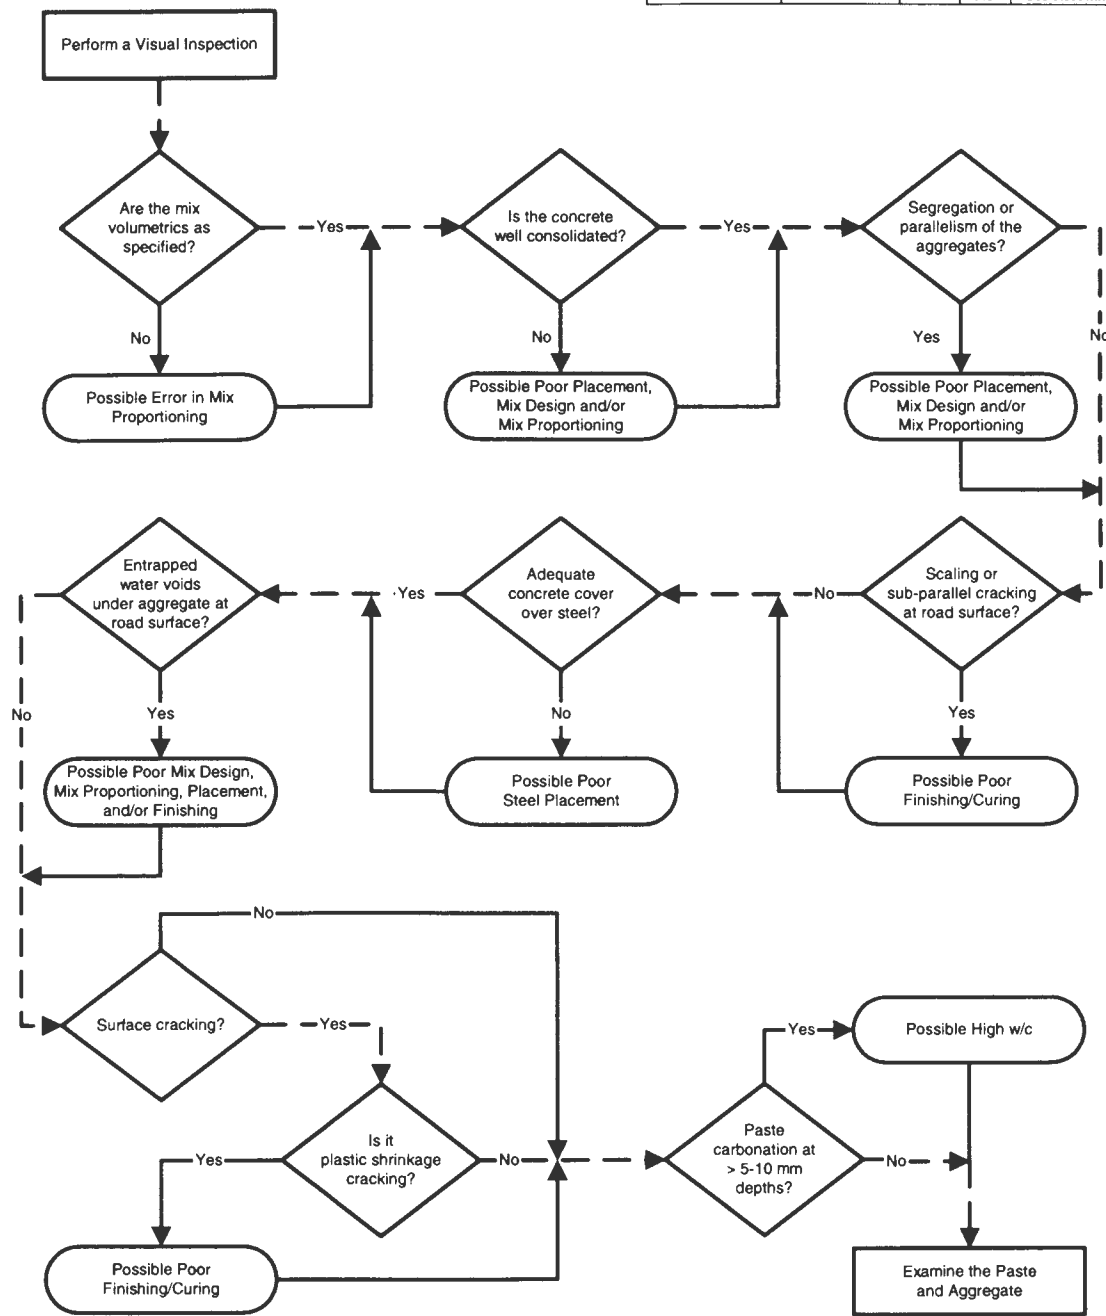
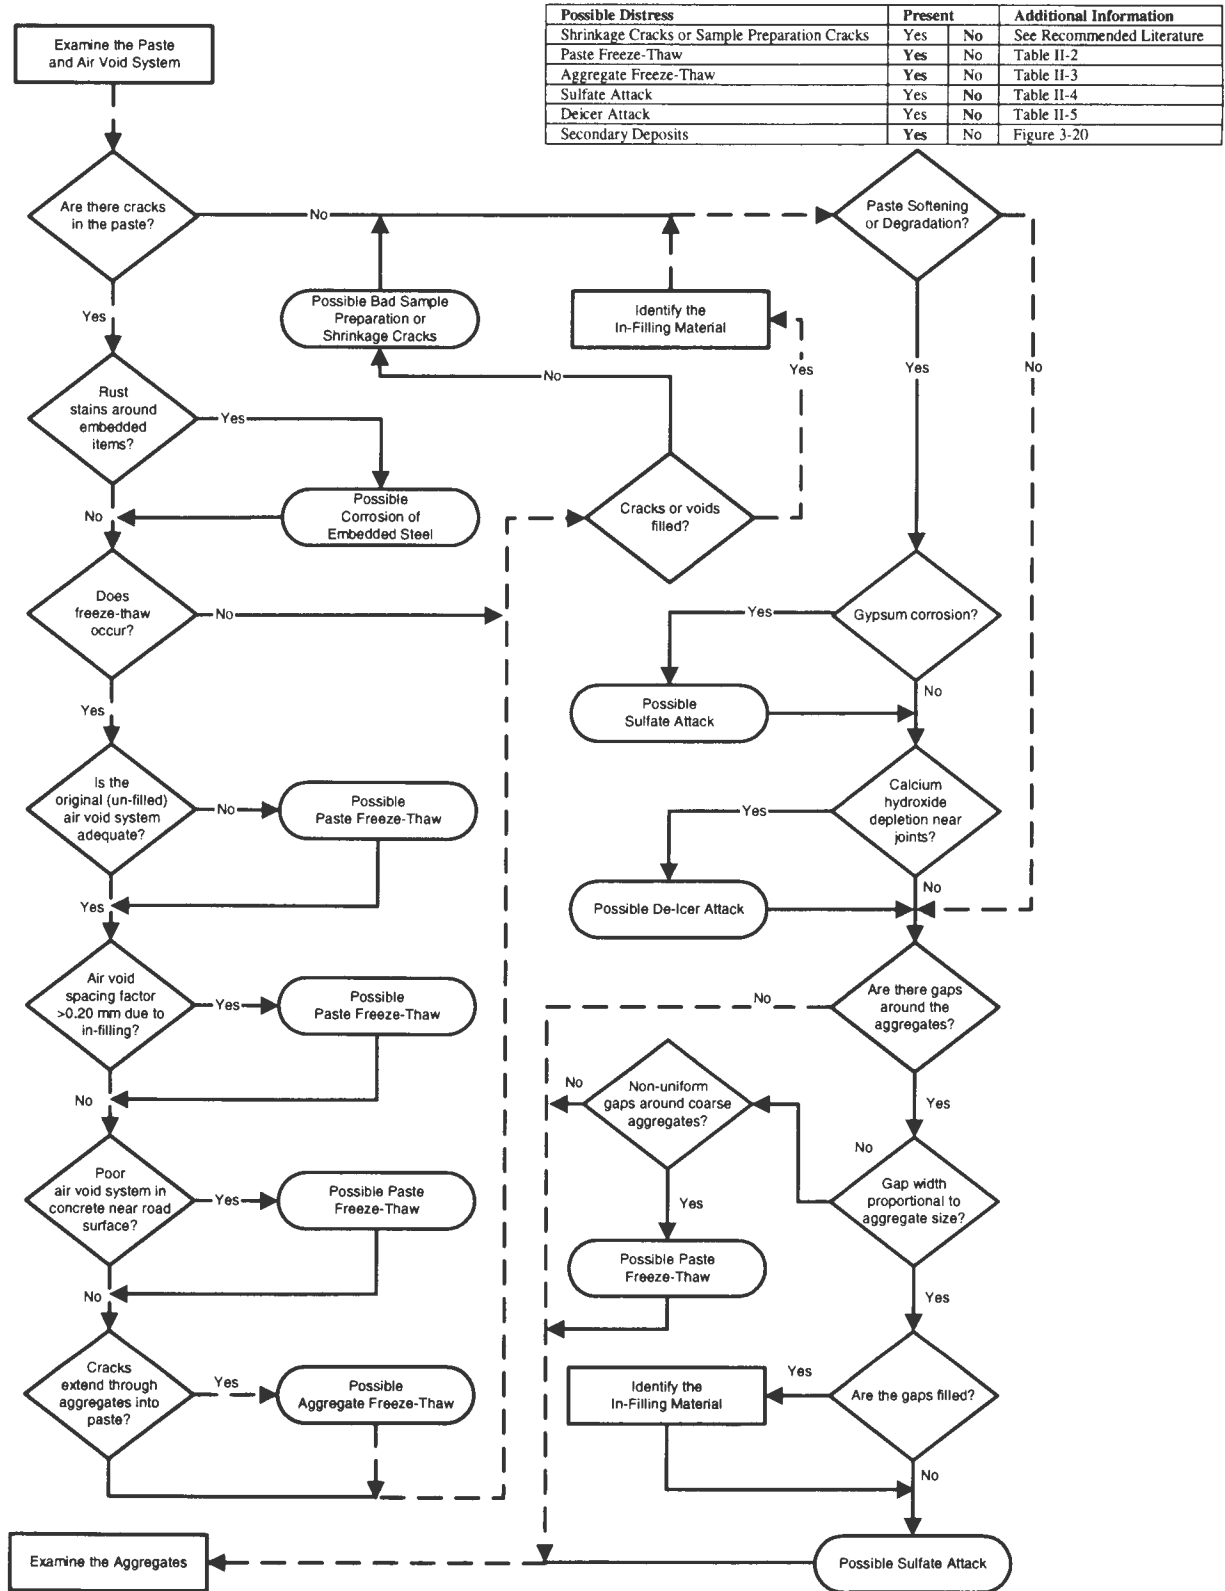
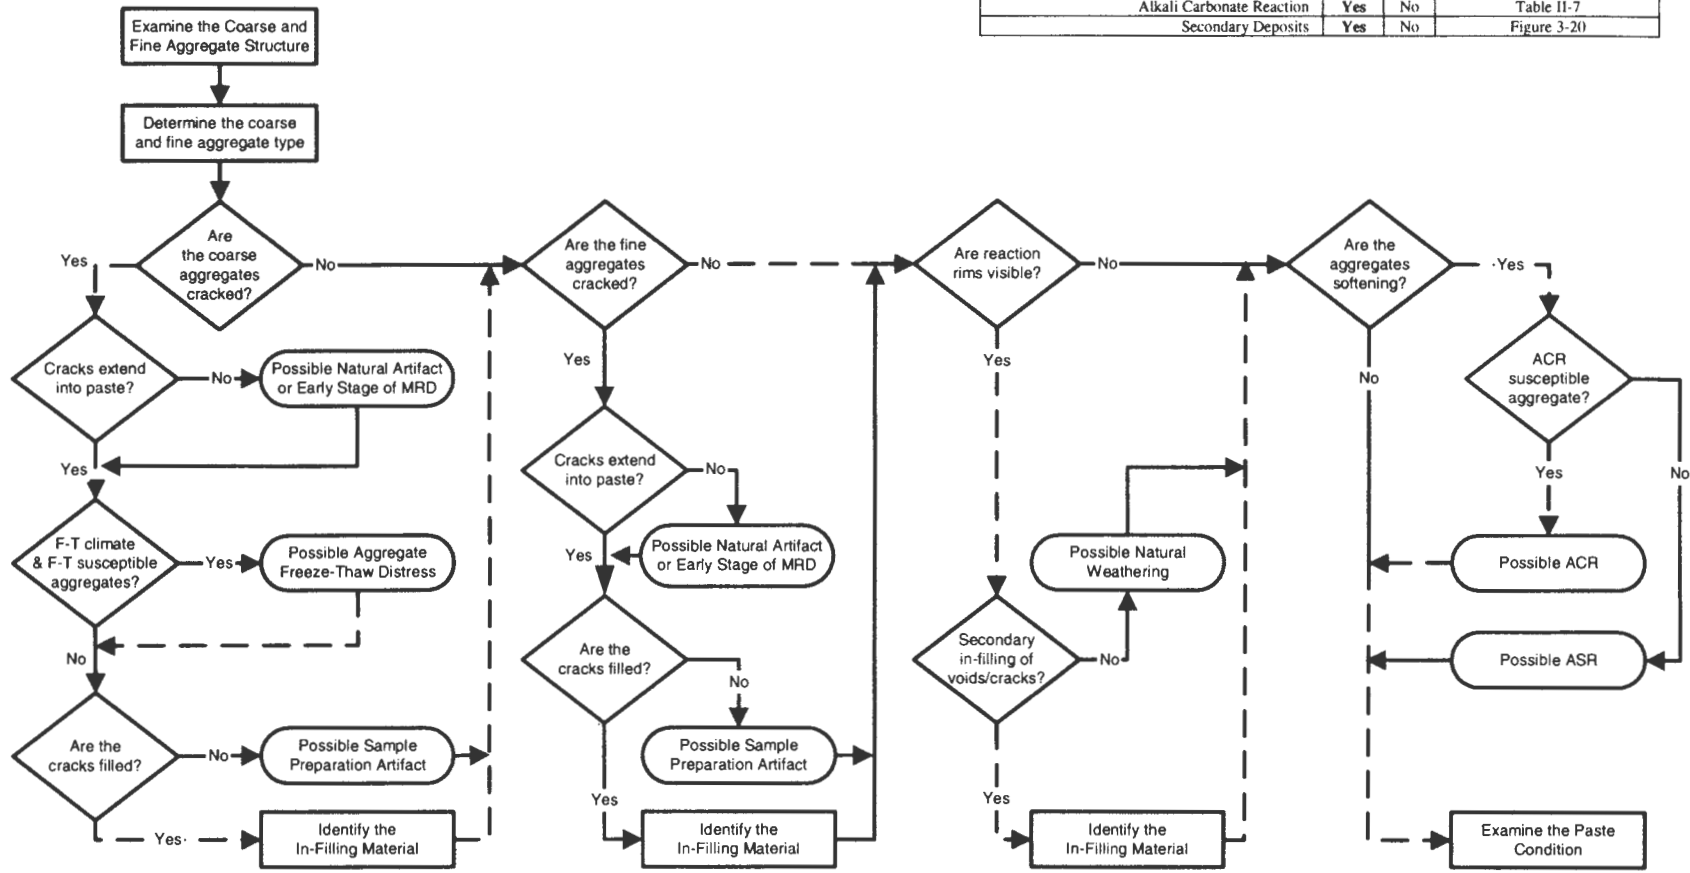
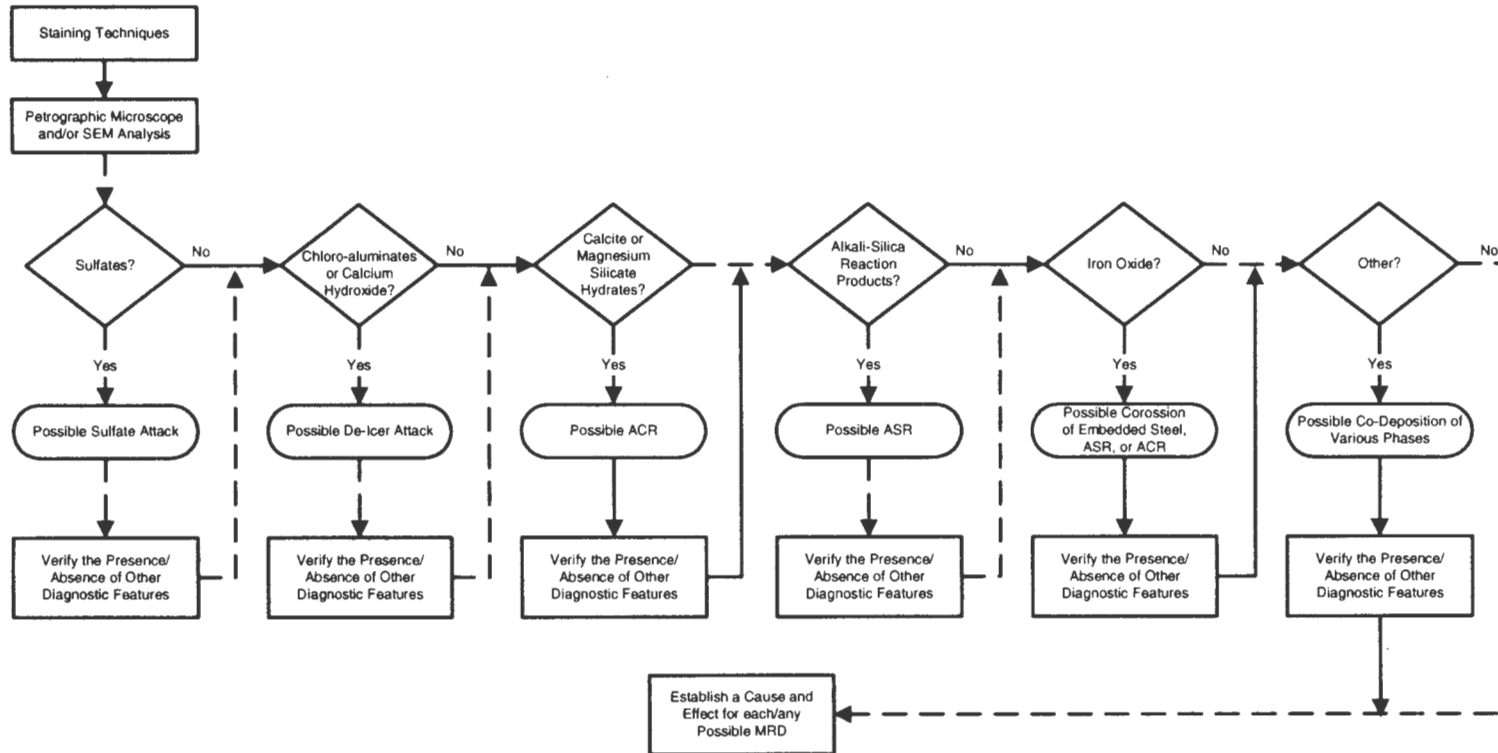
Having performed the described laboratory analyses and applied the diagnostic flowcharts as shown in figures 3-16 through 3-20, several possible MRDs were identified in SD-090-019-001, including ASR, ACR, aggregate freeze-thaw, and deicer attack. This is consistent with the visual observations of the distress reported from the field where mixtures of diagnostic features were apparent. To finalize the diagnosis, the diagnostic tables were consulted. The diagnostic features identified in the analysis processes are listed below in table 3-9 along with their associated MRD type and significance as related to this pavement. A brief discussion follows of each possible MRD identified in the laboratory analysis:

Figure 3-16. Flowchart for assessing the likelihood of MRD causing the observed distress in the pavement as applied to the Spearfish, South Dakota site.

Figure 3-17. Flowchart for assessing general concrete properties based on visual examination as applied to the Spearfish, South Dakota site.

Figure 3-18. Flowchart for assessing the condition of the concrete paste as applied to the Spearfish, South Dakota site.

Figure 3-19. Flowchart for assessing the condition of the concrete aggregates as applied to the Spearfish, South Dakota site.

Figure 3-20. Flowchart for identifying infilling materials in cracks and voids as applied to the Spearfish, South Dakota site.

The use of patching is still feasible even though ASR was observed since most deterioration is isolated in the vicinity of joints and cracks. Further, lithium compounds are not suggested since they are ineffective in delaying aggregate freeze-thaw damage.

Ultimately, as the pavement continues to deteriorate, a reconstruction/recycling option becomes more viable. If recycling is considered, precautions must be taken to avoid aggregate freeze-thaw deterioration and/or ASR in the newly constructed pavement.

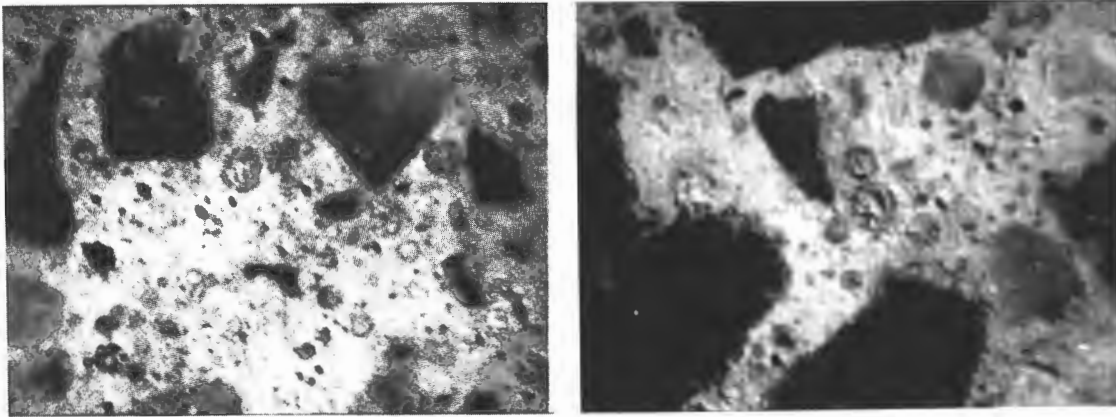
The rock type for the coarse aggregate was characterized as varying, but was dominantly mafic rock types typical of the Superior Lobe. The fine aggregate was the same, but with more quartz. No unusual alteration of the aggregate was observed. For this study, the most useful role for the stereo microscope was for observing stained specimens and determination of the hardened air content. The barium chloride/potassium permanganate stain described in Guideline II colors sulfate minerals a brilliant pink to purple hue as shown in figure 3-23.

Figure 3-23. Stereo optical micrographs showing sulfate minerals filling air voids.

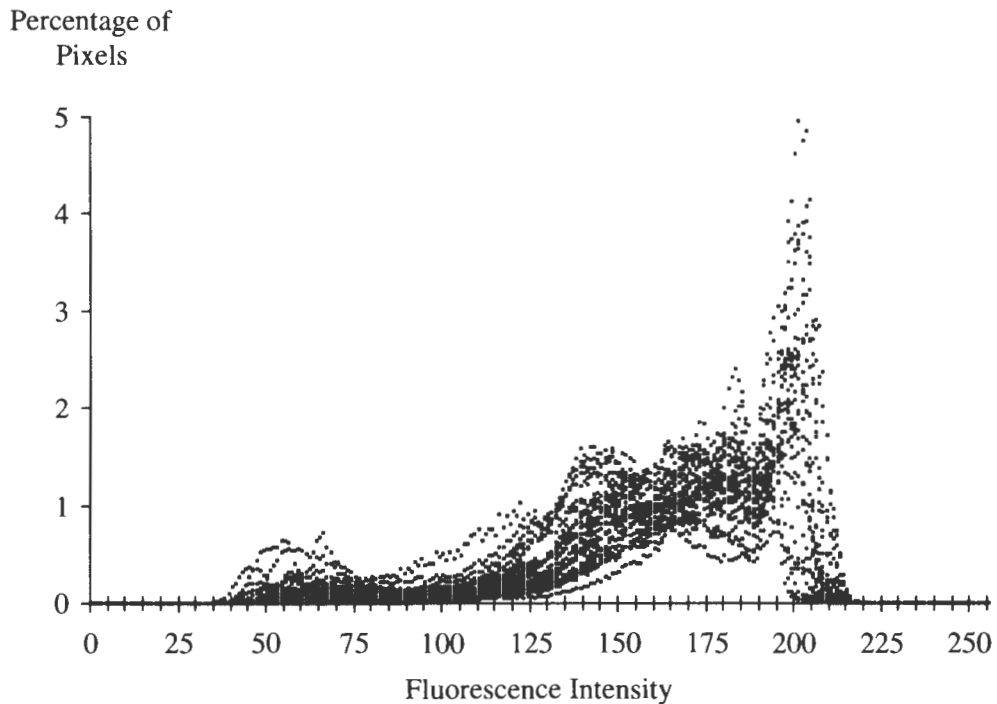
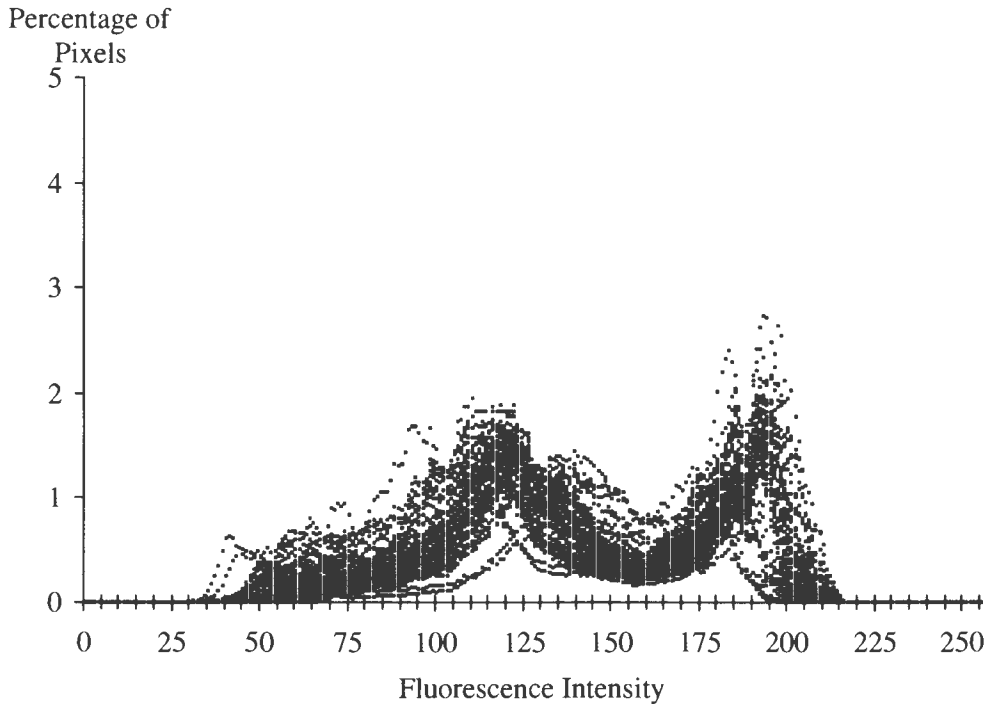
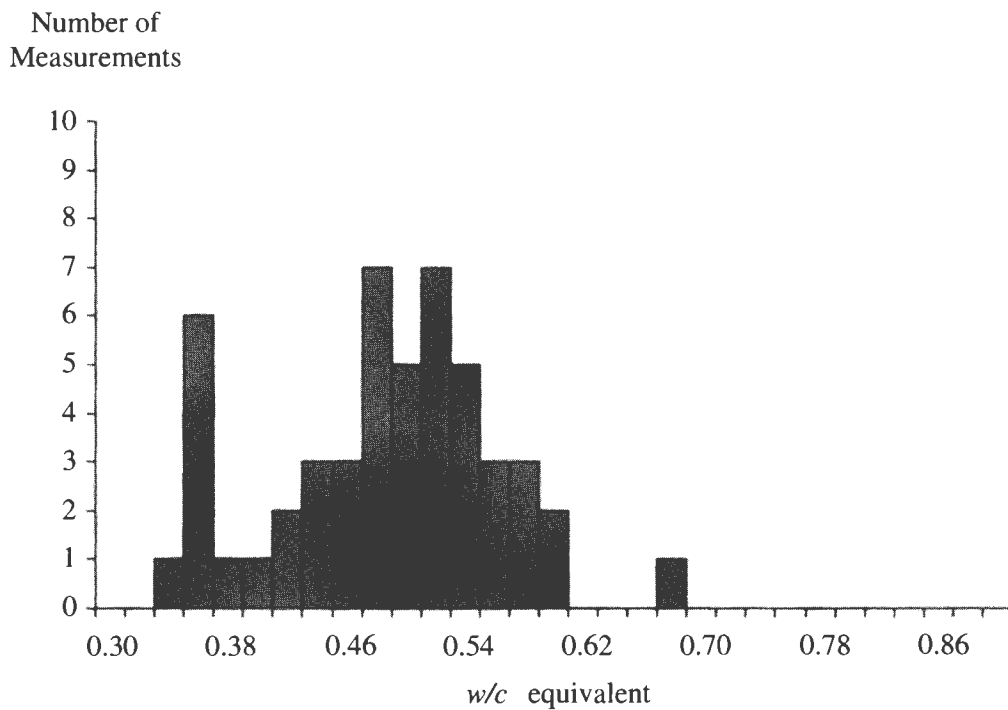
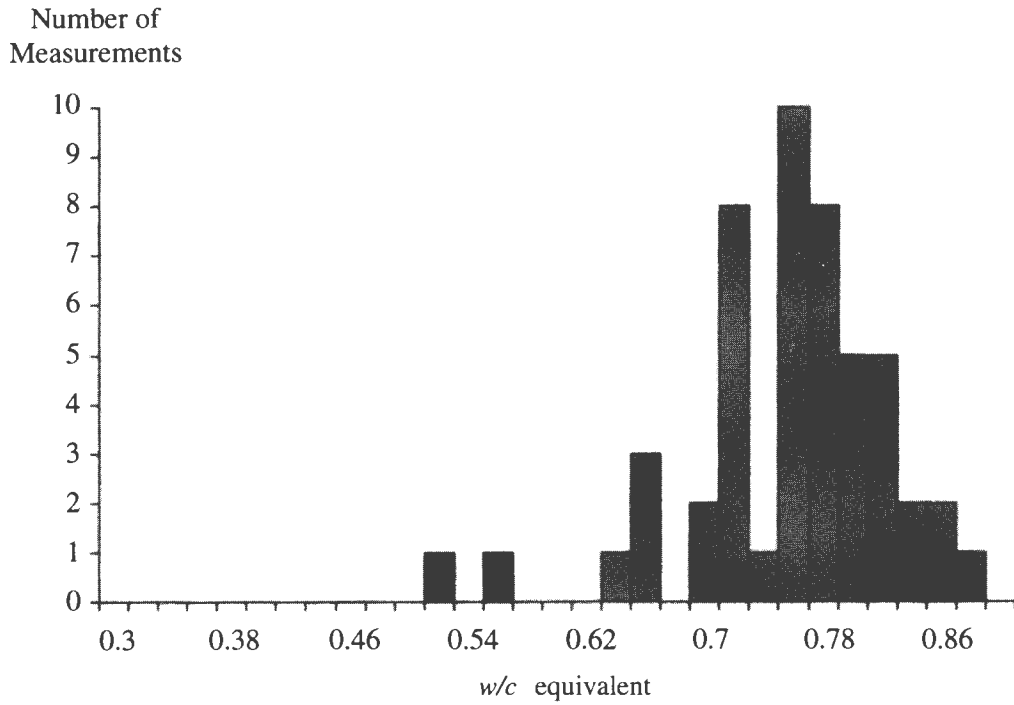
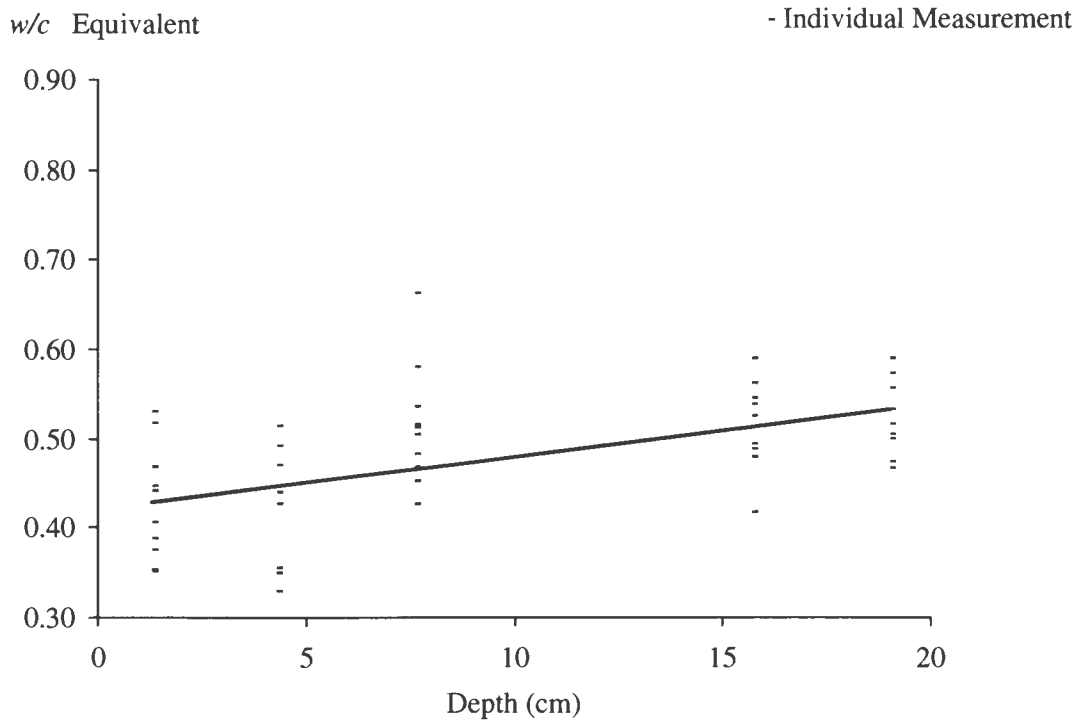
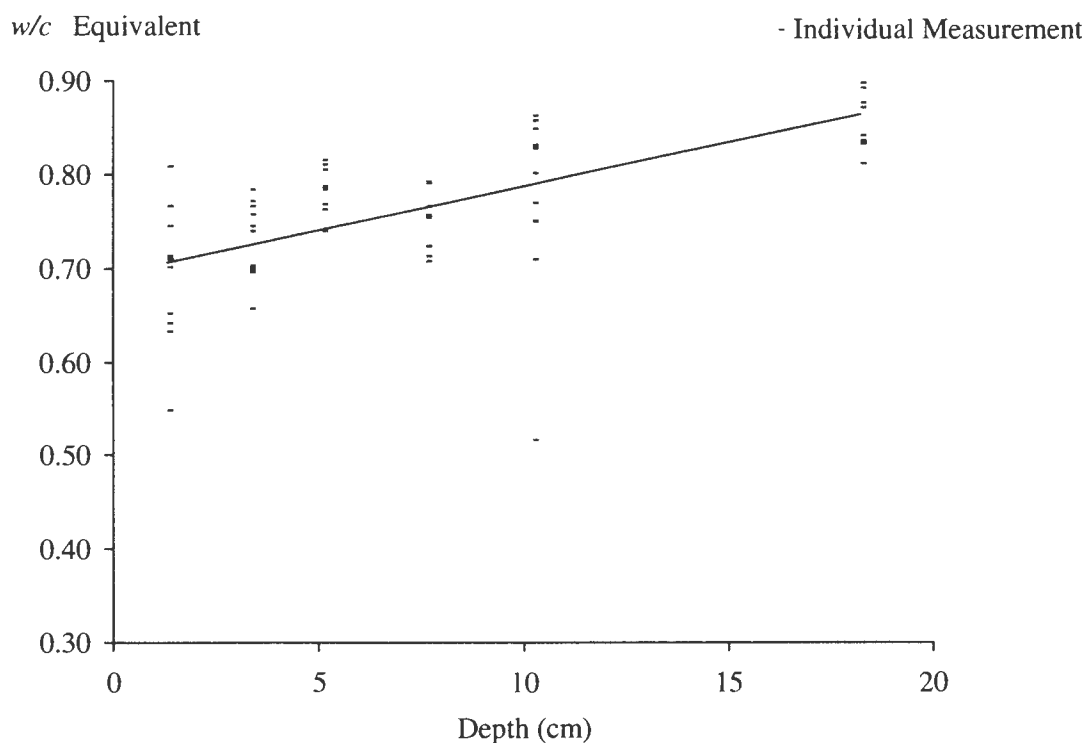
Figure 3-33. Histogram of fluorescence measurements from 1950 concrete from mid-panel of the left-turn lane of site MN-065-064-001.

Figure 3-34. Histogram of fluorescence measurements from 1990 concrete from mid-panel of the traffic lane of site MN-065-064-001.

Figure 3-35. Distribution of the w/c values from the 1950 concrete from mid-panel of the left-turn lane of site MN-065-064-001.

Figure 3-36. Distribution of the w/c values from the 1990 concrete from mid-panel of the traffic lane of site MN-065-064-001.

Figure 3-37. The w/c values versus depth from the 1950 concrete from mid-panel of the left-turn lane of site MN-065-064-001.

Figure 3-38. The w/c values versus depth from the 1990 concrete from mid-panel of the traffic lane of site MN-065-064-001.

Paste Freeze-Thaw – Clearly, there were two distinguishing features of this distressed concrete. The first was the softness and high effective *w/c* for this concrete. The porous paste was evident even in the mid panel when compared to the passing lane constructed with similar aggregates but approximately 40 years before the failed concrete. Of course, changes in cement characteristics and other factors may be contributors to the observed paste characteristics. However, it is unlikely that these factors would result in a difference of the magnitude seen in these pavement sections. It is most probable that a high *w/c* contributed to the observed distress. In addition, the original air system was marginal and once infilling occurred; the hardened air system became inadequate to protect the weakened paste.

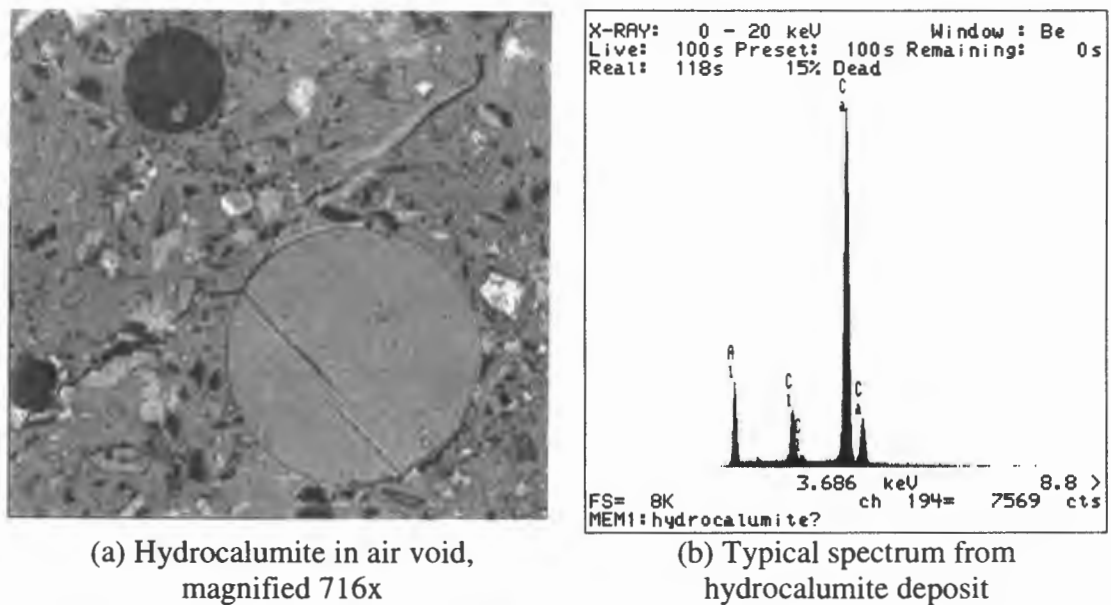
SEM was used to identify infilling material in voids and cracks. As indicated earlier, the principal materials identified were ettringite and hydrocalumite as shown in the typical SEM micrographs and x-ray analyses presented in figures 3-39 and 3-40.

Figure 3-40. Typical SEM micrograph and x-ray analysis for hydrocalumite infilling air void.

Deicer Attack – This MRD may be opportunistic or it may be a contributor. Given the degree of distress seen near the joint, it is reasonable to infer that deicer attack was a factor. Also, the presence of hydrocalumite is an indicator that this concrete was exposed to a high chloride environment, given the necessary high chloride concentration required for this phase to precipitate.

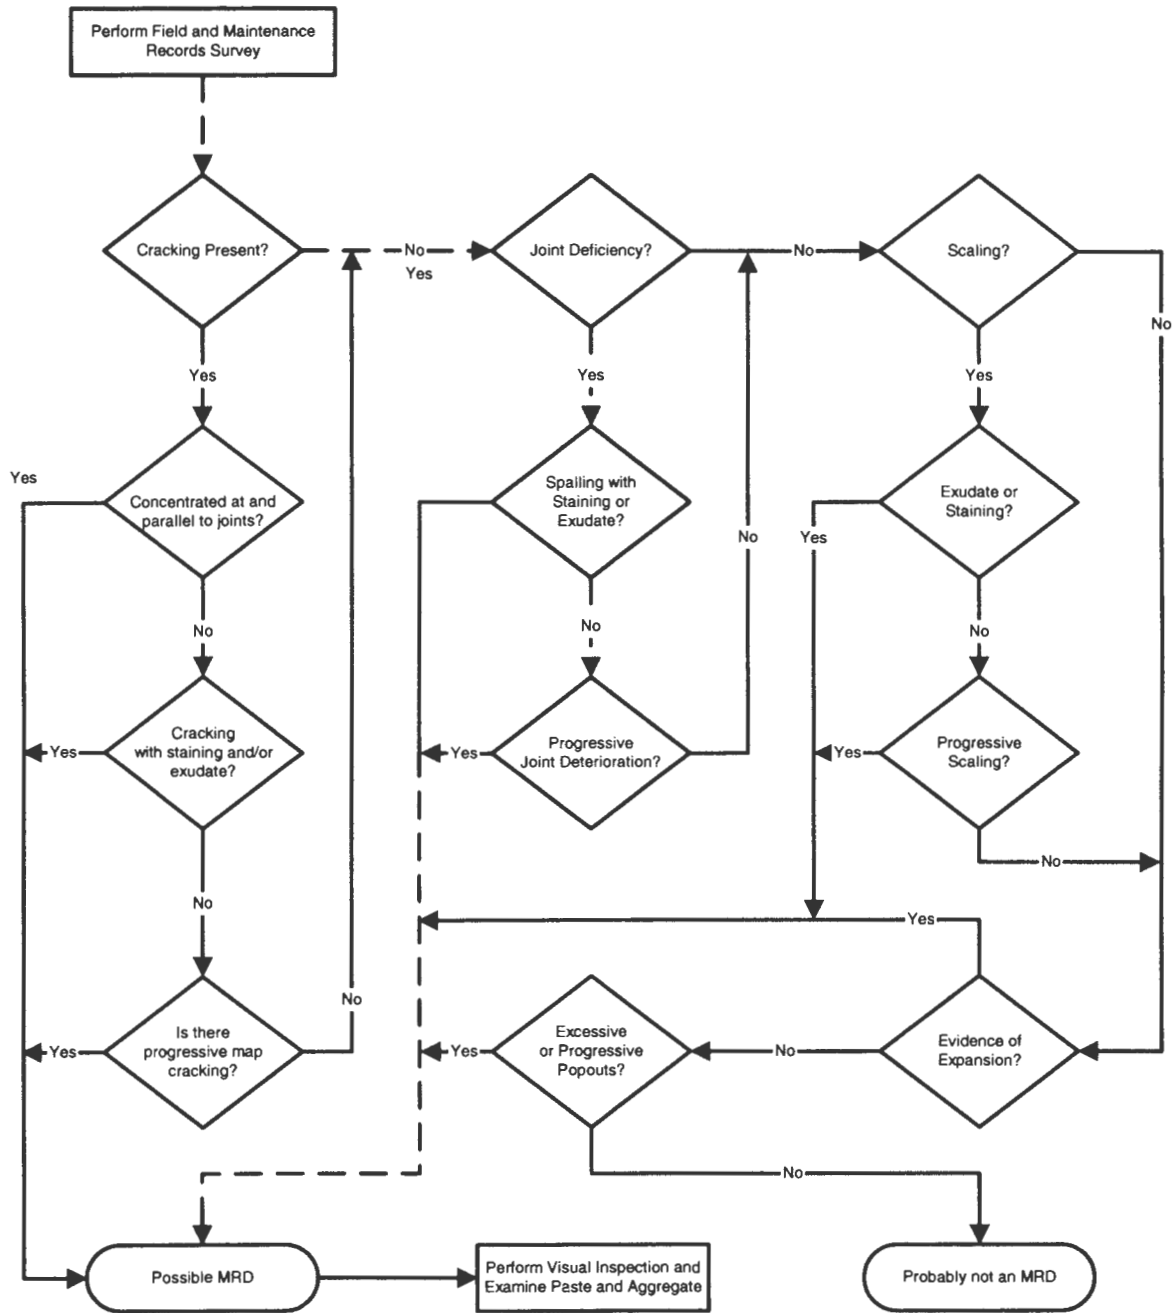
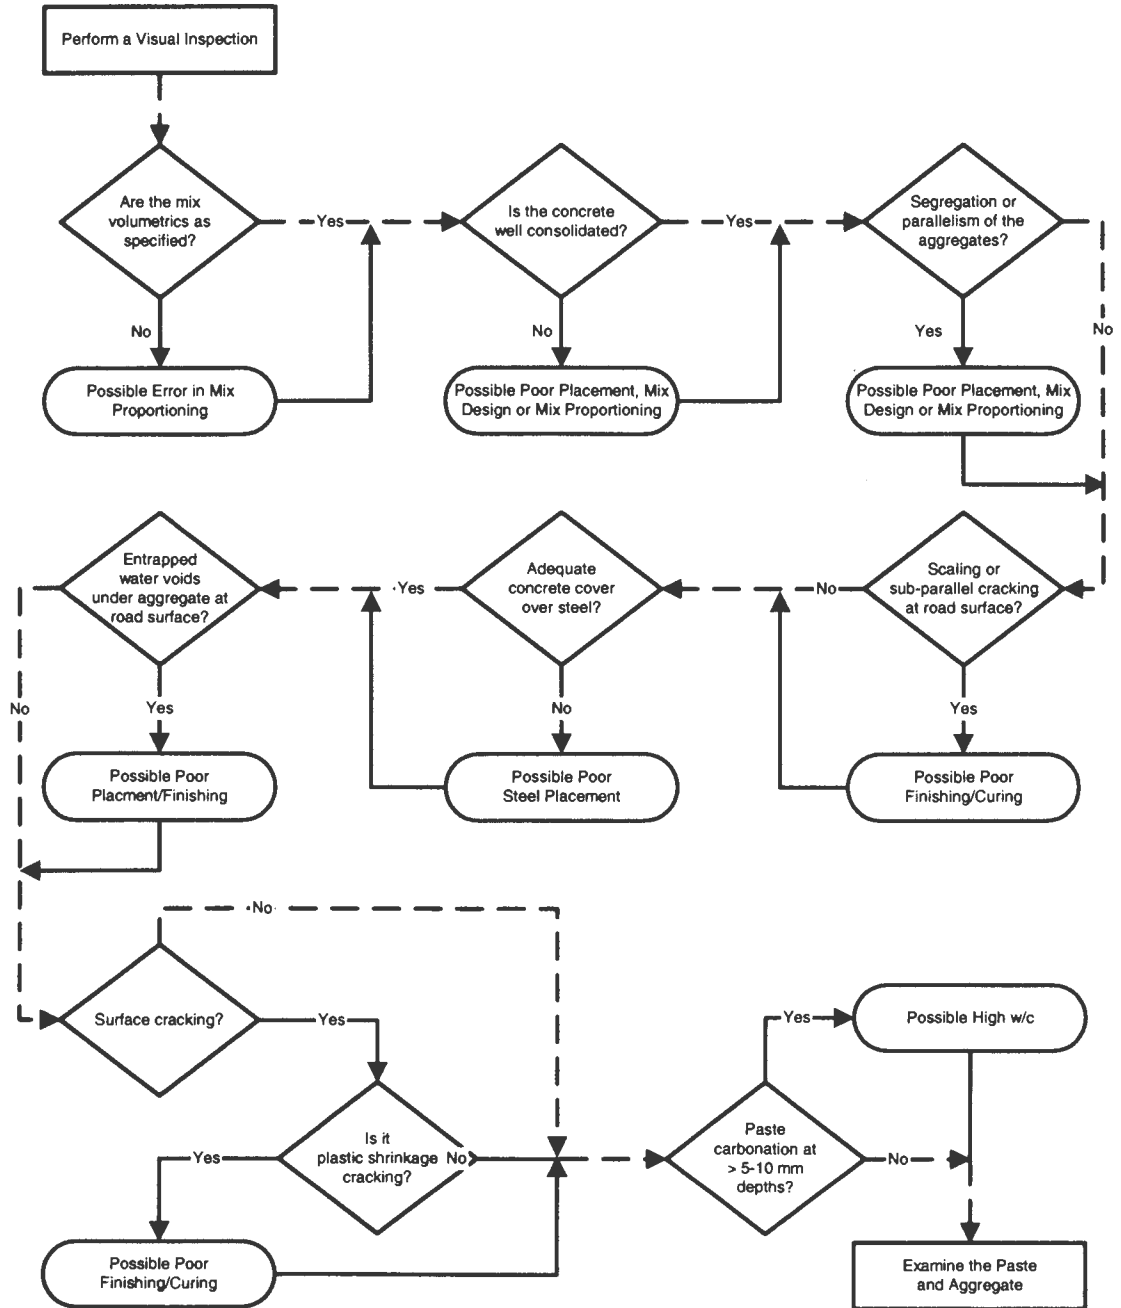
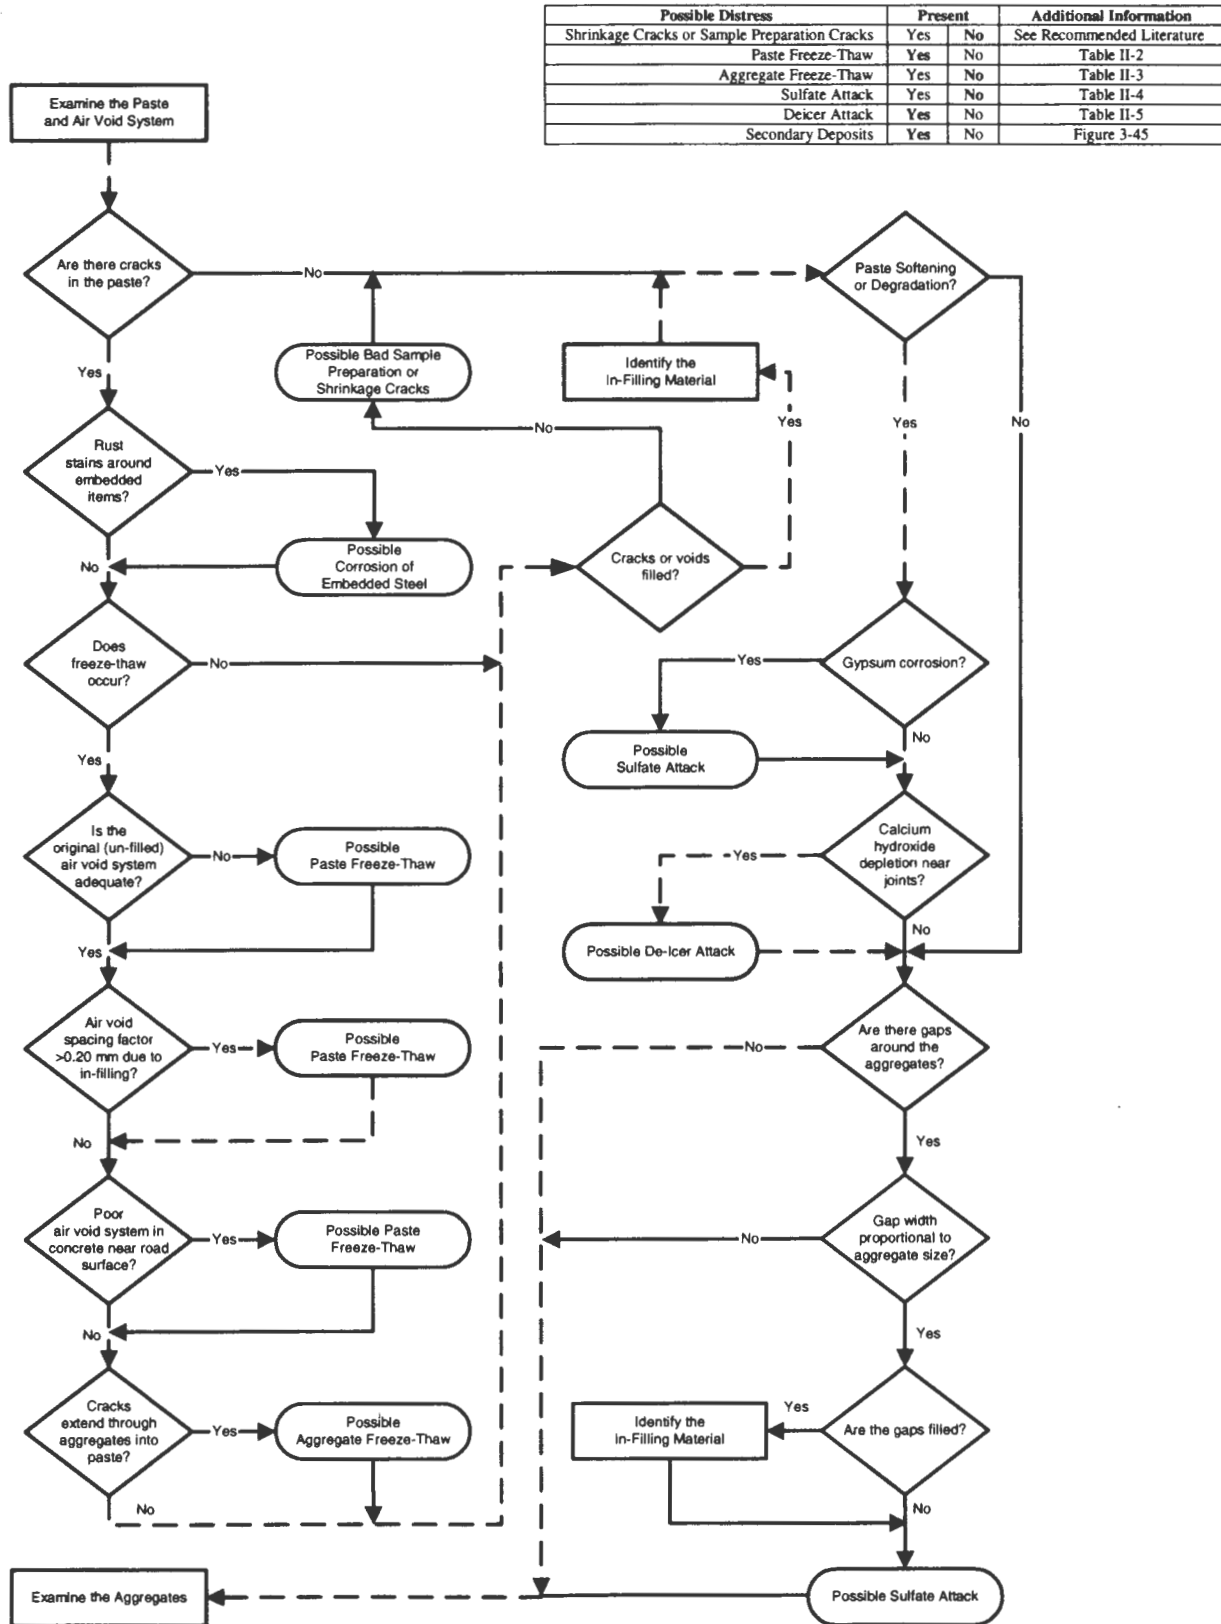
Having performed the described laboratory analyses and applied the diagnostic flowcharts reproduced in figures 3-41 to 3-45, two possible MRDs were identified in MN-065-064-001, including paste freeze-thaw and deicer attack. To finalize the diagnosis, the diagnostic tables were consulted. The diagnostic features identified in the analysis processes are listed below in table 3-17 along with their associated MRD type and significance as related to this pavement. A brief discussion follows of each possible MRD identified in the laboratory analysis:

Figure 3-41. Flowchart for assessing the likelihood of MRD causing the observed distress in the pavement as applied to MN-065-064.

Figure 3-42. Flowchart for assessing general concrete properties based on visual examination as applied to MN-065-064.

Figure 3-43. Flowchart for assessing the condition of the concrete paste as applied to MN-065-064.
