Guidelines for Detection, Analysis, and Treatment of Materials-Related Distress in Concrete Pavements Volume 3: Case Studies Using the Guidelines

PUBLICATION NO. FHWA-RD-01-165

AUGUST 2002

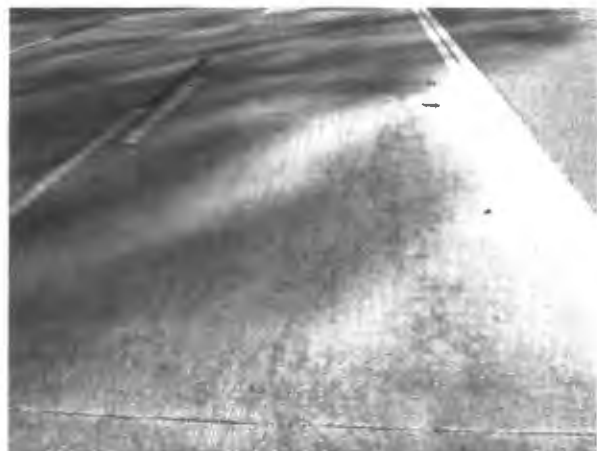
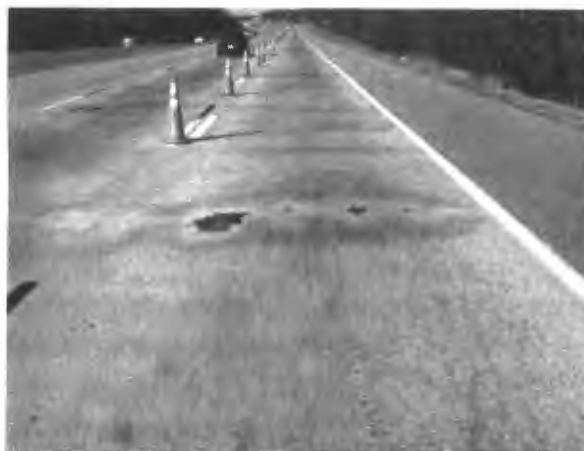
The primary distress, and the reason this section was selected as part of this project, is the extensive surface cracking exhibited over the entire pavement area. These hairline cracks run parallel to the longitudinal joints and are more prevalent near the outer edge of the slab (i.e., near the longitudinal joints). Some cracks are stained immediately around the cracks, which further highlights the presence of the cracks. The staining is typically dark gray areas around the crack; no exudate appears to be present in the cracks.

Figure 3-46. Typical cracking pattern at NC-444-015. Note distress over entire slab length with spalling occurring at joints.

For the most part, these surface cracks are not causing any immediate concerns or problems. At a few joints and at the two transverse cracks, the surface cracks have begun to deteriorate and create loose pieces and some large spalls were seen on the side of the road. These areas have been patched with AC. Otherwise, the cracks are not adversely affecting the ride quality.

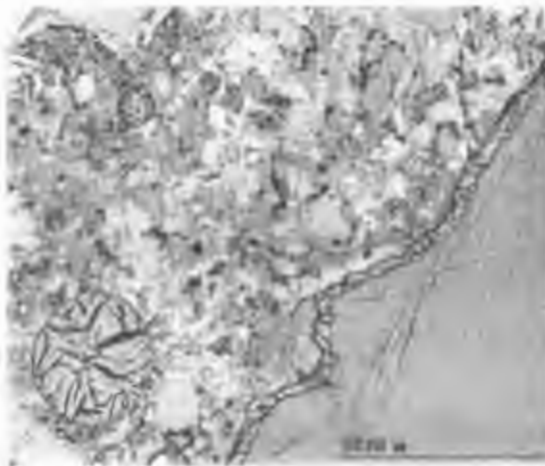
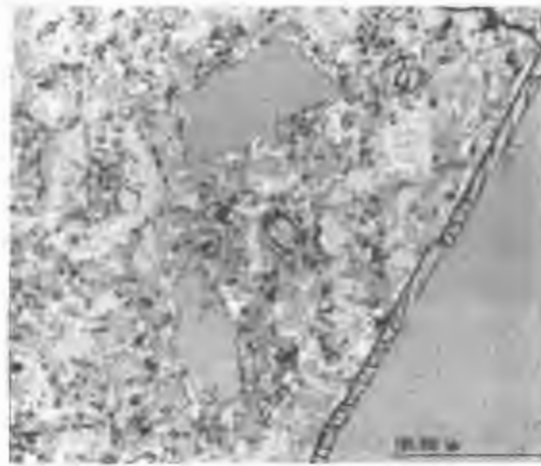
Using the SEM, quantitative measurements of ettringite and ASR “gel” compositions were made. Ettringite deposits were extensive and found both in entrained air voids and in cracks in the cement paste and in cracks along the contact with coarse aggregates. Measurements were made of the coarse aggregate ASR product pictured in figure 3-54, both within the crack in the coarse aggregate, and in the region where the crack comes into contact with the cement paste. Measurements were also made of the gel blobs associated with the fine aggregates. The presence of small amounts of iron in the ASR product is unusual. Figures 3-55 and 3-56 are SEM micrographs of ettringite and ASR reaction product. Figure 3-57 shows the typical spectra for ettringite and ASR reaction product.

(a) Ettringite in entrained air void, and in crack along contact between cement paste and coarse aggregate.

(b) Ettringite in entrained air void, and in crack along contact between cement paste and coarse aggregate. Large relict cement grain also visible.

Figure 3-55. SEM micrograph of ettringite filling air voids and crack.

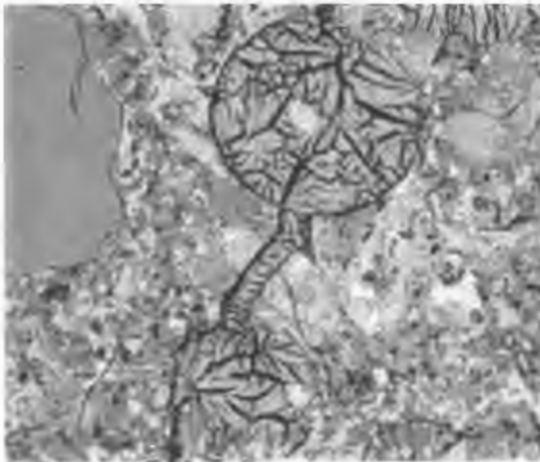
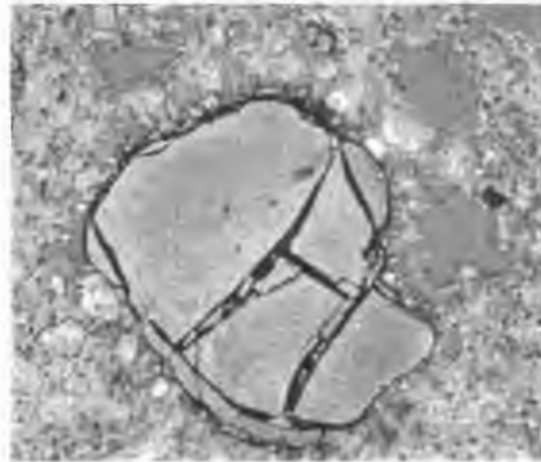
(a) Two ettringite filled air voids connected by a crack, also filled with ettringite.

(b) ASR "gel blob" associated with fine aggregate. Spectrum shown in figure 3-57 contain data collected from this deposit.

Figure 3-56. SEM micrograph of ettringite and ASR reaction product.

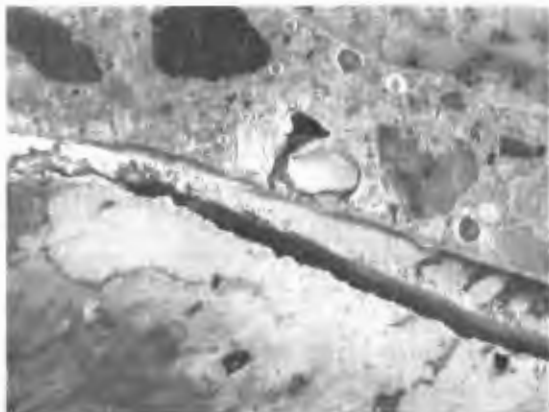
Cores C and D were slabbed and stained using the sodium cobaltinitrite stain for identifying ASR reactive aggregates and reaction products. Also, slabs were stained with the potassium permanganate/barium chloride stain for identifying sulfate minerals. ASR reaction product was seen in cracks associated with the coarse aggregate. Ettringite was common in cracks and voids, and actually was more common than ASR reaction product. Examples of these stains as applied are shown in figure 3-65.

(a) Sodium cobaltinitrite yellow stain picked up in crack within felsic volcanic coarse aggregate

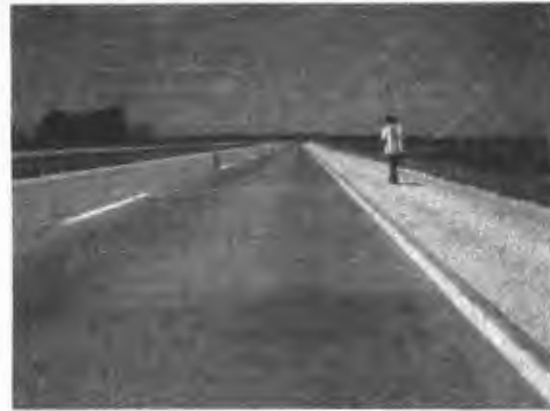
(b) Staining along transverse joints

Figure 3-81. Site conditions at IA-002-002.

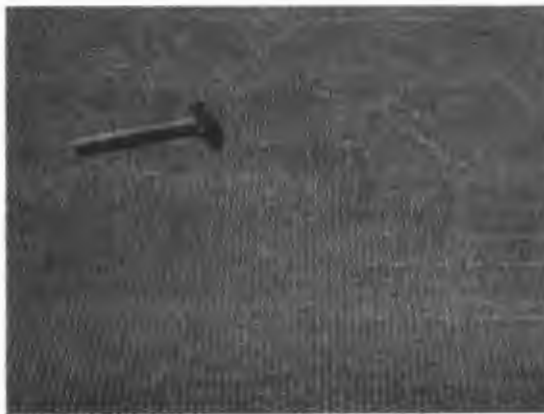
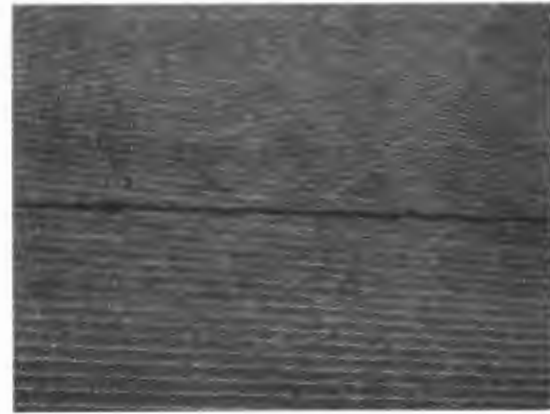
A characterization of potential MRD was conducted in the field to assist in the diagnosis of the type and cause of the distress. The potential MRD on both sections is the presence of short longitudinal cracks throughout the sections. These cracks are generally confined to the wheel paths and in many cases initiate at a transverse joint. There is some slight staining, which is brownish-gray in appearance, around transverse joints and in the wheel paths. There is no exudate observed at the cracks. Table 3-37 provides a summary of the MRD characteristics for this project. Figure 3-81(a) shows staining along longitudinal cracks and at the transverse joints. Figure 3-81(b) shows closeup views of the hairline cracks. Additional site conditions are shown in figure 3-82.

Figure 3-82. Closeup view of longitudinal hairline cracks.

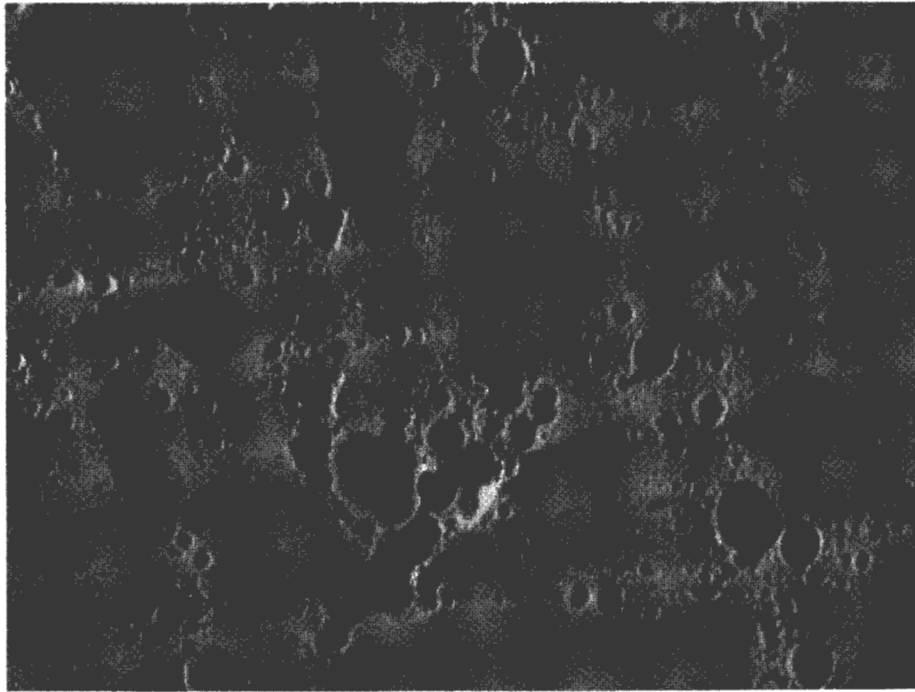
The most striking feature of the concrete was the abundance of small, entrained air voids, as shown in figure 3-84. Although the concrete did contain a large percentage of air, the specific surface and spacing factors were within reasonable values. A summary of the Modified Point Count is included in table 3-38. There was moderate infilling of the void structure by secondary ettringite. Some isolated alkali-silica gel deposits were observed with some of the fine aggregate particles. The gel deposits were found filling air voids near the reactive particles, and were not associated with any cracking. The coarse aggregates were intact, and did not appear to be reactive.

Figure 3-84. Stereo micrograph showing air void structure of IA-002-002-001A, magnified 7.5x.
