Detectable Warnings: Synthesis of U.S. and International Practice

Accessible Design for the Blind

12 May 2000

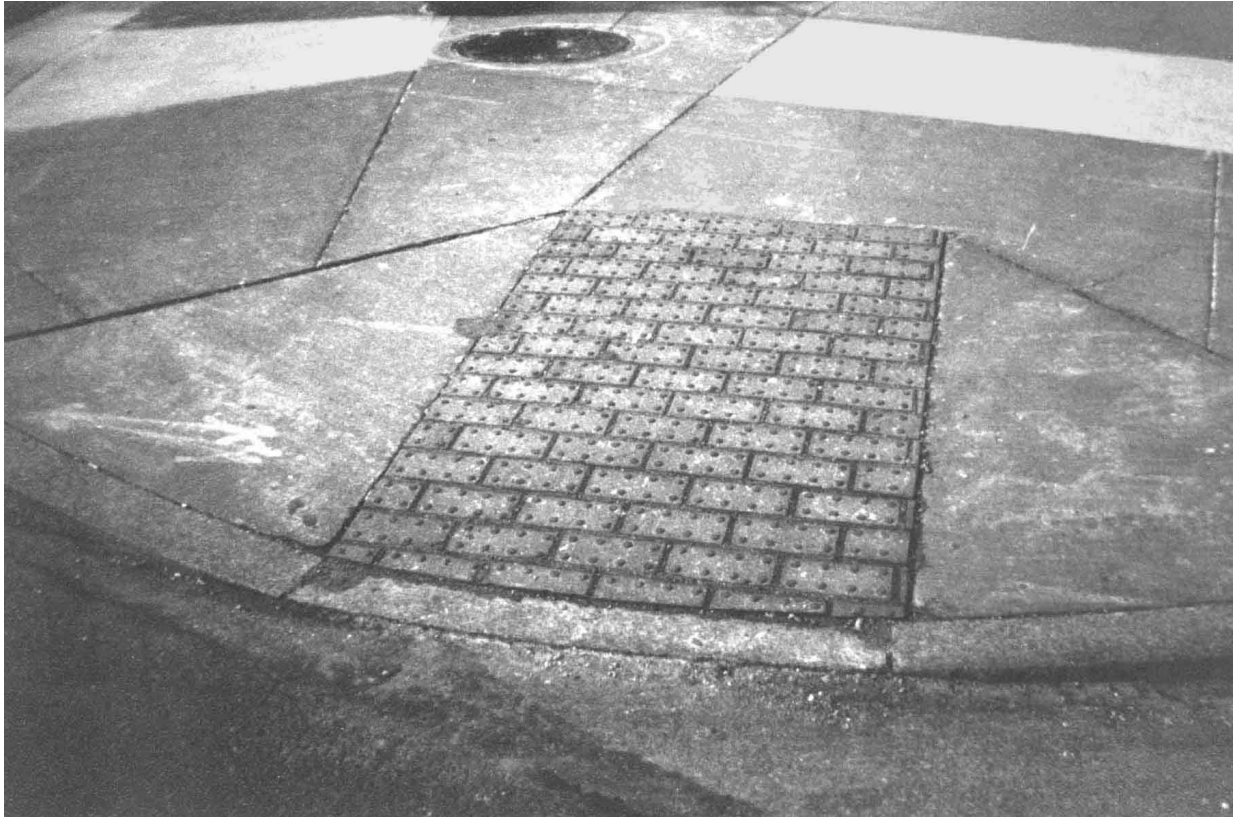
FIG. 0-2. CURB RAMP COMPLYING WITH ADAAG 4.7.7
(TEMPORARILY SUSPENDED), CLEVELAND, OH.

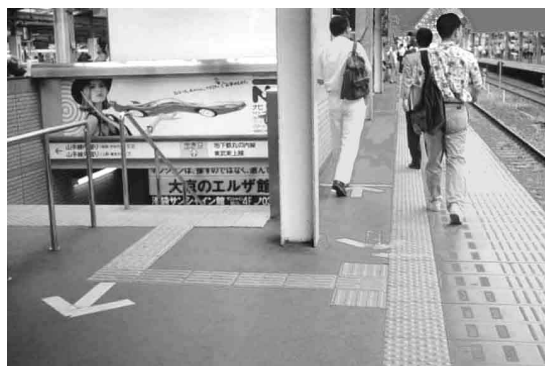
FIG 1-1. JAPANESE TRANSIT PLATFORM SHOWING DETECTABLE WARNING AT THE TOP OF STAIRS AND PARALLEL TO THE PLATFORM EDGE, AND A TACTILE PATH LEADING FROM THE STAIRS TO THE WAITING AREA ALONG THE PLATFORM.

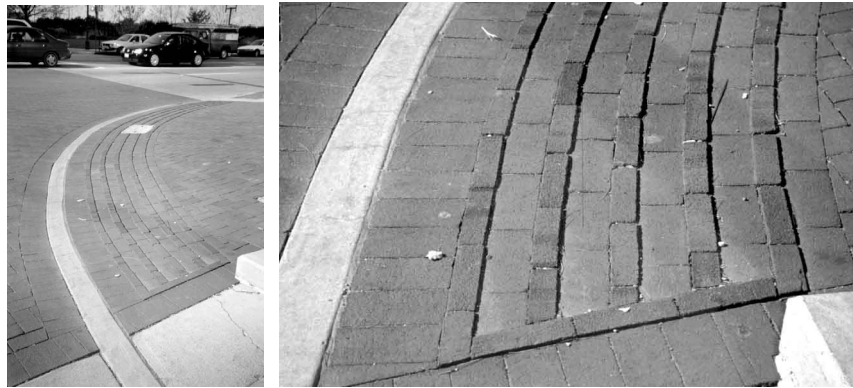
FIG. 1-3. A BLENDED CURB IN COLUMBUS, OH, WHICH USES DIFFICULT-TO-DETECT ROWS OF RAISED BRICK.

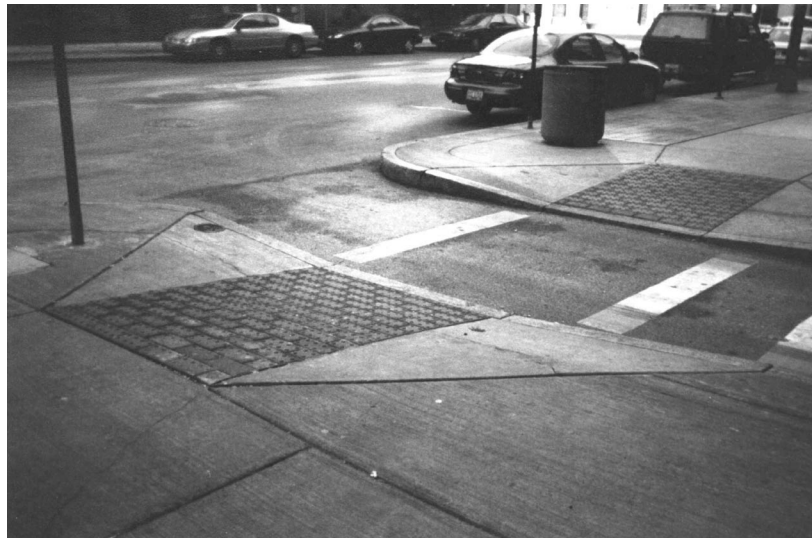
FIG. 1-8. CURB-RAMPS WITH TRUNCATED DOME DETECTABLE WARNINGS ON OPPOSITE SIDES OF AN ALLEY, CLEVELAND, OH.

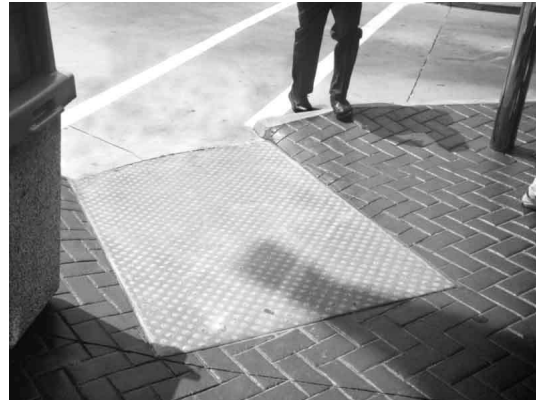
FIG. 2-5. FLORIDA CURB RAMP COMPLYING WITH ADAAG 4.7.7.

A curb ramp shall have a detectable warning complying with [ADAAG] 4.29.2. The detectable warning shall extend the full width and depth of the curb ramp.

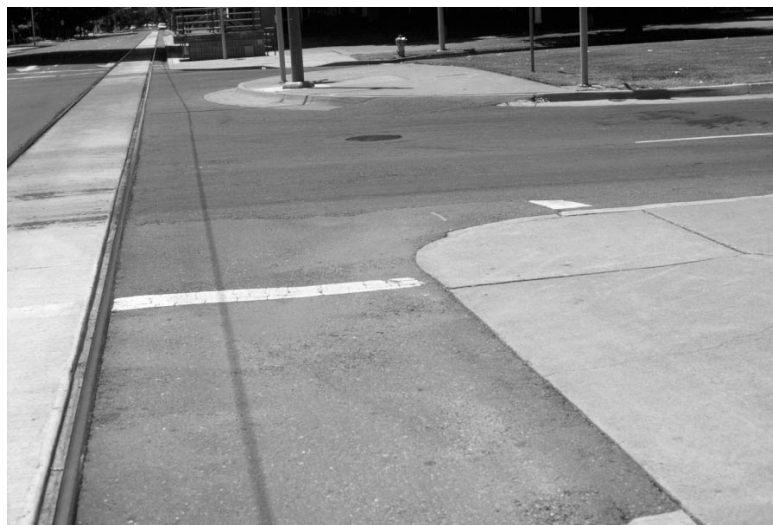
FIG. 3-1. WHERE THERE IS NO DIFFERENCE IN SLOPE OR ELEVATION BETWEEN THE SIDEWALK AND STREET, IT IS PARTICULARLY DIFFICULT FOR PEDESTRIANS WHO ARE BLIND TO DETERMINE WHEN THEY HAVE REACHED AN INTERSECTING STREET. BLENDED CURB IN SACRAMENTO, CA.

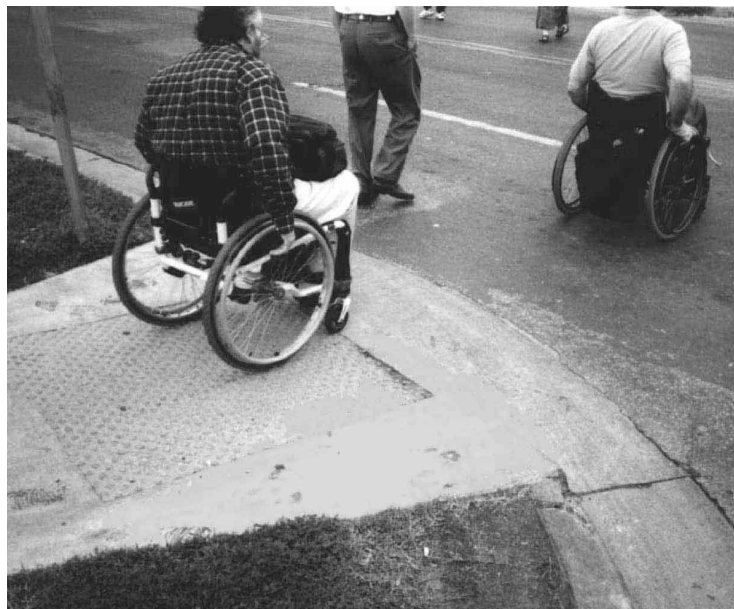
FIG. 3-2. STAMPED CONCRETE DETECTABLE WARNING ON CURB RAMP, AUSTIN, TX.

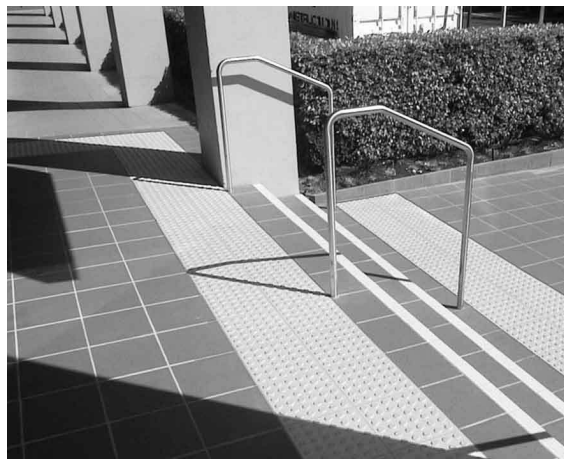
FIG.3-5. DETECTABLE
WARNING AT TOP &
BOTTOM OF STAIRS,
EXTERIOR USE IN
AUSTRALIA.

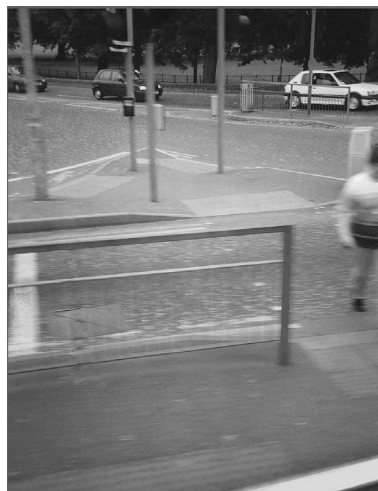
FIG. 3-6. (LEFT)
DETECTABLE WARNINGS
(BLISTER SURFACE)
ON THE THREE CURB-RAMPS
AT A SPLITTER ISLAND,
IRELAND

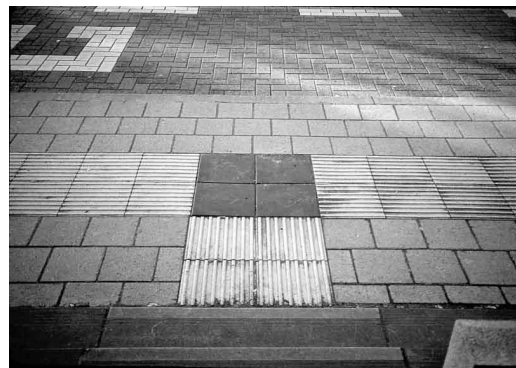
FIG. 3-7. (RIGHT)
TACTILE GROUND
SURFACE INDICATORS
LEADING AWAY FROM
STAIRS, LOUVAIN,
BELGIUM.

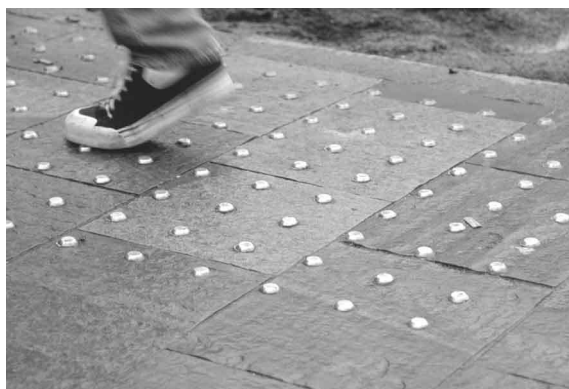
FIG. 4-4. BRASS NAILS INSTALLED IN PAVEMENT AS DETECTABLE WARNINGS.

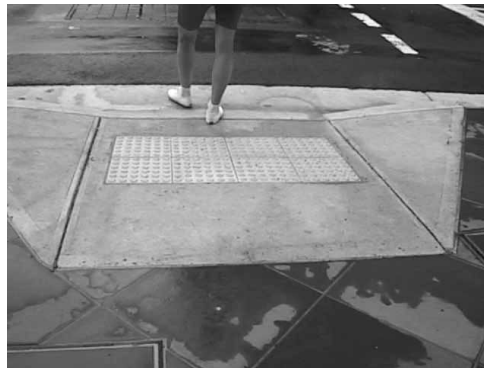
FIG. 4-5. (LEFT)
AUSTRALIAN CURB RAMP
WITH DETECTABLE
WARNING.

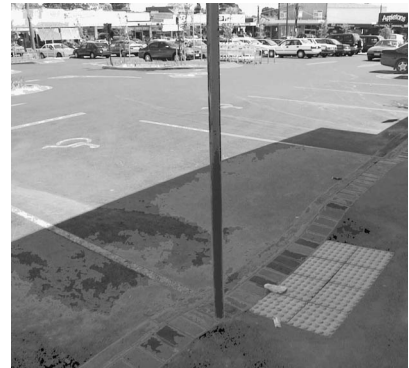
FIG. 4.6. (RIGHT)
CURB RAMP LEADING TO
HANDICAPPED PARKING
SPACE, AUSTRALIA.

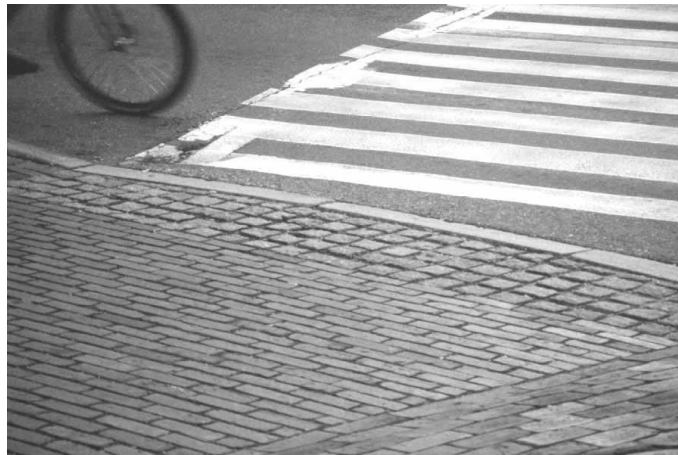
FIG. 5-1.
A MINIMALLY DETECT-
ABLE WARNING SURFACE
IN PORTLAND, ME.

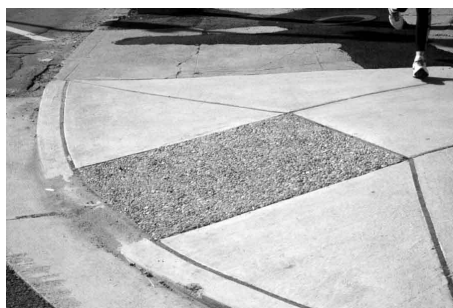
FIG. 5-2. CURB RAMP EXPOSED AGGREGATE SURFACE IN VIRGINIA. PEDESTRIANS WHO ARE BLIND DO NOT RELIABLY DETECT EXPOSED AGGREGATE CONCRETE.

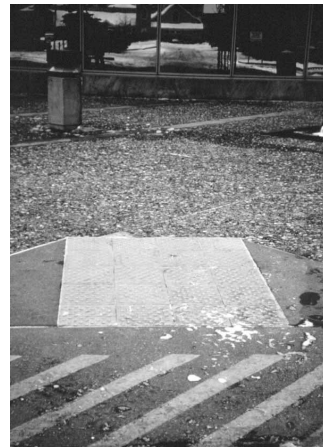
FIG. 5-3. (LEFT)
CURB RAMP IN
ANCHORAGE, AK.

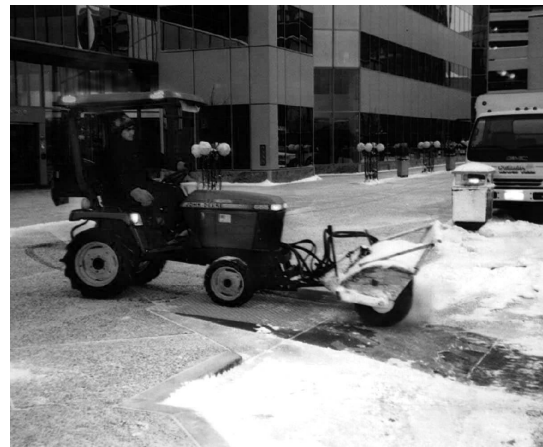
FIG. 5-4. (RIGHT)
CURB RAMP IN
ANCHORAGE, AK
SHOWING SNOW
REMOVAL WITH A
BRUSH.

- A detectable warning, thought to be Pathfinder Tile, was installed before 1996 in Fairbanks, AK, and it is still in good condition. It is across a driveway and subject to extreme cold, regular plowing, and some traffic by heavy vehicles. On a similar detectable warning installed in Anchorage, Alaska, snow is regularly removed with the same brush used for sidewalk snow removal (see Fig. 5-4).

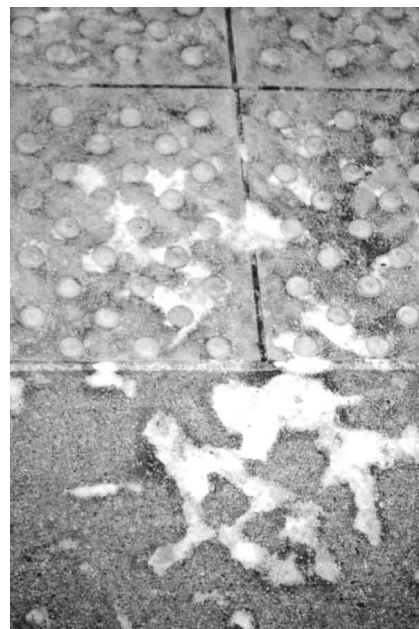
FIG. 5-5. DETECTABLE WARNING SURFACE WITH A PARTIAL SNOW COVER BETWEEN THE DOMES, ANCHORAGE, ALASKA.

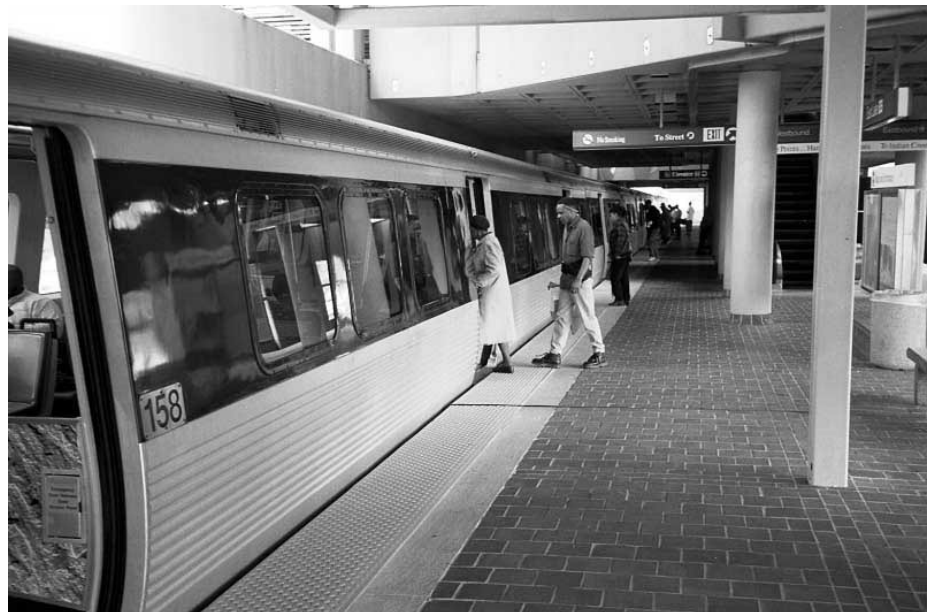
FIG. 5-8. MARTA STATION SHOWING INSTALLATION OF ARMOR-TILE.

- Tiles are secured with mechanical fasteners and structural adhesive.
 - In the retrofit installations, the detectable warning tiles replaced a two-foot portion of a three-foot granite strip along the edge of the platform, which was originally installed as a tactile warning. A portion of the granite strip was ground down to allow installation of the tiles. This installation was accomplished in stages, with most of the construction done at night when trains were not in service.
 - Tiles are a gray color, preferred by MARTA architects to provide contrast with the original platform colors.
-

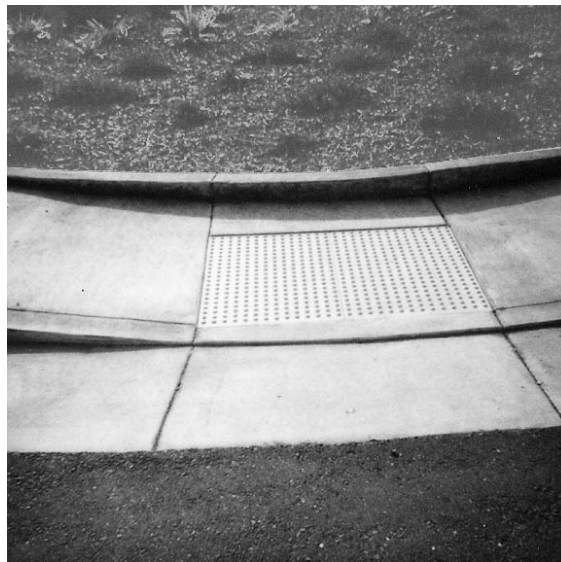
FIG. 5-10. PARALLEL
CURB RAMP IN
ROSEVILLE USING
ARMOR-TILE PANEL.

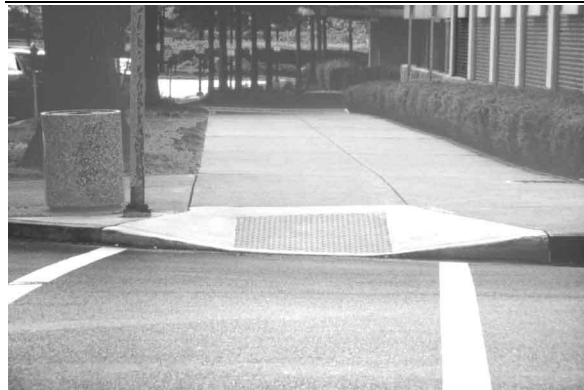
FIG. 5-11. BRICK
DETECTABLE WARNING
SURFACE CONTRASTS
WITH ADJACENT
CONCRETE,
HARRISBURG, PA.

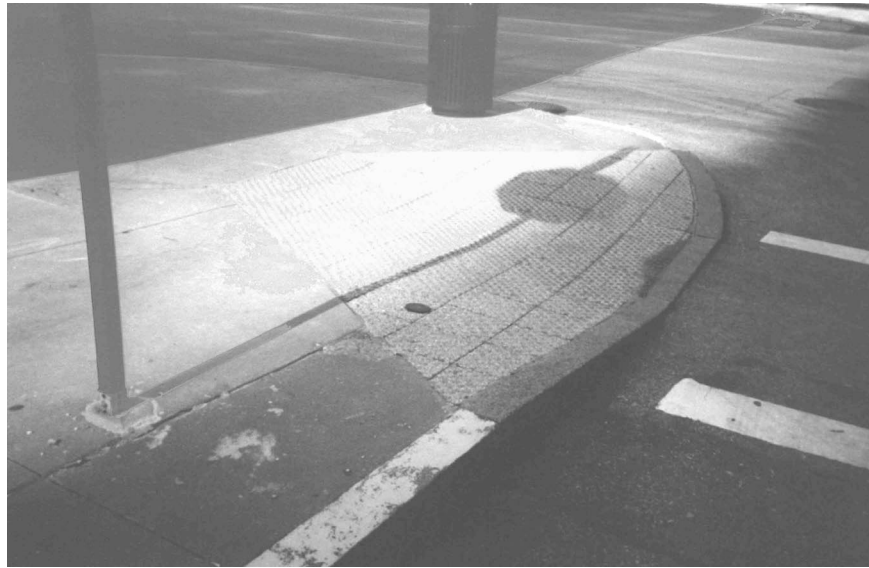
FIG. 5-13. TRUNCATED
DOME PAVERS CUT AND
FITTED TO THE ENTIRE
SURFACE OF A PERPEN-
DICULAR CURB RAMP,
INCLUDING FLARES,
CLEVELAND, OH.

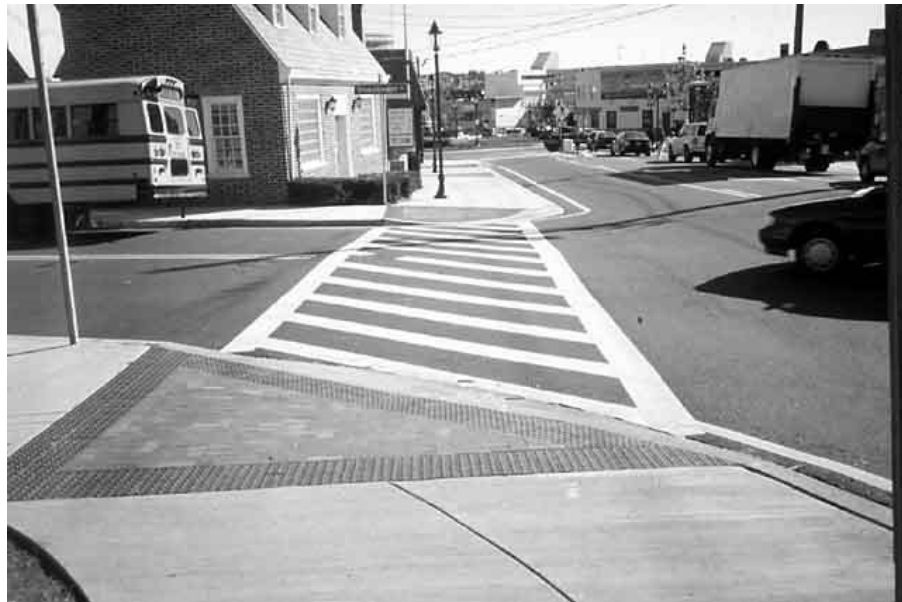
FIG. 5-14. A BAND OF DETECTABLE WARNING PAVERS OUTLINES THE TRIANGULAR SHAPE OF THIS CURB RAMP IN TOWSON, MD.

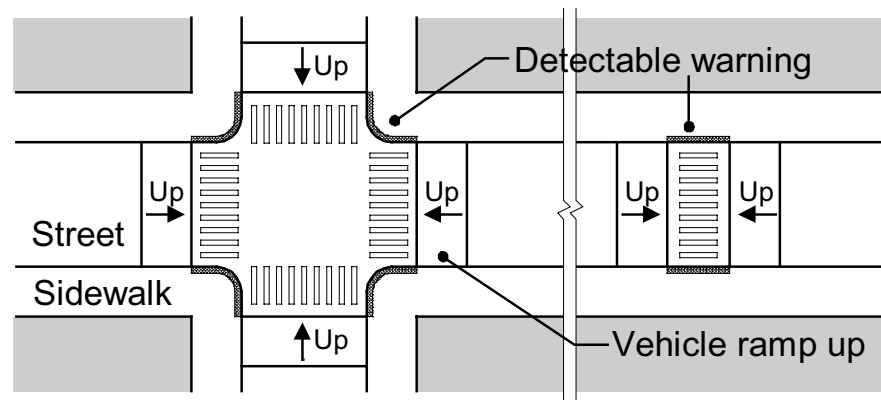
FIG. 6-10. AT LEFT, A RAISED INTERSECTION. AT RIGHT, A RAISED CROSSWALK SHOWN AT MIDBLOCK

A raised intersection is a traffic calming element that has flat raised areas covering the entire intersection, including adjoining crosswalks, with vehicle ramps on all street approaches. A raised intersection is also known as a raised junction, intersection hump, table, or plateau.

Designing sidewalks and trails for access: Part II of II: A best practices guidebook (Axelson, et al., 2000, FHWA) recommends a 24 in deep detectable warning on the sidewalk at each end of raised crosswalks.

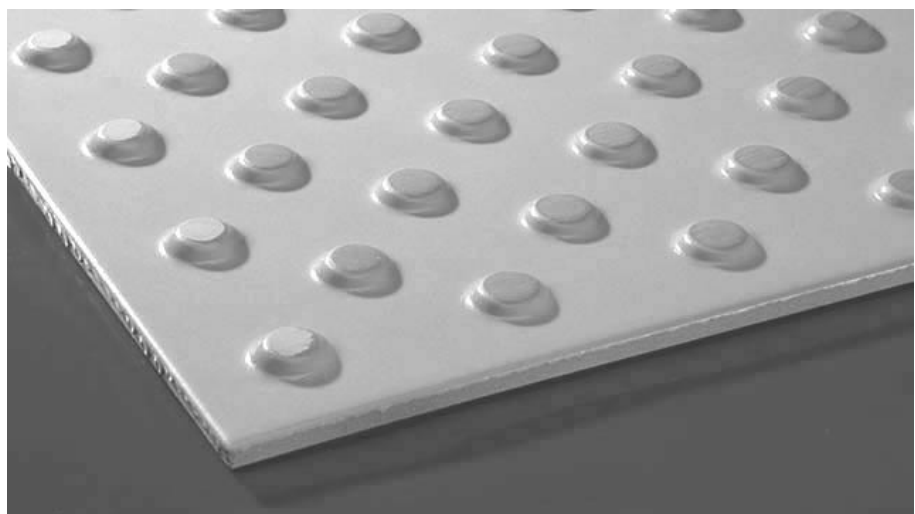
FIG. 7-19.
**SUMMITVILLE
TILES, INC.**
TACTILE-TREAD
CERAMIC TILE.
