# Los Angeles Union Station

## TEA-21 Improvements

Section 106 Review

**FTA Project Number CA-03-0504-01**

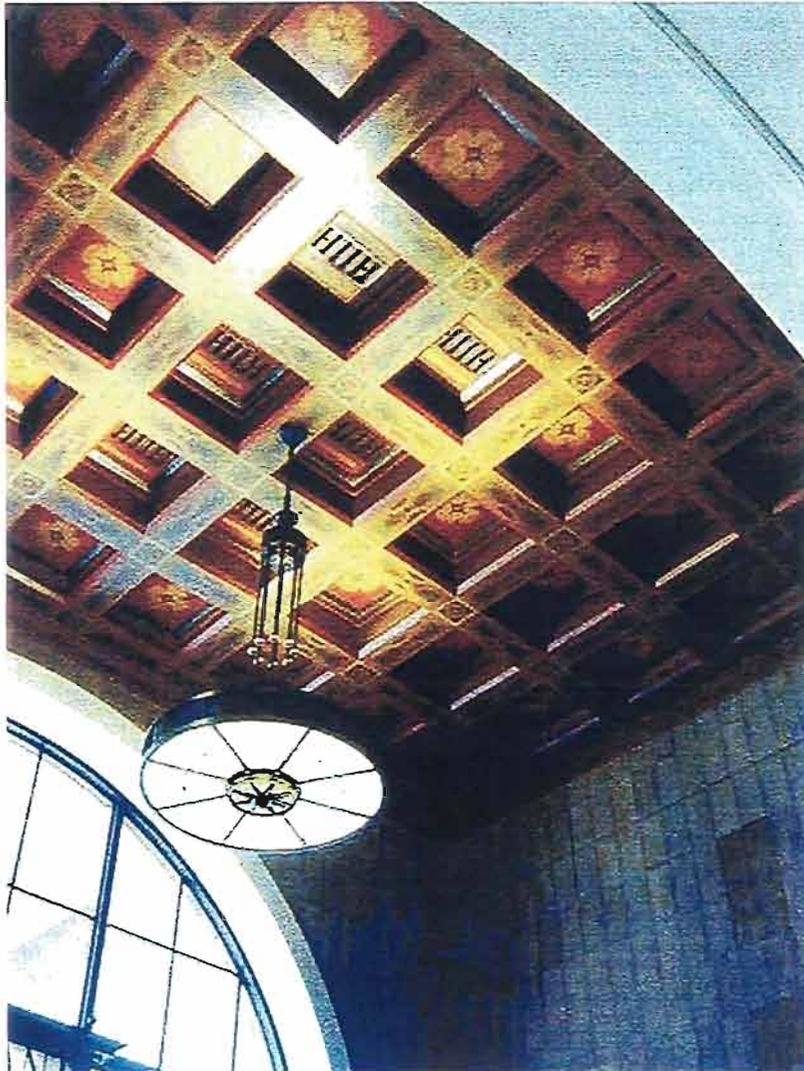
**SOUTH VESTIBULE CEILING AND ADJACENT ACOUSTICAL TILE WALL SURFACE**

Generally, the ceilings are comprised of suspended metal lath and plaster formed into beams, coffers and corbels into which Celotex acoustical perforated tiles have been set. (See attached drawings details A, B and C from original working plans. These have been provided for information purposes only and may not reflect the exact configuration of the present ceilings). The acoustical tiles appear to be friable and to have been attached to the substrate with adhesive and screws. The screws have been painted, as observed in the Waiting Room. Intermittent gouges, scratches and loss to both plaster and paint are evident. Please see the following for specific description of each area.

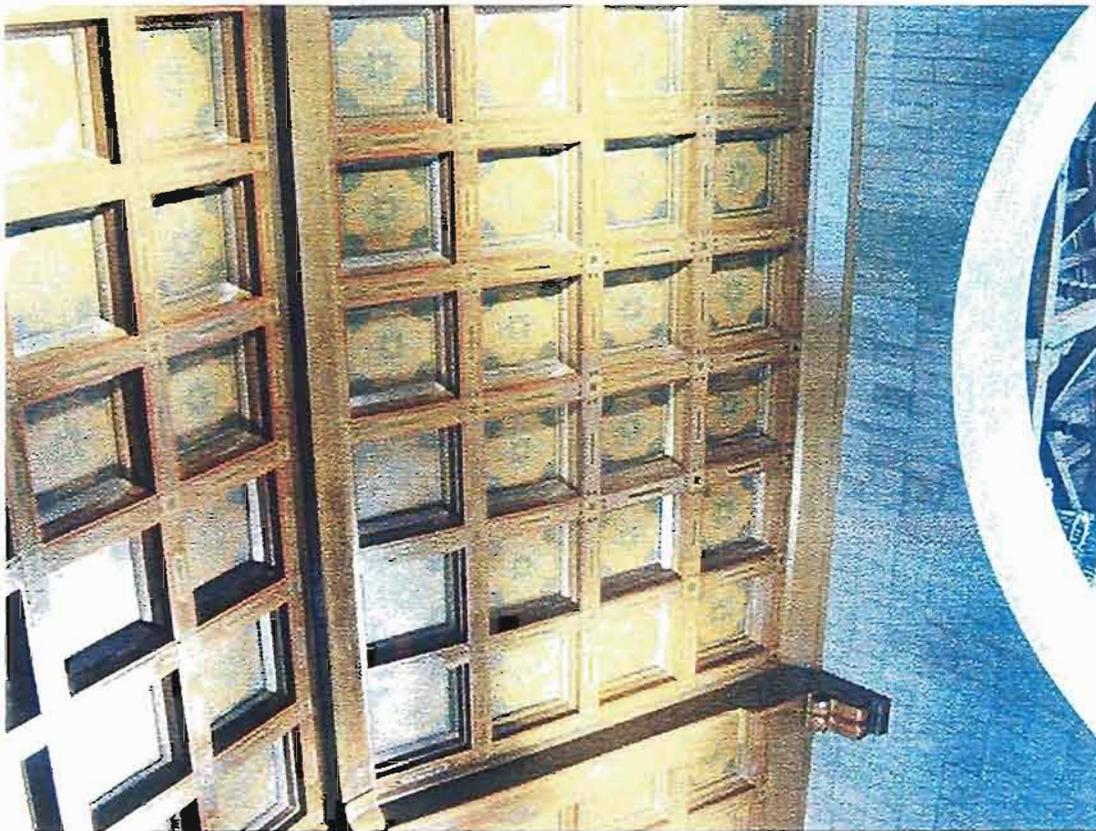
DETAIL OF LOBBY CEILING

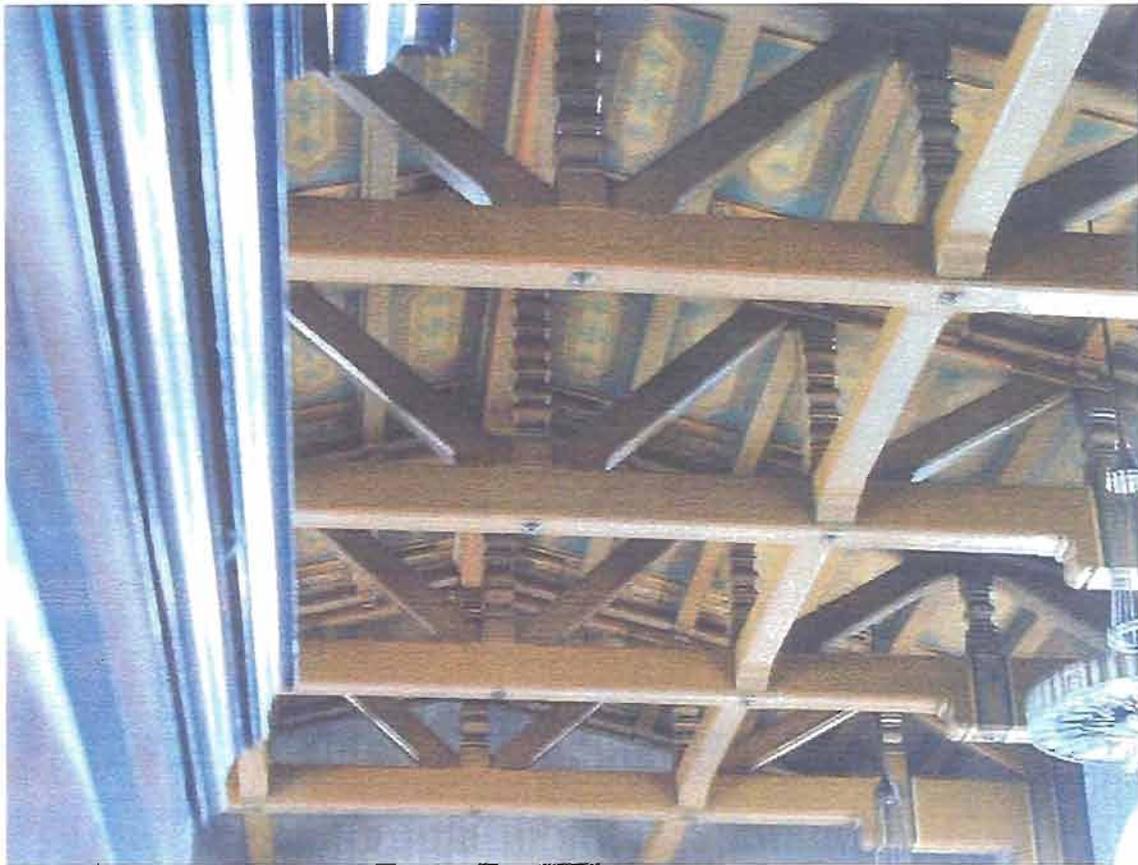
DETAIL OF CEILING OF TICKET CONCOURSE

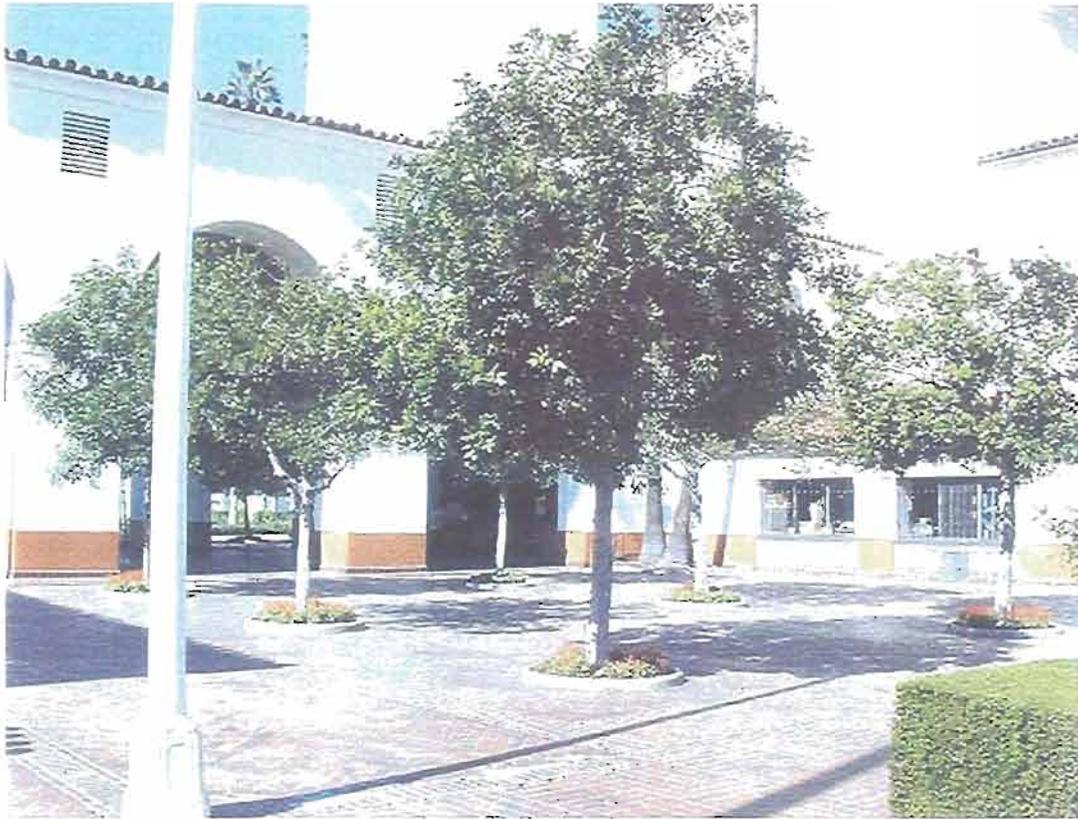
**CARROT WOOD TREES TO BE REPLACED BY OLIVE TREES**

Affected Feature	Character-Defining?	Proposed Work
Original/historic Mexican fan palms	Yes	Retain in place; no change
Magnolia trees in four central quadrants	No	To be replaced with the original species, California pepper trees. Source: original drawings and specifications; historic post card views of the patio.
Carrot Wood trees in six circular planters at west end, four planters along east wall.	No	To be replaced with the originally specified and planted species, olive trees. Source: original drawings and specifications.
Historic pedestal light fixtures	Yes	Retain in place; no change
Irrigation system	No	Improvements to irrigation will involve some temporary removal of the paving. The historic pavers will be reinstalled once piping is installed.
Historic outdoor furniture	Yes	Some original benches remain in the patio, and five additional ones have been located in storage and will be reused. Any additional furnishings for the patio will be similar in design and material to the historic examples. Source: Drawings of the benches, dating to the 1930s and post card views of the patio.

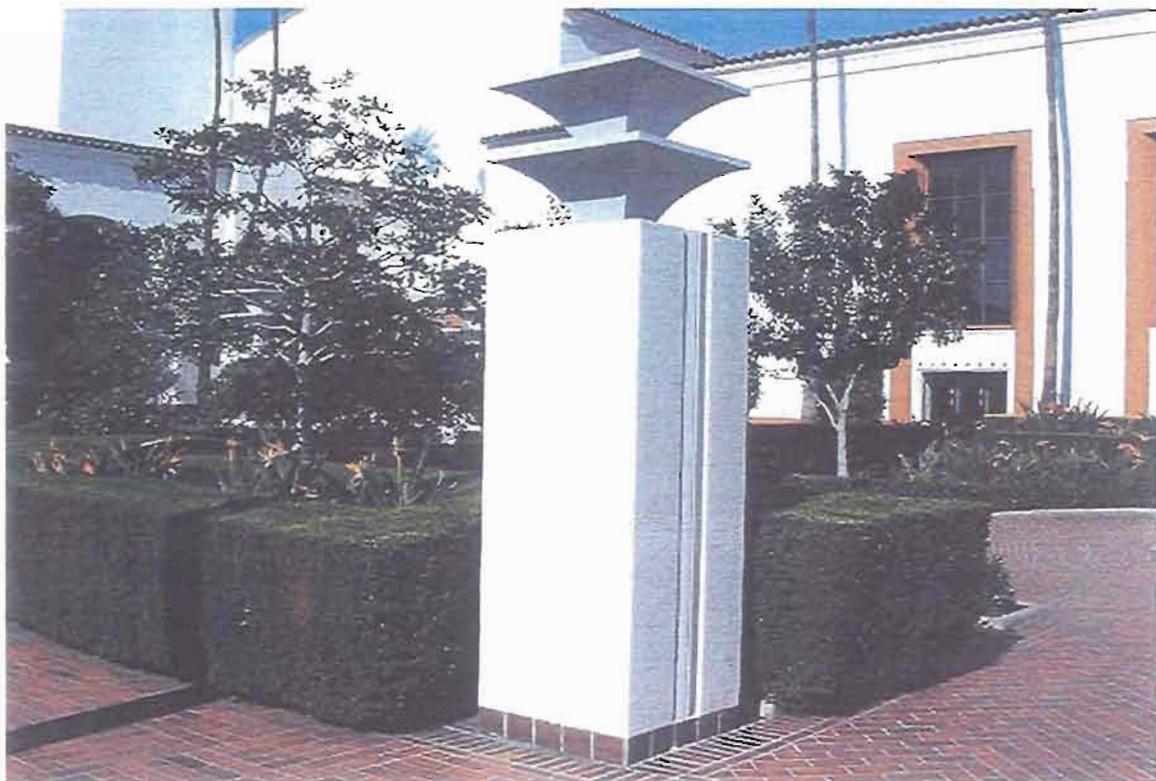
**SMALL MAGNOLIA TREES (TO LEFT AND RIGHT OF LIGHT STANDARD) TO BE REPLACED BY PEPPER TREES**

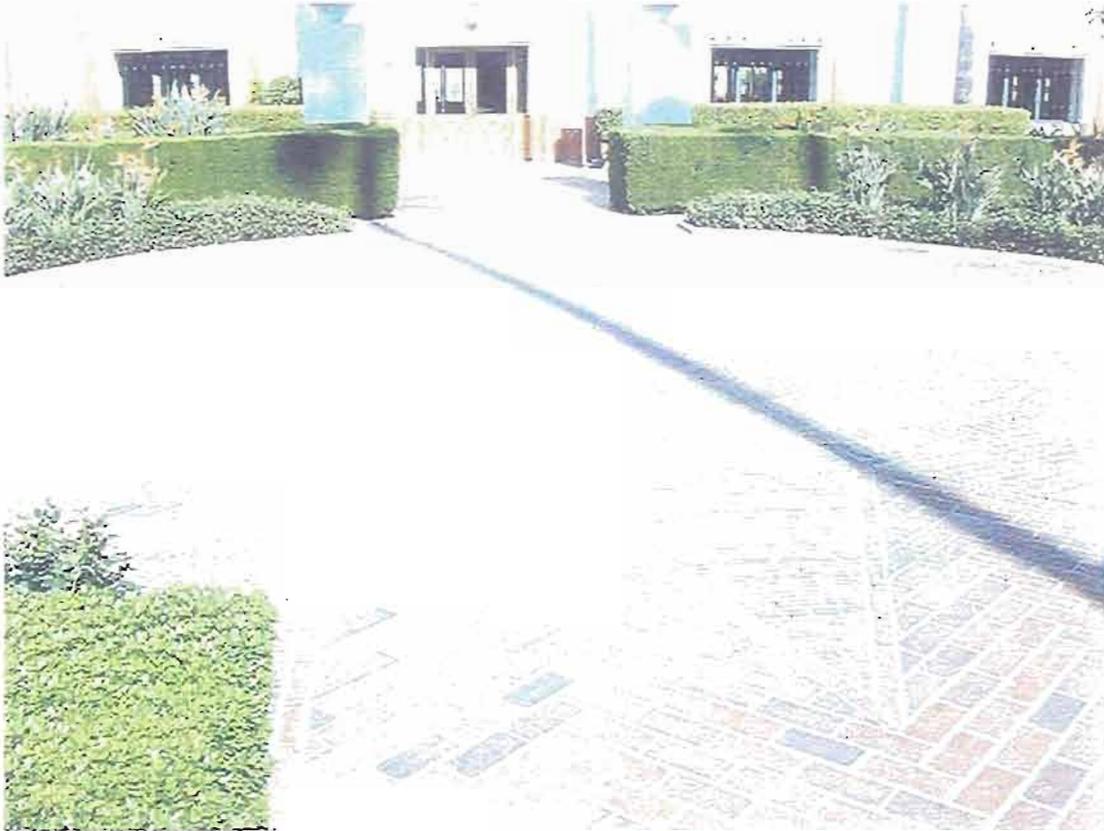
SUNBURST PATTERN IN CENTER OF PATIO. NEW FOUNTAIN TO BE CONTAINED IN CENTRAL AREA OF PATTERN, PRESERVING STARBURST AND CONCENTRIC RINGS

Affected Feature	Character-Defining?	Proposed Work
Cruciform layout: original paving and all planter beds	Yes	To remain unchanged; paving to be repaired and replaced where necessary (for exception, see next item)
Fountain concept; not executed historically	No	A circular fountain is to be added to the center of the patio. Source: a 1937 street elevation of the building shows a fountain in the center of the south patio which would be visible through the central bay of the west arcade. Though the fountain was not fully designed or executed historically, the concept is in keeping with the historic design of the patio and is therefore compatible. Installation of the fountain will involve removal of some original paving in center of patio.
Myrtle box hedges	Yes	The hedges were meant to be low in height to surround low, flowering ground cover. These have overgrown, and will be replaced with new plants of the same species to return hedges to the originally intended effect. Source: original drawings and specifications; historic post card views of the patio.

The proposed scope of work will have no adverse effect on the character-defining materials and features of the patio. The removal of historic brick paving from the center of the space for addition of a fountain does not constitute an adverse effect, as the vast majority of the paving, which extends throughout the patio, remains intact. The fountain itself is compatible with the existing scheme and was indicated in historic concept drawings, as noted above. Historic plantings still extant will remain. Plant material which is overgrown or has replaced original species will be replanted with originally specified plant material.

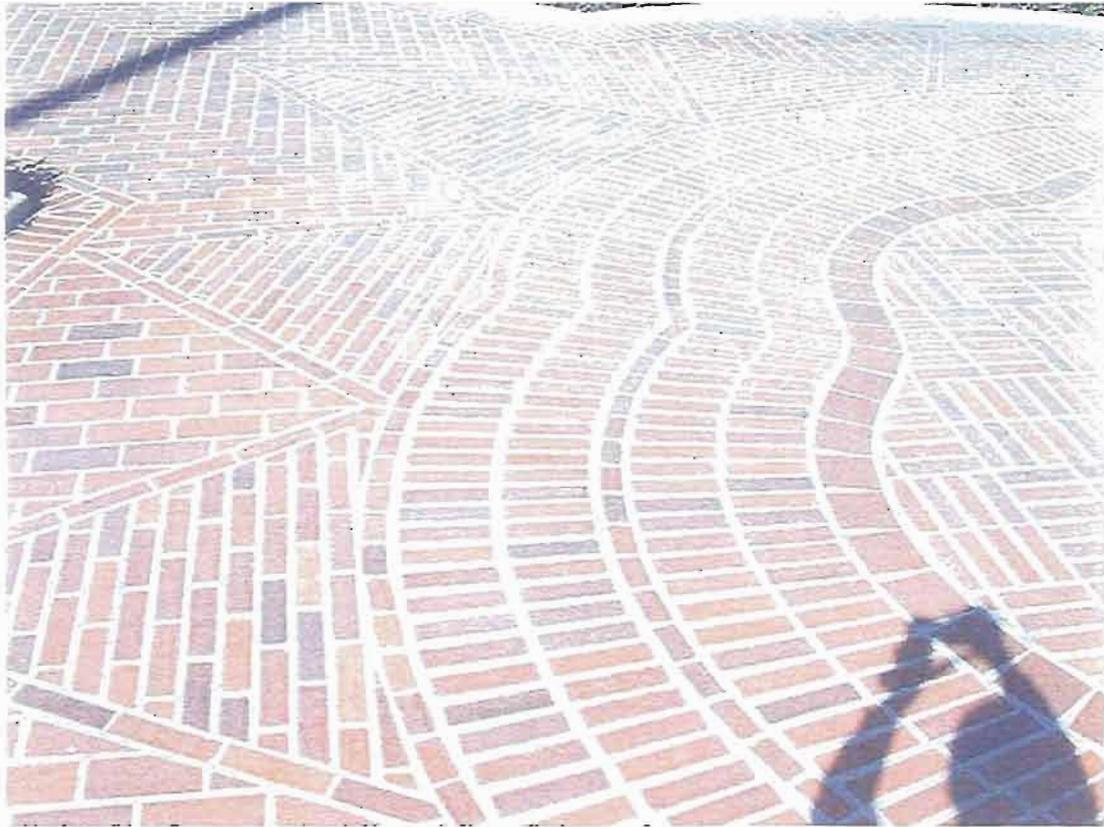
DETAIL OF CENTRAL SUBURST PATTERN IN PAVING

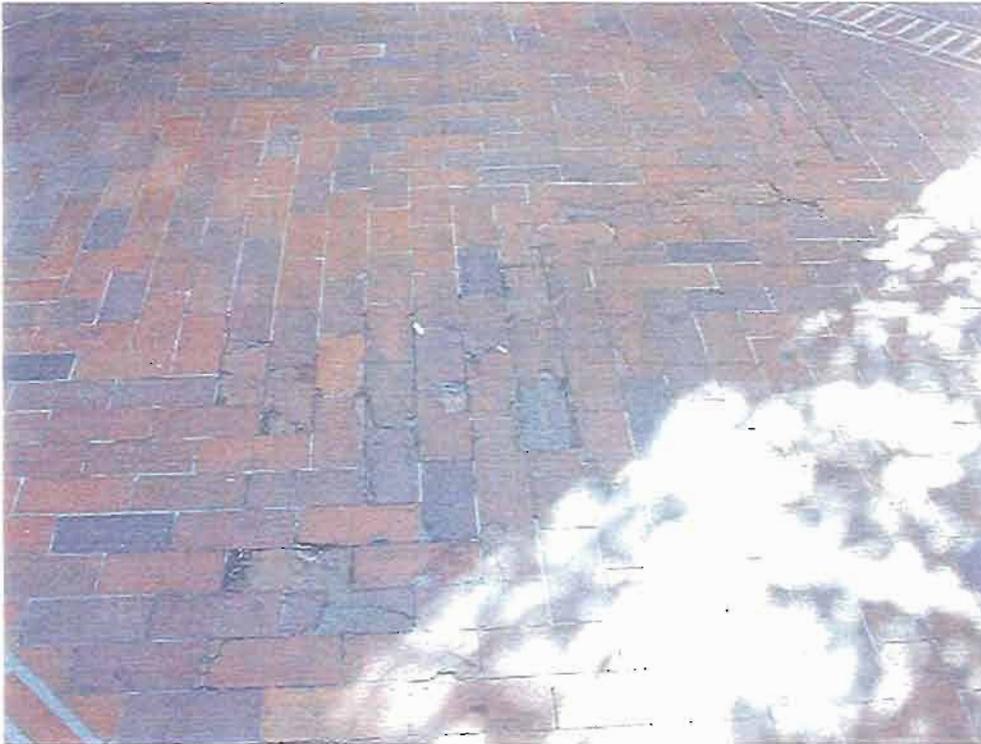
**EXAMPLE OF DAMAGED PAVING TO BE PATCHED WITH REPLACEMENT BRICK WHERE NECESSARY**

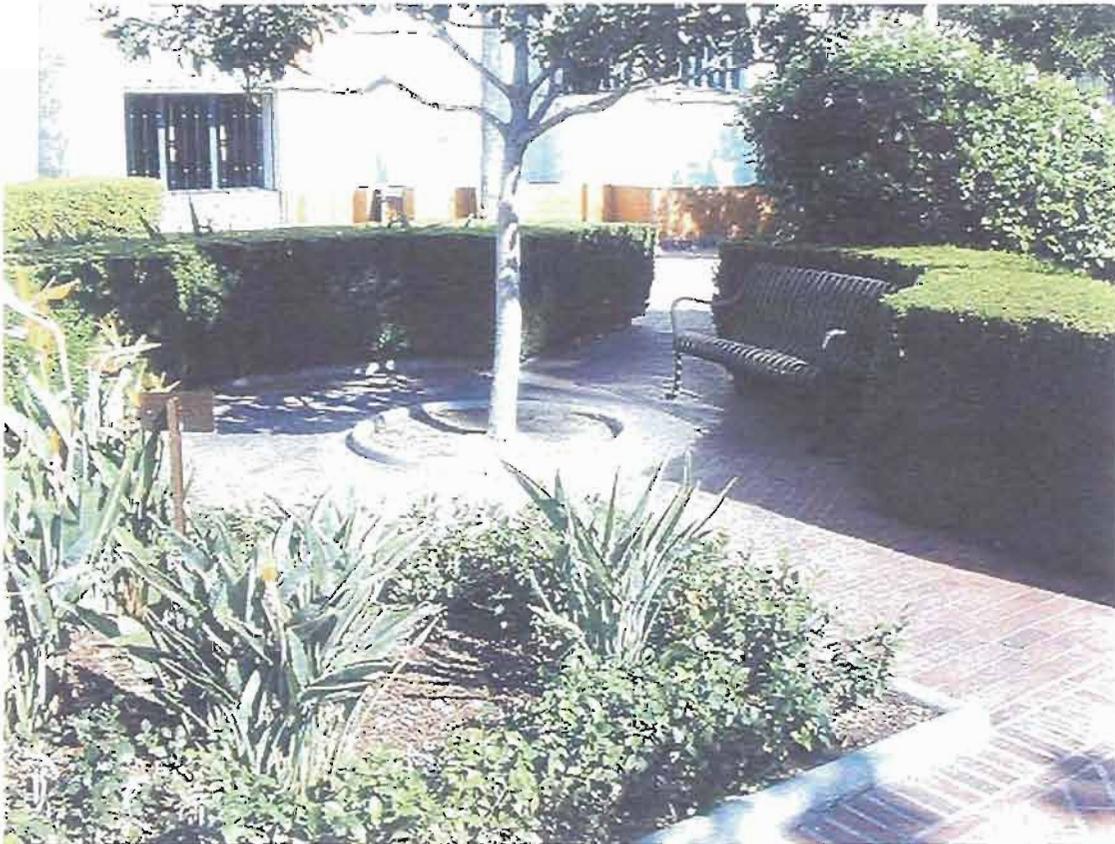
**TYPICAL CONCRETE-EDGED PLANTER BEDS IN EACH QUADRANT. OVERGROWN MYRTLE HEDGES**

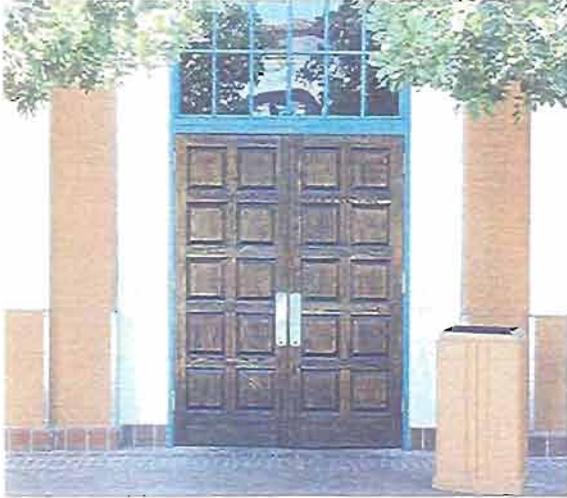
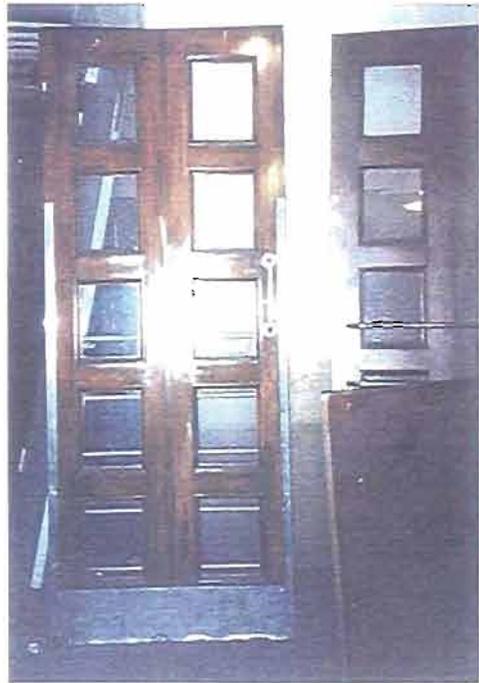
LEFT: NONORIGINAL DOORS ON EAST SIDE OF SOUTH PATIO IN ARCHWAY THAT WAS ORIGINALLY OPEN AND UNGLAZED. RIGHT: DOORS FOUND IN STORAGE, WHICH WILL REPLACE NON-ORIGINAL DOORS TO SOUTH PATIO.

Wood doors between the South Patio and the current ticketing area	No	These archways were originally open and unglazed. Ten-light, wood frame doors were located in storage, and will replace the similar, ten-panel doors now in place (which are not historic).

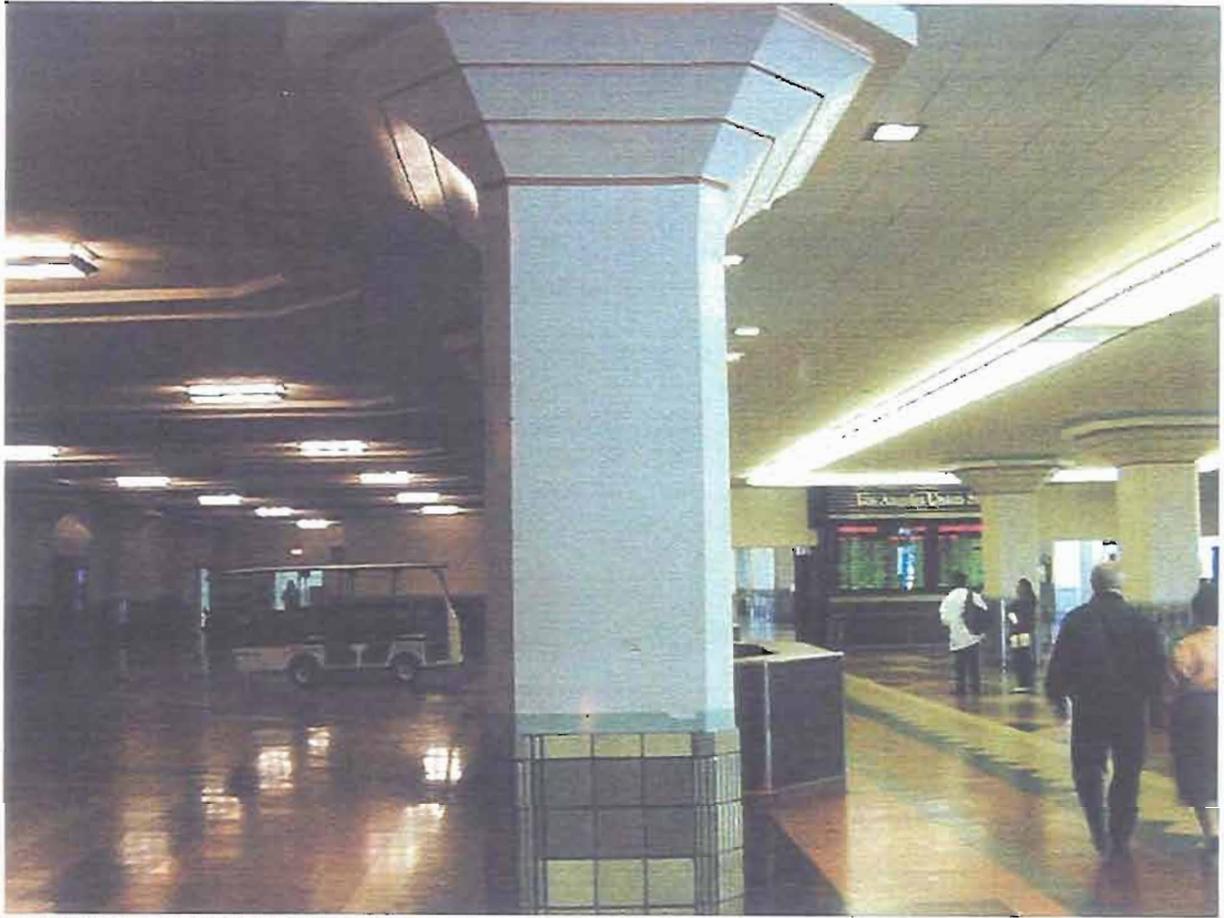
**DIFFERING LIGHT LEVELS AND CEILING TREATMENTS IN LOBBY (LEFT) AND CONCOURSE (RIGHT)**

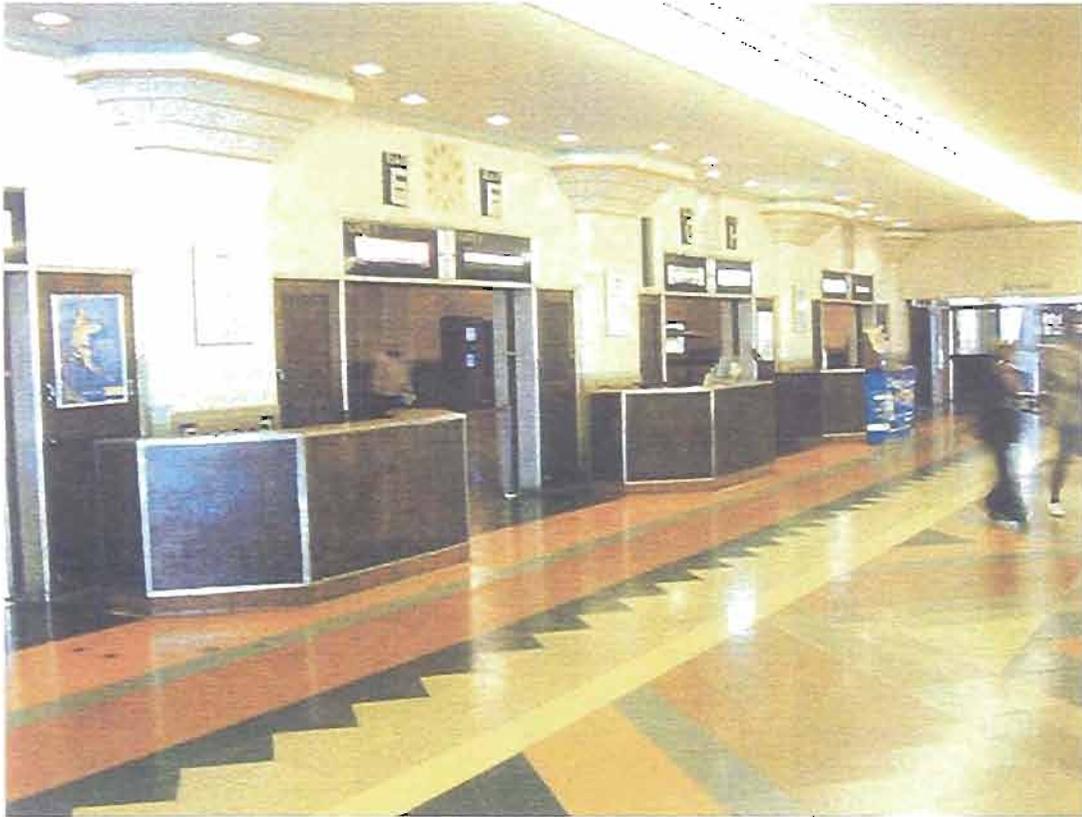
**DEPARTURE GATES: INFIL BETWEEN HISTORIC TRAIN CONCOURSE AND PASSENGER LOBBY, VIEW SOUTHEAST**

The historic train concourse is divided into two long zones by a row of structural piers running north to south. The historic passenger arrival and departure lobby is located directly east of and parallel to the historic train concourse, separated from the concourse by structural piers (identical to those just noted) which are spanned by infill material. This infill material dividing the historic train concourse from the passenger lobby consists of thin, stained plywood walls that frame departure gates used by Amtrak (non-commuter train) passengers. Seven of the eight column bays are filled with these gates; the gate has been removed from the northernmost column bay.

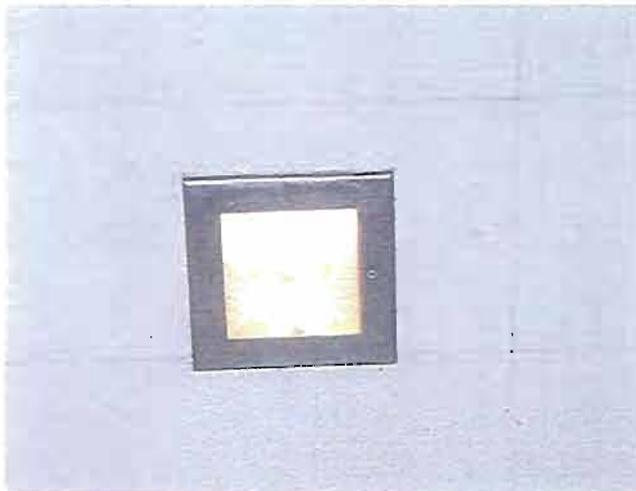
**SQUARE CEILING LIGHTS FROM TRAIN CONCOURSE TO BE REMOVED AND REINSTALLED IN NEW RESTROOMS**

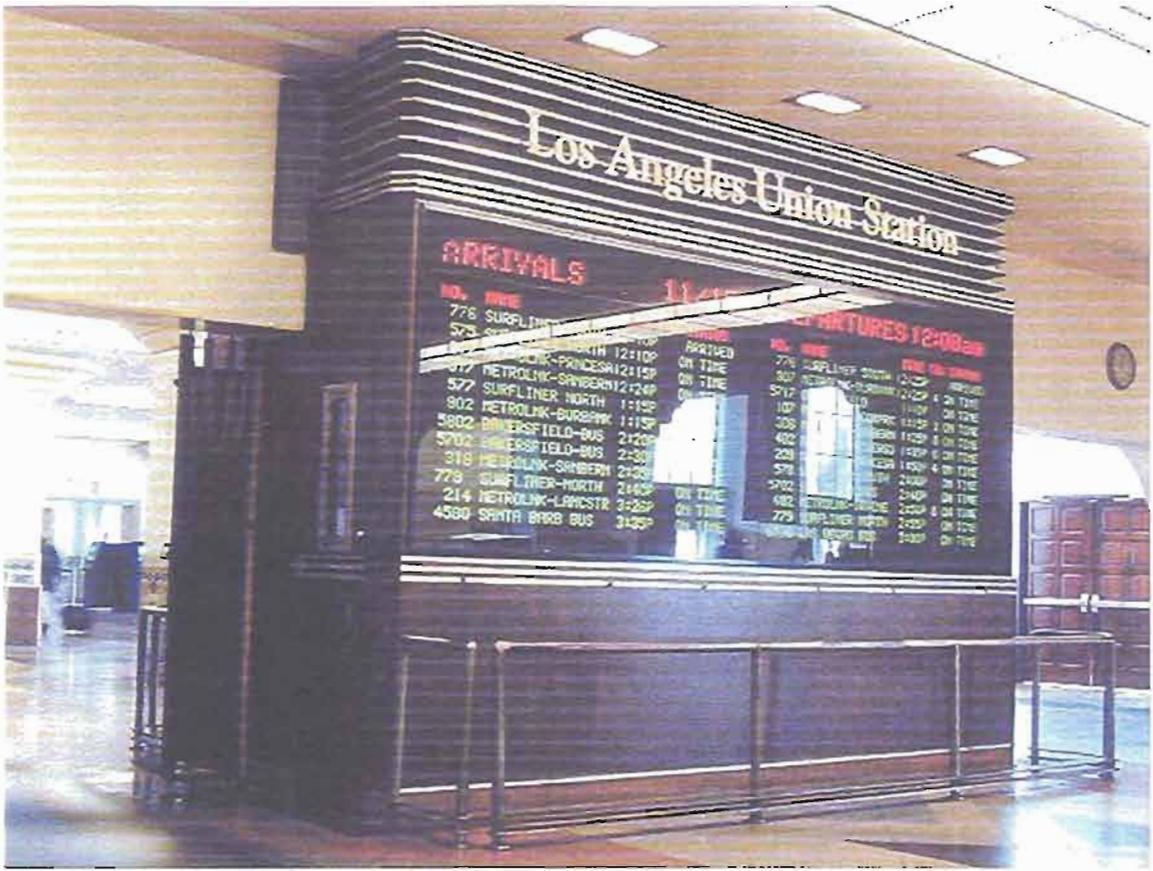
TRAIN BOARD, VIEW SOUTH: SOFFITS TO EITHER SIDE TO BE REMOVED

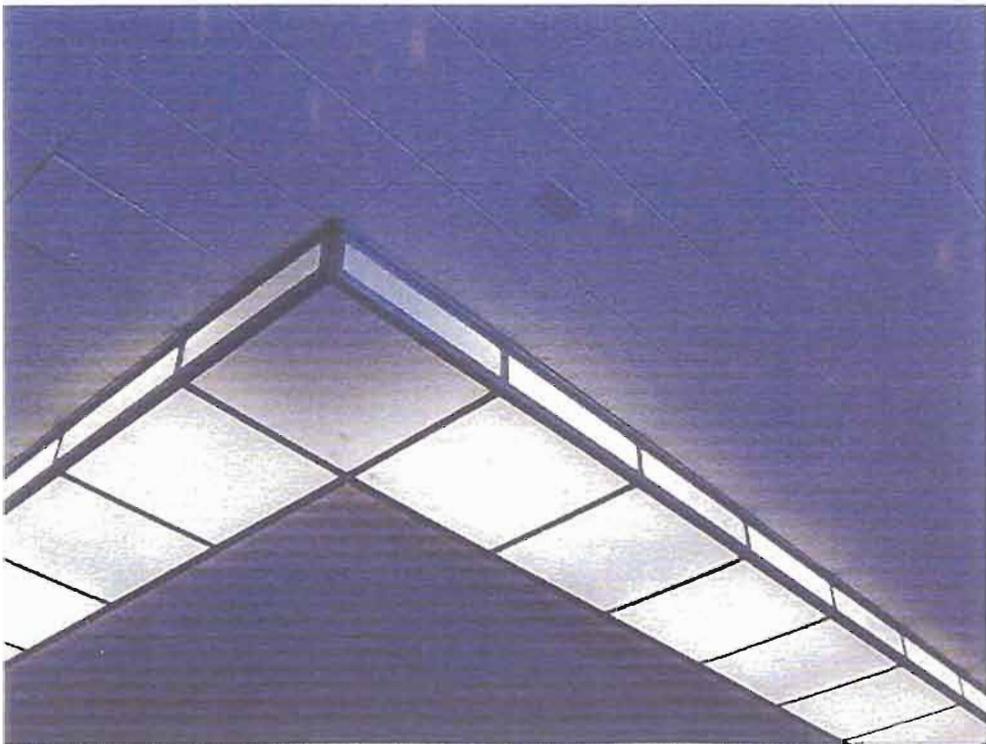
ACOUSTICAL CEILING TILES (TO BE REMOVED) AND CEILING TRACK, WHICH WILL BE RECONFIGURED

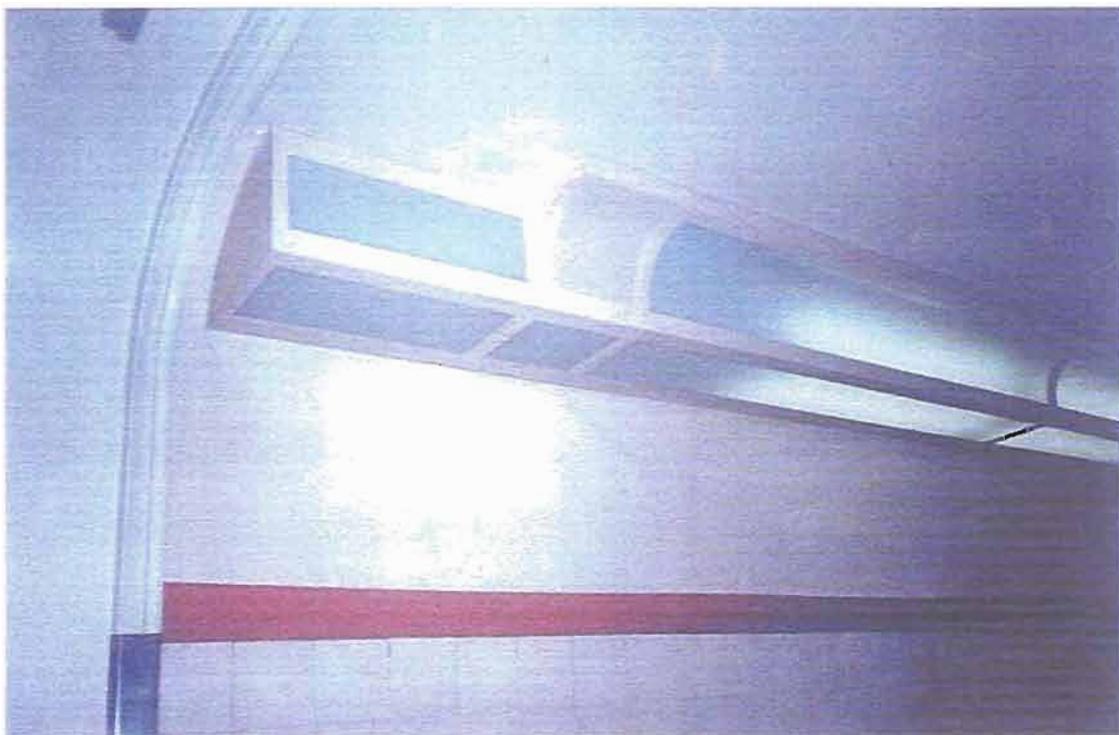
**WEST END OF (NON-HISTORIC) COVE LIGHT FIXTURE  
AND COVERED CEILING PROFILE OF TUNNEL**

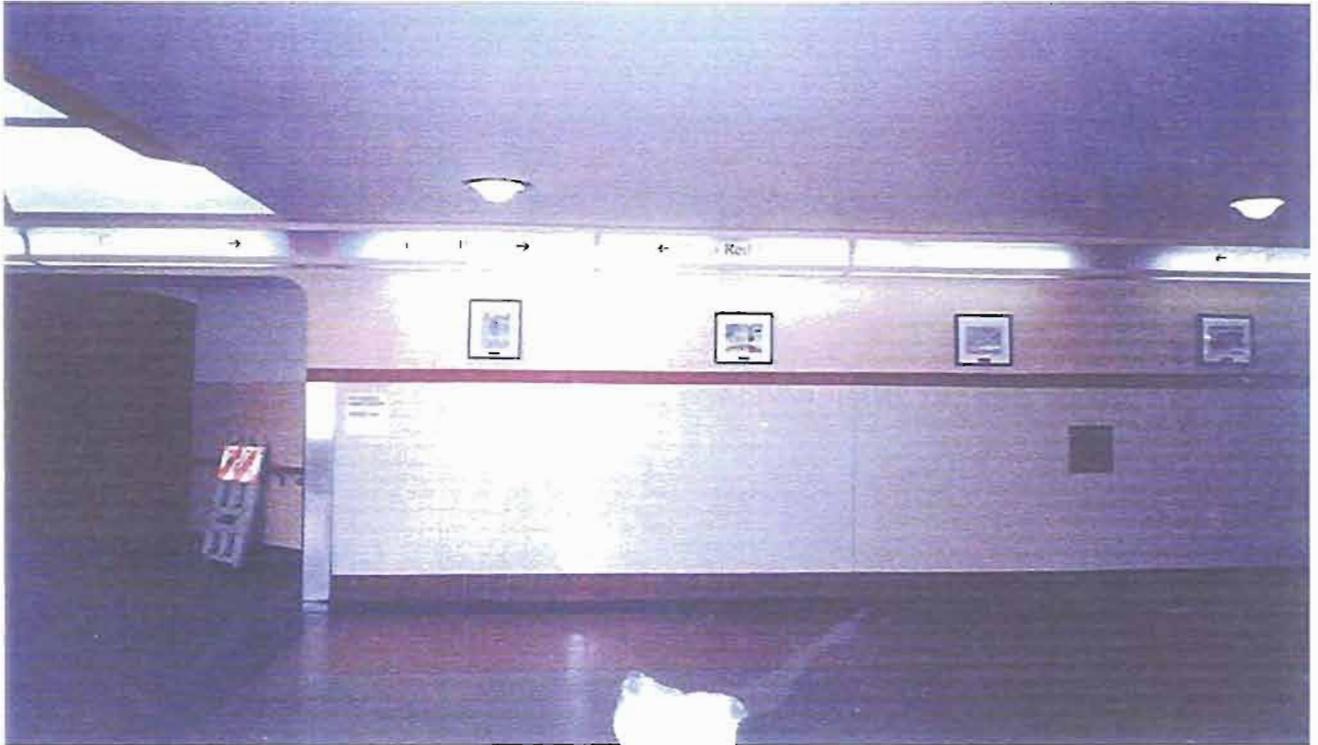
NON-HISTORIC TILE WAINSCOT IN TUNNEL; BORDER AT TOP IS PAINTED ON

Affected Feature	Character-Defining?	Proposed Work
Painted concrete wall and ceiling surfaces	No	Signage to be added to tunnel includes track numbers, direction to baggage claim, and direction to connecting forms of transit. The signage programs will be attached to the walls and ceilings.
Linear fluorescent cove lighting	No	Cove lighting will be replaced and faced in a louvered baffle in order to direct more light to the ceiling and to the wall below, to reduce glare.
Round lights mounted in ceiling	No	Lights will be left in place with no changes.
Tiled wall surfaces	No	The top four rows of tiles will be removed and replaced with a new top row of decorative tile with a scalloped or similar profile. The wall tiles are not historic, and will be otherwise left in place. A hand rail will be added near the new top level of the wainscot, attached through the tile.

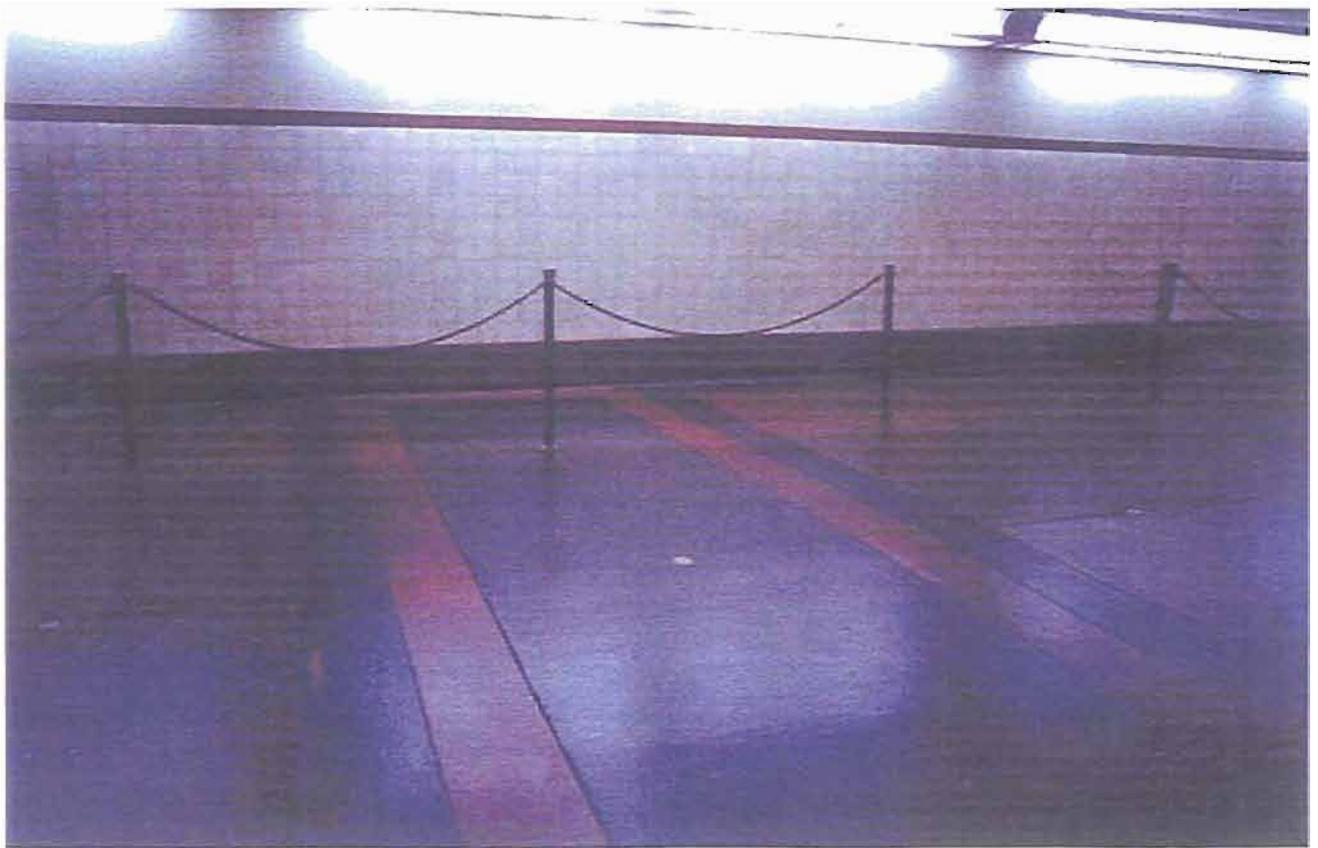
TUNNEL: CONCRETE FLOOR AND NON-HISTORIC WALL TILE

Affected Feature	Character-Defining?	Proposed Work
Tunnel adjacent to track entrances	No	Non-historic signage (including an electronic sign board) will be lowered for better visibility. Historic signage for track numbers, found in storage, will be re-installed. Non-historic backlit panels will be removed.
Colored concrete floor	Yes	Over half of the current floor is a replication of the historic floor. A large amount of the original floor was removed for the construction of the Metro Red Line. The floor will be left in place with no changes.

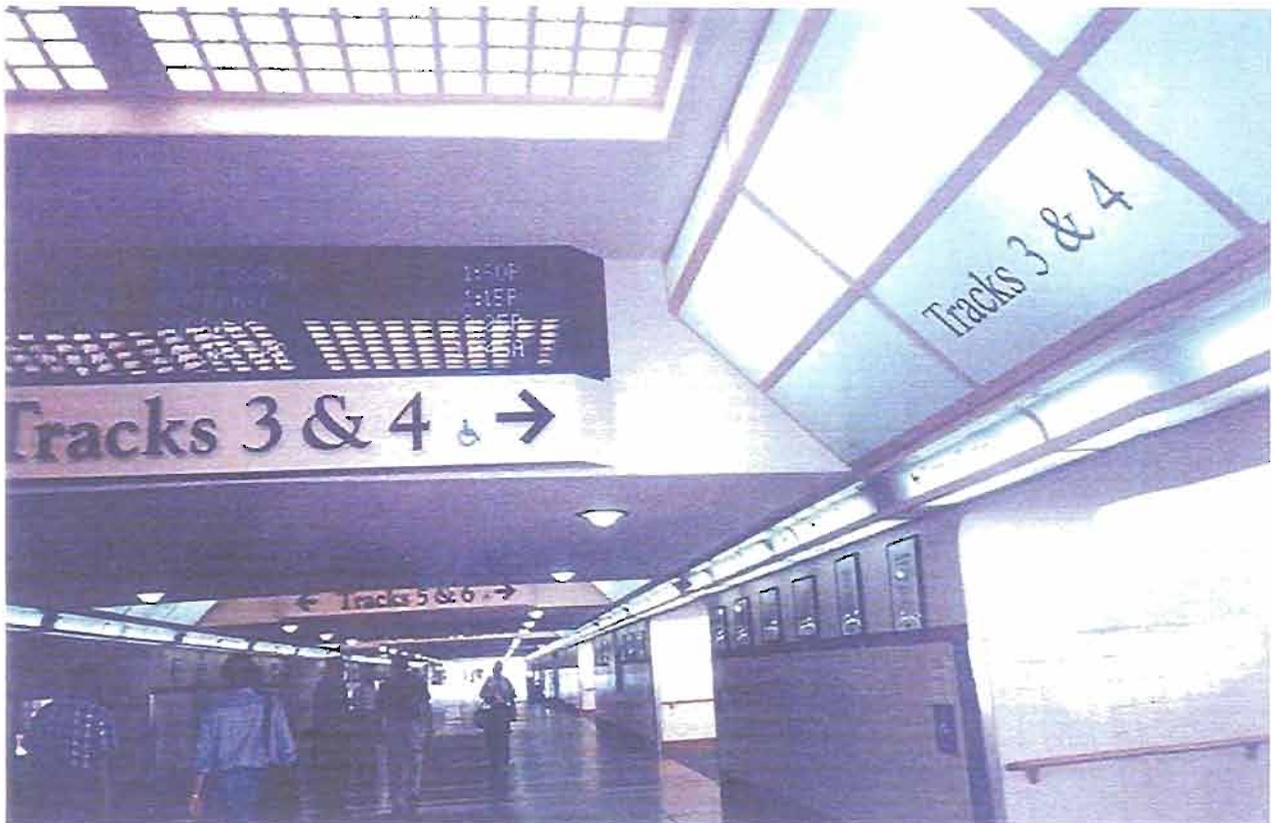
**TRACK ENTRANCES AT EAST END OF TUNNEL (VARIED CEILING HEIGHT IS NOT A HISTORIC CONDITION)**

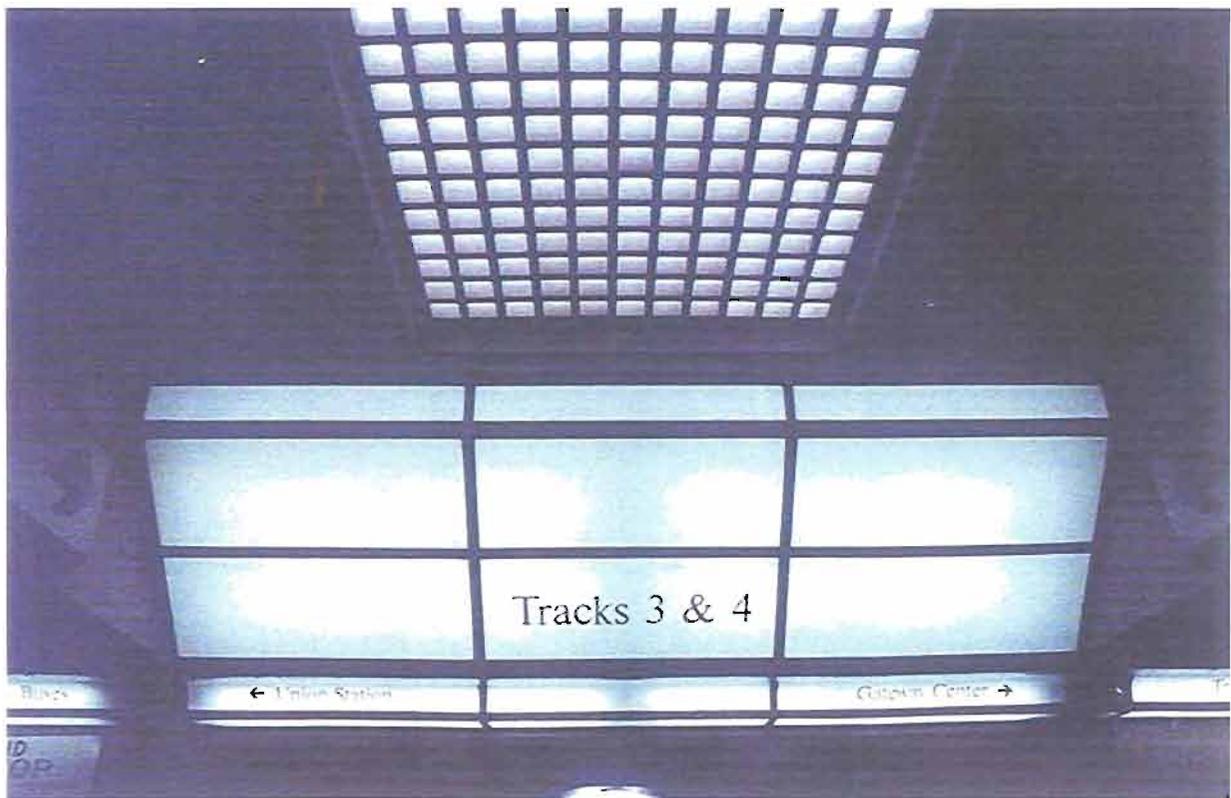
**TRACK ENTRANCE: NON-HISTORIC BACKLIT PANEL TO BE REMOVED;  
NON-HISTORIC GLASS BLOCK SKYLIGHT TO REMAIN**

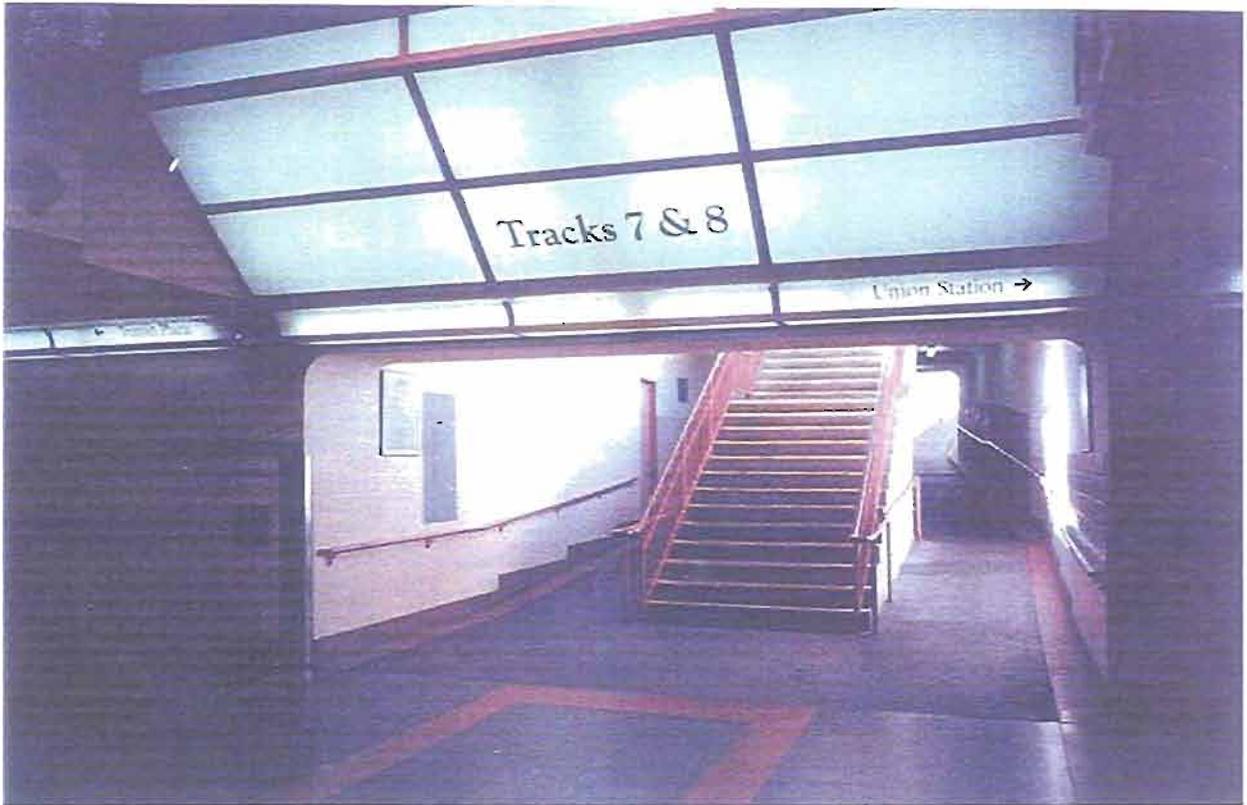
**TYPICAL SOUTH SIDE TRACK ENTRANCE WITH STAIRS TO PLATFORM AND RAMP BEHIND; STAIR RAILING IS NOT HISTORIC**

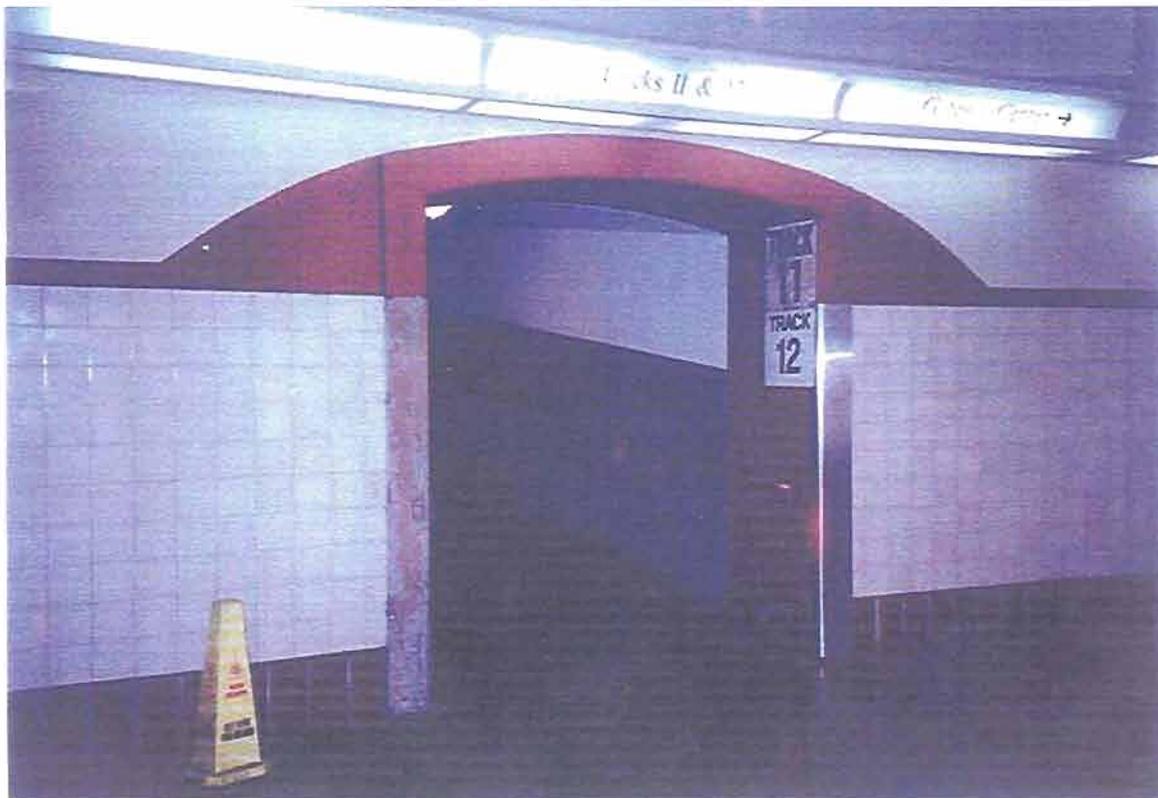
**TYPICAL NORTH SIDE TRACK ENTRANCE WITH RAMP TO PLATFORM**
