# Los Angeles Union Station

## TEA-21 Improvements

Section 106 Review

**FTA Project Number CA-03-0504-01**

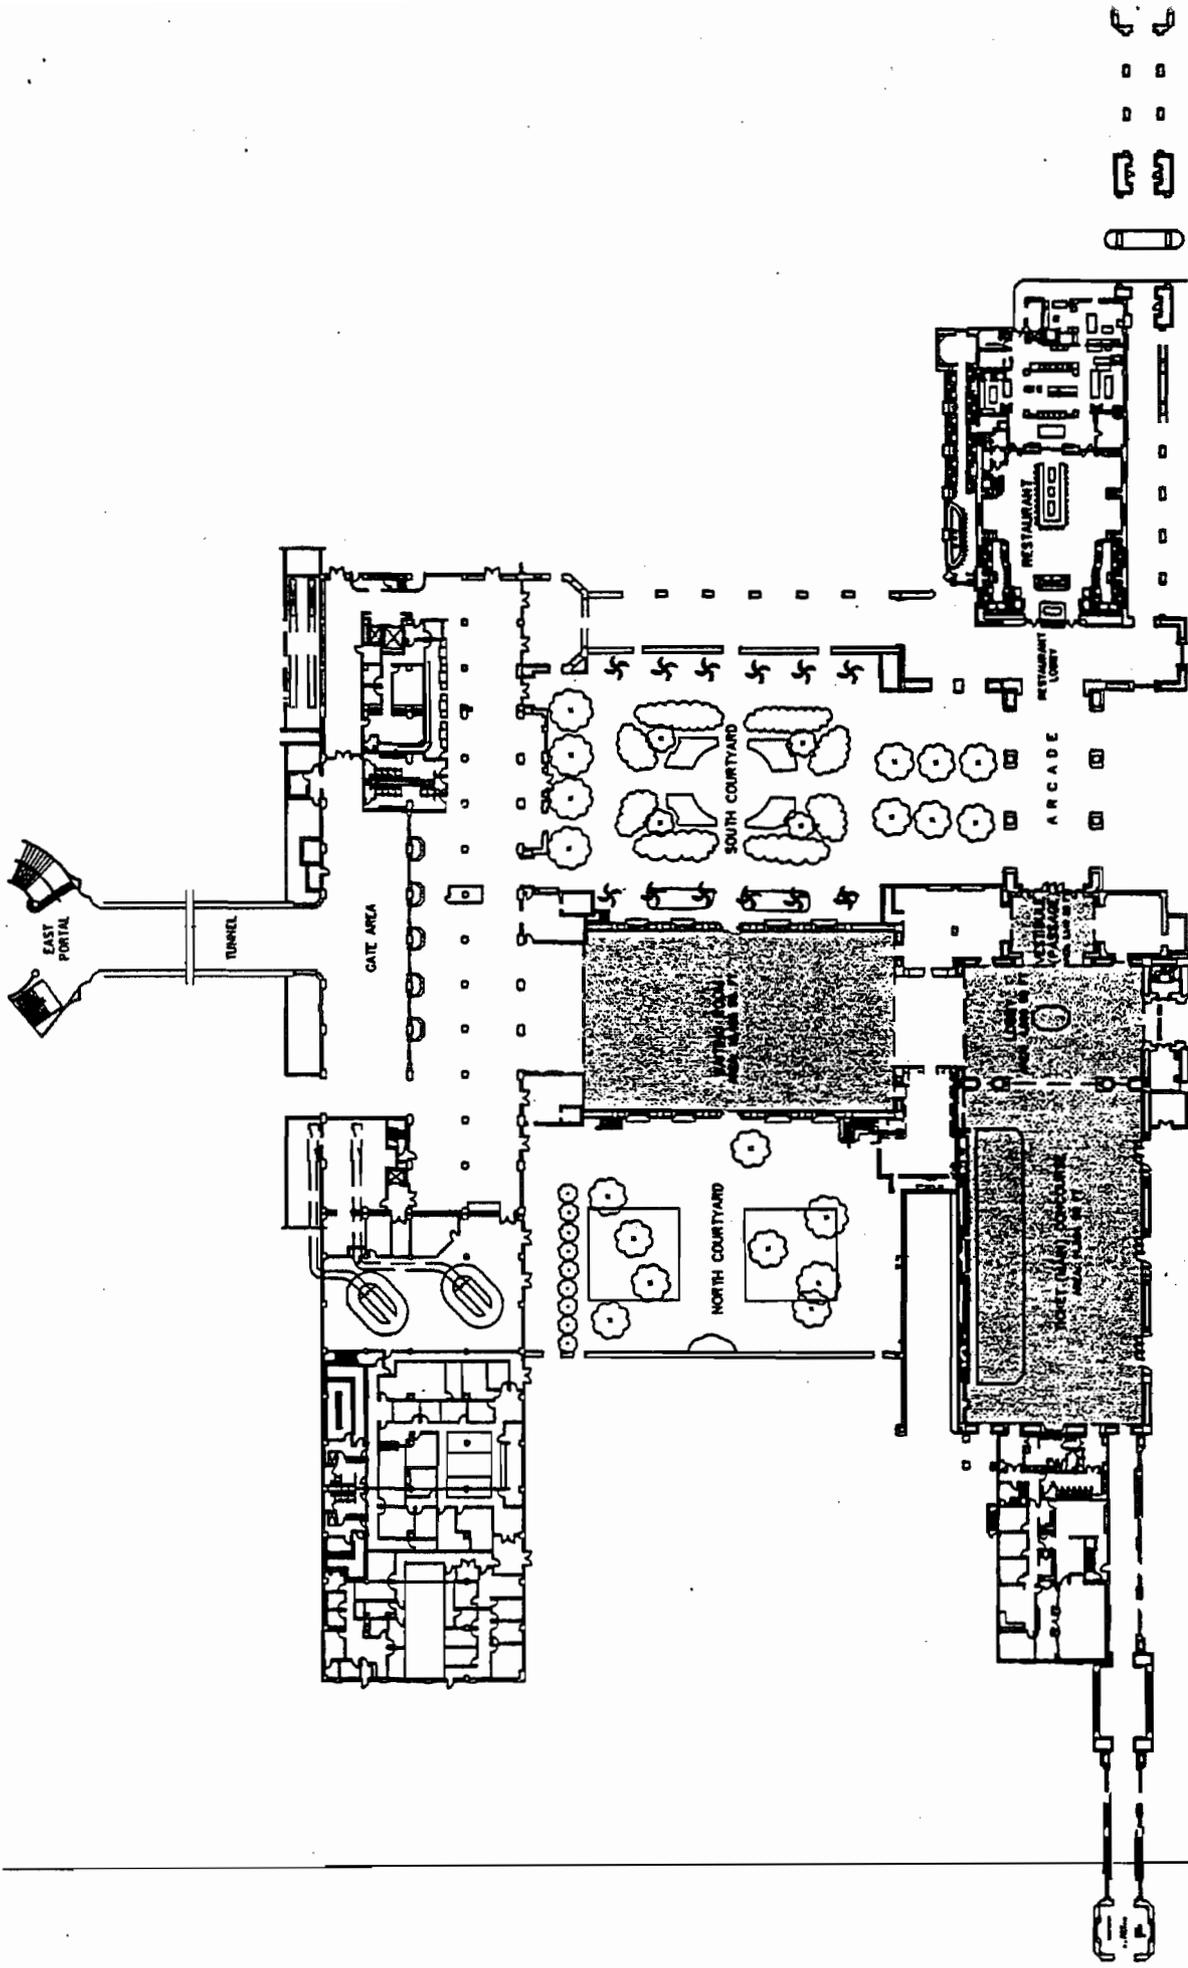
**LOS ANGELES UNION STATION**  
**EXISTING FIRST FLOOR PLAN**  
*Ceiling Restoration Key Plan*

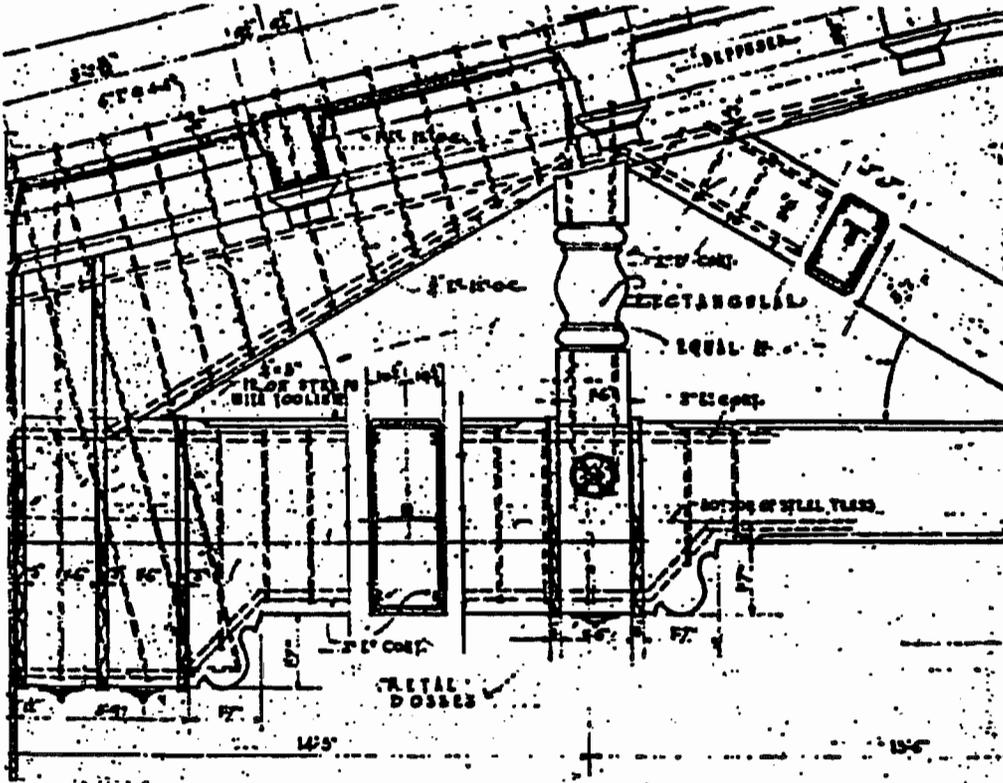
TICKET CONCOURSE

Generally, the ceilings are comprised of suspended metal lath and plaster formed into beams, coffers and corbels into which Celotex acoustical perforated tiles have been set. (See attached drawings details A, B and C from original working plans. These have been provided for information purposes only and may not reflect the exact configuration of the present ceilings). The acoustical tiles appear to be friable and to have been attached to the substrate with adhesive and screws. The screws have been painted, as observed in the Waiting Room. Intermittent gouges, scratches and loss to both plaster and paint are evident. Please see the following for specific description of each area.

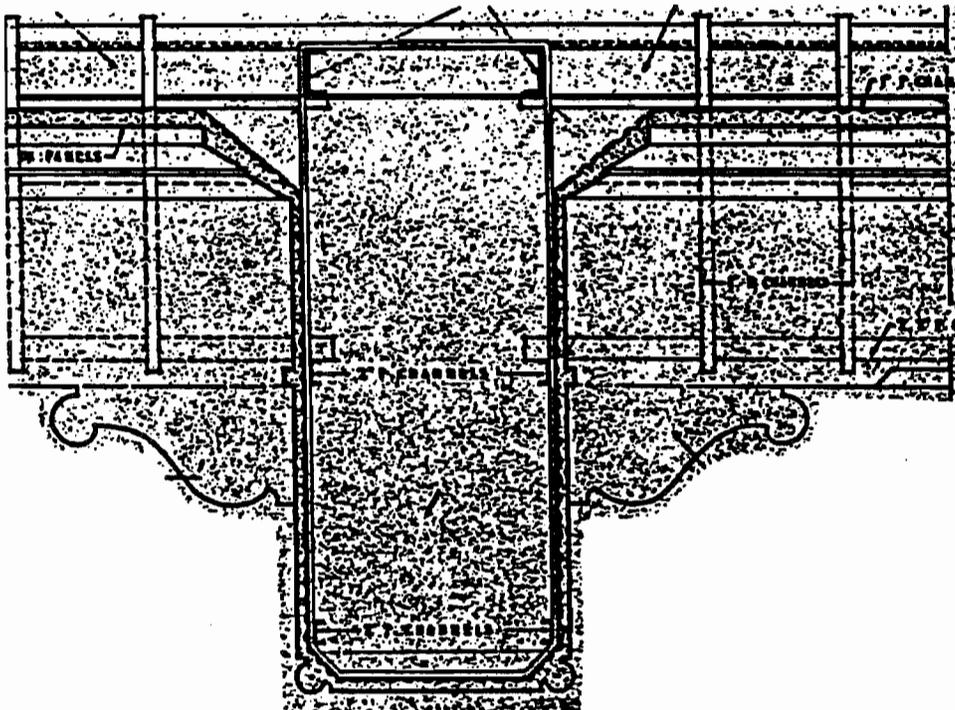
WAITING ROOM

TYPICAL EXISTING CONDITION DETAIL

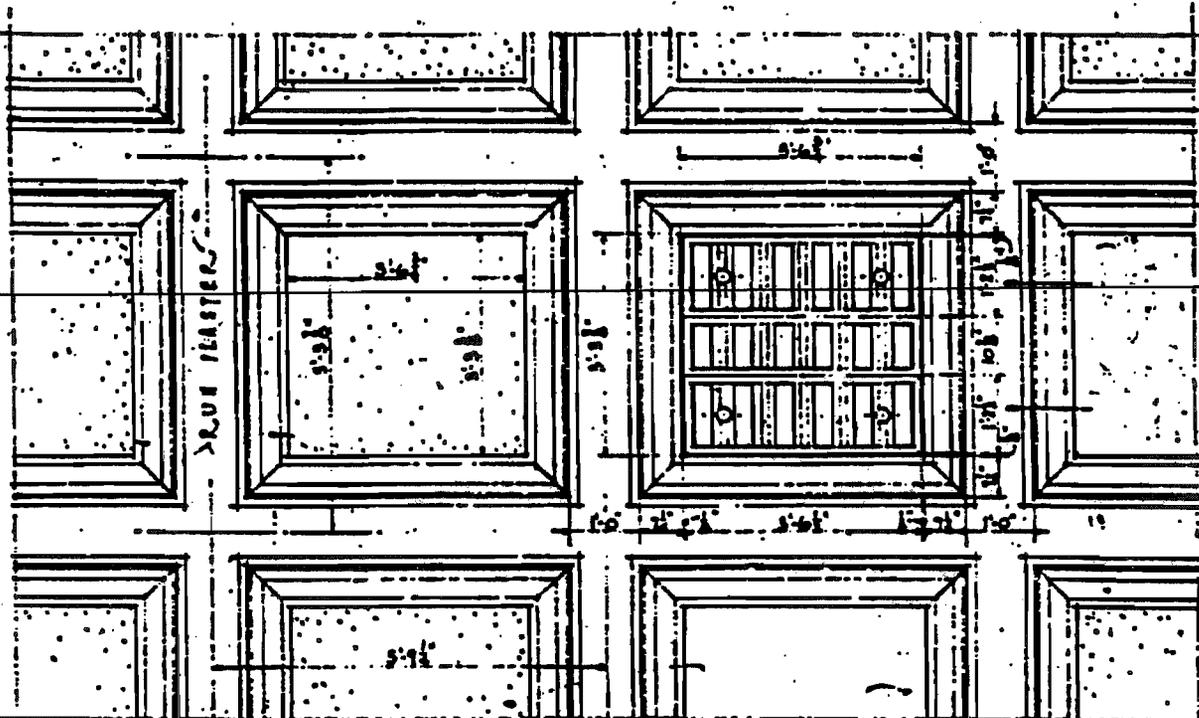
PLAN 'X-X' OF CEILING

VESTIBULE

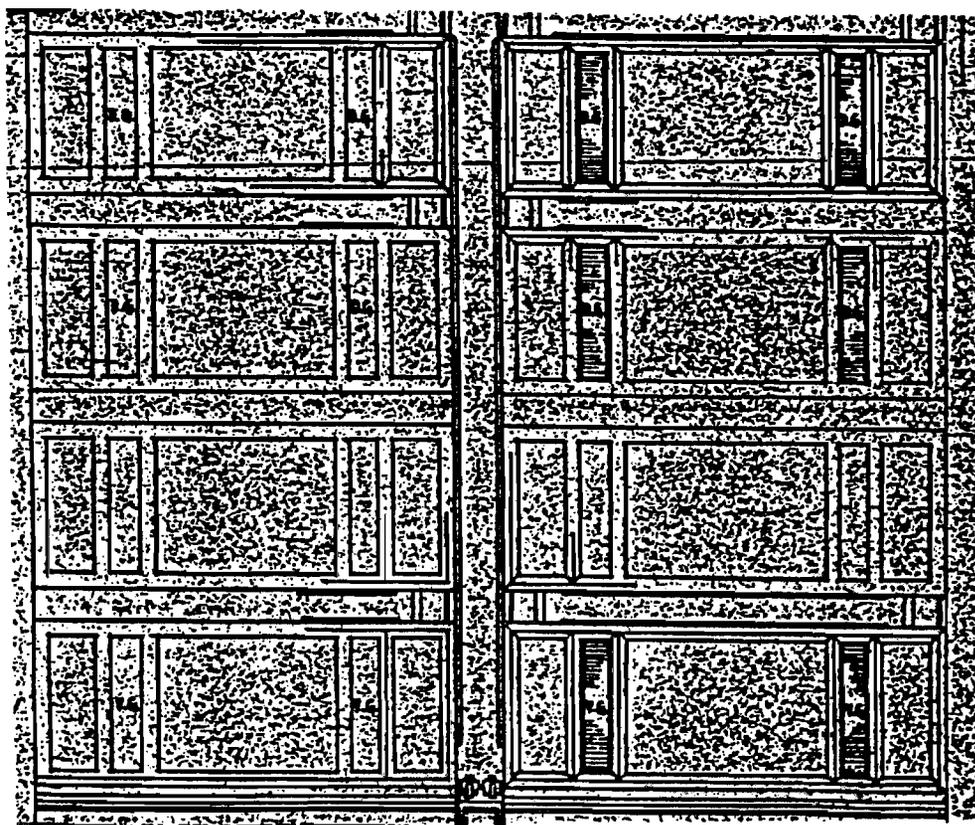
WAITING ROOM

TYPICAL EXISTING/PARTIAL CEILING PLANS

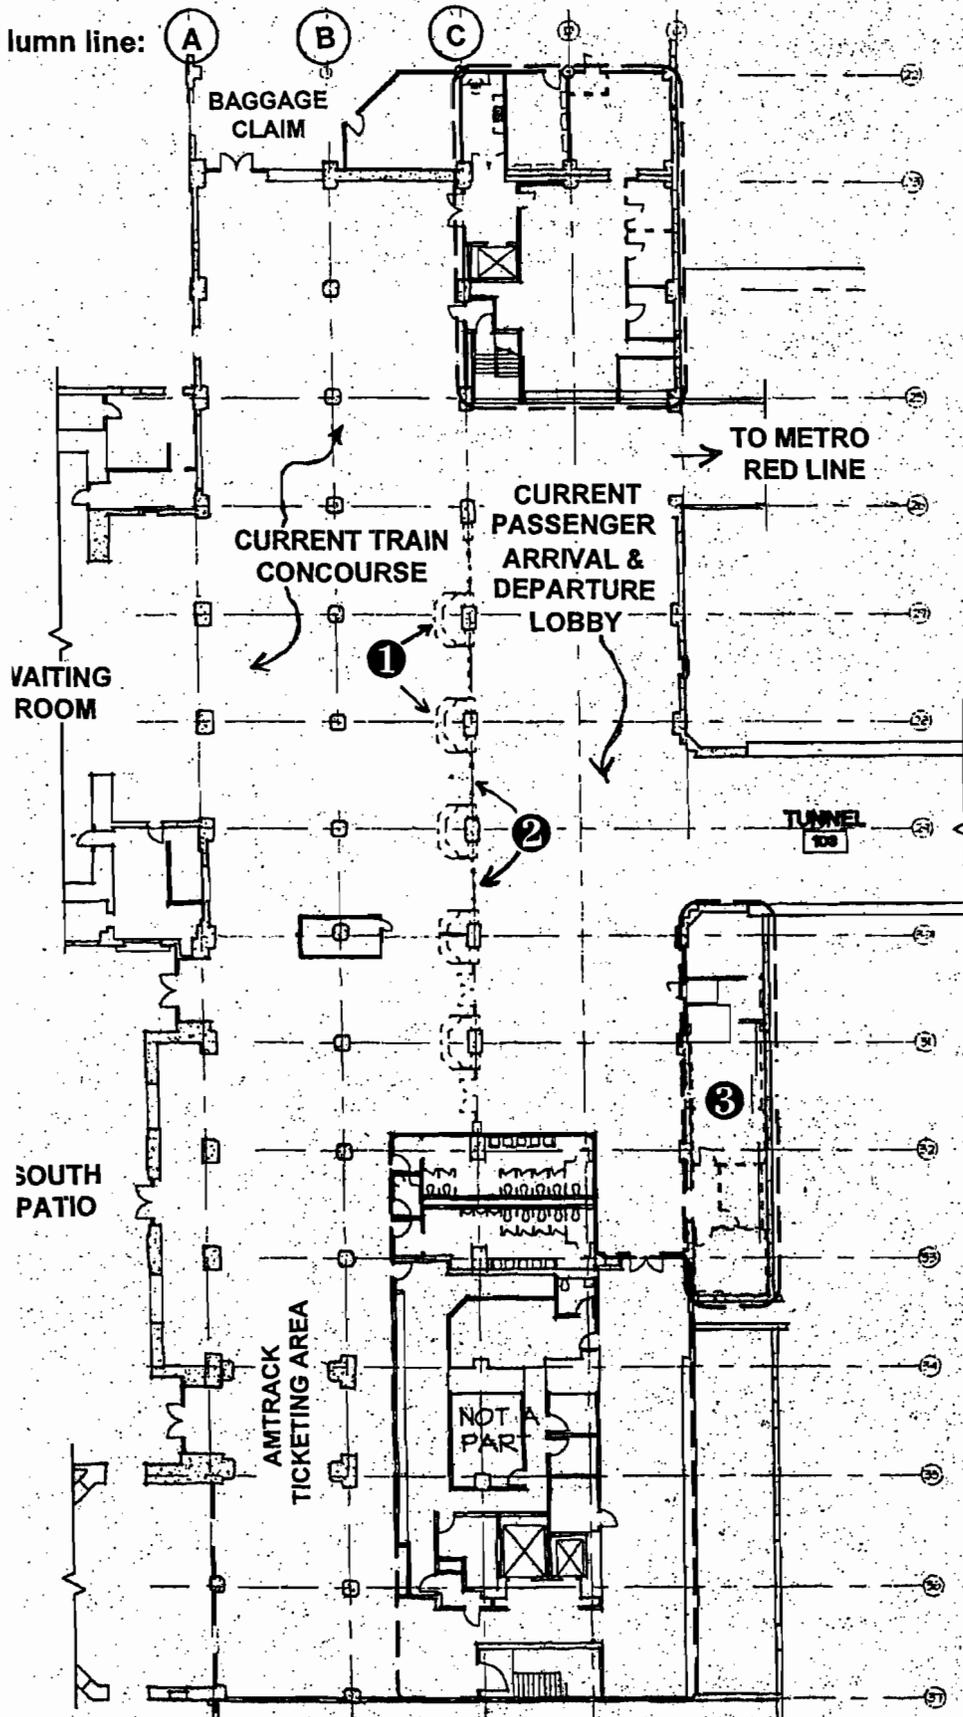
This drawing shows, in dashed lines, a floor plan of what is to be removed from the current Train Concourse (the space between Column Lines A and C) and current Passenger Arrival and Departure Lobby (the space to the right (east) of Column Line C).

- 1) Information counters are to be removed: counters at the five locations indicated in dashed lines along left (west) side of Column Line C (counters to be stored).
- 2) Departure Gates are to be removed: doors, surrounds, metal trim, associated signage located between columns in Column Line C (items to be stored) at the six locations indicated in dashed lines.
- 3) Non-historic partitions are to be removed from the area where restrooms will be installed; area does not contain historic, character-defining features.

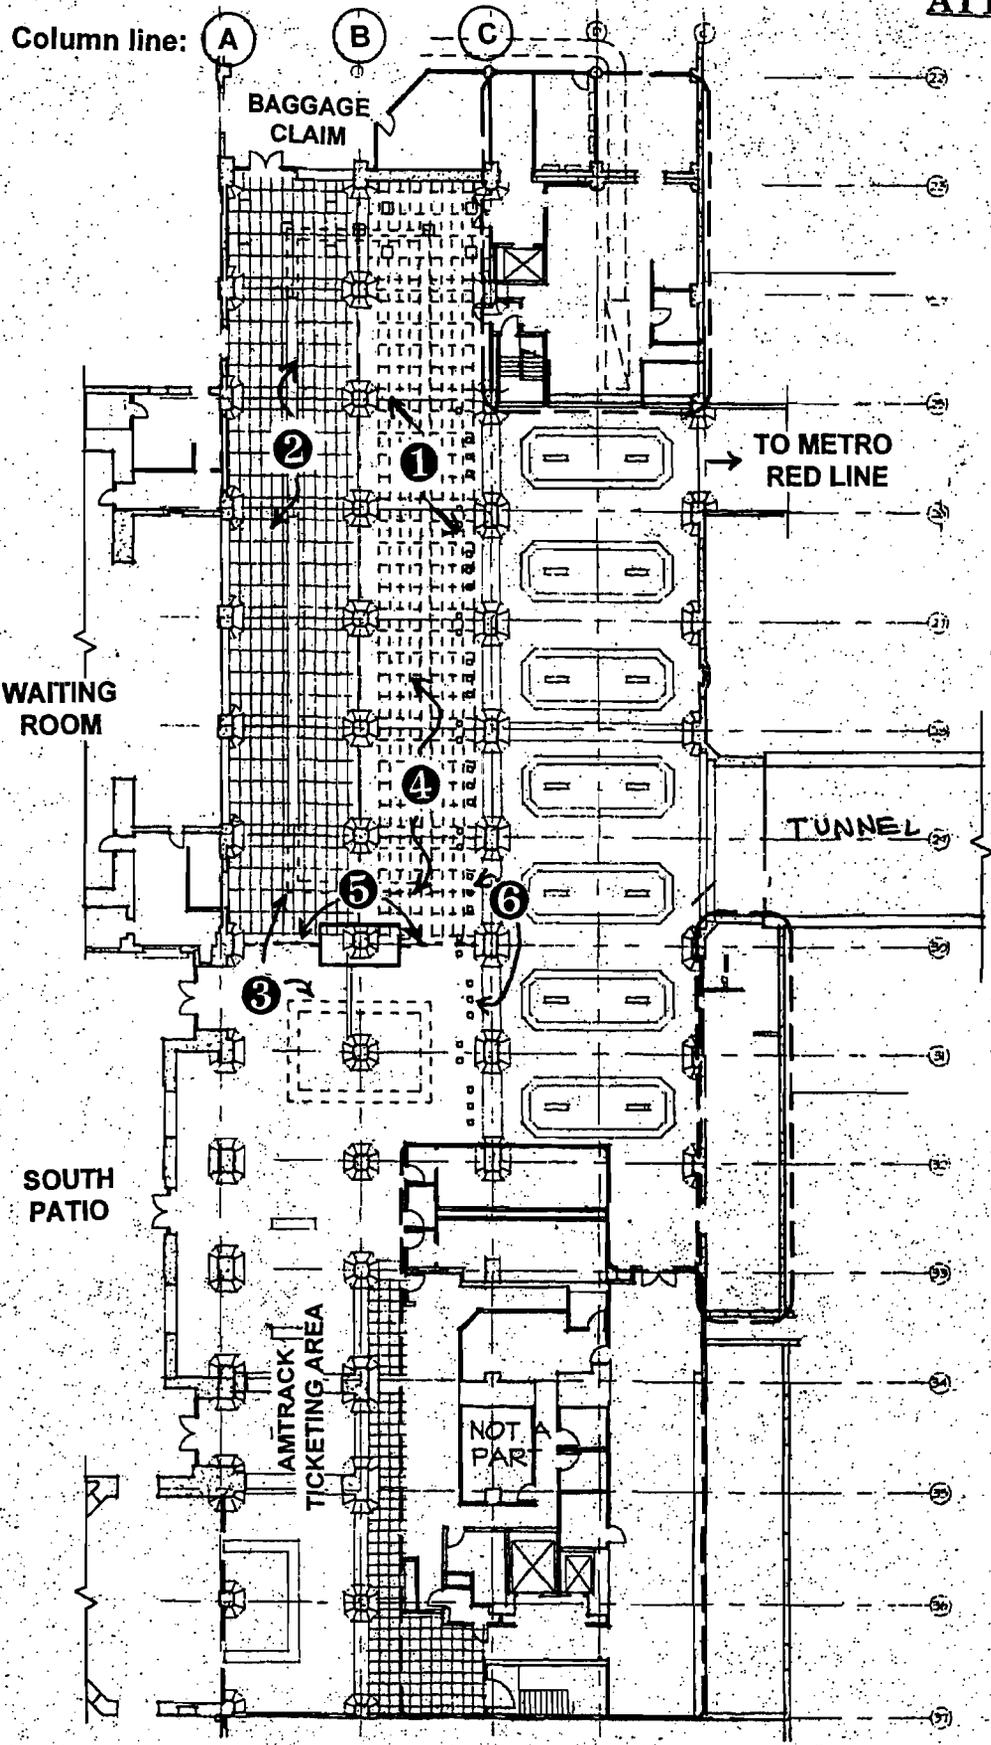
TRAIN CONCOURSE REFLECTED CEILING DEMOLITION PLAN

This drawing shows, in dashed lines, a reflected ceiling plan of what is to be removed from the current Train Concourse and current Passenger Arrival and Departure Lobby.

- 1) Original acoustical tiles to be removed between Column Lines B and C.
- 2) Original acoustical tiles to remain between Column Lines A and B.
- 3) Light track to be partially removed for relocation (see Attachment E). Track currently runs in a rectangular configuration surrounding piers in Column Line B.
- 4) Ceiling to be cut into (between Column Lines B and C) to create shallow coffers similar to those in the adjacent area, which is now known as the passenger arrival and departure lobby (i.e., the area to the right of Column Line C in these diagrams).
- 5) Soffit to be removed to either side of train board. This soffit does not appear to be original material.
- 6) Small, square ceiling lights to be removed and relocated nearby (see new restrooms, Item 5 on Attachment E).

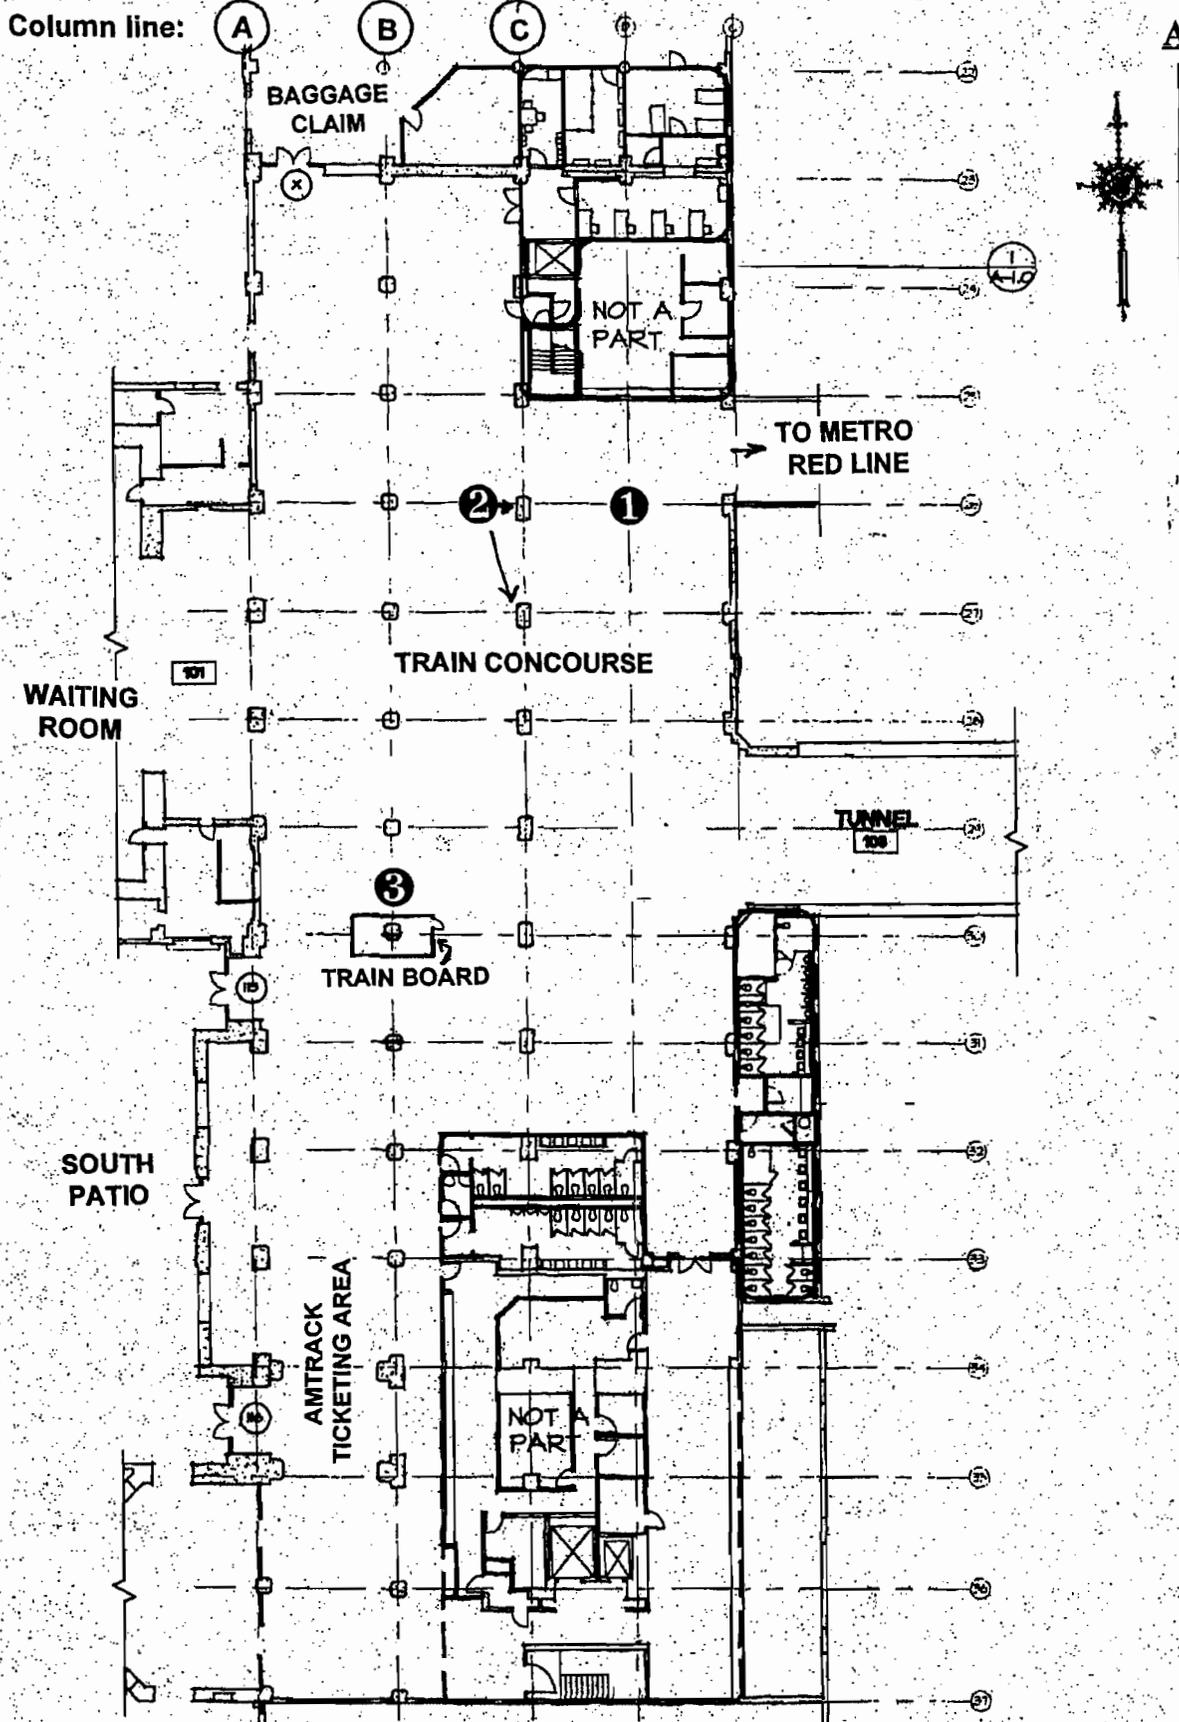
PROPOSED  
TRAIN CONCOURSE PLAN

SCALE  
1/8" = 1'-0" 1
