HIGHWAYS AND PUBLIC WORKS

MAY-JUNE
1945

New Traffic Counting Procedure for Commercial Vehicles Inaugurated

There will be no attempt made to enumerate all maintenance problems encountered, but the more important features of the work, with illustrations, will be covered in a series of articles, of which this is the fourth. It deals with Repair of Steel Trusses.

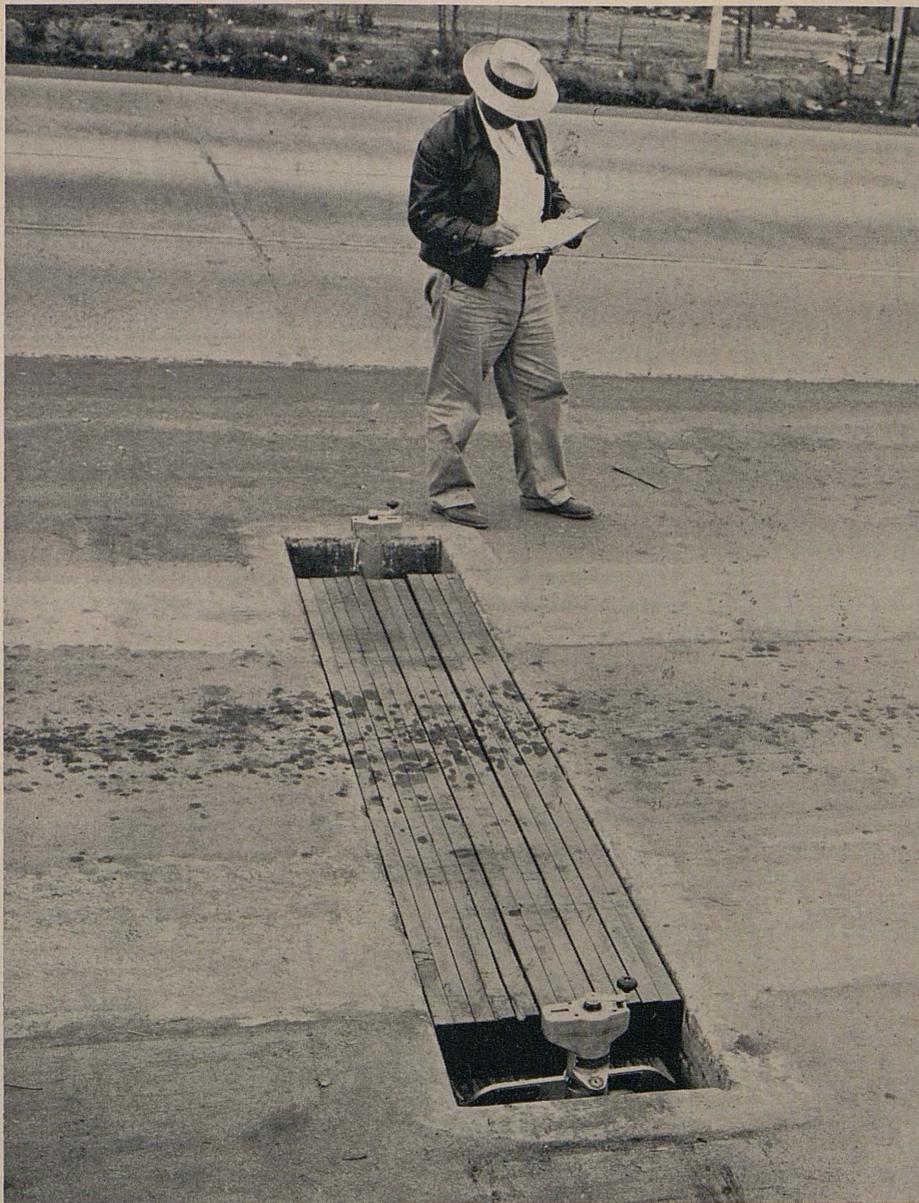
Equalizing beam and loadometers in place in concrete loadometer pit

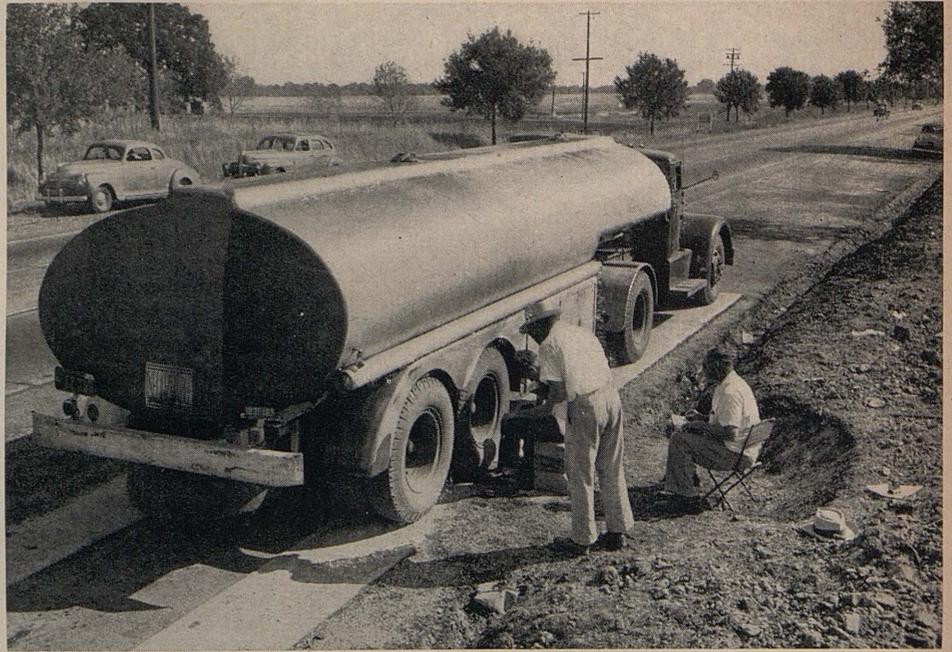
Weighing third axle of type 2s2 gasoline transport combination

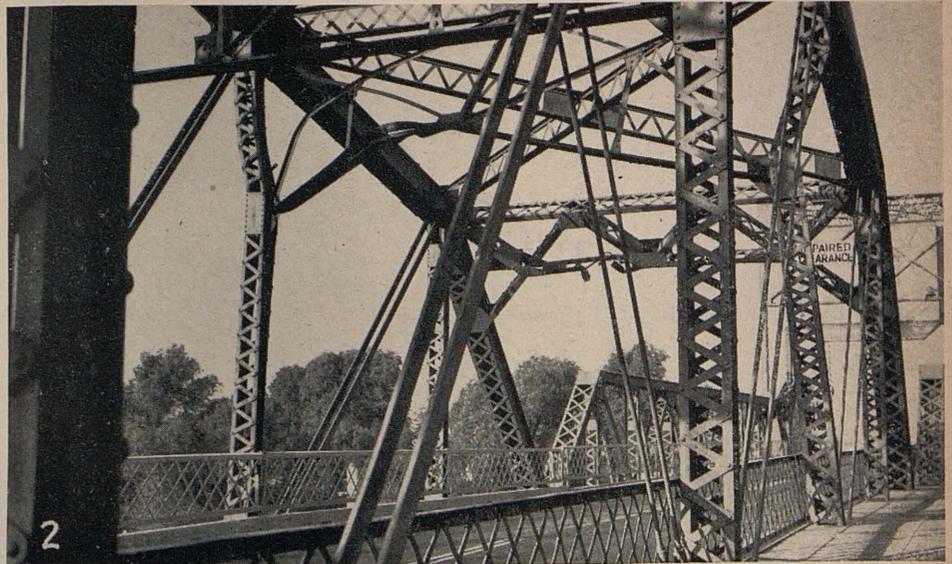
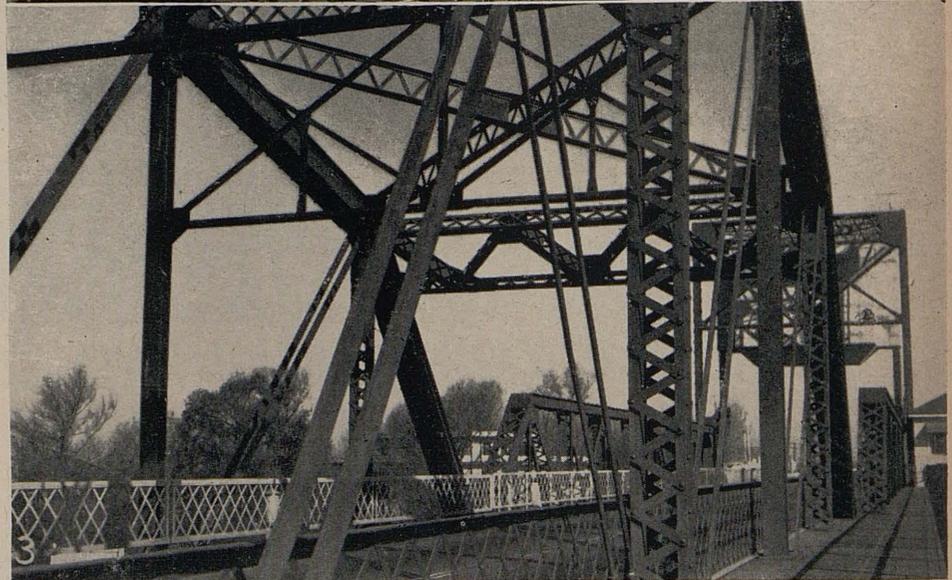
Before and after pictures of traffic damage repair on the Mossdale Bridge. Figure 3 shows the damaged posts replaced with H beams

no longer act as designed, it continued to carry all traffic for some time before the condition was reported. In this case the temporary supports were steel H-beams jacked between the truss chords alongside the damaged posts. The repair consisted of replacing the damaged posts with 10-inch H-beams, the use of rolled beams rather than an attempt to match the laced channel compression members being standard procedure. However, in this case, instead of trying to fit existing connections at the chords, the damaged posts were merely cut away between the end batten plates, the stubs capped with steel plates, and lengths of H-beam welded between. The damaged sway frames were replaced with new members welded into place. The damaged

truss and the completed repair are shown respectively in **Photos 2 and 3**.

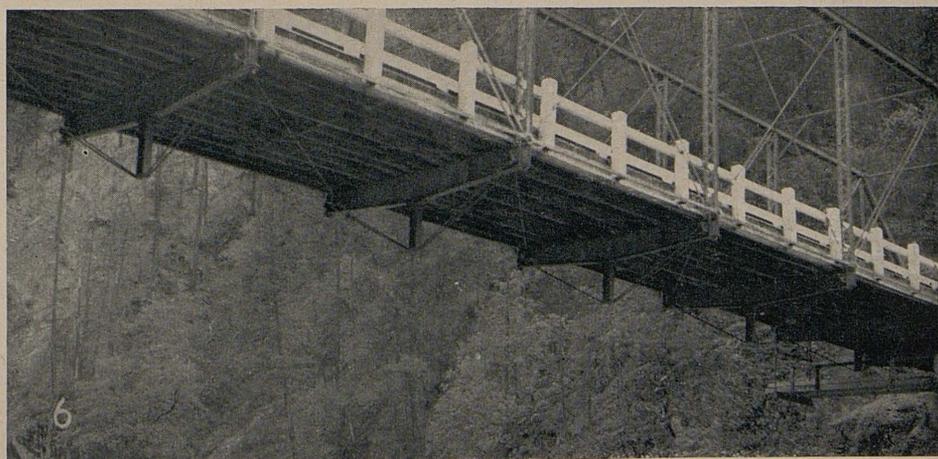
Floor beams of a through truss bridge strengthened by the truss beam method

The trussed beam method of strengthening floorbeams is often used where clearances and drift conditions permit. This method consists in converting the floorbeam into an inverted king post truss by means of a vertical post and one or more bent steel rods, commonly known as "hog-rods." Generally, under this method, dead load is supported by beam action and live load is taken by the truss. However, where conditions permit jacking from below, the dead load stress in the beam may be relieved before the rods are welded into place. The two primary methods of strengthening floorbeams are illustrated in this article and **Photo No. 6** shows the use of the trussed beam method to reinforce floorbeams on a steel truss span.

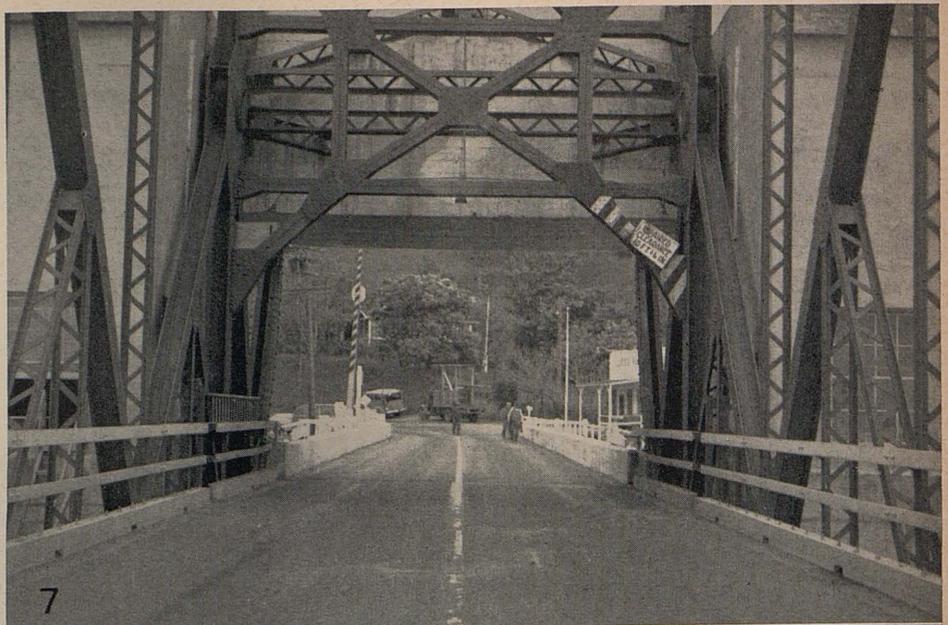
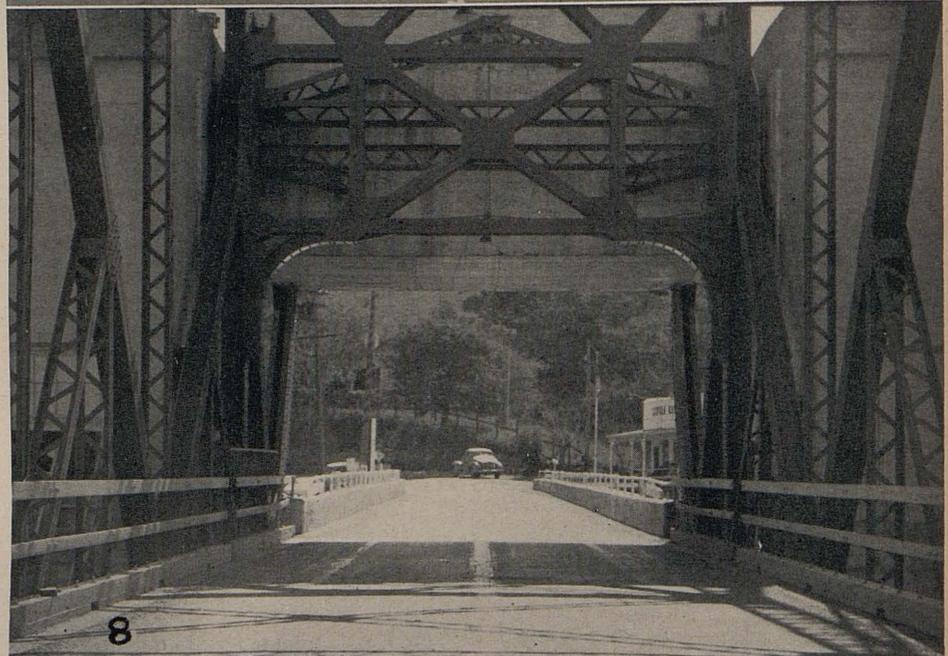
Improvement of vertical clearance by replacement of main trunion braces on the Petaluma Creek Bridge

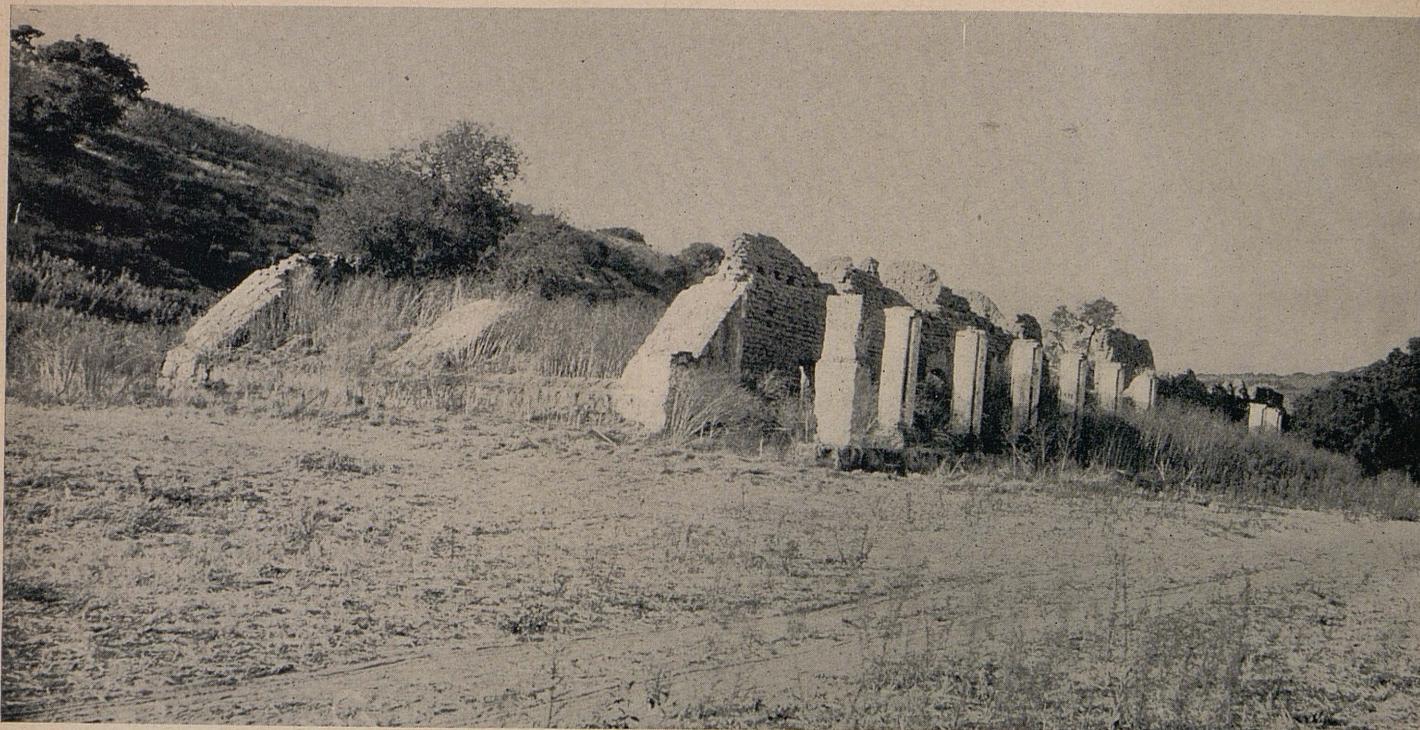
Upper—Ruins of Mission La Purisima Concepcion before restoration work was begun *Byron Dome Photo*

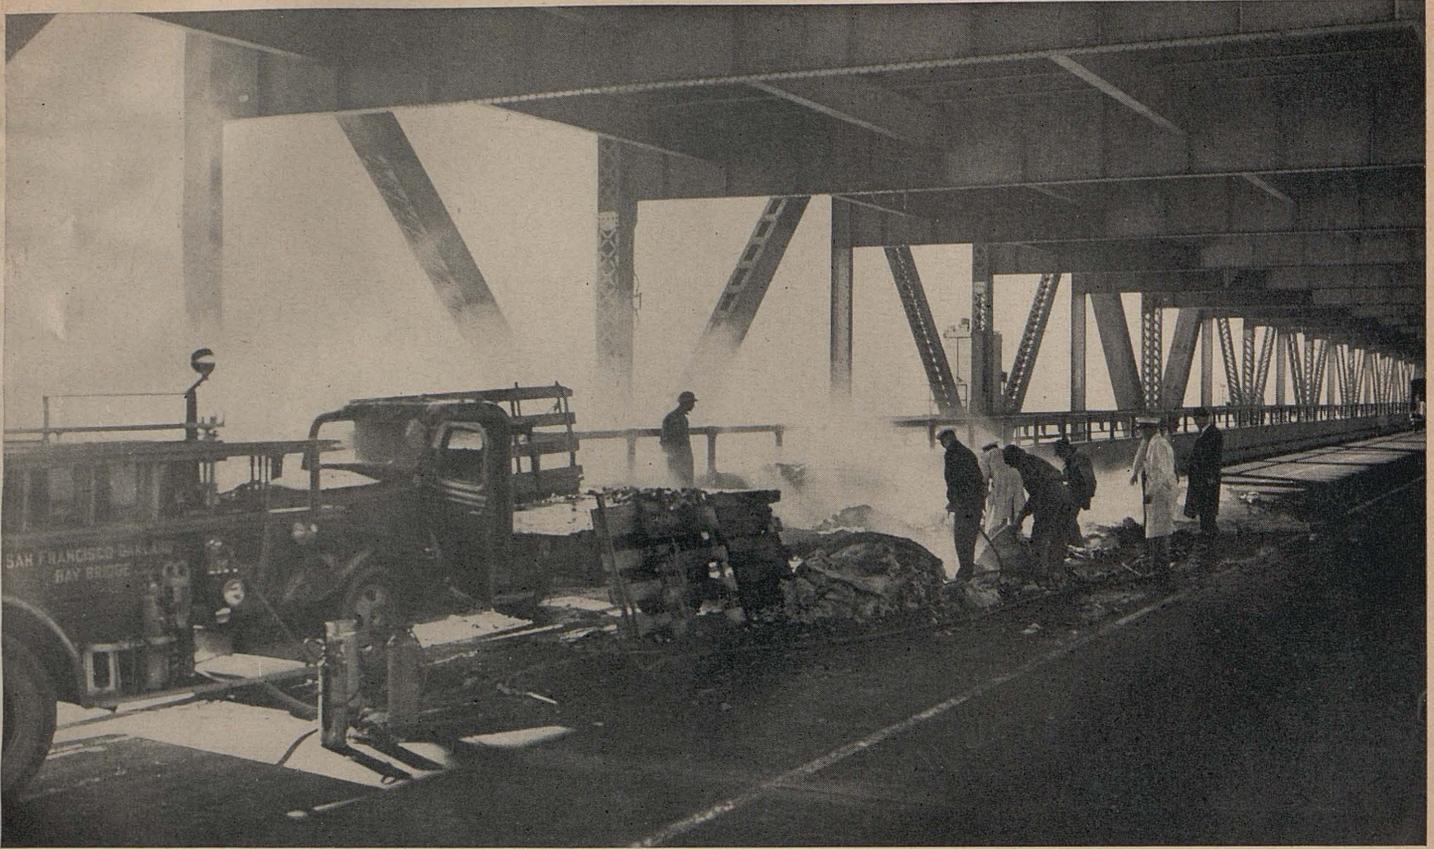
This photograph shows what happened on the Bay Bridge when a cigarette was carelessly thrown into a truck load of mattresses

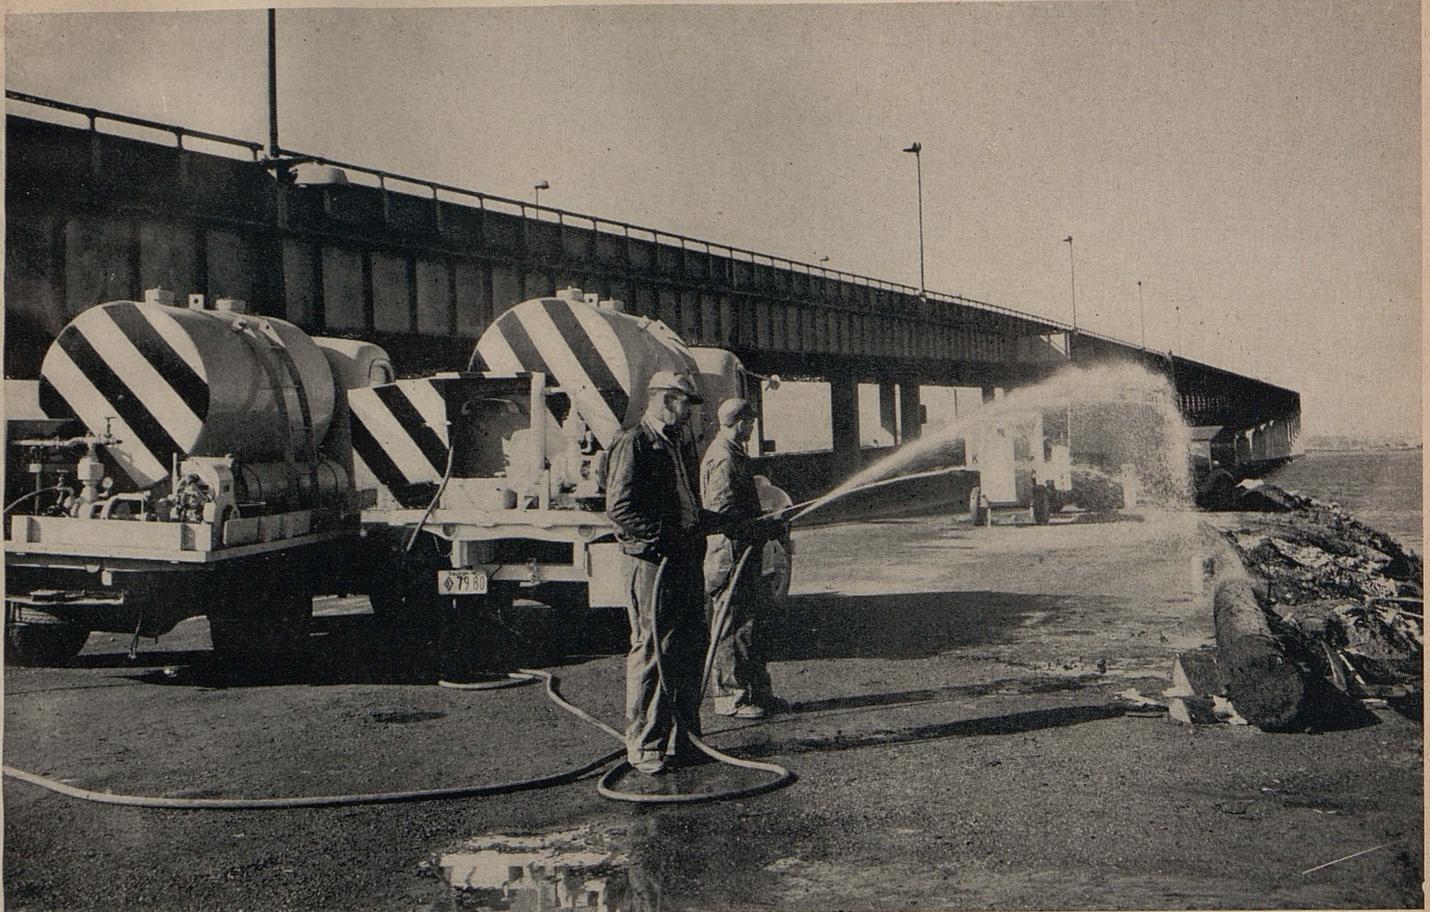
Truck-mounted tanks are 580-gallon capacity equipped with small, centrifugal pumps for fire fighting purposes on Bay Bridge

Auxiliary bridge fire-fighting equipment has been provided by installing small gasoline-engine-driven centrifugal pumps and hose on two 580-gallon truck-mounted water tanks normally used by the bridge painting crew for preliminary cleaning operations, and by installing a pump and pertinent equipment on the bridge maintenance boat *Active* for possible use on certain bridge piers having a timber protection fender. The *Active* is a 14-ton launch of 42-foot length and 12-foot beam powered by a 3-cylinder, 50 H.P. Corliss marine engine. The boat was used by bridge engineers during construction and on completion of that operation was assigned to the bridge maintenance forces. The fire-fighting equipment mounted on the boat consists of a Chrysler-Hale auxiliary fire pump of 500 g.p.m. rated capacity, 200 feet of 2½-inch and 1½-inch hose and a monitor nozzle mounted atop the pilot house. At the rated capacity the pump readily develops 125 pounds pressure.

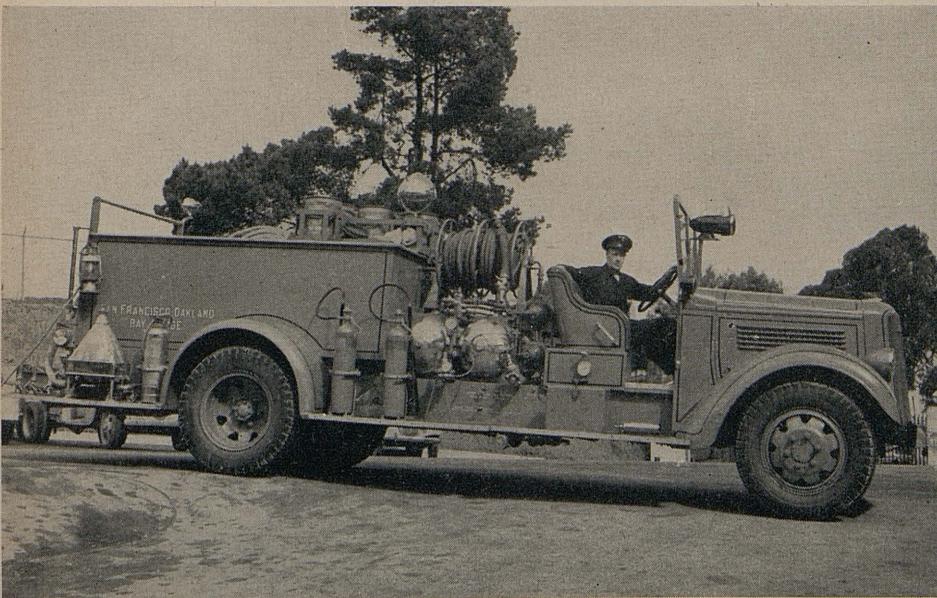
Fire truck unit operated by Bay Bridge

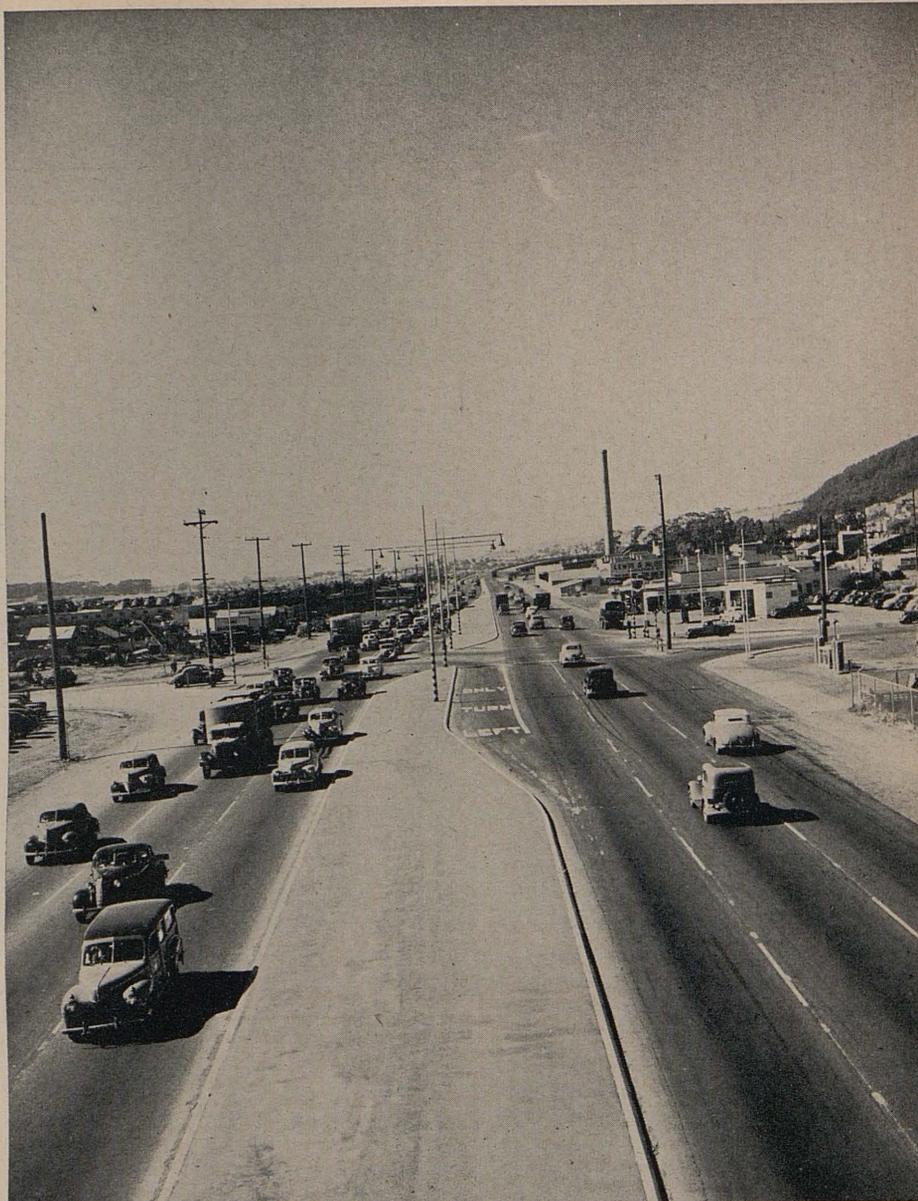
This view of Gilman Street, looking north toward Richmond, with Albany overhead in distance, shows channelization with left turn lanes flaring to widen center strip

These storage or left turn lanes are indentations in the center divisional strip. On the Eastshore Highway the opposing traffic lanes are divided by a six-foot median strip, except at the channelized intersections where the

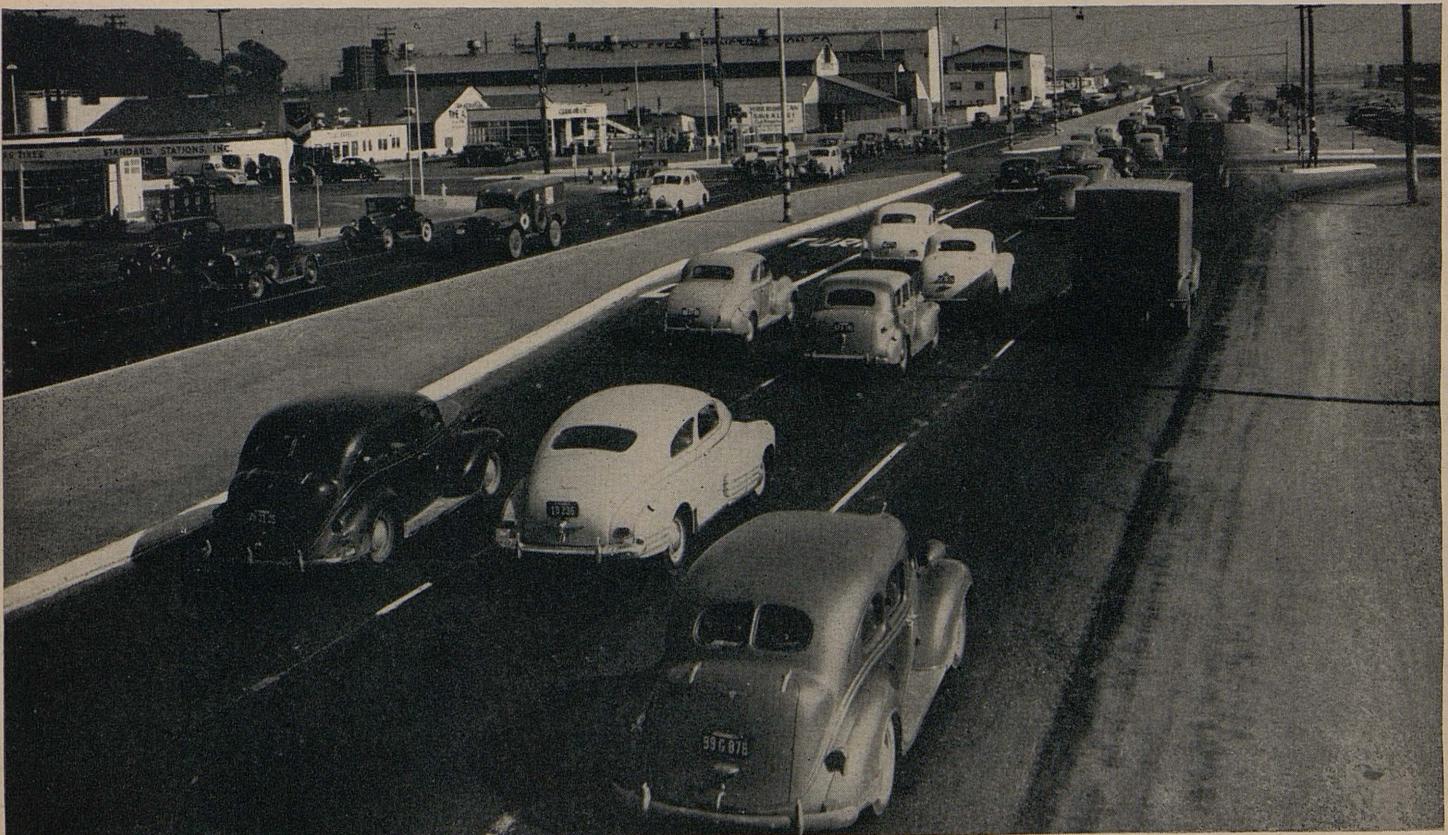
View of intersection on Gilman Street, showing left-turn lane and channelizing islands. Traffic lights look south toward Bay Bridge
