1. Report No. FHWA/TX-01/1792-3		2. Government Accession No.		3. Recipient's Catalog No.	
4. Title and Subtitle TESTING AND EVALUATION OF A PEDESTAL BASE SIGN SUPPORT				5. Report Date January 2001

6. Performing Organization Code	
7. Author(s) D. Lance Bullard, Jr., Roger P. Bligh, Wanda L. Menges, and Sandra K. Schoeneman				8. Performing Organization Report No. Report 1792-3

#### TEST INSTALLATION FOR TESTS 417920-1 AND 2

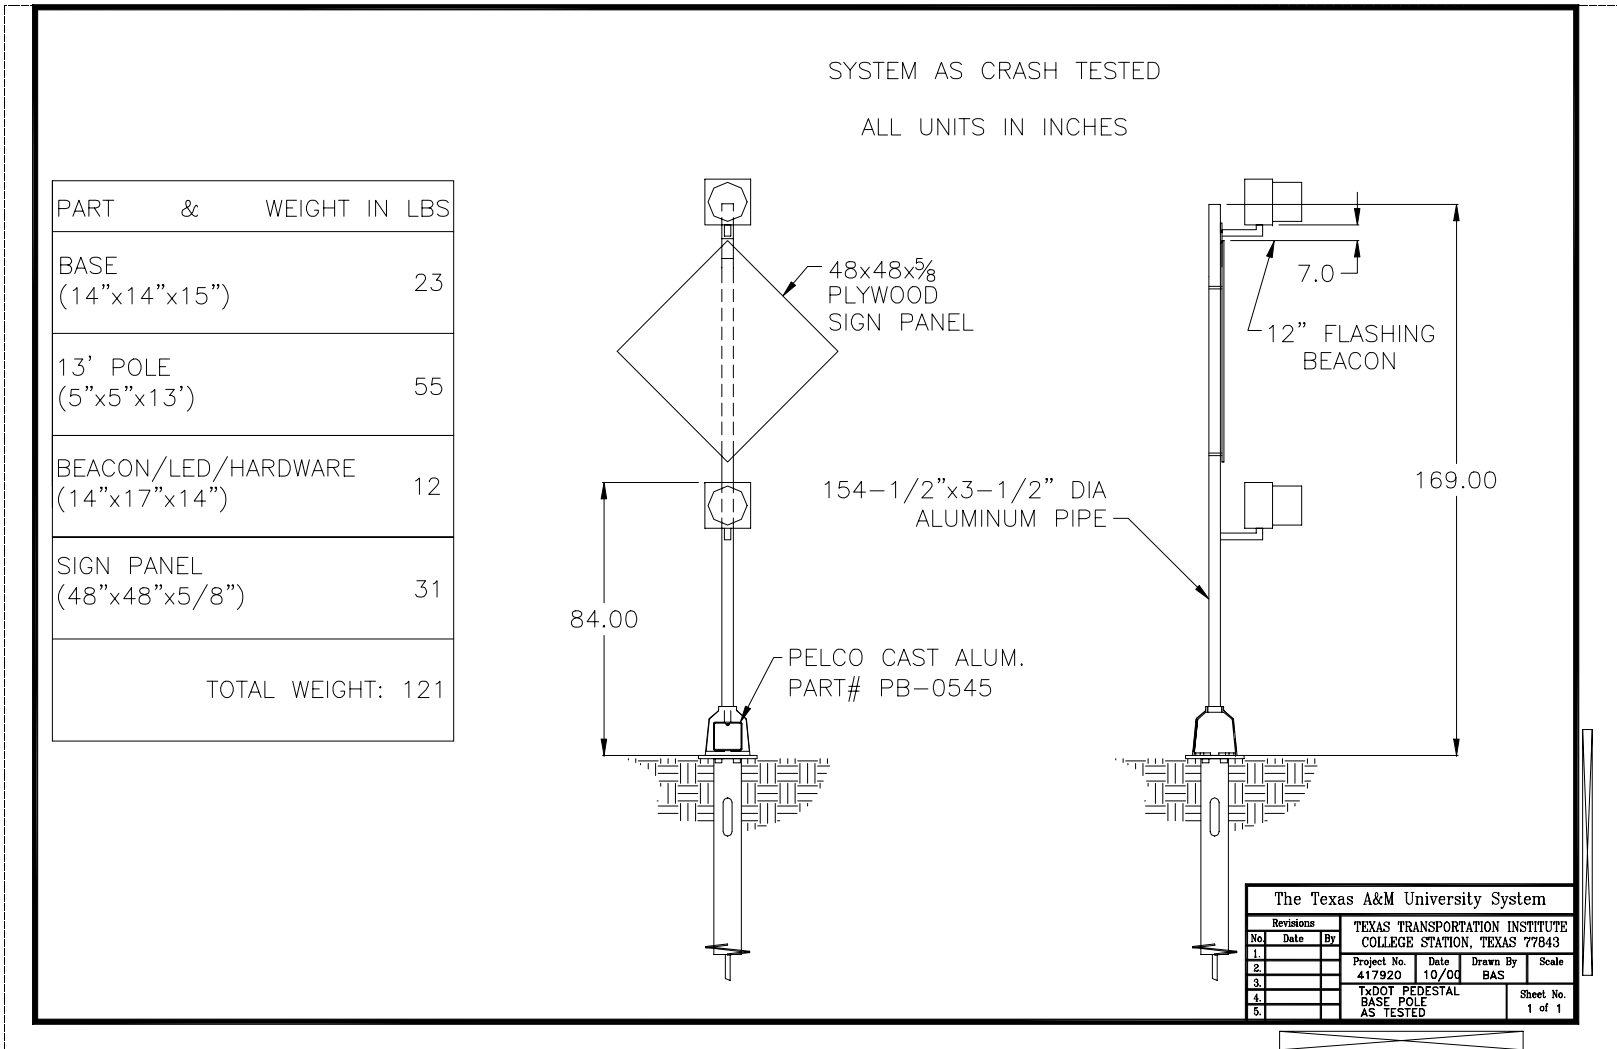
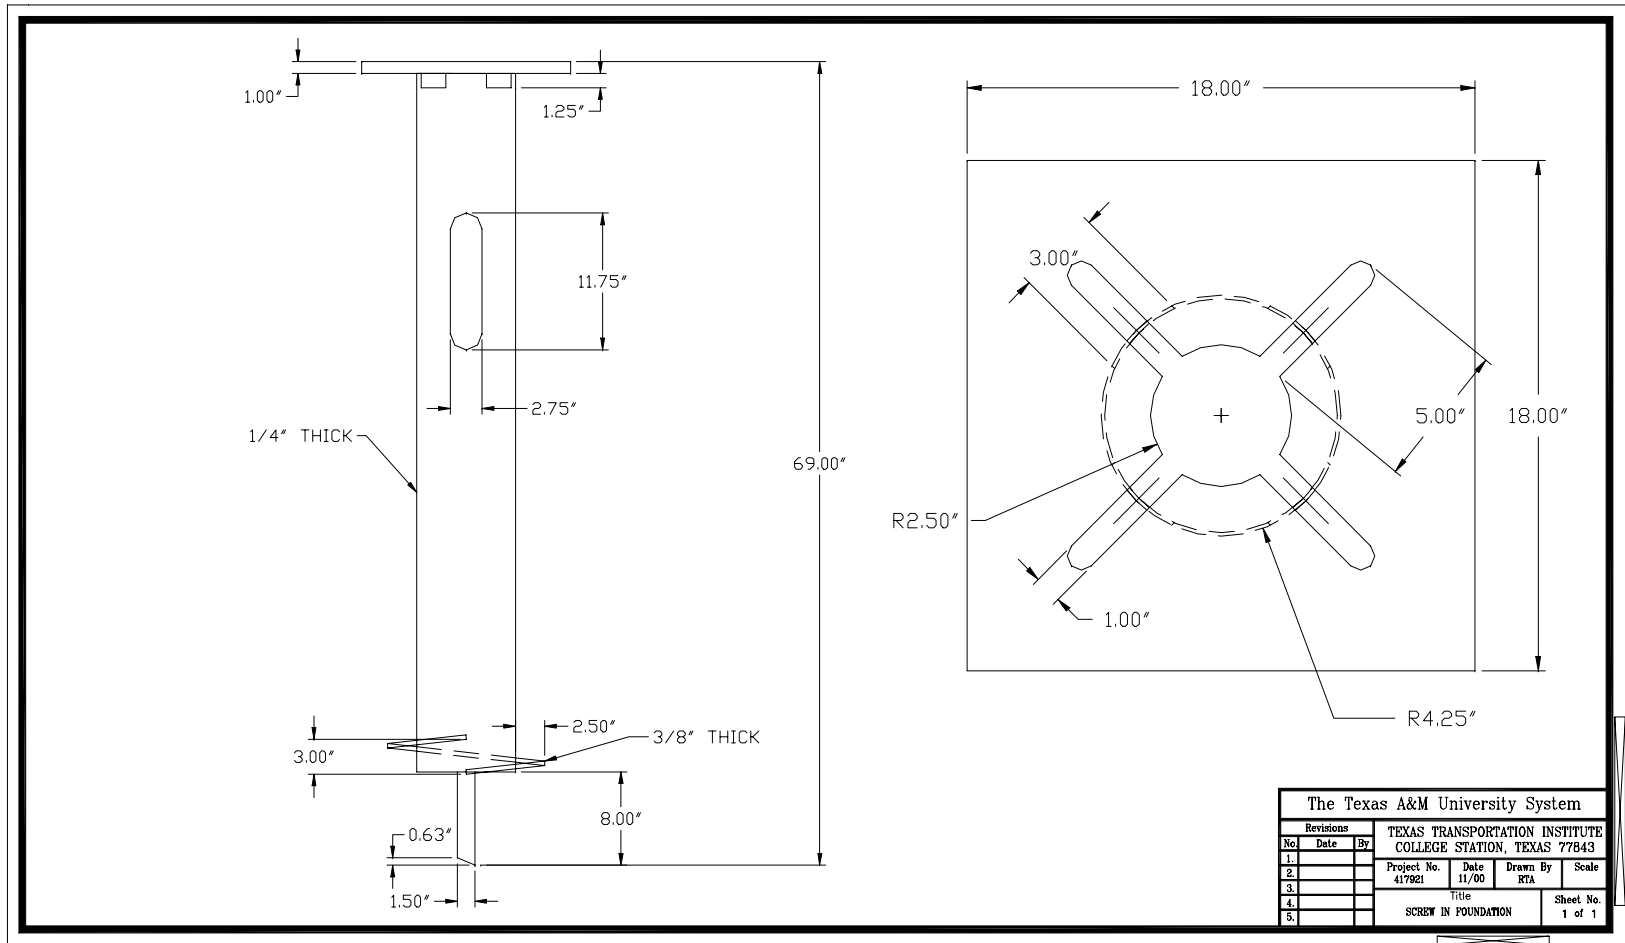
**Figure 1. Pedestal Base Sign Support as Used in Tests 417920-1 and 417920-2.**

Figure 1. Pedestal Base Sign Support as Used in Tests 417920-1 and 417920-2 (continued).

A pedestal base sign installation attached to the ground with a helical type screw-in foundation anchor assembly was constructed for crash testing and evaluation. The installation was fabricated using a Pelco (model SP 1014 TX) square cast aluminum traffic signal base with a 114 mm (4.5 in) O.D.  $\times$  3.96 m (13 ft) long spun aluminum pole. Attached to the pole was a 16 mm  $\times$  1.2 m  $\times$  1.2 m (0.625 in  $\times$  48 in  $\times$  48 in) plywood warning sign with the bottom of the sign mounted at a height of 2.26 m (7.4 ft). In addition, a 305 mm (12.0 in), LED lamp, flashing yellow signal beacon was mounted directly above and below the sign panel. The helical type screw-in foundation anchor assembly (model PB5306) was placed in *NCHRP Report 350* standard soil. [Figure 1](#) shows the details of the support structure and screw-in anchor. The system was constructed identically for each test. The screw-in anchors were installed using an auger truck, as shown in [Figure 2](#). Photographs of the completed installation for the low-speed (35 km/h) and high-speed (100 km/h) tests are shown in [Figures 3](#) and [4](#).

A pedestal base sign support attached to a screw-in foundation, shown in [Figure 1](#) and [Figure 2](#), was evaluated in this crash test.

A pedestal base sign support attached to a screw-in anchor foundation, shown in [Figure 1](#) and [Figure 3](#), was evaluated in this crash test.

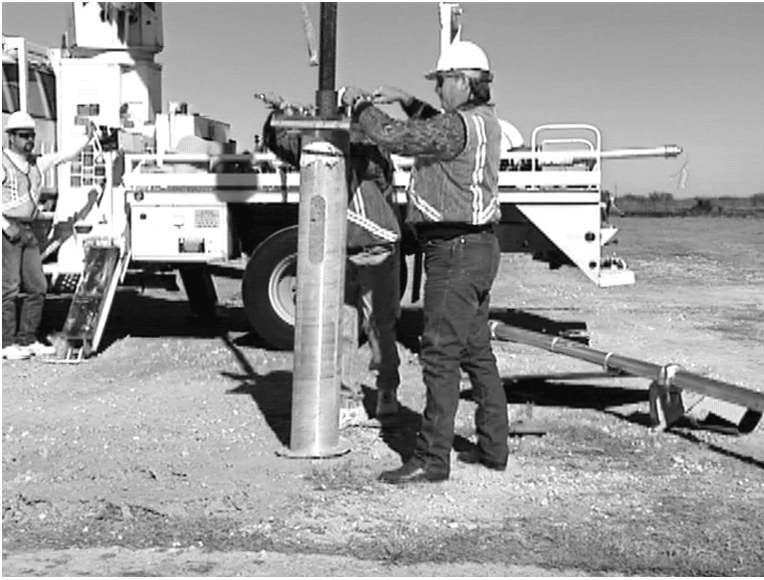
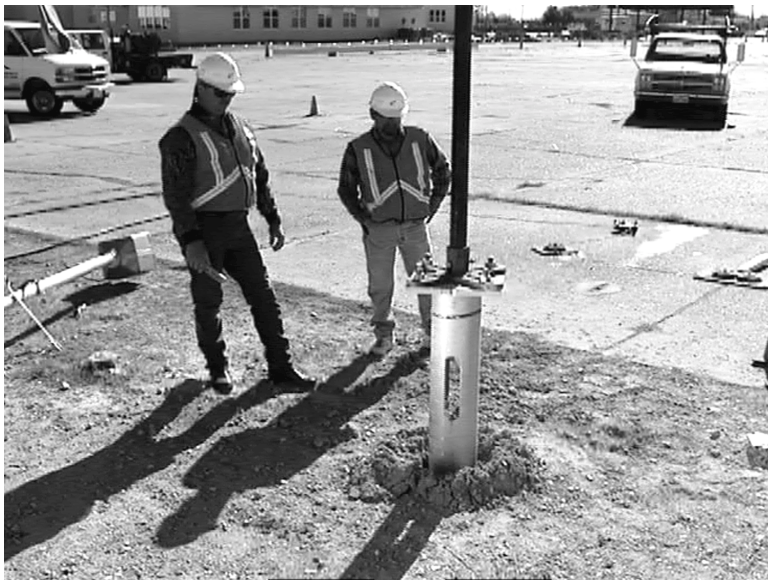
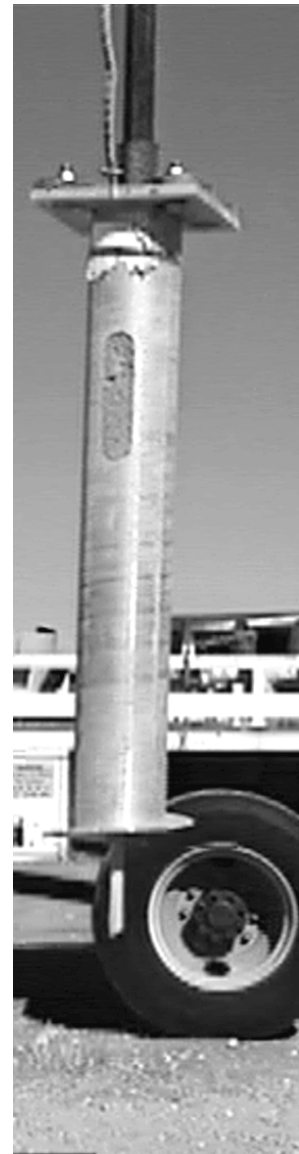
**Figure 2. Installation of Anchor Used in Tests 417920-1 and 417920-2.**

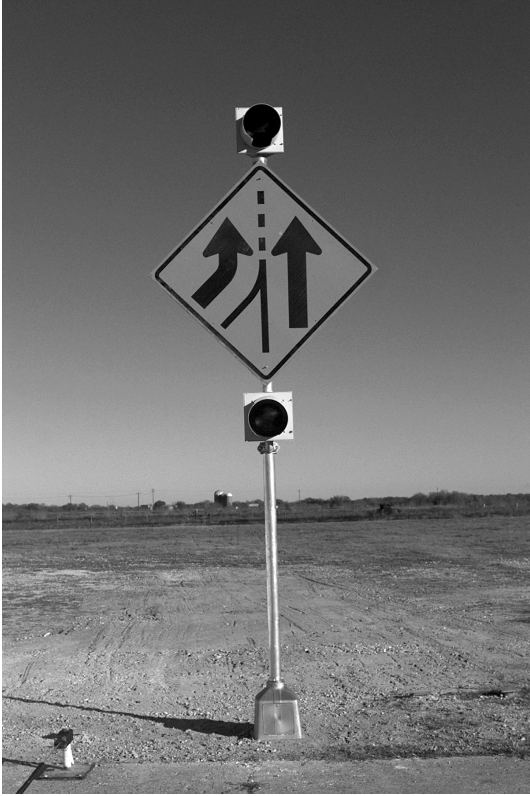
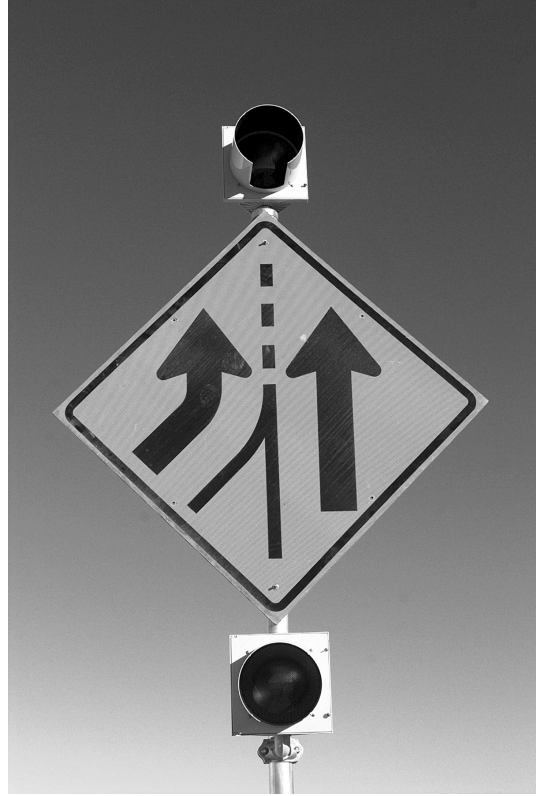
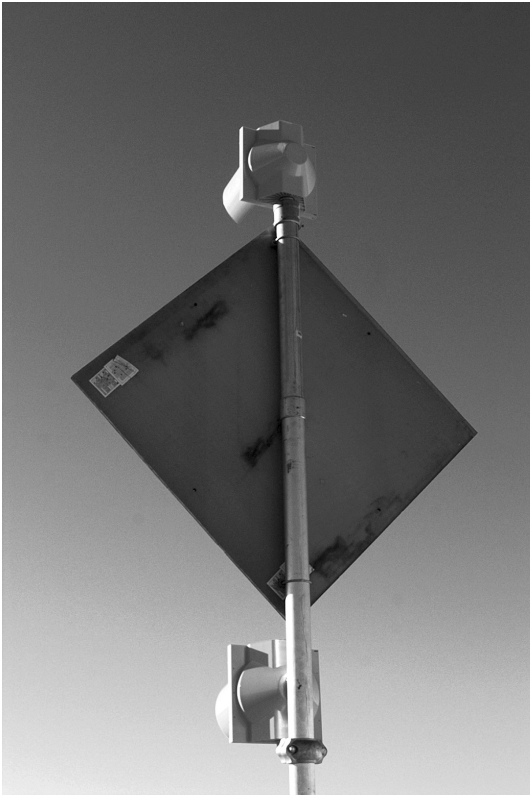
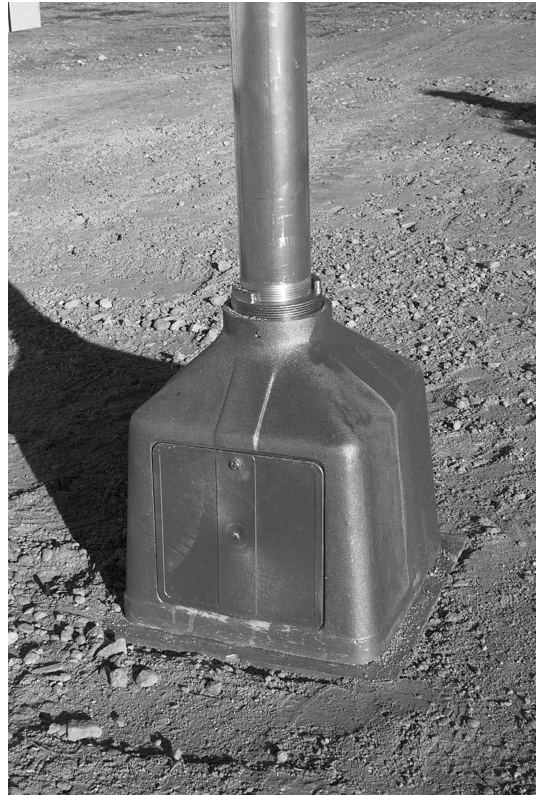
**Figure 3. Pedestal Base Sign Support before Test 417920-1.**

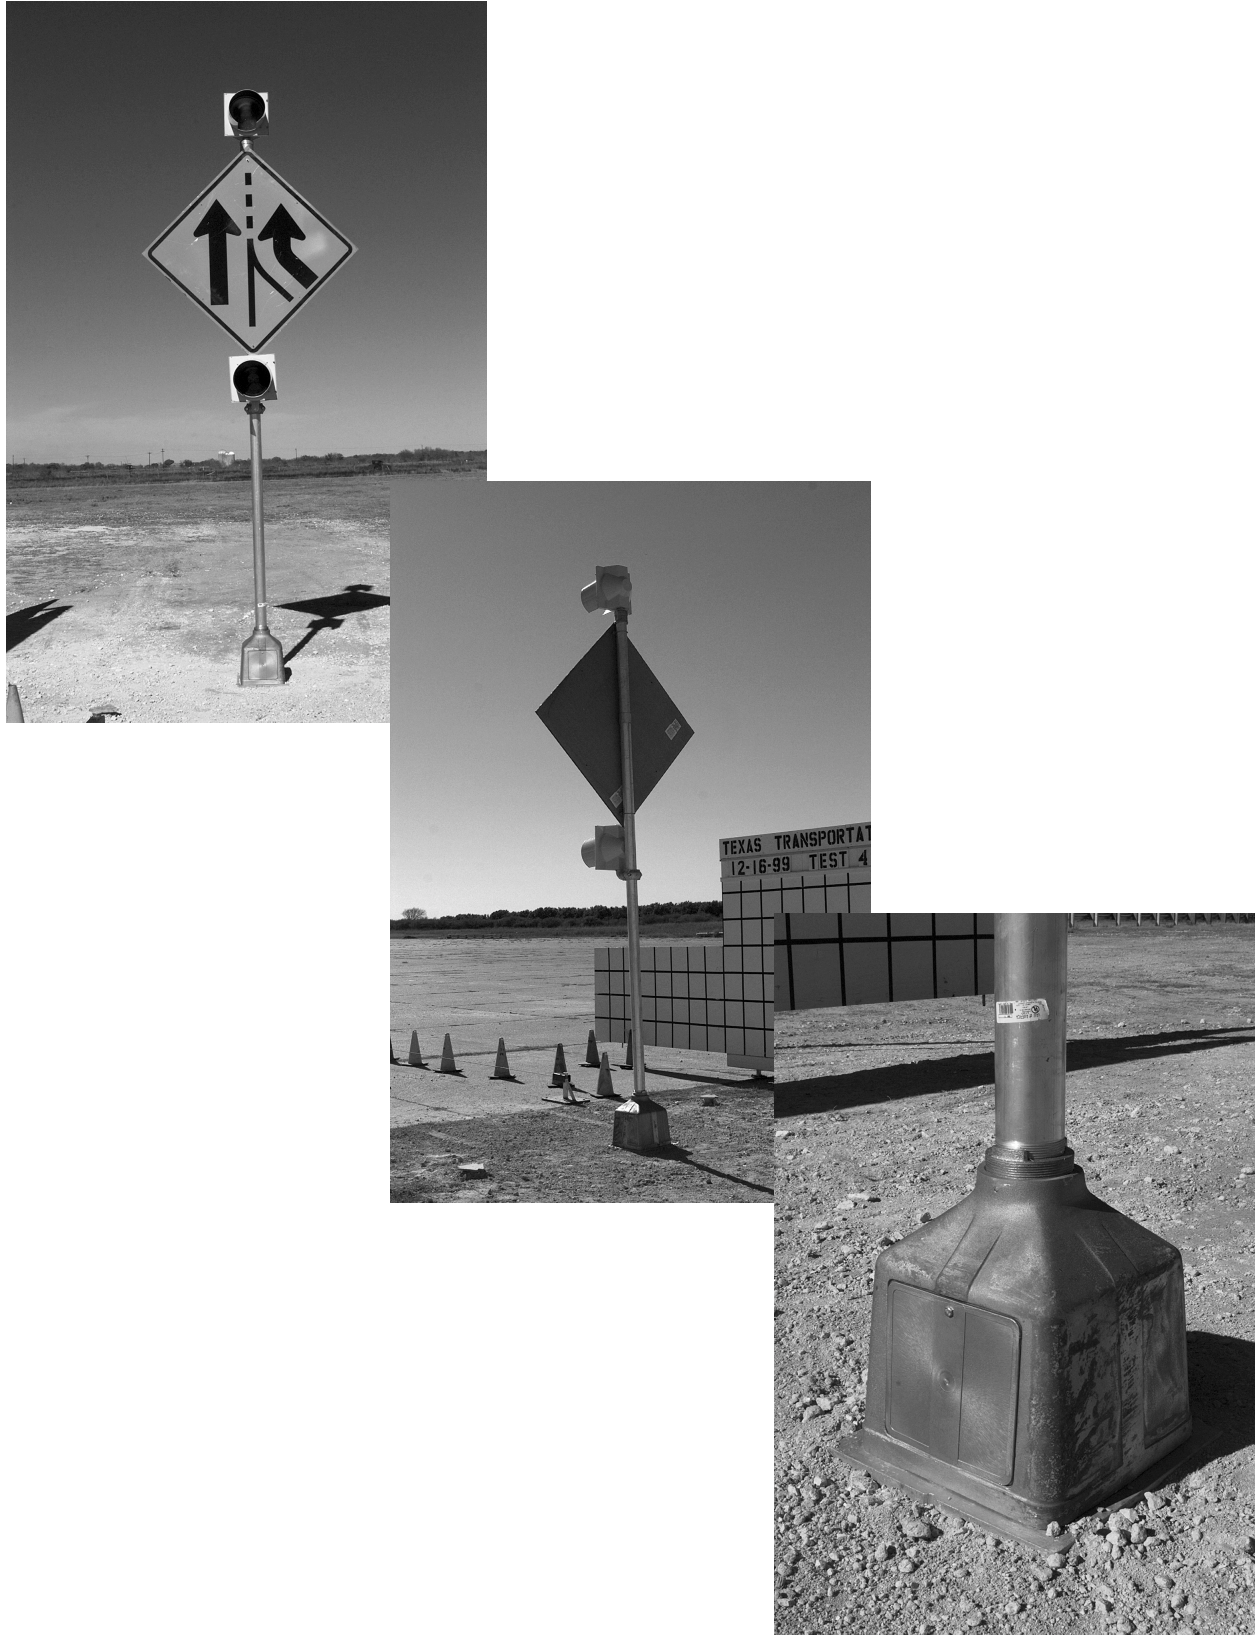
**Figure 4. Pedestal Base Sign Support before Test 417920-2.**

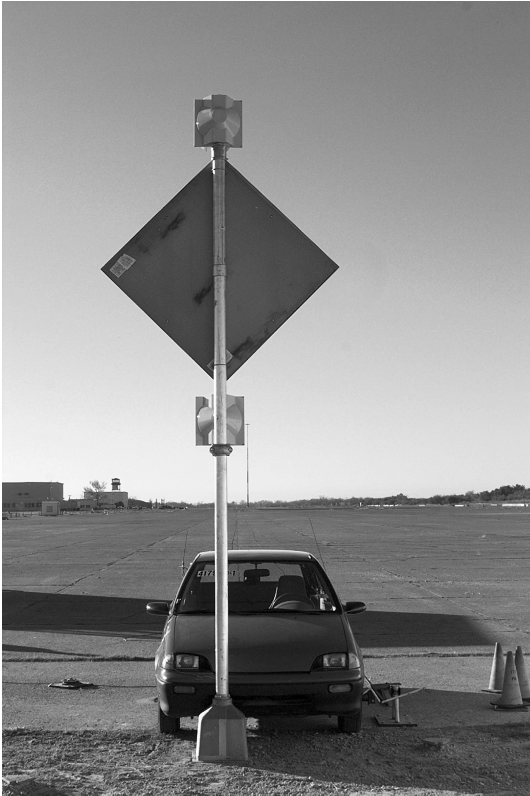
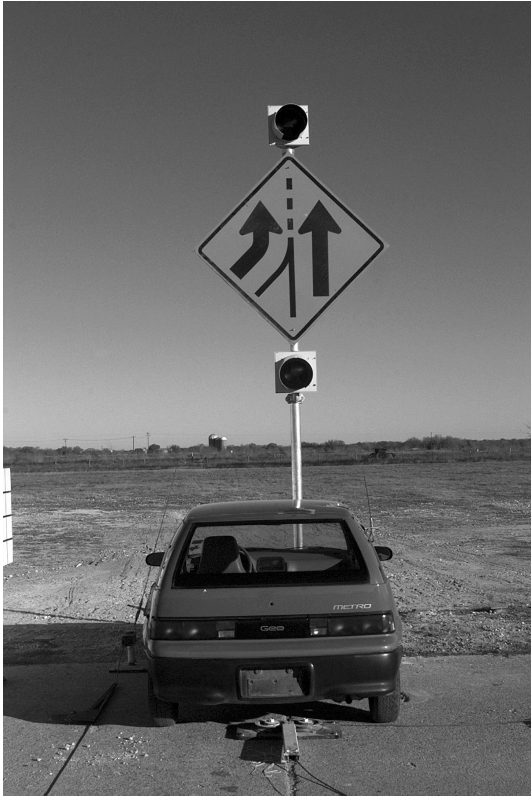
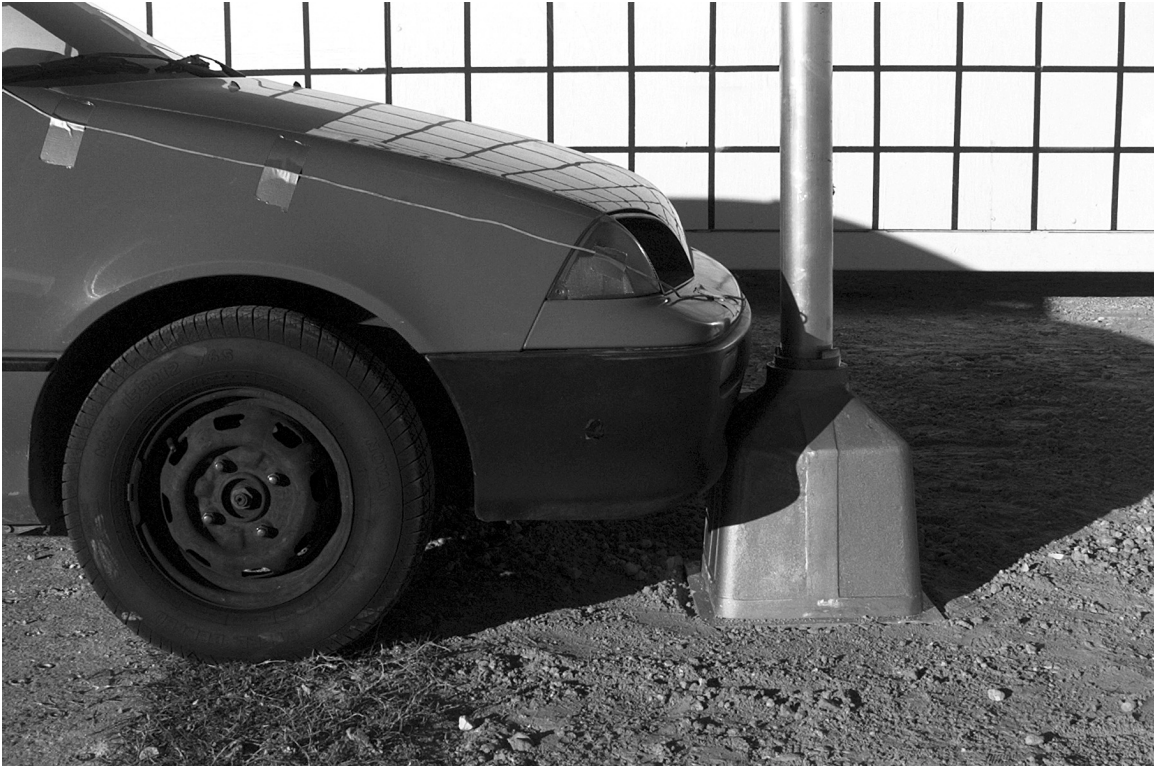
**Figure 5. Vehicle/Installation Geometrics for Test 417920-1.**

A 1994 Geo Metro, shown in [Figures 5](#) and [6](#), was used for the crash test. Test inertia weight of the vehicle was 820 kg (1806 lb), and its gross static weight was 894 kg (1969 lb). The height to the lower edge of the vehicle bumper was 370 mm (14.6 inch), and it was 455 mm (18.0 inch) to the upper edge of the bumper. Additional dimensions and information on the vehicle are given in [Appendix B, Figure 19](#). The vehicle was directed into the installation using the cable reverse tow and guidance system, and was released to be free-wheeling and unrestrained just prior to impact.

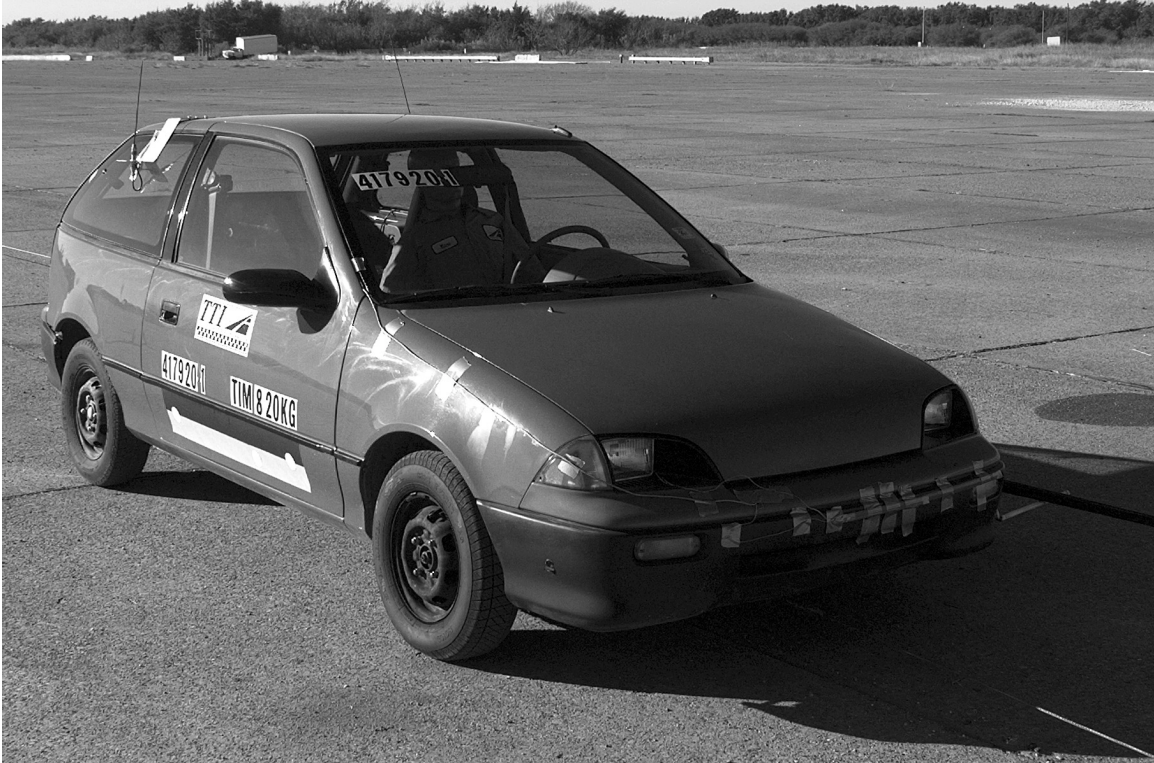
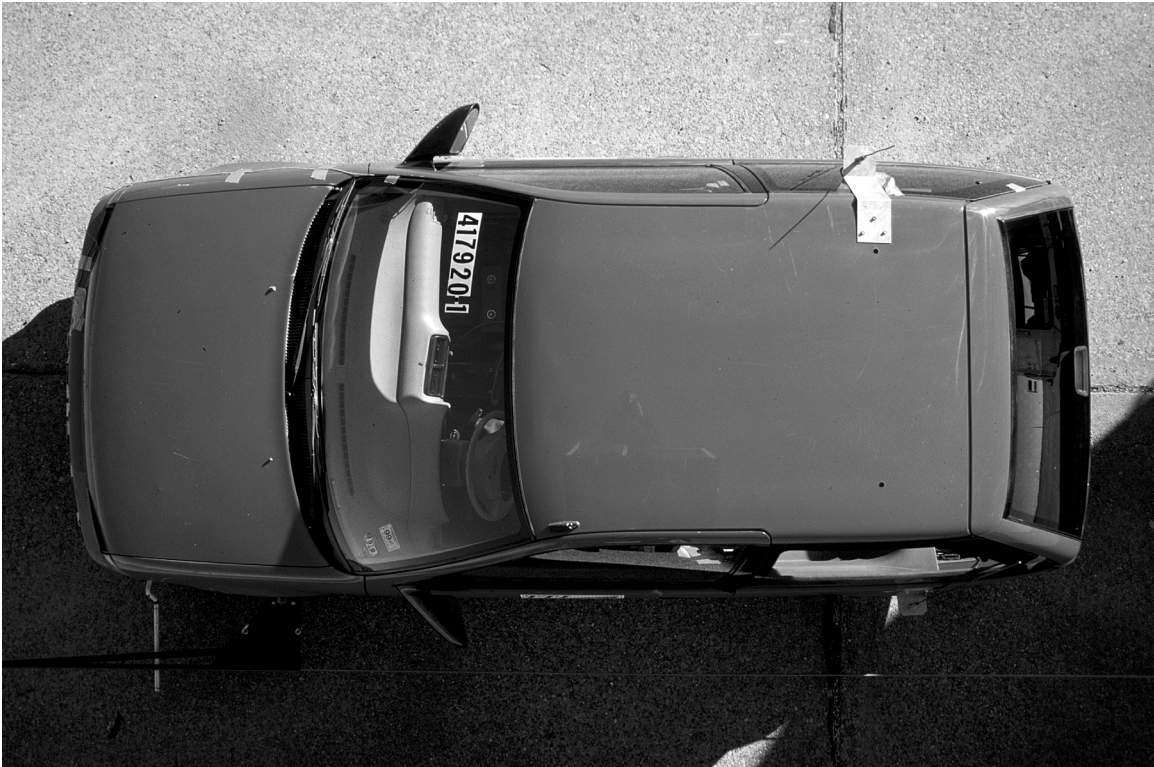
**Figure 6. Vehicle before Test 417920-1.**

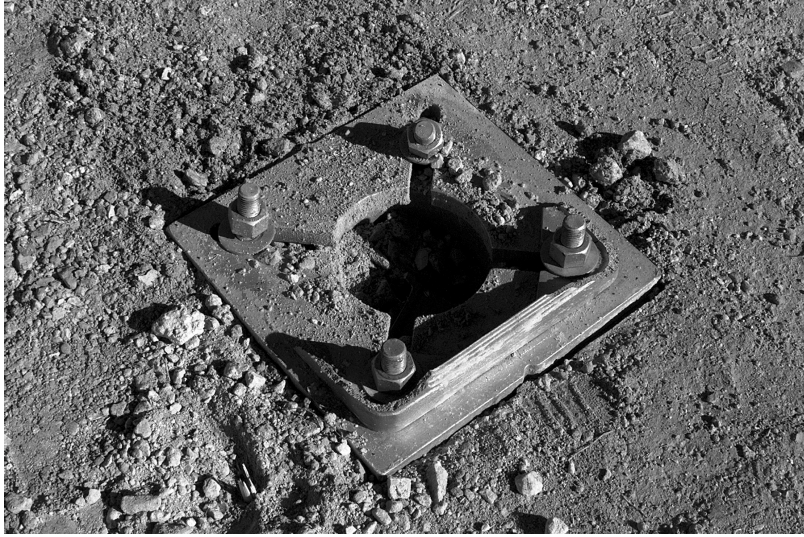
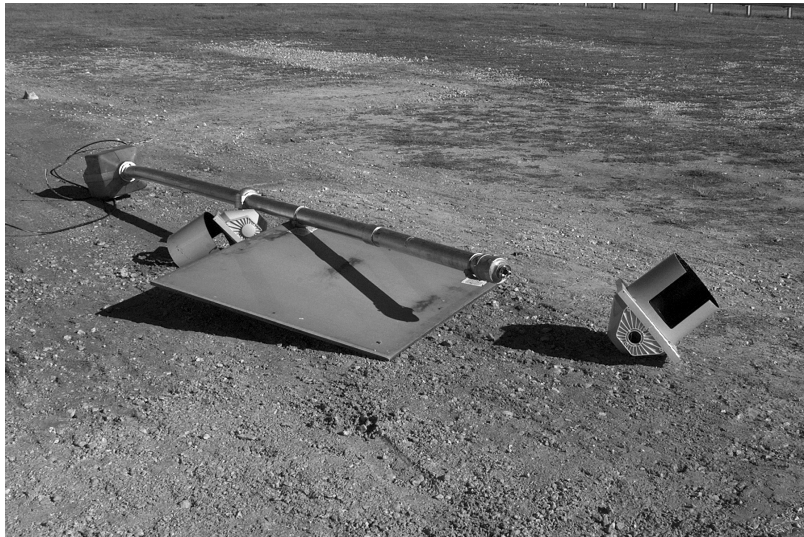
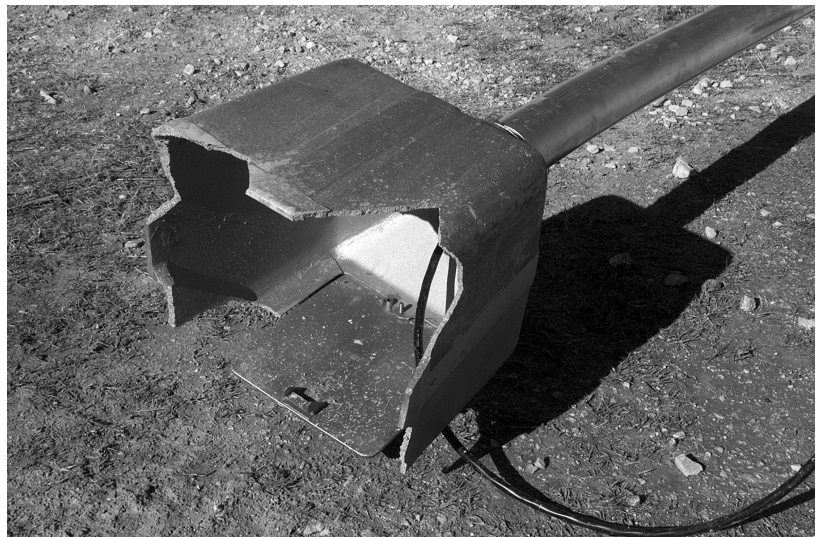
**Figure 8. Installation after Test 417920-1.**

The pedestal base fractured into several pieces, as shown in [Figures 7 and 8](#). The base of the pedestal moved 15 mm (0.6 inch) on the right front side and 10 mm (0.4 inch) on the left rear side. The sign panel detached from the top bracket. The top beacon detached, and the bottom beacon was cracked but remained attached to the pole. The debris extended 9.0 m (30.0 ft) downstream from the impact point.

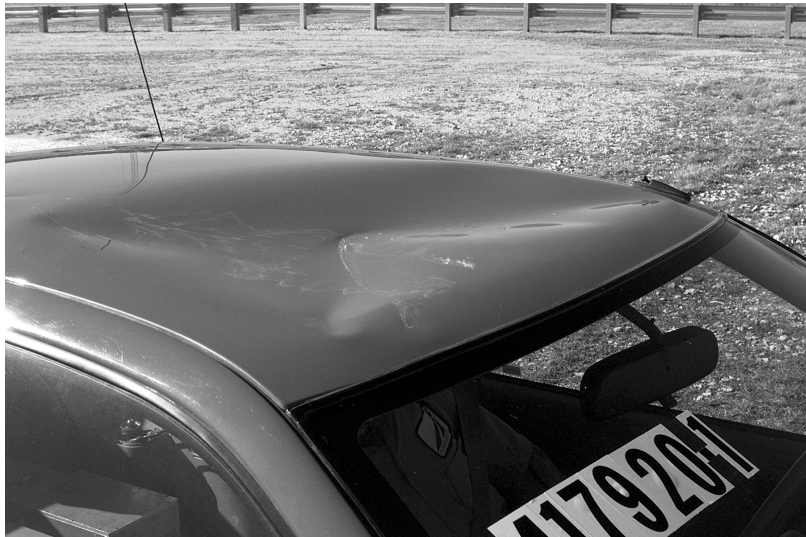
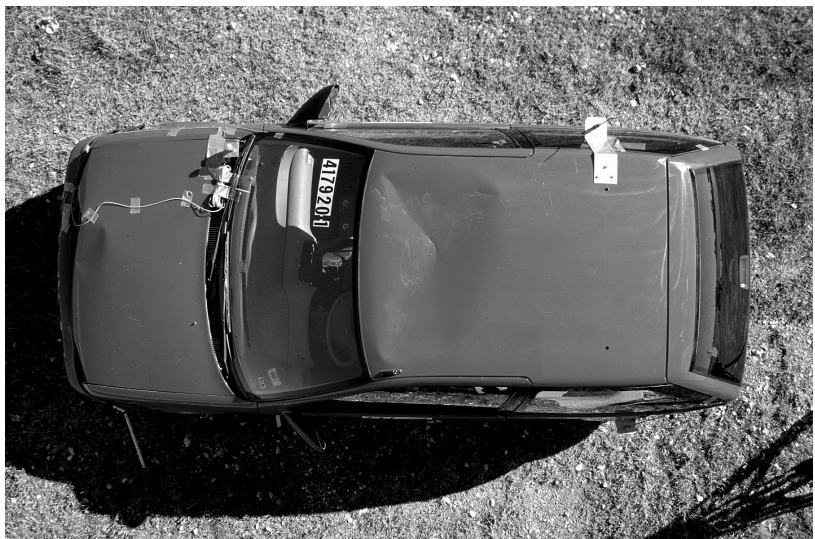
**Figure 9. Vehicle after Test 417920-1.**

As shown in [Figure 9](#), the vehicle sustained minimal damage to the bumper, hood, fan, radiator, and radiator support. Maximum exterior crush to the vehicle was 140 mm (5.5 inch) to the right front inner bumper at bumper height. Maximum deformation of the occupant compartment was 30 mm (1.2 inch) to the center of the roof. The interior of the vehicle is shown in [Figure 10](#). Exterior vehicle crush and occupant compartment measurements are shown in [Appendix B, Tables 3 and 4](#).

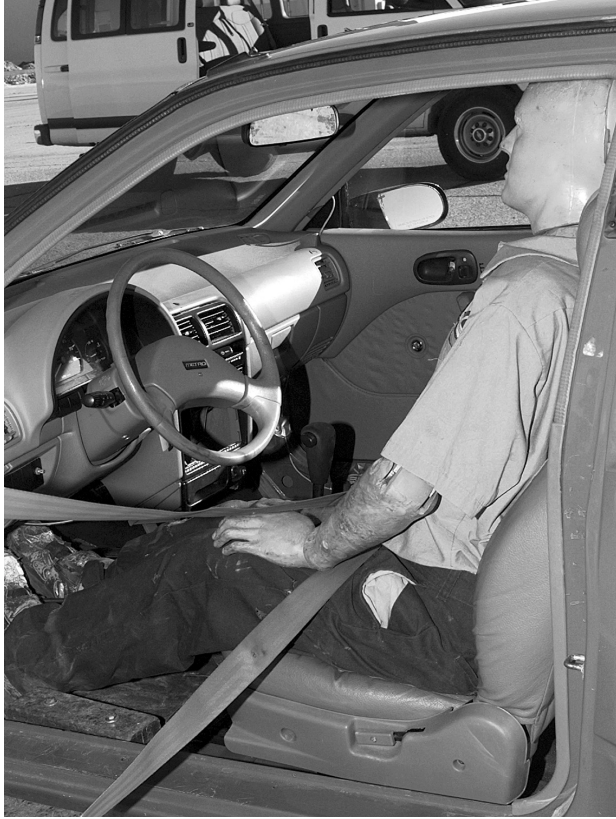
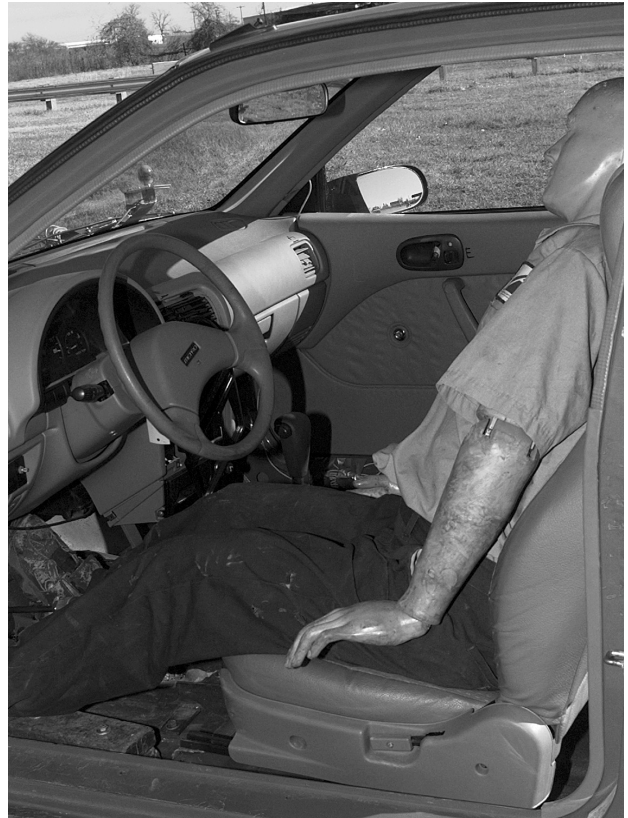
Before test

After test

**Figure 10. Interior of Vehicle for Test 417920-1.**

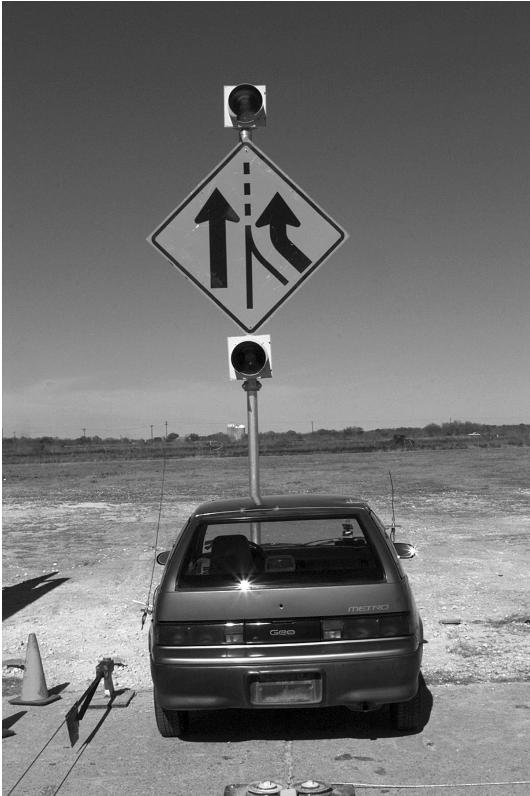
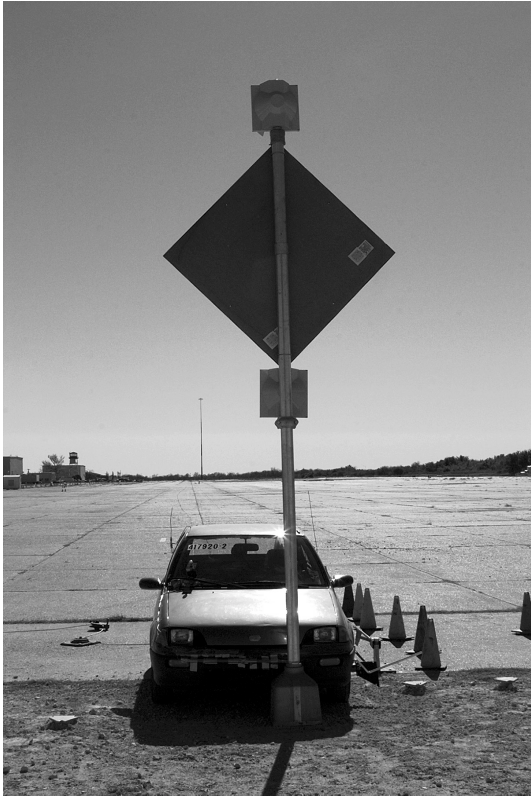
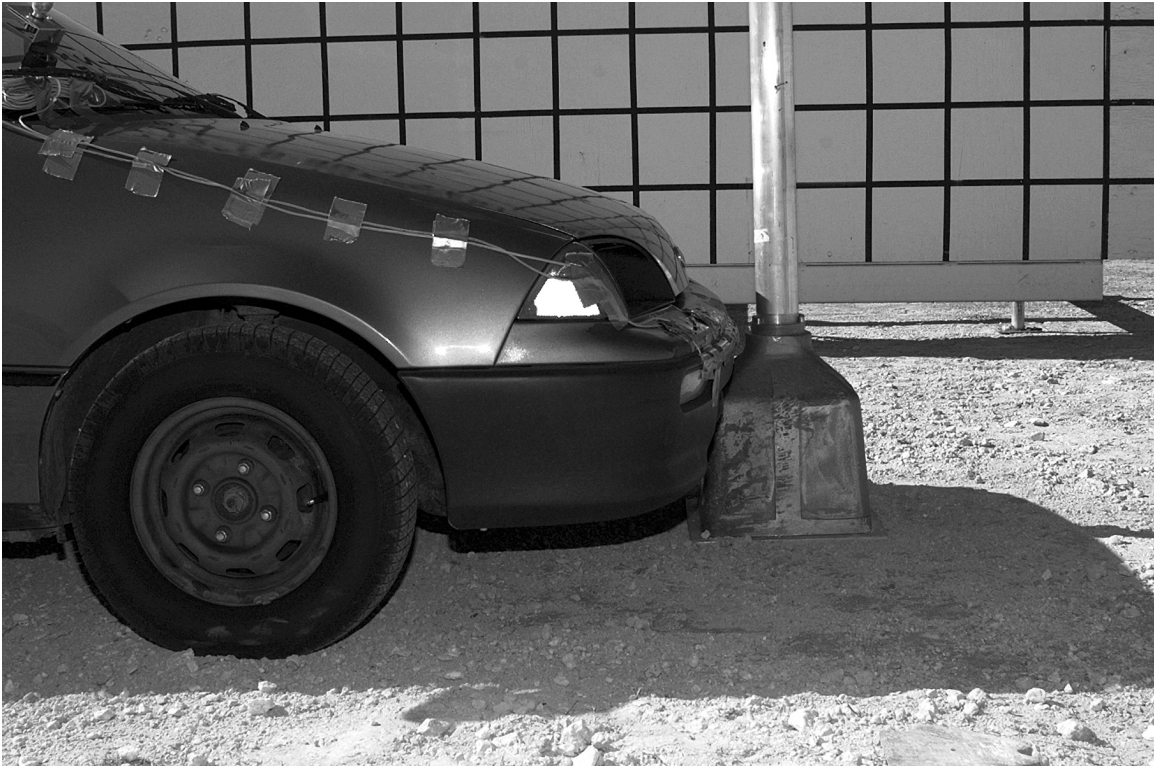
**Figure 12. Vehicle/Installation Geometrics for Test 417920-2.**

A 1994 Geo Metro, shown in [Figures 12](#) and [13](#), was used for the crash test. Test inertia weight of the vehicle was 820 kg (1806 lb), and its gross static weight was 896 kg (1974 lb). The height to the lower edge of the vehicle bumper was 370 mm (14.6 inch) and it was 455 mm (18.0 inch) to the upper edge of the bumper. Additional dimensions and information on the vehicle are given in [Appendix B, Figure 20](#). The vehicle was directed into the installation using the cable reverse tow and guidance system, and was released to be free-wheeling and unrestrained just prior to impact.

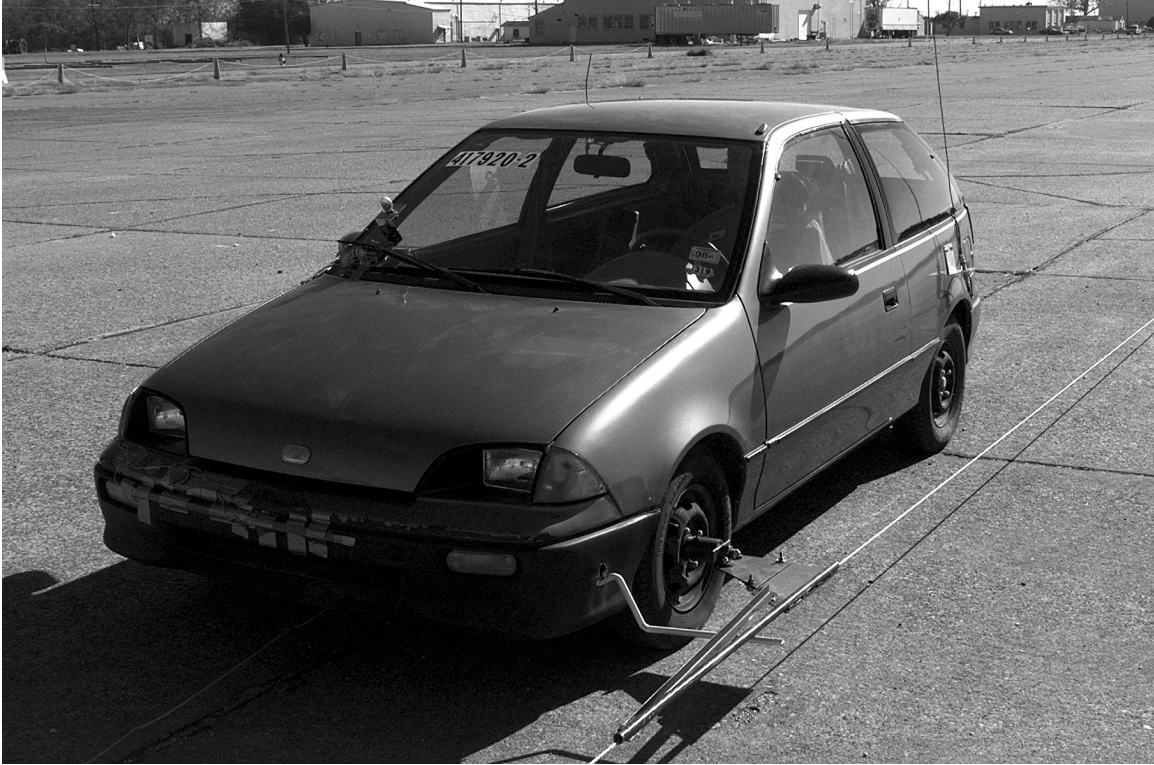
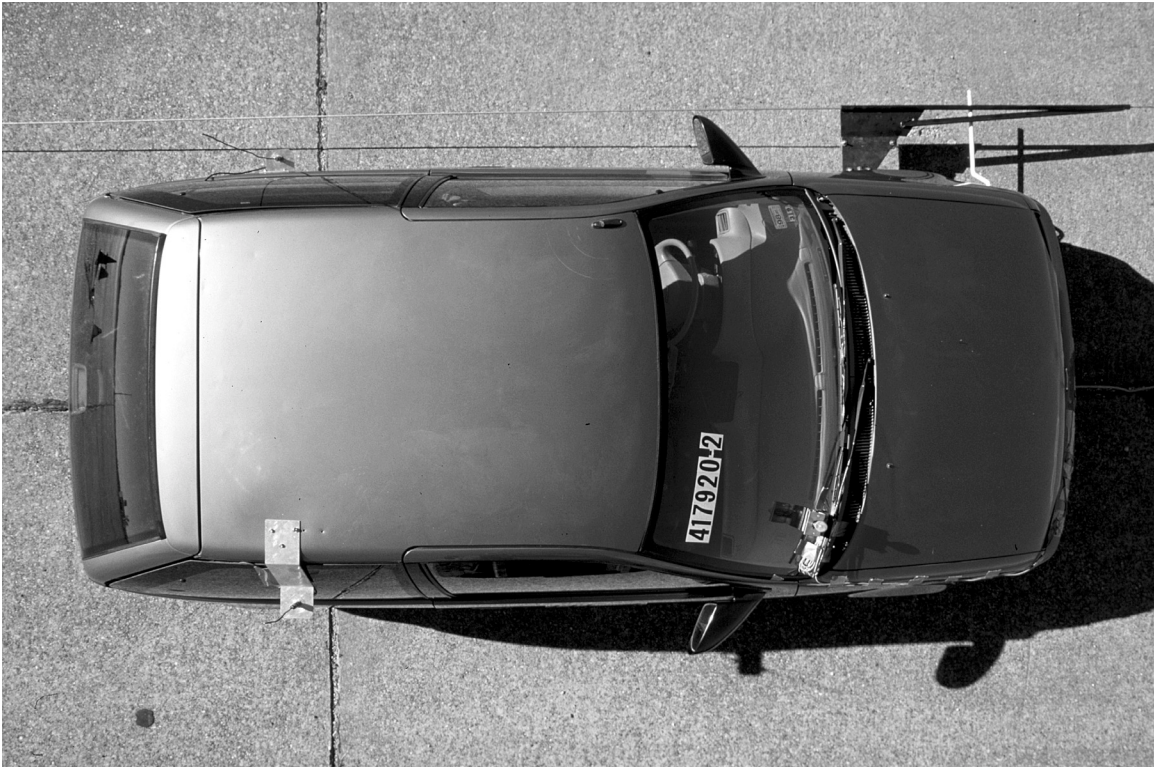
**Figure 13. Vehicle before Test 417920-2.**

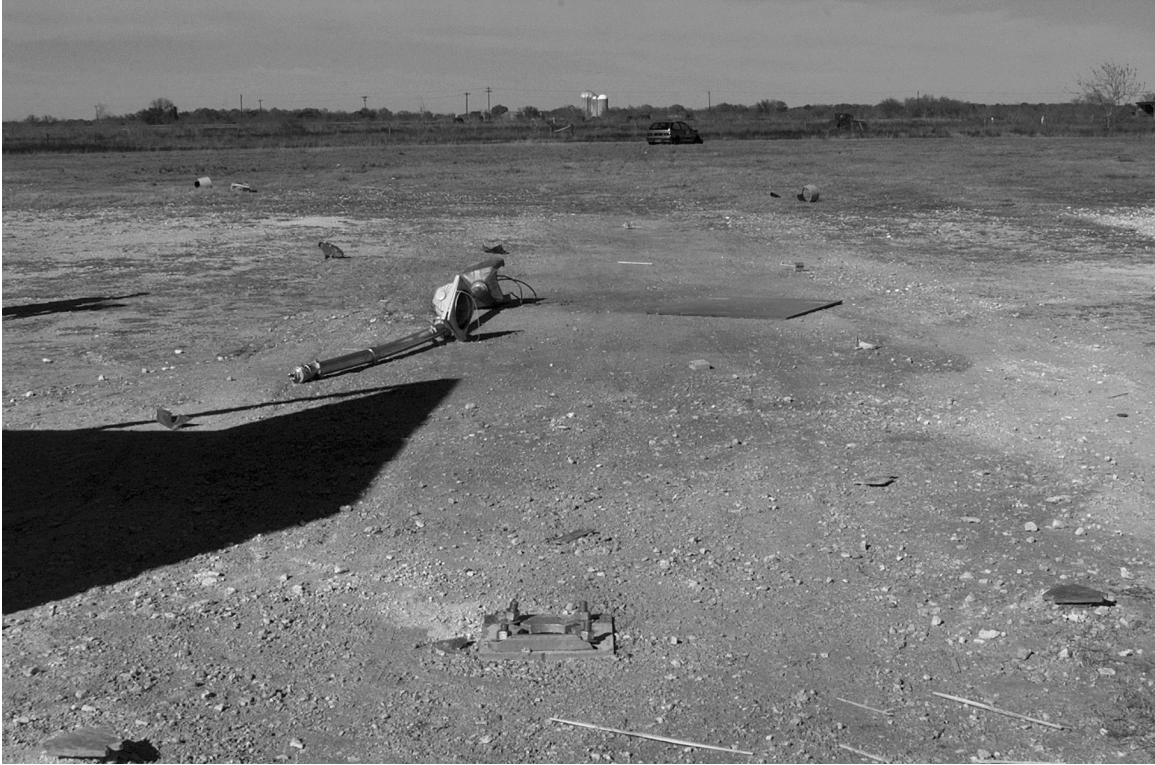
**Figure 14. After Impact Trajectory for Test 417920-2.**

The pedestal base fractured into several pieces, as shown in [Figures 14 and 15](#). The base of the pedestal sign moved 8 mm (0.3 in) on the right front side and 15 mm (0.6 in) on the left rear side. The sign panel detached from the pole. The top beacon signal detached, and the bottom beacon broke but stayed attached to the pole. The debris extended 30.0 m (98.4 ft) downstream, 1.5 m (5.0 ft) to the right, and 5.3 m (17.4 ft) to the left of the impact point.

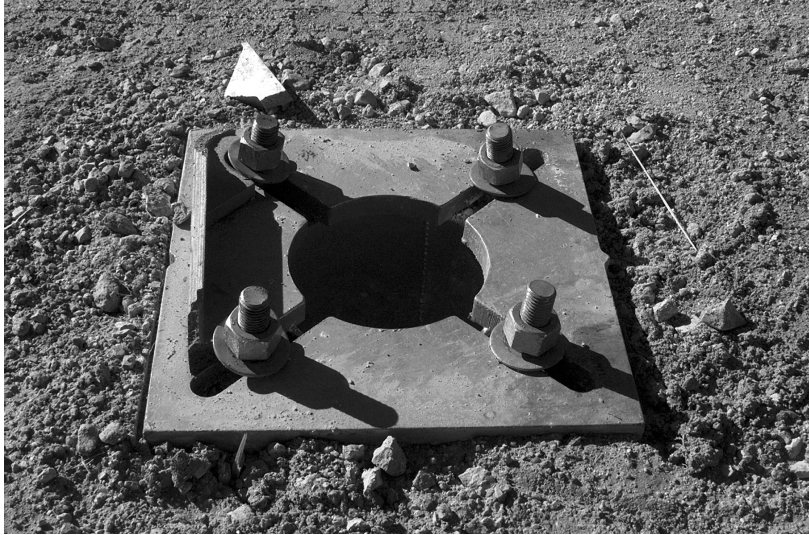
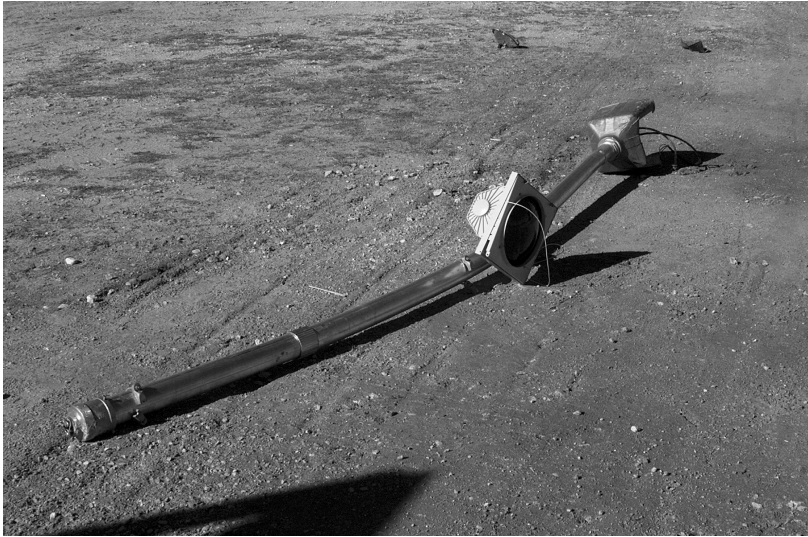
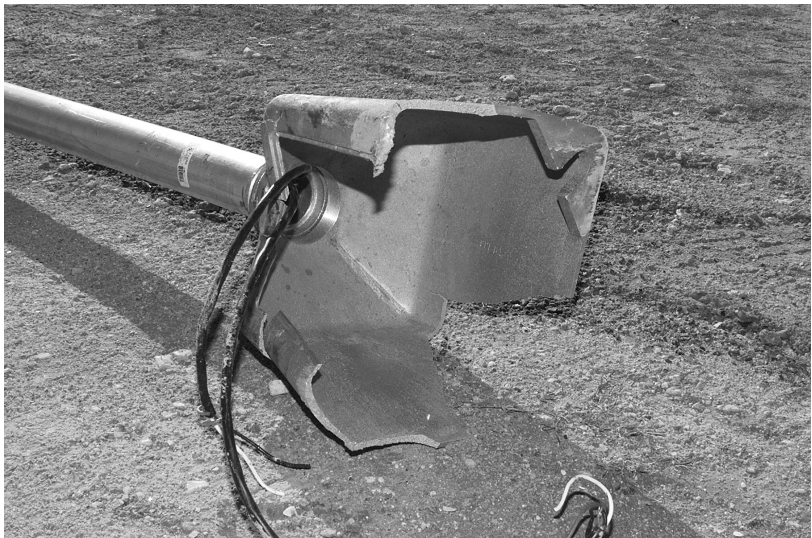
**Figure 15. Installation after Test 417920-2.**

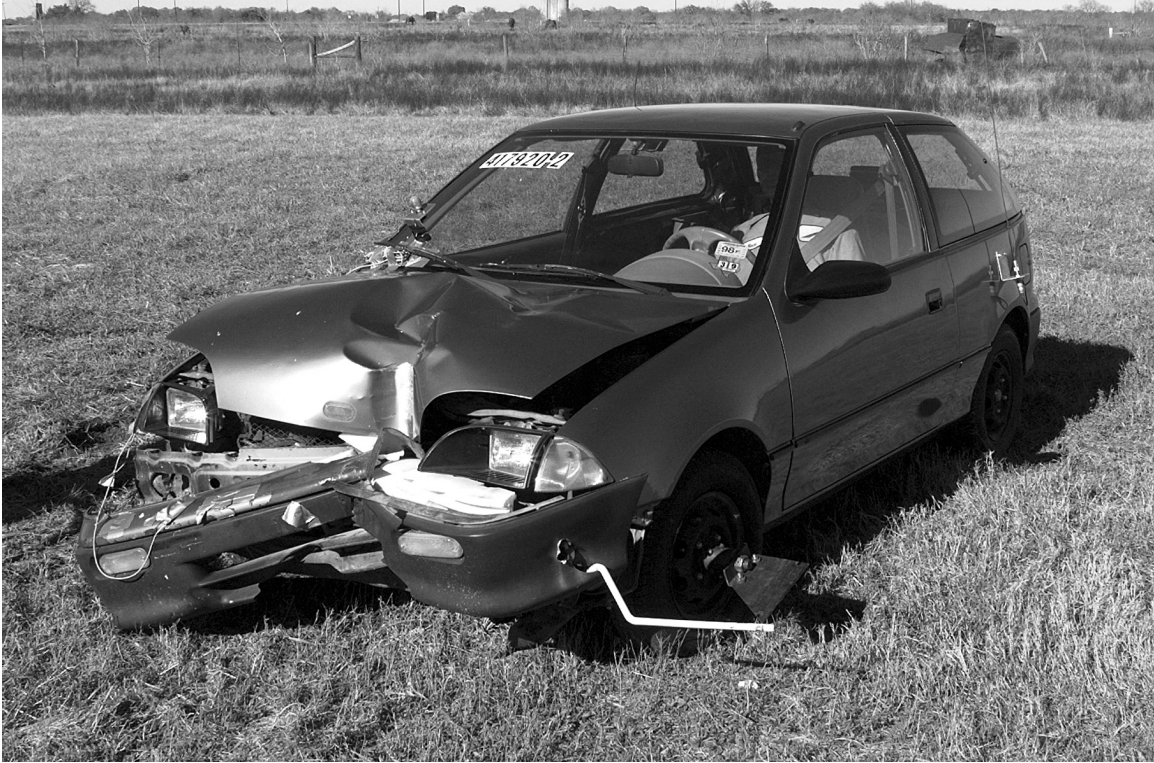
**Figure 16. Vehicle after Test 417920-2.**

As shown in [Figure 16](#), the vehicle sustained minimal damage to the bumper, hood, fan, radiator and radiator support. Maximum exterior crush to the vehicle was 200 mm (7.9 inch) to the left front inner bumper at bumper height. The interior of the vehicle is shown in [Figure 17](#). Exterior vehicle crush and occupant compartment measurements are shown in [Appendix B, Tables 5 and 6](#).
