1. Report No. FHWA/TX-01/1792-3		2. Government Accession No.		3. Recipient's Catalog No.	
4. Title and Subtitle TESTING AND EVALUATION OF A PEDESTAL BASE SIGN SUPPORT				5. Report Date January 2001

6. Performing Organization Code	
7. Author(s) D. Lance Bullard, Jr., Roger P. Bligh, Wanda L. Menges, and Sandra K. Schoeneman				8. Performing Organization Report No. Report 1792-3

#### TEST INSTALLATION FOR TESTS 417920-1 AND 2

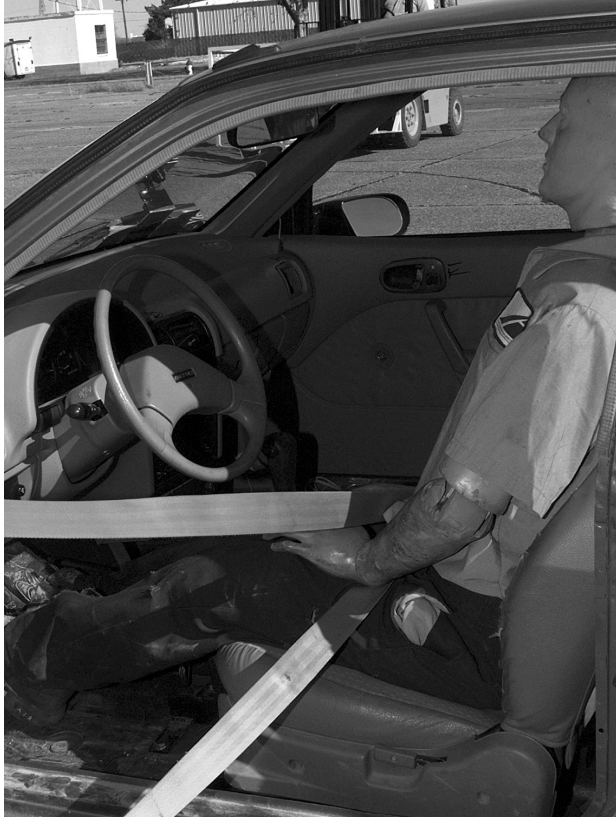
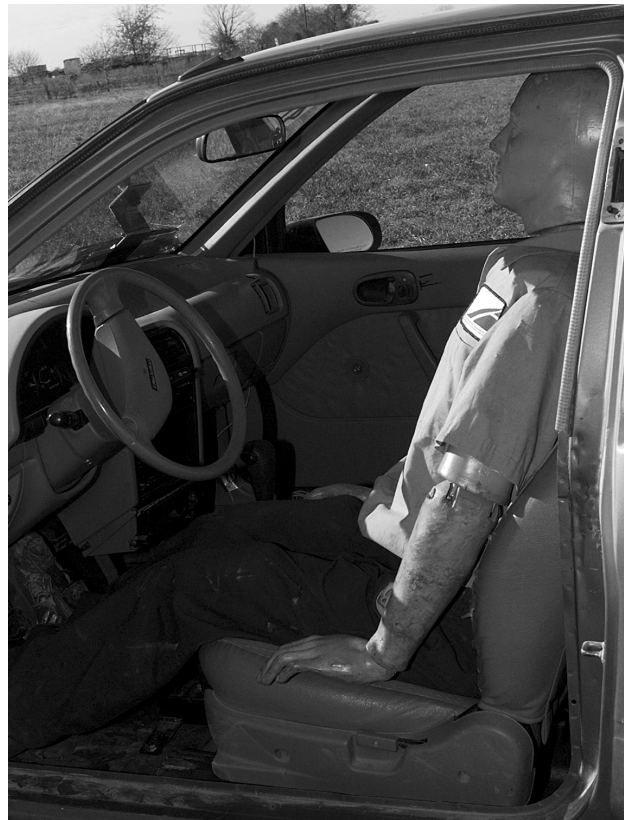
Before test

After test

**Figure 17. Interior of Vehicle for Test 417920-2.**

As shown in [Figure 16](#), the vehicle sustained minimal damage to the bumper, hood, fan, radiator and radiator support. Maximum exterior crush to the vehicle was 200 mm (7.9 inch) to the left front inner bumper at bumper height. The interior of the vehicle is shown in [Figure 17](#). Exterior vehicle crush and occupant compartment measurements are shown in [Appendix B, Tables 5 and 6](#).

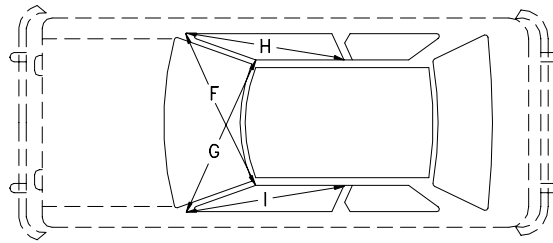
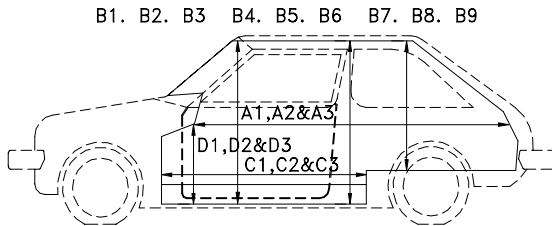
### Occupant Compartment Deformation

BEFORE	AFTER
A1	2020	2020
A2	2065	2065
A3	2025	2025
B1	970	970
B2	906	876
B3	975	975
B4	948	938
B5	870	870
B6	955	955
B7	774	774
B8	760	760
B9	780	780
C1	581	581
C2	705	705
C3	585	585
D1	290	290
D2	100	100
D3	280	280
E1	1230	1230
E2	1230	1230
F	1215	1215
G	1215	1215
H	1000	1000
I	1000	1000

DATE: 12/16/99 TEST NO.: 417920-2 VIN NO.: 2C1MR246XR6767583  
 YEAR: 1994 MAKE: GEO MODEL: METRO  
 TIRE INFLATION PRESSURE: \_\_\_\_\_ ODOMETER: 80039 TIRE SIZE: 155R12

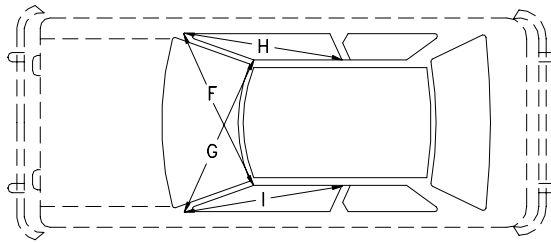
### Occupant Compartment Deformation

BEFORE	AFTER
A1	1440	1440
A2	267	267
A3	1448	1448
B1	980	980
B2	925	925
B3	980	980
B4	951	951
B5	875	875
B6	955	955
B7	780	780
B8	791	791
B9	779	779
C1	705	705
C2	705	705
C3	570	570
D1	285	285
D2	100	100
D3	275	275
E1	1225	1225
E2	1226	1226
F	1210	1210
G	1210	1210
H	1100	1000
I	1100	1100

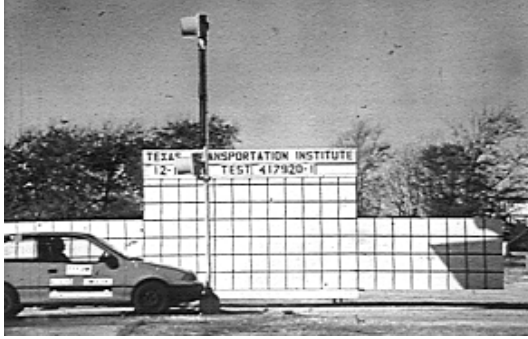
0.000 s

**Figure 21. Sequential Photographs for Test 417920-1 (Perpendicular and Oblique Views).**

(16.5 mi/h). By 0.811 s, the upper warning beacon contacted the ground surface. Brakes on the vehicle were applied as the vehicle exited the test site and the vehicle came to rest 32.0 m (105.0 ft) from the impact point. Sequential photographs of the test can be found in [Appendix C, Figure 21](#).

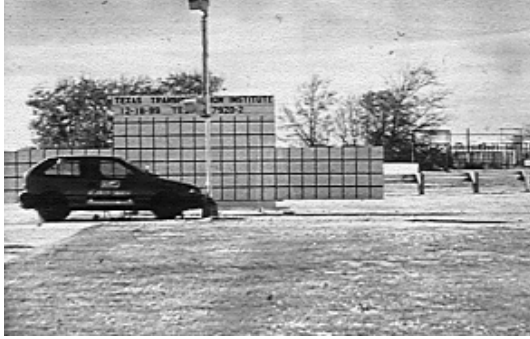
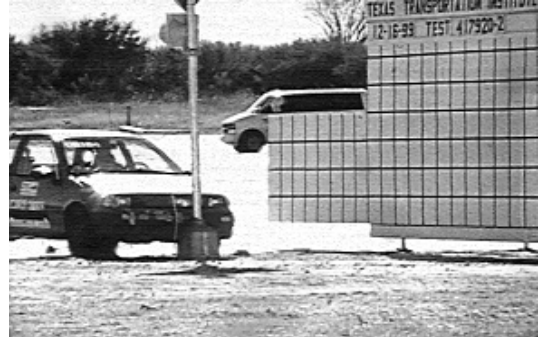
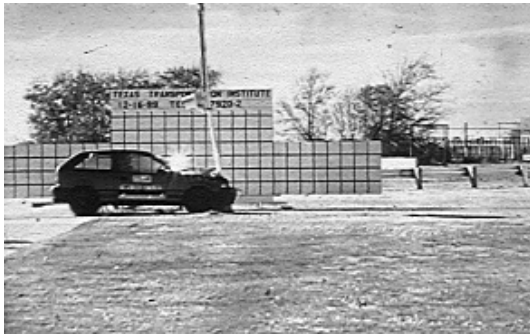
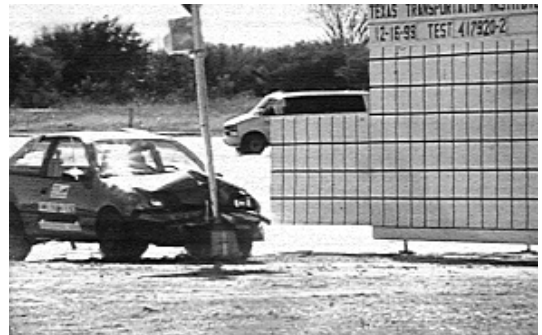
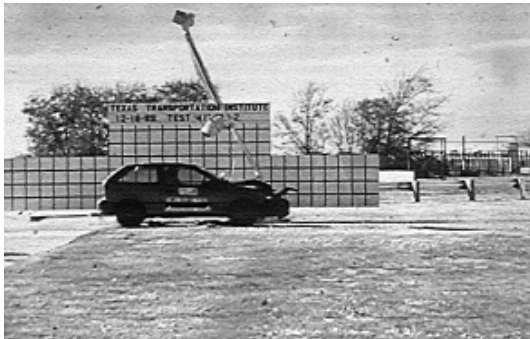
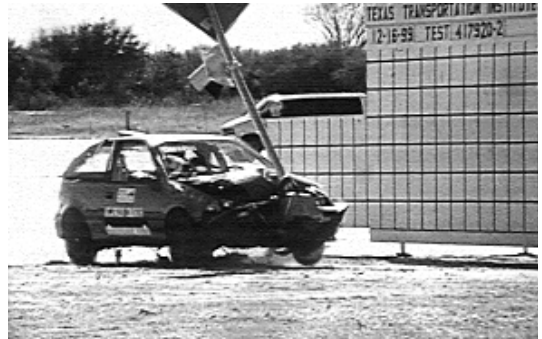
**Figure 22. Sequential Photographs for Test 417920-2  
(Perpendicular and Oblique Views).**

was traveling at a speed of 94.2 km/h (58.5 mi/h). The sign panel detached from the pole at 0.277 s. Brakes on the vehicle were applied as it exited the test site, and the vehicle came to rest 86.9 m (285.1 ft) downstream from impact point and 3.0 m (9.8 ft) toward traffic lanes. Sequential photographs of the test can be found in [Appendix C, Figure 22](#).

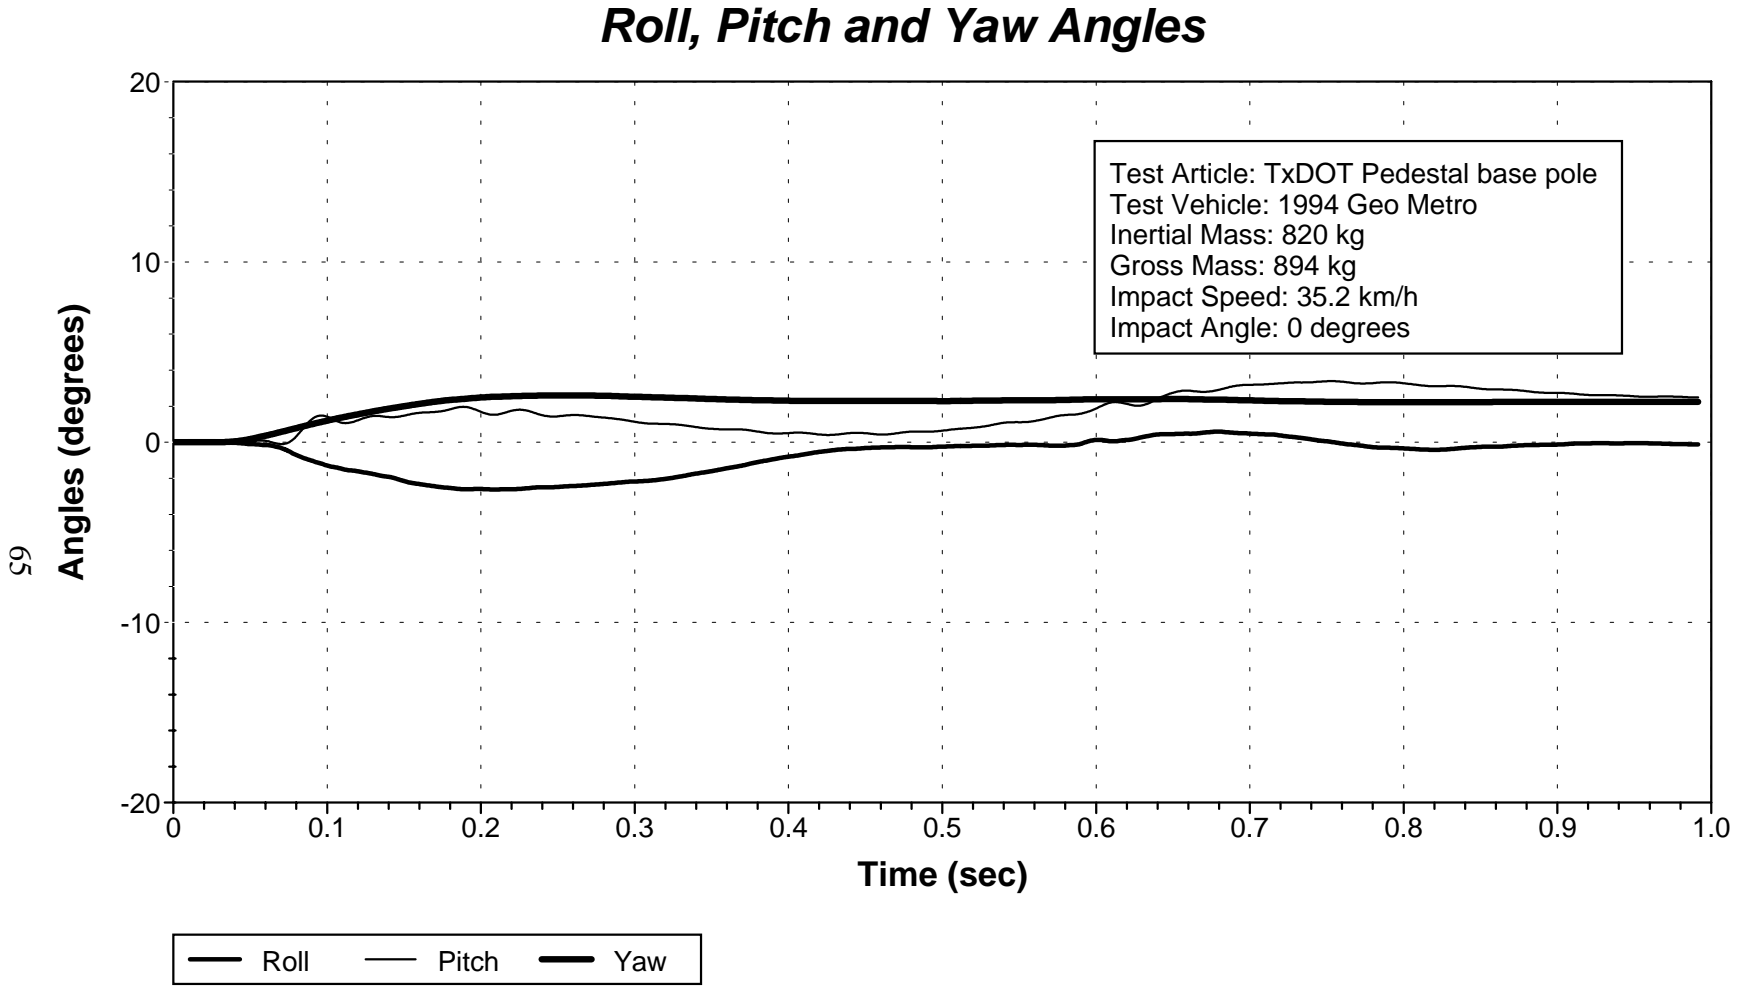
Figure 23. Vehicular Angular Displacements for Test 417920-1.

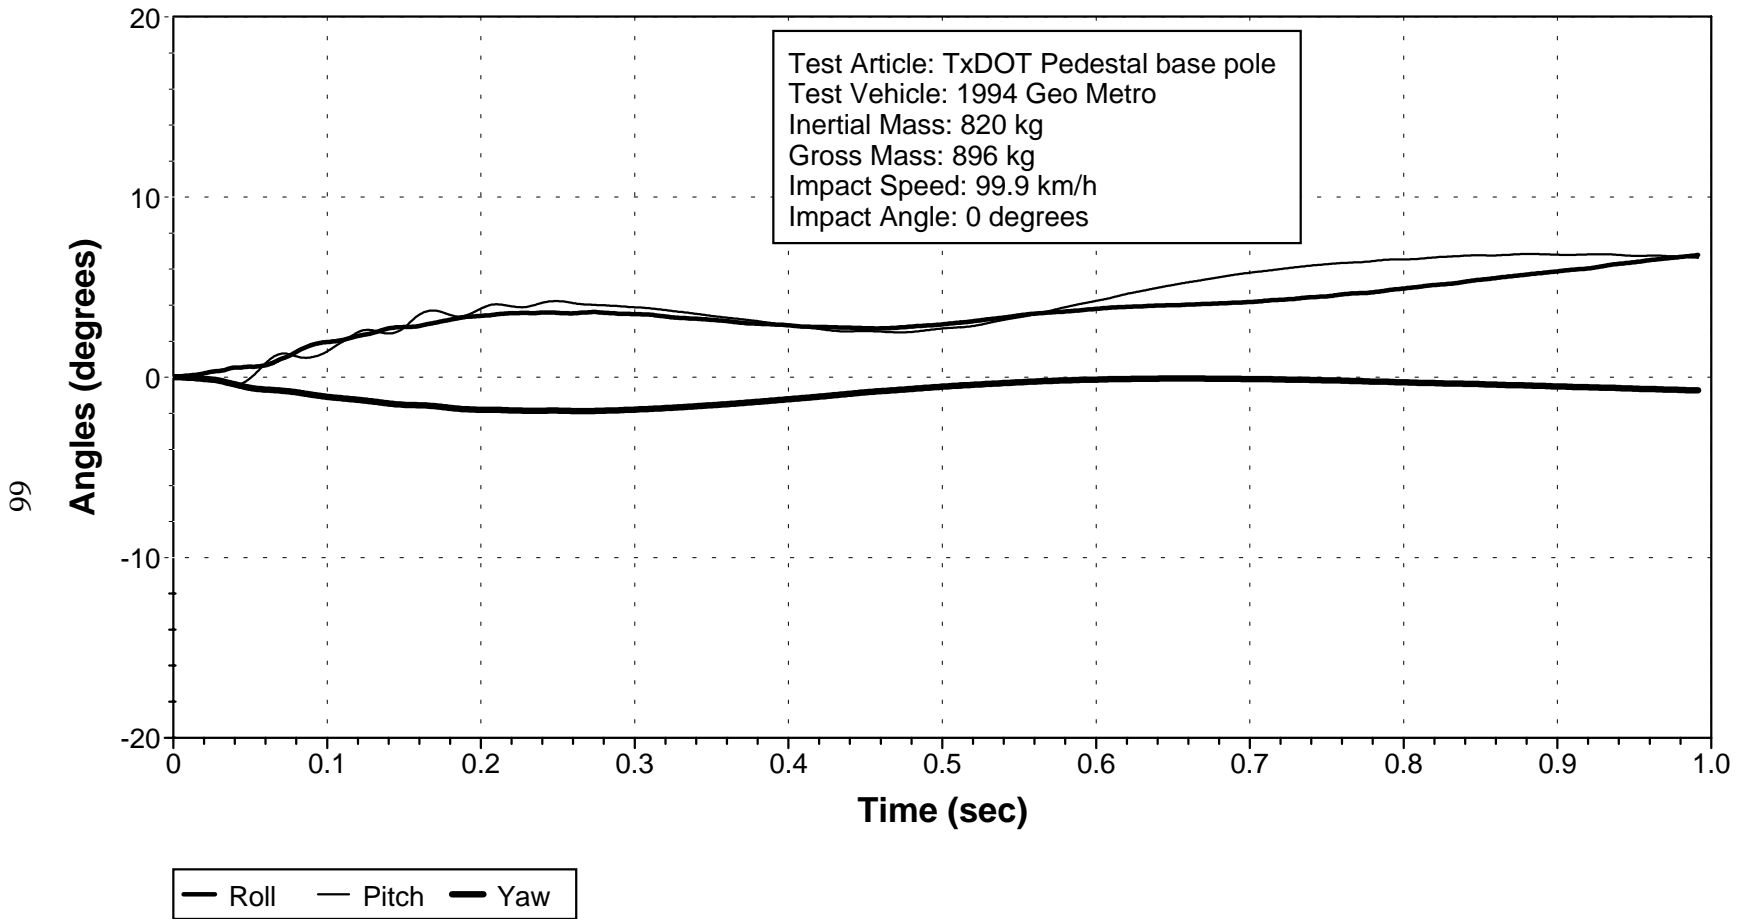
Figure 24. Vehicular Angular Displacements for Test 417920-2.

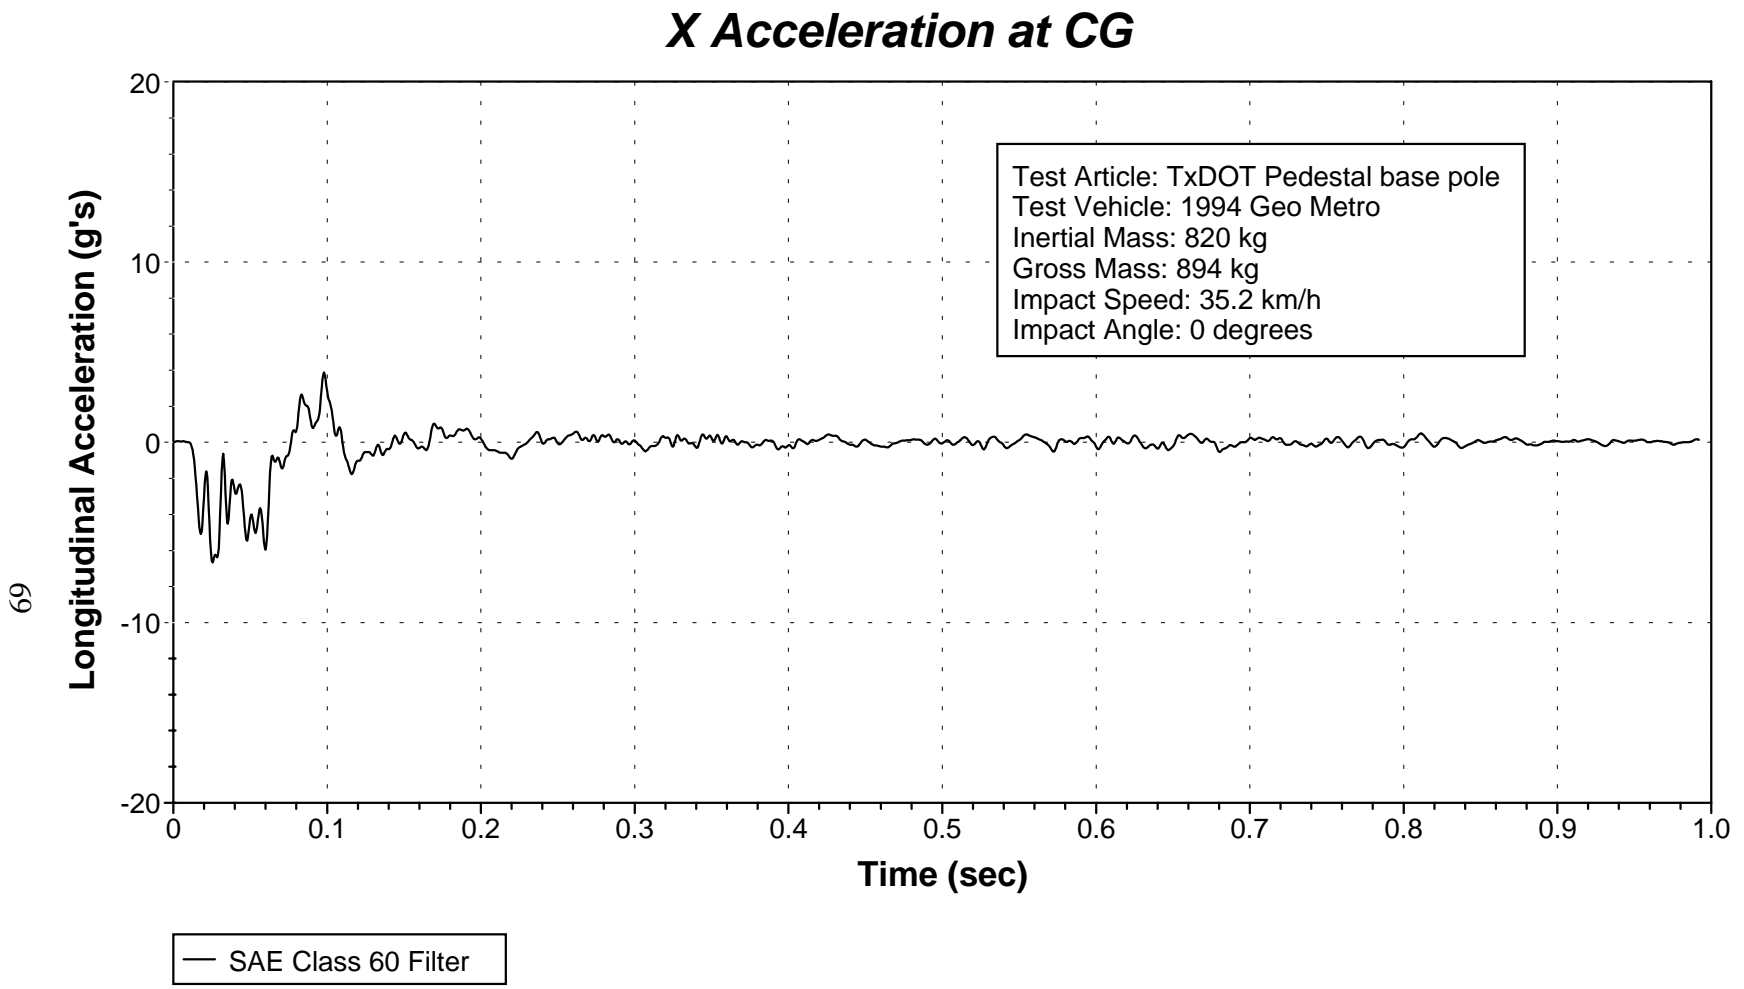
Figure 25. Vehicle Longitudinal Accelerometer Trace for Test 417920-1.

Data from the accelerometer located at the vehicle center of gravity were digitized for evaluation of occupant risk and were computed as follows. In the longitudinal direction, the occupant impact velocity was 1.6 m/s (5.2 ft/s) at 0.397 s, the highest 0.010-s occupant ridedown acceleration was 0.4 g's from 0.653 to 0.663 s, and the maximum 0.050-s average acceleration was -3.9 g's between 0.013 and 0.063 s. In the lateral direction, the occupant impact velocity was 0.3 m/s (1.0 ft/s) at 0.397 s, the highest 0.010-s occupant ridedown acceleration was -0.4 g's from 0.585 to 0.595 s, and the maximum 0.050-s average was 0.4 g's between 0.075 and 0.125 s. These data and other pertinent information from the test are summarized in [Figure 11](#). Vehicle angular displacements are shown in [Appendix D, Figure 23](#), and vehicle accelerations versus time traces are presented in [Appendix E, Figures 25 through 27](#).

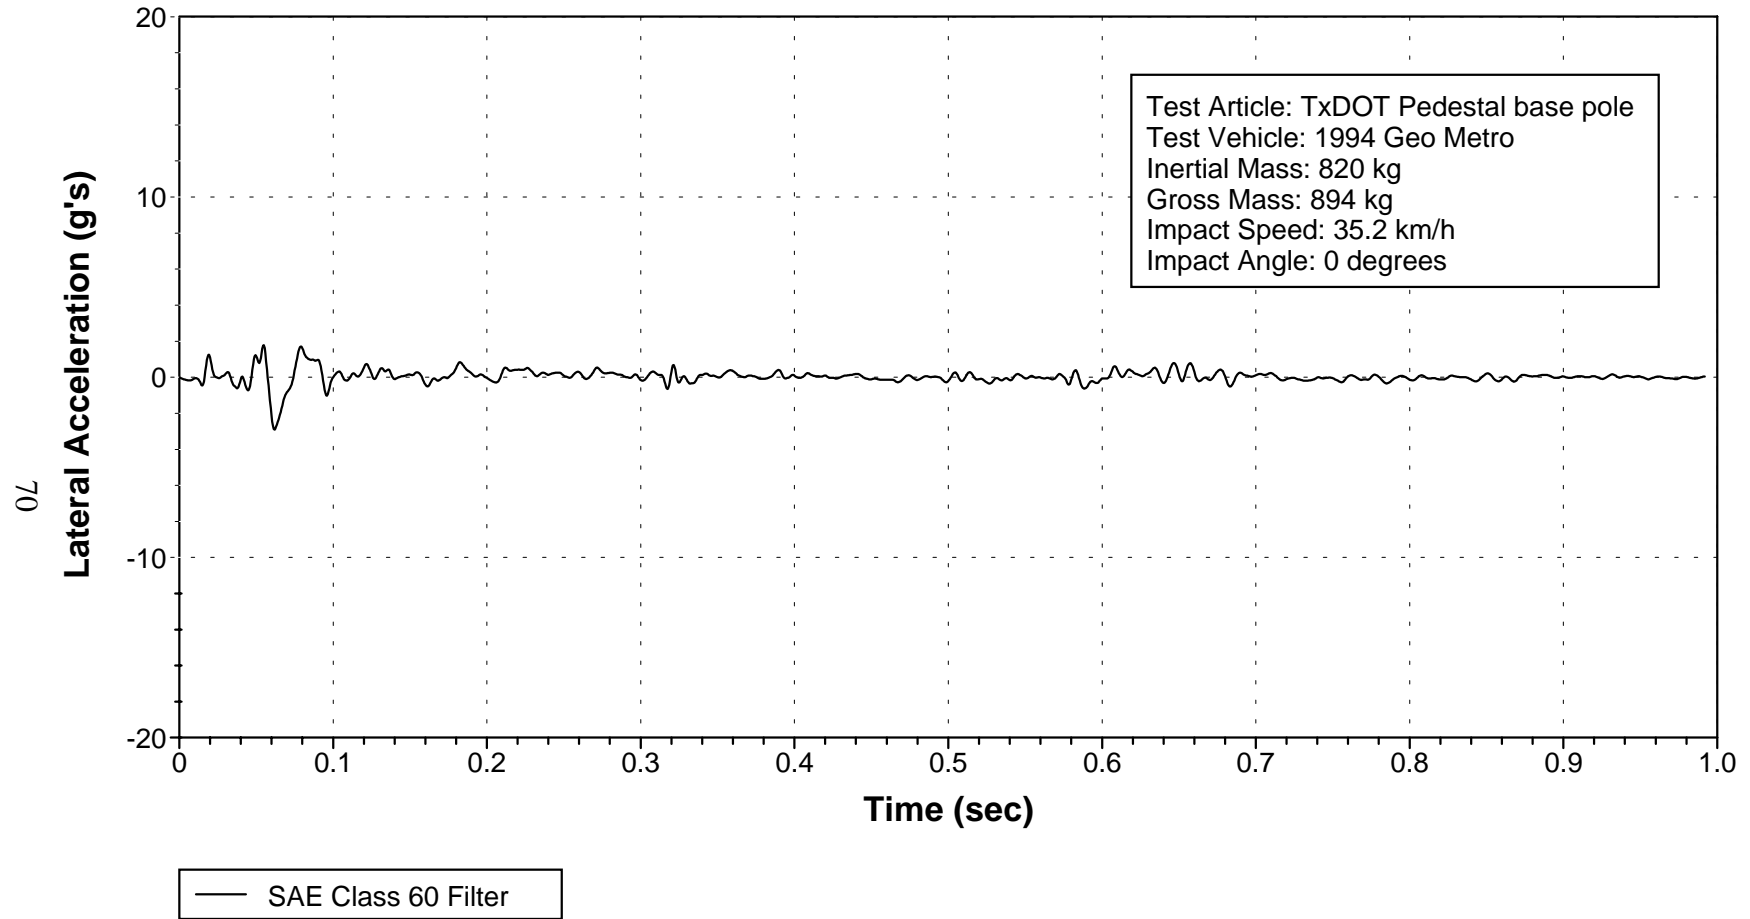
Figure 26. Vehicle Lateral Accelerometer Trace for Test 417920-1.

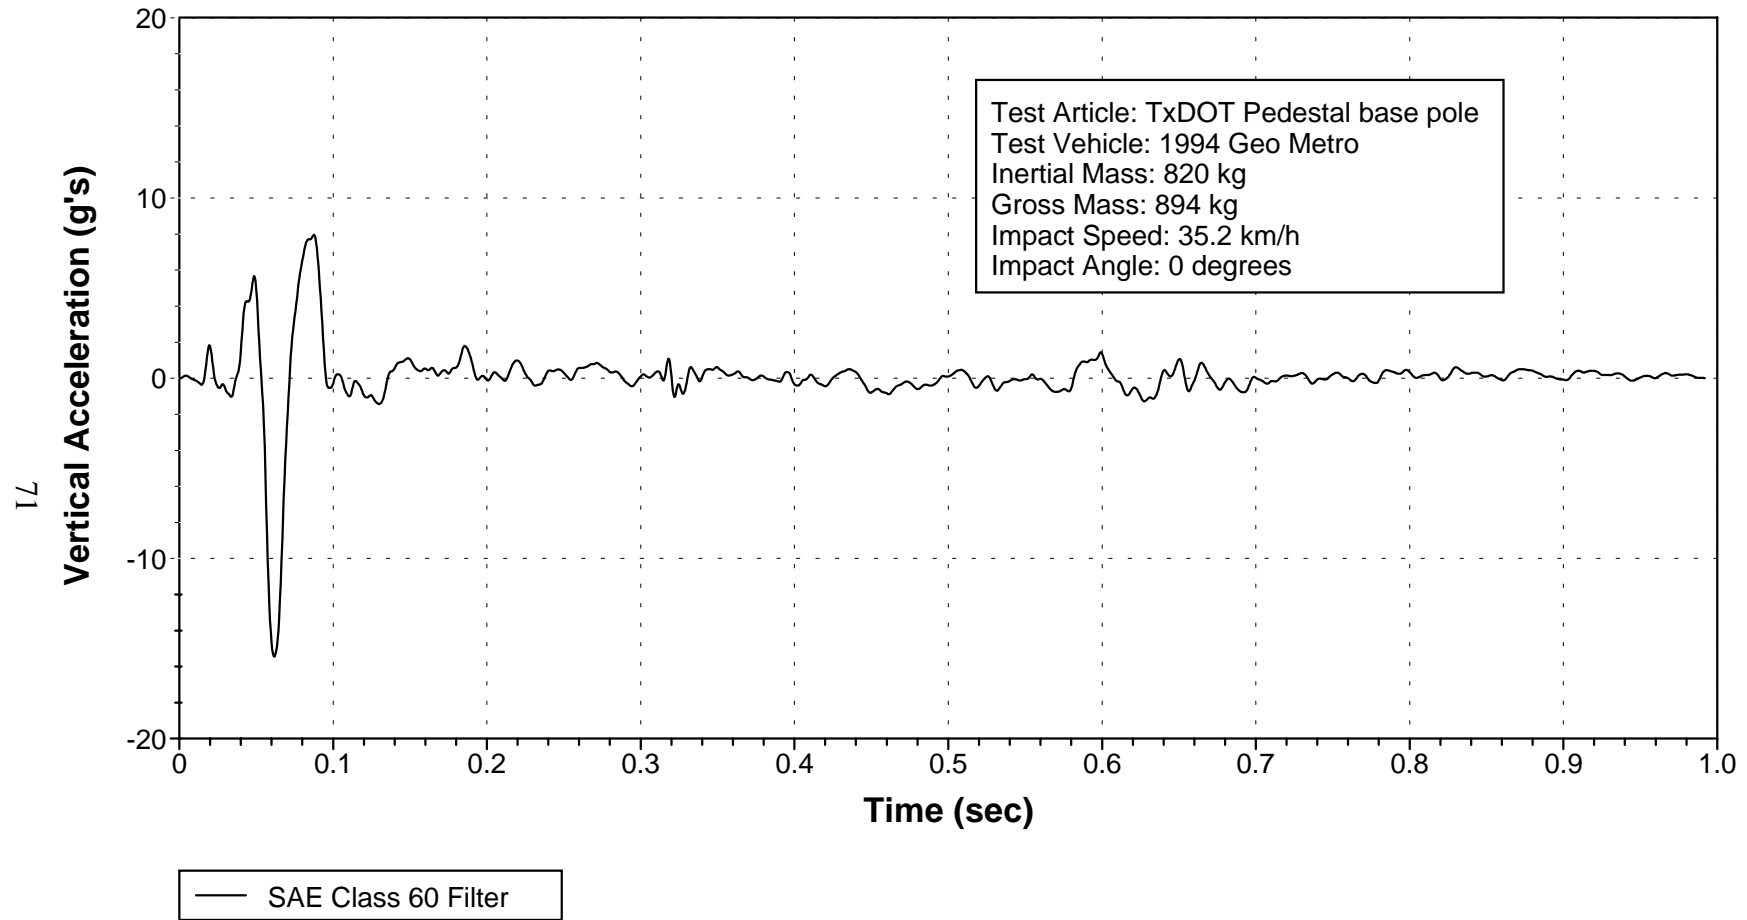
Figure 27. Vehicle Vertical Accelerometer Trace for Test 417920-1.

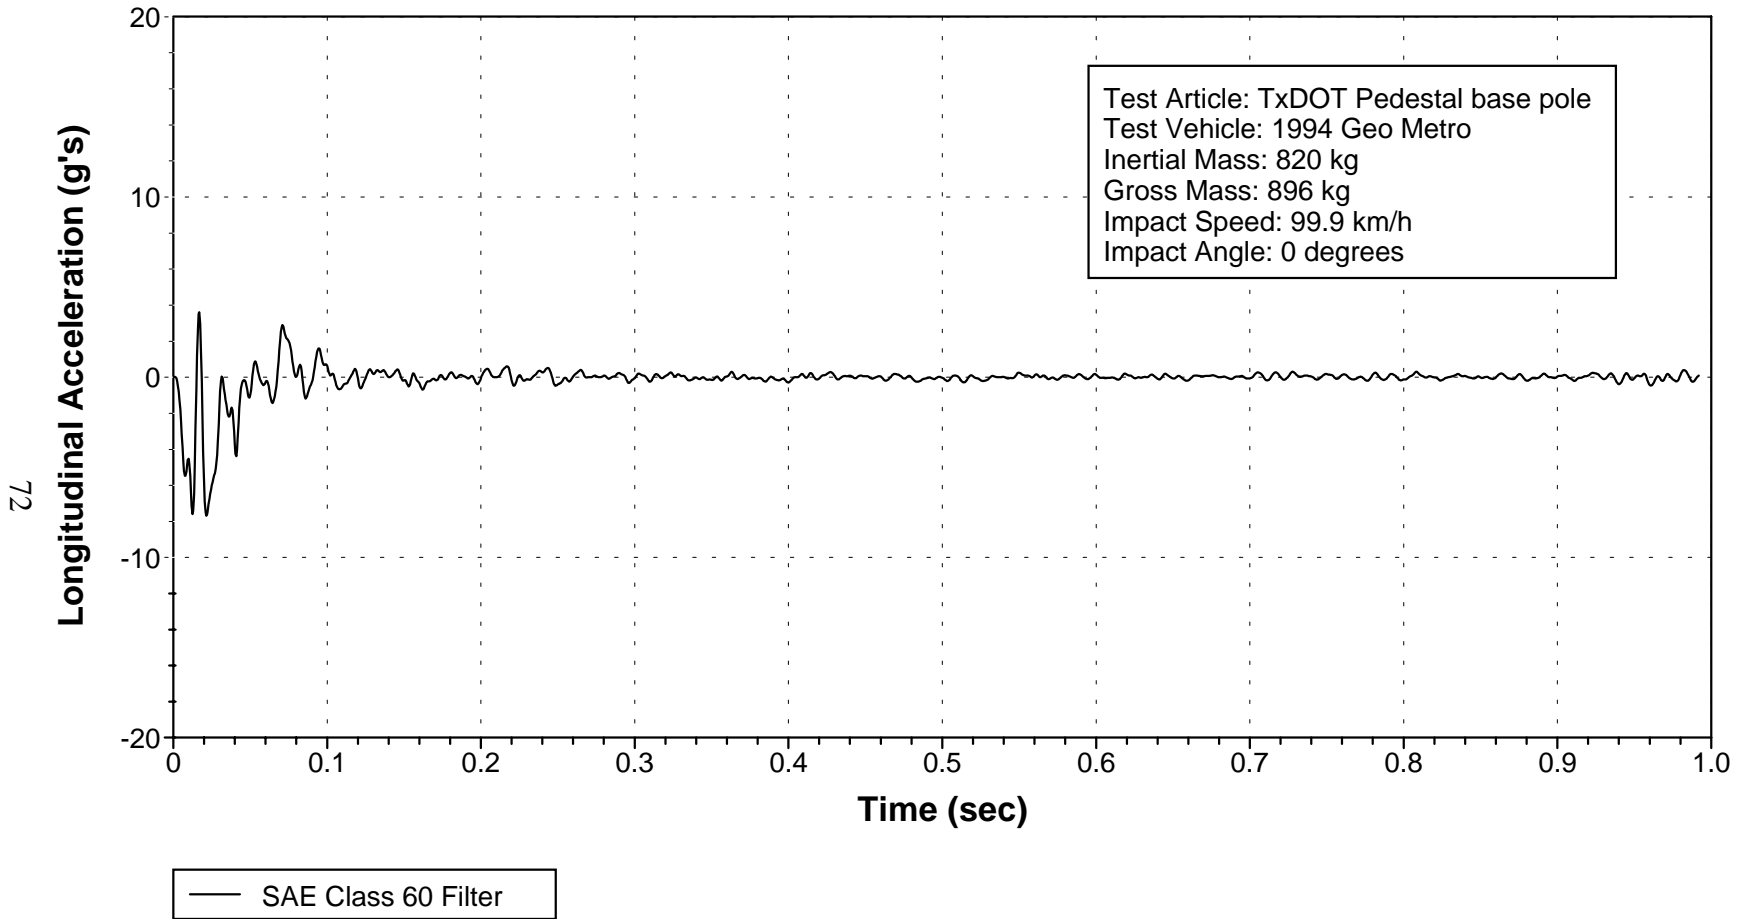
Figure 28. Vehicle Longitudinal Accelerometer Trace for Test 417920-2.

Data from the accelerometer located at the vehicle center of gravity were digitized for evaluation of occupant risk and were computed as follows. In the longitudinal direction, the occupant impact velocity was 1.2 m/s (3.9 ft/s) at 0.521 s, the highest 0.010-s occupant ridedown acceleration was -0.3 g's from 0.959 to 0.969 s, and the maximum 0.050-s average acceleration was -2.8 g's between 0.001 and 0.051 s. In the lateral direction, the occupant impact velocity was 0.4 m/s (1.3 ft/s) at 0.521 s, the highest 0.010-s occupant ridedown acceleration was 0.2 g's from 0.538 to 0.548 s, and the maximum 0.050-s average was -0.3 g's between 0.059 and 0.109 s. These data and other pertinent information from the test are summarized in [Figure 18](#). Vehicle angular displacements are shown in [Appendix D, Figure 24](#), and vehicle accelerations versus time traces are presented in [Appendix E, Figures 28 through 30](#).

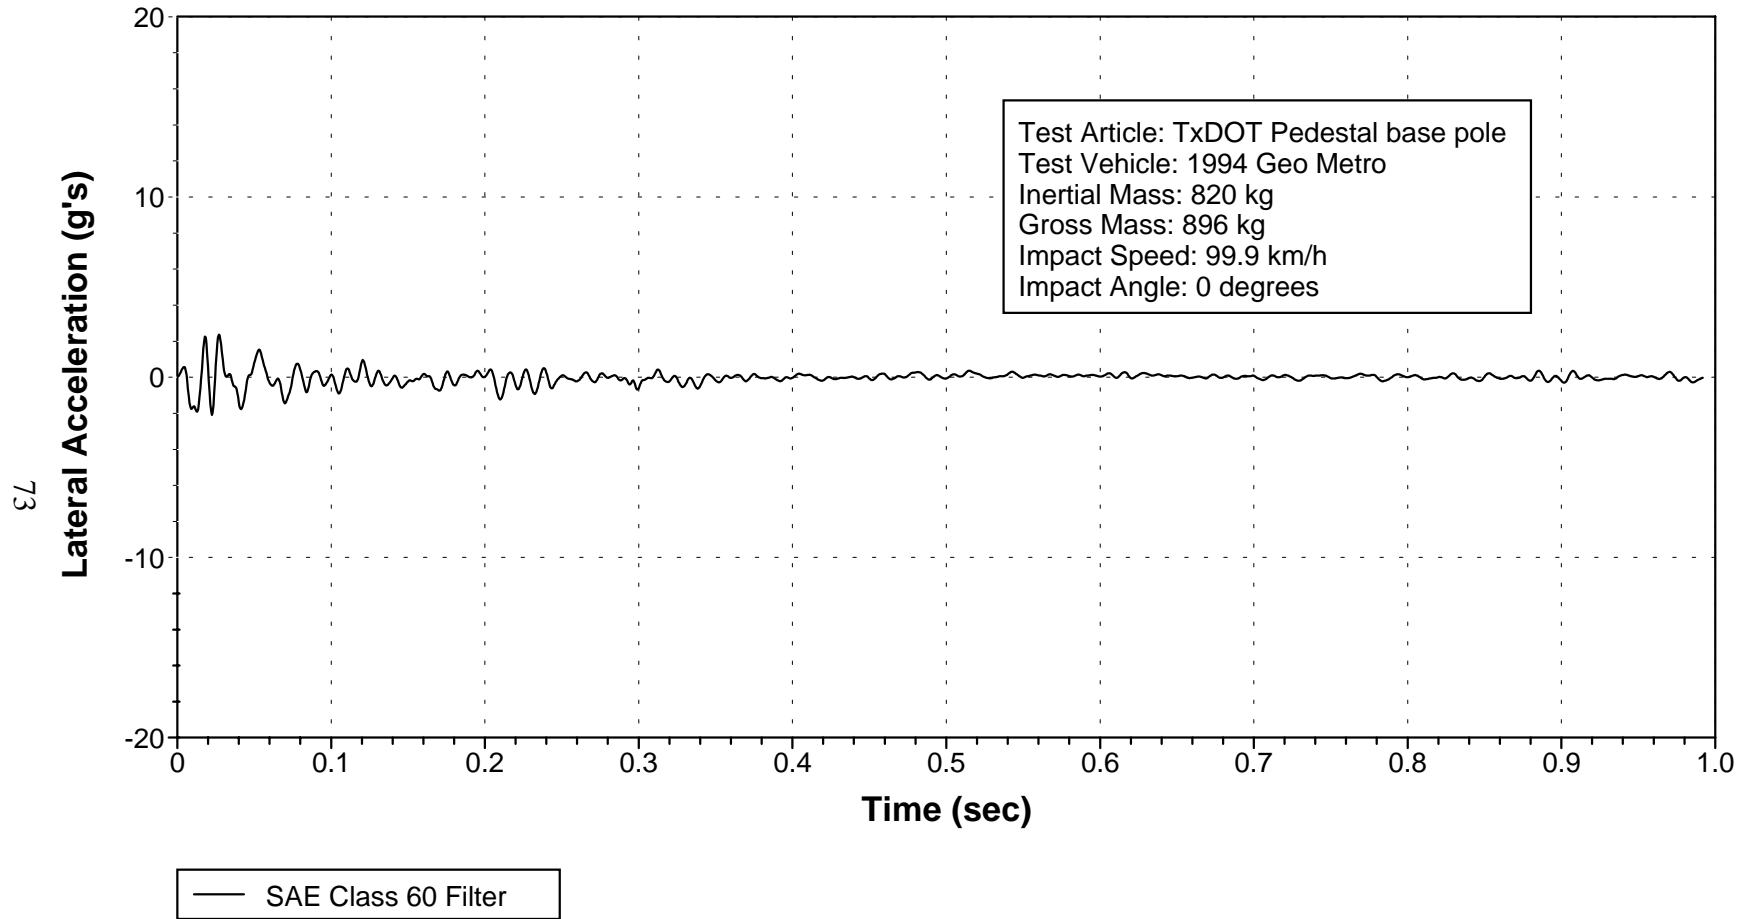
Figure 29. Vehicle Lateral Accelerometer Trace for Test 417920-2.

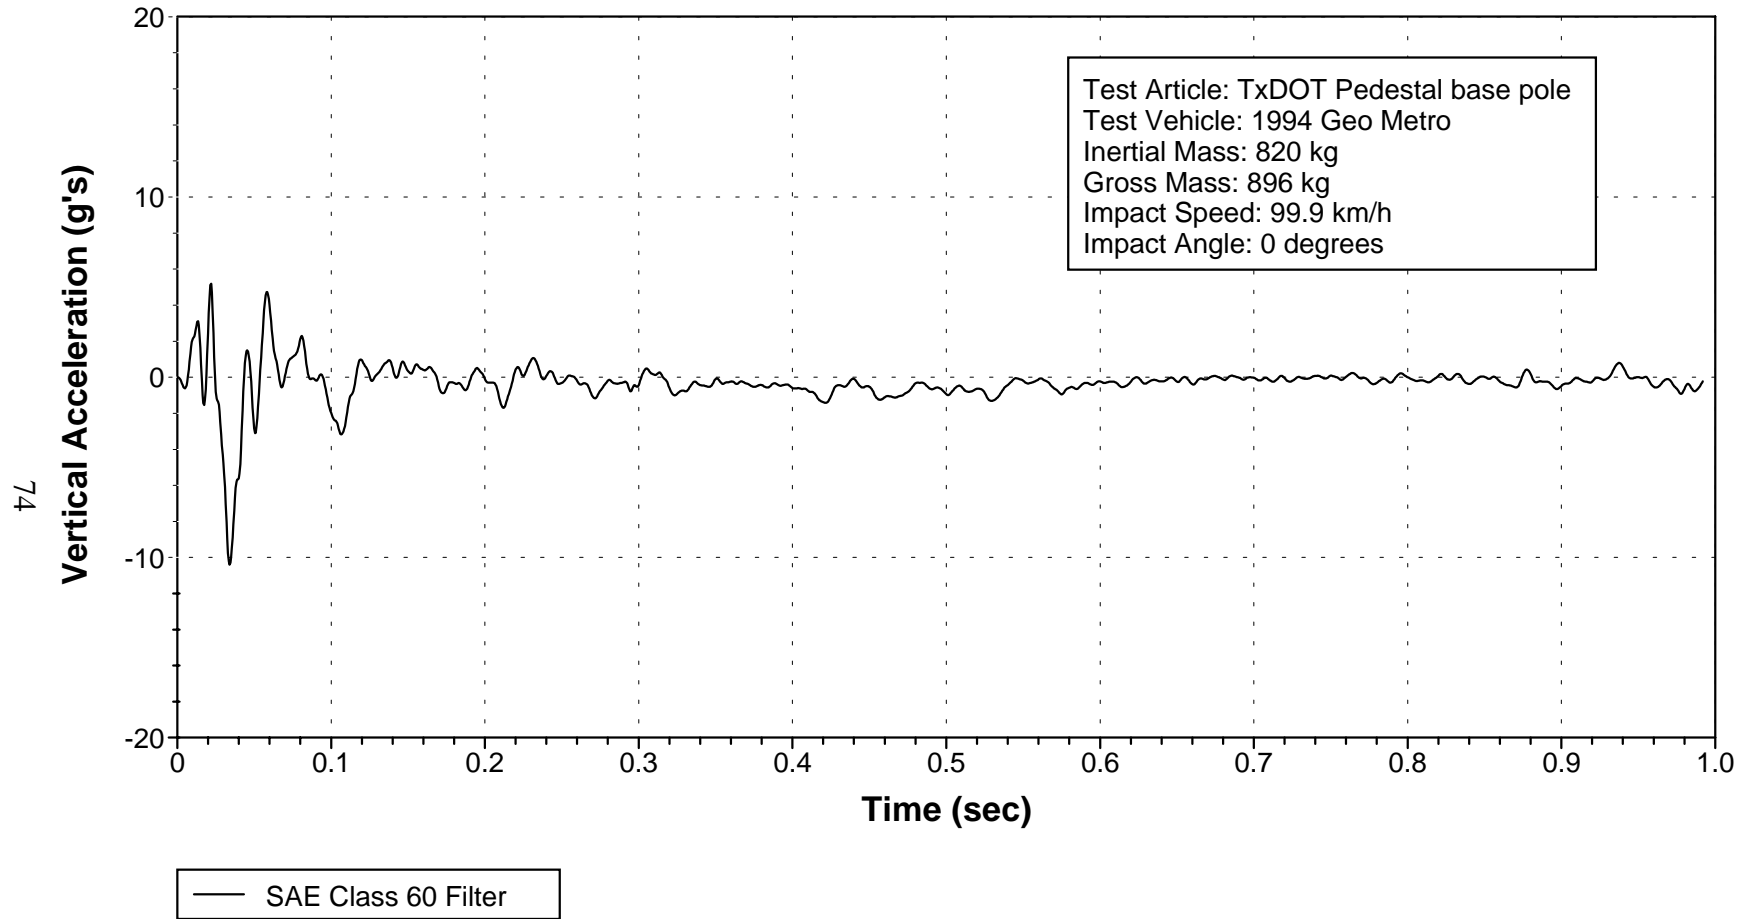
Figure 30. Vehicle Vertical Accelerometer Trace for Test 417920-2.
