REPORT NO. 3374  
PACIFIC ELECTRIC RAILWAY COMPANY  
IN RE ACCIDENT  
AT LOS ANGELES, CALIF., ON  
OCTOBER 10, 1950

Kind of accident: Rear-end collision

Accident at Los Angeles, Calif., on October 10, 1950, caused by failure properly to control the speed of the following train in accordance with flagman's instructions.

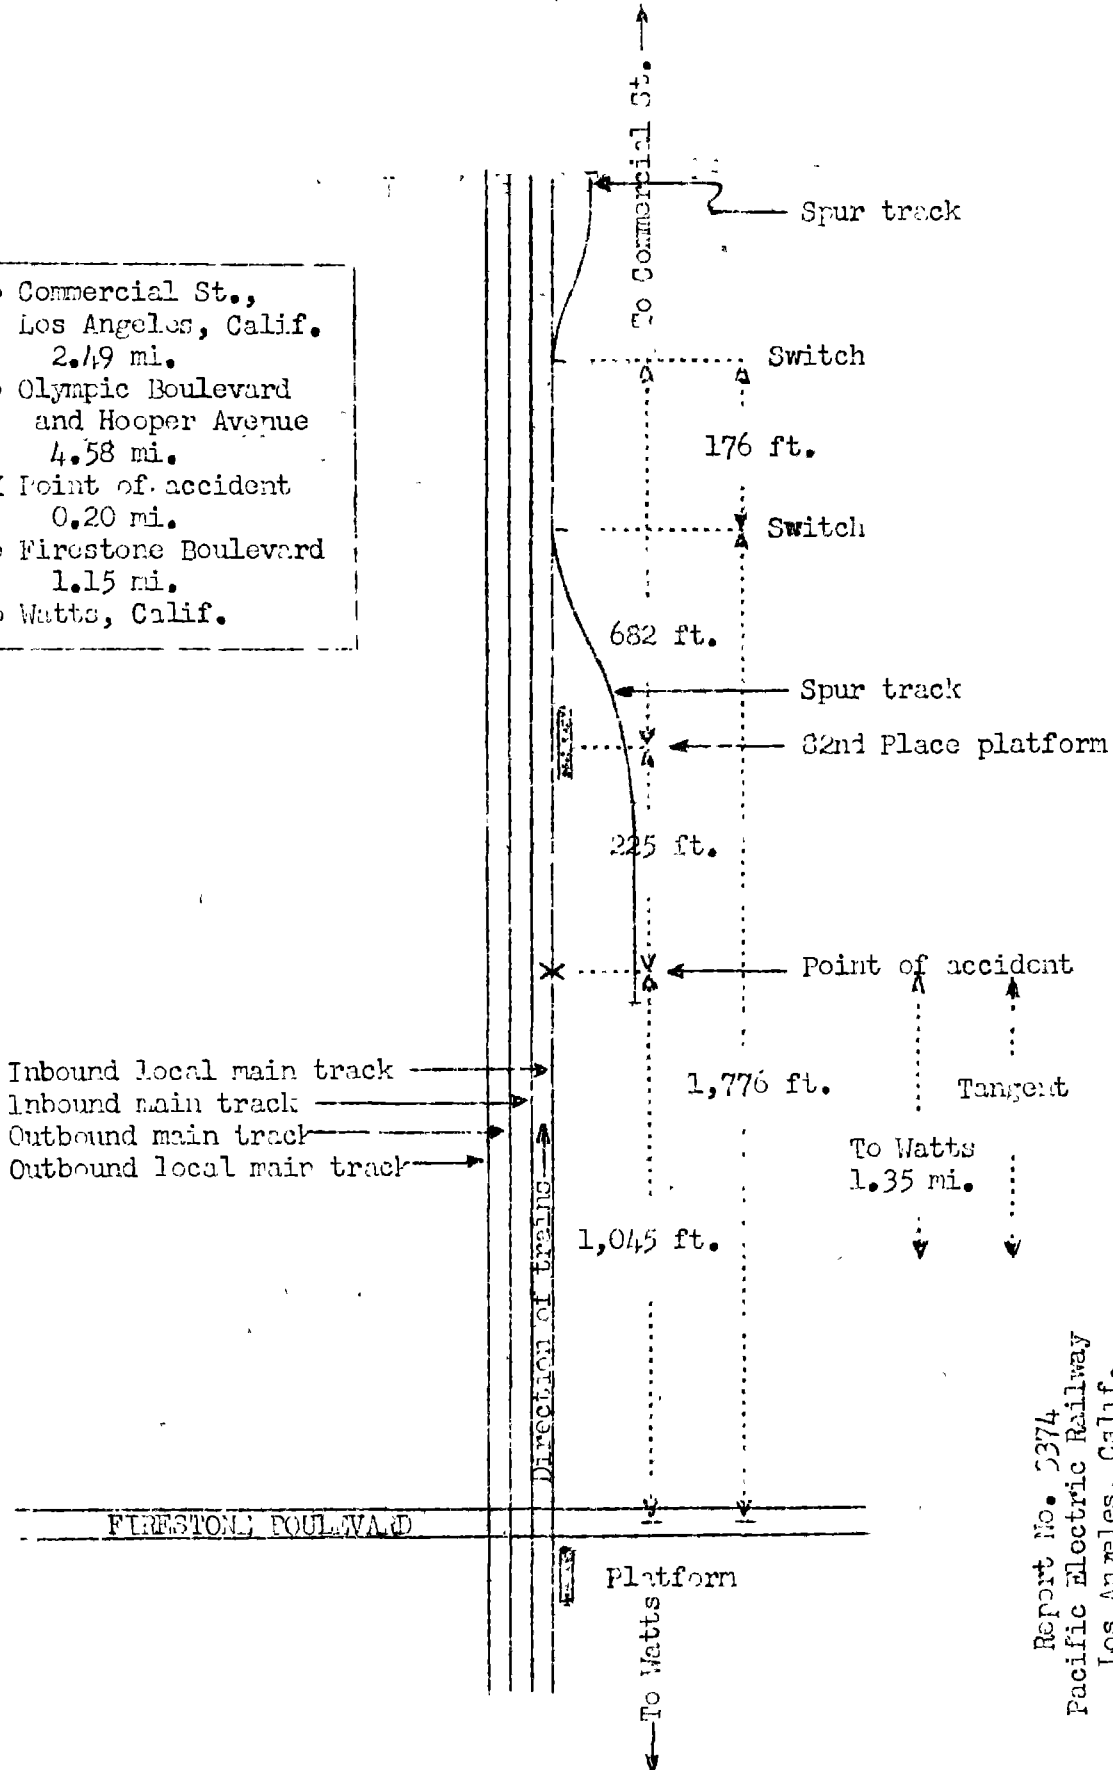
Report No. 3374  
 Pacific Electric Railway  
 Los Angeles, Calif.  
 October 10, 1950

- o Commercial St.,  
Los Angeles, Calif.  
2.49 mi.
- o Olympic Boulevard  
and Hooper Avenue  
4.58 mi.
- X Point of accident  
0.20 mi.
- o Firestone Boulevard  
1.15 mi.
- o Watts, Calif.
