TRANSBUS SAFETY AND HUMAN FACTORS

SUMMARY REPORT

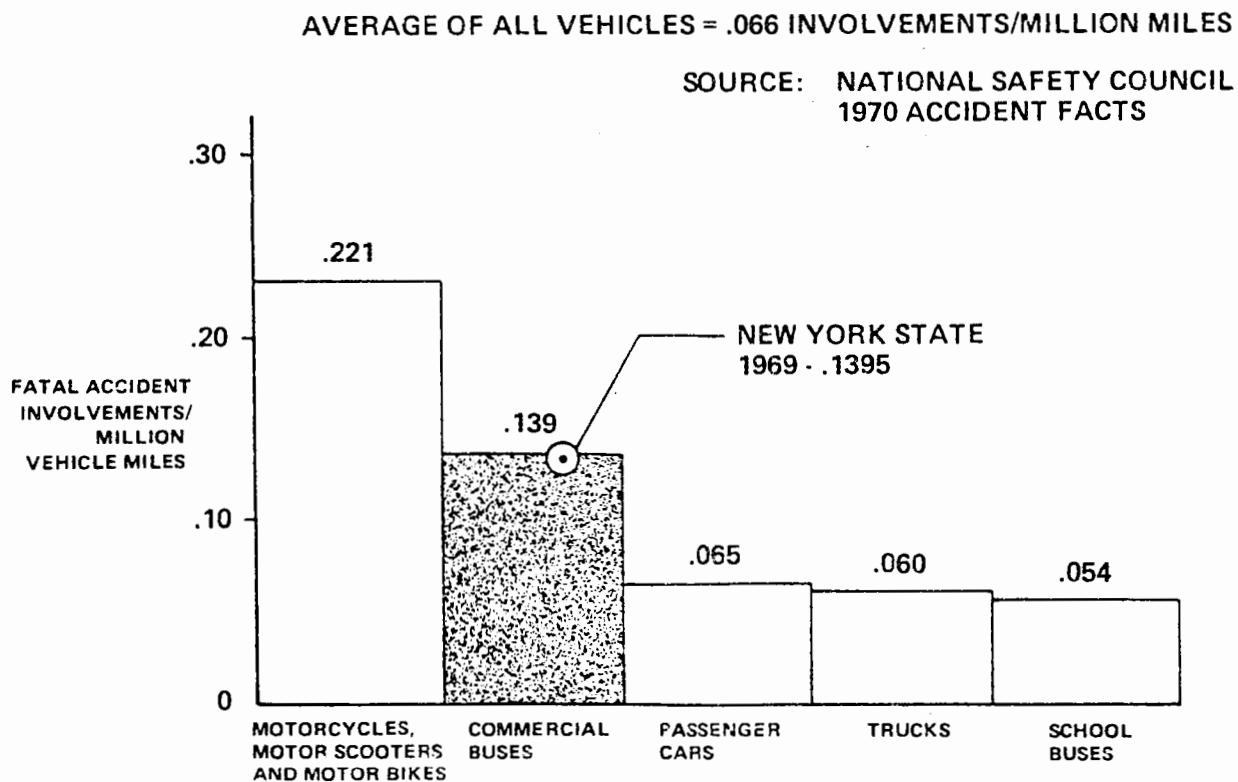
FIGURE 1
Fatal Accident
Involvement Rate - 1969

As a consequence, on a vehicle mileage basis, commercial buses (transit and intercity) have a relatively high fatal accident involvement rate, second only to motorcycles, motor bikes and motor scooters. See Figure 1 which is based on data from the National Safety Council. (1)*

As mentioned earlier, pedestrians are the most common victim in fatal accidents involving urban transit buses. As shown in Figure 1, the fatal accident involvement rate of commercial buses is relatively high on a vehicle mileage basis. In 1969, as shown on the figure, New York State reported a fatal accident involvement rate for commercial buses which was almost precisely the national average. Thus New York, which has the largest number of commercial bus registrations of any state was selected as a source of detailed data regarding fatal bus accidents.

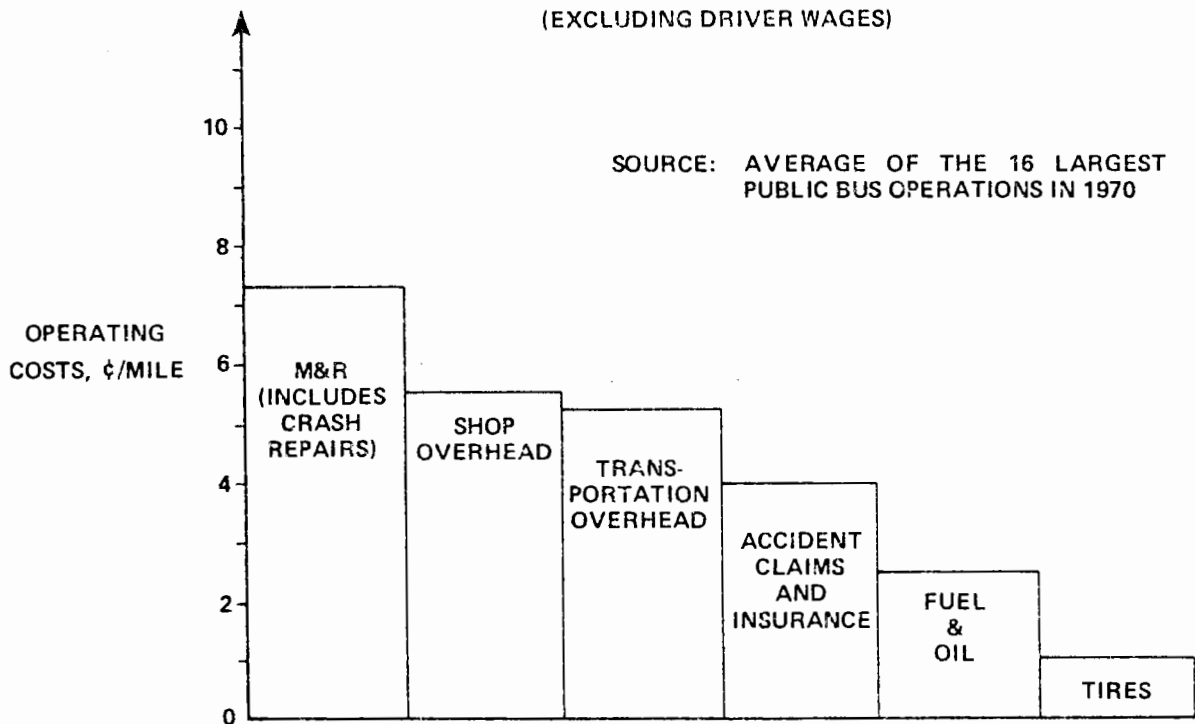
FIGURE 3
Safety in Relation
to Other Vehicle Costs

Figure 2 puts the cost of accident claims and insurance in perspective with other operating costs. (2) In Figure 3, the 4¢/mile safety related cost (accident claims and insurance) is shown to exceed the combined costs of fuel, oil, and tires. (2) Over the 500,000 mile life of a typical transit bus accident costs are equal to about one-half of the initial price of the vehicle. These cost summary statistics strongly indicate that a safer bus holds the promise of significant operating cost reductions for the transit industry. Also, given the current program of Federal Capital Assistance grants for the purchase of new buses, these operating cost reductions could be obtained with reduced capital investment requirements if a safer bus design were available.

SOURCE: AVERAGE OF THE 16 LARGEST PUBLIC BUS OPERATIONS
IN 1970

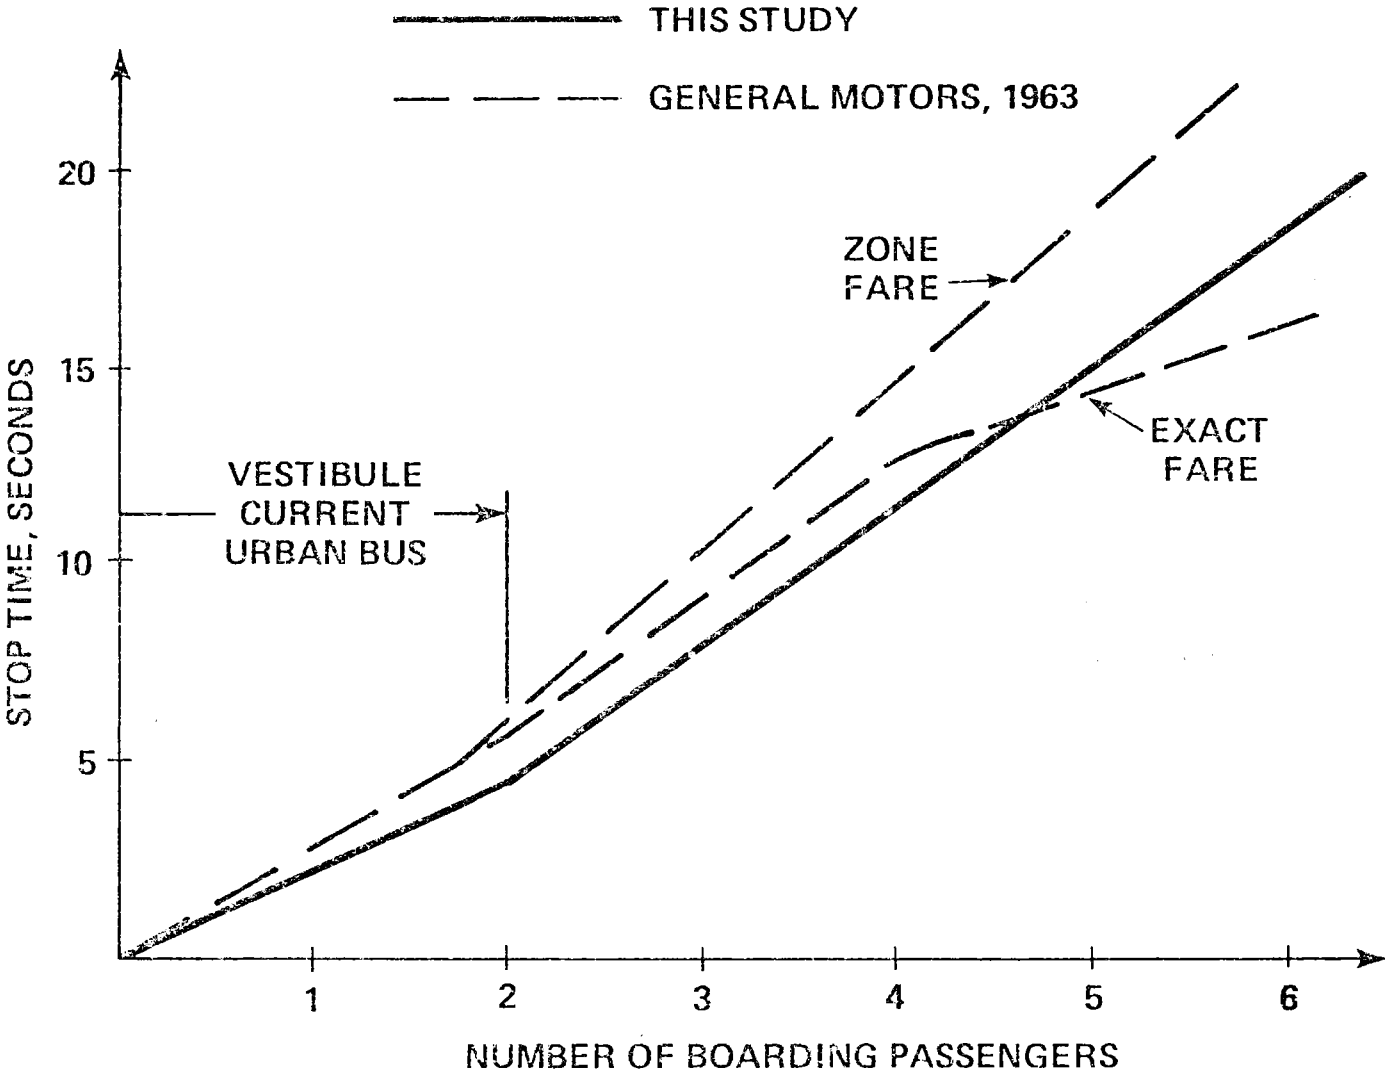
STOP TIME VS. NUMBER OF BOARDING PASSENGERS

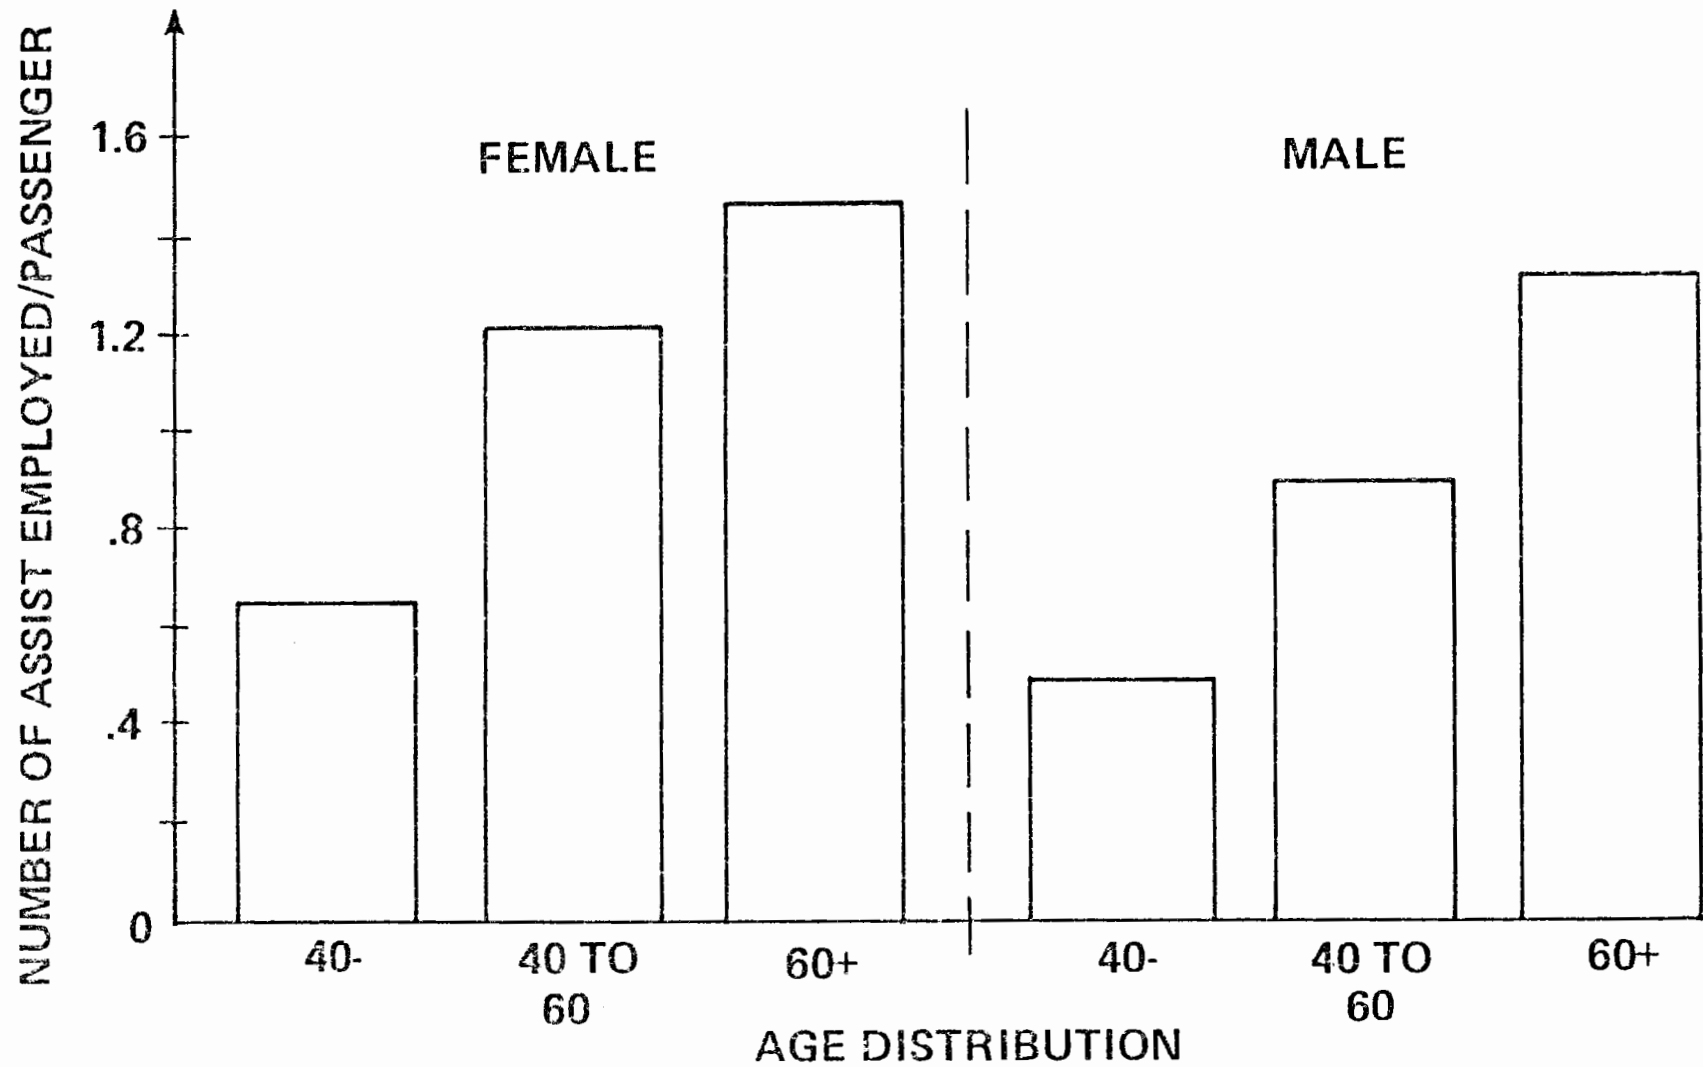
USE OF ASSISTS BY AGE AND SEX

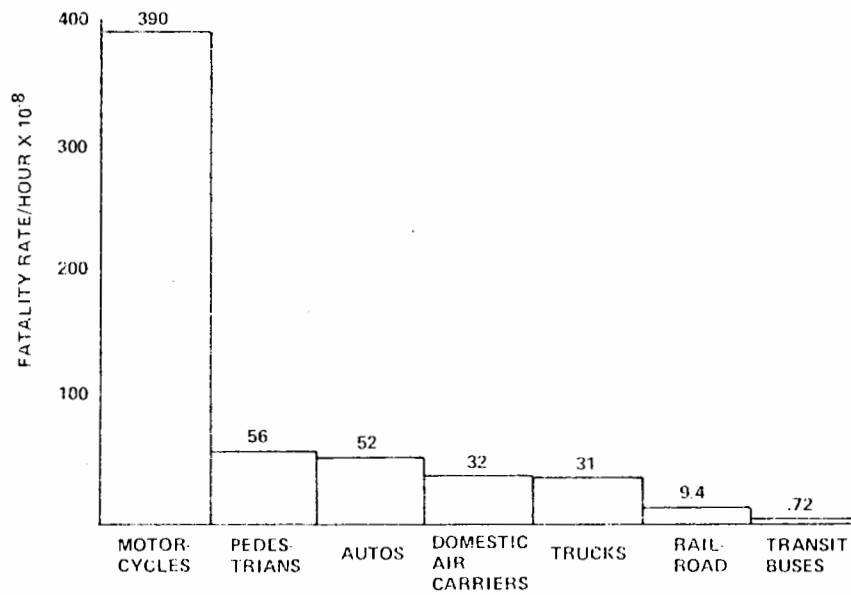
RISK OF FATALITY BY
TRANSPORTATION MODE

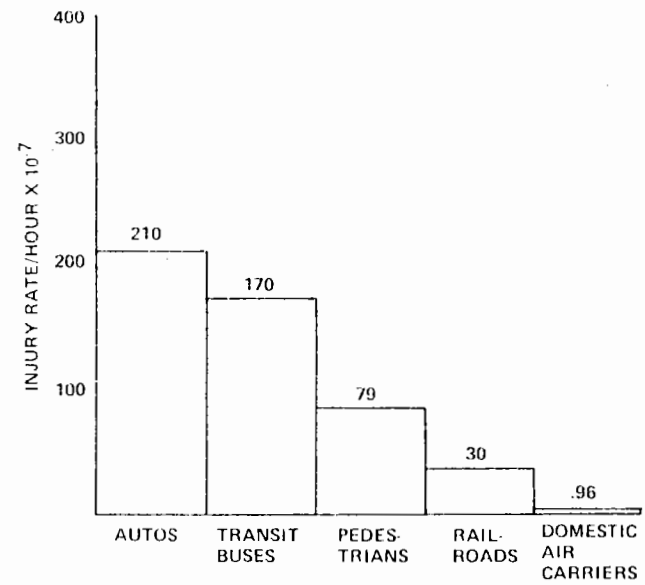
RISK OF INJURY BY
TRANSPORTATION MODE

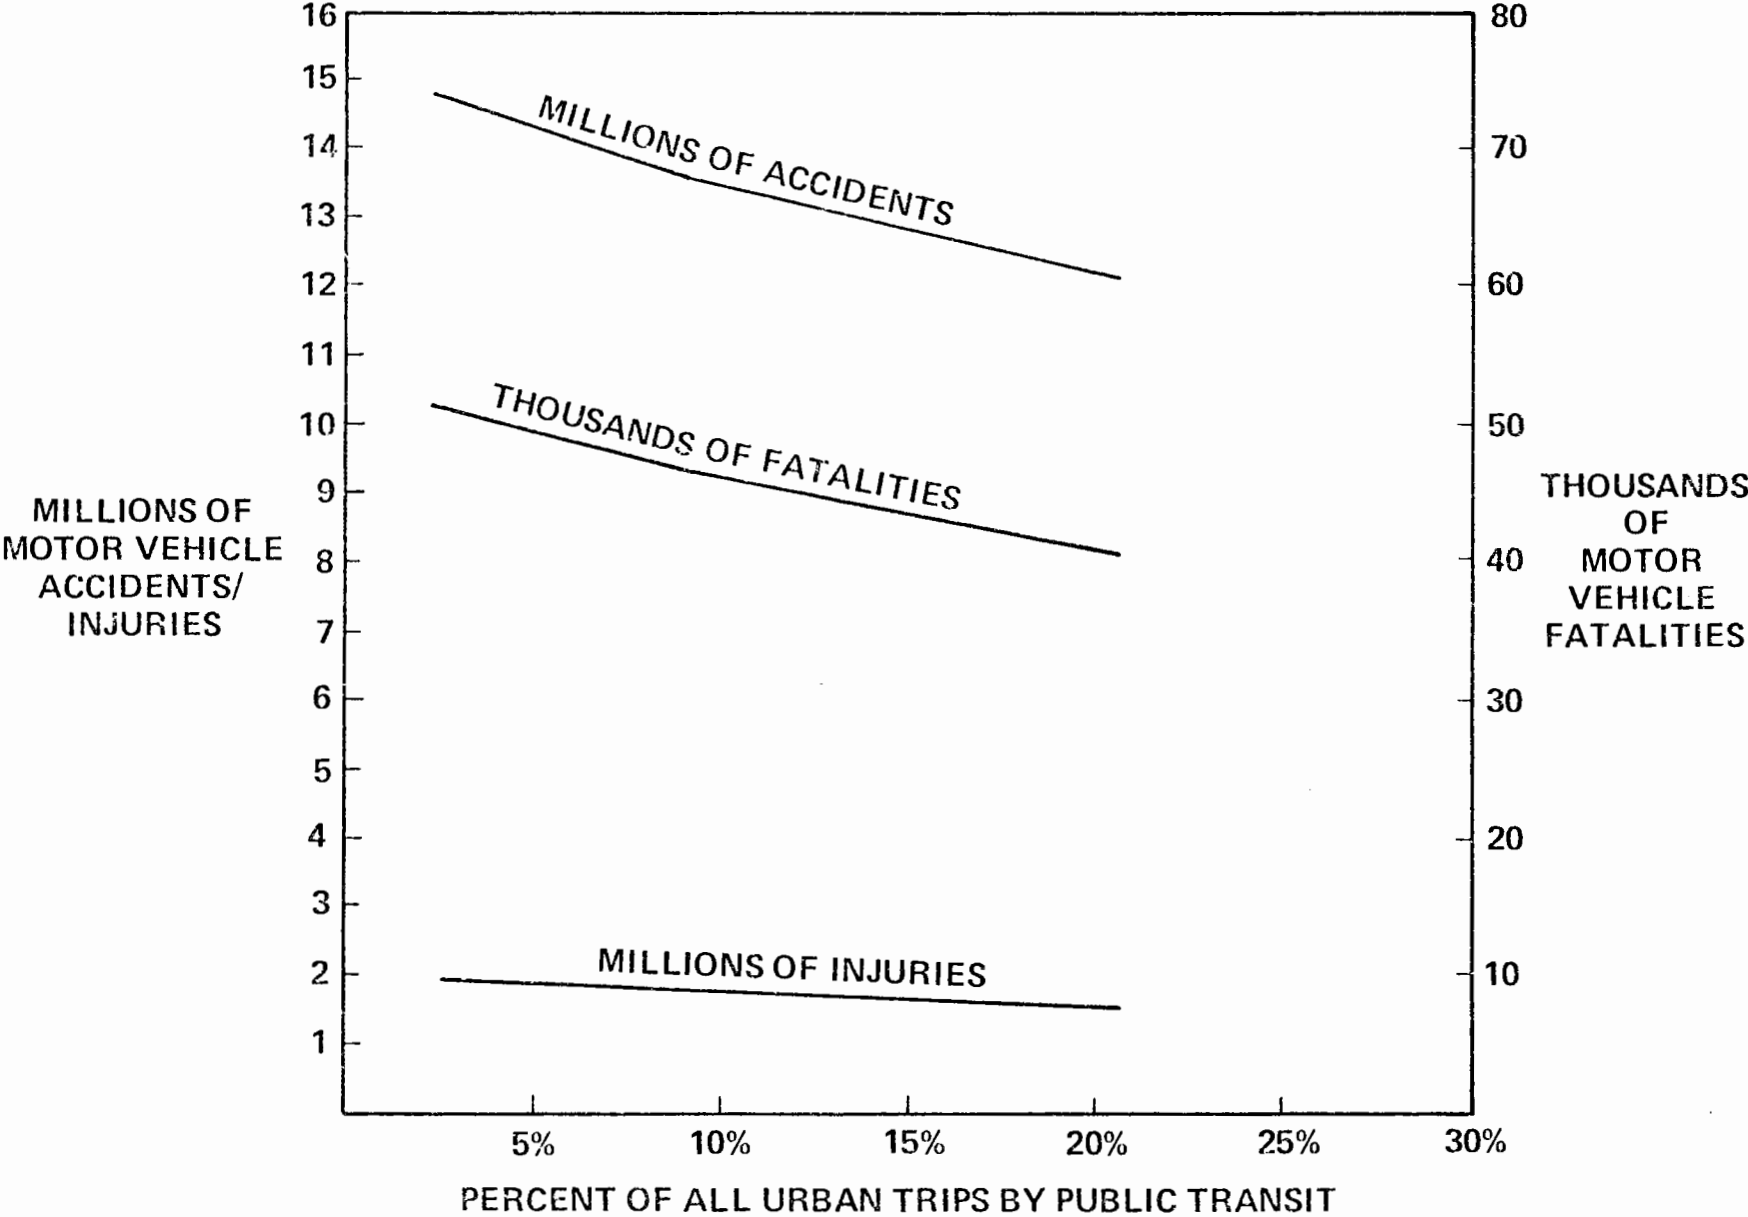
IMPACT OF PUBLIC TRANSIT RIDERSHIP ON URBAN TRAFFIC SAFETY
