# STATIC AND DYNAMIC TESTS OF FULL-SCALE DOUBLE-TEE GIRDERS FOR DADE COUNTY RAPID TRANSIT SYSTEM

METROPOLITAN DADE COUNTY  
OFFICE OF  
TRANSPORTATION ADMINISTRATION

OCTOBER 10, 1979

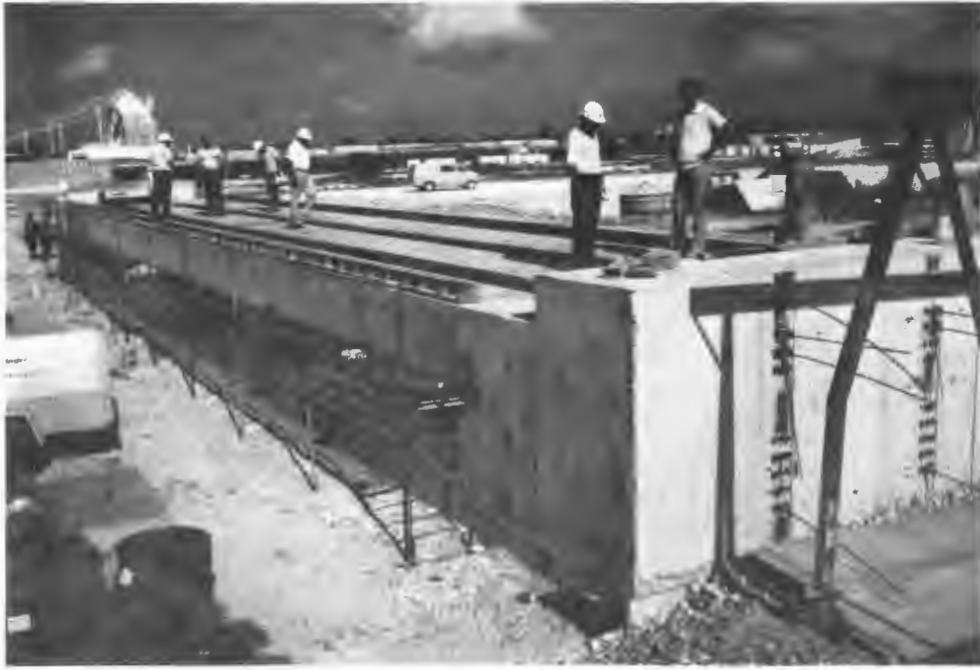
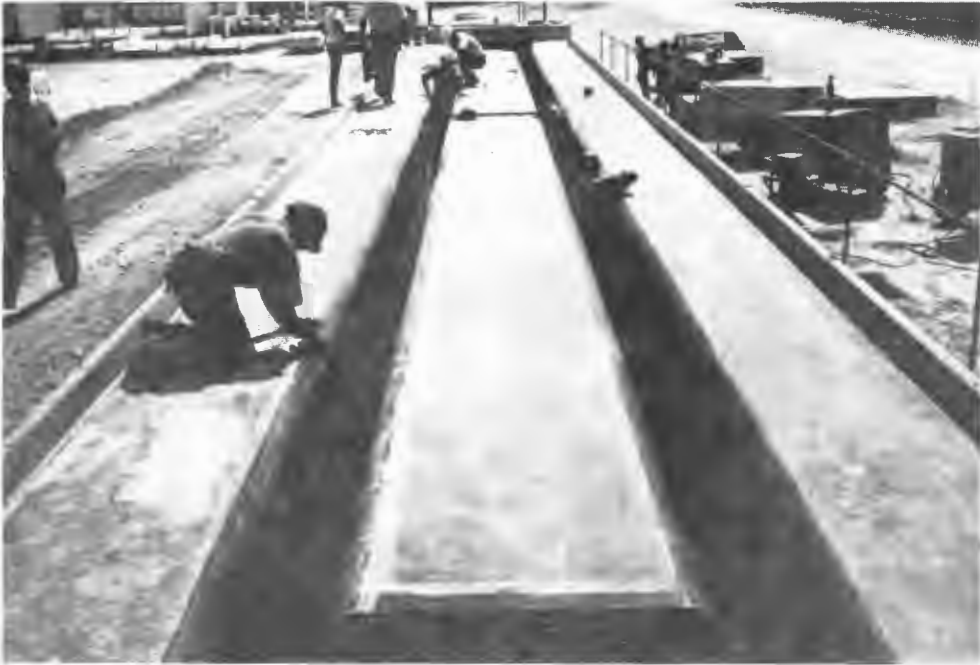
Fig. 2a Form for Manufacture of Girders

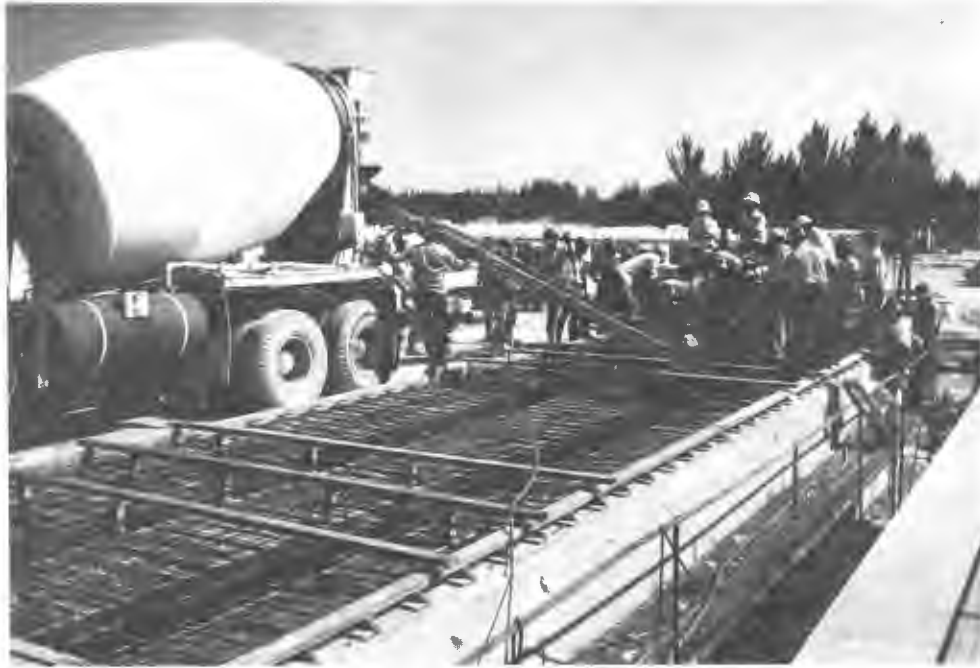
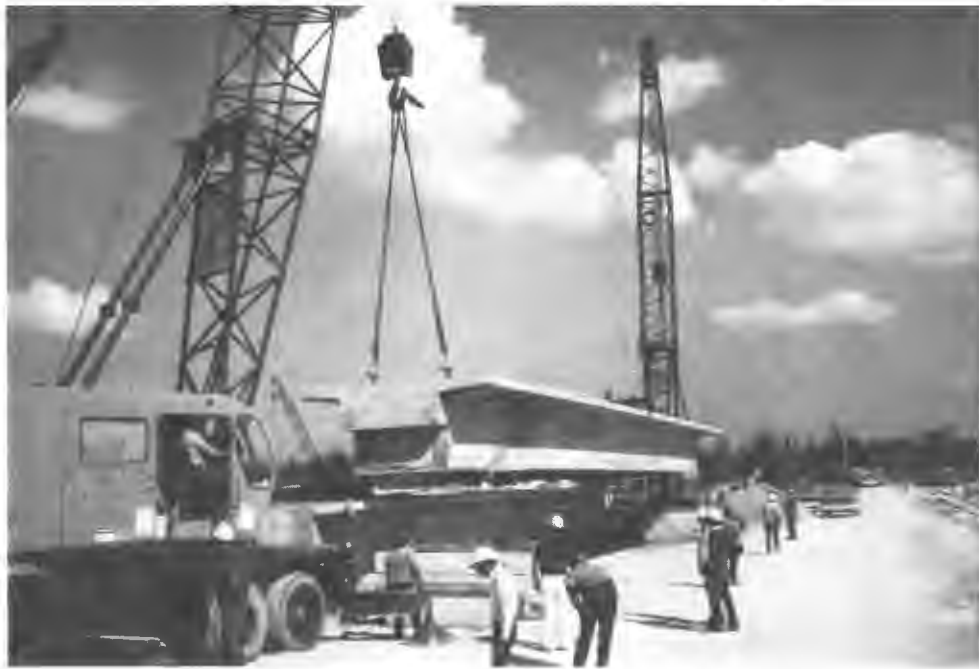
Fig. 2b    Manufacture of Girders

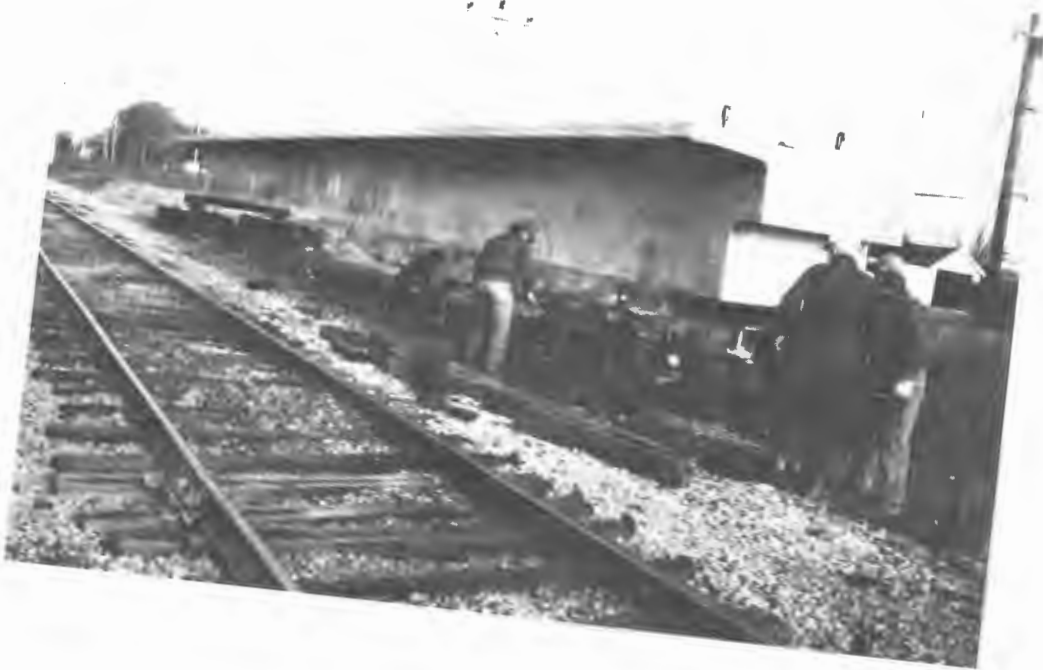
Fig. 3 Transportation of Girders by Railroad

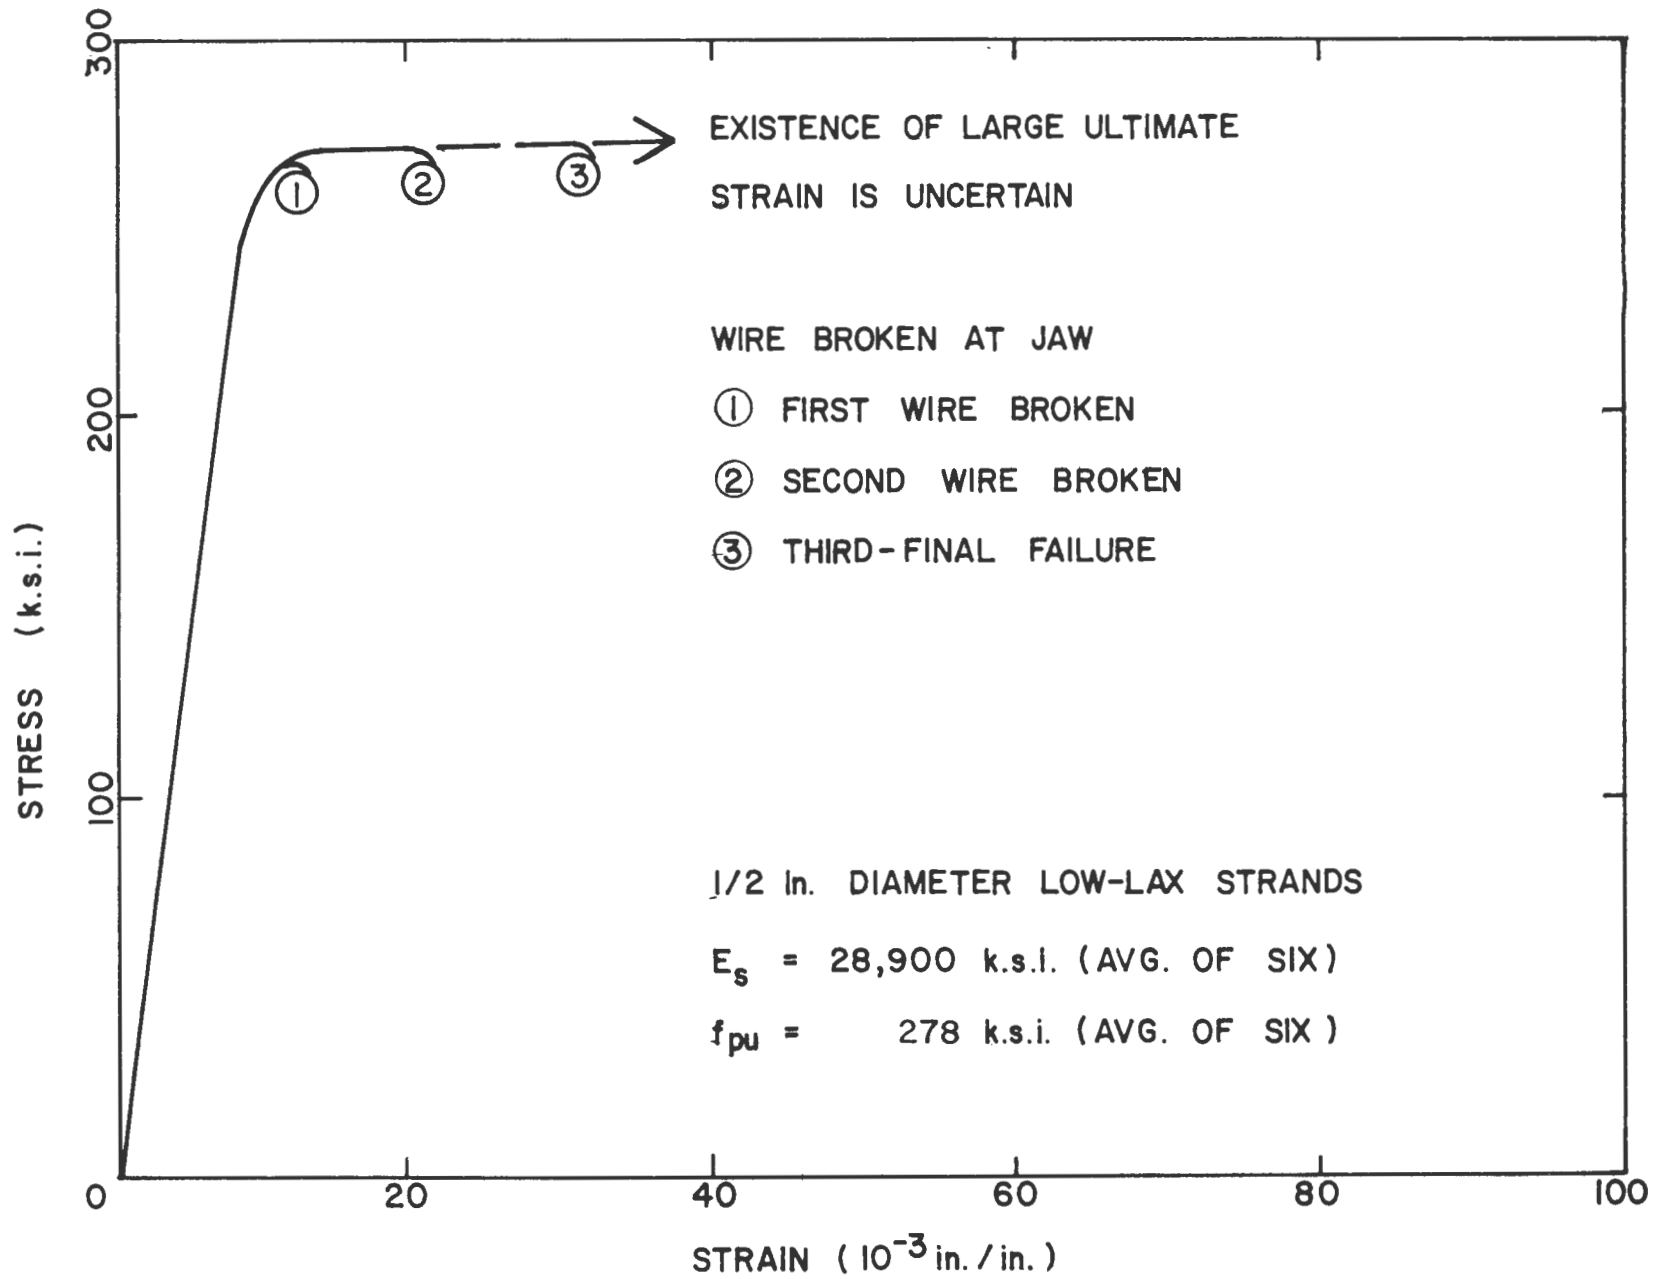
Fig. 7. Stress-Strain Curve of Prestress Strands

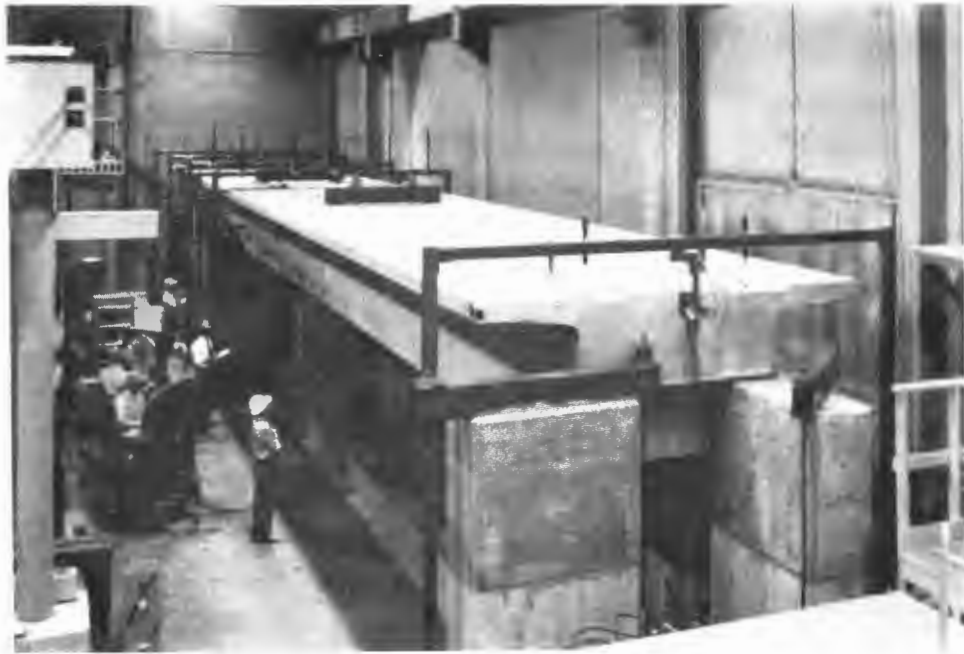
Fig. 9 General View of Initial Static Test - Girder 2

The natural frequencies of the uncracked Girder 2 were measured in flexure and in torsion before the initial static test. The girder has been set-up on the supports as shown in Fig. 9 (without the loading systems and without tightening the hold-down rods at support). Two LVDT's were installed at midspan near the north and south edges

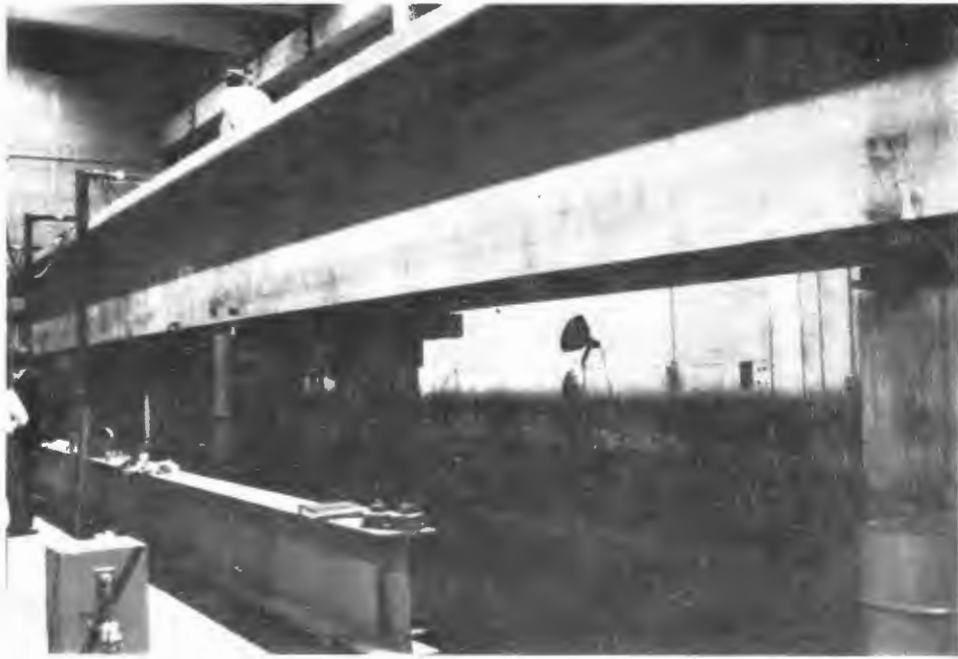
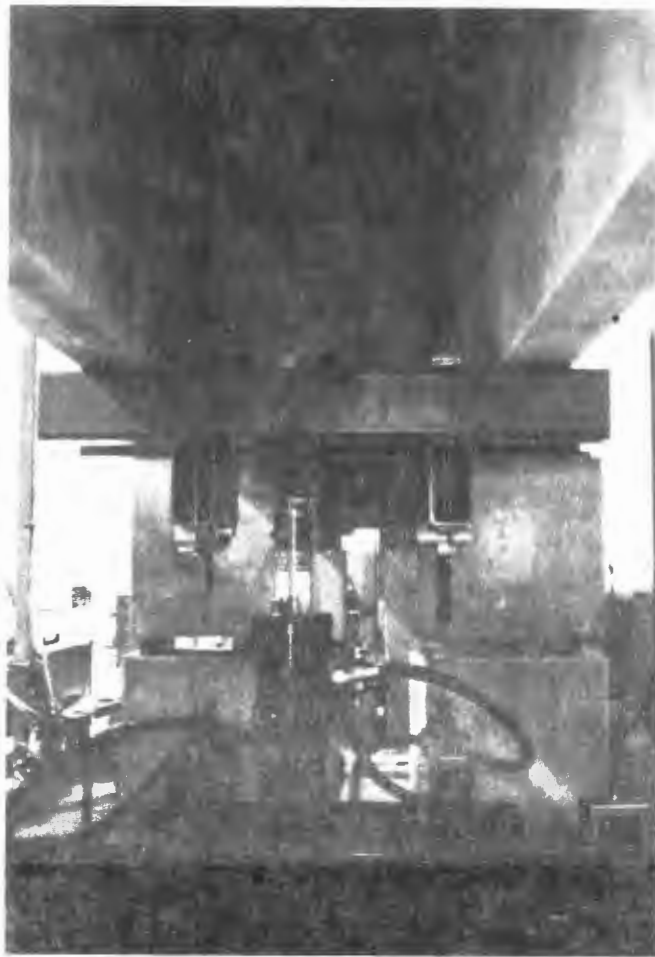
Fig. 13 General View of Fatigue Test - Girder 2

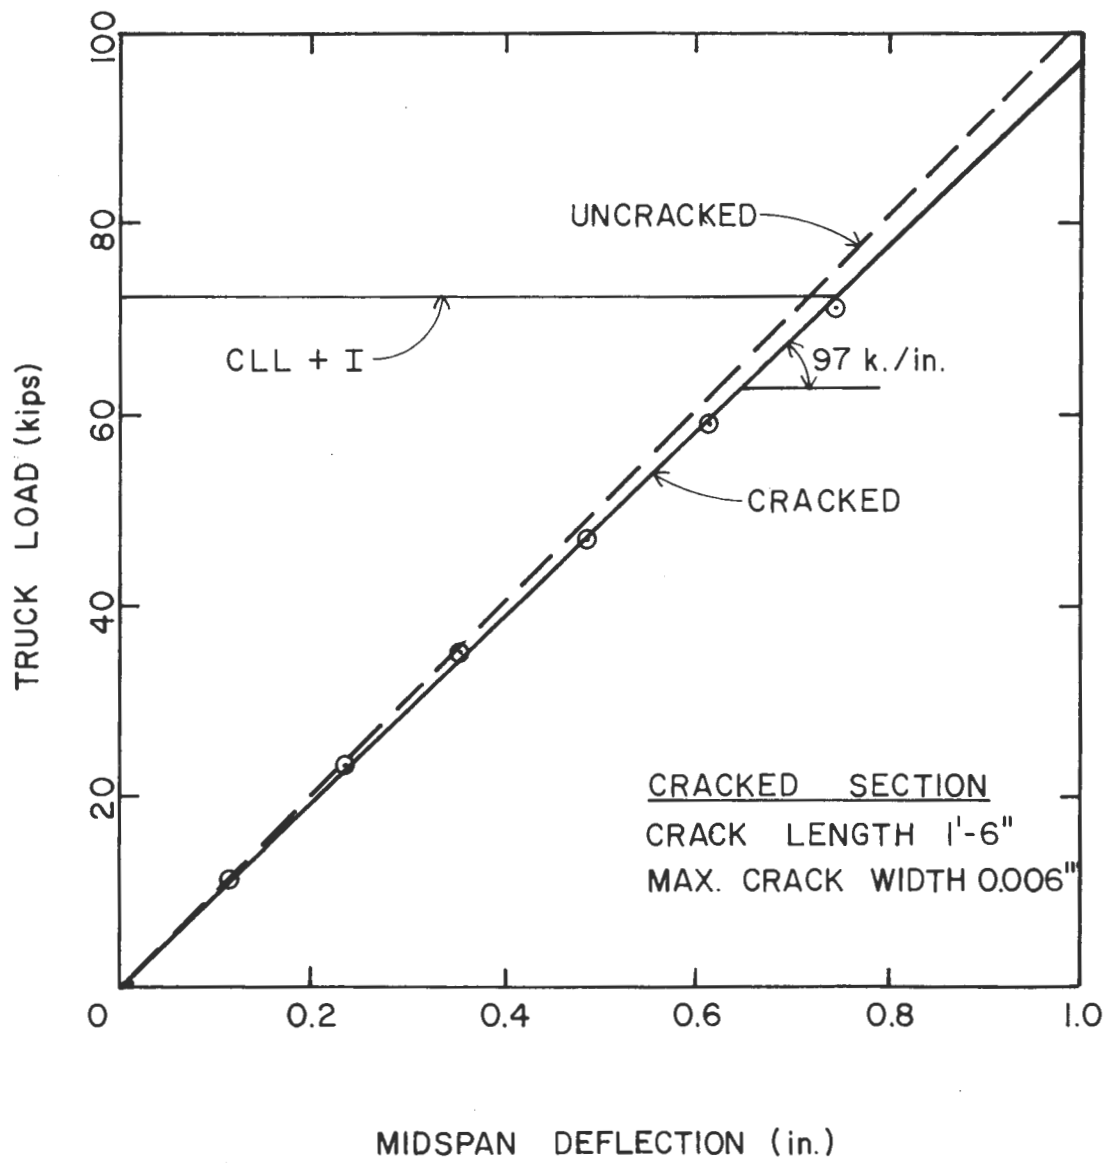
Fig. 27. Load vs. Midspan Deflections (Cracked)  
 - Girder 2, Initial Static Test.

The midspan rotations obtained from tests in Fig. 27 and the corresponding differential deflections at midspan are given below for the three design criteria (1), (2) and (3).

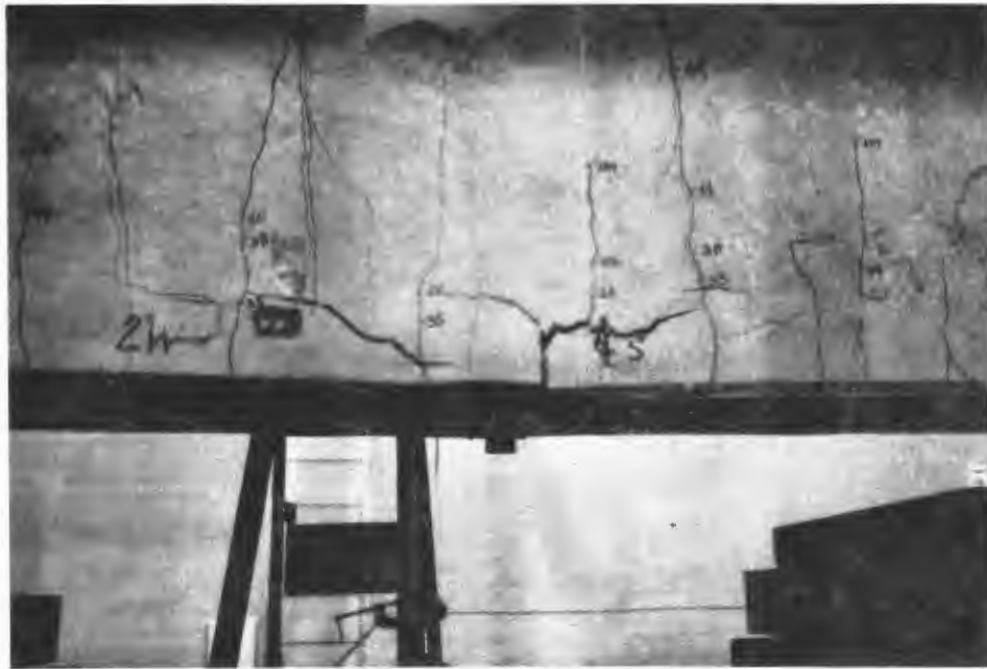
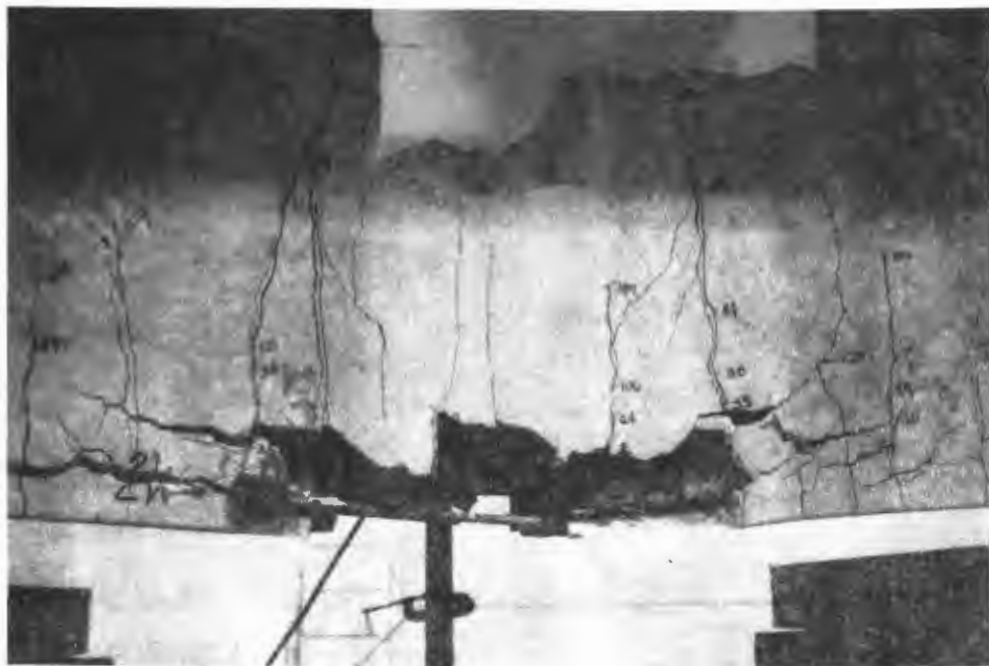
Fig. 42a Development of Cracks at Midspan  
- Girder 2, Derailment Test

8.2.4.6 Midspan Diaphragm - Figs. 42a and b show an interesting observation; i.e. the development of horizontal cracks in the stem at midspan below the bottom face of the diaphragm. These horizontal cracks started to develop rapidly at  $P_3 = 106$  kips and destroyed the bond between the strands and the surrounding concrete. As a result, the girder behaved like an unbonded girder in this region, and one vertical flexural crack could widen very rapidly.

It should be noted that the local horizontal cracks in the stem at midspan, which was very prominent in Girder 2, (Figs. 42a and 42b) also existed in Girder 3. These local horizontal cracks are shown in Fig. 65. Their widths, however, were small.

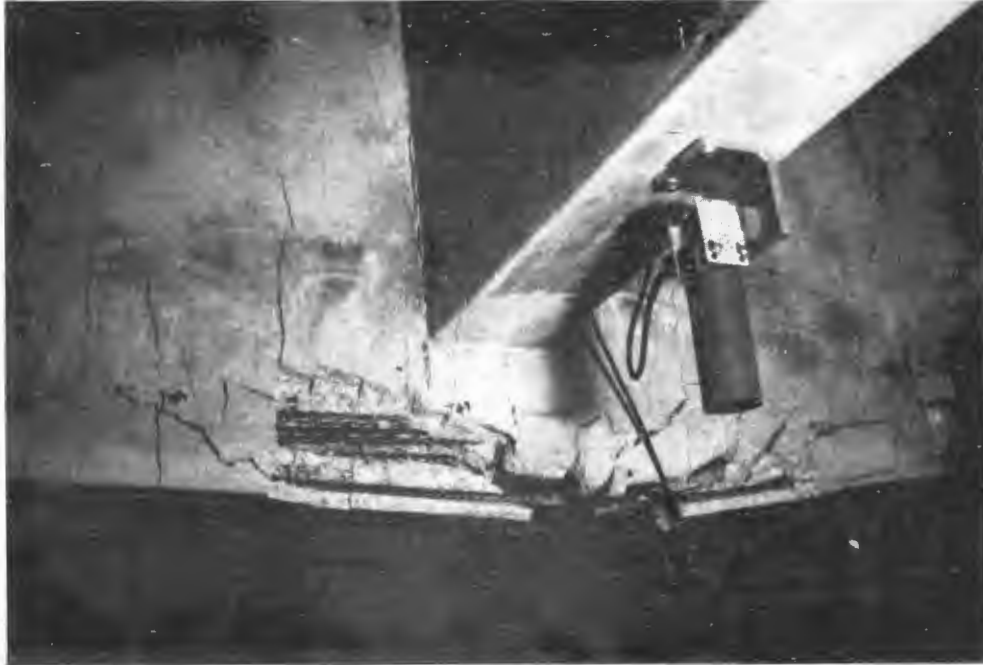
Fig. 42b Development of Cracks at Midspan  
- Girder 2 Derailment Test

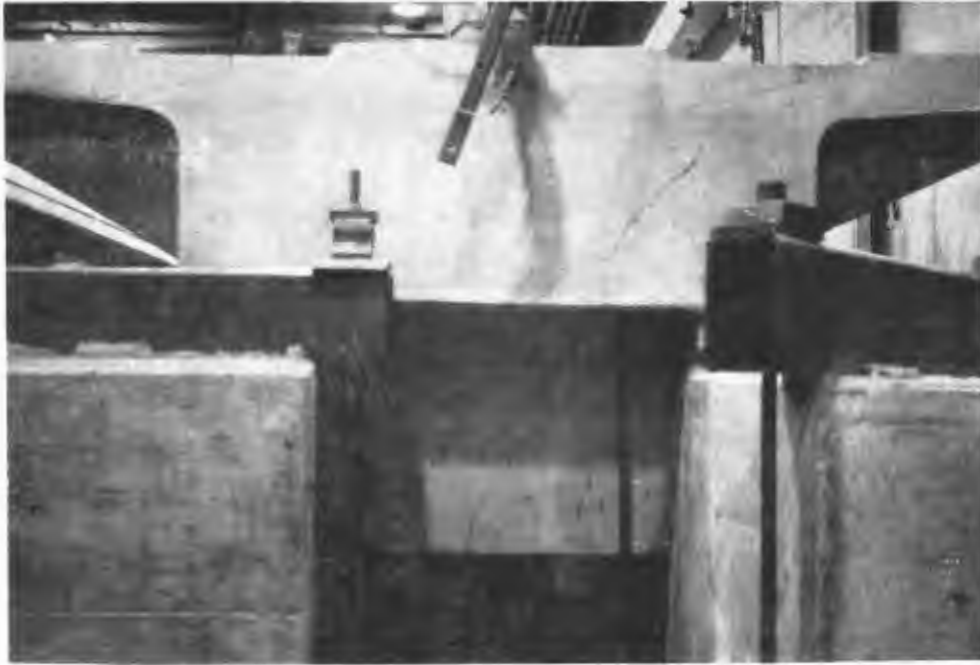
Fig. 44 Diagonal Cracking of End Diaphragm

- Girder 2, Derailment Test

8.2.4.7 End Diaphragms - The diagonal torsional cracking of one end diaphragm is shown in Fig. 44. The cracking of the stem at the junction with the inner face of an end diaphragm is shown in Fig. 45. This typical cracking is produced by the differential bending of the two stems (or warping torsion). Since these cracks occurred at loads beyond the design derailment load (i.e. 2 times the crush live load), they satisfy completely the serviceability requirements.

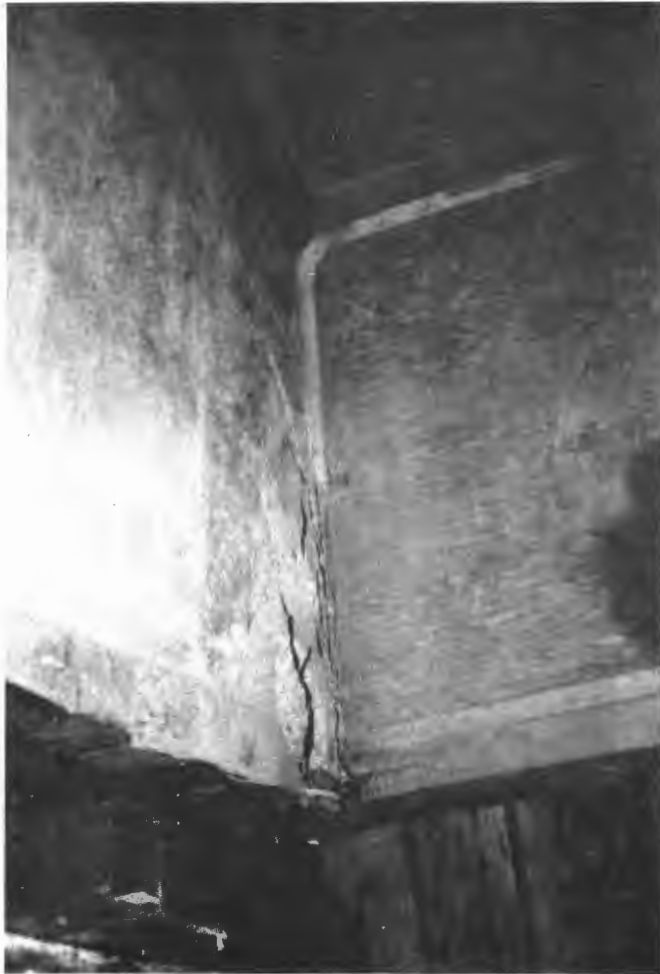
Fig. 45    Cracking of Stem at End Diaphragm  
- Girder 2, Derailment Test

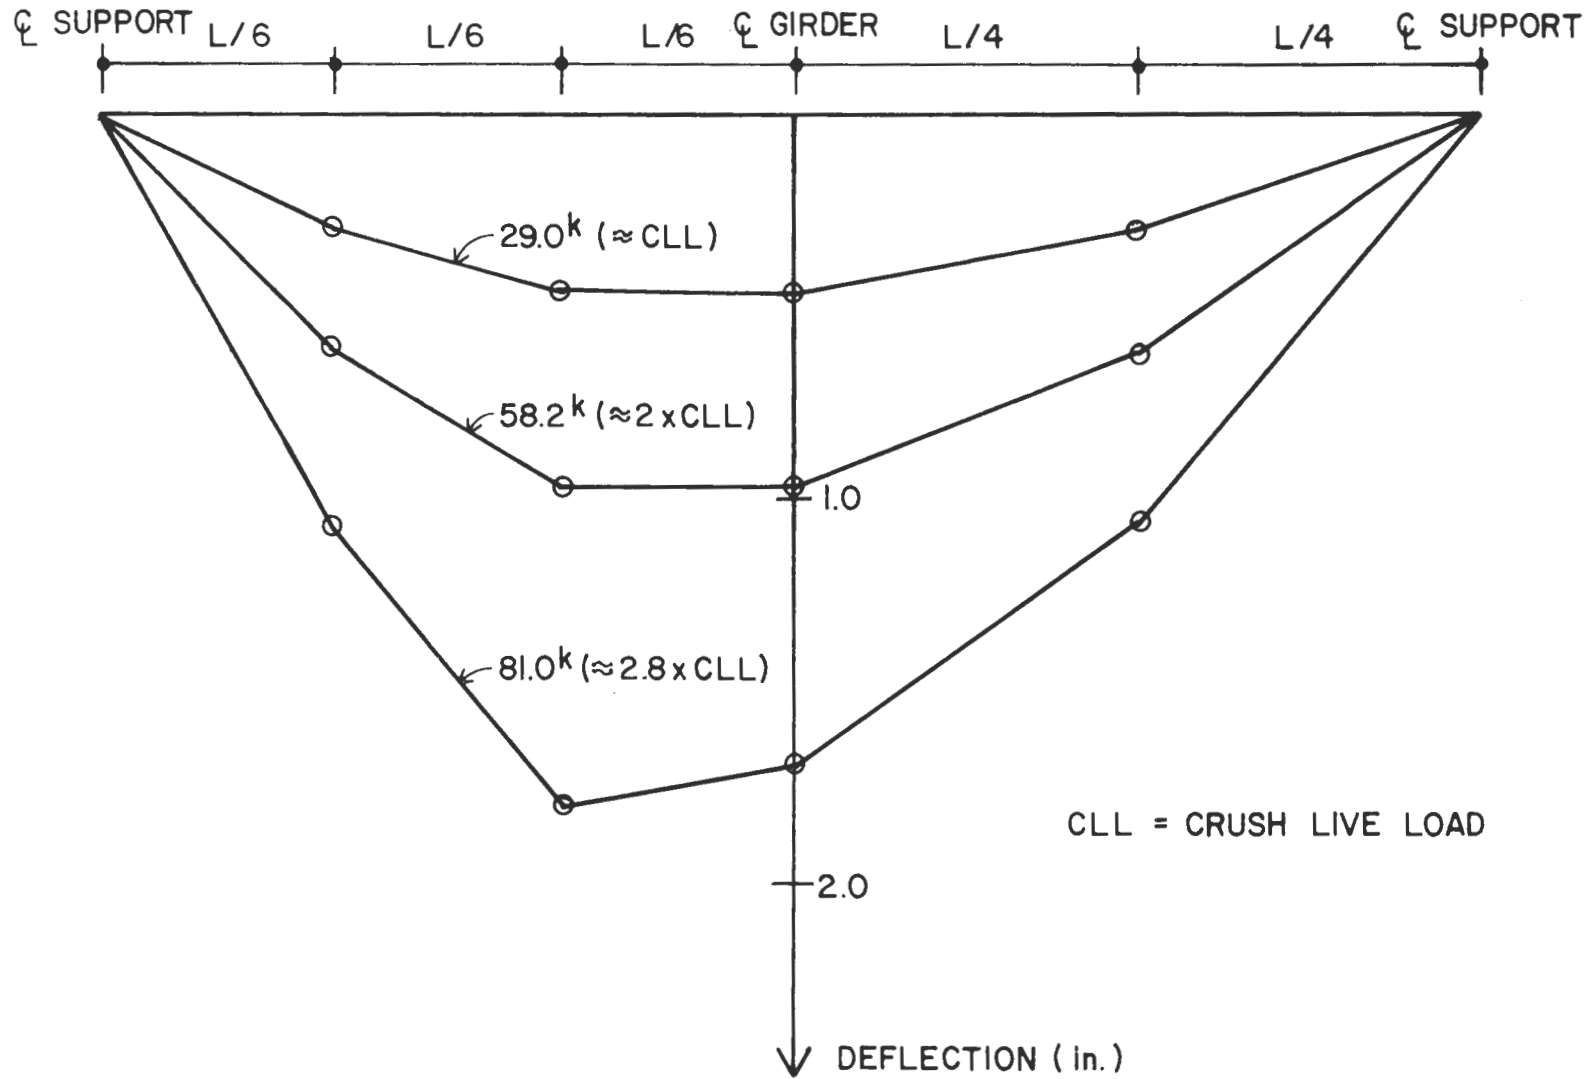
Fig. 51. Deflection Along Heavily-Loaded Stem - Girder 3, Derailment Test.

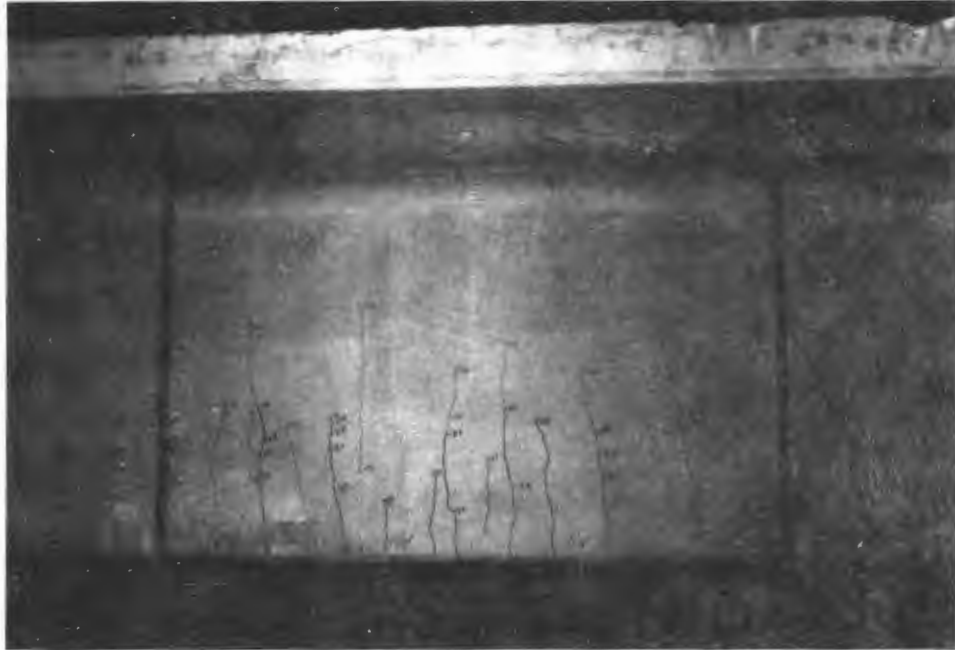
Fig. 59. Flexural Cracking Pattern - Girder 3 at  
5.0 x crush Live Load (2.5 x Derailment Load)

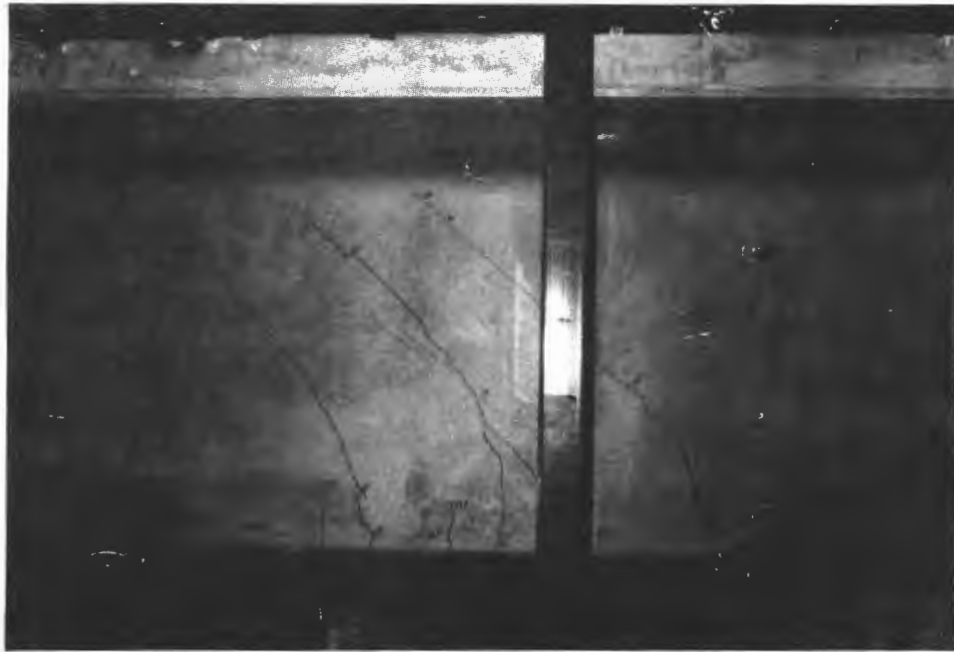
Fig. 60. Shear Cracking Near Midspan - Girder 3, at  
5.0 x Crush Live Load (2.5 x Derailment Load)

cracks in the vicinity of midspan was given in Fig. 60.

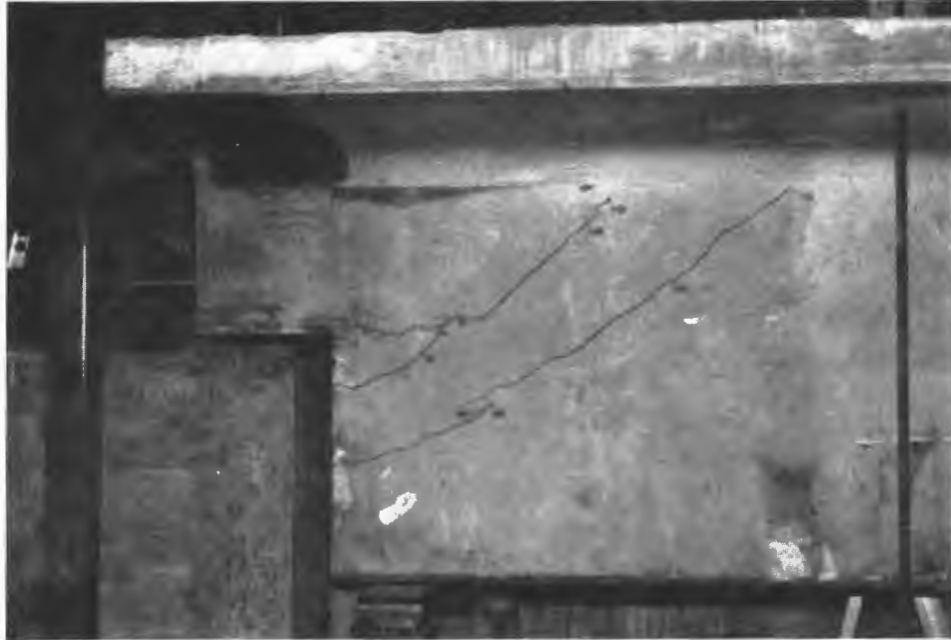
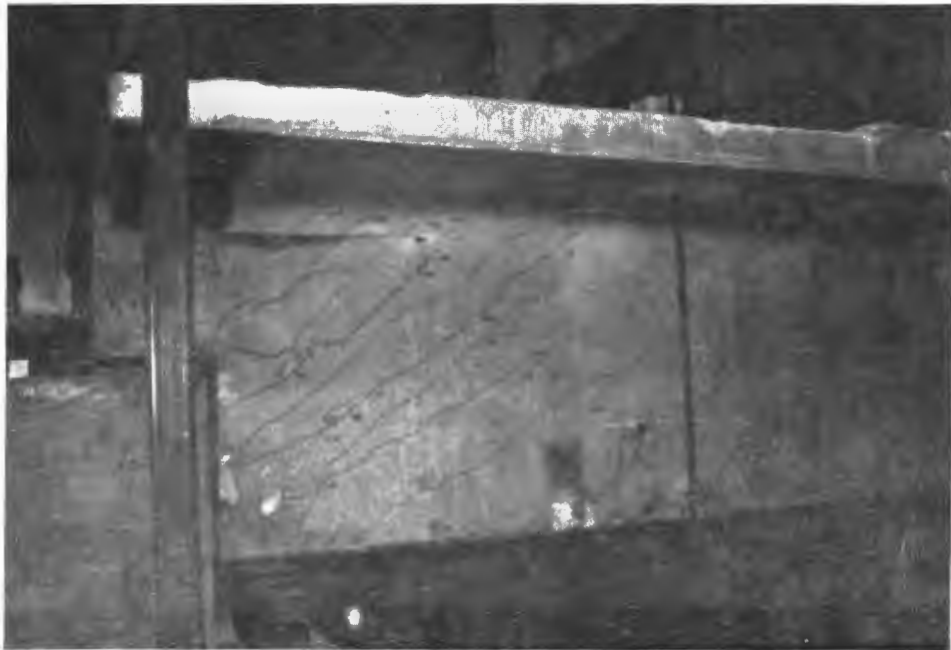
(a) At 2.0 x Crush Live Load

(b) At 5.0 x Crush Live Load

Fig. 61. Cracking Pattern at the Heavily-Loaded End - Girder 3

8.3.2.6 Re-entrant Corner of Dapped End - The pre-existing small crack (see Section 5.2.1) at the re-entrant corner of the dapped end **first** re-opened at a low load of  $P_3 = 14.4$  kips with a maximum crack width of 0.002 in.. This maximum crack width, however, increases very slowly and reached only 0.005 in. at the derailment load of  $P_3 = 58.2$  kips. It was 0.011 in. at  $P_3 = 108.7$  kips and 0.017 in. at  $P_3 = 140$  kips. The cracking patterns are shown in Fig. 61a at  $P_3 = 58.2$  kips (2 times crush live load) and in Fig. 61b at  $P_3 = 146.1$  kips (5 times crush live load).

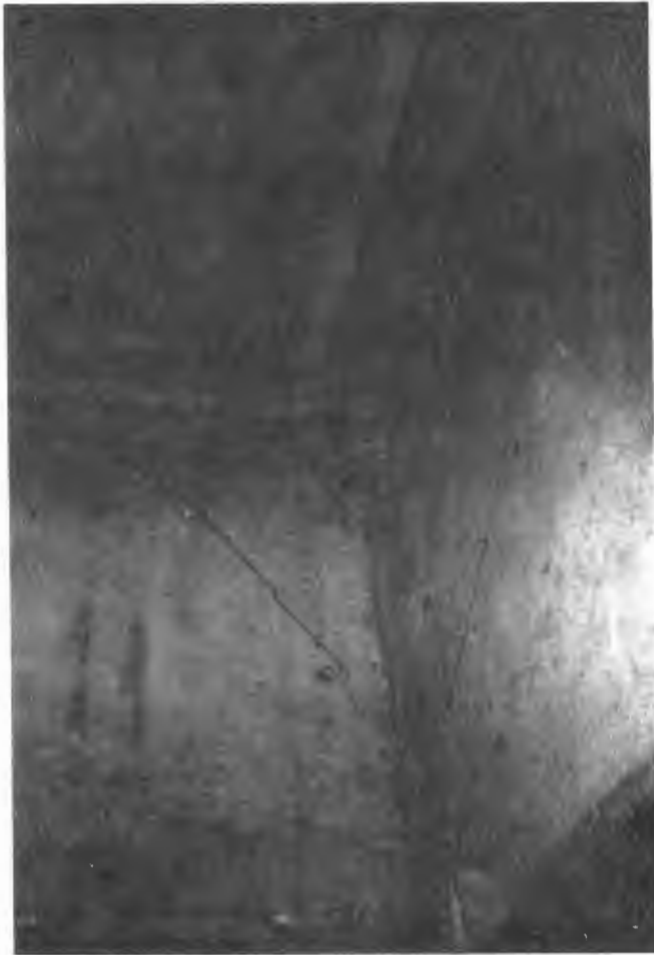
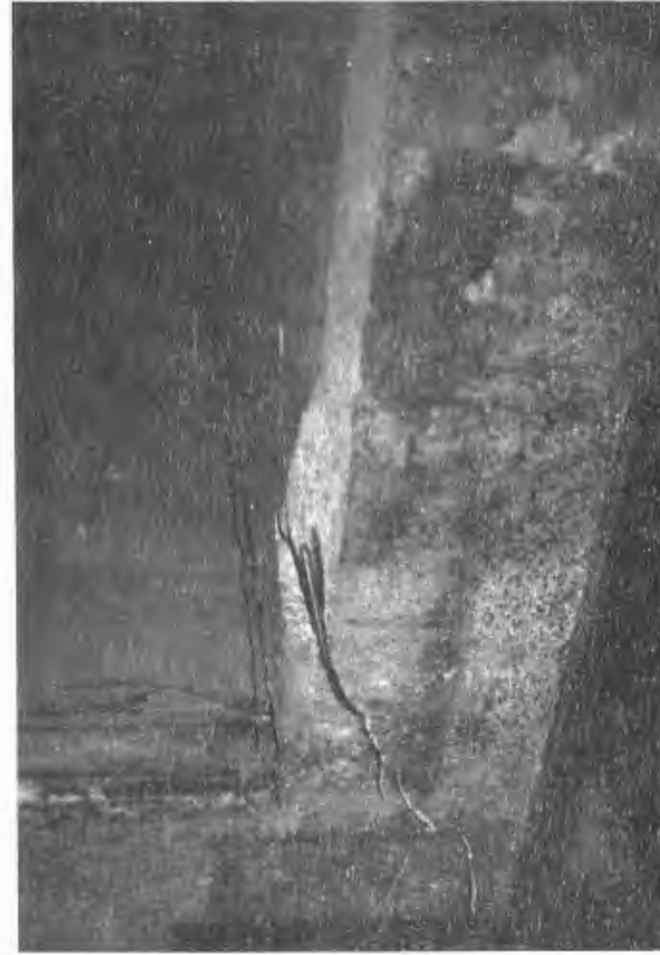
Fig. 62 Crack Pattern at the Joint Between Stem and End Diaphragm - Girder 3,  
at 5.0 x Crush Live Load (2.5 x Derailment Load)

8.3.2.7 Joint Between Stem and End Diaphragm - The joint crack between the stem and the end diaphragm was first observed at  $P_3 = 51.3$  kips. This crack developed rapidly, and the crack width was recorded to be 0.010 in. at the derailment load of  $P_3 = 58.2$  kips. At higher loading this crack continued to widen, reaching 1/8 in. at  $P_3 = 110$  kips. This was accompanied by spalling of concrete and longitudinal splitting at the bottom of the stem. Figs. 62a and 62b showed the condition of this joint at 5 times crush live load or 2.5 times severe derailment load ( $P_3 = 146$  kips).

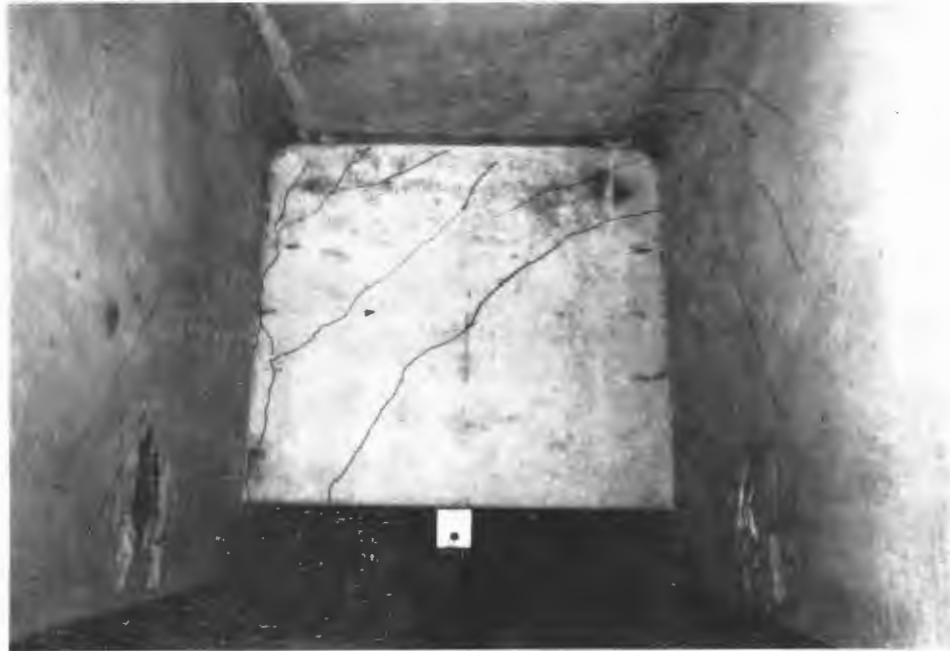
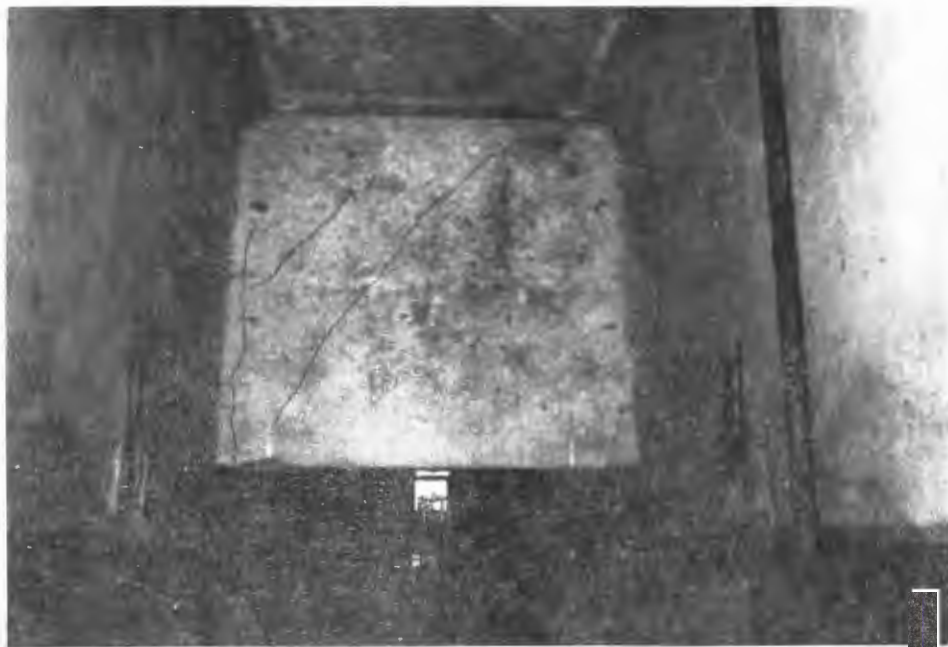
(a) East Face

(b) West Face

Fig. 64. Crack Pattern of Midspan Diaphragm - Girder 3 at  
5.0 x Crush Live Load (2.5 x Derailment Load)

was 5.0 times the crush live load. The cracking pattern on both sides of the diaphragm is shown in Fig . 64.

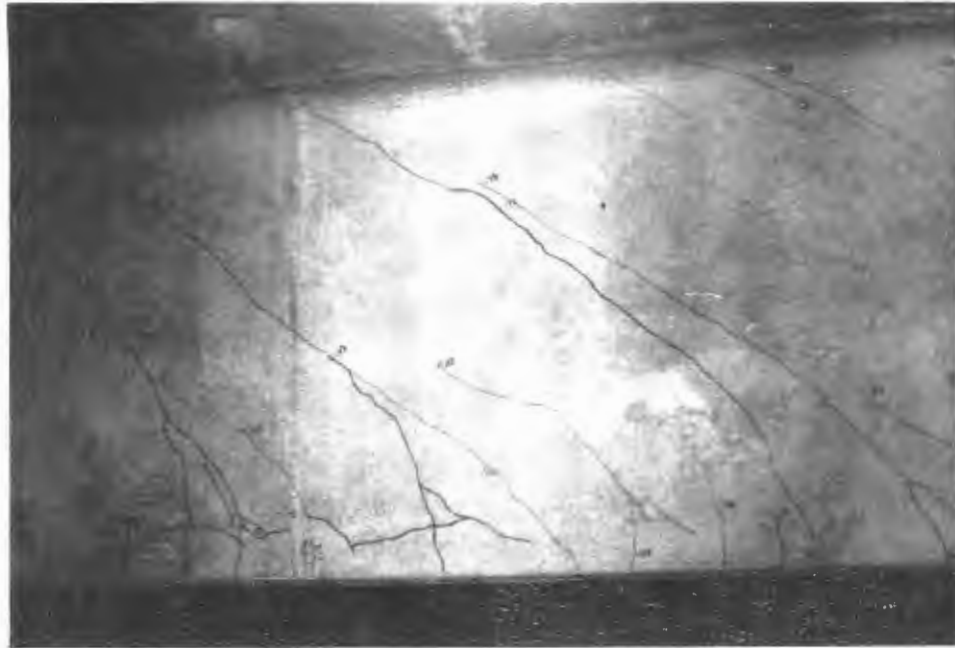
Fig. 65. Local Horizontal Cracks at Midspan - Girder 3 at  
5.0 x Crush Live Load (2.5 x Derailment Load)

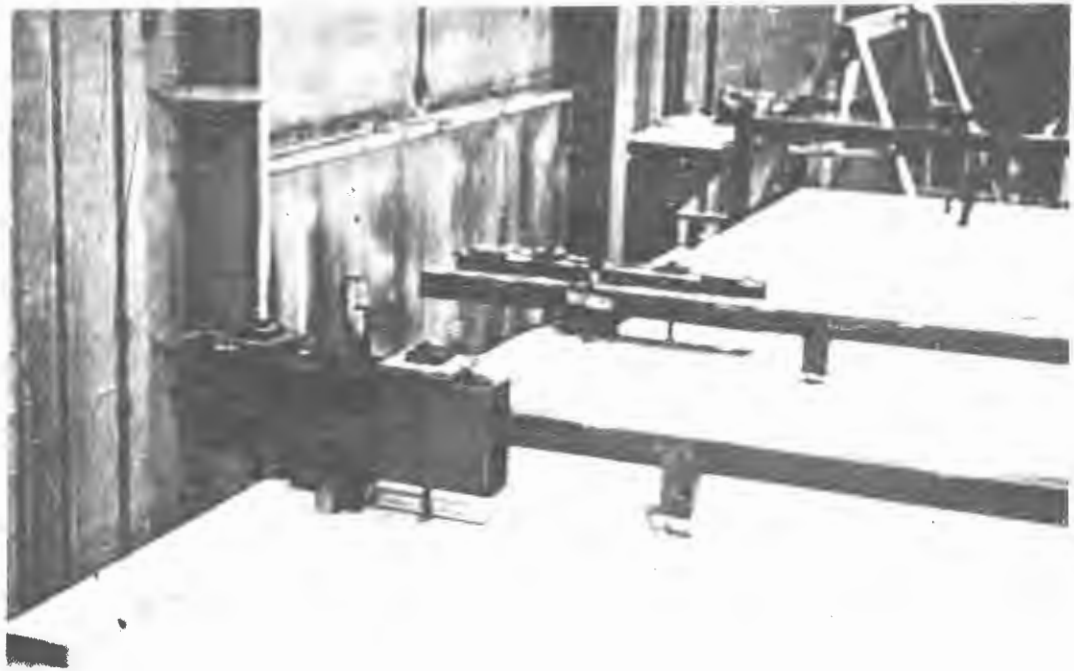
Fig. 67. Instrumentation in Flange Slab Test

Each load was applied through a system of crossheads and tie rods (Fig. 67a) and was activated by a ram. The oil pressure for the two rams was supplied from the same pump to provide simultaneous loading of equal pressure. Each of the two loads was measured by a 50-ton pre-calibrated load cell. It was found that the two loads may differ as much as 11% due to friction in the rams and the hoses.

Deflections of the flange were measured by potentiometers each mounted on a steel tube connected rigidly to both stems of the girder as shown in Fig. 67b. A potentiometer was provided for each load point at approximately 5 in. from the center of the load point on the straight line connecting the two load points.
