# STATIC AND DYNAMIC TESTS OF FULL-SCALE DOUBLE-TEE GIRDERS FOR DADE COUNTY RAPID TRANSIT SYSTEM

METROPOLITAN DADE COUNTY  
OFFICE OF  
TRANSPORTATION ADMINISTRATION

OCTOBER 10, 1979

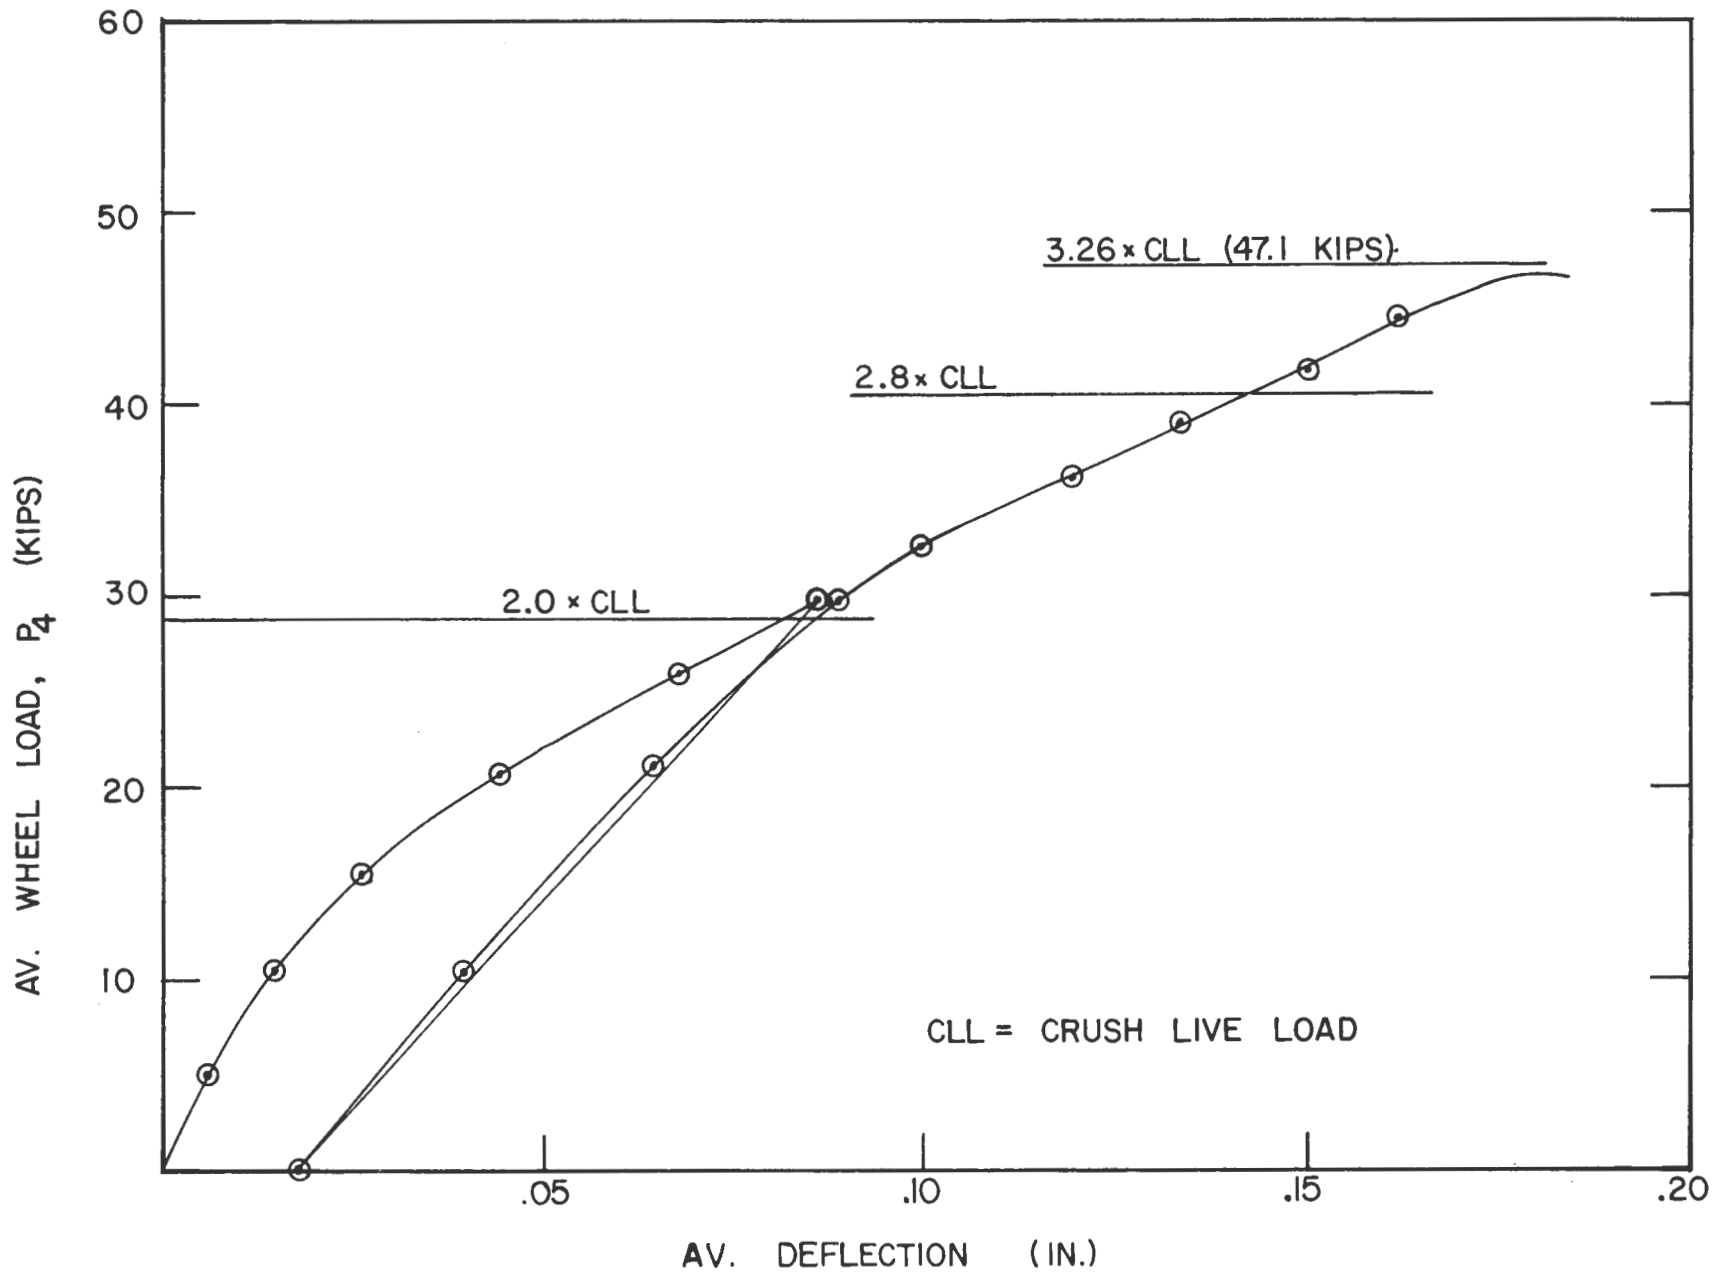
Fig. 68 Load vs. Deflection Curve for Flange Slab Test

The test results were summarized in Table 9. The load-deflection relationship was plotted in Fig. 68 using the average value of the two loads and the average value of the two deflections. At a load  $P_4 = 20.9$  kips, the very fine pre-existing cracks caused by torsional derailment test on top of the flange reopened. At a load  $P_4 = 26.0$  kips new cracks on top of the flange began to develop in roughly concentric circles around the two loads. These cracks multiplied and widened to a maximum crack width of 0.005 in. and an average crack width of 0.004 in. at  $P_4 = 29.9$  kips. This load corresponded approximately to 2.0 times the crush live load. After unloading, the residual deflection was about 20% and the maximum crack width was less than 0.001 in.

Reloading of the flange showed that the load-deflection relationship was quite linear up to  $P_4 = 29.7$  kips (see Fig. 68). At this load crack widths were also the same as those before unloading. When the load was increased to  $P_4 = 41.7$  kips, corresponding approximately to 2.8 times the crush live load, the average crack width became 0.010 in.
