Bus Support Facilities: Conditions and Needs

Final Report
January 1993

ATE Management and Service Company, Inc.
1911 North Fort Myer Drive
Arlington, VA 22209

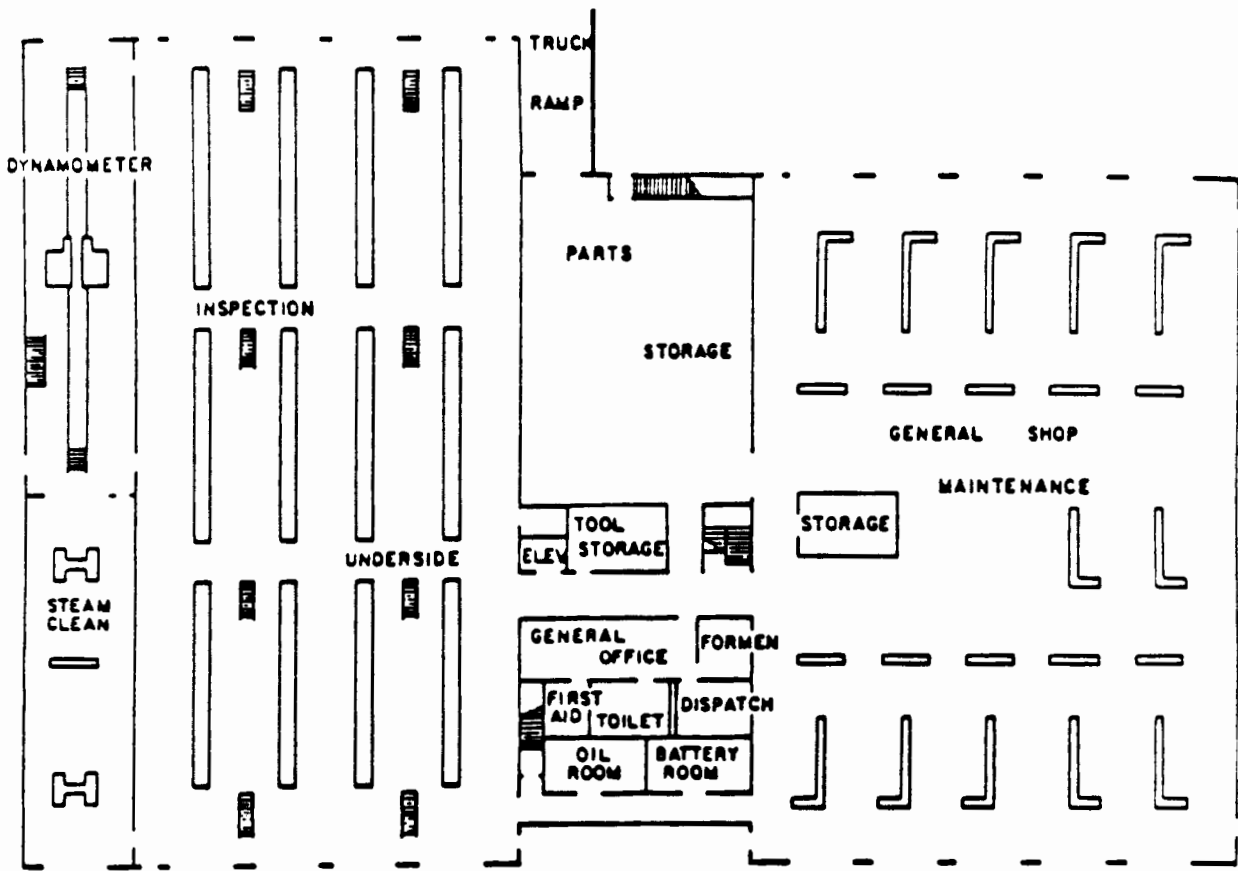
**EXHIBIT C-4
GARAGE PLAN
FOND DU LAC
MAINTENANCE BUILDING**

FIRST FLOOR

SECOND FLOOR

**SECOND FLOOR
DYNAMOMETER
ROOM**

Milwaukee County Transit System (MCTS) in Milwaukee, Wisconsin has three operating bus garages. The Fond du Lac garage is one of these garages and it is 10 years old and its bus storage building is over 30 years old. Exhibit C-3 provides a lot plan for the facility and Exhibit C-4 provides a plan for the garage. It was reported that the local community was supportive of the establishment of the bus garage in this location because it has existed there for many years and because it offers another employer in a poorer neighborhood. The location was also chosen because it is centrally located within the structure of passenger routes served. The central location reduces the number of deadhead miles and is a nominal distance from freeway access. Another factor in the decision making process was the land parcel size. To acquire a parcel large enough to meet its needs would have probably required exercising the "right of eminent domain" (condemning land adjacent to a desired parcel in order to have enough land to meet the needs of the location). MCTS strongly
