Regional Connector Transit Corridor Draft Environmental Impact Statement/ Draft Environmental Impact Report

Regional Connector Transit Corridor Safety and Security Technical Memorandum

March 23, 2010

Los Angeles County Metropolitan Transportation Authority

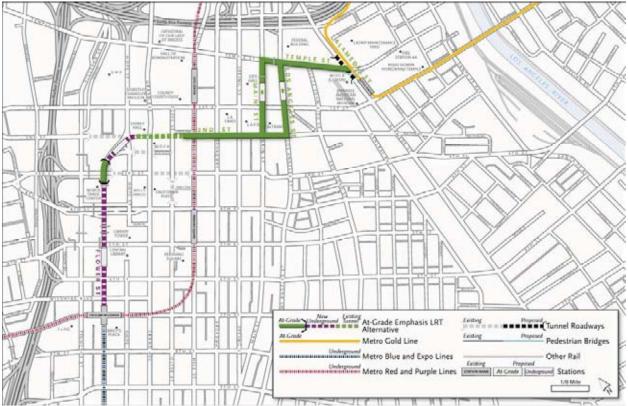
Figure 5-3. At-Grade Emphasis LRT Alternative

This alignment includes both underground and at-grade configurations (46 percent of the route is underground) and serves the Financial District, Grand Avenue, and the Civic Center. Conversion of 2nd Street to a pedestrian-friendly transit mall is assumed. To implement this alternative, the number of traffic lanes and on-street parking on 2nd Street would be reduced. As a result, traffic would likely divert to adjacent parallel streets such as 1st Street and 3rd Street, but the roadway capacity along these streets would remain unchanged, as with the No Build Alternative.

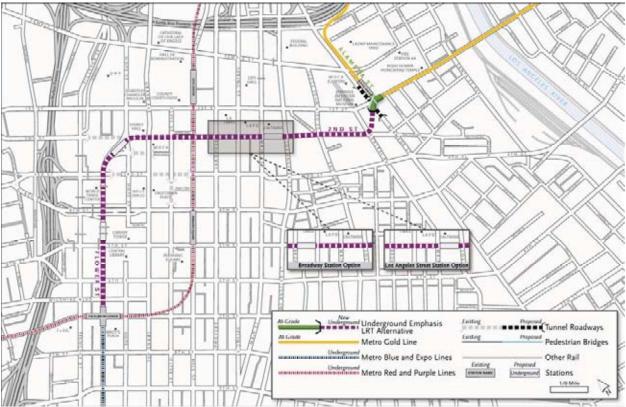
Figure 5-4. Underground Emphasis LRT Alternative

The only at-grade crossing proposed for the Underground Emphasis LRT Alternative is located at 1st and Alameda Streets. At this location, most vehicles and pedestrians would be grade-separated from the LRT tracks. A proposed pedestrian bridge structure over the intersection would allow pedestrians to cross the intersection without crossing paths with auto traffic or trains. For motor vehicles and LRVs operating at-grade at this intersection, Metro would prepare grade crossing applications in coordination with the CPUC and local public agencies, such as LADOT, Bureau of Engineering, and the City and County Fire departments. Based on review of grade crossing applications, additional safety and security design features may be incorporated if necessary. Applications would be available for review by the public prior to approval. The grade crossing application process would reduce potential safety concerns between motor vehicles and LRVs to a less than significant level.
