U.S. Department
of Transportation

Rail Modernization Study

April 1987

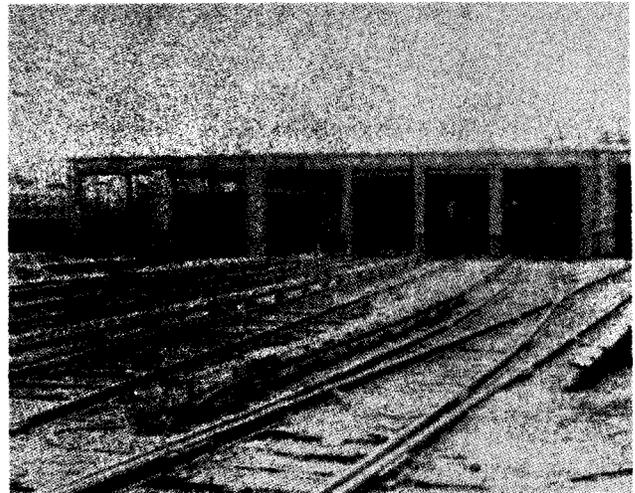
The inspected transit systems have 153 major maintenance facility buildings and these buildings contain almost 8.6 million square feet of area. Approximately 62 percent of this area is located on rapid rail systems, 9 percent on light rail systems, and 29 percent on commuter rail systems. Inspection determined that approximately 4 percent of this area was in "excellent" condition, 24 percent in "good" condition, 14 percent in "fair" condition, 54 percent in "poor" condition and 4 percent in "bad" condition. The largest number of maintenance facility buildings were over 50 years old and most of those were in "poor" or "bad" condition. Less than 25 percent of the buildings were included in a maintenance program and most of the buildings receive only minimum maintenance.

Car House

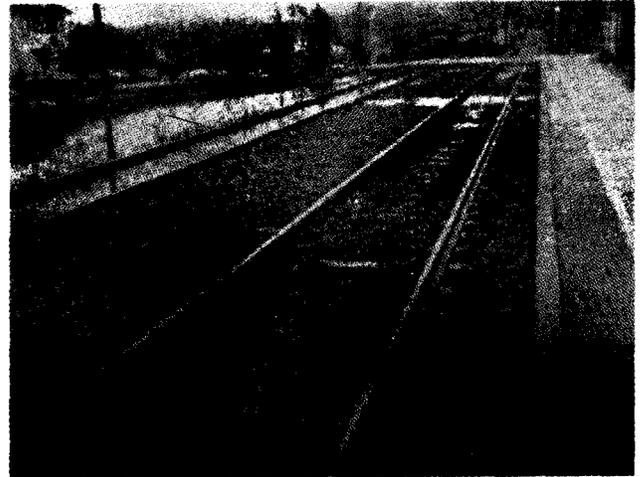
New Continuous Welded Rail

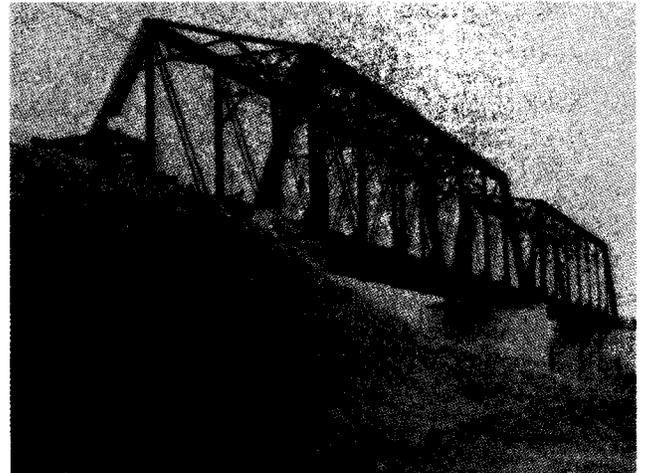
Through Truss Bridge

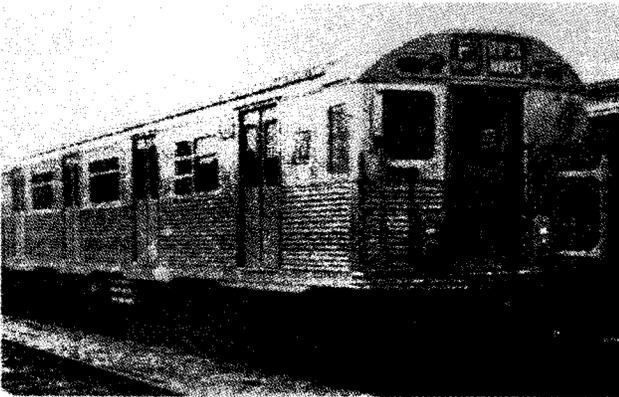
- Rapid Rail, sometimes known as "subway" or "elevated", operates on exclusive right-of-way that may be subway, elevated, or grade separated at or near ground level. Rapid rail has electrically propelled rail cars operated in trains. Power collection is generally from a third rail. Rapid rail typically features off-vehicle fare collection and has high level platform stations.

Rapid Rail Vehicle

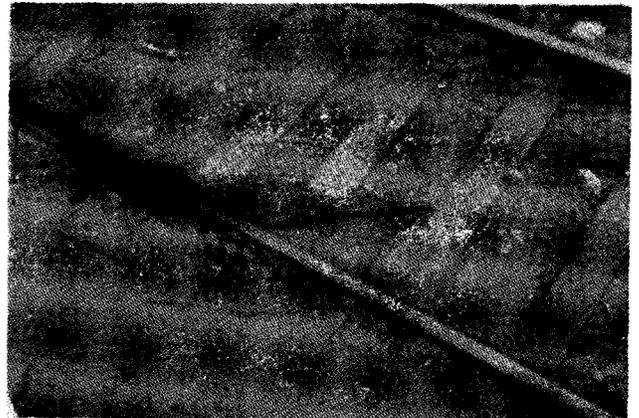
sawn timber ties were judged to be in generally "poor" condition. Most ballast, where it exists, is in generally "fair" to "poor" condition and is fouled to the point where drainage is becoming a serious problem, particularly in the ballasted tunnel segments. Switches were judged to be in either "poor" or only "fair" condition; besides being heavily worn, many switches are of the obsolete knuckle-and-lap type rather than the American Railway Engineering Association (AREA) standard switch. The drainage was judged to be in "poor" to "fair" condition over most track segments in the tunnel and at-grade. Fouled ballast within the tunnel portions of the system has resulted in many clogged drains and has created drainage problems. At-grade ditches were also found to be clogged and silted in a number of areas.

Fouled Ballast and Mud

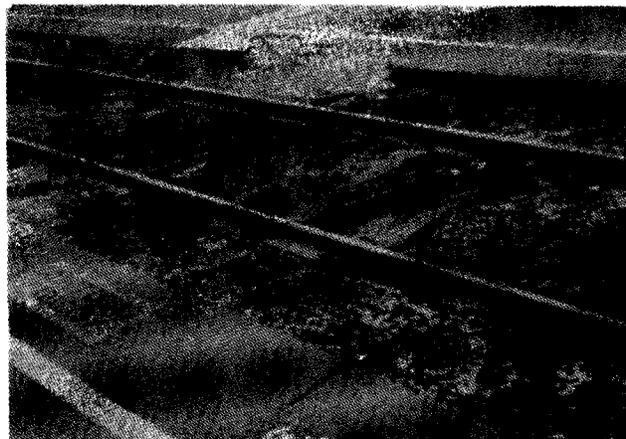
Loose Spikes and Deteriorated Ties

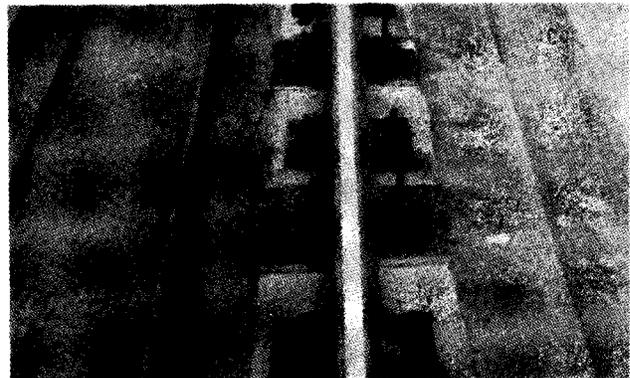
The rapid rail track is in "excellent" condition but the direct fixation systems on all elevated structures and tunnels have provided some problems.

Direct Fixation Fasteners

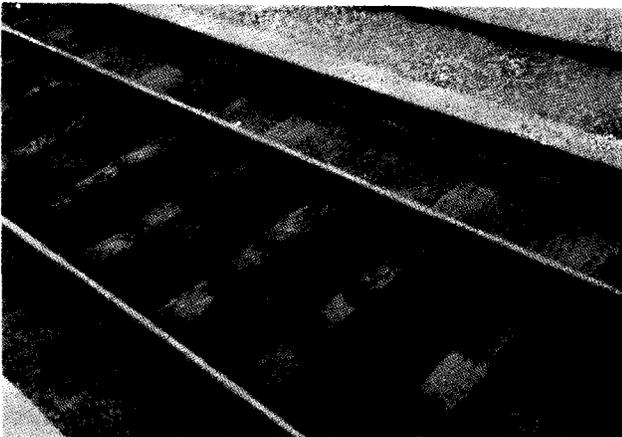
flange wear was noted on the rails themselves. Installation of rail lubricators has lessened the wear rate significantly. Some problems exist with the direct fixation fastening system on the sharp curves; the metal anchorage embedded in the concrete is weakening, resulting in the rail clips falling out. The spring clip fasteners on the concrete ties are performing very well. Turnouts and crossovers are in generally "good" condition, although the rail clips must be continuously tightened, particularly in the frog areas. The gauge problems are primarily in curves, where the fasteners are defective and the rail wear is significant. Although drainage is "good" throughout the system, some ponding of water was evident on the viaducts and in tunnels. In some tunnel sections, grooves are being cut in the concrete to keep the water away from the fasteners.

Spring Clip Fasteners on Concrete Ties

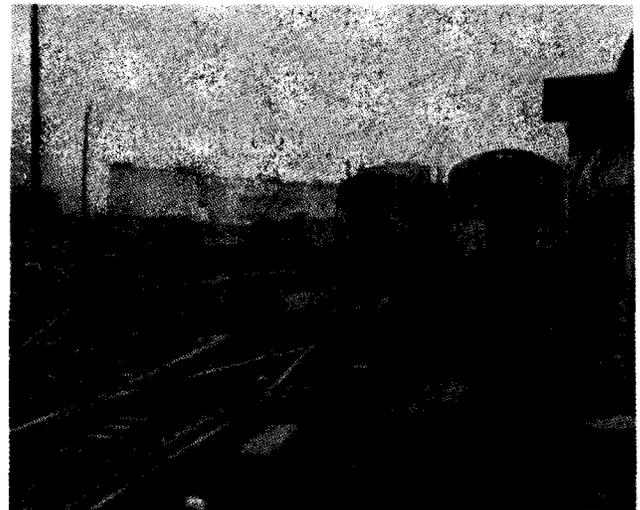
from "poor" to "good". The cars in "poor" condition are 26 years old and are "worn out"; present plans are to phase out these cars. The PA-1/2 cars are 19 years old and appear to have no major structural problems. The rotating components should be replaced. The door operation and controls are in "poor" condition, have proven unreliable and need complete replacement. The compressors also should be replaced. The PA-3 cars are approximately 12 years old and no structural problems exist. The door operators are in relatively "good" condition.

Old K-Cars and Newer PA Cars

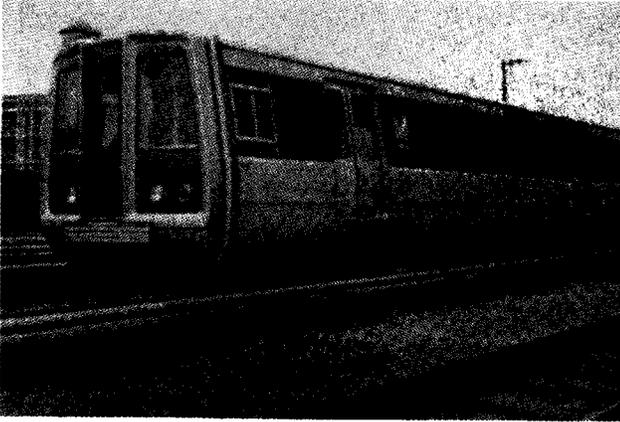
The rapid rail system includes 316 rail cars, all of which are either in "good" or "excellent" condition.

Self-Propelled Rail Car

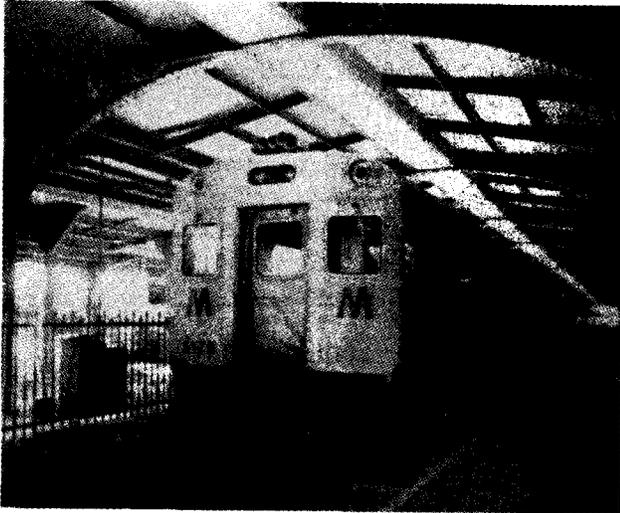
Unpowered Rail Car

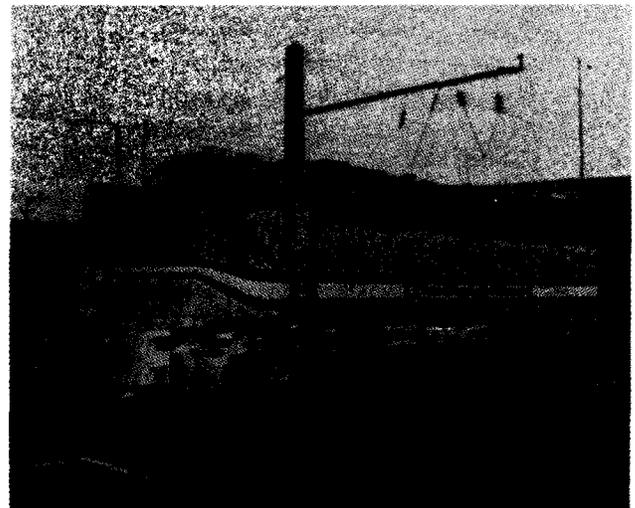
The locomotives were rebuilt 3 years ago and are in "good" condition; the only problem is the low horsepower. Although adequate for the 5-car trains now operated, these locomotives will not be able to pull longer trains without slowing the rate of acceleration, and thus affecting the schedule. The unpowered cars were rebuilt 2 years ago and also are in "good" condition. However, the unpowered cars are not currently fitted with control cabs for push-pull operation, although the trainline cables were installed during rehabilitation.

Locomotive

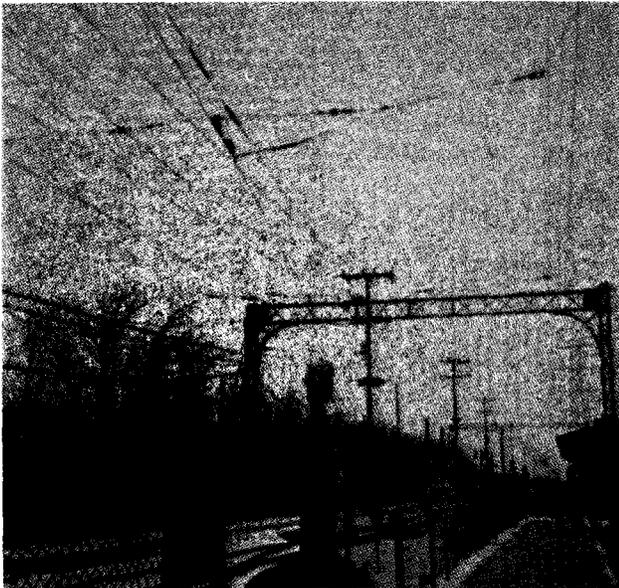
The rapid rail system has approximately 39 miles of overhead wire; all in "good" condition. The light rail overhead wire is new and is in "excellent" condition.

Overhead Wire

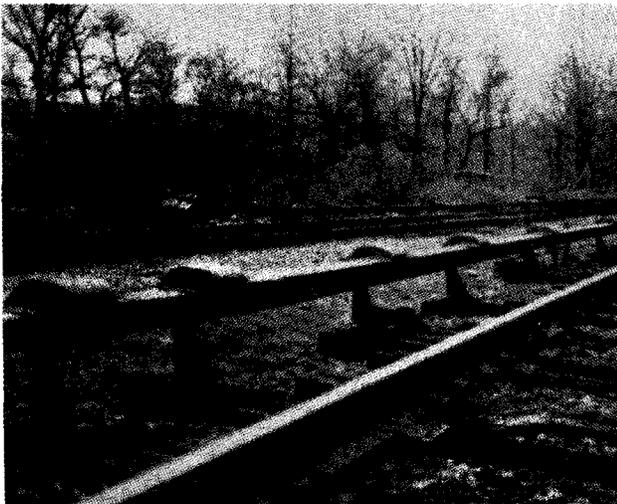
New 150 lb Third Rail

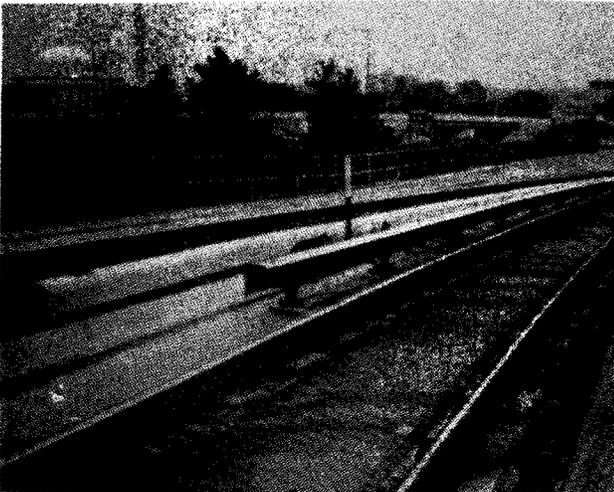
The rapid rail system has 98 miles of third rail and all of this third rail is in "good" condition.

Third Rail

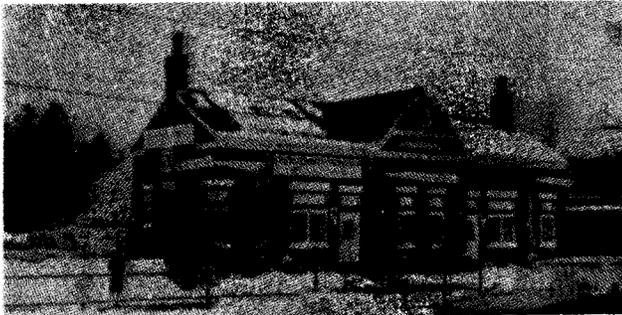
Station

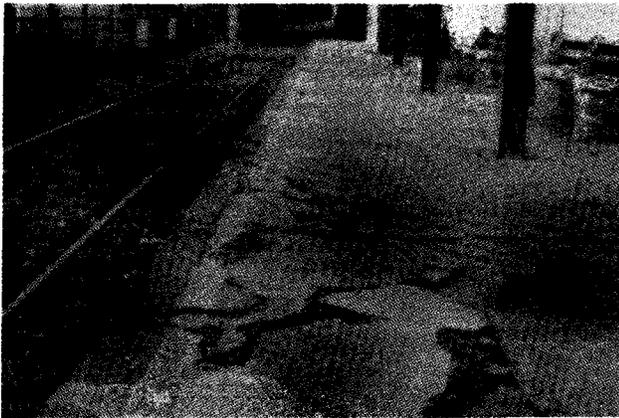
The light rail system includes 9 stations, 4 of which are in "fair" condition and 5 in "poor" condition. The stations in "fair" condition are 49 to 54 years old and are either historic or subway stations. When station stops are added, 50,000 square feet is in "poor" condition, and 38,000 square feet is in "fair" condition. Contributing to the "fair" condition are stairs, which are badly worn or uneven and need improvement; escalators in "poor" condition; stair railings at the

Deteriorated Platform

grade crossing barriers which exhibit substantial wear; concrete platforms showing major deterioration; inadequate station graphics; and no provisions for security. Interior finishes for the subway stations are in "poor" condition and the canopies and structure indicate some corrosion and decay.

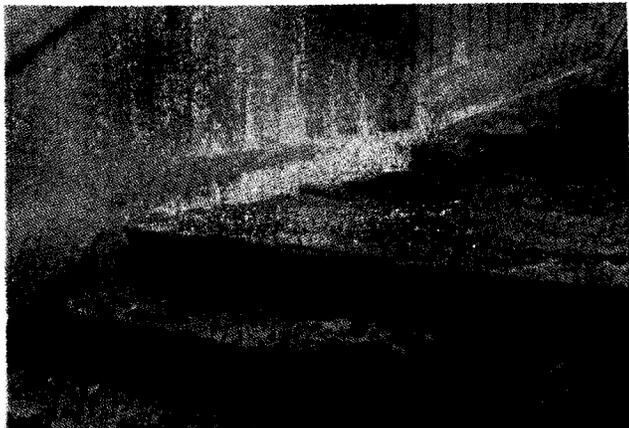
The commuter rail system has 123 stations, 1 of which is in "bad" condition, 54 are in "poor" condition and 66 are in "fair" condition. When station stops are added, 14,000 square feet are in "bad" condition, 478,000 square feet in "poor" condition, 672,000 square feet in "fair" condition, and the remaining 25,000 square feet in "good" or "excellent" condition. The station in "bad" condition is an at-grade station, which is approximately 54 years old. The stations in "poor" condition are all approximately 64 years old and include elevated and at-grade stations. Although some platforms are only experiencing minor spalling and settlement, a few do show signs of major deterioration. Concourse floor areas, occasionally provided with a finished floor material, are below acceptable standards for passenger stations. In many stations, circulation patterns are awkward since direct passage from the concourse area to the platforms are not provided. Some of the stations have stairs, which are in "poor" condition. The lack of slip resistant surfaces and insufficient railings for the elderly and handicapped and the absence of weather protection has aided the deterioration of much of the equipment. The station finishes typically are in "poor" to "fair" condition and require substantial rehabilitation. Interior finishes

including brick, concrete block, woodplank, cement plaster, acoustical tile, drywall and plastic laminent, which are in "poor" to "fair" condition.

Deteriorated Stairwell

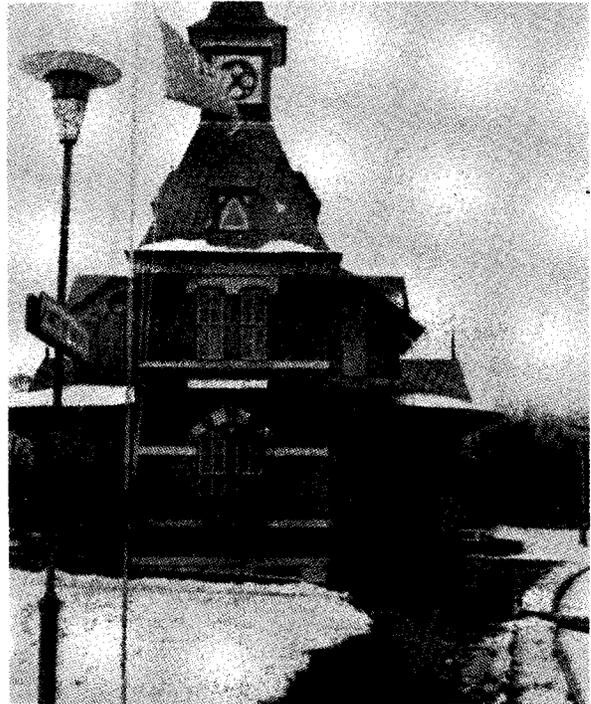
The commuter rail system has approximately 13 stations, 2 of which are in "bad" condition, 6 in "fair" condition and the remainder are in either "good" or "excellent" condition. The total area associated with both stations and station stops is 6,000 square feet in "bad" condition, 5,000 square feet in "poor" condition, 17,000 square feet in "fair" condition, and the remainder is in "good" or "excellent" condition. The 2 stations in "bad" condition range in age from 44 to 58 years and are being abandoned. The stations in "fair" condition range in age from 4 to 56 years.

Commuter Rail Station

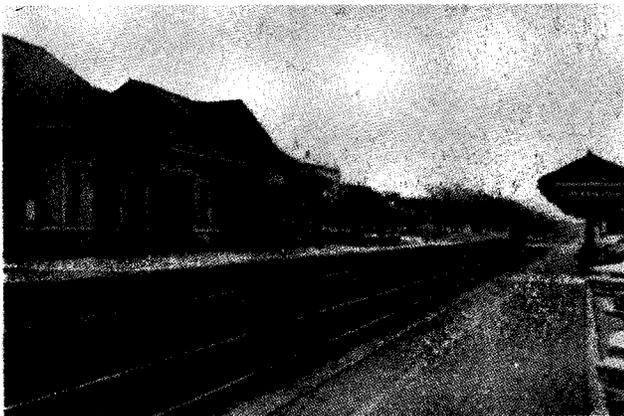
The commuter rail systems have 160 stations, 1 of which is in "bad" condition, 37 are in "poor" condition, and 63 are in "fair" condition. The station in "bad" condition is an elevated station that is approximately 50 years old and is being abandoned. The stations in "poor" condition range in age from 24 to 59 years. When both stations and station stops are included, 9,000 square feet is in "bad" condition, 199,000 square feet in "poor" condition, 495,000 square feet in "fair" condition, and the remainder in "good" or "excellent" condition.

Commuter Rail Station

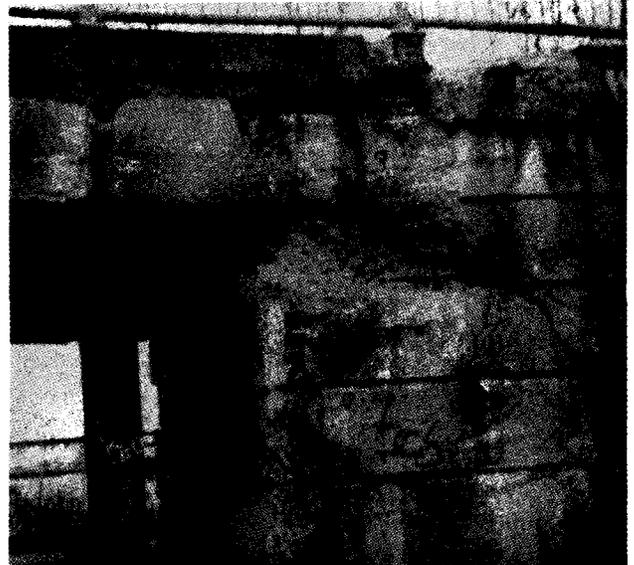
Cracked and Failed Abutment and Fascia

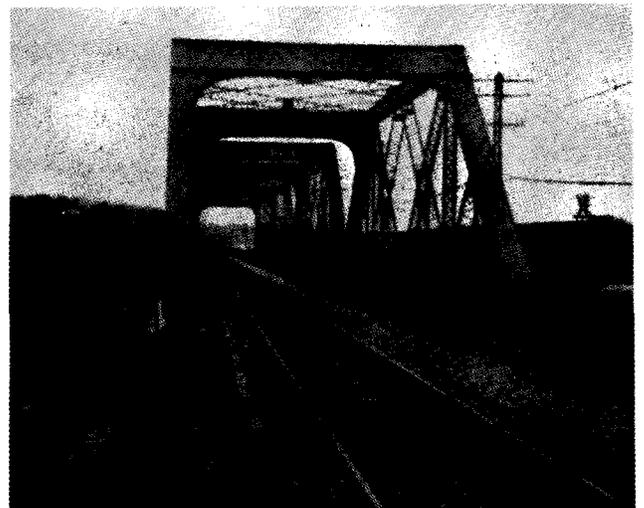
Through Truss and Through
Girder Bridge

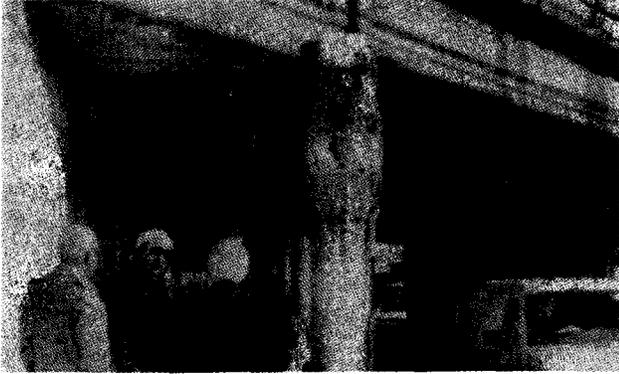
Spalled Concrete

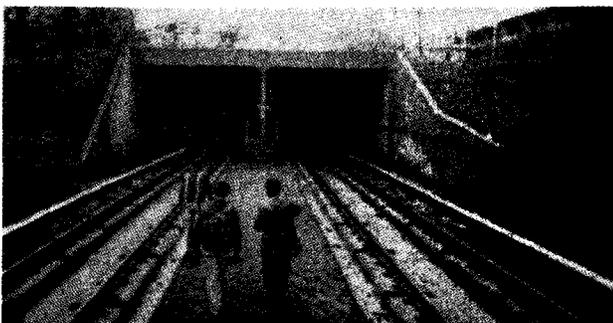
The rapid rail system contains about 28,000 lineal feet of tunnel, all of which is in either "good" or "excellent" condition. These tunnels are approximately 5 years old.

Cut and Cover Tunnel

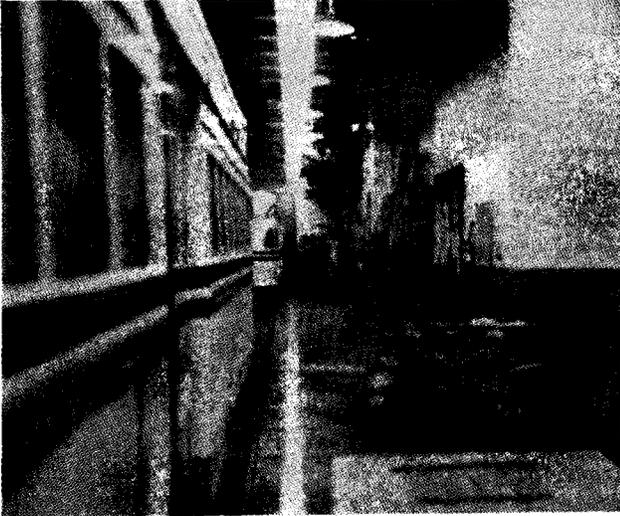
carwash facilities in the yard area are manual, the cars appear clean and well washed. The office areas and some of the facilities are too small for efficient operations, but are adequate.

Small Work Area

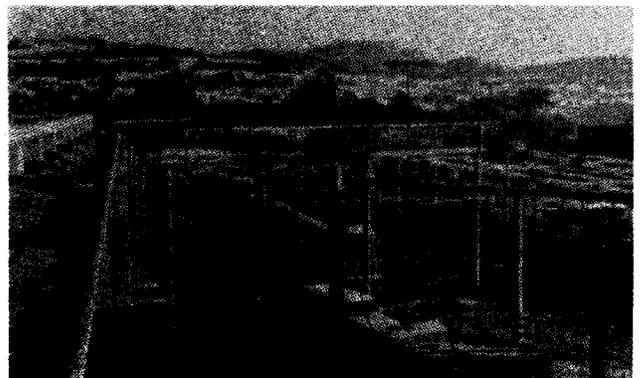
The light rail system has 1 maintenance/storage yard, which is 3 years old and in "good" condition.

Maintenance/Storage Yard
