Narrowing the Gap on Metro Rail Platforms

- Distance between platform and car door is too wide at some stations

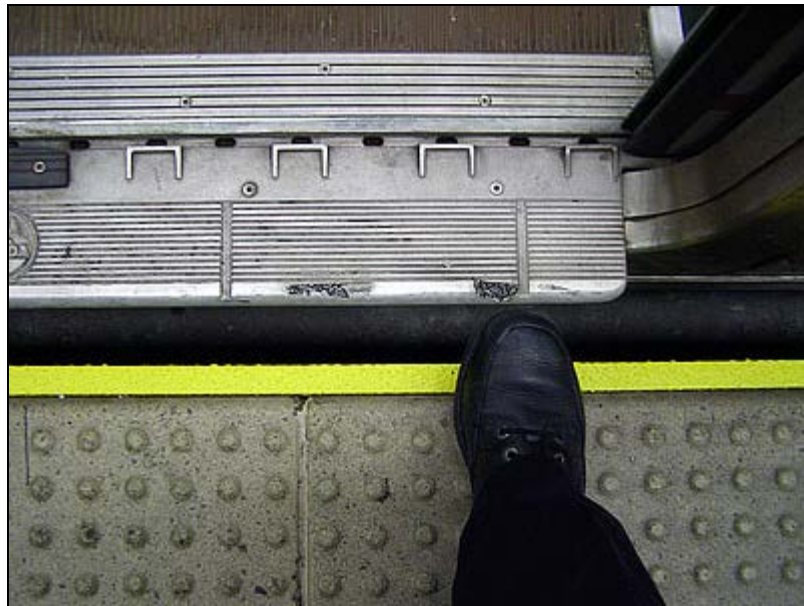
Installation of the L-brackets effectively narrowed the gap between platform and train car to the three inches required by the ADA.

Louis Campos, facilities maintenance supervisor, said stainless steel anchors hold the 15-foot brackets in place. Maintenance crews spend approximately six hours over the course of two days installing

The crews must work during non-revenue hours between 1 and 4 a.m. because they must turn off power to the tracks they are working near.

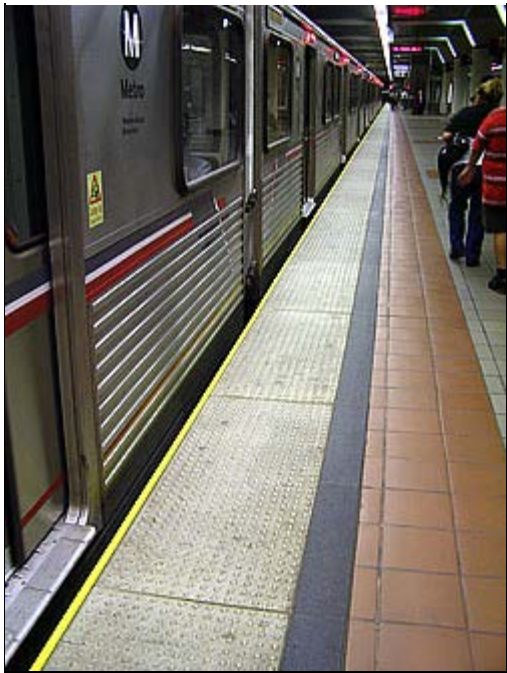
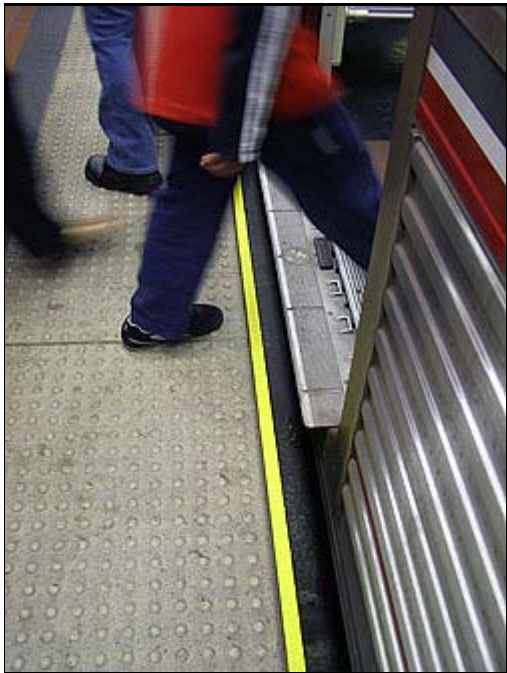
The bright yellow L-brackets are being installed at a number of Metro Rail stations following an agreement with the FTA. Below, Passengers step over the yellow L-bracket to board a subway train.
