TCRP Synthesis 12

**Transit Bus Service
Line and Cleaning Functions**

A Synthesis of Transit Practice

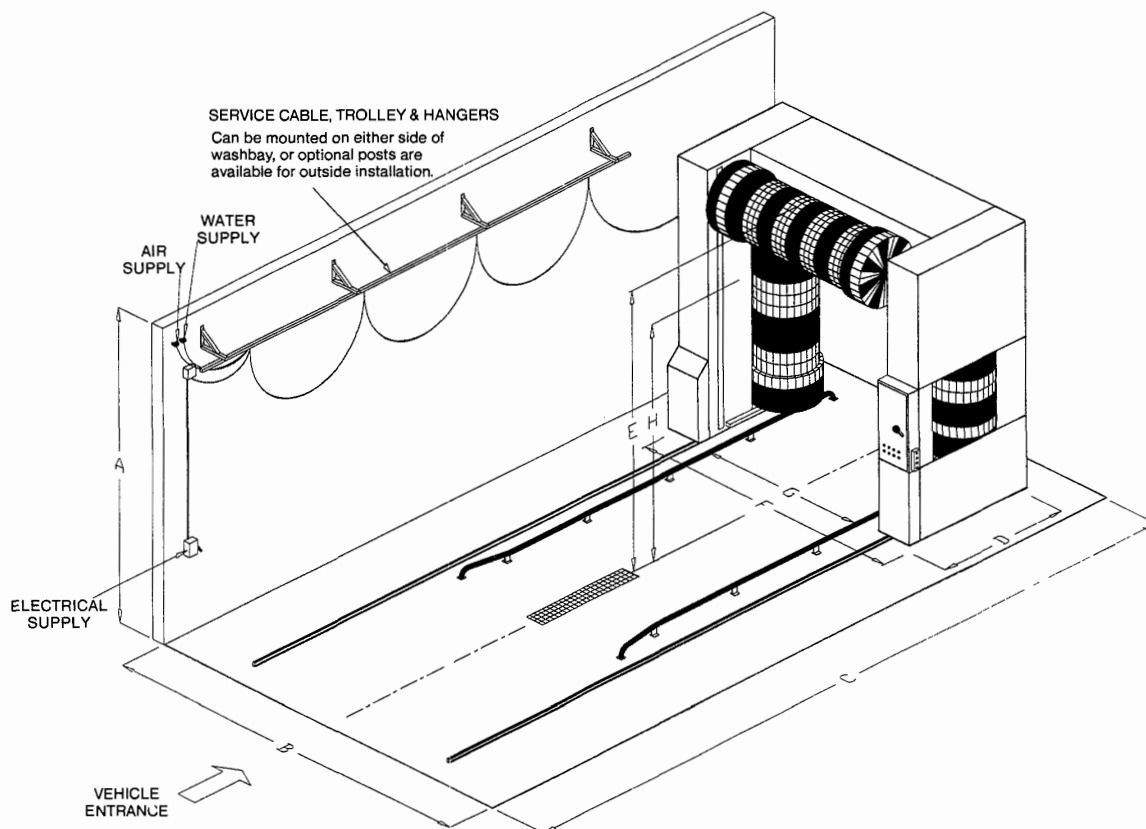
FIGURE 5 Schematic drawing of a typical gantry washing system. (Courtesy of SSI Corp.)

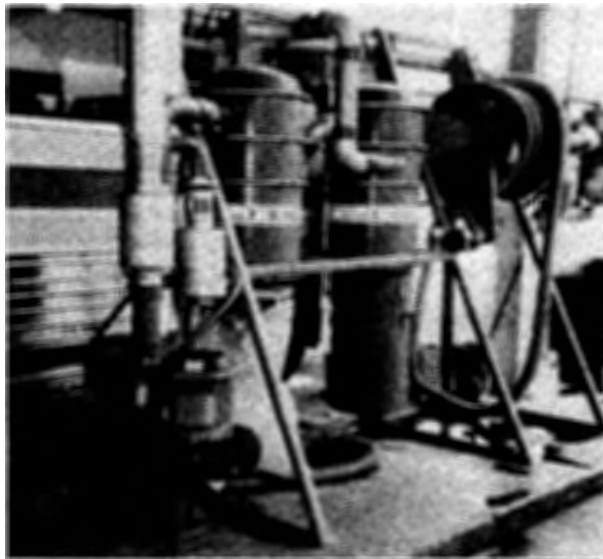
FIGURE 8 Central vacuum system in use at Santa Monica Municipal Bus Lines.

The central vacuum system used by Santa Monica does not use a pneumatic transport system for coarse refuse. Newspapers and recyclable items are removed manually from the bus and placed in ordinary containers on the service line. Except for clean recyclable objects, Santa Monica is concerned about protecting workers from physically touching the refuse left on buses. As a result, a system with larger diameter (3-in.) hoses and more suction power has been specified.

The system is capable of picking up coarse refuse and finer dirt in one operation. Santa Monica was especially concerned with debris lodged between seat cushions and wanted a vacuum system strong enough to pull out any material that workers would normally use their hands to remove. The system also features an automatic-feed hose assembly, making it easy to get the vacuum hose into the bus. When finished, the cleaner leaves the entire length of hose on the bus and pushes a switch on the service line to retract and recoil the hose automatically.

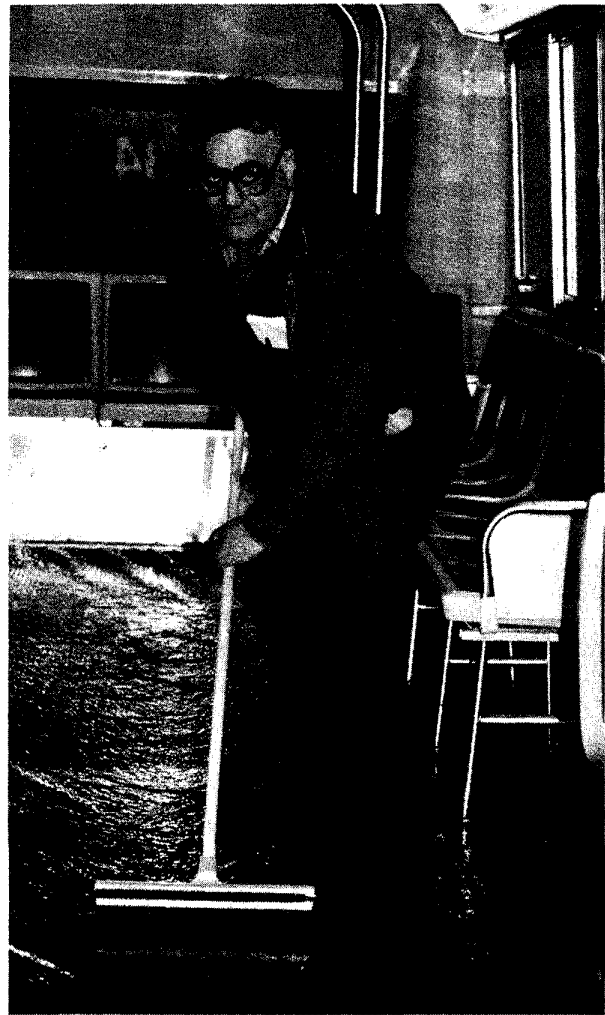
FIGURE 11 Innovative floor washing system developed by the Toronto Transit Commission. (Courtesy of TTC)
