Evaluation of a Combined Bicycle Lane/Right Turn Lane in Eugene, Oregon

PUBLICATION NO. FHWA-RD-00-151
August 2000

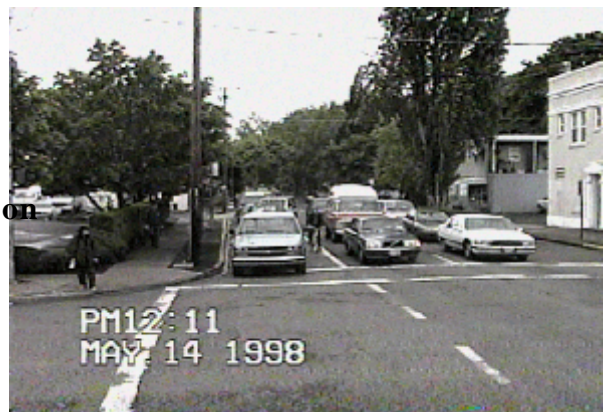
Figure 5. Bicyclist behind motor vehicle at the narrow right-turn lane site (13th and Patterson).

Upon arriving at a red traffic signal indication, the proximity of the bicyclists to the motor vehicles was coded. It was expected that some bicyclists and motor vehicles would be positioned behind each other at the narrow-lane site (figure 5), and

indeed this was the case (table 6). Almost all of the bicyclists positioned themselves next to motor vehicles at the standard-lane site, while 24 percent and 19 percent positioned themselves in front of or behind a motor vehicle, respectively, at the narrow-lane site (?). These differences were statistically significant ($p < 0.001$). There were no differences in proximity by gender of bicyclist at either site. As would be expected, the bicyclists were more likely to be in front of or behind a heavy vehicle than a passenger car or light truck at the narrow-lane site.

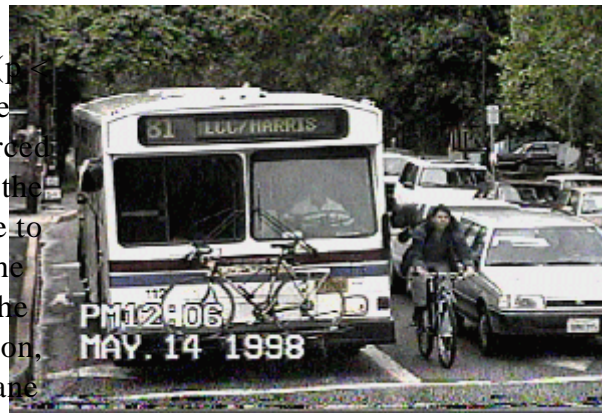
Figure 6. Bus forces bicyclist into the traffic lane at the narrow right-turn lane site (13th and Patterson).

Not surprisingly, significantly more bicyclists ($p < 0.05$) were forced into the adjacent through lane (figure 6) at the narrow-lane site (table 7). “Forced into” means that when the bicyclist approached the intersection proper, there was not enough space to comfortably use the bike pocket to the left of the right-turn area. This occurred for 7 percent of the bicyclists arriving at a red traffic signal indication, and all of these events occurred at the narrow-lane site (?). There were no differences by gender of bicyclist. In two-thirds of the cases where the bicyclist was forced into the adjacent lane, the motor vehicle was a heavy truck. There were proportionately more heavy vehicles at the narrow-lane site.

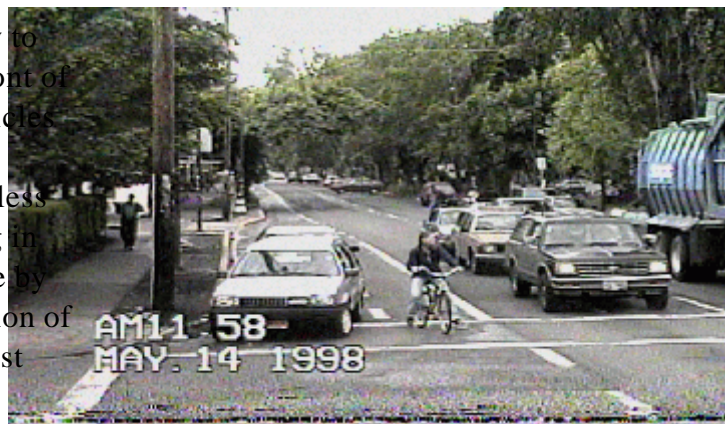
Figure 7. Motor vehicle making right turn on red with bicyclist in bike lane at narrow right-turn lane site (13th and Patterson).

The videotapes were examined closely to determine whether bicyclists at the front of the traffic queue prevented motor vehicles from making a right turn on red. It was expected that this would occur due to less space at the narrow-lane site, resulting in motor vehicles having to share the lane by lining up behind a bicyclist. The decision of whether a bicyclist prevented a motorist from making a right turn was based on both the amount of cross-street motor vehicle traffic and the available time to turn right. None of the motor vehicles at the

standard-lane site was prevented from turning right on red, compared to 6 percent (seven vehicles) at the narrow-lane site (no table shown). This difference approached significance ($p = 0.052$). Figure 7 shows a motor vehicle making a right turn on red in the presence of a bicyclist in the bike lane at the narrow-lane site.

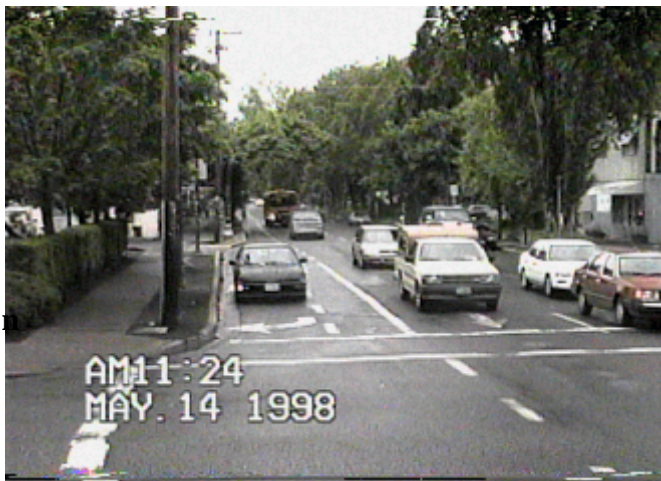
where a motor vehicle failed to stay within the through-lane boundaries, and this was a heavy vehicle that encroached across the entire bike lane. The same was true at the standard-width site, where one heavy vehicle was partially in the bike lane. Examining the placement in the narrow-width site right-turn lane, motor vehicles arriving without a bicyclist present actually used only the narrowed portion of the right-turn lane 18 percent of the time (figure 9).
