Metro®

Executive Summary

The Federal Transit Administration (FTA) and Los Angeles County Metropolitan Transportation Authority (Metro) propose to construct a project called the East San Fernando Valley Transit Corridor Project (Undertaking). The FTA is the Lead Agency under the National Environmental Policy Act (NEPA) and Metro is the Lead Agency under the California Environmental Quality Act (CEQA).

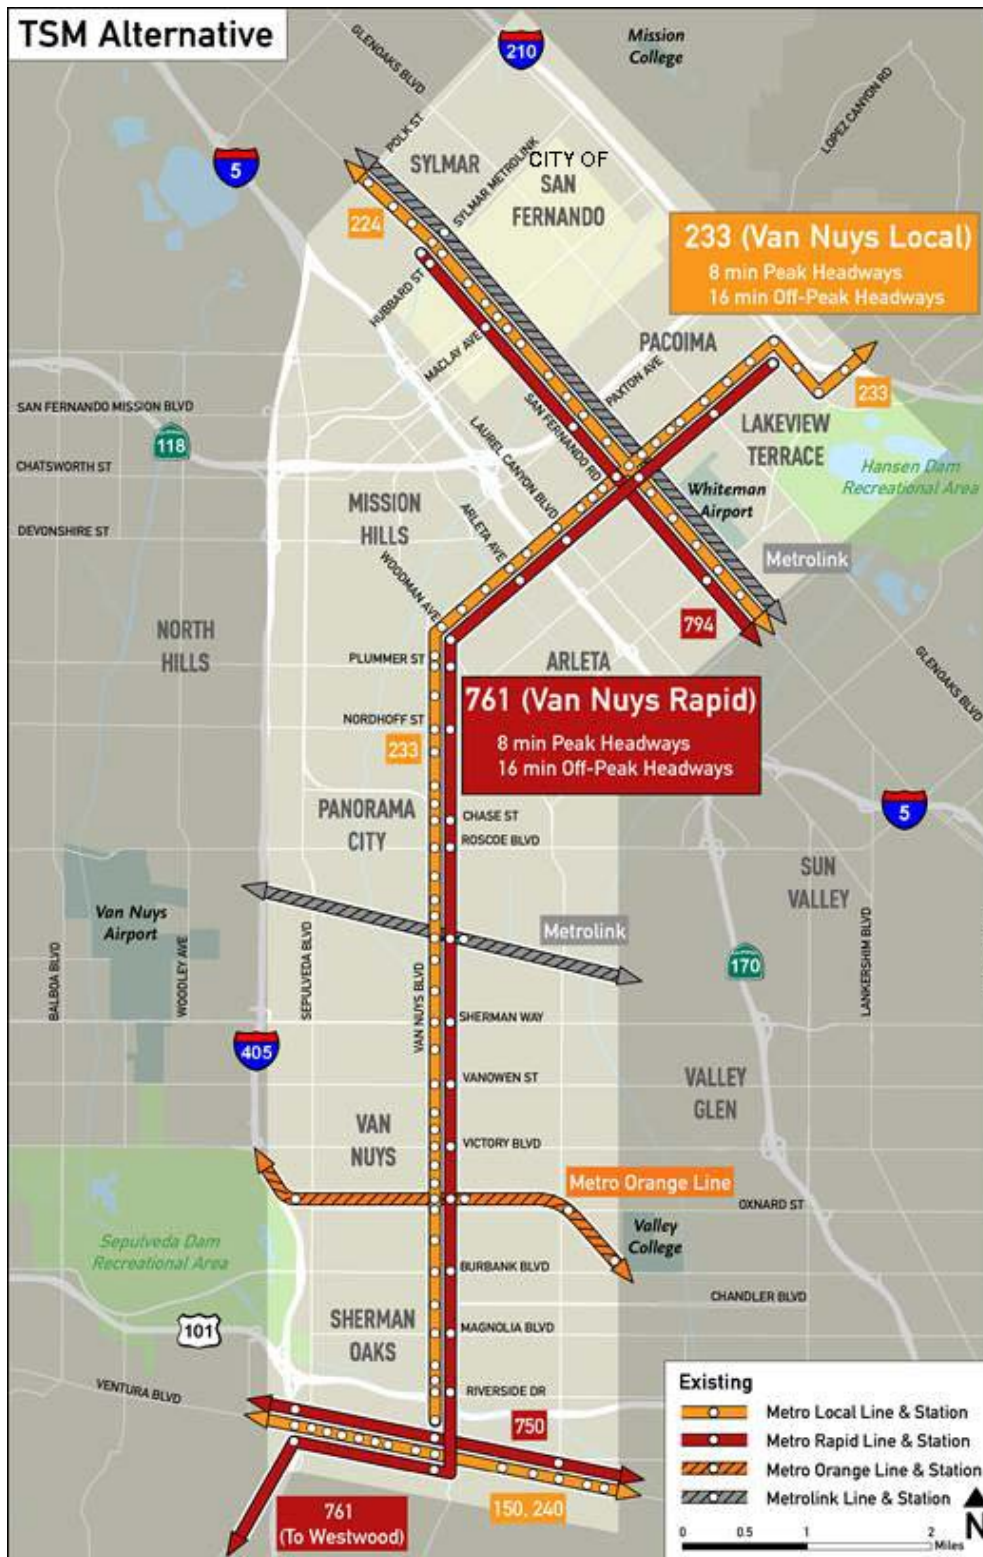
Figure 1-1: TSM Alternative

The TSM Alternative emphasizes transportation systems upgrades, which may include relatively low-cost transit service improvements. It represents efficient and feasible improvements to transit service, such as increased bus frequencies and minor modifications to the roadway network. Additional TSM Alternative transit improvements that may be considered include, but are not limited to, traffic signalization improvements, bus stop amenities/improvements, and bus schedule restructuring (Figure 1-1).

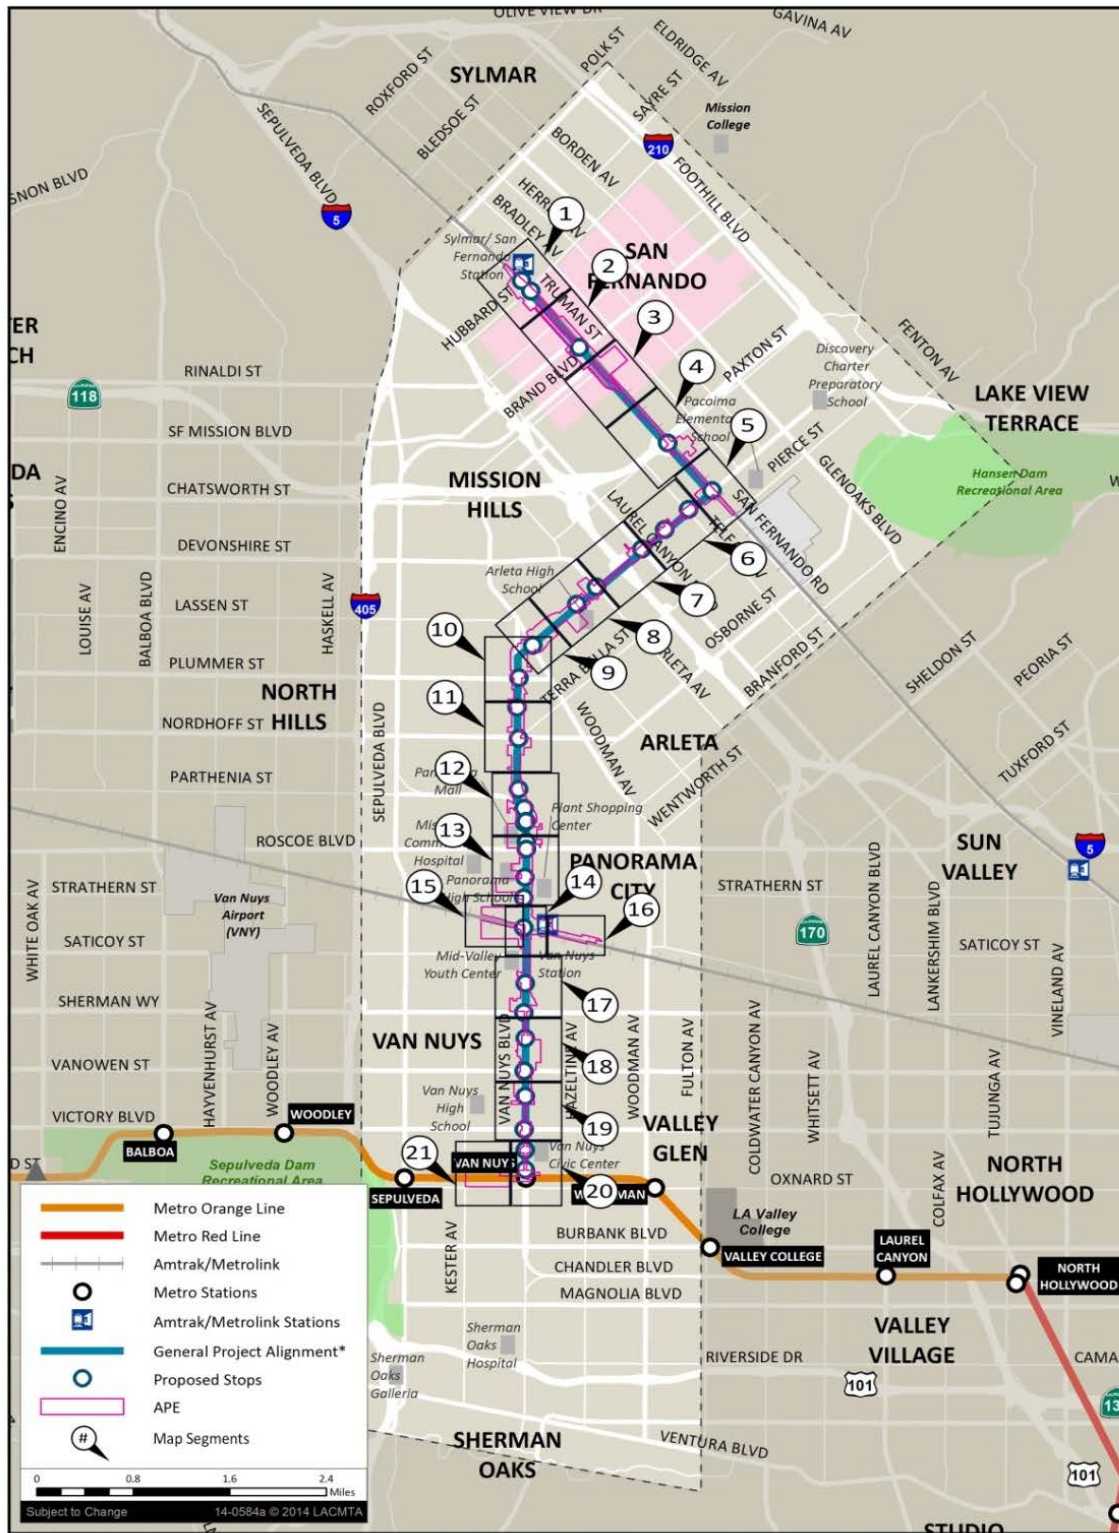
Figure 2-2: Area of Potential Effects Overview Map

*Alignment generalized for this overview map only for clarity at this scale. Detailed alignments for each alternative are included on the map segments.

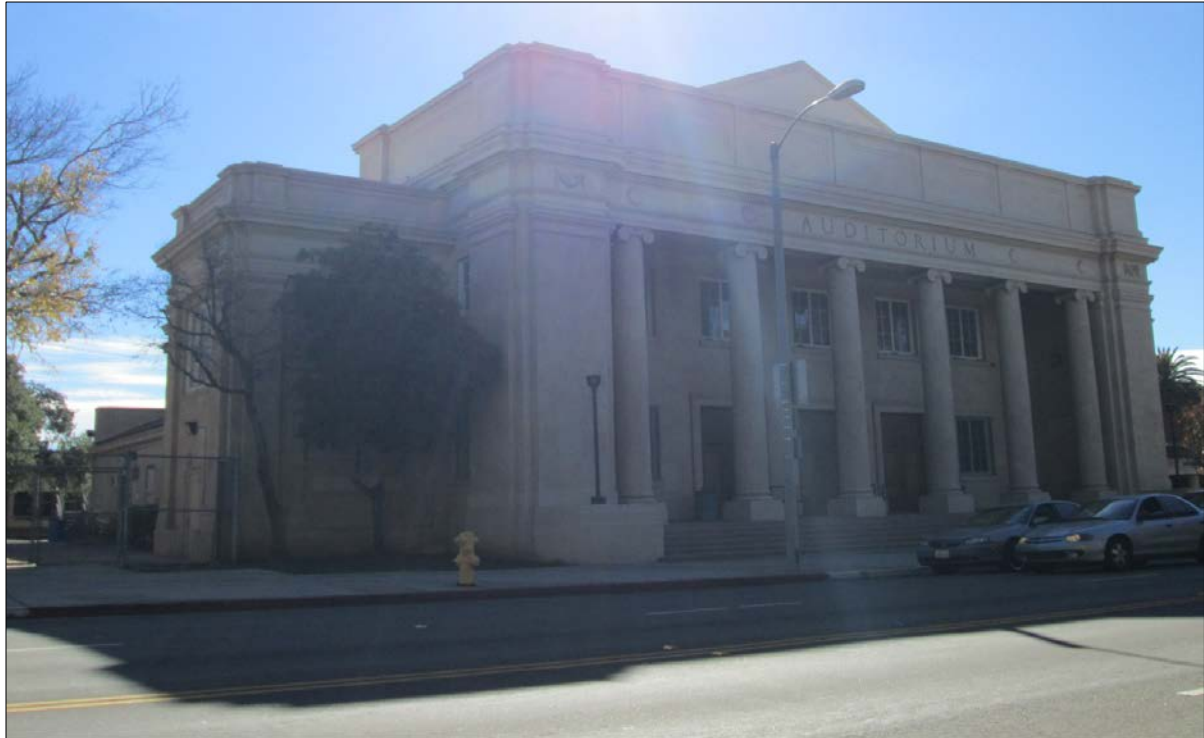
Figure 3-2: 130 N. Brand Boulevard, Auditorium, view looking southwest

130 N. Brand Boulevard is a junior high school campus. In 1995, the Auditorium (built in 1916), Science Building (built in 1916), and Boys' Gymnasium (built in 1937) were found to be individually significant for their architecture as part of a survey of properties damaged in the 1994 Northridge Earthquake. The prior evaluation and an update form are included in Appendix A.

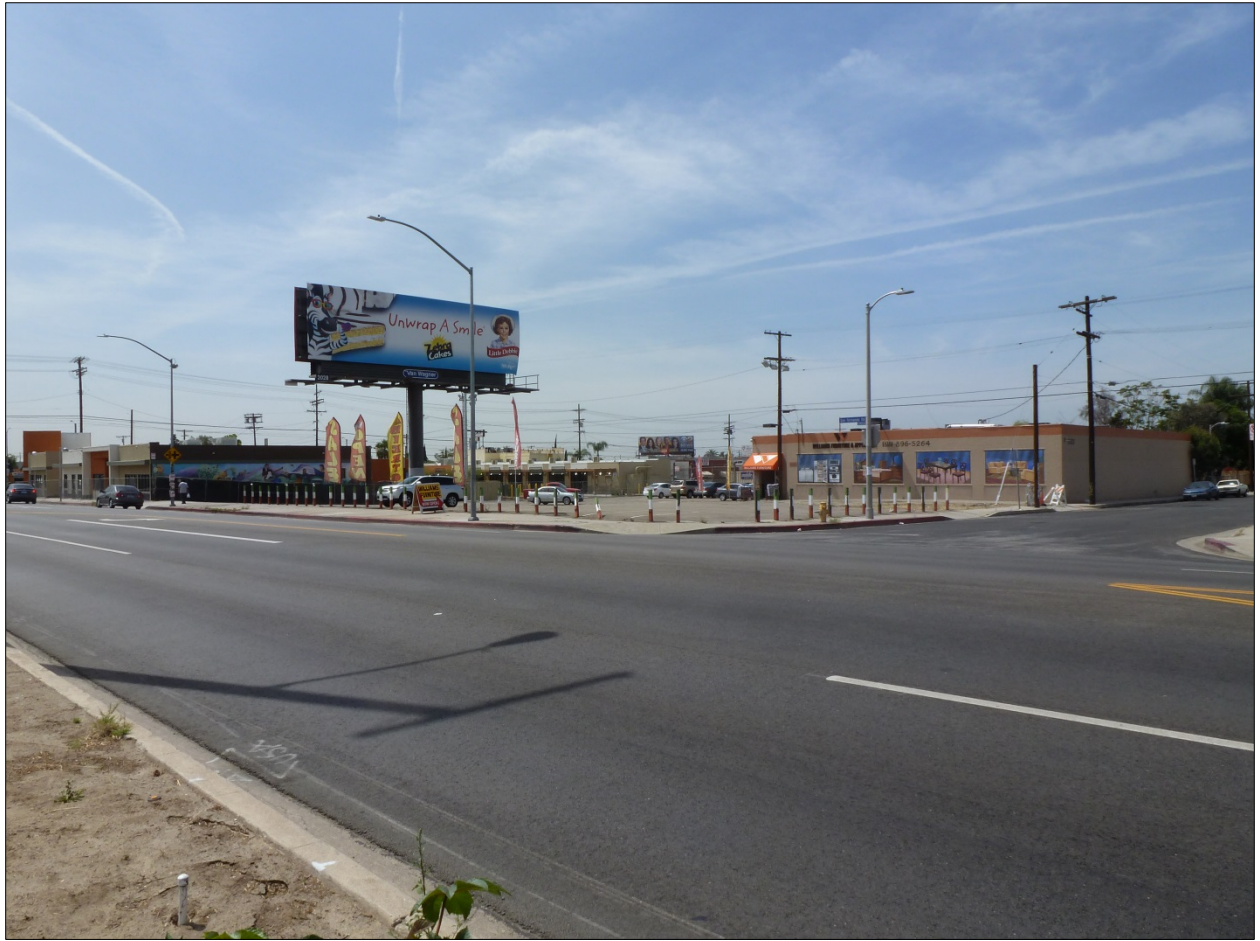
Figure 3-3: San Fernando Road at Pinney Street, looking south

One segment, "Segment B," is located within the APE, which includes Bridge #53C-0302, the San Fernando Bridge over Pacoima Wash. This segment spans between the southern end of Truman Street to North Lincoln Street/Victory Place; the portion within the APE is located between the southern end of Truman Street to Pierce Street, a distance of approximately 1.5 miles. The prior evaluation and an update form are included in Appendix A.

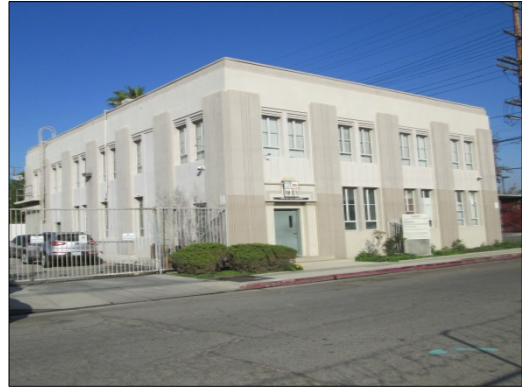
14601-3 Aetna Street was identified for further study as an example of PWA Moderne architecture and early infrastructure in the San Fernando Valley. It is listed in the California Historic Resources Information System (CHRIS) with a 2S2 status code from March 20, 2002. The SCCIC was contacted on July 24, 2015 for additional documentation and information regarding this previous evaluation. Michelle Galaz, Assistant

Coordinator at the SCCIC responded on July 27, 2015 to say that there was no documentation for this address in their office, or for its alternative address, 14603 Aetna Street. SCCIC made a request to the OHP for additional documentation and information. On August 13, 2015, the information from the prior evaluation was received from the SCCIC, which are included in Appendix A. The property was individually re-evaluated for listing on the NRHP and CRHR as part of this study. The evaluation determined that the property appears to be significant at the national and state level as a rare example of a pre-war DWP facility in the San Fernando Valley, and as an excellent example of the PWA Moderne style; the property retains sufficient integrity to convey its association with that trend and architectural style. As a result of this evaluation, the property was assigned a 3S status code, “Appears eligible for NRHP as an individual property through survey evaluation.”

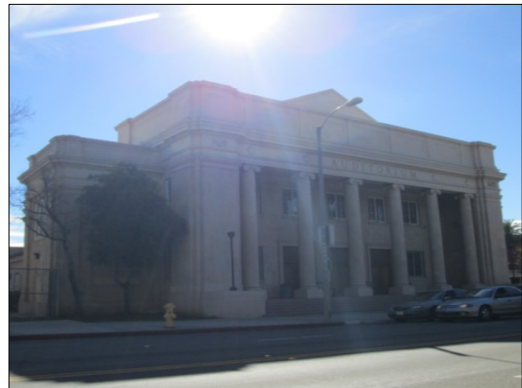
130 N. Brand Boulevard – 2S2

130 N. Brand Boulevard was identified for further study due to its Classical Revival architecture on the junior high campus. It was previously evaluated in 1995 as part of a Section 106 survey of earthquake-damaged properties. It was given a status code of 2S2, “individual property determined eligible for NRHP by consensus through Section 106 process,” and listed in the CRHR as an excellent example of Classical Revival architecture. Therefore, it was subsequently listed in the CRHR. The project team reviewed the previous evaluation and after field inspection determined that the existing 2S2 status code is still valid.

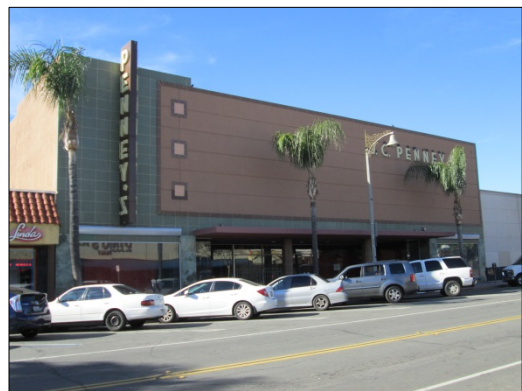
1140 San Fernando Road – 3S

1140 San Fernando Road was identified for further study as a unique example of a J.C. Penney department store in a commercial strip, as opposed to a shopping mall. The property was individually evaluated for listing on the NRHP and CRHR. The evaluation determined that the property appears to be eligible for the NRHP and CRHR at the local level of significance for its association with the commercial development of the City of San Fernando and for its architectural style; it retains sufficient integrity to convey those associations. As a result of this evaluation, the property was assigned a 3S status code, “Appears eligible for NRHP as an individual property through survey evaluation.”

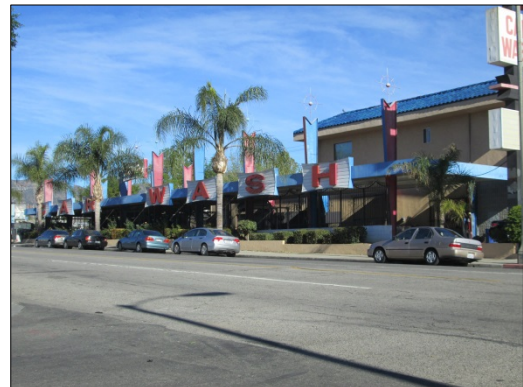
1601 San Fernando Road – 3S

1601 San Fernando Road was identified for further study as an example of a Googie style car wash on San Fernando Road. The property was individually evaluated for listing on the NRHP and CRHR. The evaluation determined that the property is significant under Criterion C as exemplifying a Googie car wash and that it retains sufficient integrity for listing. As a result of this evaluation, the property was assigned a 3S status code, “Appears eligible for NRHP as an individual property through survey evaluation.”

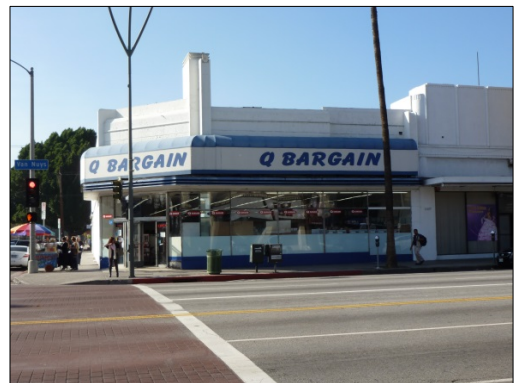
6353 Van Nuys Boulevard - 3S

6353 Van Nuys Boulevard was identified for further study as an example of Streamline Moderne architecture that represents an early period of commercial development in the San Fernando Valley. The property was individually evaluated for listing on the NRHP and CRHR. The evaluation determined that the property appears to meet the NRHP and CRHR Criteria at the local level of significance as a rare example of pre-World War II commercial development in the San Fernando Valley, as well as exemplifying the Streamline Moderne style; the property retains sufficient integrity to convey this significance. As a result of this evaluation, the property was assigned a 3S status code, “Appears eligible for NRHP as an individual property through survey evaluation.”

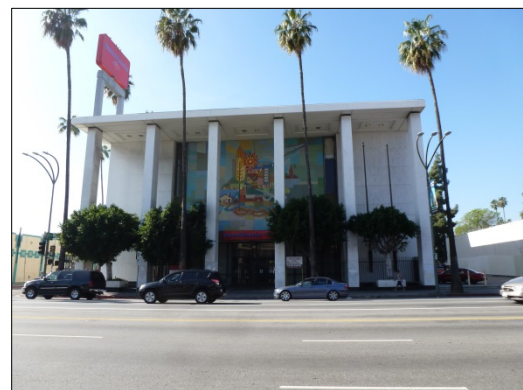
6551 Van Nuys Boulevard – 3S

6551 Van Nuys Boulevard was identified for further study as an example of New Formalist architecture and the work of Millard Sheets. The property was individually evaluated for listing on the NRHP and CRHR. The evaluation determined that the property appears to be eligible for the NRHP and CRHR as a good example of New Formalism in the San Fernando Valley. As a result of this evaluation, the property was assigned a 3S status code, “Appears eligible for NRHP as an individual property through survey evaluation.”

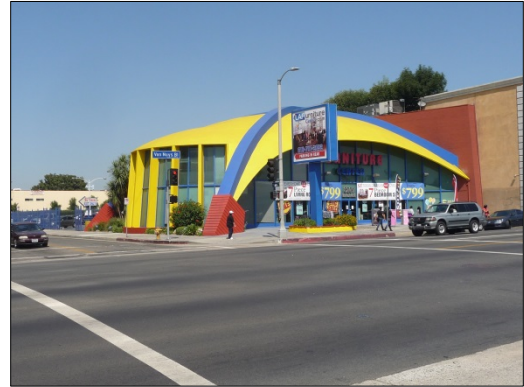
8201 Van Nuys Boulevard – 3S

8201 Van Nuys Boulevard was identified for further study as a rare example of Expressionist architecture. The property was individually evaluated for listing on the NRHP and CRHR. The evaluation determined that the property appears to meet the NRHP and CRHR Criteria for its architecture and as the work of W.A. Sarmiento, who was pivotal to the shift in bank design during the twentieth century, and that it retains sufficient integrity to convey that significance. As a result of this evaluation, the property was assigned a 3S status code, “Appears eligible for NRHP as an individual property through survey evaluation.” (Photo: SurveyLA).

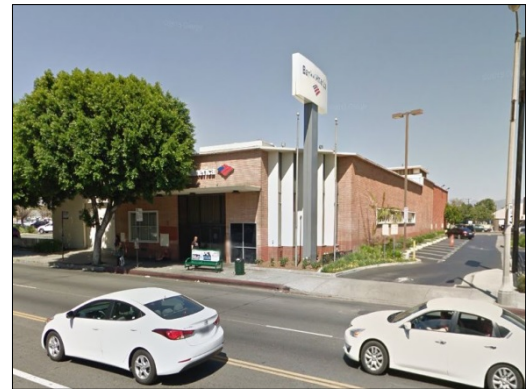
8324 Van Nuys Boulevard – 3S

8324 Van Nuys Boulevard was identified for further study as part of a planned commercial strip for the successful post-war suburb of Panorama City. The property was individually evaluated for listing on the NRHP and CRHR. The evaluation determined that the property appears to be eligible for the NRHP and CRHR at the local level for its association with the planned development of Panorama City, and it retains sufficient integrity to convey that significance. As a result of this evaluation, the property was assigned a 3S status code, “Appears eligible for NRHP as an individual property through survey evaluation.” (Photo: Google Maps).

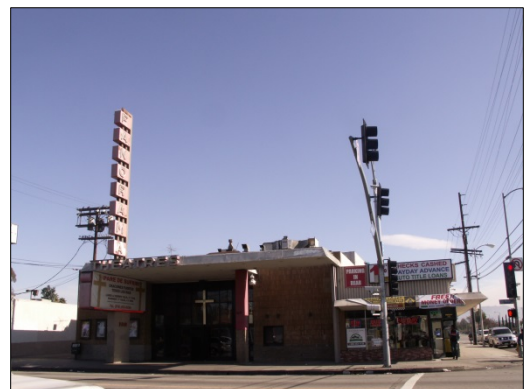
9110 Van Nuys Boulevard – 3S

9110 Van Nuys Boulevard was identified for further study as part of a planned commercial strip for the successful post-war suburb of Panorama City, and as the work of master architect William Pereira. The property was individually evaluated for listing on the NRHP and CRHR. The evaluation determined that the property was not an important example of Pereira’s work, but that it appears to meet the NRHP and CRHR Criteria at the local level for its association with Panorama City, and it retains sufficient integrity to convey that significance. As a result of this evaluation, the property was assigned a 3S status code, “Appears eligible for NRHP as an individual property through survey evaluation.” (Photo: GPA)

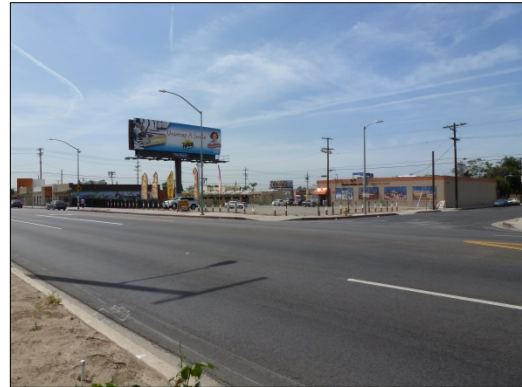
San Fernando Road – 3S

A portion of San Fernando Road was identified for further study due to its historic alignment, dating from as early as 1871. It was previously evaluated in 2013 as part of a CEQA review process. Segments of the road were given a status code of 3S, “Appears eligible for NRHP as an individual property through survey evaluation.” One of the segments is included within the APE. The project team reviewed the previous evaluation and after field inspection determined that the existing 3S status code appears to still be valid. (Photo: GPA)

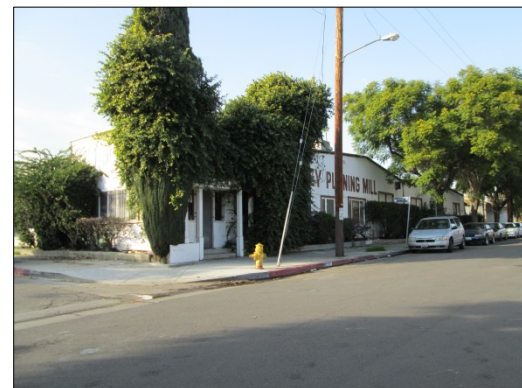
1. 6103 Cedros Avenue -6Z

6103 Cedros Avenue was identified for further study as an early example of an industrial planning mill in Los Angeles. The property was individually evaluated for listing on the NRHP and CRHR. The evaluation determined that the property lacks historical and architectural significance, and is therefore not eligible for listing on either register. As a result of this evaluation, the property was assigned a 6Z status code, “Found ineligible for NRHP, CRHR, or Local designation through survey evaluation.” (Photo: GPA)

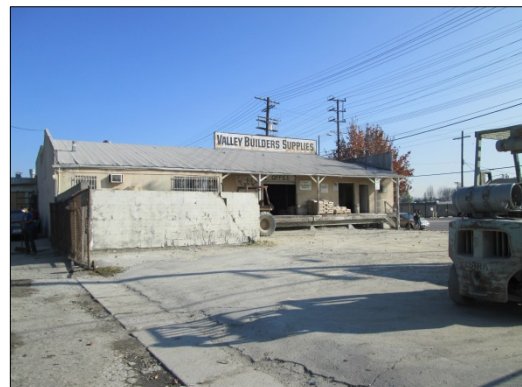
6000 Kester Avenue - 6Z

6000 Kester Avenue was identified for further study as an example of a building supply warehouse in Los Angeles dating from the post-war building boom period. The property was individually evaluated for listing on the NRHP and CRHR. The evaluation determined that the property lacks historical and architectural significance and is therefore not eligible for listing on either register. As a result of this evaluation, the property was assigned a 6Z status code, “Found ineligible for NRHP, CRHR, or Local designation through survey evaluation.” (Photo: GPA)

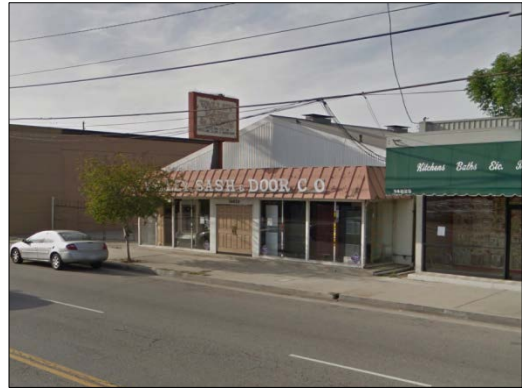
14829-33 Oxnard Street – 6Z

14829-33 Oxnard Street was identified for further study as an example of a building supply warehouse in Los Angeles dating from the post-war building boom period. The property was individually evaluated for listing on the NRHP and CRHR. The evaluation determined that the property lacks historical and architectural significance, and is therefore not eligible for listing on either register. As a result of this evaluation, the property was assigned a 6Z status code, “Found ineligible for NRHP, CRHR, or Local designation through survey evaluation.” (Photo: GPA)

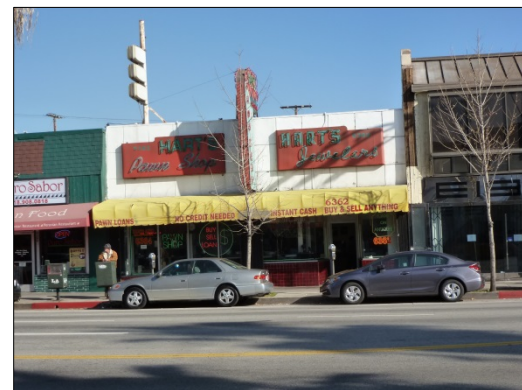
6362 Van Nuys Boulevard - 6Z

6362 Van Nuys Boulevard was identified for further study as an example of early period of commercial development in the San Fernando Valley and for its distinctive signage. The property was individually evaluated for listing on the NRHP and CRHR. The evaluation determined that the property has significance, but lacks sufficient integrity for listing. As a result of this evaluation, the property was assigned a 6Z status code, “Found ineligible for NRHP, CRHR, or Local designation through survey evaluation.” (Photo: GPA)

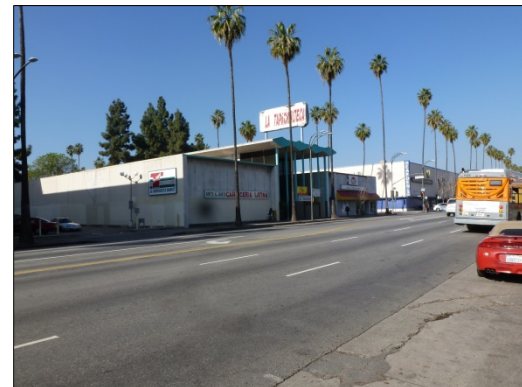
6569 Van Nuys Boulevard – 6Z

6569 Van Nuys Boulevard was identified for further study as an example of Mid-Century Modern architecture and the work of Culver Heaton and Millard Sheets. The property was individually evaluated for listing on the NRHP and CRHR. The evaluation determined that the property lacks historical and architectural significance, and is therefore not eligible for listing on either register. As a result of this evaluation, the property was assigned a 6Z status code, “Found ineligible for NRHP, CRHR, or Local designation through survey evaluation.” (Photo: GPA)

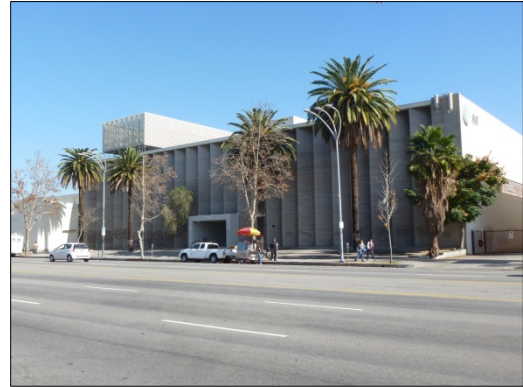
6920 Van Nuys Boulevard – 6Z

6920 Van Nuys Boulevard was identified for further study as an example of a Mid-Century Modern architecture and for its association with post-war infrastructure in the San Fernando Valley. The property was individually evaluated for listing on the NRHP and CRHR. The evaluation determined that the property lacks historical and architectural significance, and is therefore not eligible for listing on either register. As a result of this evaluation, the property was assigned a 6Z status code, “Found ineligible for NRHP, CRHR, or Local designation through survey evaluation.” (Photo: GPA)

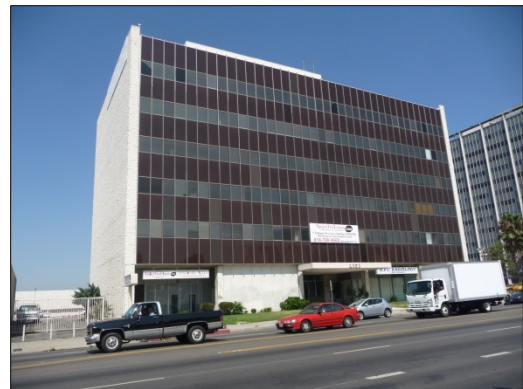
8121 Van Nuys Boulevard – 6Z

8121 Van Nuys Boulevard was identified for further study as an example of Corporate International architecture. The property was individually evaluated for listing on the NRHP and CRHR. The evaluation determined that the property lacks historical and architectural significance, and is therefore not eligible for listing on either register. In addition, the building is less than 50 years old and is not of exceptional importance, so it would not meet the requirements of NRHP Criteria Consideration G. As a result of this evaluation, the property was assigned a 6Z status code, “Found ineligible for NRHP, CRHR, or Local designation through survey evaluation.” (Photo: SurveyLA).

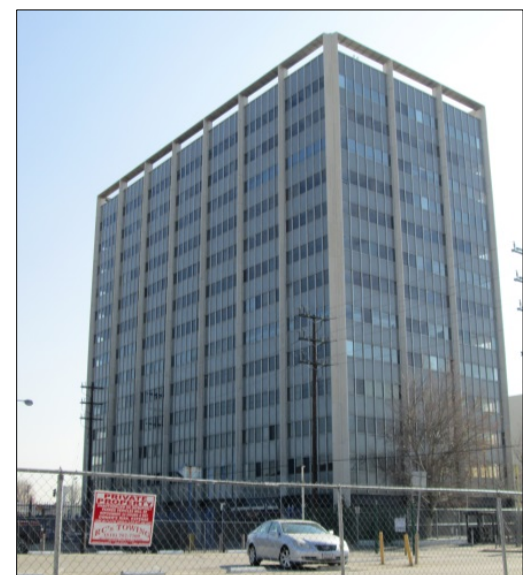
8155 Van Nuys Boulevard – 6Z

8155 Van Nuys Boulevard was identified for further study as an example of Corporate International architecture. The property was individually evaluated for listing on the NRHP and CRHR. The evaluation determined that the property lacks historical and architectural significance, and is therefore not eligible for listing on either register. As a result of this evaluation, the property was assigned a 6Z status code, “Found ineligible for NRHP, CRHR, or Local designation through survey evaluation.” (Photo: GPA)

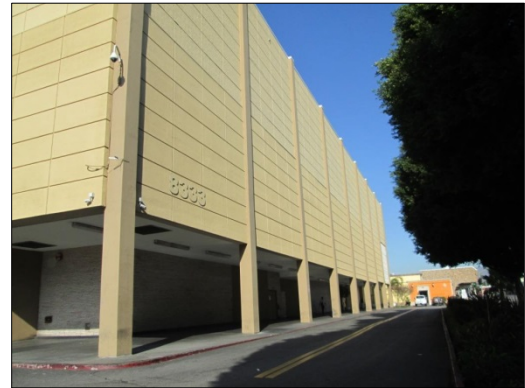
8333 Van Nuys Boulevard – 6Z

8333 Van Nuys Boulevard was identified for further study as an example of an early department store in the San Fernando Valley, and specifically Panorama City. The property was individually evaluated for listing on the NRHP and CRHR. The evaluation determined that the property likely has significance for its association with Post-war Suburbanization and Commercial Development, but that it lacks sufficient integrity to convey that association, and is therefore ineligible for listing on either register. As a result of this evaluation, the property was assigned a 6Z status code, “Found ineligible for NRHP, CRHR, or Local designation through survey evaluation.” (Photo: GPA)

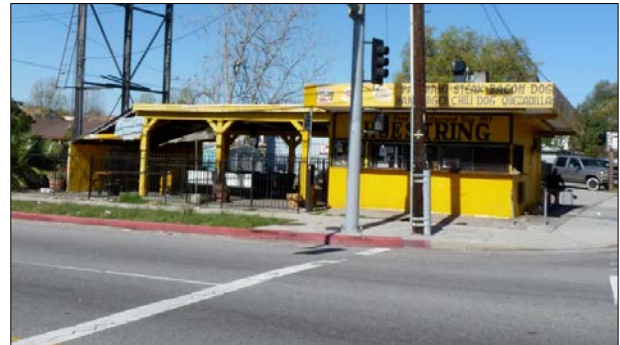
14035 Van Nuys Boulevard – 6Z

14035 Van Nuys Boulevard was identified for further study as an example of the walk-up food stand property type. The property was individually evaluated for listing on the NRHP and CRHR. The evaluation determined that the property lacks historical and architectural significance, and is therefore not eligible for listing on either register. As a result of this evaluation, the property was assigned a 6Z status code, “Found ineligible for NRHP, CRHR, or Local designation through survey evaluation.” (Photo: GPA)

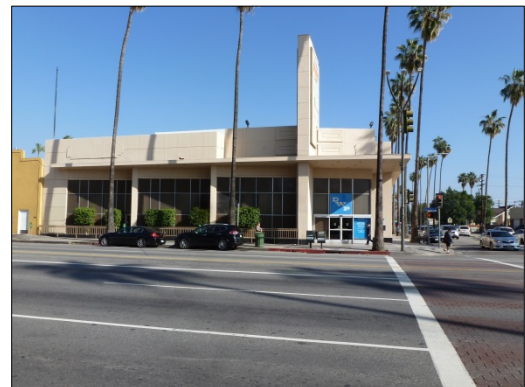
14463 Haynes Boulevard – 6Z

14463 Haynes Boulevard was identified for further study as an example of a Mid-Century Modern commercial building and for its association with post-war infrastructure in the San Fernando Valley. The property was individually evaluated for listing on the NRHP and CRHR. The evaluation determined that the property lacks historical and architectural significance, and is therefore not eligible for listing on either register. As a result of this evaluation, the property was assigned a 6Z status code, “Found ineligible for NRHP, CRHR, or Local designation through survey evaluation.” (Photo: GPA)

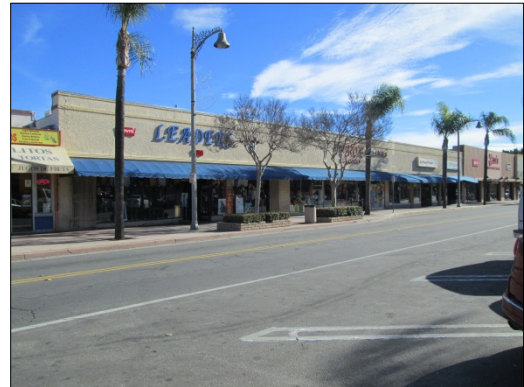
San Fernando Road Commercial District – 7N1

The San Fernando Road Commercial District area was identified for further study as a concentration of low-rise commercial buildings in San Fernando, the majority of which were developed prior to World War II. This area is the commercial center of San Fernando. The area was evaluated as a district for listing on the NRHP and CRHR. The evaluation determined that the area likely has significance for its association with the Development of the City of San Fernando, but that it lacks sufficient integrity to convey its period of significance, and is therefore ineligible for listing on either register at this time. Should enough of the alterations be removed, the area could become eligible for listing on a historic register. As a result of this evaluation, the potential district was assigned a 7N1 status code, “Needs to be reevaluated – may become eligible for NRHP with restoration or when meets other specific conditions.” (Photo: GPA)

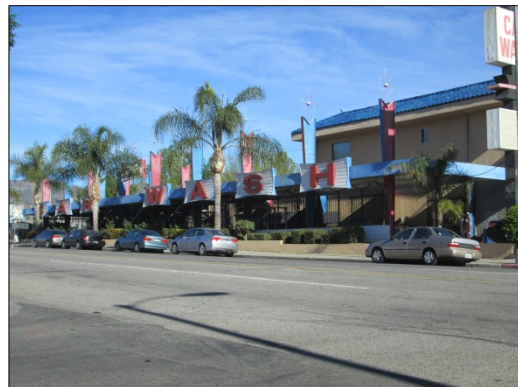
1. 1601 San Fernando Road

Under Alternative 1, the southbound Hubbard Station would be constructed along Truman Street at the southwest corner of Truman and Meyer Streets. While the historic property (indicated with green shading in figure on page 4-5) is near the proposed bus stop canopy and ticketing kiosk (indicated with light blue shading), the station would be located to the rear of the property that faces Truman Street. The primary views of the historic car wash from San Fernando Road and Lazar Street would not be adversely affected by a new visual element or the sidewalk widening

required to accommodate the new bus stop canopies. The property is already located in an urban area with existing bus service and other vehicular traffic. Streetscape elements, such as billboards, bus stops, lighting, and other transportation infrastructure, already exist in the area immediately surrounding the property. Therefore, the introduction of the new bus station would not diminish the property's integrity of setting in such a way that it would no longer be eligible for the NRHP, and all other aspects of integrity would remain unchanged. Therefore, this alternative would not result in adverse effects on this historic property. (Photo: GPA)

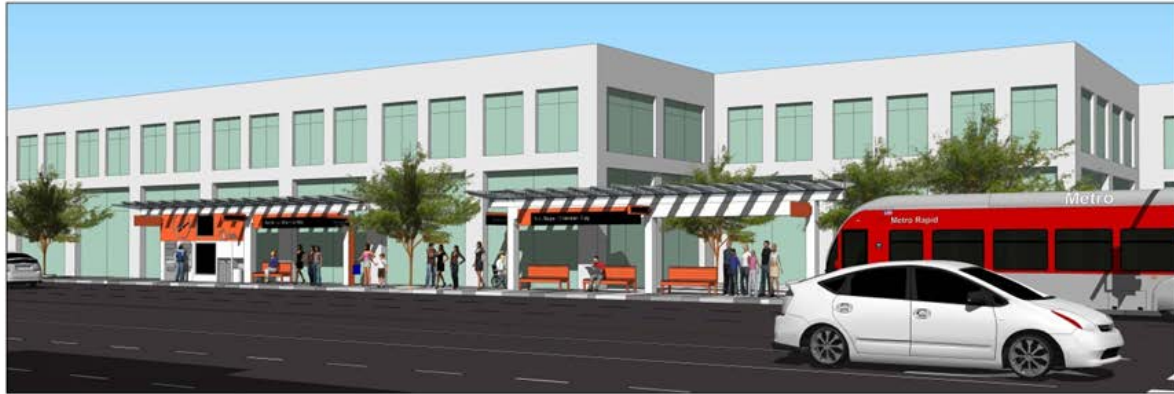
Figure 4-1: Illustrative Design Details for Curb-Running BRT Alternative Figure

The bus stop platforms for Alternative 1 would be located on the existing sidewalk. On the platform, there would be a covered Informational Kiosk and Ticketing Portal and a seating area. The kiosk and ticketing portal would be under one canopy and the seating canopy under a second canopy. The metal canopies would be approximately 10 to 12 feet high, 8 to 10 feet wide and approximately 46 feet long. The two canopies would be approximately 24 feet apart. Sidewalk widening would be required on Truman Street at Hubbard Avenue (Meyer Street) and in both directions at Maclay Avenue where the existing sidewalk is less than 10 feet wide, in order to accommodate the canopy. Figure 4-1 and Figure 4-2 illustrate a typical station with a canopy that would be constructed under Build Alternative 1.

01 CURBSIDE BRT STATION ILLUSTRATION

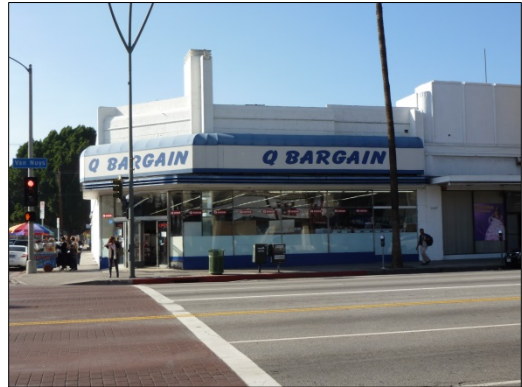
2. 6353 Van Nuys Boulevard

Under Alternative 1, the proposed southbound Victory Station would be constructed along Van Nuys Boulevard at the southwest corner of Van Nuys and Victory Boulevards. While the historic property (indicated with green shading) is near the proposed station (indicated with light blue shading), the station would not be constructed directly in front of the building. The primary views of the historic property from Van Nuys Boulevard and Friar Street would not be adversely affected by a new visual element. The property is already located in a dense urban area with existing bus service and other vehicular traffic. Streetscape elements, such as billboards, bus stops, lighting, and other transportation infrastructure, already exist in the area immediately surrounding the property. Therefore, the introduction of the new bus station at the opposite end of the block would not diminish the property's integrity of setting in such a way that it would no longer be eligible for the NRHP, and all other aspects of integrity would remain unchanged. Therefore, this alternative would not result in adverse effects on this historic property. (Photo: GPA)

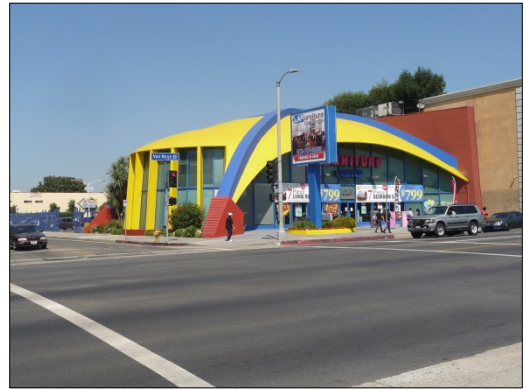
3. 8201 Van Nuys Boulevard

Under Alternative 1, the proposed southbound Roscoe Station would be constructed along Van Nuys Boulevard at the southwest corner of Roscoe and Victory Boulevards. While the historic property (indicated with green shading) is near the proposed station (indicated with light blue shading), the new station would not be constructed directly in front of the historic property. The primary views of the historic building from Van Nuys Boulevard and Titus Street would not be adversely affected by a new visual element down the street. The property is already located in a dense urban area with existing bus service and other vehicular traffic. Streetscape elements, such as billboards, bus stops, lighting, and other transportation infrastructure, already exist in the area immediately surrounding the property. Therefore, the introduction of the new bus station would not diminish the property’s integrity of setting in such a way that it would no longer be eligible for the NRHP, and all other aspects of integrity would remain unchanged. Therefore, this alternative would not result in adverse effects on this historic property. (Photo: SurveyLA).

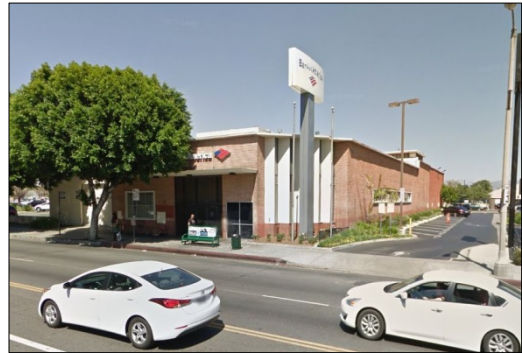
4. 8324 Van Nuys Boulevard

Under Alternative 1, the proposed northbound Roscoe Station would be constructed along Van Nuys Boulevard north of its intersection with Roscoe Street. While the historic property (indicated with green shading) is near the proposed station (indicated with light blue shading), the station would not be constructed directly in front of the building. The primary view of the building from Van Nuys Boulevard would not be adversely affected by a new visual element. The property is already located in a dense urban area with existing bus service and other vehicular traffic. Streetscape elements, such as billboards, bus stops, lighting and other transportation infrastructure, already exist in the area immediately surrounding the property. Therefore, the introduction of the new bus station would not diminish the property's integrity of setting in such a way that it would no longer be eligible for the NRHP, and all other aspects of integrity would remain unchanged. Therefore, this alternative would not result in adverse effects on this historic property. (Photo: GPA)

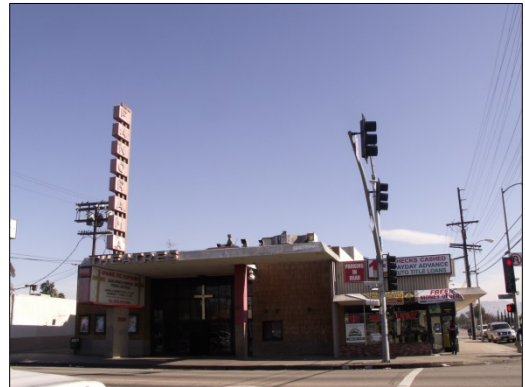
5. 9110 Van Nuys Boulevard

Under Alternative 1, the proposed northbound Nordhoff Station would be constructed along Van Nuys Boulevard north of its intersection with Nordhoff Street. While the historic property (indicated with green shading) is near the proposed station (indicated with light blue shading), the station would not be constructed directly in front of the building. The primary views of the building from Van Nuys Boulevard and Nordhoff Street would not be adversely affected by a new visual element. The property is already located in a dense urban area with existing bus service and other vehicular traffic. Streetscape elements, such as billboards, bus stops, lighting, and other transportation infrastructure, already exist in the area immediately surrounding the property. Therefore, the introduction of the new bus station would not diminish the property's integrity of setting in such a way that it would no longer be eligible for the NRHP, and all other aspects of integrity would remain unchanged. Therefore, this alternative would not result in adverse effects on this historic property. (Photo: GPA)

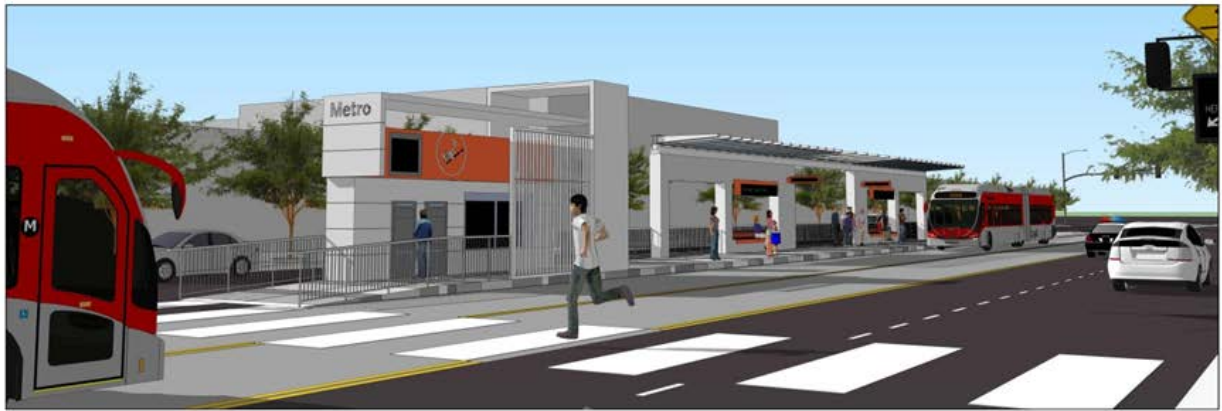
Figure 4-3: Illustrative Design Details for Median-Running BRT Alternative

01 MEDIAN BRT STATION ILLUSTRATION

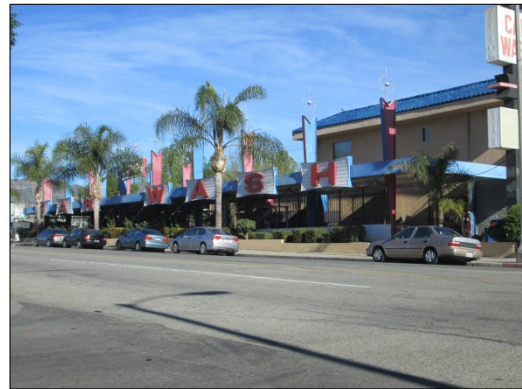
1. 1601 San Fernando Road

Under Alternative 2, the southbound Hubbard Station along Truman Street at the southwest corner of Truman and Meyer Streets would be upgraded. While the historic property (indicated with green shading) is near the proposed station (indicated with light blue shading), the station would be located to the rear of the property that faces Truman Street. The primary views of the building from San Fernando Road and Lazar Street would not be adversely affected by a new visual element or the sidewalk widening. The property is already located in an urban area with existing bus service and other vehicular traffic. Streetscape elements, such as billboards, bus stops, lighting, and other transportation infrastructure, already exist in the area immediately surrounding the property. Therefore, the introduction of the new bus station would not diminish the property's integrity of setting in such a way that it would no longer be eligible for the NRHP, and all other aspects of integrity would remain unchanged. Therefore, this alternative would not result in adverse effects on this historic property. (Photo: GPA)

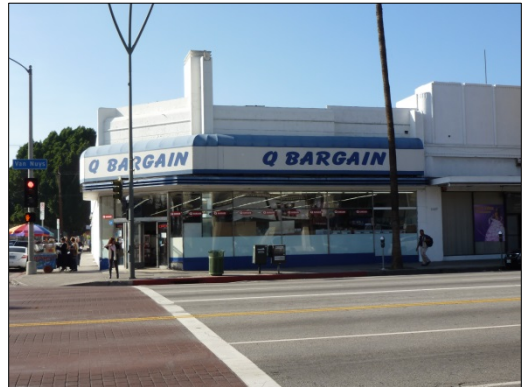
2. 6353 Van Nuys Boulevard

Under Build Alternative 2, the proposed southbound Victory Station would be constructed near the center of Van Nuys Boulevard between the intersection of Victory Boulevard and Friar Street. While the historic property (indicated with green shading) is near the proposed station (indicated with light blue shading), the station would not be constructed directly in front of the building; there would be two lanes of traffic separating the property from the proposed bus station. The primary views of the building from the west side of Van Nuys Boulevard and Friar Street would not be adversely affected by a new visual element. While the view might be obscured from the east side of Van Nuys Boulevard, the property is already located in a dense urban area with existing bus service and other vehicular traffic. Streetscape elements, such as billboards, bus stops, lighting, and other transportation infrastructure, already exist in the area immediately surrounding the property. Therefore, the introduction of the new bus station would not diminish the property's integrity of setting in such a way that it would no longer be eligible for the NRHP, and all other aspects of integrity would remain unchanged. Therefore, this alternative would not result in adverse effects on this historic property. (Photo: GPA)

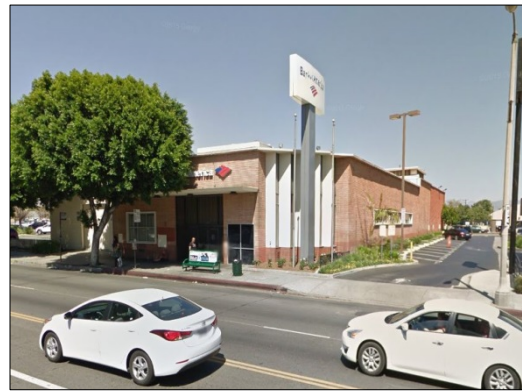
3. 8324 Van Nuys Boulevard

Under Alternative 2, the proposed southbound Roscoe/Chase Station would be constructed near the center of Van Nuys Boulevard north of its intersection with Roscoe Street. While the historic property (indicated with green shading) is near the proposed station (indicated with light blue shading), the station would not be constructed directly in front of the building. The primary view of the building from Van Nuys Boulevard would not be adversely affected by a new visual element. The property is already located in a dense urban area with existing bus service and other vehicular traffic. Streetscape elements, such as billboards, bus stops, lighting, and other transportation infrastructure, already exist in the area immediately surrounding the property. Therefore, the introduction of the new bus station would not diminish the property's integrity of setting in such a way that it would no longer be eligible for the NRHP, and all other aspects of integrity would remain unchanged. Therefore, this alternative would not result in adverse effects on this historic property. (Photo: GPA)

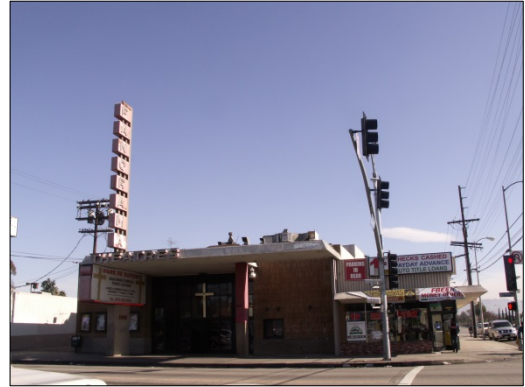
4. 9110 Van Nuys Boulevard

Under Alternative 2, the proposed northbound Nordhoff Station would be constructed near the center of Van Nuys Boulevard north of its intersection with Nordhoff Street. While the historic property (indicated with green shading) is near the proposed station (indicated with light blue shading), the station would not be constructed directly in front of the building; there would be two lanes of traffic separating the property from the proposed bus station. The primary views of the building from the east side of Van Nuys Boulevard and Nordhoff Street would not be adversely affected by a new visual element. While the view might be obscured from the west side of Van Nuys Boulevard, the property is already located in a dense urban area with existing bus service and other vehicular traffic. Streetscape elements, such as billboards, bus stops, lighting, and other transportation infrastructure, already exist in the area immediately surrounding the property. Therefore, the introduction of the new bus station would not diminish the property's integrity of setting in such a way that it would no longer be eligible for the NRHP, and all other aspects of integrity would remain unchanged. Therefore, this alternative would not result in adverse effects on this historic property. (Photo: GPA)

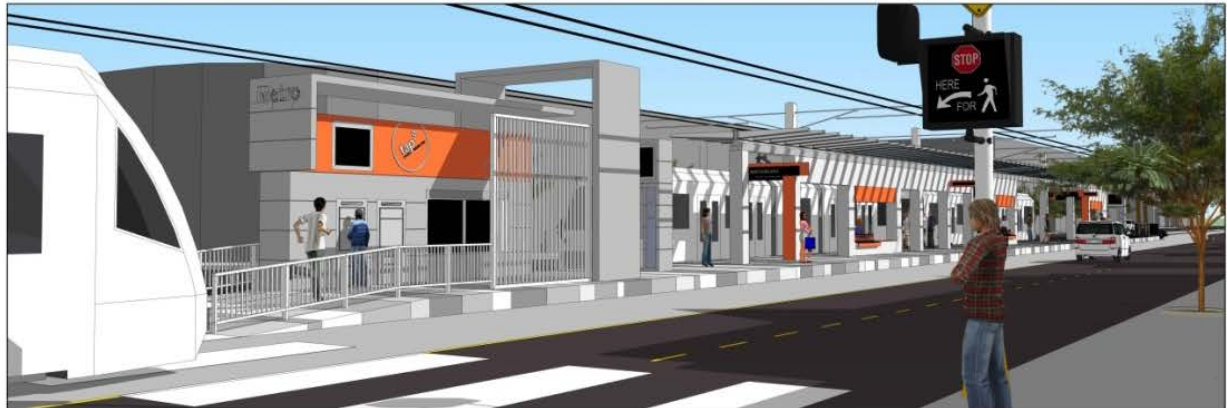
Figure 4-5: Illustrative Design Details for Low-Floor LRT/Tram Alternative

Figure 4-5 and Figure 4-6 illustrate a typical station with a canopy that would be constructed under Alternative 3.

01 MEDIAN TRAM STATION ILLUSTRATION

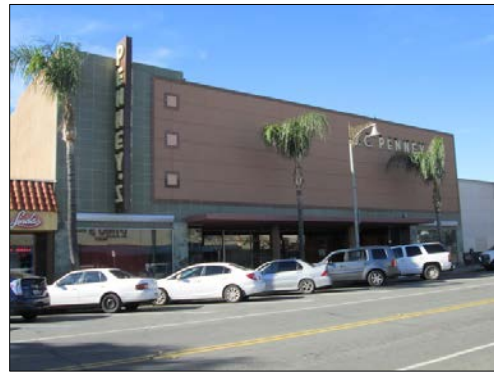
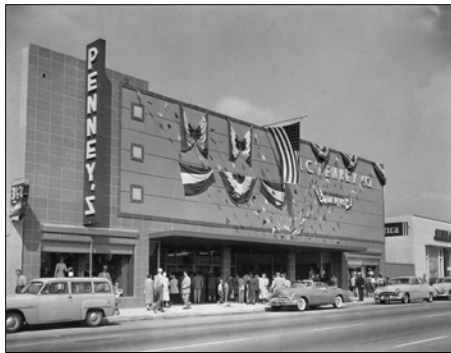
1. 1140 San Fernando Road

Under Build Alternative 3, the northbound Maclay Station would be constructed along the east side of San Fernando Road, north of its intersection with Maclay Avenue. While the historic property (indicated with green shading in figure on the next page) is near the proposed station (indicated with light blue shading in figure on the next page), the station would not be constructed directly in front of the building. While there would be an OCS and Low-Floor LRT/Trams passing in front of the building, the primary view of the façade from San

Fernando Road would not be adversely affected by this new visual element. The primary character-defining features of the building are located near the top of the building, including the distinctive original signage and Late Moderne detailing, which would likely still be visible over the 10- to 12-foot canopy. In addition, the integrity of setting has already been somewhat diminished. Many of the properties along the commercial strip have been heavily altered or are infill construction, and the sidewalks along San Fernando Road were widened at an unknown date. Historic photos

and aerial photography indicate that the existing curb bulb-outs, street planters, and the diagonal street parking configuration were added around 1969. Therefore, the setting has already been altered from its original, narrower sidewalk and parallel street parking configuration, as seen in the historic photograph to the left. The sidewalk narrowing (indicated in green hatching in figure on the next page) proposed as part of Alternative 3 and the construction of the Maclay Low-Floor LRT/Tram station would actually remove non-original features from the building's setting. Therefore, the introduction of the new Low-Floor LRT/Tram station and OCS would not diminish the property's integrity of setting in such a way that it would no longer be eligible for the NRHP; rather, it would remove non-original features from the existing setting, and the station would not obscure the existing primary view of the building in a manner that it would no longer qualify for the NRHP. All other aspects of integrity would remain unchanged. Therefore, this alternative would not result in adverse effects on this historic property. (Photo: GPA)
