Metro®

Executive Summary

The Federal Transit Administration (FTA) and Los Angeles County Metropolitan Transportation Authority (Metro) propose to construct a project called the East San Fernando Valley Transit Corridor Project (Undertaking). The FTA is the Lead Agency under the National Environmental Policy Act (NEPA) and Metro is the Lead Agency under the California Environmental Quality Act (CEQA).

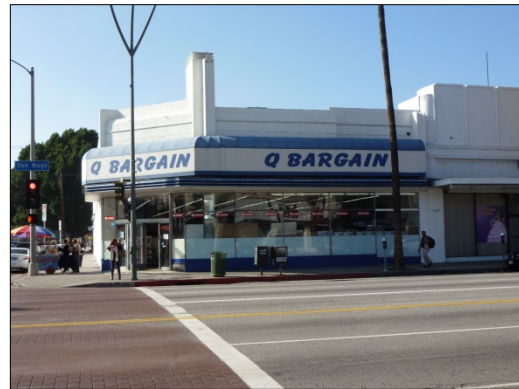
2. 6353 Van Nuys Boulevard

Under Alternative 3, the proposed southbound Victory Station would be constructed near the center of Van Nuys Boulevard between the intersection of Victory Boulevard and Friar Street. While the historic property (indicated with green shading) is near the proposed station (indicated with light blue shading), the station would not be constructed directly in front of the building; there would be two lanes of traffic separating the property from the proposed rail station. The primary views of the building from the west side of Van Nuys Boulevard and Friar Street would not be adversely affected by a new visual element. While the view might be obscured from the east side of Van Nuys Boulevard, the property is already located in a dense urban area with existing transit service and other vehicular traffic. Streetscape elements, such as overhead power lines, billboards, bus stops, lighting, and other transportation infrastructure, already exist in the area immediately surrounding the property. Therefore, the introduction of the new Low-Floor LRT/Tram station and OCS would not diminish the property's integrity of setting in such a way that it would no longer be eligible for the NRHP, and all other aspects of integrity would remain unchanged. Therefore, this alternative would not result in adverse effects on this historic property. (Photo: GPA)

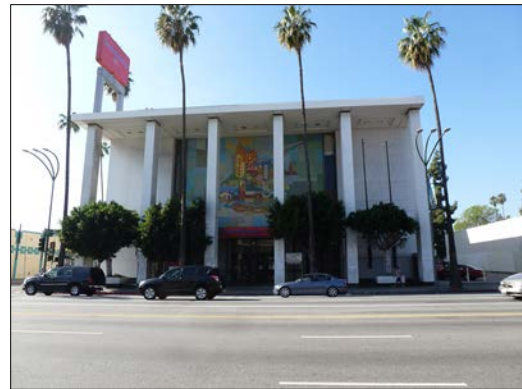
3. 6551 Van Nuys Boulevard

Under Alternative 3, the proposed southbound Kittridge Station would be constructed near the center of Van Nuys Boulevard between the intersections of Haynes Street and Kittridge Street. While the historic property (indicated with green shading) is near the proposed station (indicated with light blue shading), the station would not be constructed directly in front of the building; there would be two lanes of traffic separating the property from the proposed Low-Floor LRT/Tram station. The primary views of the building from the west side of Van Nuys Boulevard and Haynes Street would not be adversely affected by a new visual element. While the view might be partially obscured from the east side of Van Nuys Boulevard, the primary character-defining features of the building are located near the top of the building, including the dramatic roof overhang and the mural, which would likely still be visible over the 10- to 12-foot canopy. The building would be easily visible from the Low-Floor LRT/Tram alignment. The building is already located in a dense urban area with existing transit service and other vehicular traffic. Streetscape elements, such as overhead power lines, billboards, bus stops, lighting, and other transportation infrastructure, already exist in the area immediately surrounding the property. Therefore, the introduction of the new tram station and OCS would not diminish the property's integrity of setting in such a way that it would no longer be eligible for the NRHP, and all other aspects of integrity would remain unchanged. Therefore, this alternative would not result in adverse effects on this historic property. (Photo: GPA)

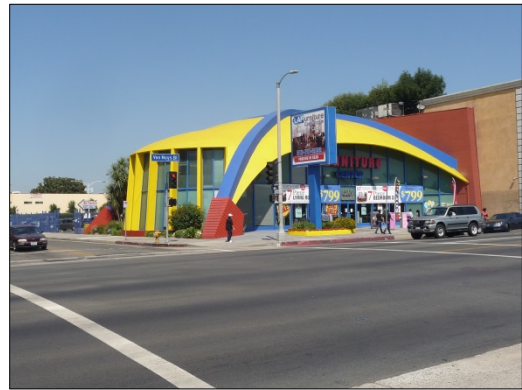
4. 8201 Van Nuys Boulevard

Under Alternative 3, the proposed northbound Roscoe Station would be constructed along Van Nuys Boulevard north of its intersection with Roscoe Street. While the historic property (indicated with green shading) is near the proposed station (indicated with light blue shading), the station would not be constructed directly in front of the building. The building is located at the opposite end of the block, and there would be two lanes of traffic separating the property from the proposed Low-Floor LRT/Tram station. The primary views of the building from the Titus Street and the west side of Van Nuys Boulevard would not be adversely affected by a new visual element. The property is already located in a dense urban area with existing transit service and other vehicular traffic. Streetscape elements, such as overhead power lines, billboards, bus stops, lighting, and other transportation infrastructure, already exist in the area immediately surrounding the property. Therefore, the introduction of the new Low-Floor LRT/Tram station and OCS would not diminish the property’s integrity of setting in such a way that it would no longer be eligible for the NRHP, and all other aspects of integrity would remain unchanged. The immediately adjacent sidewalk is not a character-defining element of the building’s significance, and therefore, the proposed narrowing of the sidewalk in front of the historic property would not cause a direct or indirect effect on the historic building. Therefore, this alternative would not result in adverse effects on this historic property. (Photo: GPA)

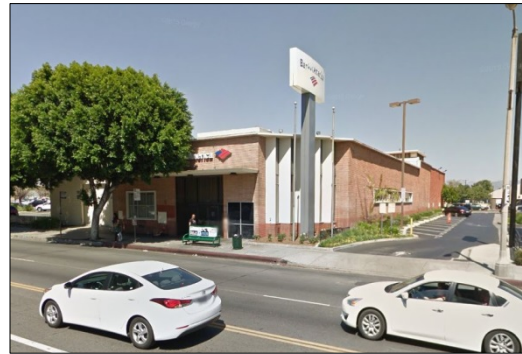
5. 8324 Van Nuys Boulevard

Under Alternative 3, the proposed northbound Roscoe Station would be constructed along Van Nuys Boulevard north of its intersection with Roscoe Street. While the historic property (indicated with green highlighting) is near the proposed station (indicated with light blue shading), the station would not be constructed directly in front of the building. There would be two lanes of traffic separating the property from the proposed Low-Floor LRT/Tram station. The primary views of the building from the east side of Van Nuys Boulevard would not be adversely affected by a new visual element. While the view might be obscured from the west side of Van Nuys Boulevard, the property is already located in a dense urban area with existing bus service and other vehicular traffic. Streetscape elements, such as overhead power lines, billboards, bus stops, lighting, and other transportation infrastructure, already exist in the area immediately surrounding the property. Therefore, the introduction of the new Low-Floor LRT/Tram station and OCS would not diminish the property’s integrity of setting in such a way that it would no longer be eligible for the NRHP, and all other aspects of integrity would remain unchanged. Also, the adjacent sidewalk is not a character-defining feature of the historic property, and the removal of the existing bus stop and narrowing of the sidewalk would not cause a direct or indirect effect to the historic property. Therefore, this alternative would not result in adverse effects on this historic property. (Photo: GPA)

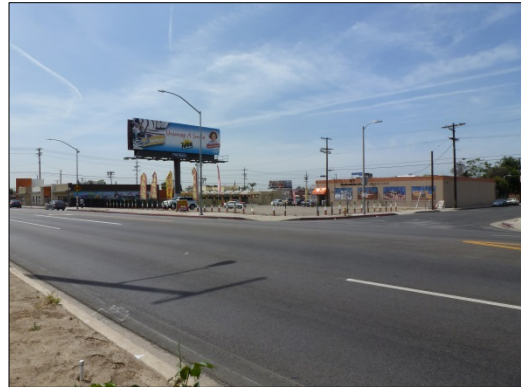
7. San Fernando Road

Under Alternative 3, the proposed Paxton Station would be constructed on San Fernando Road between its intersection with Weidner Street and the 118 Freeway ramps, south of Paxton Street. While the proposed station (indicated with light blue shading) would be constructed on the historic property (indicated with green shading), the station would not diminish the property's integrity in such a way that it would no longer be eligible for the NRHP. In the previous evaluation, the property's significance was determined to be directly tied to its historic alignment rather than other physical attributes, such as materials or design. Because there are no proposed changes or adjustments to the existing alignment as part of the project, this alternative would not result in adverse effects on this historic property as the historic alignment, and the property's significance, would remain unchanged. (Photo: GPA)

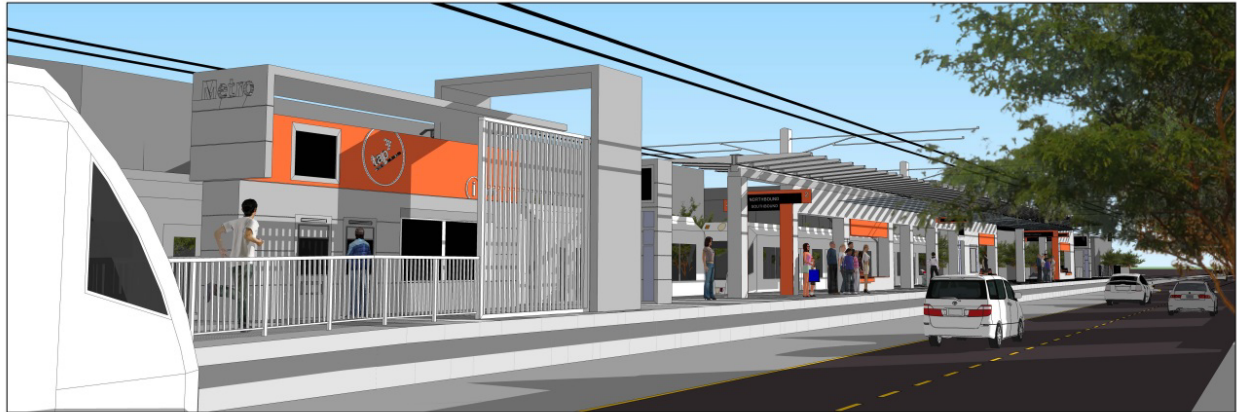
Figure 4-7: Illustrative Design Details for LRT Alternative

01 LRT ENTRY PORTAL ILLUSTRATION

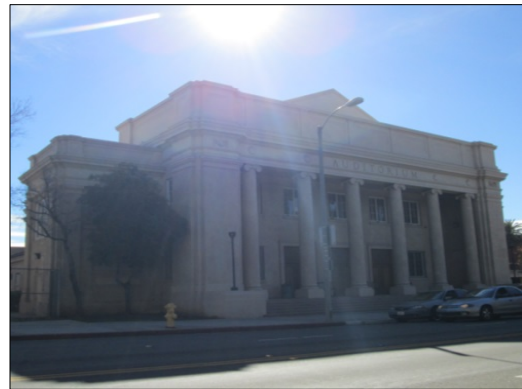
1. 130 N. Brand Avenue

Under Alternative 4, the proposed Maclay Station would be constructed on the Antelope Valley Metrolink Railroad Corridor, south of its crossing with Maclay Street. While the school campus (indicated with purple shading) is near the proposed station (indicated with light turquoise shading), the station would not be constructed near the historic properties on the campus. The Auditorium, Science Building, and Boys' Gymnasium are set back onto the campus, and would be visually separated from the proposed station by other, non-historic school buildings, and the primary views of the historic properties would not be adversely affected by a new visual element. The properties' integrity of setting has already been diminished through the introduction of new school buildings, but the properties are still able to convey their significance through other aspects of integrity. Furthermore, the three properties are significant for their architecture. Properties significant for this reason are able to convey their significance even if their integrity of setting has been diminished (e.g., architectural specimens that have been moved from their original locations can still be eligible for the NRHP regardless of setting). The property is already located along the railroad track, which is an early alignment that predates the historic school buildings. Therefore, the introduction of the new LRT station and increased use of the existing railroad tracks would not diminish the property's integrity of setting in such a way that it would no longer be eligible for the NRHP. All other aspects of integrity would remain unchanged. There would be no other anticipated effects. Therefore, this alternative would not result in adverse effects on this historic property. (Photo: GPA)

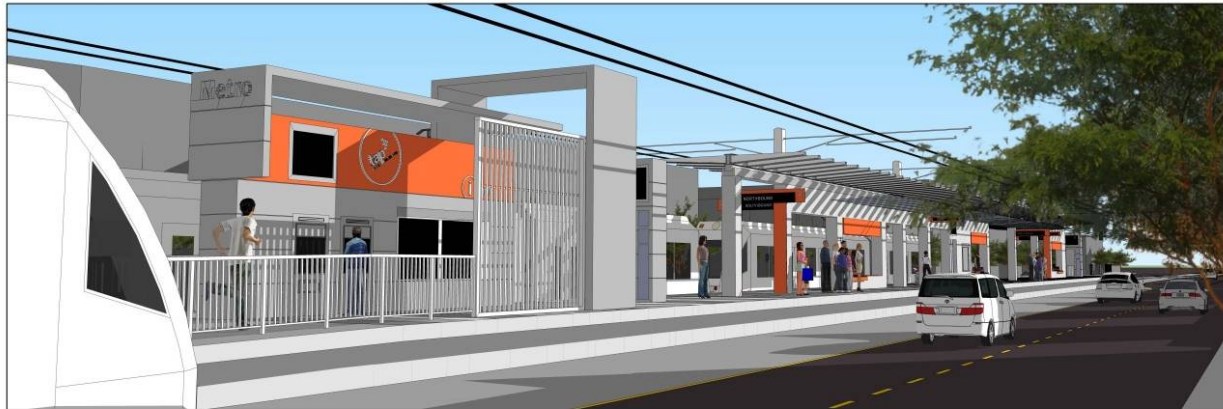
Figure 4.16-12: Illustrative Design Details for LRT Alternative

Figure 4.16-12 and Figure 4.16-13 illustrate a typical station with a canopy that would be constructed under Build Alternative 4.

01 LRT ENTRY PORTAL ILLUSTRATION

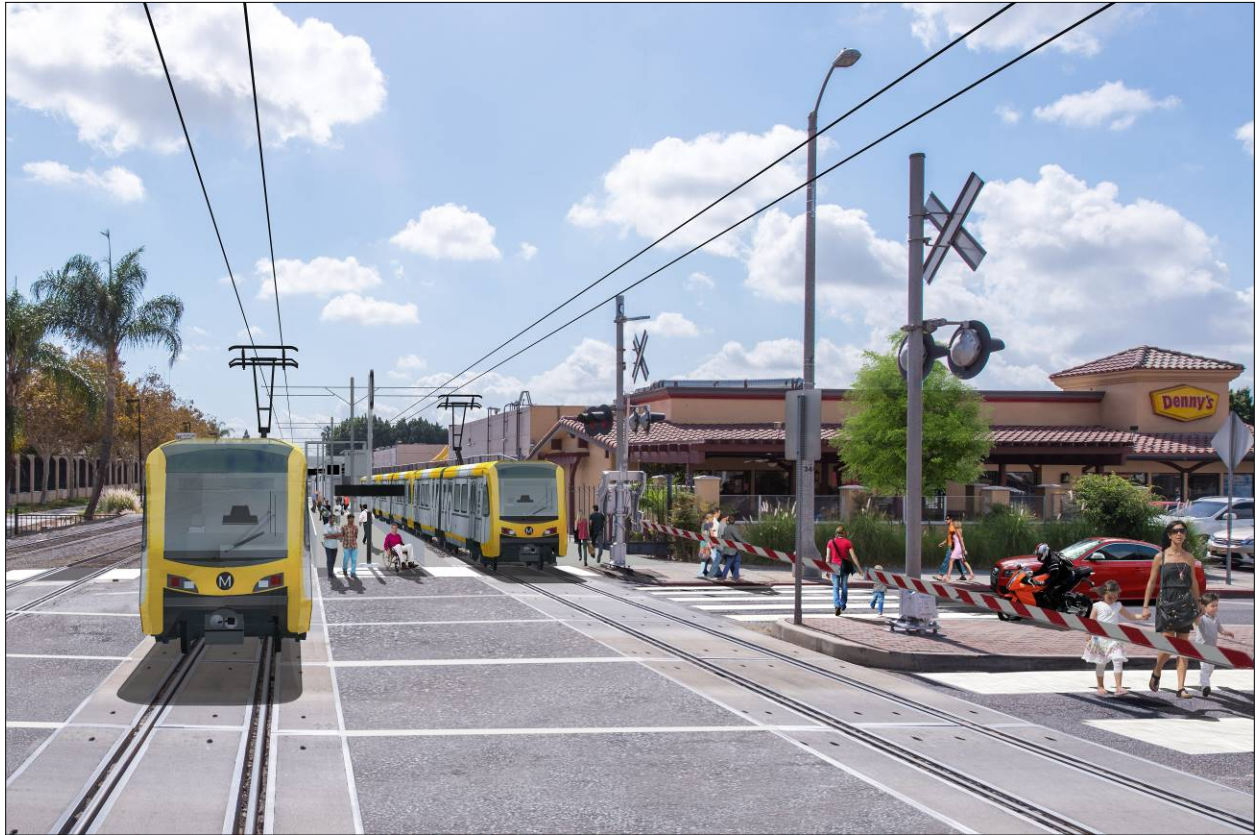
Figure 4.16-13: Architectural Rendering for LRT Alternative

Under Alternative 4, there are 3 historic properties that have a potential to be affected by the construction of proposed aboveground LRT stations. None of the buildings within the APE appear to be Building Category IV, such as an adobe building, so the lowest possible threshold of vibration damage would be 0.2 in/sec PPV. The highest predicted level of vibration for an aboveground station is the use of a vibratory roller at 0.21 in/sec PPV from a distance of 25 feet. (See Tables 4.16-5 and 4.16-6 for additional information regarding the FTA construction damage criteria and predictions of vibration caused by typical construction equipment).

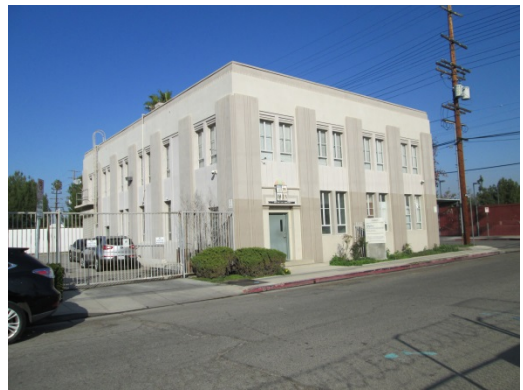
1. 14601-3 Aetna Street

Build Alternatives 3 and 4 with MSF Option A include a possible MSF near the proposed Metro Orange Line Station. 14601-3 Aetna is located at the northeast corner of this possible MSF site and would be demolished; the physical demolition or damage of a historic property meets the Criteria for substantial adverse change. Therefore, unless demolition could be avoided, Alternatives 3 and 4, with MSF Option A, would cause a substantial adverse change to the historic property at 14601-3 Aetna Street and a significant impact under CEQA, after implementation of proposed mitigation measures.

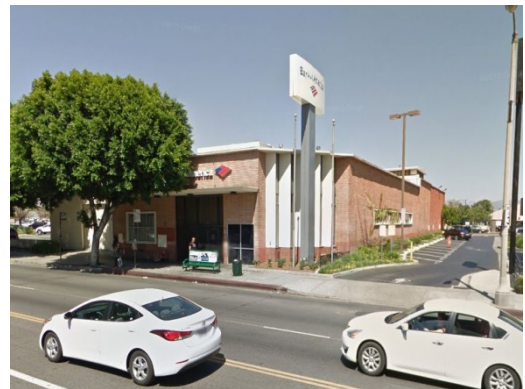
2. 8324 Van Nuys Boulevard

Under Build Alternative 4, the proposed underground Roscoe Station would be constructed underneath Van Nuys Boulevard, between its intersections with Roscoe Boulevard and Chase Street. An entry plaza is proposed at the northeast corner of Roscoe Boulevard and Van Nuys Boulevard. 8324 Van Nuys Boulevard is located at the center of this proposed entry plaza site and would be demolished; the physical demolition or damage of a historic property meets the Criteria for substantial adverse change. Therefore, unless demolition can be avoided, Alternative 4 would cause a substantial adverse change to the historic property at 8324 Van Nuys Boulevard and a significant impact under CEQA, after implementation of proposed mitigation measures.

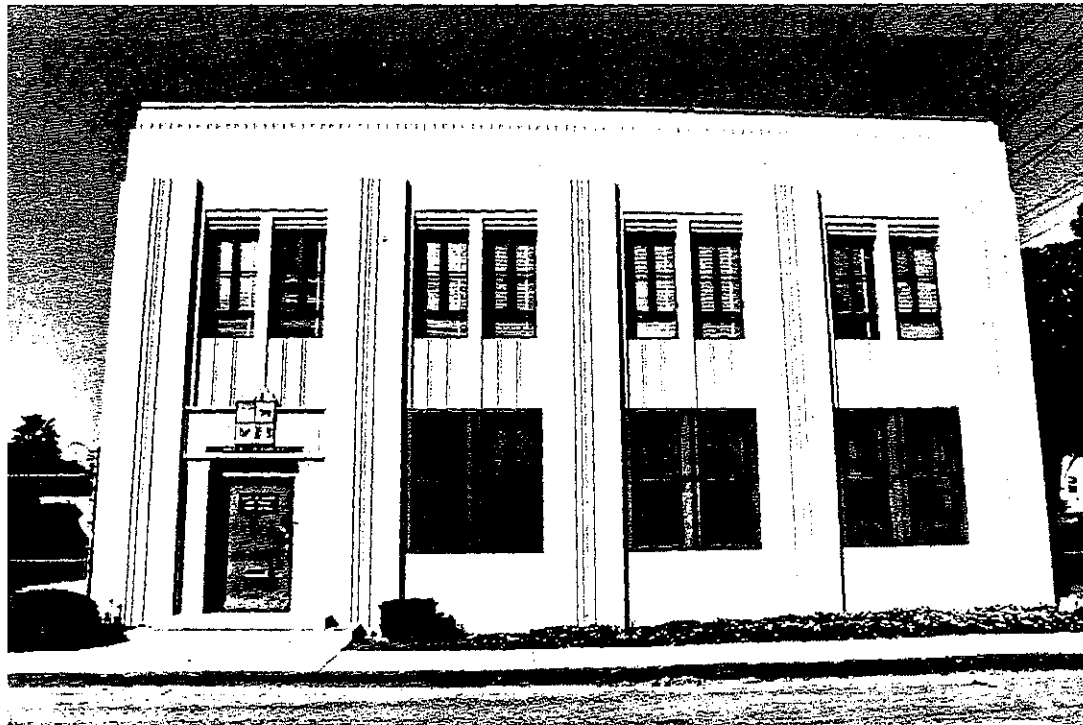
P5a. Photographs, dated January 17, 2001
Top-South elevation, facing north

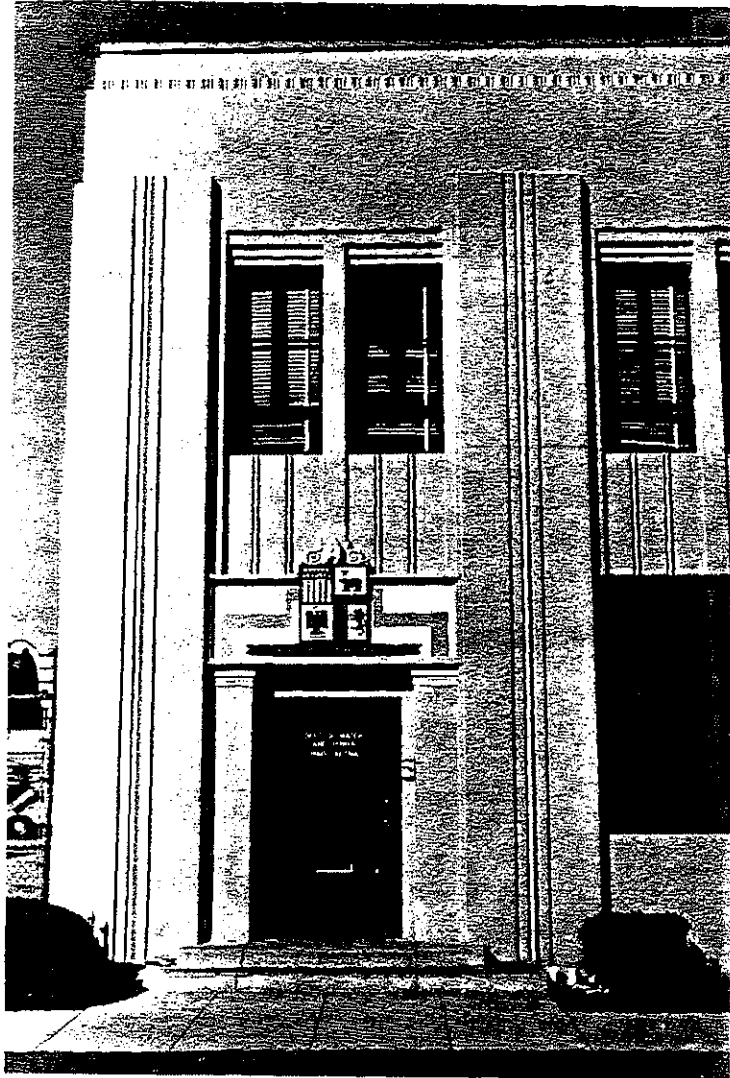
Bottom-Detail, entrance area, facing north

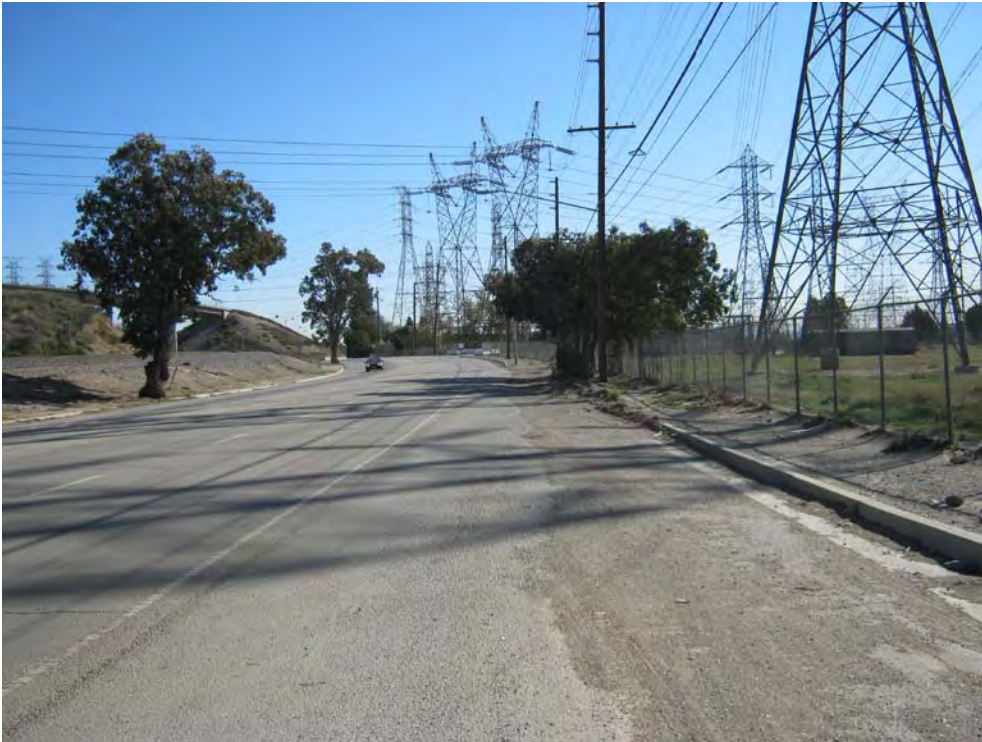
P5b. Description of Photo: (View, date, accession #) Overview of San Fernando Road just south of Balboa Blvd, view to the southeast; December 7, 2011, Img_547.

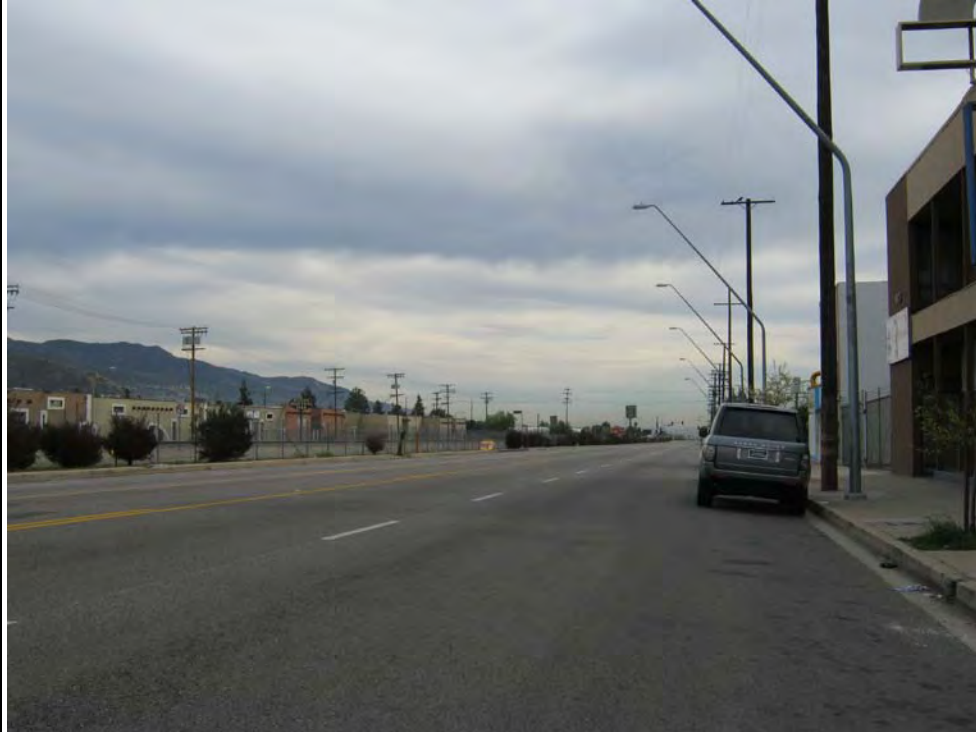
L8b. Description of Photo, Map, or Drawing (View, scale, etc.)
San Fernando Road at Ratner, view to the southeast

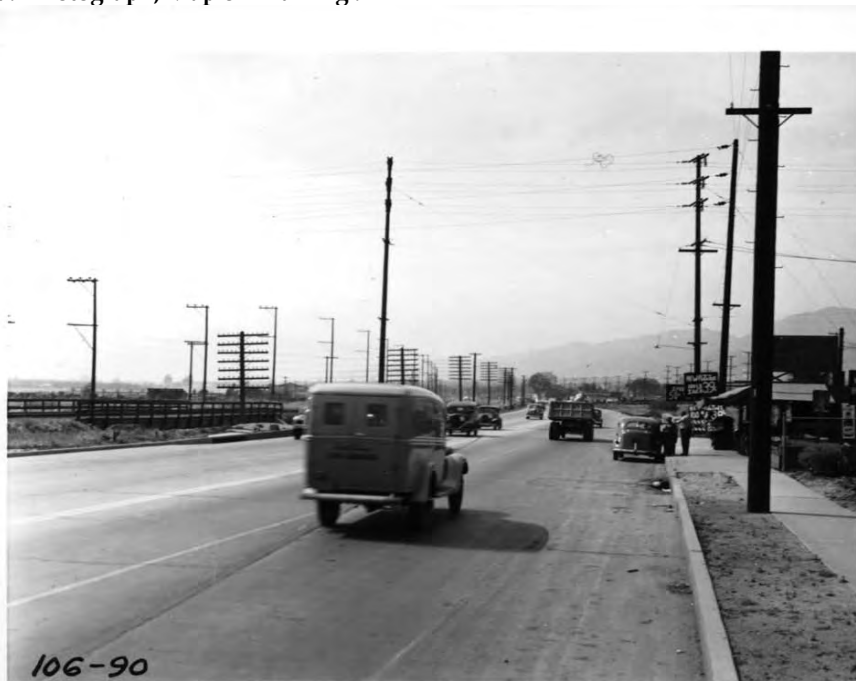
San Fernando Road at Verdugo Wash, view to the north, 1938
USC Digital Library - Automobile Club of Southern California Collection

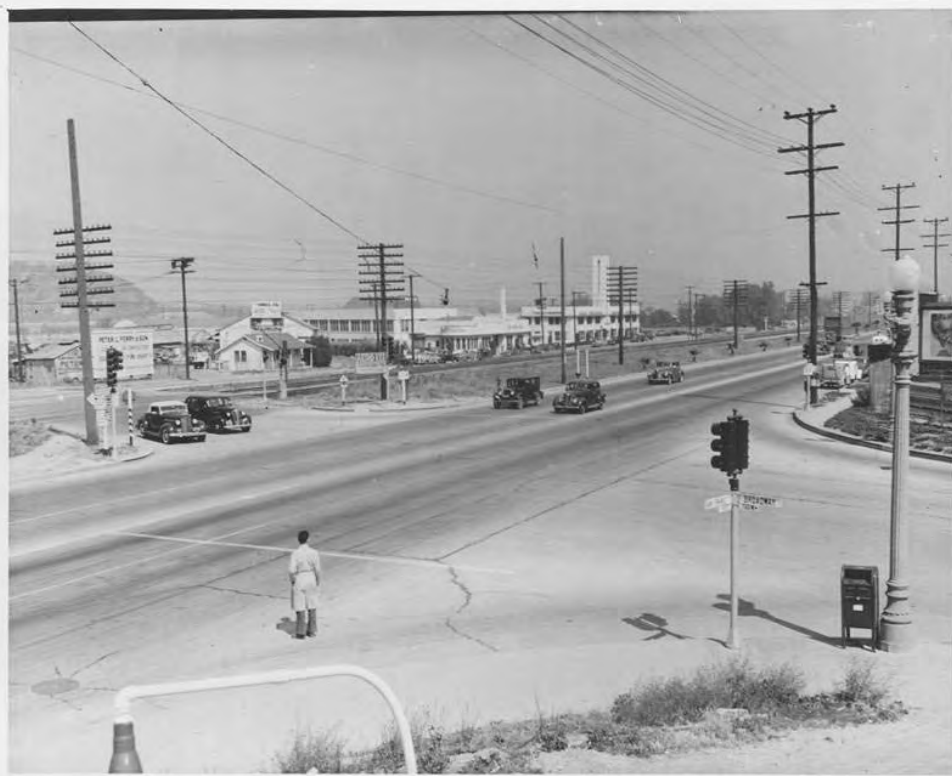
Intersection of San Fernando Road and Broadway in Glendale, 1942
CSUN Oviatt Library Digital Collection

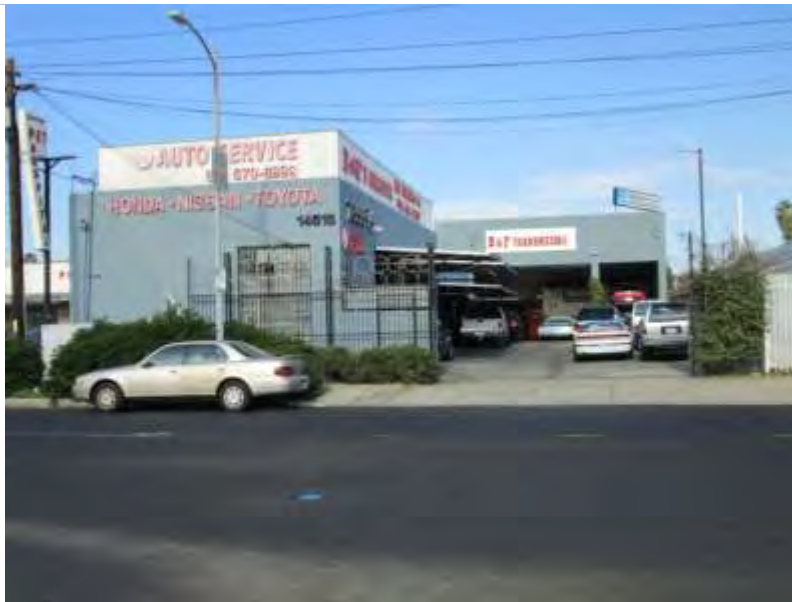
(View, date, accession #)
View looking N, 1/8/2015

P3a. Description: (Describe resource and its major elements. Include design, materials, condition, alterations, size, setting, and boundaries.)
Los Angeles County Assessor's parcel number 2210-022-010 includes a one-story automotive repair building. It is located on the north side of Arminta Street, west of its intersection with Van Nuys Boulevard.

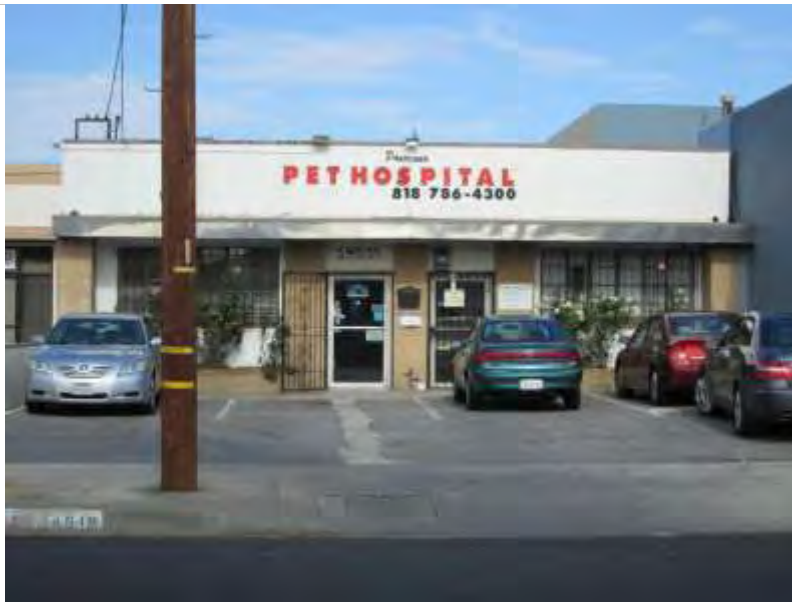
(View, date, accession #)
View looking N, 1/8/2015

P3a. Description: (Describe resource and its major elements. Include design, materials, condition, alterations, size, setting, and boundaries.)
Los Angeles County Assessor's parcel number 2210-022-009 includes a one-story industrial building. It is located on the north side of Arminta Street, west of its intersection with Van Nuys Boulevard.

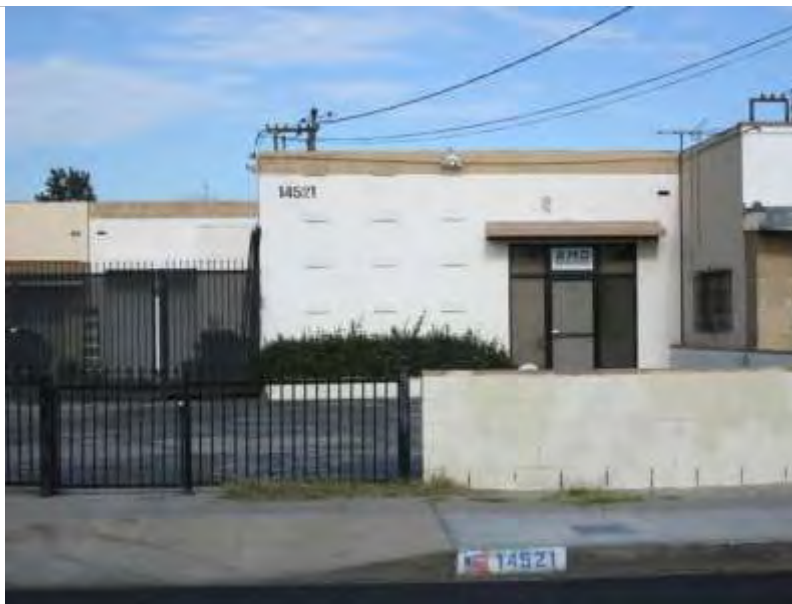
(View, date, accession #)
View looking N, 1/8/2015

P3a. Description: (Describe resource and its major elements. Include design, materials, condition, alterations, size, setting, and boundaries.)
Los Angeles County Assessor's parcel number 2210-022-038 includes a one-story industrial building. It is located on the north side of Arminta Street, west of its intersection with Van Nuys Boulevard.

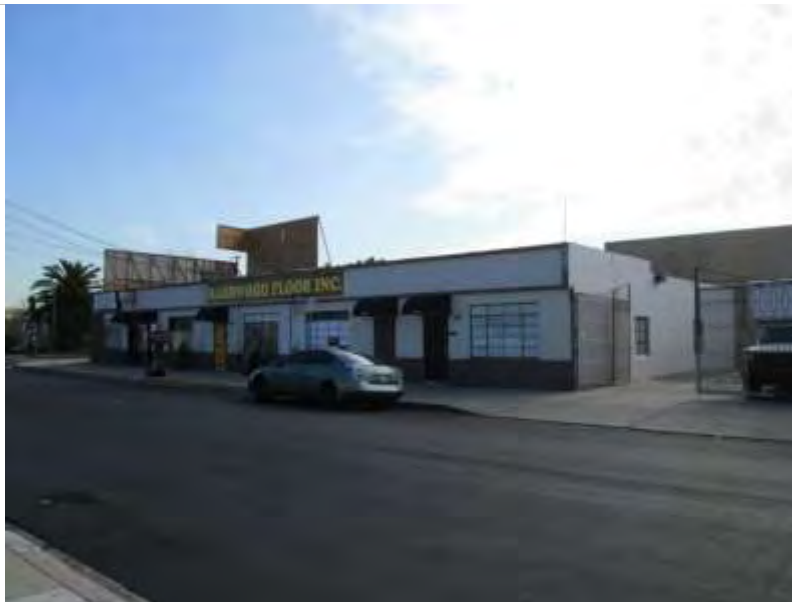
(View, date, accession #)
View looking SE, 1/8/2015

P3a. Description: (Describe resource and its major elements. Include design, materials, condition, alterations, size, setting, and boundaries.)
Los Angeles County Assessor's parcel number 2210-023-015 includes two one-story industrial buildings. The buildings are located on the southwest corner of Arminta Street and Van Nuys Boulevard.

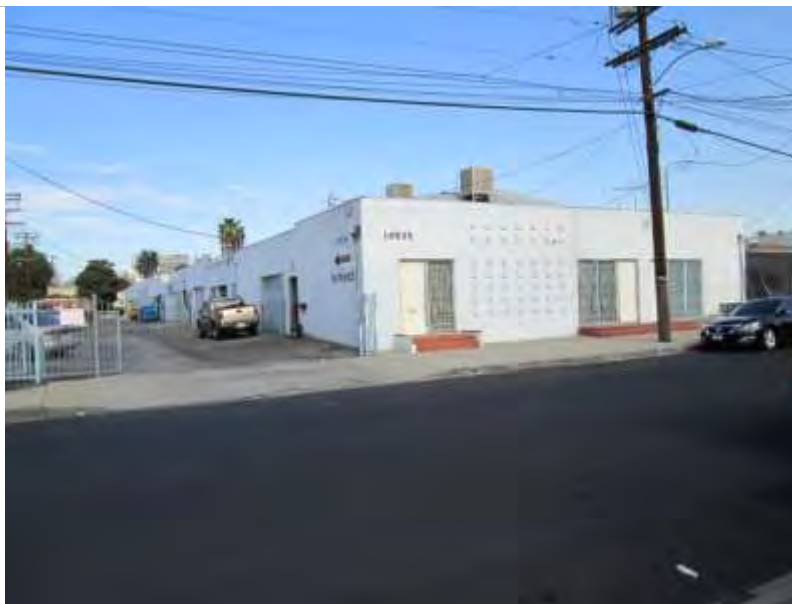
(View, date, accession #)
View looking NE, 1/8/2015

P3a. Description: (Describe resource and its major elements. Include design, materials, condition, alterations, size, setting, and boundaries.)
Los Angeles County Assessor's parcel number 2210-022-042 includes a one-story industrial building. It is located on the north side of Arminta Street, west of its intersection with Van Nuys Boulevard.

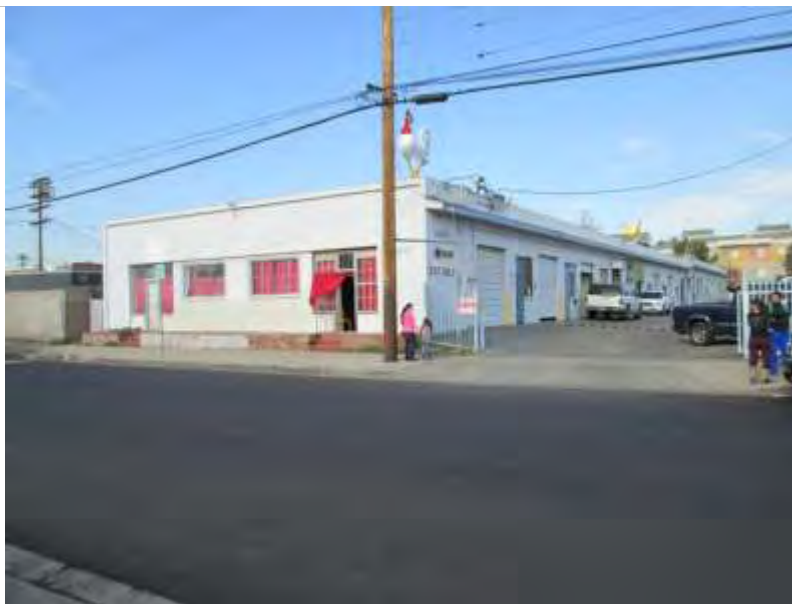
(View, date, accession #)
View looking NW, 1/8/2015

P3a. Description: (Describe resource and its major elements. Include design, materials, condition, alterations, size, setting, and boundaries.)
Los Angeles County Assessor's parcel number 2210-022-042 includes a one-story industrial building. It is located on the north side of Arminta Street, west of its intersection with Van Nuys Boulevard.

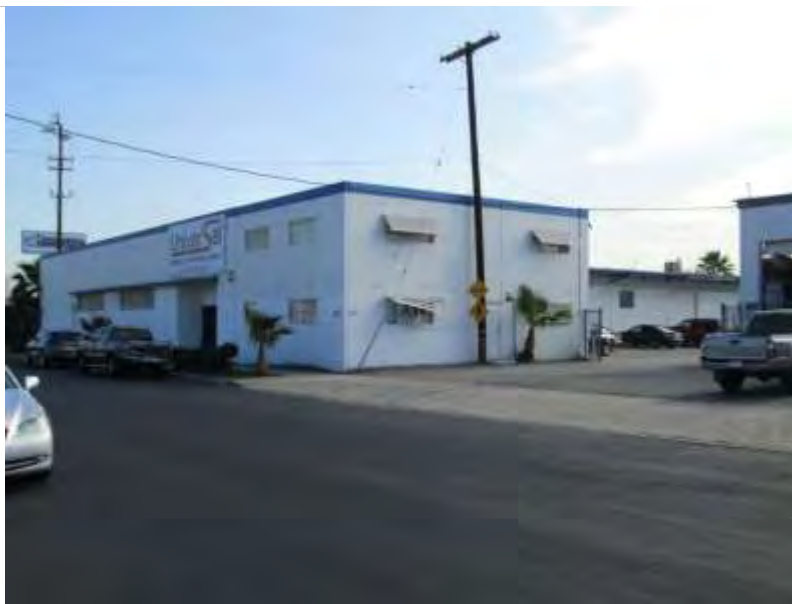
(View, date, accession #)
View looking SE, 1/8/2015

P3a. Description: (Describe resource and its major elements. Include design, materials, condition, alterations, size, setting, and boundaries.)
Los Angeles County Assessor's parcel number 2210-023-003 encompasses two large, one-story industrial buildings. The buildings are located on Arminta Street, east of its intersection with Willis Avenue.

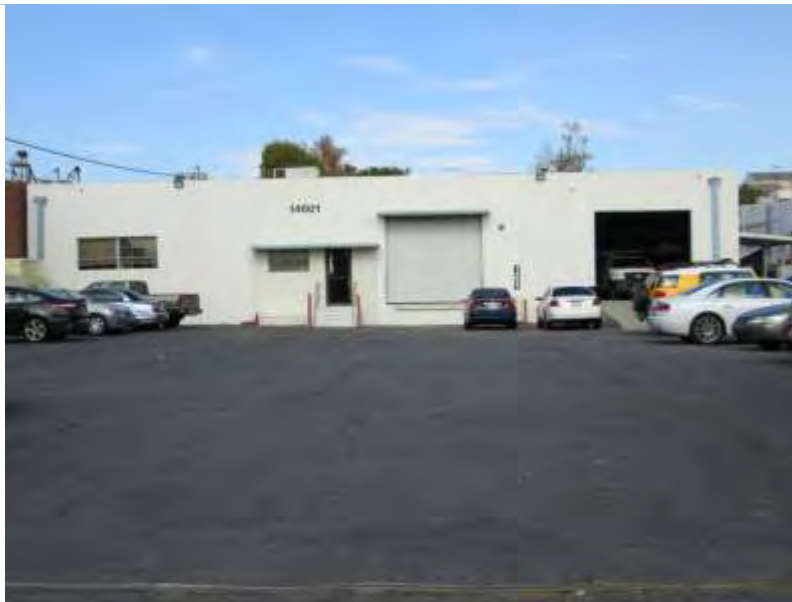
(View, date, accession #)
View looking N, 1/8/2015

P3a. Description: (Describe resource and its major elements. Include design, materials, condition, alterations, size, setting, and boundaries.)
Los Angeles County Assessor's parcel number 2210-022-005 includes a one-story industrial building. It is located on Arminta Street, west of its intersection with Van Nuys Boulevard.

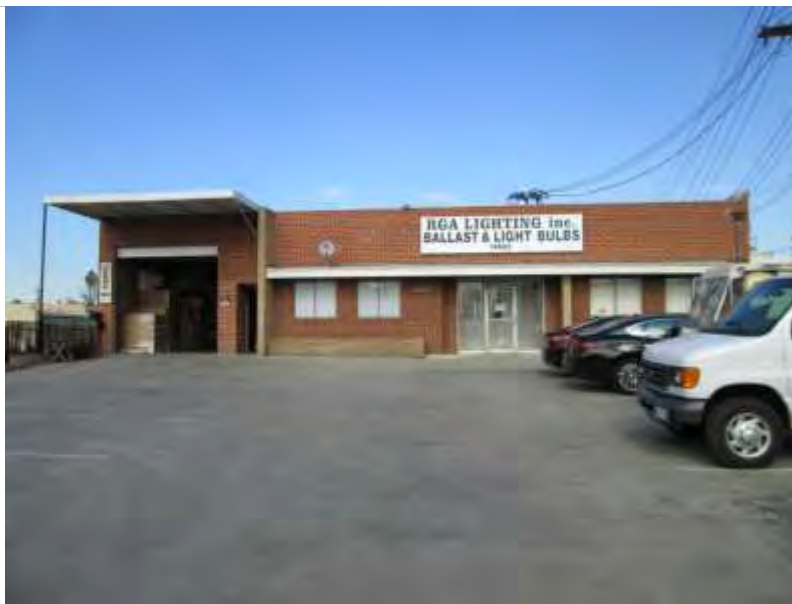
(View, date, accession #)
View looking N, 1/8/2015

P3a. Description: (Describe resource and its major elements. Include design, materials, condition, alterations, size, setting, and boundaries.)
Los Angeles County Assessor's parcel number 2210-022-030 includes a one-story industrial building. It is located on Arminta Street, west of its intersection with Van Nuys Boulevard.

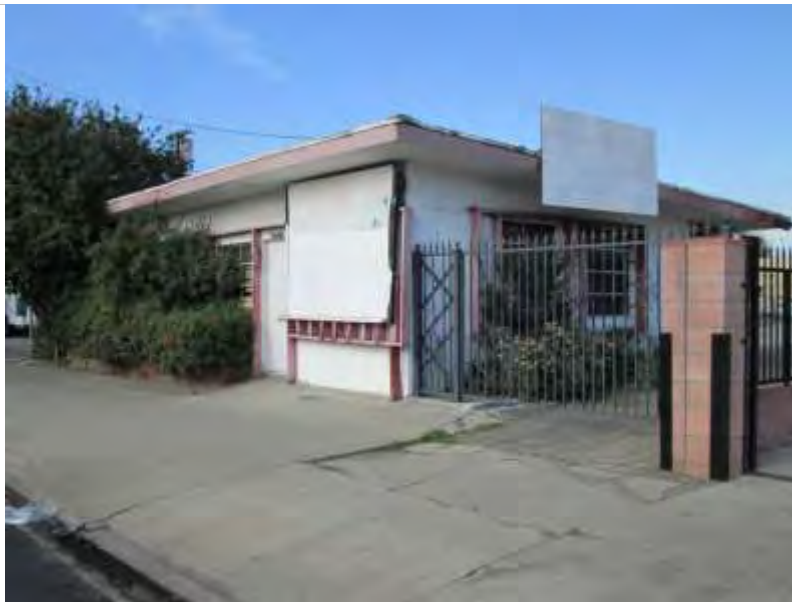
(View, date, accession #)
View looking NW, 1/8/2015

P3a. Description: (Describe resource and its major elements. Include design, materials, condition, alterations, size, setting, and boundaries.)
Los Angeles County Assessor's parcel number 2210-022-048 includes a one-story commercial building. It is located on Arminta Street, west of its intersection with Van Nuys Boulevard.

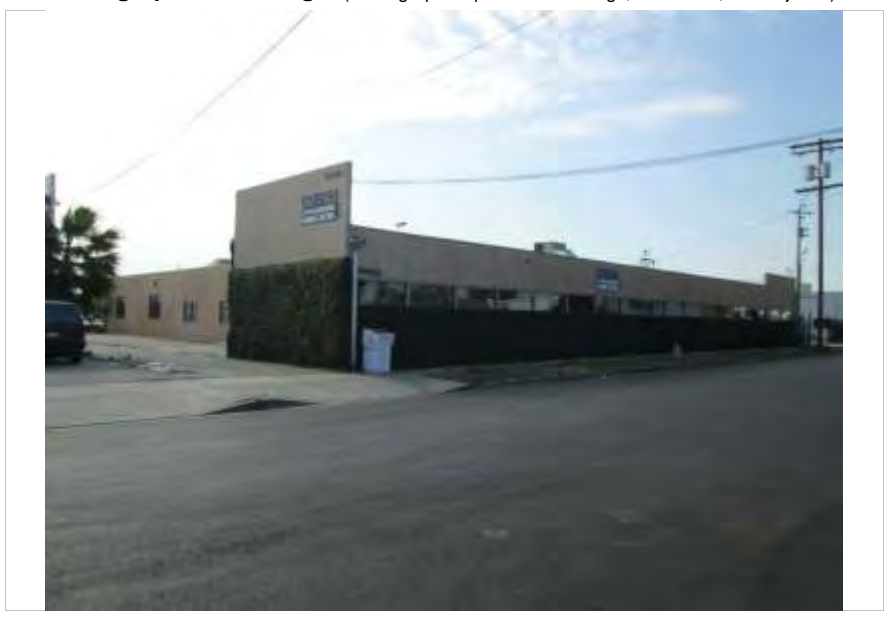
P5b. Description of Photo:
(View, date, accession #)
View looking SW, 1/8/2015

P3a. Description: (Describe resource and its major elements. Include design, materials, condition, alterations, size, setting, and boundaries.)
Los Angeles County Assessor's parcel number 2210-023-002 includes a large, one-story industrial building. The building is located on Arminta Street, east of its intersection with Willis Avenue.

*P6. Date Constructed/Age and Source: Historic Prehistoric
 Both
1953 Los Angeles County Tax Assessor

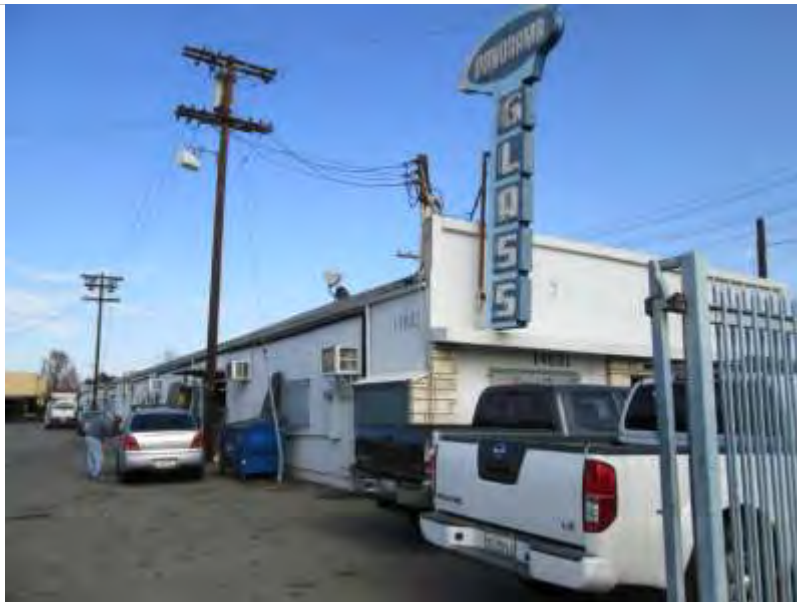
(View, date, accession #)
View looking NE, 1/8/2015

P3a. Description: (Describe resource and its major elements. Include design, materials, condition, alterations, size, setting, and boundaries.)
Los Angeles County Assessor's parcel number 2210-022-035 includes two one-story industrial buildings. They are located on Arminta Street, west of its intersection with Van Nuys Boulevard.

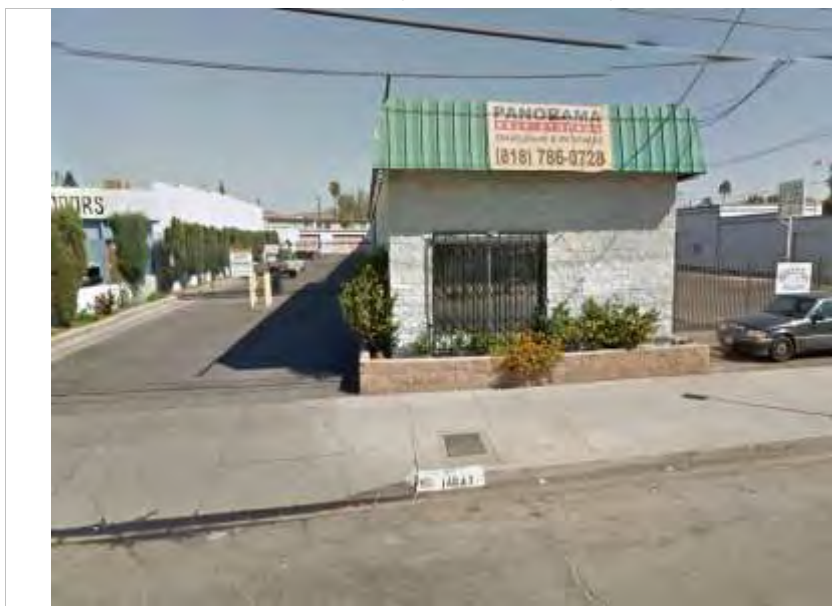
(View, date, accession #)
View looking N, Google Maps, 6/3/2015

P3a. Description: (Describe resource and its major elements. Include design, materials, condition, alterations, size, setting, and boundaries.)
Los Angeles County Assessor's parcel number 2210-022-001 includes two one-story industrial buildings. They are located on Arminta Street, west of its intersection with Van Nuys Boulevard.

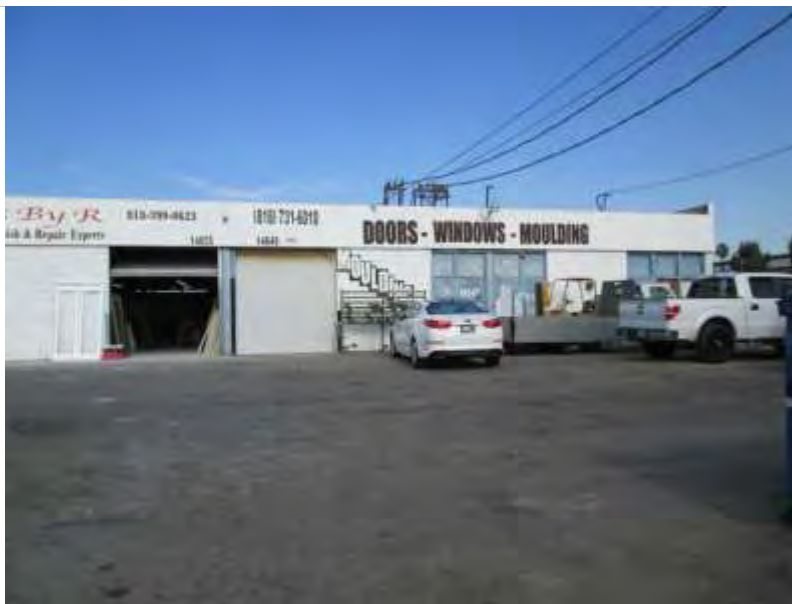
(View, date, accession #)
View looking N, 1/8/2015

P3a. Description: (Describe resource and its major elements. Include design, materials, condition, alterations, size, setting, and boundaries.)
Los Angeles County Assessor's parcel number 2210-022-047 includes a one-story industrial building. It is located on Arminta Street, west of its intersection with Van Nuys Boulevard.

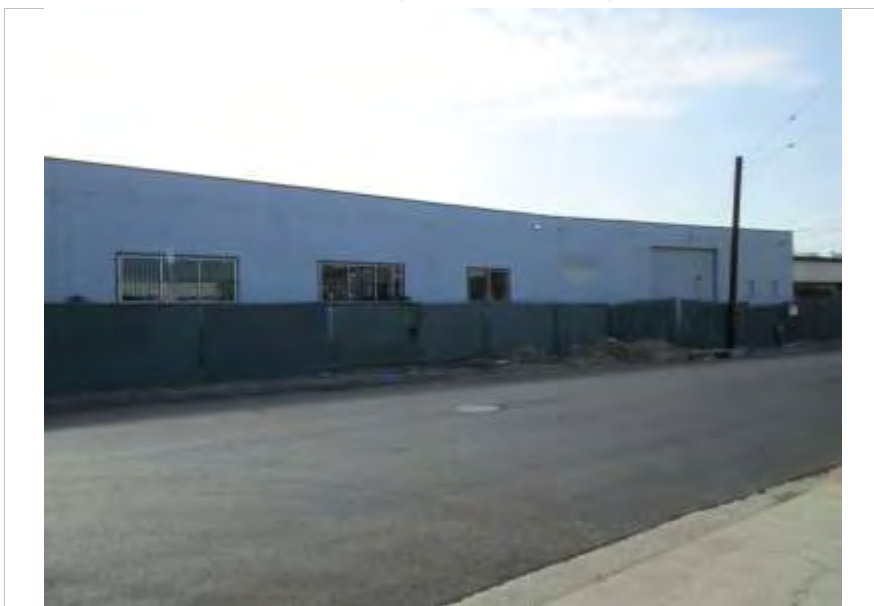
(View, date, accession #)
View looking SW, 1/8/2015

P3a. Description: (Describe resource and its major elements. Include design, materials, condition, alterations, size, setting, and boundaries.)
Los Angeles County Assessor's parcel number 2210-021-015 includes a large, one-story industrial building. The building is located on Arminta Street, east of its intersection with Willis Avenue.

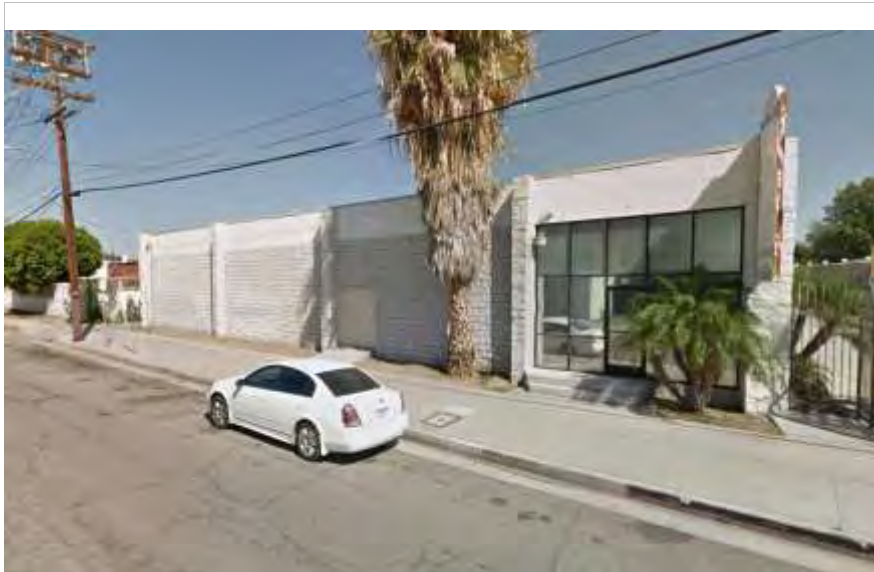
(View, date, accession #)
View looking NW, Google Maps, 6/3/2015

P3a. Description: (Describe resource and its major elements. Include design, materials, condition, alterations, size, setting, and boundaries.)
Los Angeles County Assessor's parcel number 2210-021-014 includes a one-story industrial building. It is located on Arminta Street, west of its intersection with Van Nuys Boulevard.

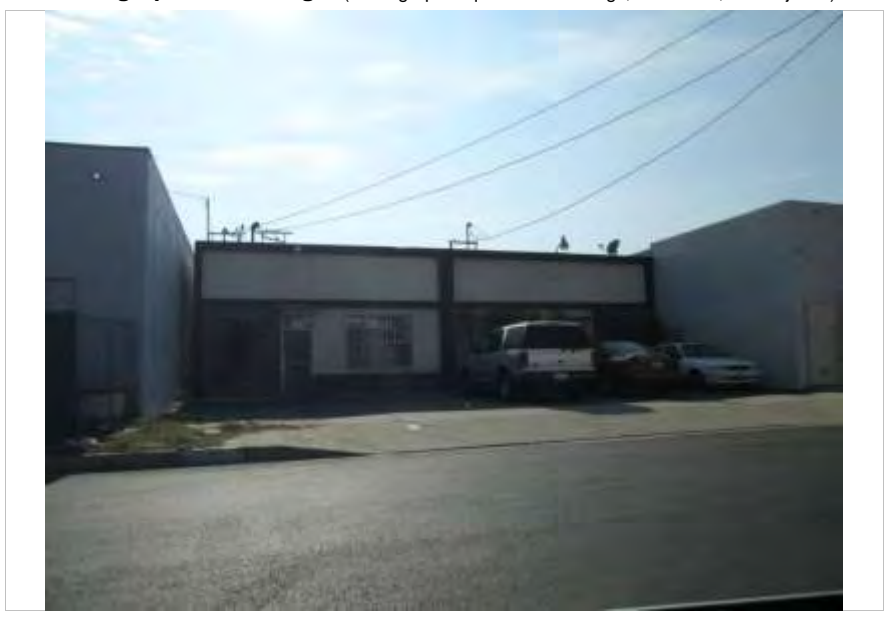
P5b. Description of Photo:
(View, date, accession #)
View looking S, 1/8/2015

P3a. Description: (Describe resource and its major elements. Include design, materials, condition, alterations, size, setting, and boundaries.)
Los Angeles County Assessor's parcel number 2210-021-021 includes a one-story industrial building. The building is located on Arminta Street, east of its intersection with Willis Avenue.

*P6. Date Constructed/Age and Source: Historic Prehistoric
 Both
1955 Los Angeles County Tax Assessor

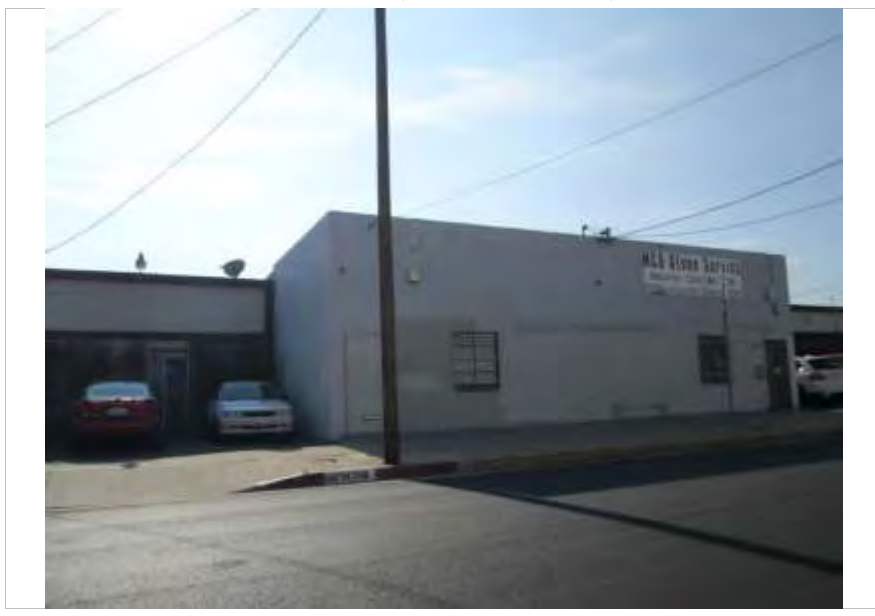
(View, date, accession #)
View looking SW, 1/8/2015

P3a. Description: (Describe resource and its major elements. Include design, materials, condition, alterations, size, setting, and boundaries.)
Los Angeles County Assessor's parcel number 2210-021-016 encompasses a one-story industrial building. The building is located on Arminta Street, east of its intersection with Willis Avenue.
