Metro®

Executive Summary

The Federal Transit Administration (FTA) and Los Angeles County Metropolitan Transportation Authority (Metro) propose to construct a project called the East San Fernando Valley Transit Corridor Project (Undertaking). The FTA is the Lead Agency under the National Environmental Policy Act (NEPA) and Metro is the Lead Agency under the California Environmental Quality Act (CEQA).

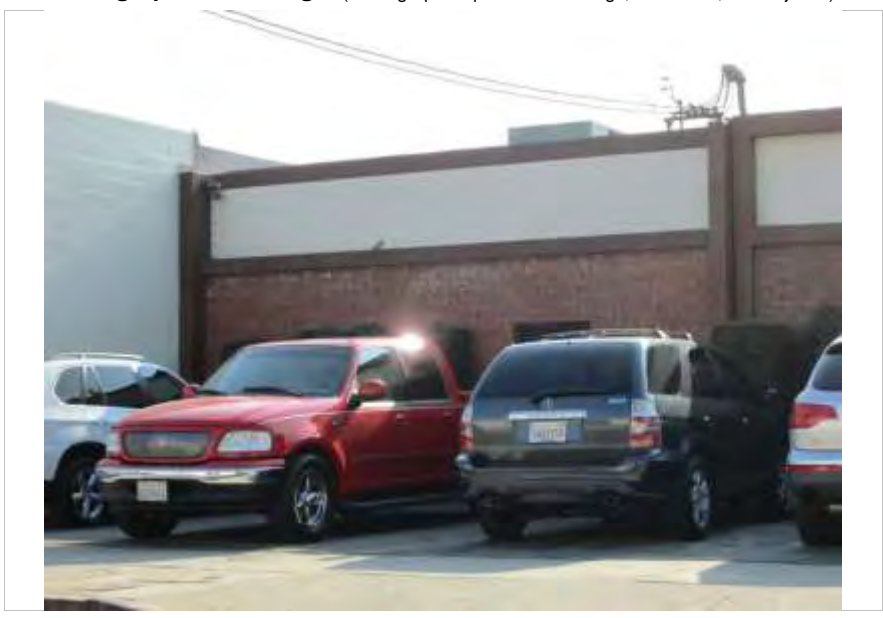
(View, date, accession #)
View looking SE, 1/8/2015

P3a. Description: (Describe resource and its major elements. Include design, materials, condition, alterations, size, setting, and boundaries.)
Los Angeles County Assessor's parcel number 2210-021-022 encompasses a one-story industrial building. The building is located on Arminta Street, east of its intersection with Willis Avenue.

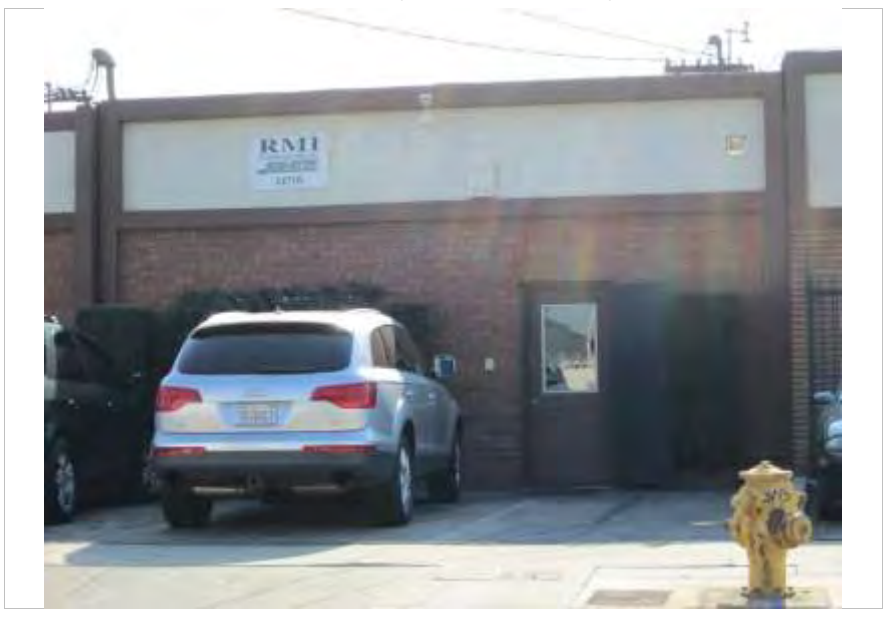
(View, date, accession #)
View looking S, 1/8/2015

P3a. Description: (Describe resource and its major elements. Include design, materials, condition, alterations, size, setting, and boundaries.)
Los Angeles County Assessor's parcel number 2210-021-023 encompasses a one-story industrial building. The building is located on Arminta Street, east of its intersection with Willis Avenue.

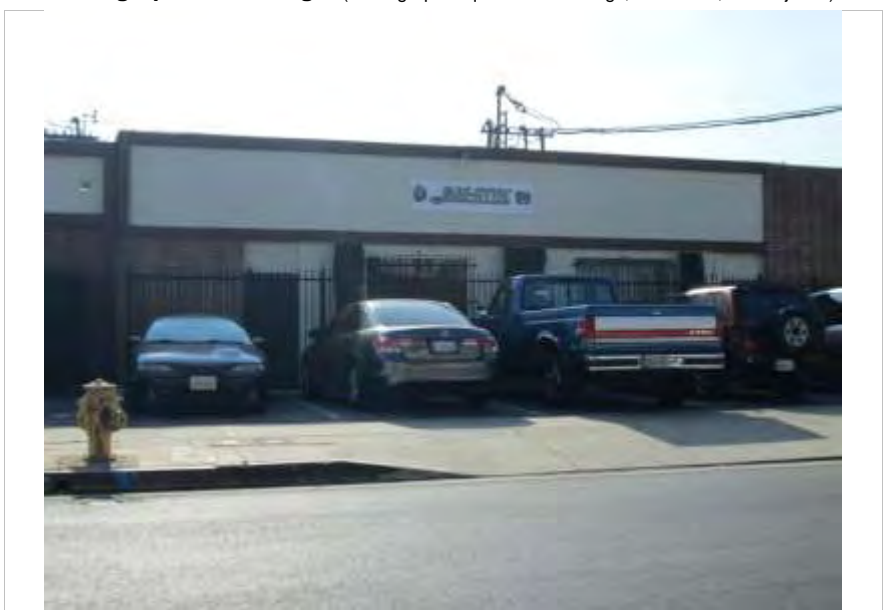
(View, date, accession #)
View looking S, 1/8/2015

P3a. Description: (Describe resource and its major elements. Include design, materials, condition, alterations, size, setting, and boundaries.)
Los Angeles County Assessor's parcel number 2210-021-017 encompasses four one-story industrial buildings that have been remodeled into one property. The buildings are located on Arminta Street, east of its intersection with Willis Avenue.

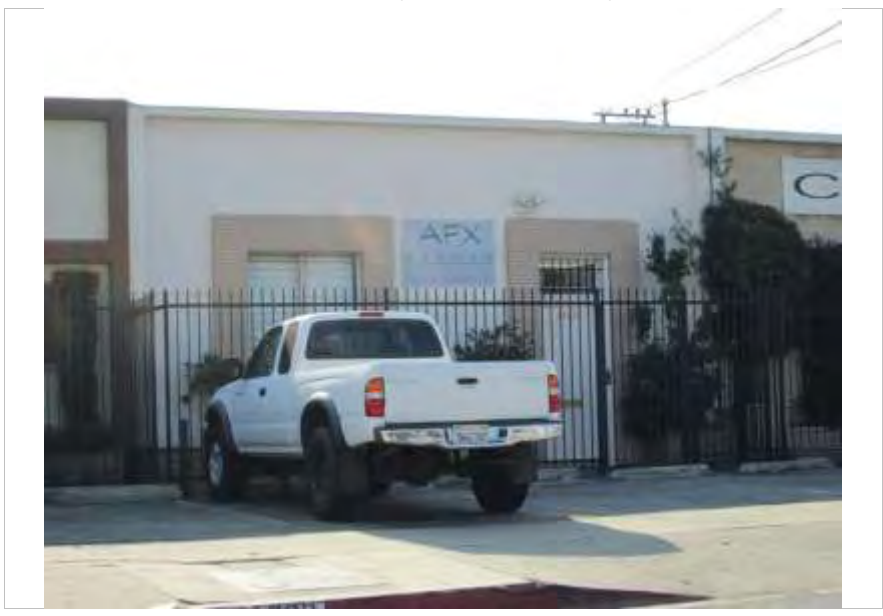
(View, date, accession #)
View looking S, 1/8/2015

P3a. Description: (Describe resource and its major elements. Include design, materials, condition, alterations, size, setting, and boundaries.)
Los Angeles County Assessor's parcel number 2210-021-028 includes a one-story industrial building. The building is located on Arminta Street, east of its intersection with Willis Avenue.

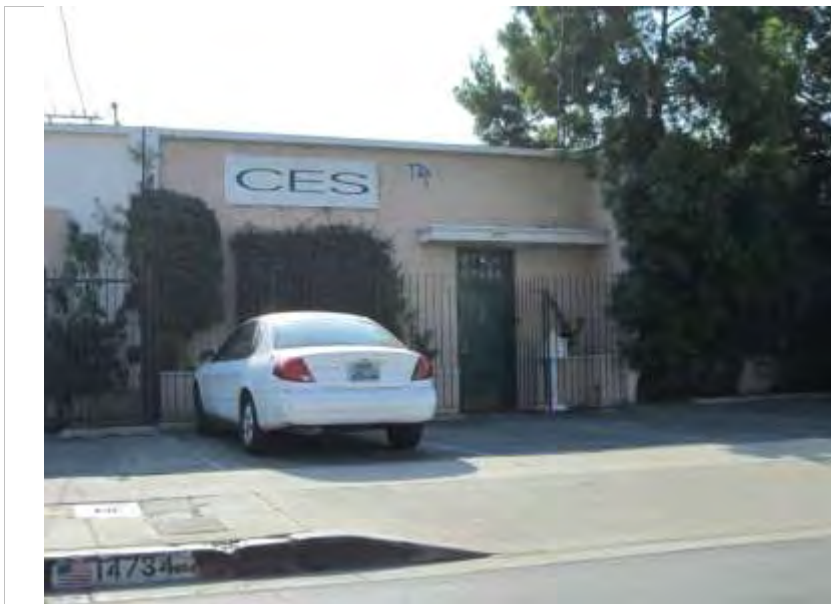
(View, date, accession #)
View looking S, 1/8/2015

P3a. Description: (Describe resource and its major elements. Include design, materials, condition, alterations, size, setting, and boundaries.)
Los Angeles County Assessor's parcel number 2210-021-024 includes a one-story industrial building. The building is located on Arminta Street, east of its intersection with Willis Avenue.

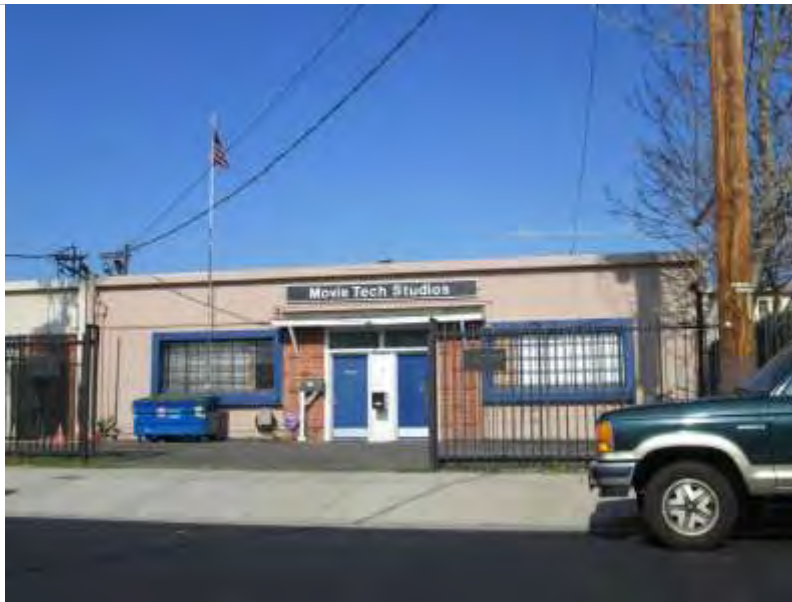
(View, date, accession #)
View looking N, 1/8/2015

P3a. Description: (Describe resource and its major elements. Include design, materials, condition, alterations, size, setting, and boundaries.)
Los Angeles County Assessor's parcel number 2210-021-040 includes a one-story industrial building. It is located on Arminta Street, west of its intersection with Van Nuys Boulevard.

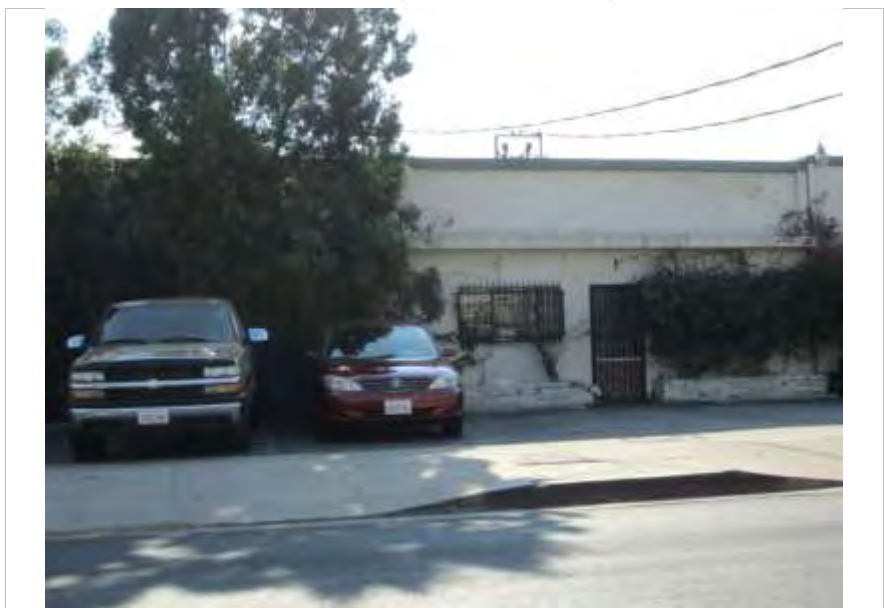
(View, date, accession #)
View looking S, 1/8/2015

P3a. Description: (Describe resource and its major elements. Include design, materials, condition, alterations, size, setting, and boundaries.)
Los Angeles County Assessor's parcel number 2210-021-019 includes a one-story industrial building. The building is located on Arminta Street, east of its intersection with Willis Avenue.

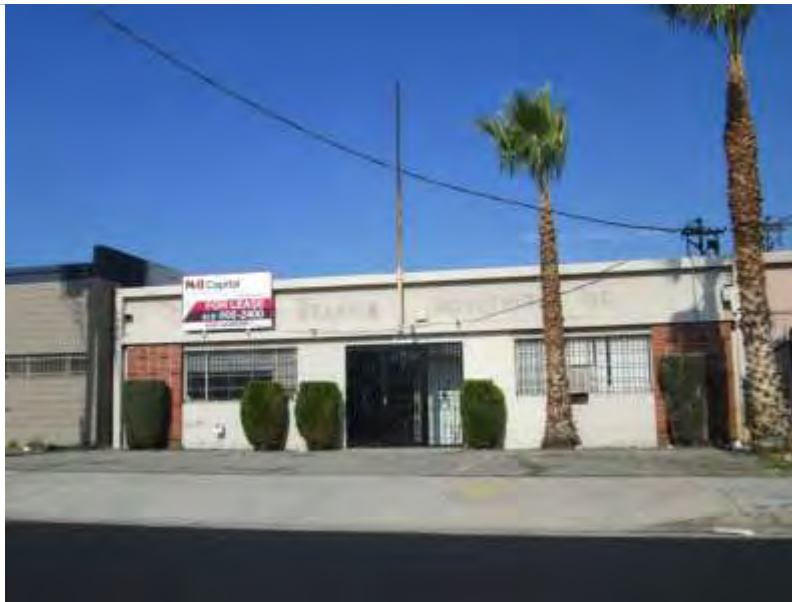
(View, date, accession #)
View looking N, 1/8/2015

P3a. Description: (Describe resource and its major elements. Include design, materials, condition, alterations, size, setting, and boundaries.)
Los Angeles County Assessor's parcel number 2210-021-039 includes a one-story industrial building. It is located on Arminta Street, west of its intersection with Van Nuys Boulevard.

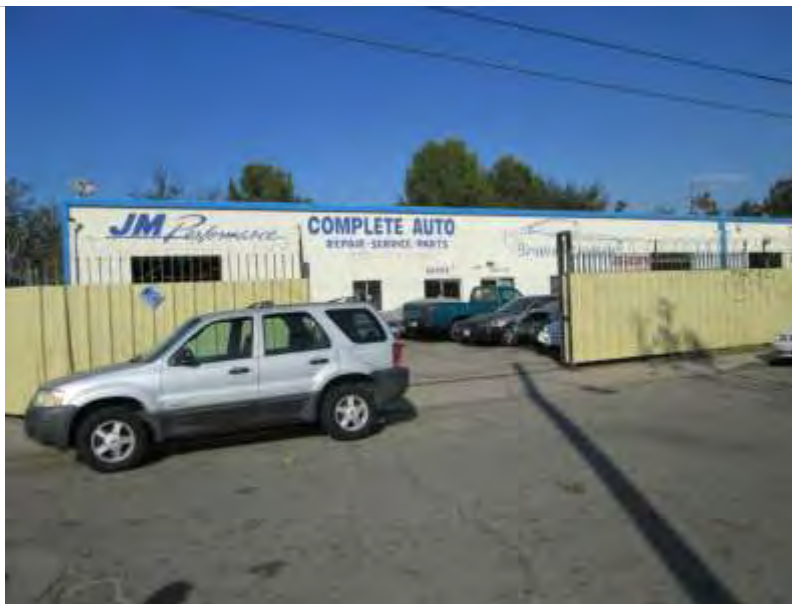
P5b. Description of Photo:

P3a. Description: (Describe resource and its major elements. Include design, materials, condition, alterations, size, setting, and boundaries.)
Los Angeles County Assessor's parcel number 2241-026-006 includes a one-story industrial building. The property is located on Aetna Street, east of its intersection with Kester Avenue.

(View, date, accession #)
View looking N, 1/8/2015

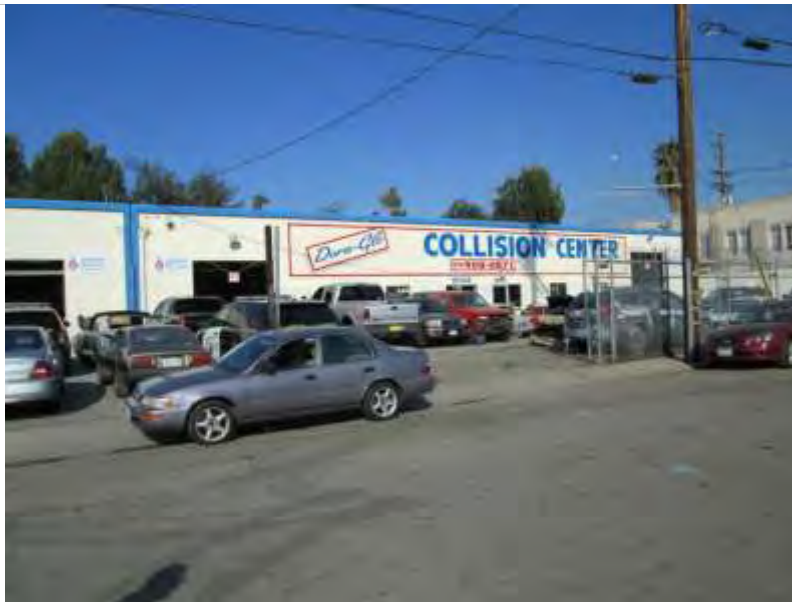
P5b. Description of Photo:

P3a. Description: (Describe resource and its major elements. Include design, materials, condition, alterations, size, setting, and boundaries.)
Los Angeles County Assessor's parcel number 2241-026-005 includes a one-story industrial building. The property is located on Aetna Street, east of its intersection with Kester Avenue.

(View, date, accession #)
View looking N, 1/8/2015

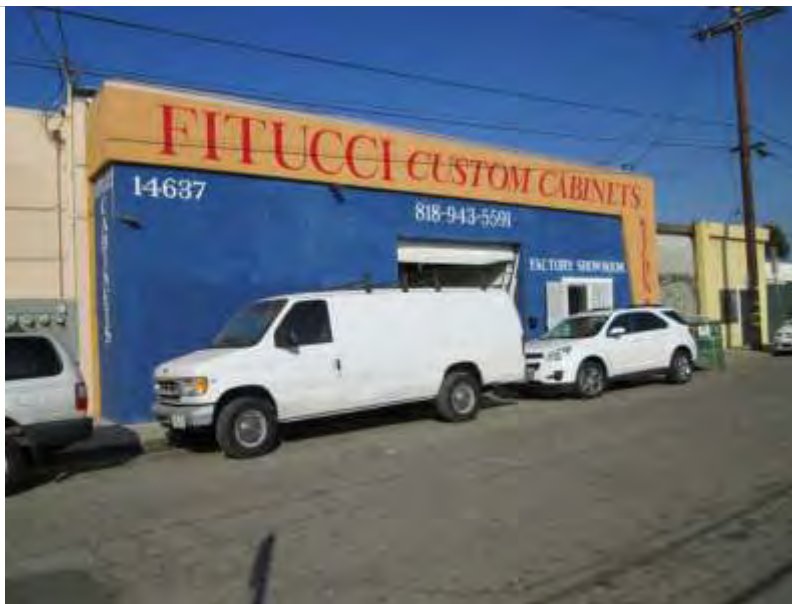
P5b. Description of Photo:

P3a. Description: (Describe resource and its major elements. Include design, materials, condition, alterations, size, setting, and boundaries.)
Los Angeles County Assessor's parcel number 2241-026-003 includes a one-story industrial building. The property is located on Aetna Street between its intersections with Cedros and Vesper Avenues.

(View, date, accession #)
View looking NE, 1/8/2015

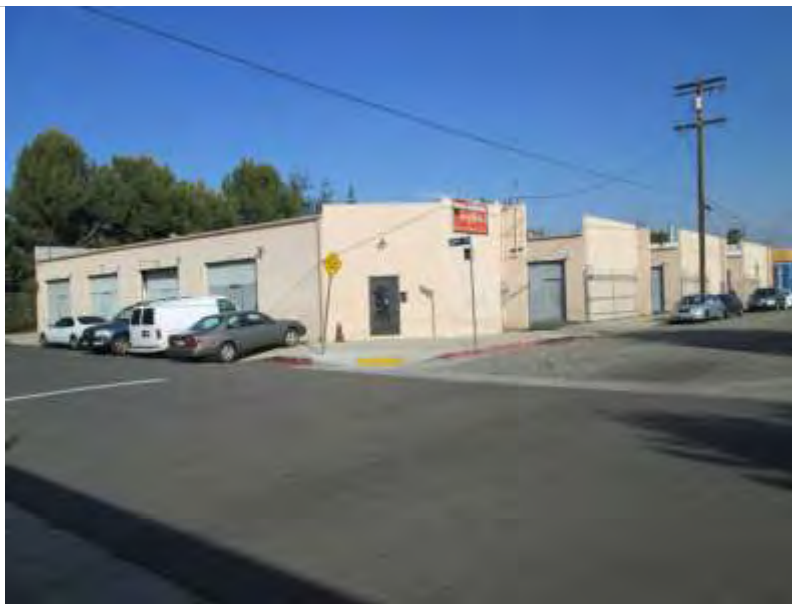
P5b. Description of Photo:

P3a. Description: (Describe resource and its major elements. Include design, materials, condition, alterations, size, setting, and boundaries.)
Los Angeles County Assessor's parcel number 2241-026-004 includes four one-story industrial buildings. The property is located on the northeast corner of Aetna Street and Cedros Avenue.

(View, date, accession #)
View looking NE, 1/8/2015

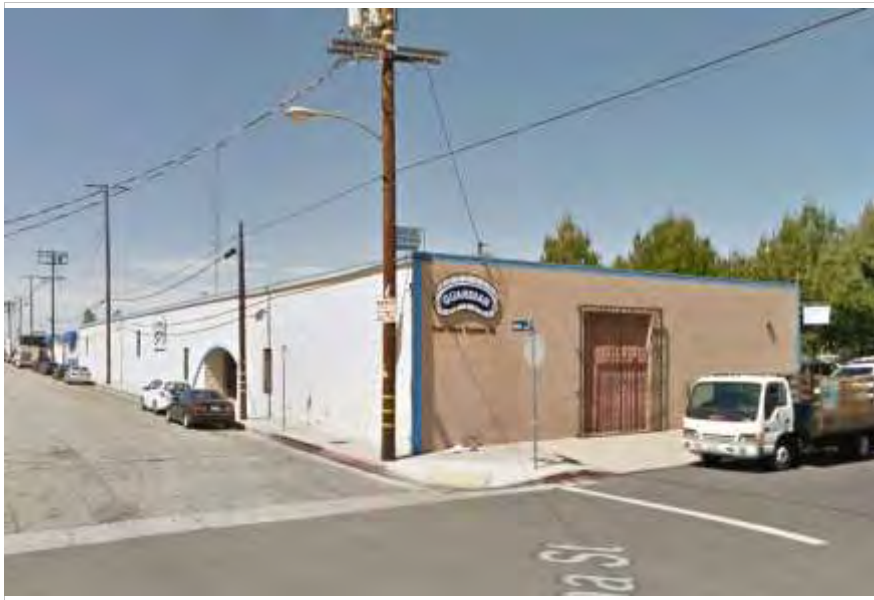
P5b. Description of Photo:

P3a. Description: (Describe resource and its major elements. Include design, materials, condition, alterations, size, setting, and boundaries.)
Los Angeles County Assessor's parcel number 2241-025-001 includes a one-story industrial building. The building is located on the northwest corner of Aetna Street and Cedros Avenue.

(View, date, accession #)
View looking NW, Google Maps, 6/3/2015

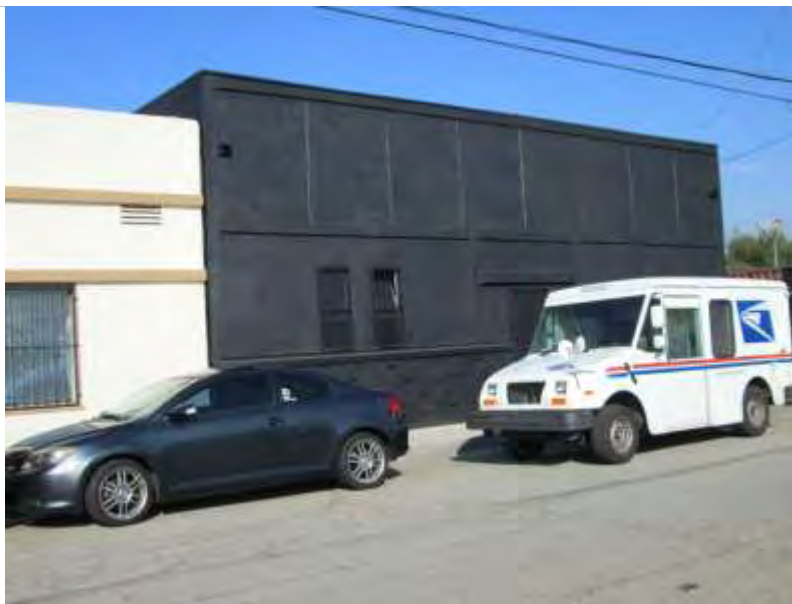
P5b. Description of Photo:

P3a. Description: (Describe resource and its major elements. Include design, materials, condition, alterations, size, setting, and boundaries.)
Los Angeles County Assessor's parcel number 2241-025-006 includes a one-story industrial building. The building is located on Aetna Street, east of its intersection with Kester Avenue.

(View, date, accession #)
View looking NE, 1/8/2015

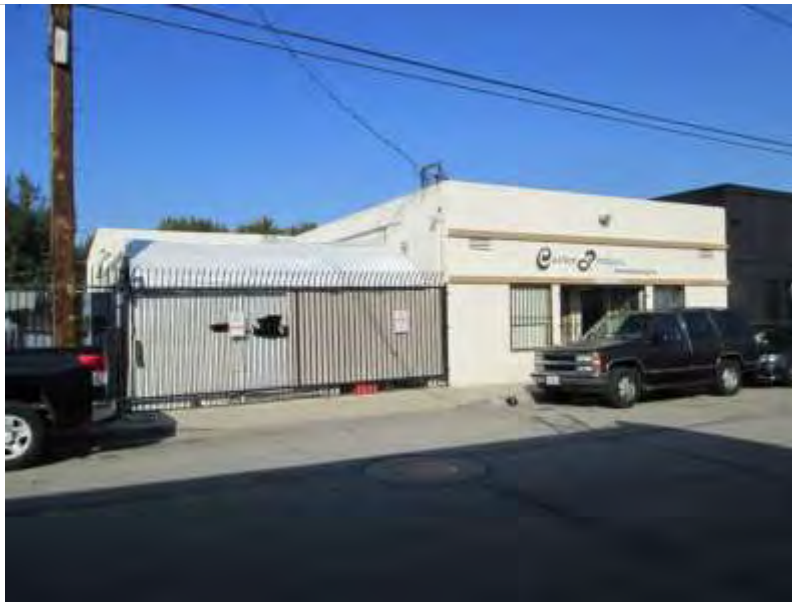
P5b. Description of Photo:

P3a. Description: (Describe resource and its major elements. Include design, materials, condition, alterations, size, setting, and boundaries.)
Los Angeles County Assessor's parcel number 2241-025-007 includes a one-story industrial building. The building is located on Aetna Street, east of its intersection with Kester Avenue.

(View, date, accession #)
View looking NE, 1/8/2015

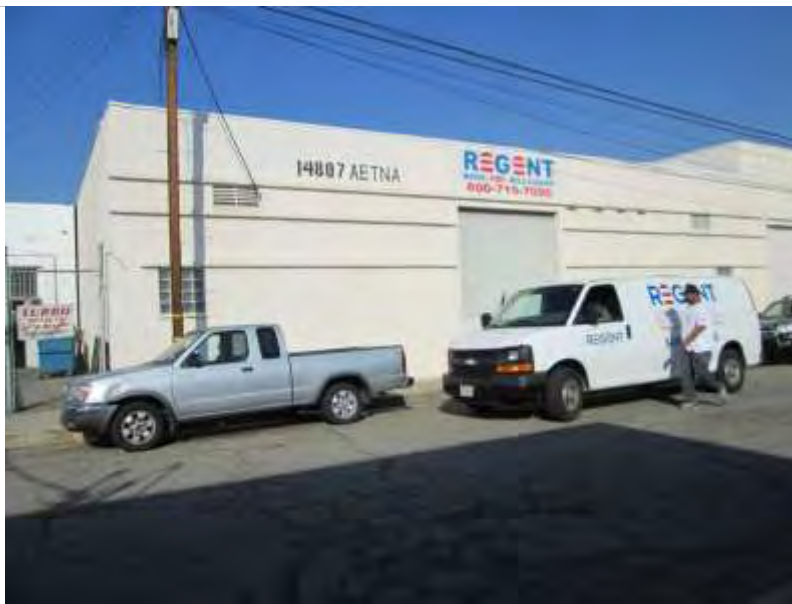
P5b. Description of Photo:

P3a. Description: (Describe resource and its major elements. Include design, materials, condition, alterations, size, setting, and boundaries.)
Los Angeles County Assessor's parcel number 2241-025-007 includes a one-story industrial building. The building is located on Aetna Street, east of its intersection with Kester Avenue.

(View, date, accession #)
View looking NE, 1/8/2015

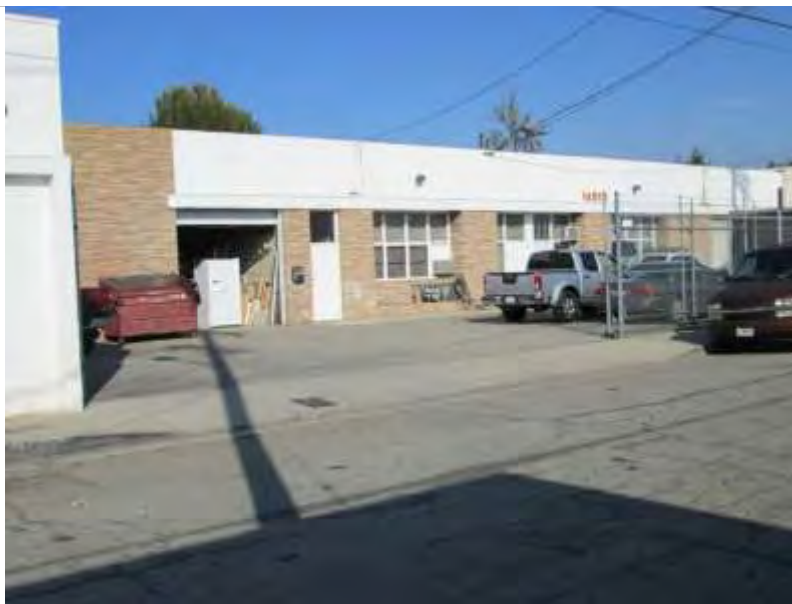
P5b. Description of Photo:

P3a. Description: (Describe resource and its major elements. Include design, materials, condition, alterations, size, setting, and boundaries.)
Los Angeles County Assessor's parcel number 2241-025-010 includes a one-story industrial building. The building is located on Aetna Street, east of its intersection with Kester Avenue.

(View, date, accession #)
View looking NE, 1/8/2015

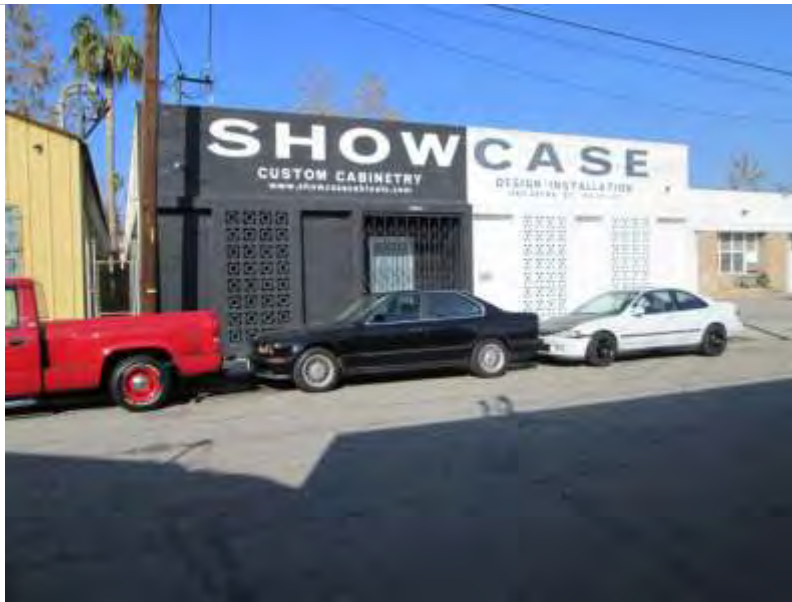
P5b. Description of Photo:

P3a. Description: (Describe resource and its major elements. Include design, materials, condition, alterations, size, setting, and boundaries.)
Los Angeles County Assessor's parcel number 2241-025-011 includes a one-story industrial building. The building is located on Aetna Street, east of its intersection with Kester Avenue.

(View, date, accession #)
View looking N, 1/8/2015

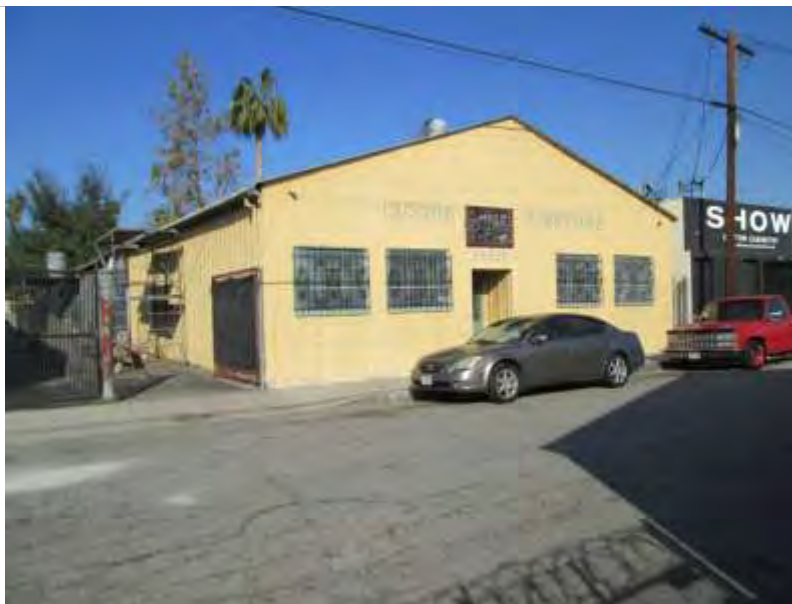
P5b. Description of Photo:

P3a. Description: (Describe resource and its major elements. Include design, materials, condition, alterations, size, setting, and boundaries.)
Los Angeles County Assessor's parcel number 2241-025-012 includes a one-story industrial building. The building is located on Aetna Street, east of its intersection with Kester Avenue.

(View, date, accession #)
View looking NE, 1/8/2015

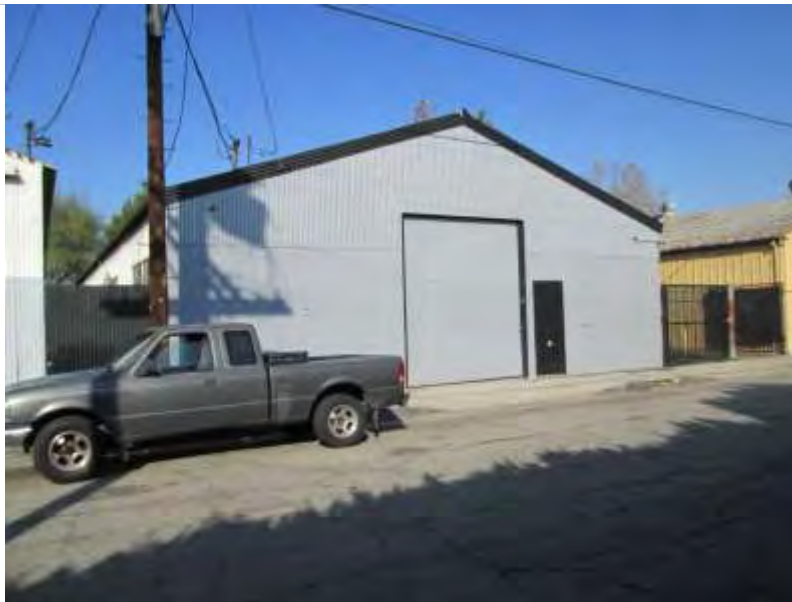
P5b. Description of Photo:

P3a. Description: (Describe resource and its major elements. Include design, materials, condition, alterations, size, setting, and boundaries.)
Los Angeles County Assessor's parcel number 2241-025-013 includes a one-story industrial building. The property is located on Aetna Street between its intersections with Cedros and Kester Avenues.

(View, date, accession #)
View looking N, 1/8/2015

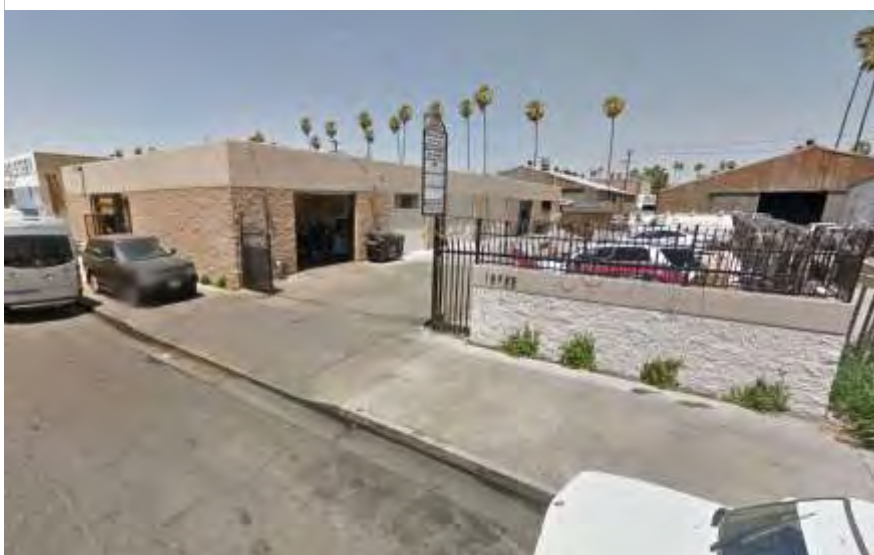
P5b. Description of Photo:

P3a. Description: (Describe resource and its major elements. Include design, materials, condition, alterations, size, setting, and boundaries.)
Los Angeles County Assessor's parcel number 2241-023-017 includes a one-story industrial building. The property is located on Bessemer Street, east of its intersection with Kester Avenue.

(View, date, accession #)
View looking NW, Google Maps, 6/3/2015

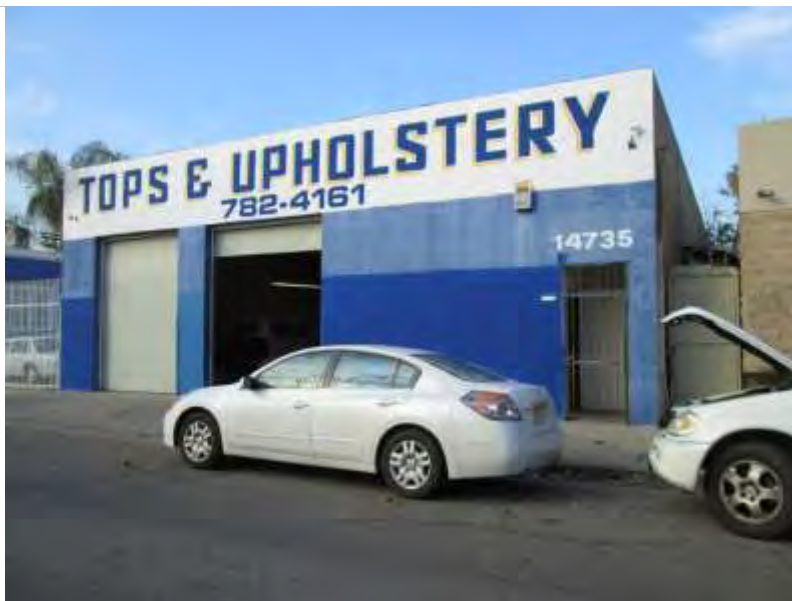
P5b. Description of Photo:

P3a. Description: (Describe resource and its major elements. Include design, materials, condition, alterations, size, setting, and boundaries.)
Los Angeles County Assessor's parcel number 2241-023-003 includes a one-story industrial building. The property is located on Bessemer Street, east of its intersection with Kester Avenue.

(View, date, accession #)
View looking NW, 1/8/2015

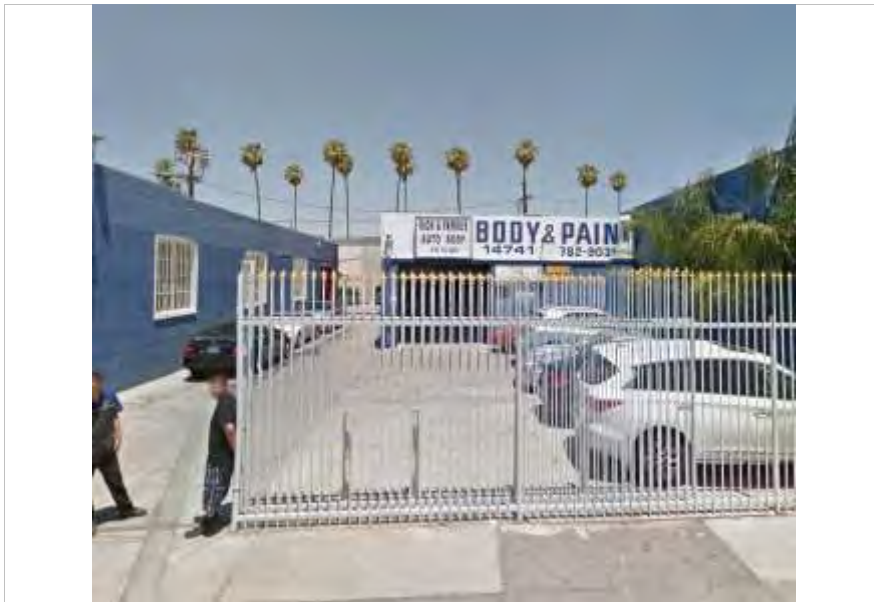
P5b. Description of Photo:

P3a. Description: (Describe resource and its major elements. Include design, materials, condition, alterations, size, setting, and boundaries.)
Los Angeles County Assessor's parcel number 2241-023-003 includes a one-story industrial building. The property is located on Bessemer Street, east of its intersection with Kester Avenue.

(View, date, accession #)
View looking N, Google Maps, 6/3/2015

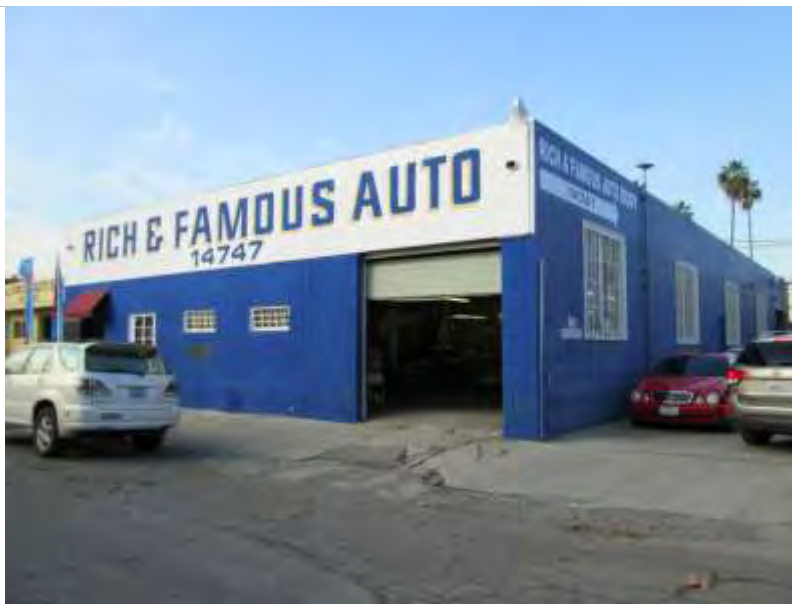
P5b. Description of Photo:

P3a. Description: (Describe resource and its major elements. Include design, materials, condition, alterations, size, setting, and boundaries.)
Los Angeles County Assessor's parcel number 2241-023-007 includes a one-story industrial building. The property is located on Bessemer Street, east of its intersection with Kester Avenue.

(View, date, accession #)
View looking NE, 1/8/2015

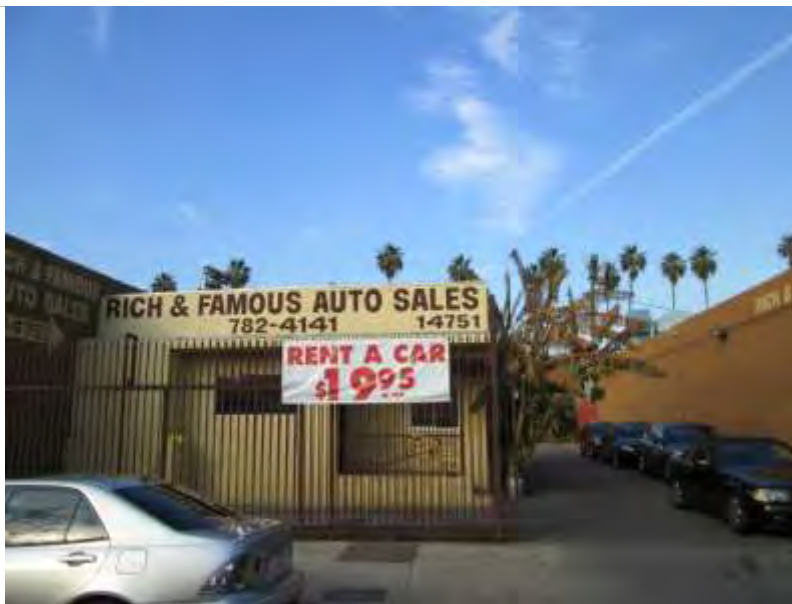
P5b. Description of Photo:

P3a. Description: (Describe resource and its major elements. Include design, materials, condition, alterations, size, setting, and boundaries.)
Los Angeles County Assessor's parcel number 2241-023-010 includes a one-story industrial building. The property is located on Bessemer Street, east of its intersection with Kester Avenue.

(View, date, accession #)
View looking N, 1/8/2015

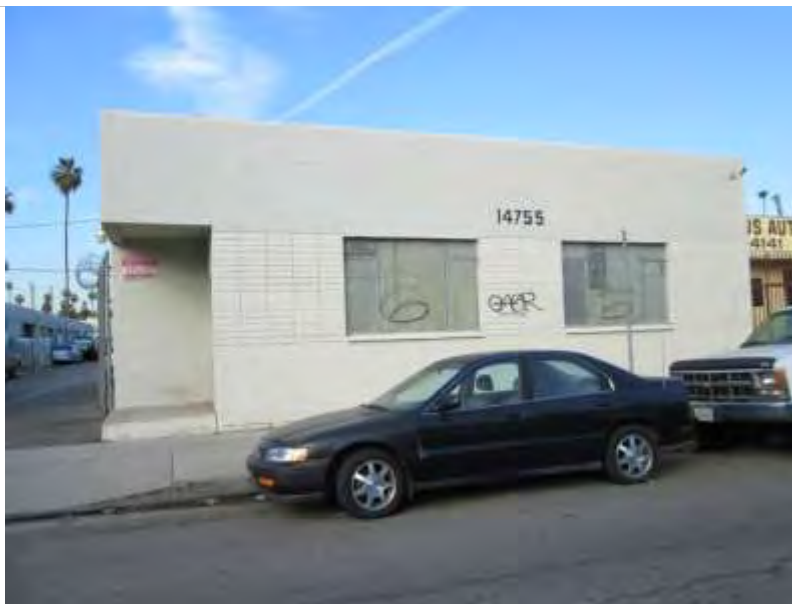
P5b. Description of Photo:

P3a. Description: (Describe resource and its major elements. Include design, materials, condition, alterations, size, setting, and boundaries.)
Los Angeles County Assessor's parcel number 2241-023-014 includes a one-story industrial building. The property is located on Bessemer Street, east of its intersection with Kester Avenue.

(View, date, accession #)
View looking N, 1/8/2015

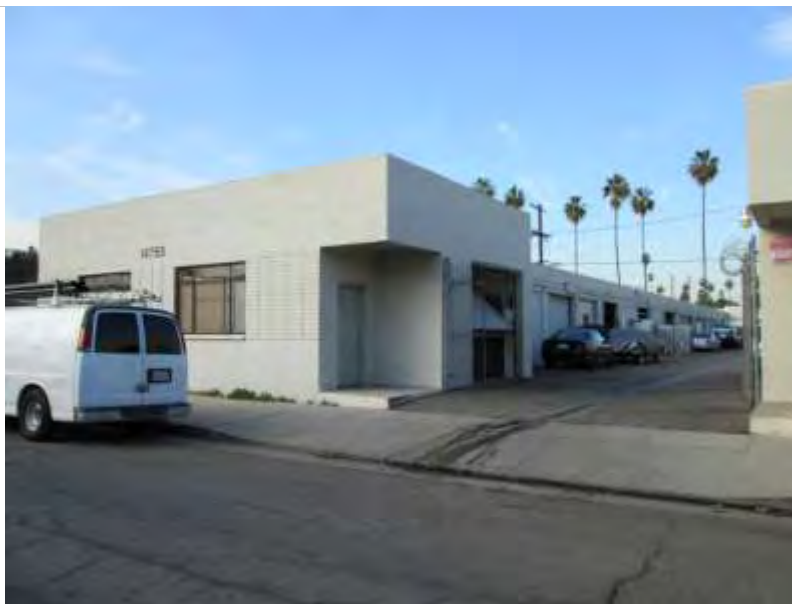
P5b. Description of Photo:

P3a. Description: (Describe resource and its major elements. Include design, materials, condition, alterations, size, setting, and boundaries.)
Los Angeles County Assessor's parcel number 2241-023-013 includes a one-story industrial building. The property is located on Bessemer Street, east of its intersection with Kester Avenue.

(View, date, accession #)
View looking NW, 1/8/2015

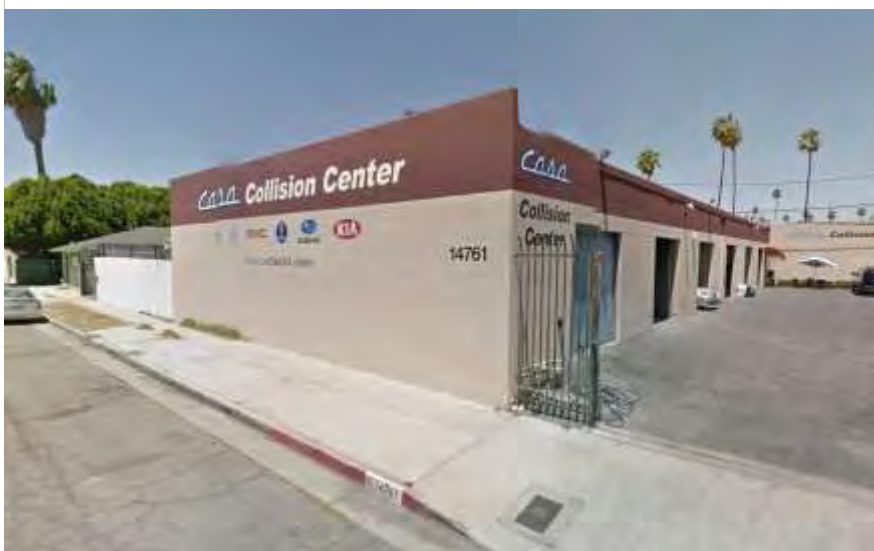
P5b. Description of Photo:

P3a. Description: (Describe resource and its major elements. Include design, materials, condition, alterations, size, setting, and boundaries.)
Los Angeles County Assessor's parcel number 2241-024-003 includes a one-story industrial building. The property is located on Bessemer Street, east of its intersection with Kester Avenue.

(View, date, accession #)
View looking NW, Google Maps, 6/3/2015

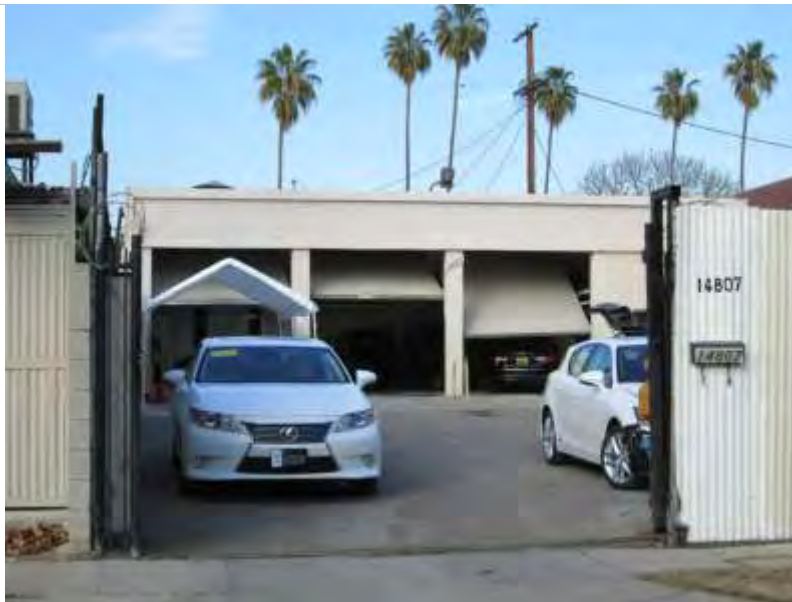
P5b. Description of Photo:

P3a. Description: (Describe resource and its major elements. Include design, materials, condition, alterations, size, setting, and boundaries.)
Los Angeles County Assessor's parcel number 2241-024-004 includes a one-story industrial building. The property is between Bessemer and Calvert Streets, east of Kester Avenue.

(View, date, accession #)
View looking N, 1/8/2015

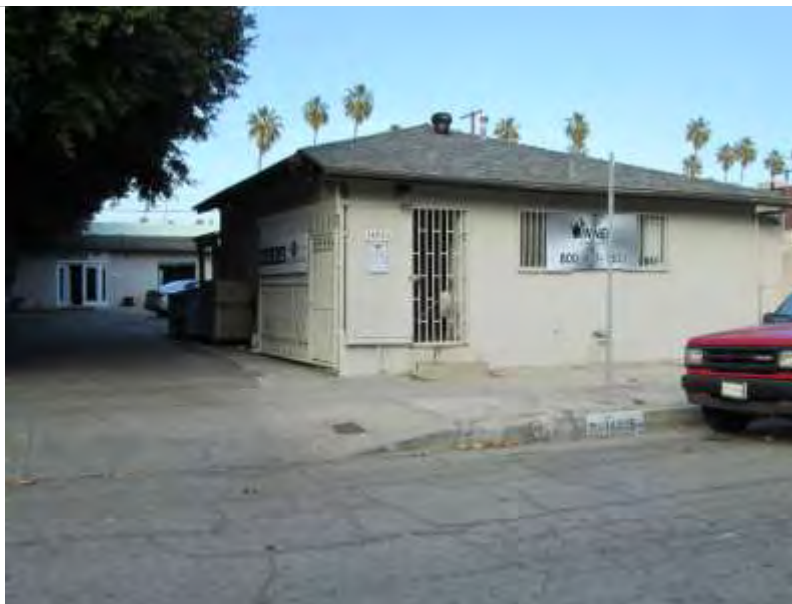
P5b. Description of Photo:

P3a. Description: (Describe resource and its major elements. Include design, materials, condition, alterations, size, setting, and boundaries.)
Los Angeles County Assessor's parcel number 2241-024-006 includes two one-story industrial buildings. The property is located on Bessemer Street, east of its intersection with Kester Avenue.

(View, date, accession #)
View looking NE, 1/8/2015

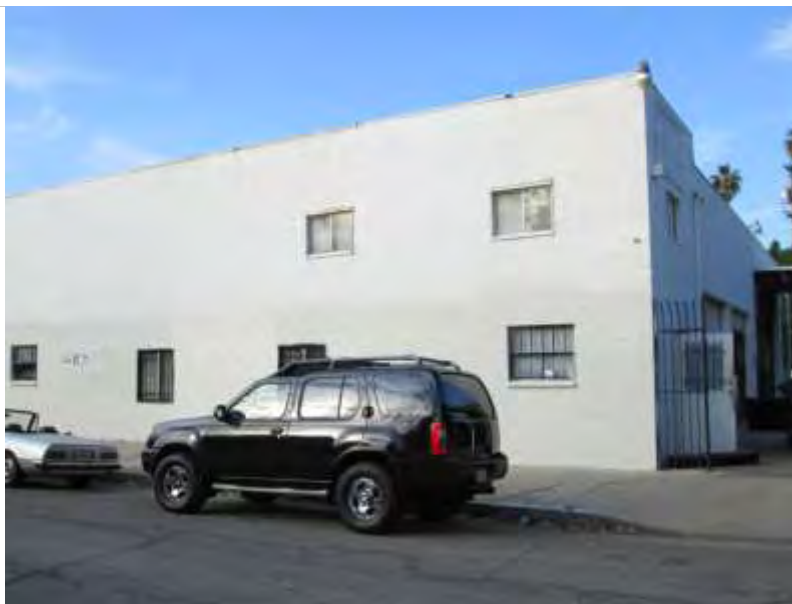
P5b. Description of Photo:

P3a. Description: (Describe resource and its major elements. Include design, materials, condition, alterations, size, setting, and boundaries.)
Los Angeles County Assessor's parcel number 2241-024-017 includes a two-story industrial building. The property is located on Bessemer Street, east of its intersection with Kester Avenue.

(View, date, accession #)
View looking NW, 1/8/2015

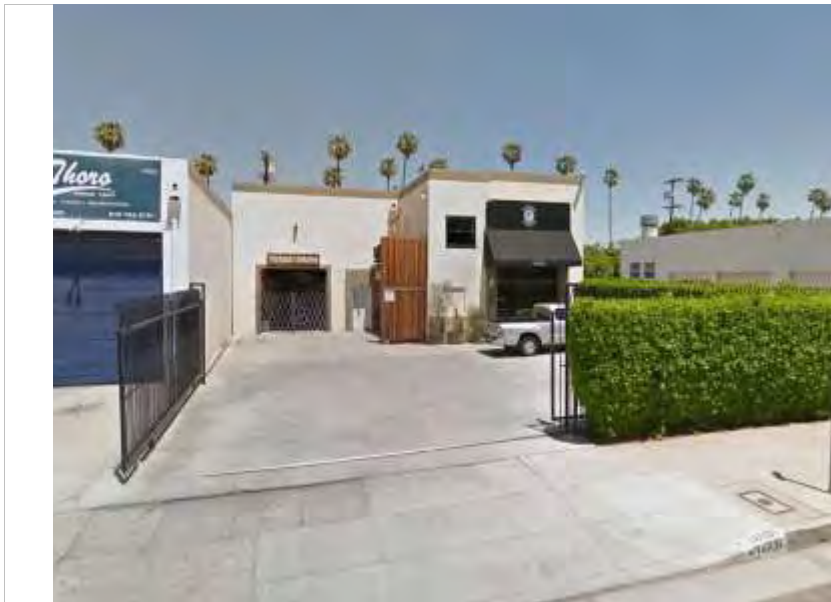
P5b. Description of Photo:

P3a. Description: (Describe resource and its major elements. Include design, materials, condition, alterations, size, setting, and boundaries.)
Los Angeles County Assessor's parcel number 2241-024-012 includes a two-story industrial building. The property is located on Bessemer Street, east of its intersection with Kester Avenue.

(View, date, accession #)
View looking N, Google Maps, 6/3/2015

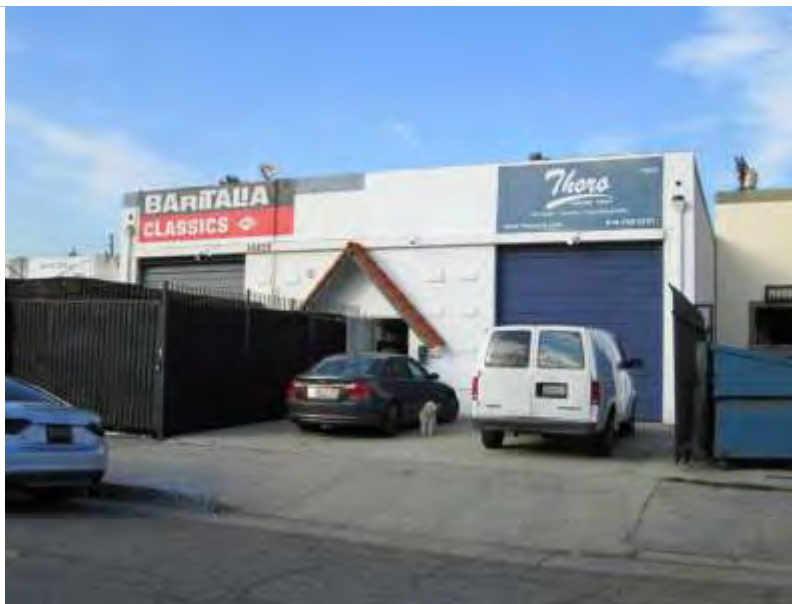
P5b. Description of Photo:

P3a. Description: (Describe resource and its major elements. Include design, materials, condition, alterations, size, setting, and boundaries.)
Los Angeles County Assessor's parcel number 2241-024-018 includes a one-story industrial building. The property is located on Bessemer Street, east of its intersection with Kester Avenue.

(View, date, accession #)
View looking N, 1/8/2015

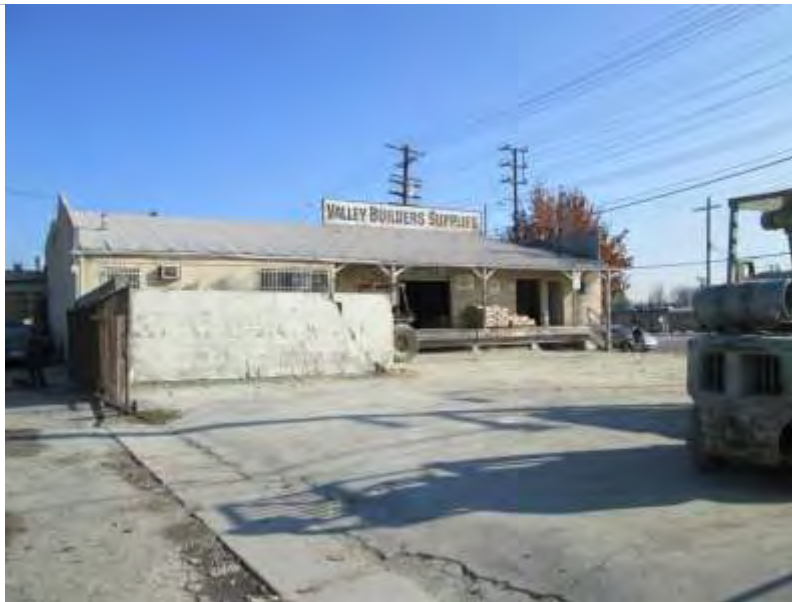
P3a. Description: (Describe resource and its major elements. Include design, materials, condition, alterations, size, setting, and boundaries.)
Los Angeles County Assessor's parcel number 2241-025-028 includes a one-story commercial building. The building is located on the northeast corner of Kester Avenue and Oxnard Street.

(View, date, accession #)
View looking SE, 1/7/2015

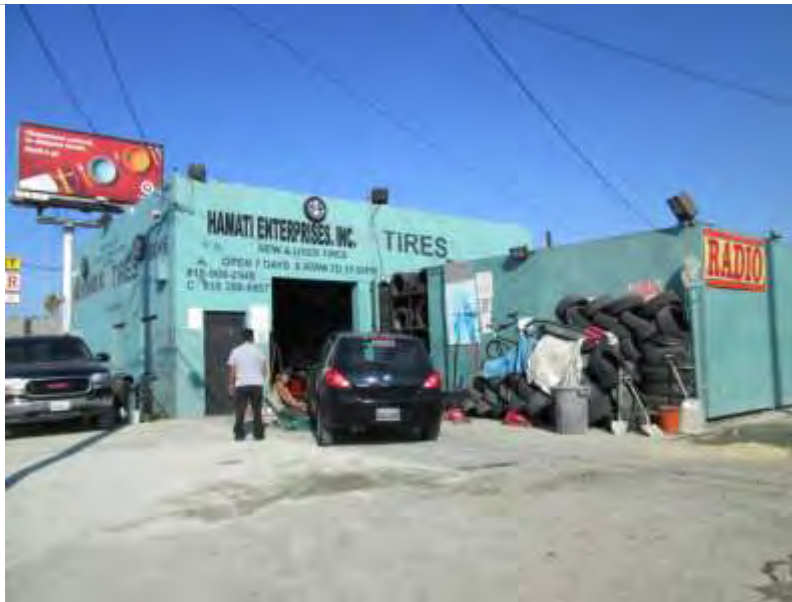
P3a. Description: (Describe resource and its major elements. Include design, materials, condition, alterations, size, setting, and boundaries.)
Los Angeles County Assessor's parcel number 2241-025-027 includes a one-story industrial building. The building is located on Kester Avenue, south of its intersection with Aetna Street.

(View, date, accession #)
View looking NE, 1/7/2015

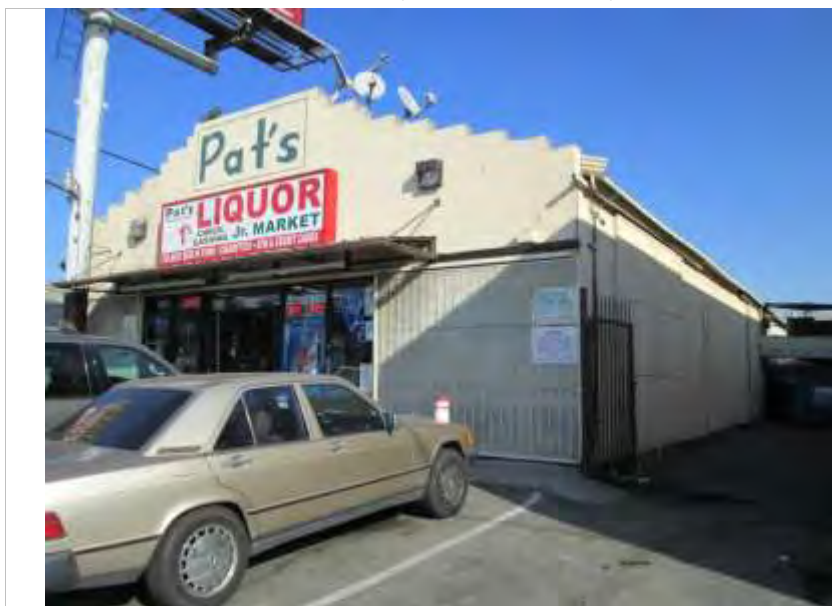
P3a. Description: (Describe resource and its major elements. Include design, materials, condition, alterations, size, setting, and boundaries.)
Los Angeles County Assessor's parcel number 2241-025-021 includes a one-story industrial building. The building is located on the southeast corner of Kester Avenue and Aetna Street.

(View, date, accession #)
View looking NE, 1/7/2015

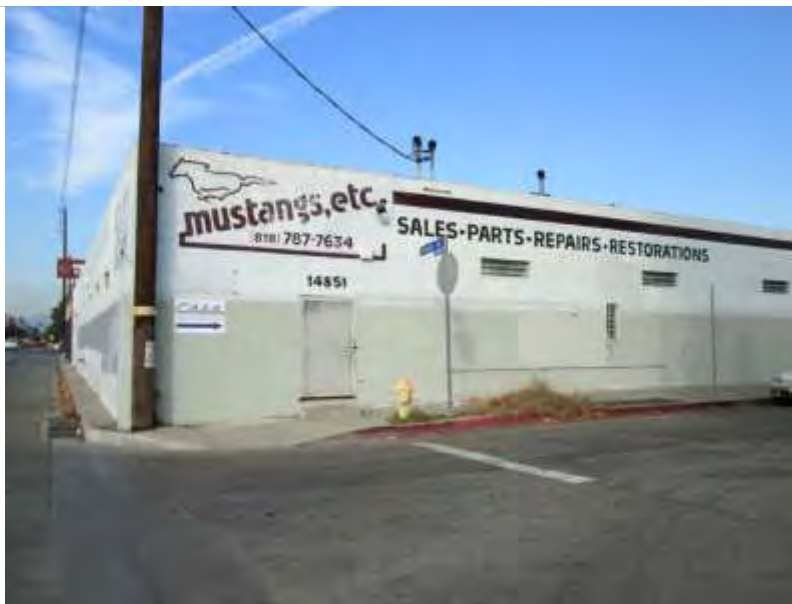
P3a. Description: (Describe resource and its major elements. Include design, materials, condition, alterations, size, setting, and boundaries.)
Los Angeles County Assessor's parcel number 2241-024-016 includes two large, one-story industrial buildings. The property is located on Kester Avenue and spans between Calvert and Bessemer Streets.

(View, date, accession #)
View looking NE, 1/7/2015
