Metro®

Executive Summary

The Federal Transit Administration (FTA) and Los Angeles County Metropolitan Transportation Authority (Metro) propose to construct a project called the East San Fernando Valley Transit Corridor Project (Undertaking). The FTA is the Lead Agency under the National Environmental Policy Act (NEPA) and Metro is the Lead Agency under the California Environmental Quality Act (CEQA).

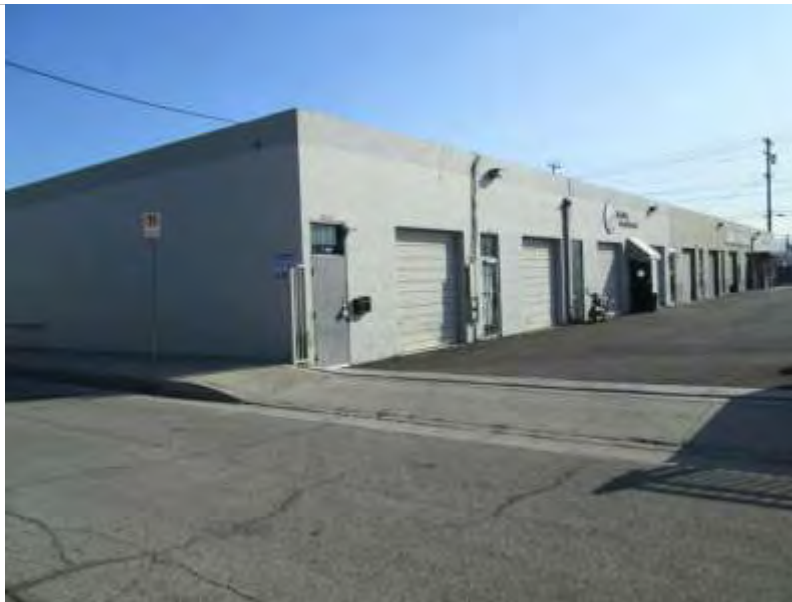
P3a. Description: (Describe resource and its major elements. Include design, materials, condition, alterations, size, setting, and boundaries.)
Los Angeles County Assessor's parcel number 2241-025-025 includes three one-story industrial buildings. The property is located on Oxnard Street, east of its intersection with Kester Avenue.

(View, date, accession #)
View looking SE, 1/8/2015

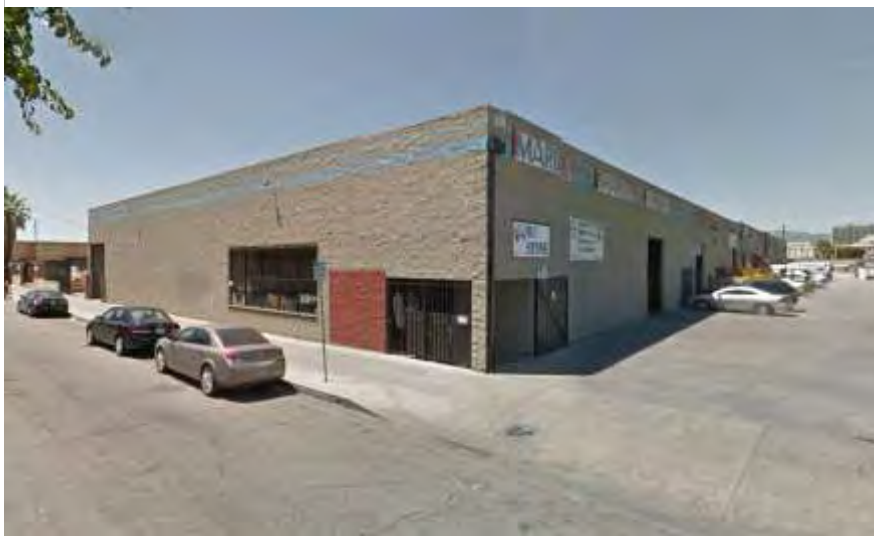
P3a. Description: (Describe resource and its major elements. Include design, materials, condition, alterations, size, setting, and boundaries.)
Los Angeles County Assessor's parcel numbers 2210-030-007, 2210-030-008, 2210-030-030, 2210-030-031 include a one-story industrial building. The building spans between Raymer and Keswick Streets, west of Van Nuys Boulevard.

(View, date, accession #)
View looking NW, Google Maps, 6/3/2015

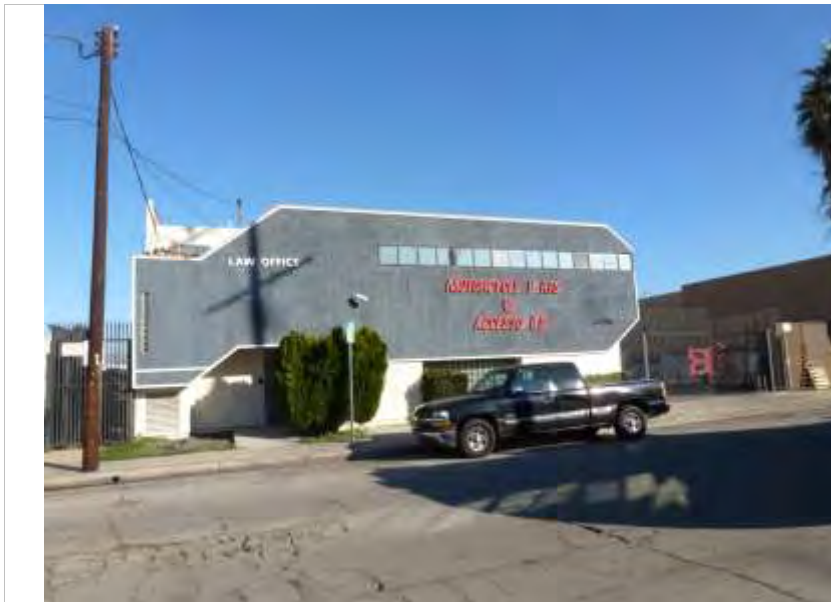
P3a. Description: (Describe resource and its major elements. Include design, materials, condition, alterations, size, setting, and boundaries.)
Los Angeles County Assessor's parcel number 2210-030-016 includes a one and two-story industrial building. It is located on Keswick Street, east of its intersection with Tobias Avenue.

(View, date, accession #)
View looking N, 1/13/2015

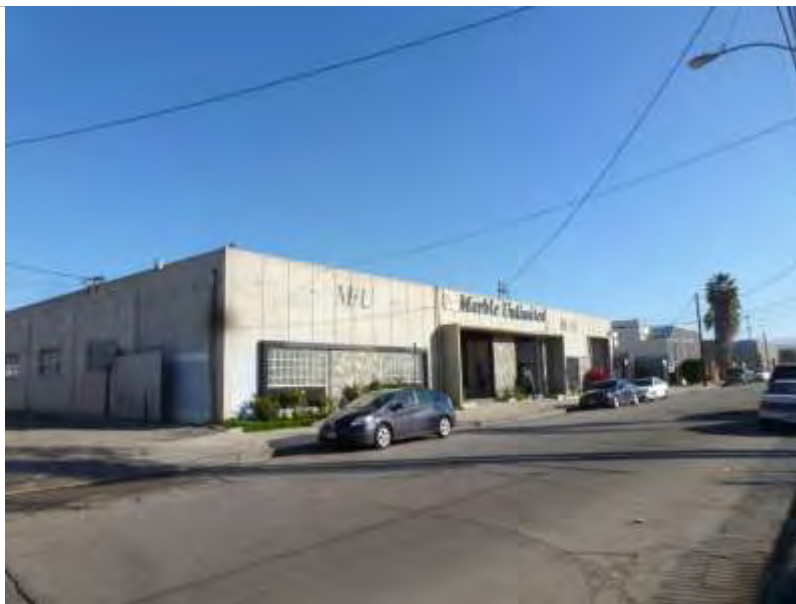
P3a. Description: (Describe resource and its major elements. Include design, materials, condition, alterations, size, setting, and boundaries.)
Los Angeles County Assessor's parcel number 2210-030-016 includes a one-story industrial building. It is located on Keswick Street, east of its intersection with Tobias Avenue.

(View, date, accession #)
View looking NE, 1/13/2015

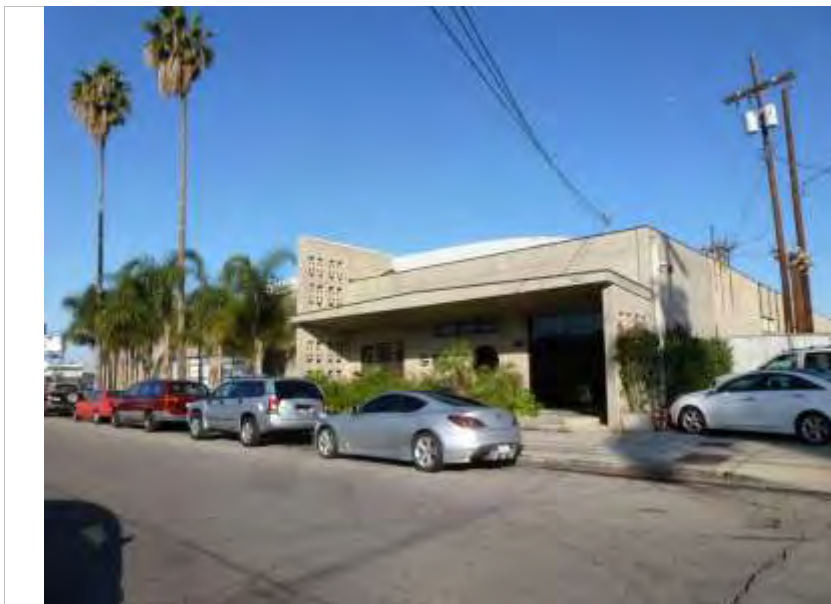
P3a. Description: (Describe resource and its major elements. Include design, materials, condition, alterations, size, setting, and boundaries.)
Los Angeles County Assessor's parcel number 2210-030-024 includes a one-story industrial building. It is located on Keswick Street, east of its intersection with Tobias Avenue.

(View, date, accession #)
View looking NW, 1/13/2015

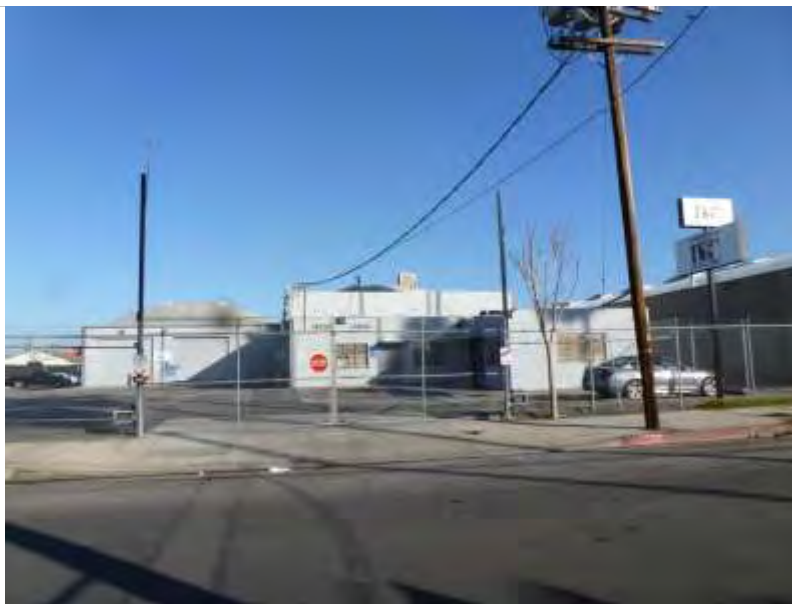
P3a. Description: (Describe resource and its major elements. Include design, materials, condition, alterations, size, setting, and boundaries.)
Los Angeles County Assessor's parcel number 2210-025-005 includes a one-story industrial building. It is located on Keswick Street, north of its intersection with Tobias Avenue.

(View, date, accession #)
View looking N, 1/13/2015

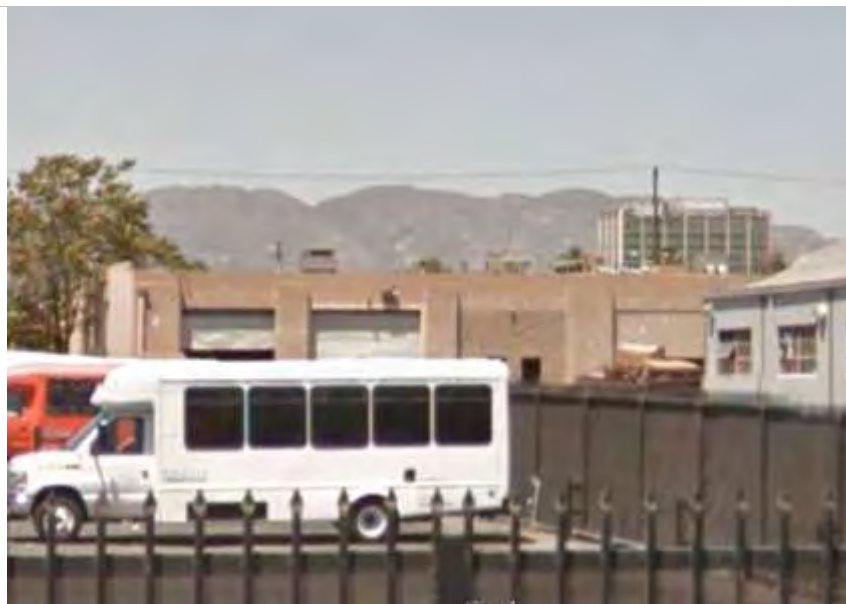
P3a. Description: (Describe resource and its major elements. Include design, materials, condition, alterations, size, setting, and boundaries.)
Los Angeles County Assessor's parcel number 2210-025-035 includes a one-story industrial building. It is located on Keswick Street, north of its intersection with Tobias Avenue.

(View, date, accession #)
View looking N, Google Maps, 6/3/2015

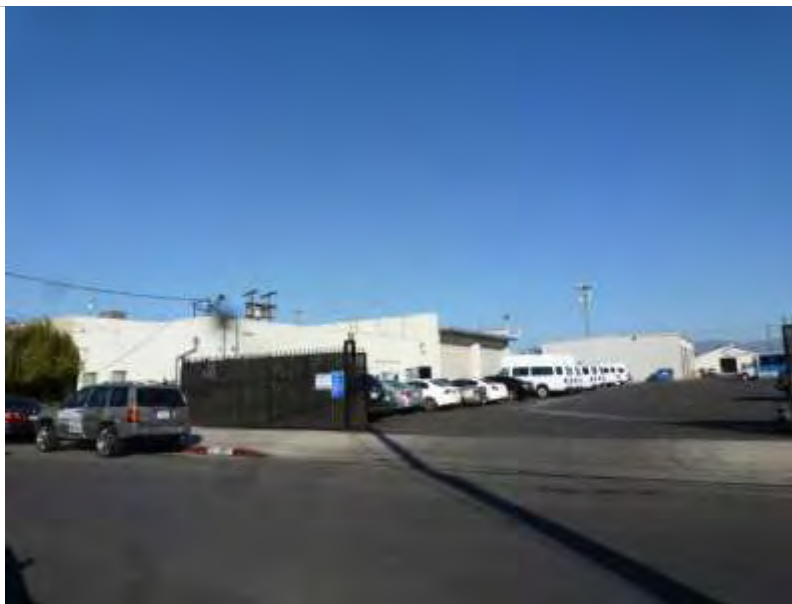
P3a. Description: (Describe resource and its major elements. Include design, materials, condition, alterations, size, setting, and boundaries.)
Los Angeles County Assessor's parcel number 2210-025-009 includes a one-story industrial building. It is located on Keswick Street, west of its intersection with Tobias Avenue.

(View, date, accession #)
View looking NW, 1/13/2015

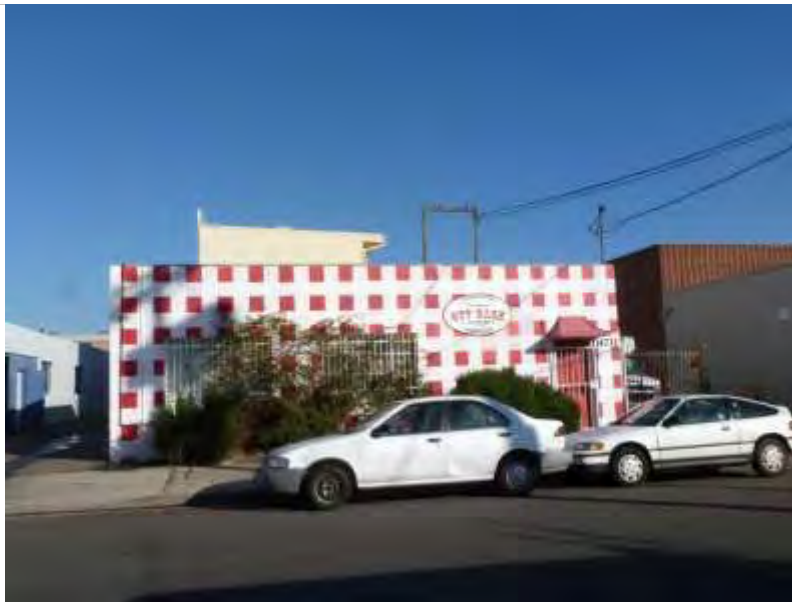
P3a. Description: (Describe resource and its major elements. Include design, materials, condition, alterations, size, setting, and boundaries.)
Los Angeles County Assessor's parcel number 2210-025-036 includes a one-story industrial building. It is located on Keswick Street, west of its intersection with Tobias Avenue.

(View, date, accession #)
View looking N, 1/13/2015

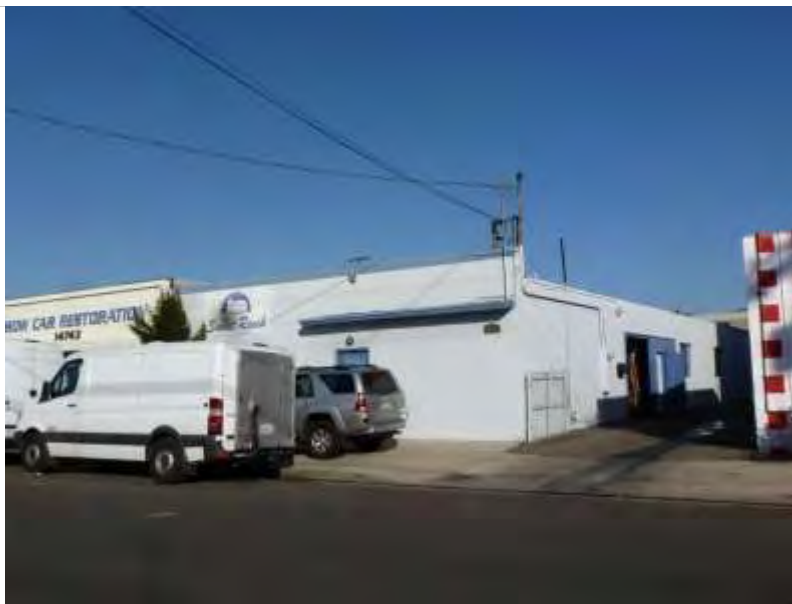
P3a. Description: (Describe resource and its major elements. Include design, materials, condition, alterations, size, setting, and boundaries.)
Los Angeles County Assessor's parcel number 2210-025-015 includes a one-story industrial building. It is located on Keswick Street, west of its intersection with Tobias Avenue.

(View, date, accession #)
View looking NW, 1/13/2015

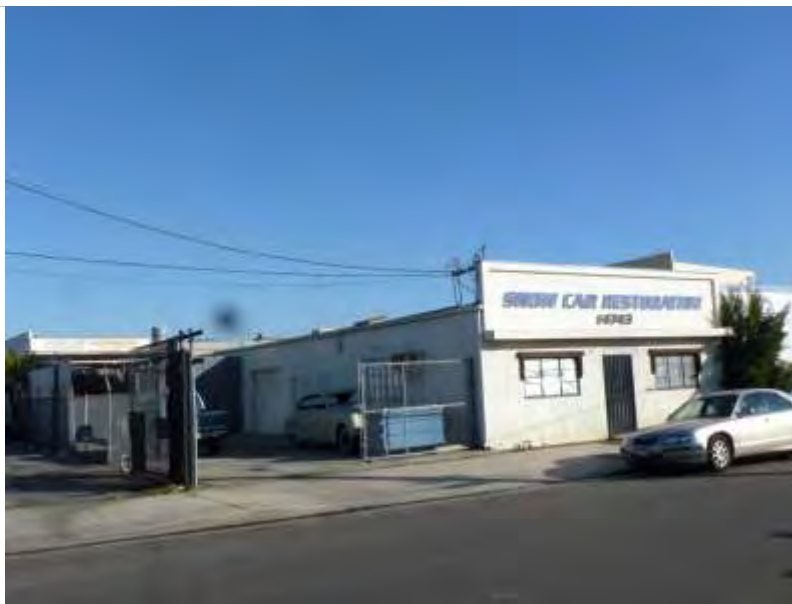
P3a. Description: (Describe resource and its major elements. Include design, materials, condition, alterations, size, setting, and boundaries.)
Los Angeles County Assessor's parcel number 2210-025-016 includes a one-story industrial building. It is located on Keswick Street, west of its intersection with Tobias Avenue.

(View, date, accession #)
View looking NE, 1/13/2015

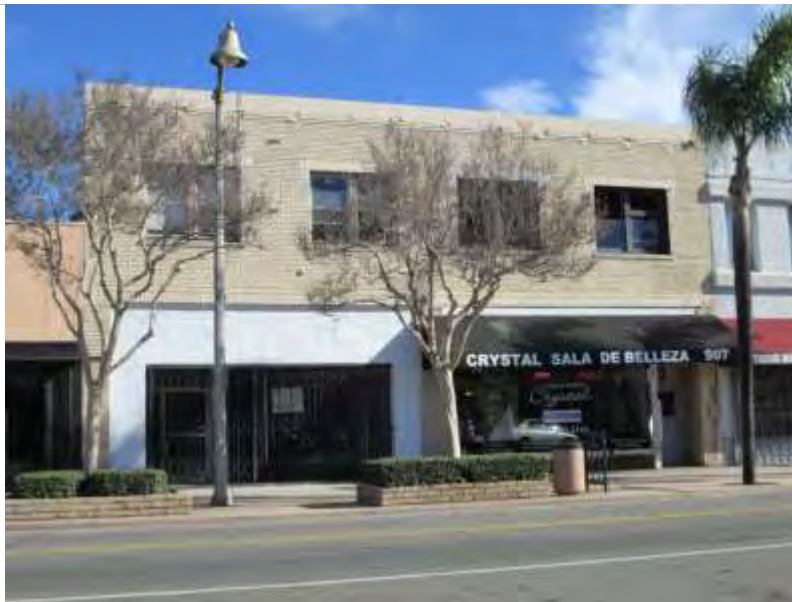
(View, date, accession #)
View looking NE, 1/6/2015

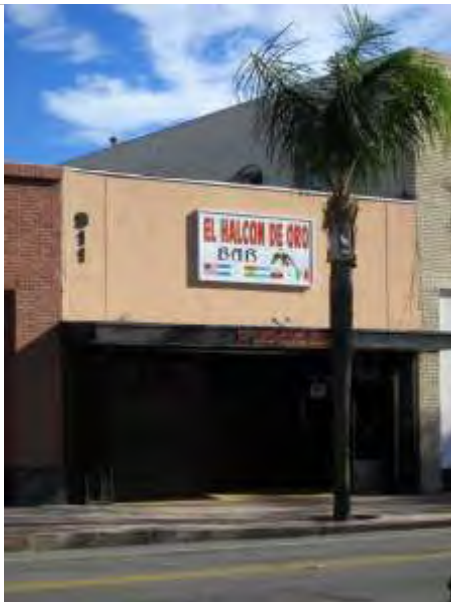
P3a. Description: (Describe resource and its major elements. Include design, materials, condition, alterations, size, setting, and boundaries.)
Los Angeles County Assessor's parcel number 2522-002-003 includes a one-story commercial building. The building is located on San Fernando Road between its intersections with Maclay Avenue and Brand Boulevard.

(View, date, accession #)
View looking NE, 1/6/2015

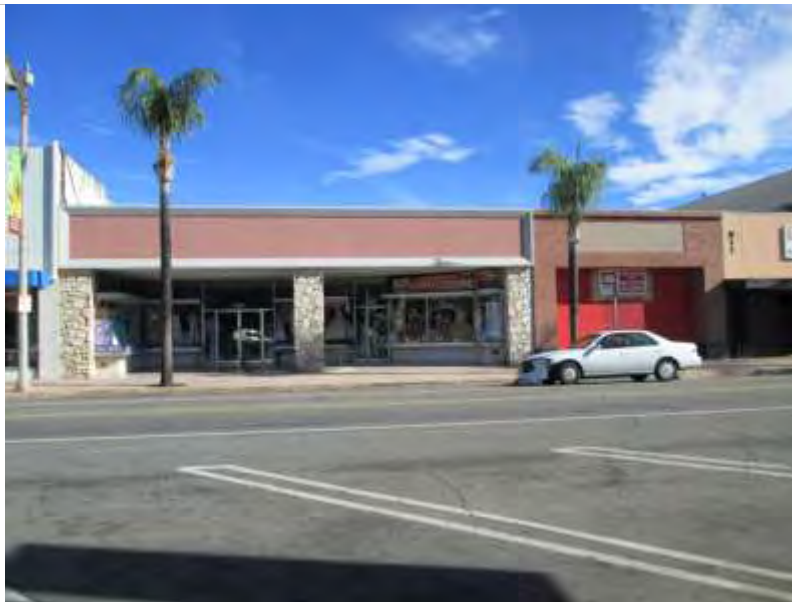
P3a. Description: (Describe resource and its major elements. Include design, materials, condition, alterations, size, setting, and boundaries.)
Los Angeles County Assessor's parcel number 2522-002-004 includes a one-story commercial building. The building is located on San Fernando Road between its intersections with Maclay Avenue and Brand Boulevard.

(View, date, accession #)
View looking NW, 1/7/2015

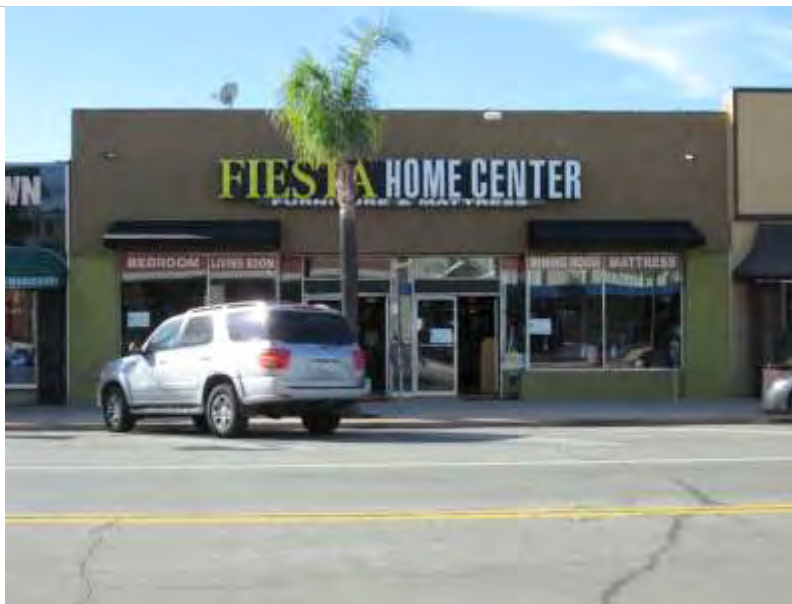
P3a. Description: (Describe resource and its major elements. Include design, materials, condition, alterations, size, setting, and boundaries.)
Los Angeles County Assessor's parcel number 2522-003-026 includes a one-story commercial building. The building is located on San Fernando Road between its intersections with San Fernando Mission Boulevard and Maclay Avenue.

(View, date, accession #)
View looking SW, 1/6/2015

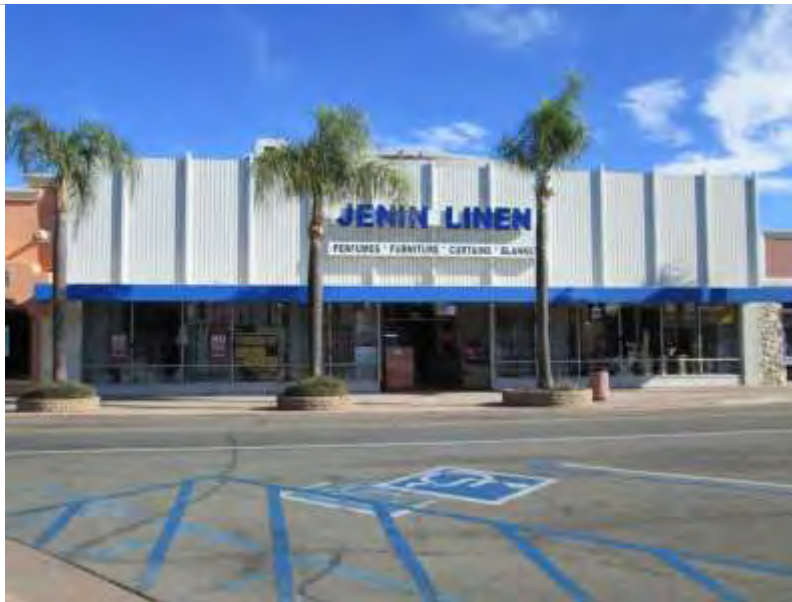
P3a. Description: (Describe resource and its major elements. Include design, materials, condition, alterations, size, setting, and boundaries.)
Los Angeles County Assessor's parcel number 2522-002-005 includes a one-story commercial building. The building is located on San Fernando Road between its intersections with Maclay Avenue and Brand Boulevard.

(View, date, accession #)
View looking NW, 1/7/2015

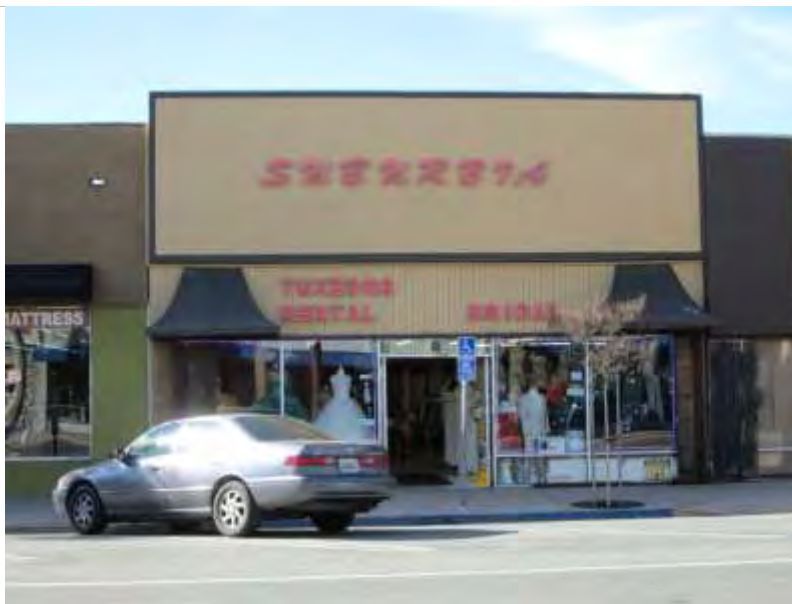
(View, date, accession #)
View looking SW, 1/6/2015

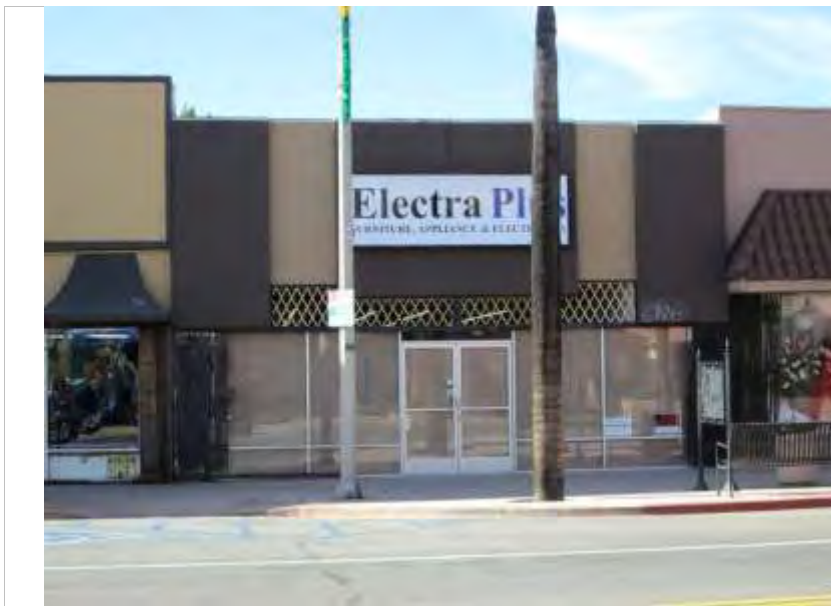
P3a. Description: (Describe resource and its major elements. Include design, materials, condition, alterations, size, setting, and boundaries.)
Los Angeles County Assessor's parcel number 2522-003-003 includes a one-story commercial building. The building is located on San Fernando Road, between its intersections with Brand Boulevard and Maclay Avenue.

(View, date, accession #)
View looking SW, 1/6/2015

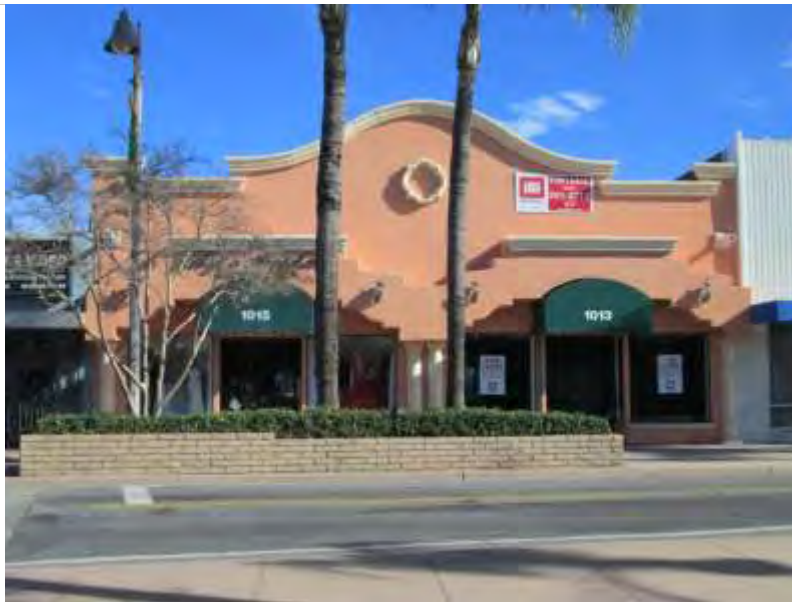
P3a. Description: (Describe resource and its major elements. Include design, materials, condition, alterations, size, setting, and boundaries.)
Los Angeles County Assessor's parcel number 2522-002-006 includes a one-story commercial building. The building is located on San Fernando Road between its intersections with Maclay Avenue and Brand Boulevard.

(View, date, accession #)
View looking NW, 1/7/2015

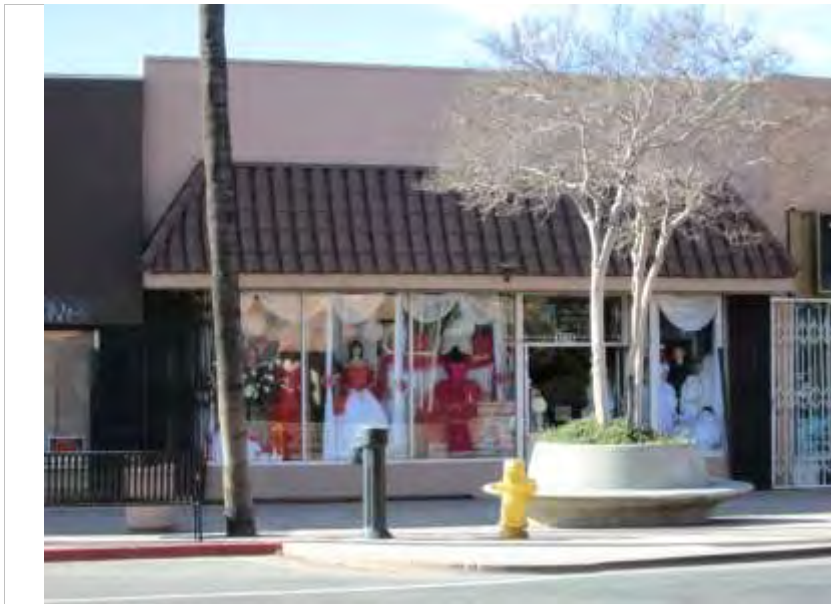
(View, date, accession #)
View looking SW, 1/6/2015

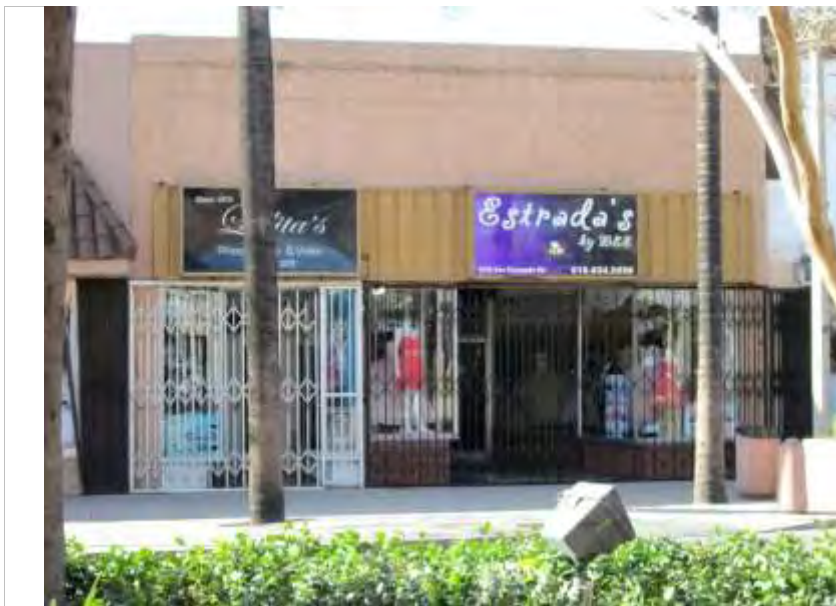
P3a. Description: (Describe resource and its major elements. Include design, materials, condition, alterations, size, setting, and boundaries.)
Los Angeles County Assessor's parcel number 2522-003-005 includes a one-story commercial building. The building is located on San Fernando Road between its intersections with San Fernando Mission Boulevard and Maclay Avenue.

(View, date, accession #)
View looking SW, 1/6/2015

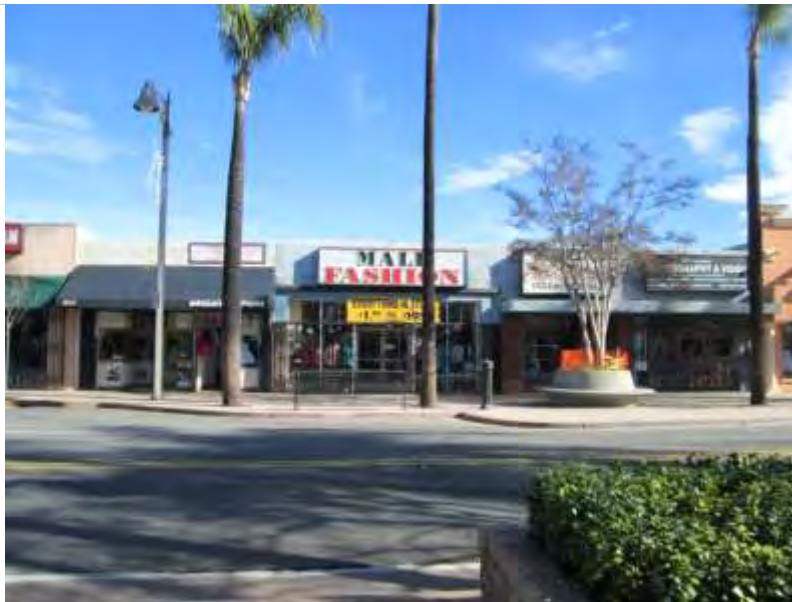
P3a. Description: (Describe resource and its major elements. Include design, materials, condition, alterations, size, setting, and boundaries.)
Los Angeles County Assessor's parcel number 2522-002-007 includes a one-story commercial building. The building is located on San Fernando Road between its intersections with Maclay Avenue and Brand Boulevard.

(View, date, accession #)
View looking NW, 1/7/2015

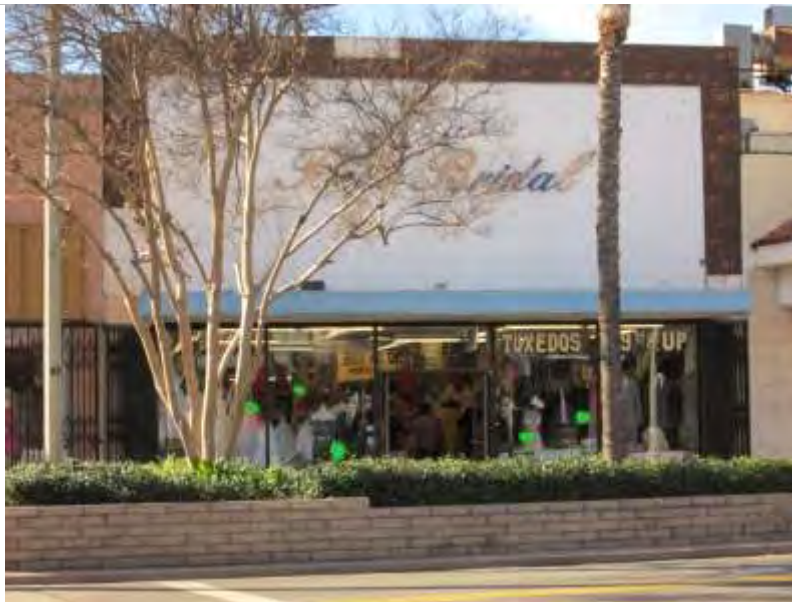
(View, date, accession #)
View looking SW, 1/6/2015

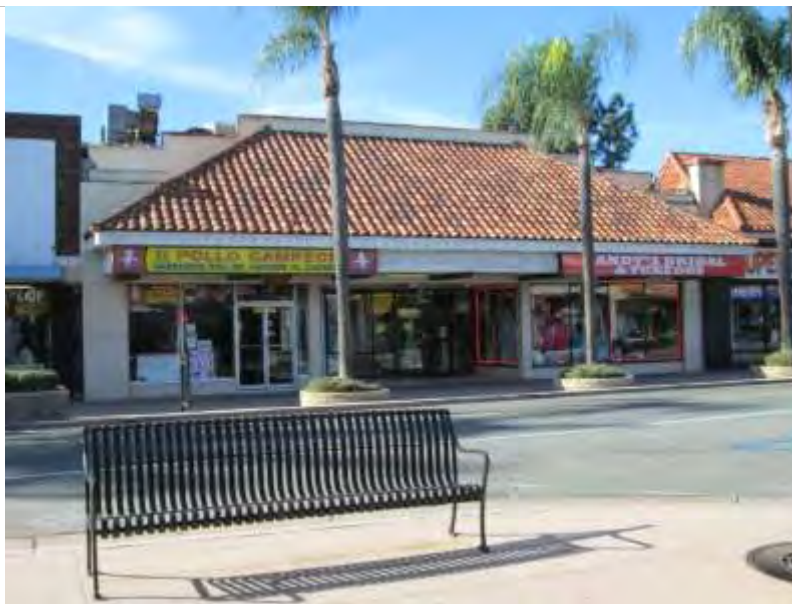
P3a. Description: (Describe resource and its major elements. Include design, materials, condition, alterations, size, setting, and boundaries.)
Los Angeles County Assessor's parcel number 2522-003-032 includes a one-story commercial building. The building is located on San Fernando Road between its intersections with San Fernando Mission Boulevard and Maclay Avenue.

(View, date, accession #)
View looking SW, 1/6/2015

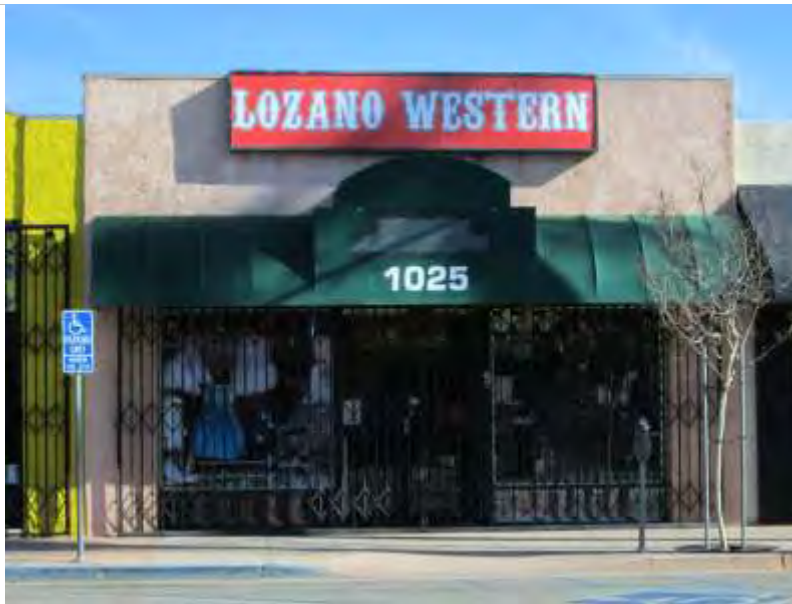
P3a. Description: (Describe resource and its major elements. Include design, materials, condition, alterations, size, setting, and boundaries.)
Los Angeles County Assessor's parcel number 2522-002-008 includes a one-story commercial building. The building is located on San Fernando Road between its intersections with San Fernando Mission Boulevard and Maclay Avenue.

(View, date, accession #)
View looking NE, 1/6/2015

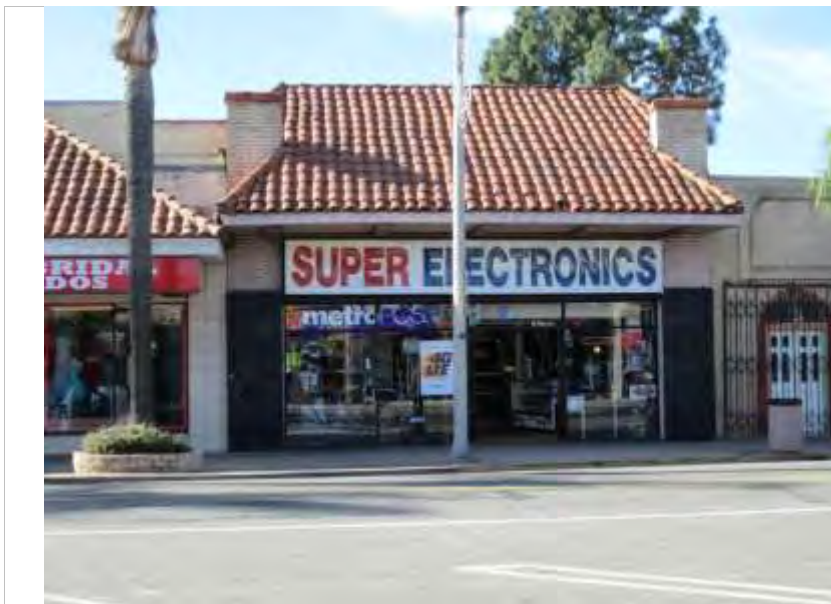
P3a. Description: (Describe resource and its major elements. Include design, materials, condition, alterations, size, setting, and boundaries.)
Los Angeles County Assessor's parcel number 2522-003-008 includes a one-story commercial building. The building is located on San Fernando Road, between its intersections with Brand Boulevard and Maclay Avenue.

(View, date, accession #)
View looking SW, 1/6/2015

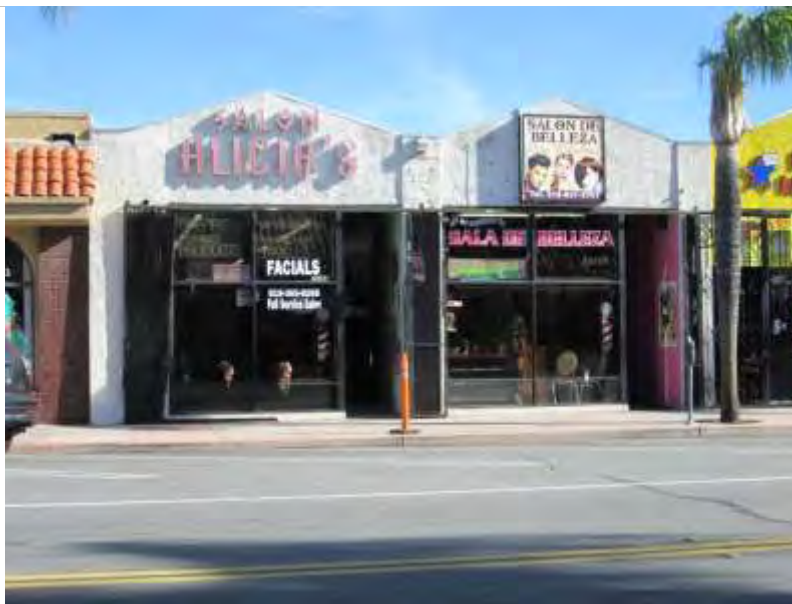
P3a. Description: (Describe resource and its major elements. Include design, materials, condition, alterations, size, setting, and boundaries.)
Los Angeles County Assessor's parcel number 2522-002-010 includes a one-story commercial building. The building is located on San Fernando Road between its intersections with Maclay Avenue and Brand Boulevard.

(View, date, accession #)
View looking NW, 1/7/2015

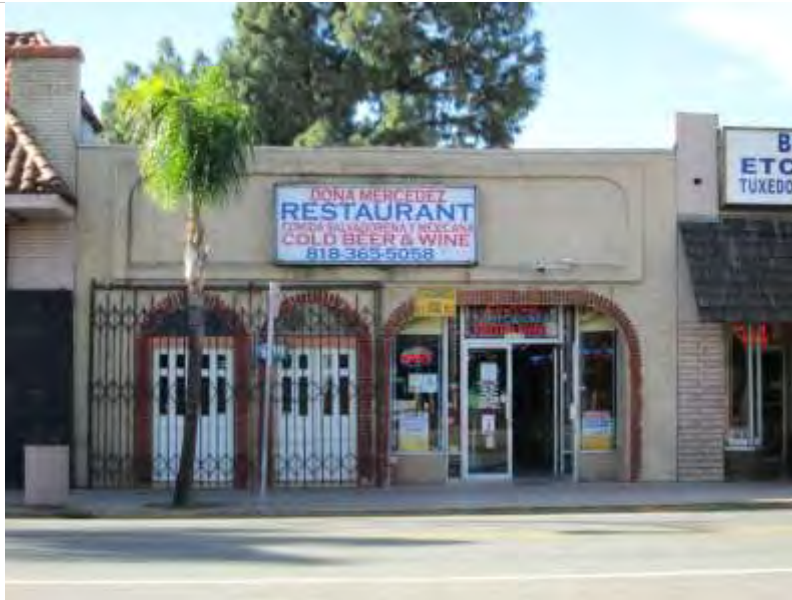
P3a. Description: (Describe resource and its major elements. Include design, materials, condition, alterations, size, setting, and boundaries.)
Los Angeles County Assessor's parcel number 2522-003-009 includes a one-story commercial building. The building is located on San Fernando Road, between its intersections with Brand Boulevard and Maclay Avenue.

(View, date, accession #)
View looking SW, 1/6/2015

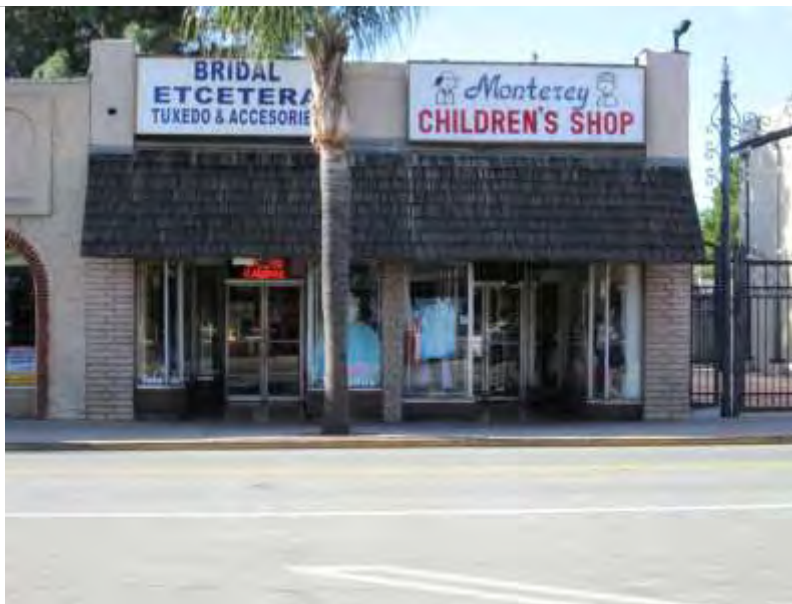
P3a. Description: (Describe resource and its major elements. Include design, materials, condition, alterations, size, setting, and boundaries.)
Los Angeles County Assessor's parcel number 2522-003-010 includes a one-story commercial building. The building is located on San Fernando Road, between its intersections with Brand Boulevard and Maclay Avenue.

(View, date, accession #)
View looking SW, 1/6/2015

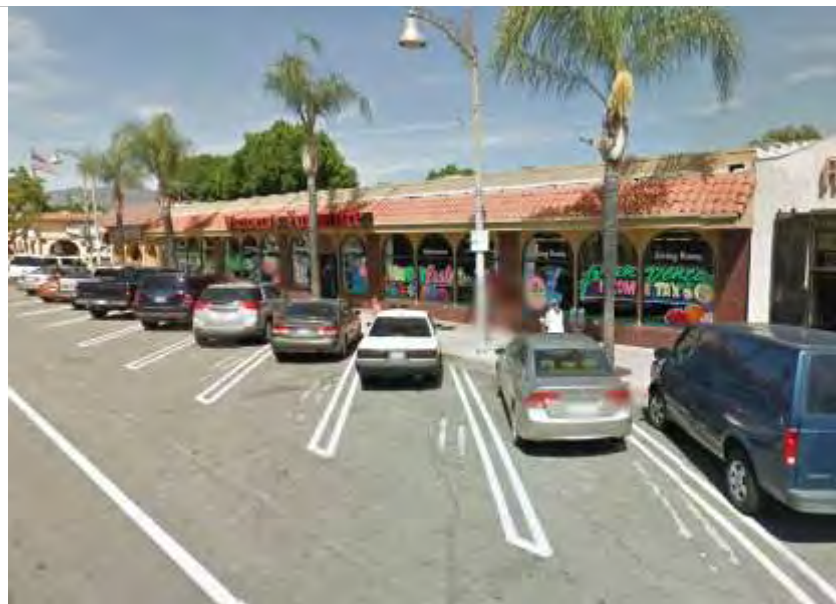
P3a. Description: (Describe resource and its major elements. Include design, materials, condition, alterations, size, setting, and boundaries.)
Los Angeles County Assessor's parcel number 2522-002-016 includes a one-story commercial building. The building is located on San Fernando Road between its intersections with San Fernando Mission Boulevard and Maclay Avenue.

(View, date, accession #)
View looking N, Google Maps, 6/3/2015

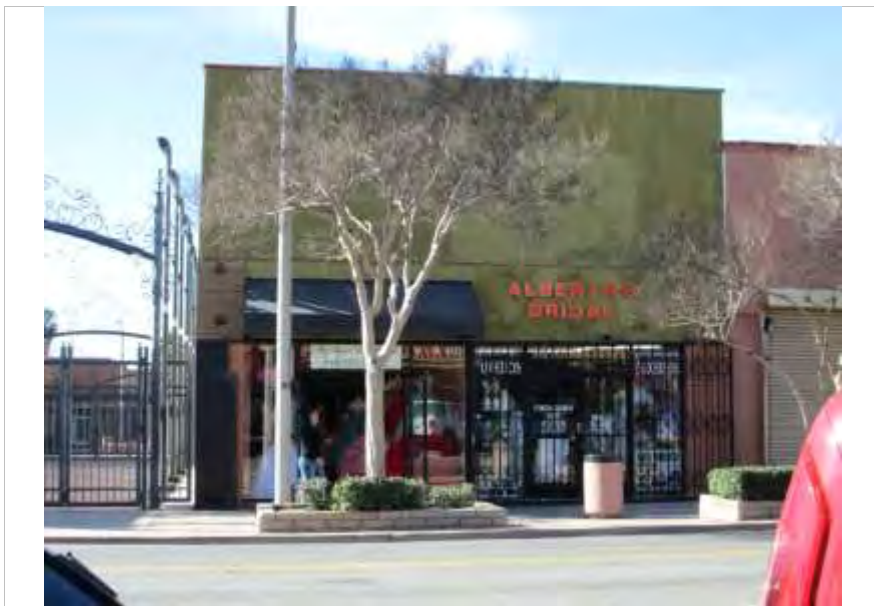
(View, date, accession #)
View looking SW, 1/6/2015

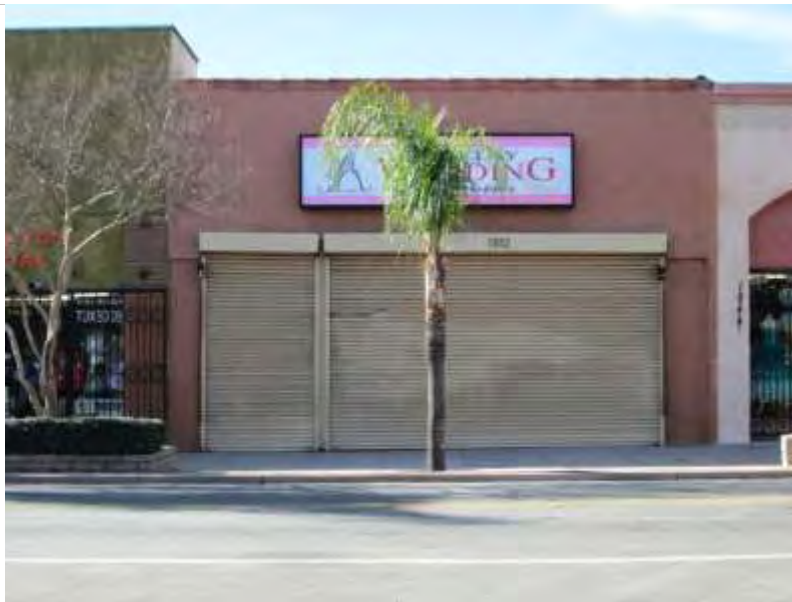
P3a. Description: (Describe resource and its major elements. Include design, materials, condition, alterations, size, setting, and boundaries.)
Los Angeles County Assessor's parcel number 2522-003-013 includes a one-story commercial building. The building is located on San Fernando Road between its intersections with San Fernando Mission Boulevard and Maclay Avenue.

(View, date, accession #)
View looking SW, 1/6/2015

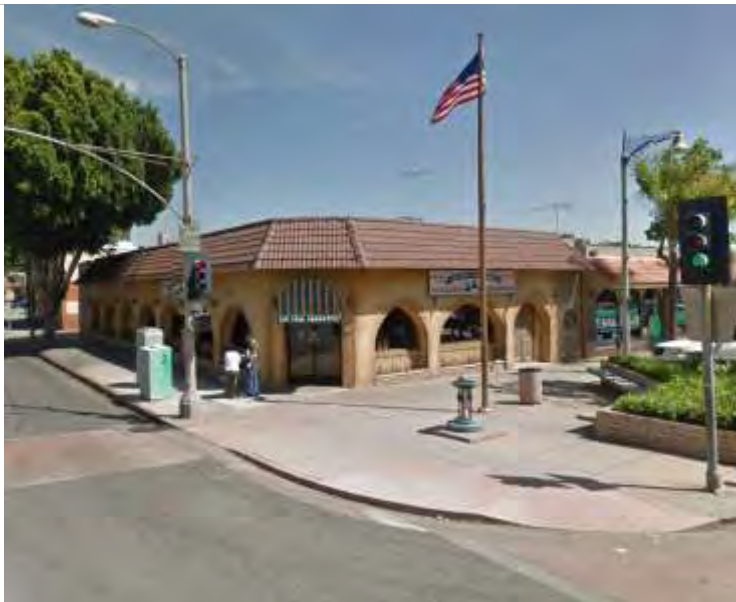
P3a. Description: (Describe resource and its major elements. Include design, materials, condition, alterations, size, setting, and boundaries.)
Los Angeles County Assessor's parcel number 2522-002-014 includes a one-story commercial building. The building is located on the east corner of Maclay Avenue and San Fernando Road.

(View, date, accession #)
View looking E, Google Maps, 6/3/2015

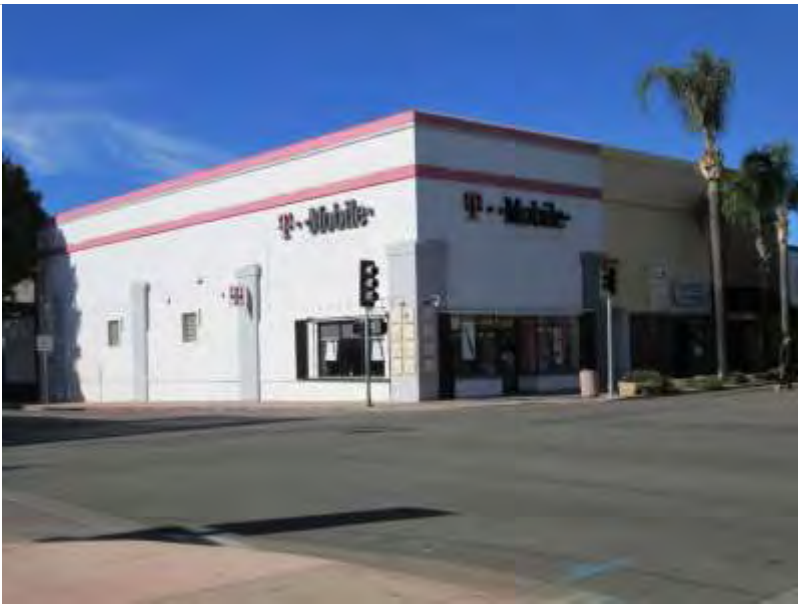
P3a. Description: (Describe resource and its major elements. Include design, materials, condition, alterations, size, setting, and boundaries.)
Los Angeles County Assessor's parcel number 2521-032-001 includes a two-story commercial building. The building is located on the west corner of San Fernando Road and Maclay Avenue.

P5b. Description of Photo:
(View, date, accession #)
View looking W, 1/6/2015

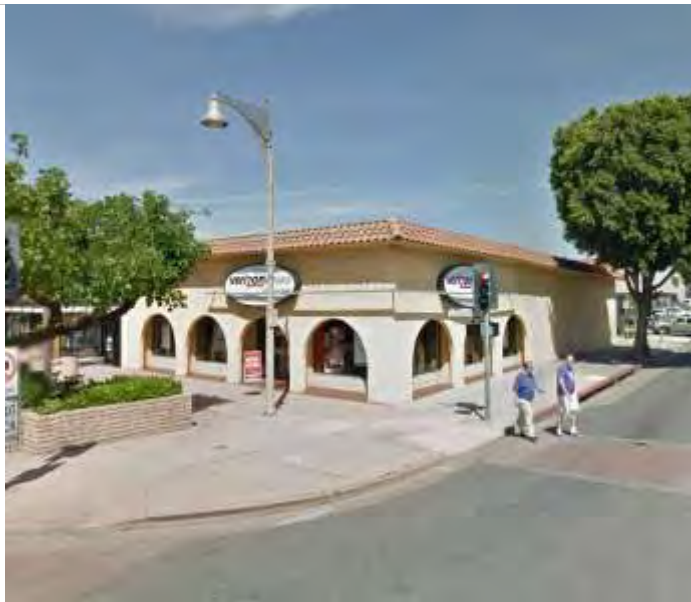
P3a. Description: (Describe resource and its major elements. Include design, materials, condition, alterations, size, setting, and boundaries.)
Los Angeles County Assessor's parcel number 2521-033-001 includes a one-story commercial building. The building is located on the north corner of San Fernando Road and Maclay Avenue.

(View, date, accession #)
View looking N, Google Maps, 6/3/2015

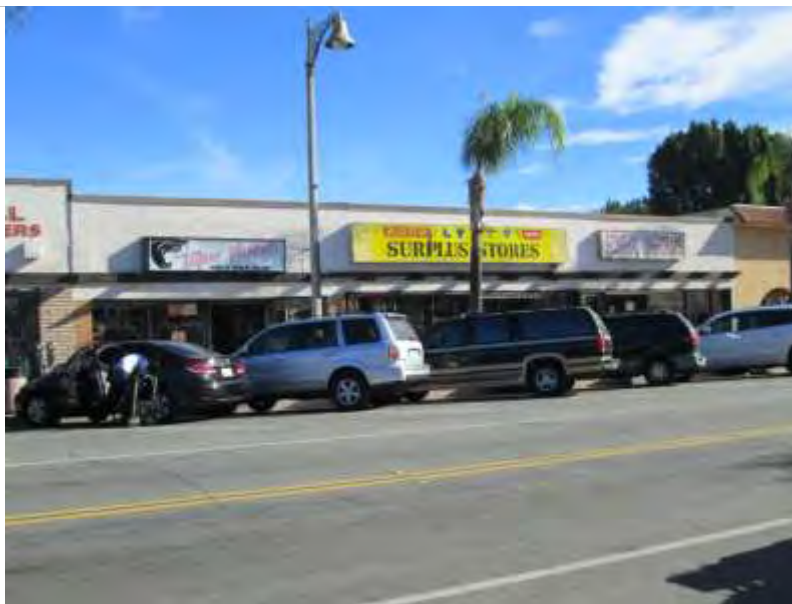
P3a. Description: (Describe resource and its major elements. Include design, materials, condition, alterations, size, setting, and boundaries.)
Los Angeles County Assessor's parcel number 2521-033-002 includes a one-story commercial building. The building is located on San Fernando Road between its intersections with San Fernando Mission Boulevard and Maclay Avenue.

(View, date, accession #)
View looking NE, 1/6/2015

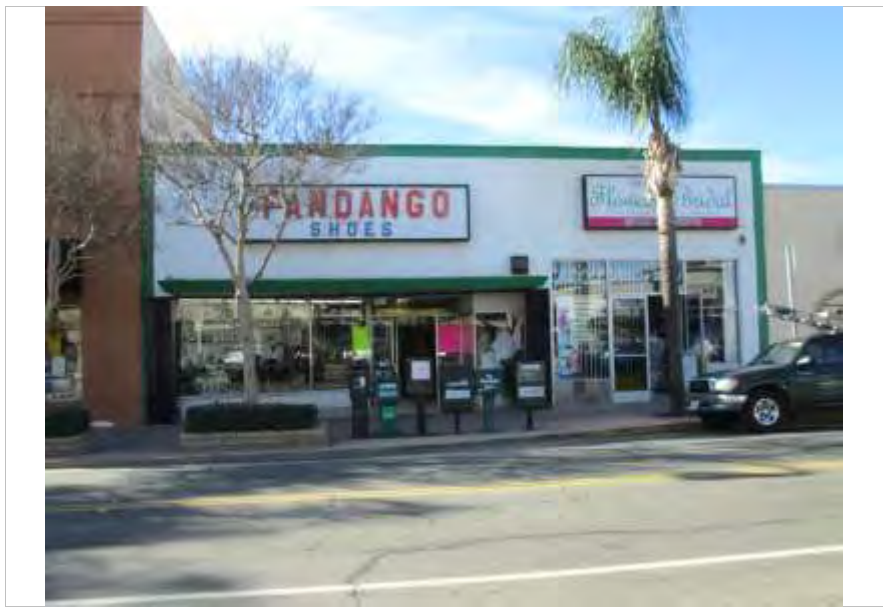
P3a. Description: (Describe resource and its major elements. Include design, materials, condition, alterations, size, setting, and boundaries.)
Los Angeles County Assessor's parcel number 2521-032-002 includes a one-story commercial building. The building is located on San Fernando Road between its intersections with Maclay Avenue and San Fernando Mission Boulevard.

(View, date, accession #)
View looking SW, 1/6/2015

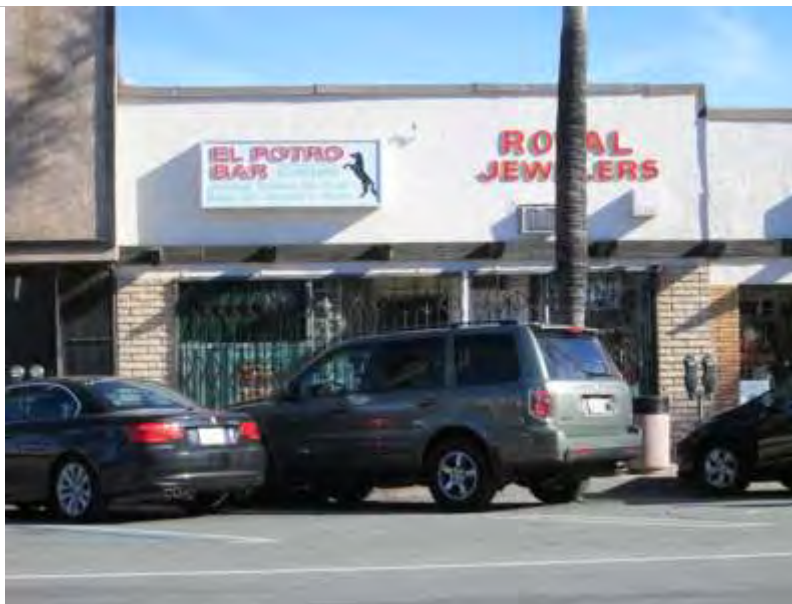
P3a. Description: (Describe resource and its major elements. Include design, materials, condition, alterations, size, setting, and boundaries.)
Los Angeles County Assessor's parcel number 2521-033-003 includes a one-story commercial building. The building is located on San Fernando Road, southeast of its intersection with San Fernando Mission Boulevard.

(View, date, accession #)
View looking NW, 1/7/2015

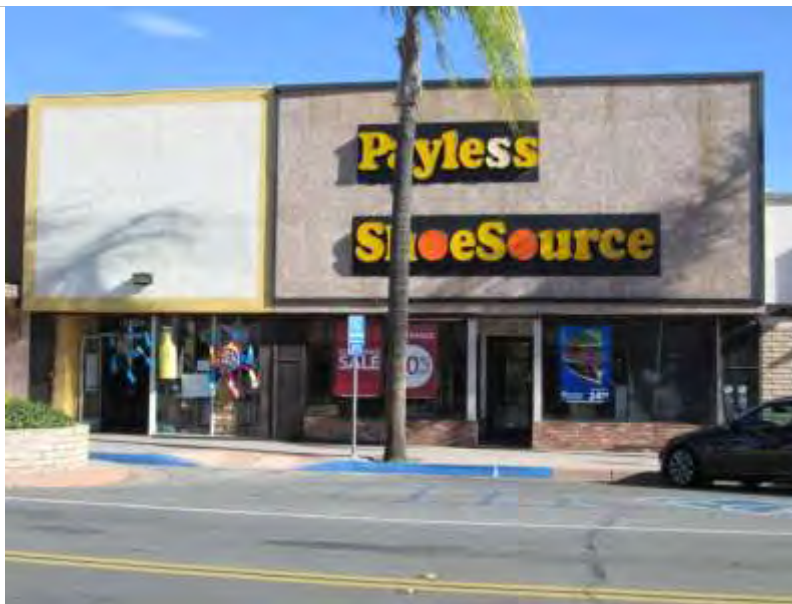
P3a. Description: (Describe resource and its major elements. Include design, materials, condition, alterations, size, setting, and boundaries.)
Los Angeles County Assessor's parcel number 2521-033-004 includes a one-story commercial building. The building is located on San Fernando Road, southeast of its intersection with San Fernando Mission Boulevard.

(View, date, accession #)
View looking NW, 1/7/2015
