Metro®

Executive Summary

The Federal Transit Administration (FTA) and Los Angeles County Metropolitan Transportation Authority (Metro) propose to construct a project called the East San Fernando Valley Transit Corridor Project (Undertaking). The FTA is the Lead Agency under the National Environmental Policy Act (NEPA) and Metro is the Lead Agency under the California Environmental Quality Act (CEQA).

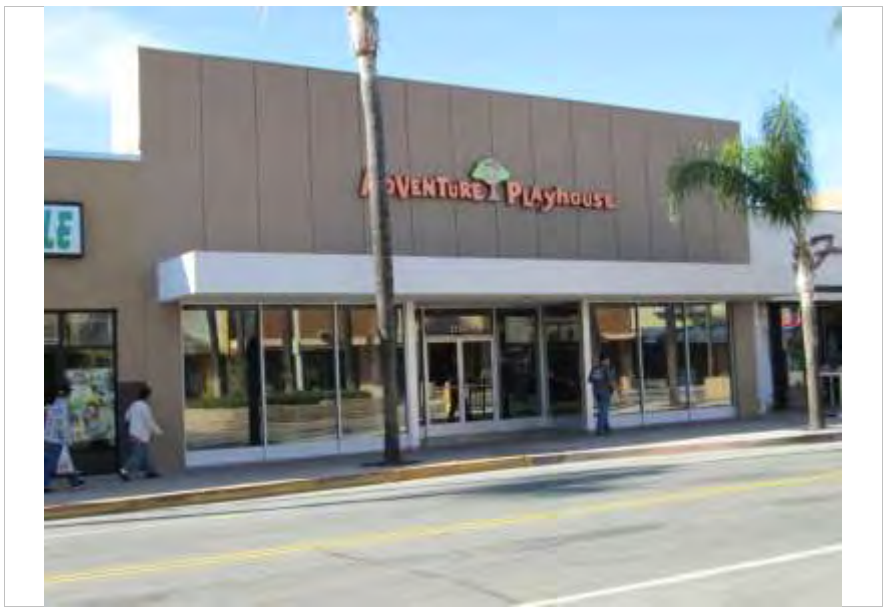
P3a. Description: (Describe resource and its major elements. Include design, materials, condition, alterations, size, setting, and boundaries.)
Los Angeles County Assessor's parcel number 2521-032-013 includes a one-story commercial building. The building is located on San Fernando Road between its intersections with Maclay Avenue and San Fernando Mission Boulevard.

(View, date, accession #)
View looking SW, 1/6/2015

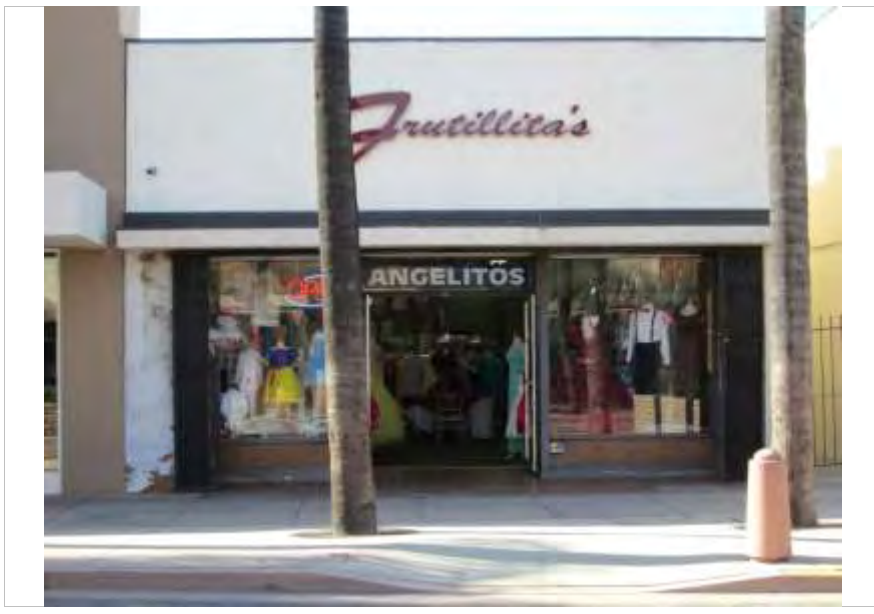
P3a. Description: (Describe resource and its major elements. Include design, materials, condition, alterations, size, setting, and boundaries.)
Los Angeles County Assessor's parcel number 2521-032-004 includes a one-story commercial building. The building is located on San Fernando Road between its intersections with Maclay Avenue and San Fernando Mission Boulevard.

(View, date, accession #)
View looking SW, 1/6/2015

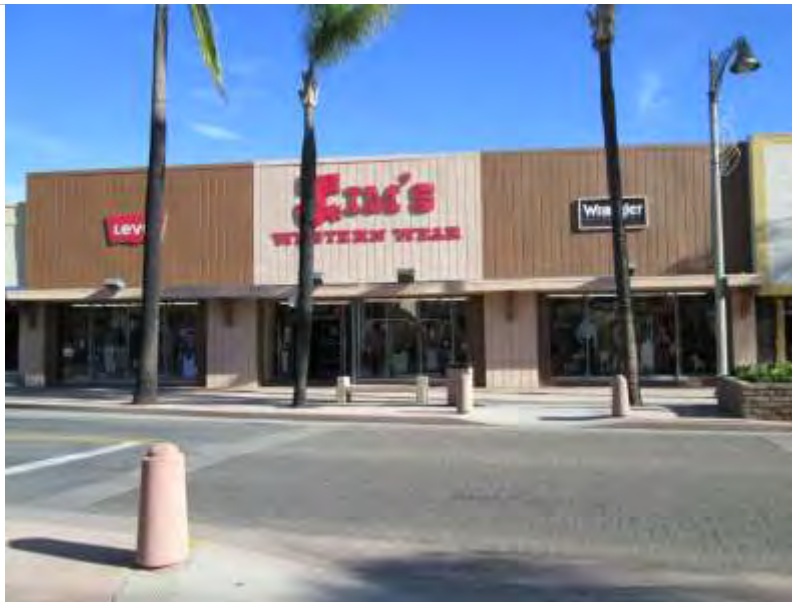
P3a. Description: (Describe resource and its major elements. Include design, materials, condition, alterations, size, setting, and boundaries.)
Los Angeles County Assessor's parcel number 2521-033-005 includes a one-story commercial building. The building is located on San Fernando Road, southeast of its intersection with San Fernando Mission Boulevard.

(View, date, accession #)
View looking NW, 1/7/2015

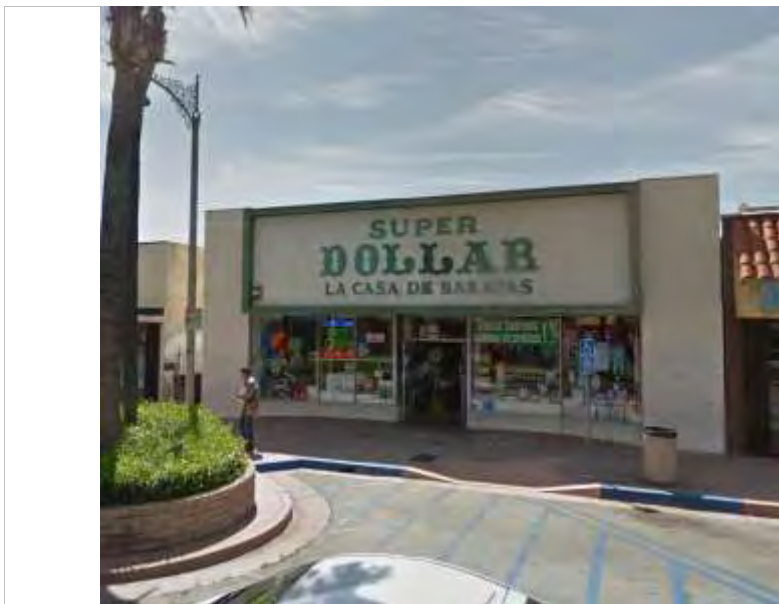
(View, date, accession #)
View looking SW, Google Maps, 6/3/2015

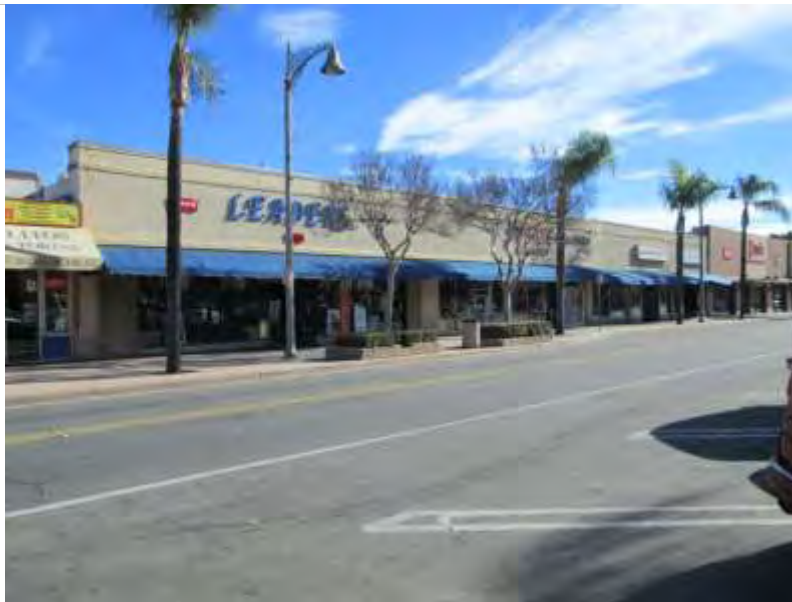
(View, date, accession #)
View looking E, 1/7/2015

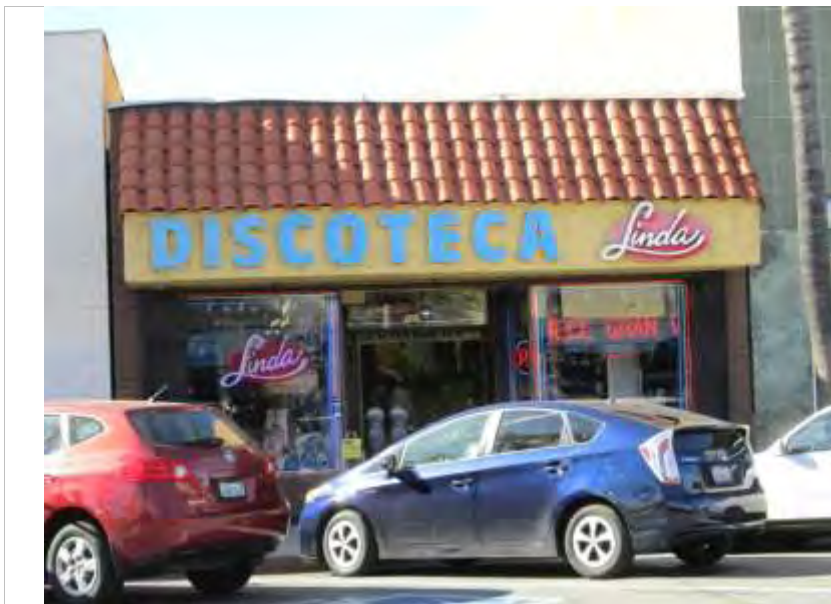
(View, date, accession #)
View looking SW, 1/6/2015

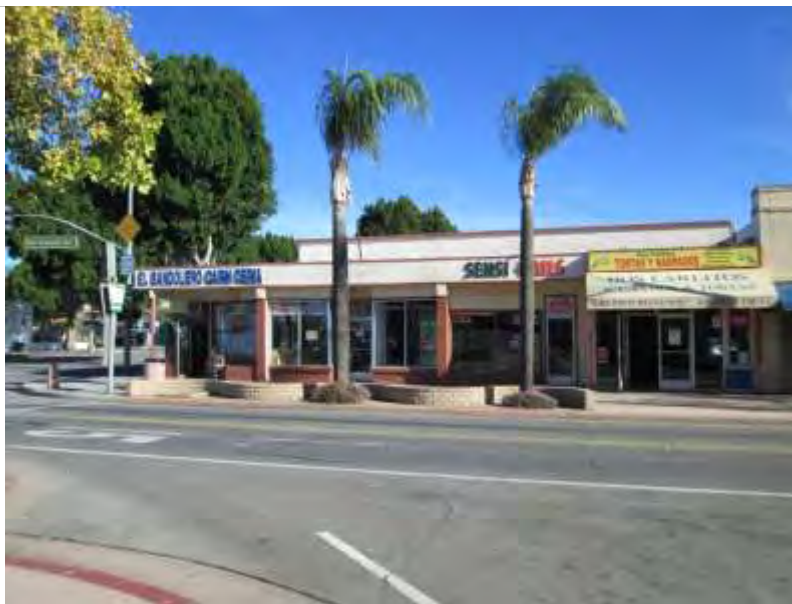
(View, date, accession #)
View looking NE, 1/6/2015
