**Report No. CDOT-2011-8
Final Report**

INVESTIGATION OF BEST OPTIONS FOR USING SCRAP TIRES IN HIGHWAY NOISE BARRIERS

June 2011

**COLORADO DEPARTMENT OF TRANSPORTATION
DTD APPLIED RESEARCH AND INNOVATION BRANCH**

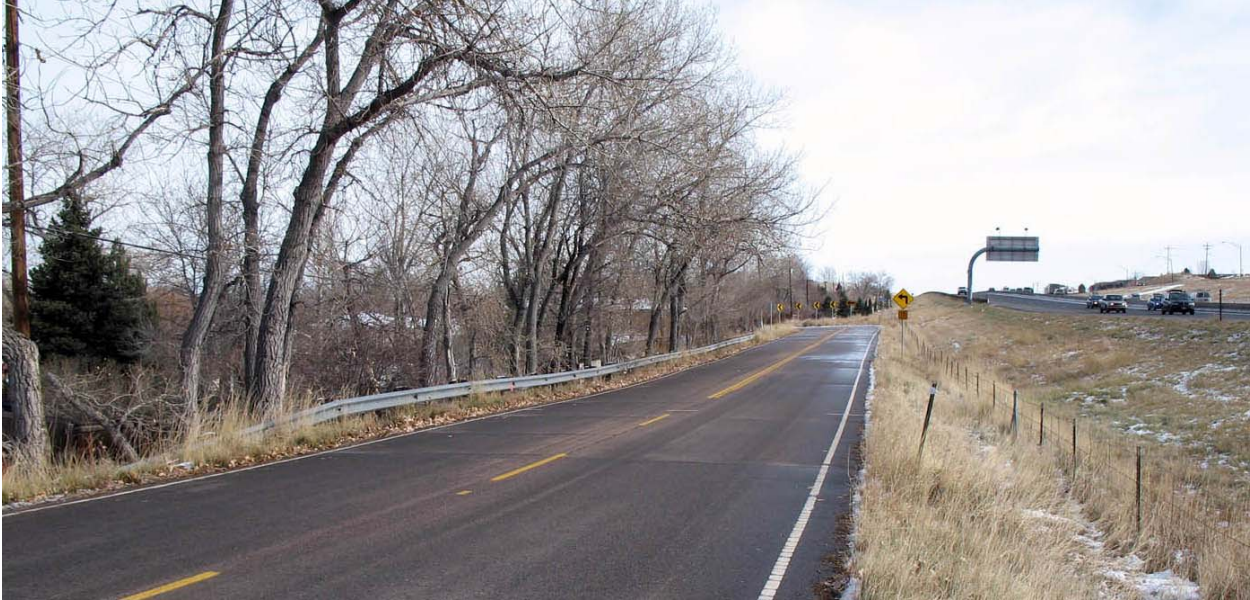
Figure 2. CDOT Test Site before Construction (Looking East)

Before project construction, the test site had a Type 3 guard rail in the approximate location of the test barrier (Figure 2). The test site also had a narrow platform of level ground for the test barrier due to the steep and deep ground slope into Lakewood Gulch immediately to the north—this was a limiting factor for both the material selection and barrier design.

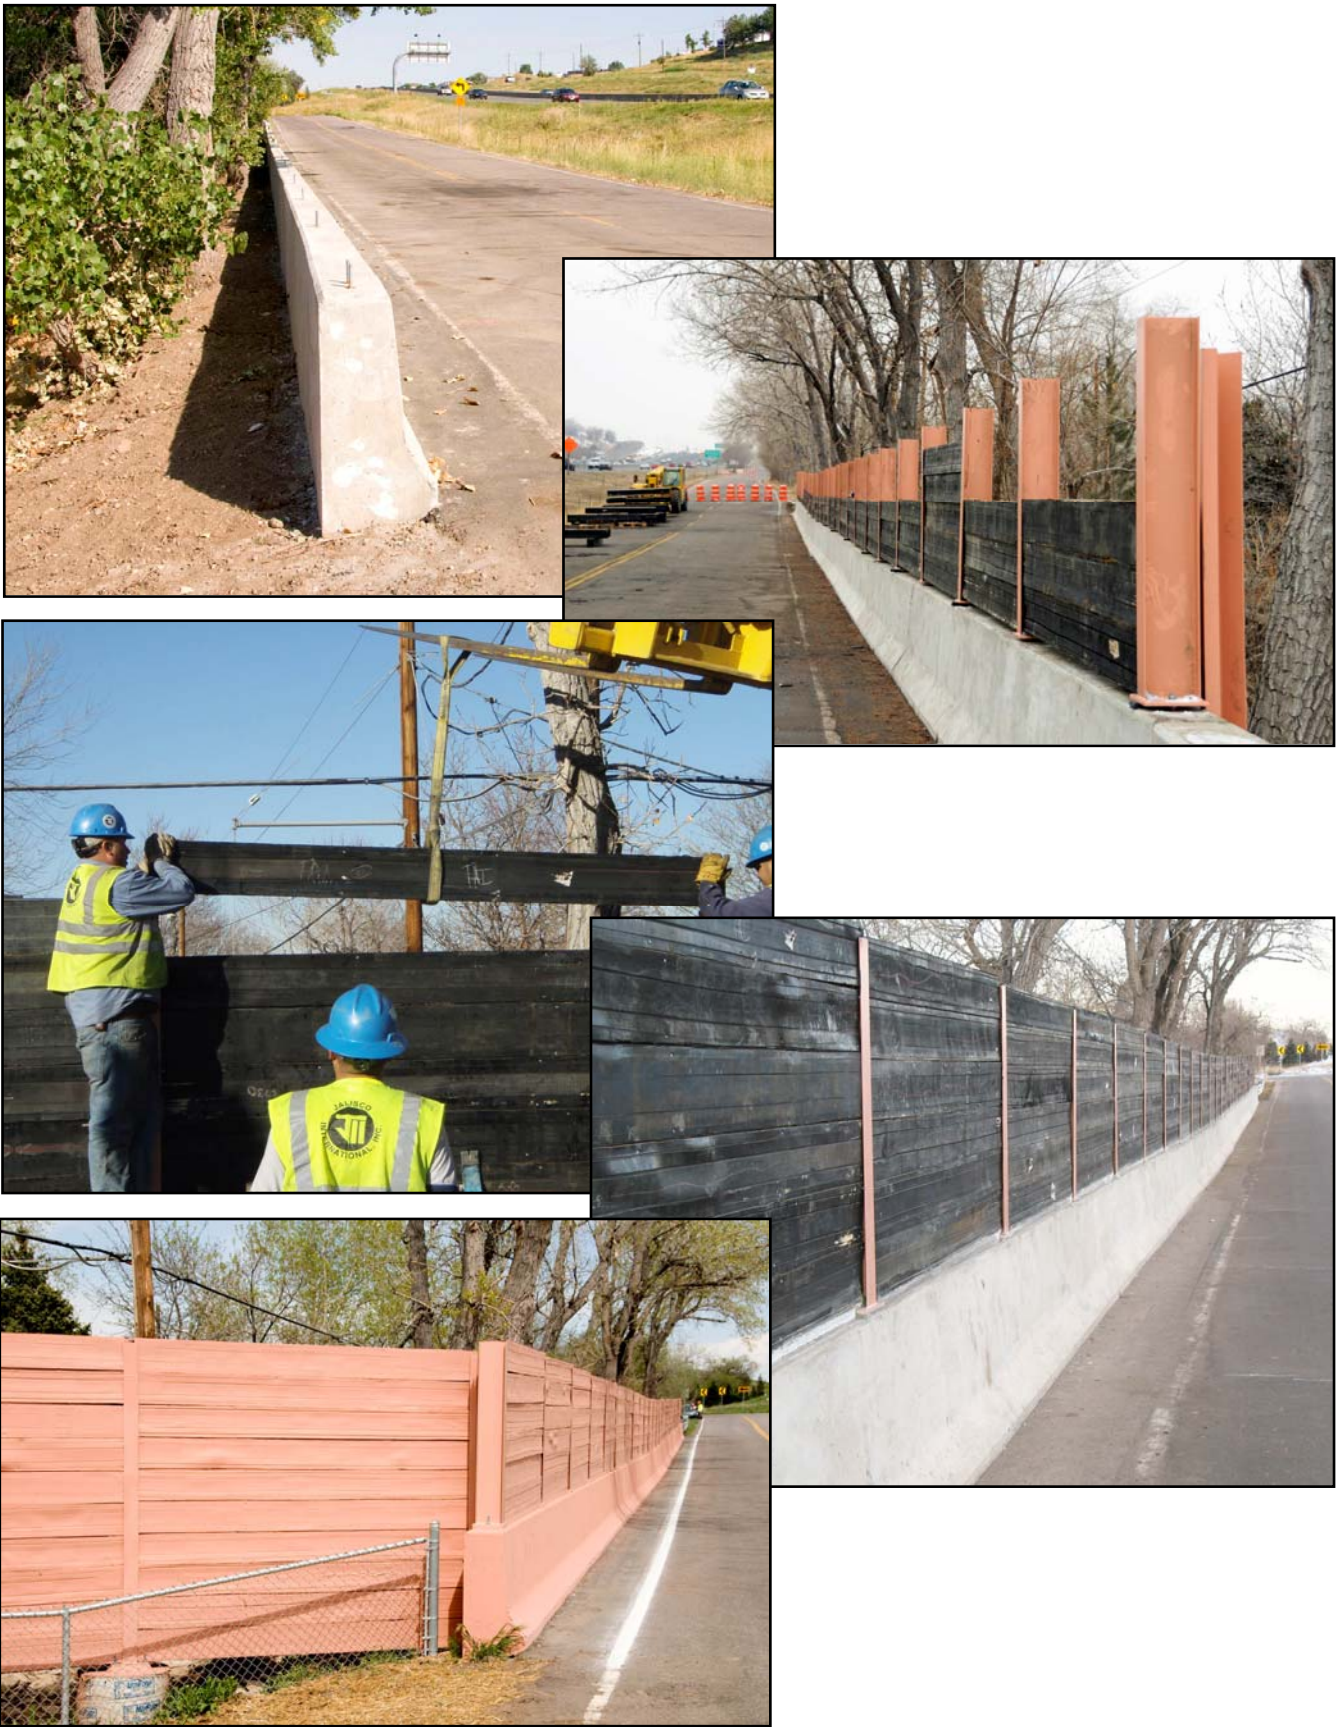
Figure 3. Construction of CDOT Barrier Wall

Construction of the barrier wall design from Task 2 was completed by the contractor in conformance with the project specifications. The barrier design was based on the common post-and-panel configuration. The contractor prepared the site for construction, drilled and poured caissons, poured a Type 7 crash barrier base, installed steel I-beam vertical supports, installed Tire-Ties™ between the vertical supports and applied a finish stain to the wall (Figure 3). The Type 7 crash barrier was constructed in August 2009. The majority of the wall was assembled in January 2010. The final stain finish was completed in April 2010 to accommodate the minimum weather requirements for the stain. (Note: the stain was applied so that CDOT's wall would have a color similar to the surrounding neighborhood walls rather than the black of the tire rubber.)

The ongoing monitoring consisted of quarterly site visits for one year (May 2010 to May 2011) with documentation of barrier condition. While the entire test barrier was examined each quarter, two of the 32 barrier panels were selected for closer scrutiny (Panels 2 and 17) during each monitoring period to represent performance of the barrier in general. Panel 2 was an end panel (east end) that represented the panels with no external support and relied on their own internal strength to maintain the barrier structure (Figure 4). Panel 17 was near the center of the barrier and represented the panels consisting of six ties stacked on the Type 7 concrete barrier base (Figure 3) that made up the majority of the barrier.

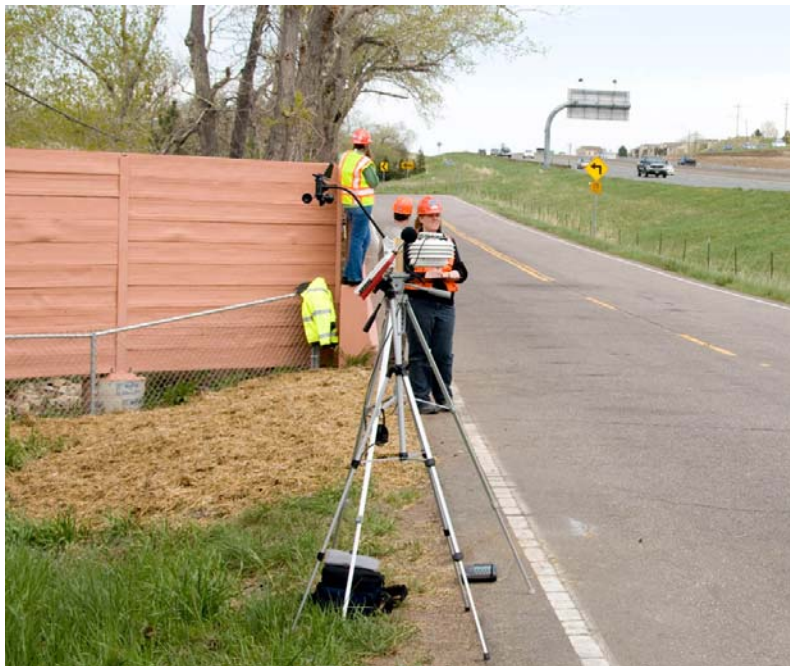
Figure 4. Measurement of Barrier Noise Reduction (Looking East)

The measurement of barrier insertion loss was a one-time event shortly after completion of the barrier. The noise-reducing performance of the selected material (Tire-Tie™) was reviewed through concurrent sound-level measurements both in front of and behind the project barrier. The first location (in front of the barrier) faced US 6 with no mitigation of traffic noise (Figure 4). The second location was immediately (less than two feet) behind the project barrier approximately five feet above ground and was protected from US 6 traffic noise by the project barrier.

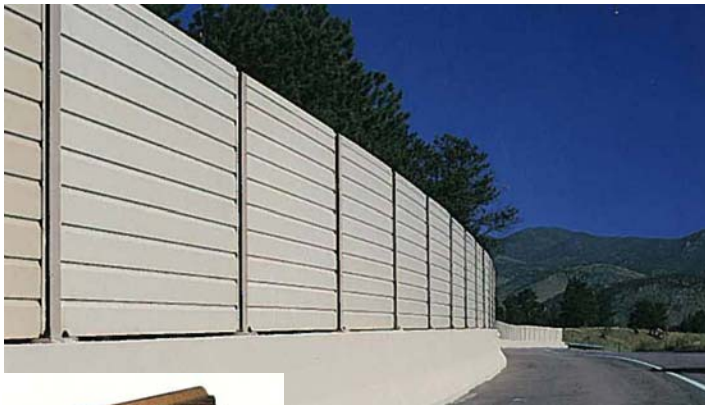
6.1.1 Carsonite AcoustaShield™

In a new process, scrap tire waste can be used in combination with a structural element to create an aesthetic, functional, and long-lasting barrier wall. The recycled scrap tire core consists of a mixture of several crumb rubber sizes and a phenolic binder. A ten-foot-high, one-mile-long wall would consume approximately 250,000 pounds of scrap tires.

The structural element, shaped into a tongue-and-groove building plank, is a fiberglass-reinforced plastic composite that has consistent and predictable mechanical properties with an expected life cycle of 50 years. The glass-reinforced plastic contains flame retardant, is self-extinguishing, and is protected by ultraviolet inhibitors to prevent solar degradation. The tongue-and-groove structural element is manufactured by a continuous process that ensures high quality and structural soundness to meet the load-bearing requirements of the sound wall.

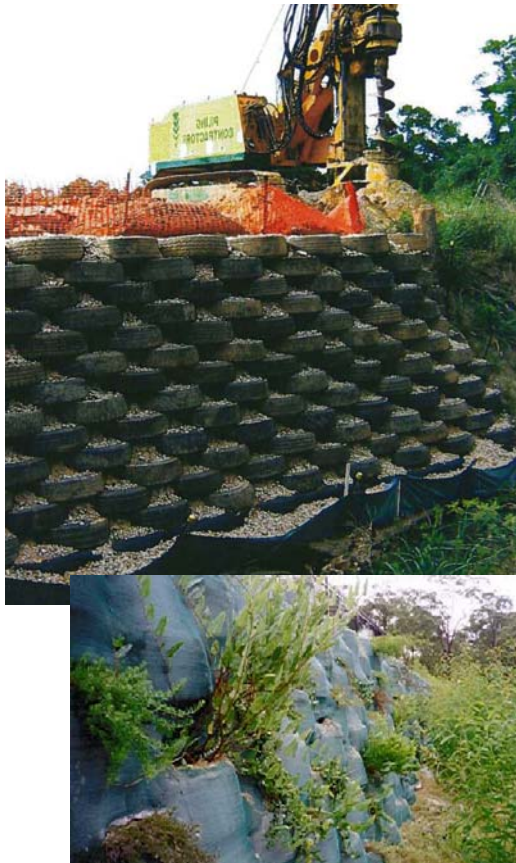
Ecoflex is based on creating a structural “container” from used tires which are unsuitable for retreading. When the container is filled with crushed rock, gravel, sand or recycled concrete, it forms a structural building module which can be combined to form an interconnected cellular structure to perform basic engineering in accordance with engineering standards and specifications.

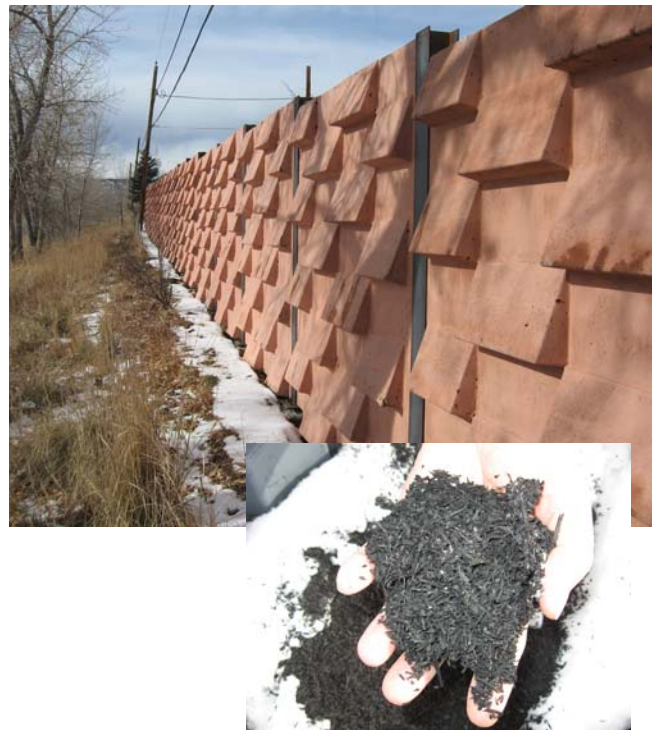
SmartWall is a concrete wall panel system that is similar to typical precast concrete wall systems, but has an added element of shredded scrap tires as aggregate in the concrete mix. The SmartWall design consists of concrete panels nominally 4-inches thick, but also includes protruding angled surface elements intended to reduce horizontal sound reflections and thereby provide better noise reduction overall.

SmartWall is available in a wide variety of colors by tinting the concrete. SmartWall has been installed in the Mountain View Estates neighborhood and abuts both ends of the CDOT test site.

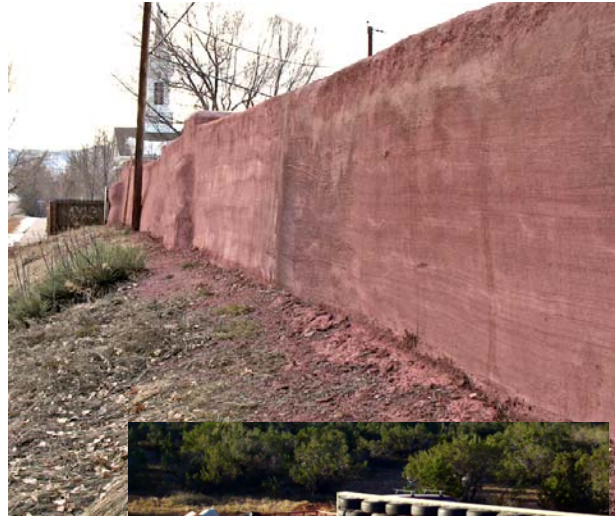
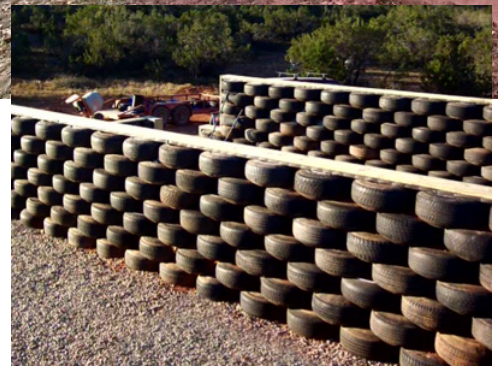
6.1.7 Tire Stack

The tire stack concept is a rough building material that is formed into a wall system. It consists of whole tires stacked on top of each other with a center vertical support column for structural stability. The tire stacks are usually filled with earth or rubble for strength. The stack height is easily modified, but the bottom tires are easily compressed by excess weight, which presents structural hurdles. The tire stack face can be finished with shot-crete or other material to fill voids, add strength and prevent noise transmission through gaps between tires.

This concept shares some similarities with other products using whole tires, but there are differences as well. A tire stack wall has been built in the Mountain View Estates neighborhood near the test site, adjacent to a SmartWall, at approximately 600 Braun Street.

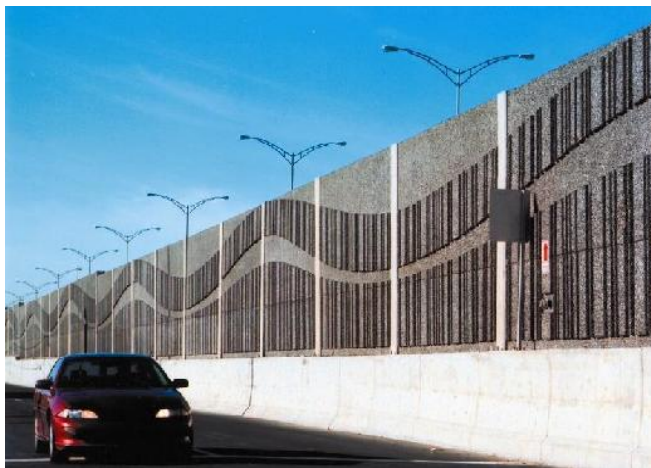
Whisper-Wall is a post-and-panel wall system. A typical precast noise wall panel is 8-inches thick and consists of four inches of a sound absorptive mixture on four inches of structural concrete. The panels are designed to be stacked using a top-down construction method. This method varies the height of the bottom panel and allows full height panels to be stacked up to the sound attenuation elevation. Cast into the top and bottom of each panel is a tongue and groove

keyway that aligns and interlocks each panel along the horizontal joint. Panels can span up to 24 feet and be stacked as high as 54 feet.

Environmentally engineered, Whisper-Wall absorbs sound using a highway generated waste product, rubber vehicle tires. Rubber tires are recycled and processed into small chips. The rubber chips are then blended with natural sound absorbing aggregate and cement to produce a sound absorbing mixture. The final product is durable in all types of climates.

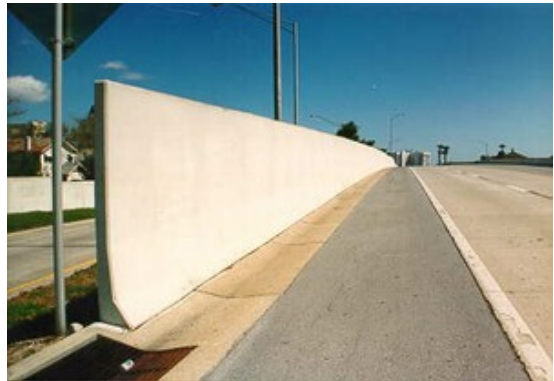
Cast-in-Place Walls

Cast-in-place concrete walls have typically been used on bridges and retaining walls because of their flexibility of design, high structural strength and resistance to vehicle impact damage. These types of barriers are constructed at the project site. The thickness of the finished wall is variable. The construction process includes excavating for the footing, erecting form work, setting reinforcement steel, pouring concrete, surface finishing, and curing.

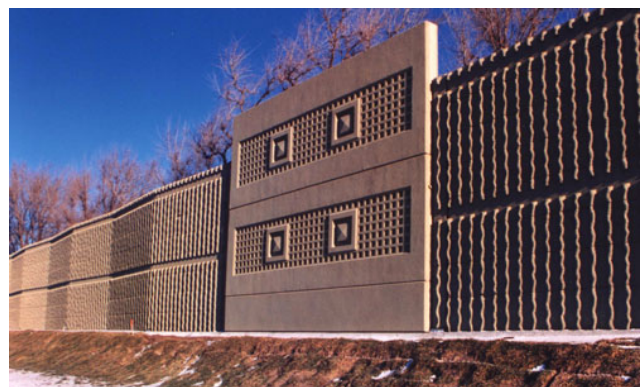
Precast Panels

Precast panels typically are poured off-site and transported to the final location, which minimizes site construction conflicts. The panels can be erected relatively quickly using cranes. Panels are often 4-inches thick. Landscape damage can be avoided by the use of properly sized cranes that can span over the landscaping when setting the panels. Precast concrete walls have the potential to be relocatable and have been used for temporary as well as permanent walls. Several of the candidate materials described above are precast concrete panels.

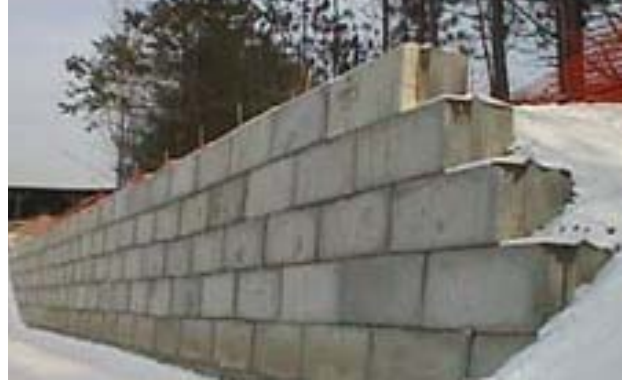
Concrete Block Walls

Versatility, flexibility, performance and pleasing aesthetics are designed elements of concrete block walls. This helps to make construction easier for the installation contractors. In addition, design engineers can take advantage of this flexibility to produce a more efficient, economical and aesthetic engineered wall design.

Concrete block walls are constructed in a wide selection of shapes that have been crafted for efficiency in the design of segmental walls for structural performance, durability, flexibility, and aesthetics in the finished wall. Block walls are typically 8-inches thick. These walls can be painted or stained in a broad range of colors to fit into a chosen color scheme for a roadway project.

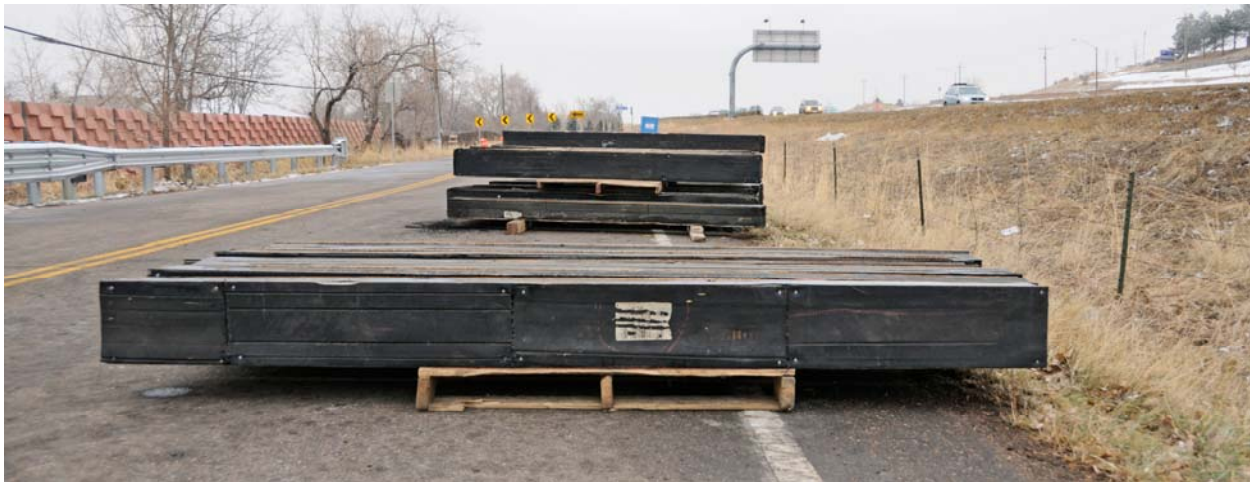
Figure 5. Tire-Ties™ Staged for Construction

The barrier was built successfully, with the final construction activities (staining) in April 2010. Insertion of the Tire-Ties™ (Figure 5) into the wall panels was completed in two days. The ties proved to be relatively easy to handle during construction.

Each Tire-Tie™ (Figure 5) ultimately cost the project \$250, which was more than originally anticipated. Several factors contributed to this. The supplier was still a start-up company and did not have personnel, supplies or production facilities to mass produce the Tire-Ties™ at the time. CDOT’s order was reported to be the largest in their history to that point. The manufacturer has reported a desired price point of approximately \$100 to \$125 per Tire-Tie™, to be cost-competitive with the wooden railroad ties they are intended to replace. If this pricing goal is

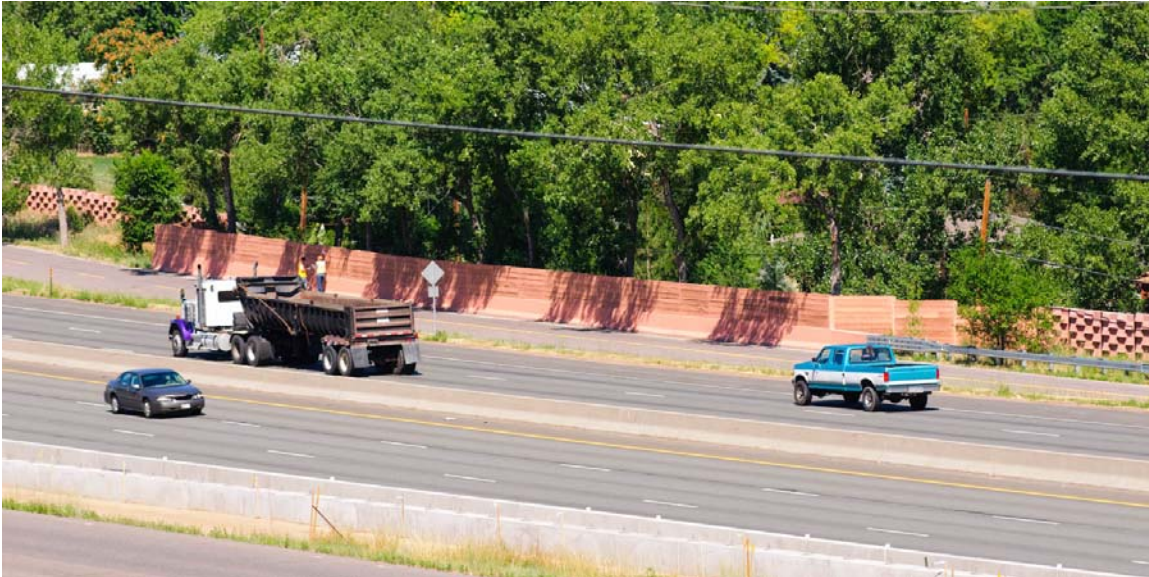
Figure 6. Completed CDOT Barrier Wall from US 6 Side

This task consisted of two primary subtasks: evaluate the noise-blocking performance of the chosen barrier material in the finished barrier wall (Figures 6 and 7) and assess generally the physical performance of the barrier material for one year. These were achieved through a combination of quantitative sound level measurements and qualitative observations.

Subtracting the measured noise levels (Section 5) resulted in the project barrier providing approximately 7.8 dBA of insertion loss immediately behind the barrier. This noise reduction is well within the CDOT goal of noise reduction of 5-10 dBA and is noticeable behind the wall (4). This result was affected by several site conditions, including:

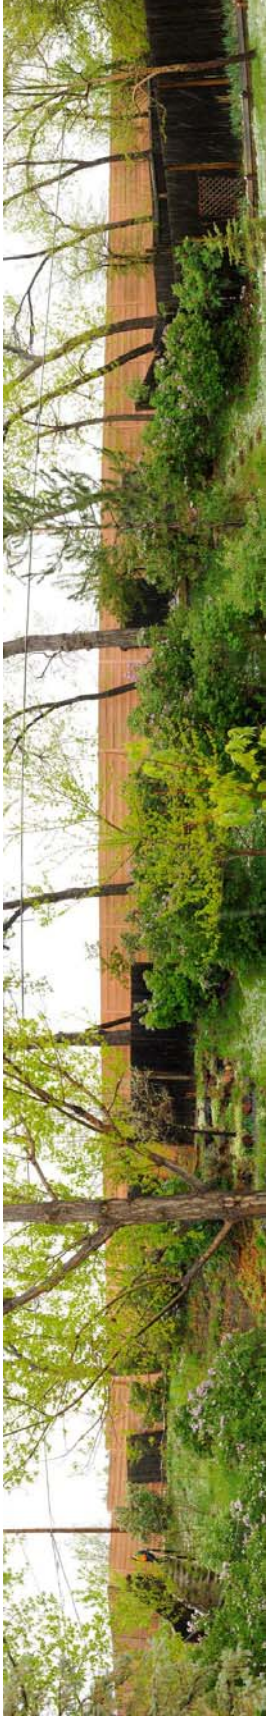
Figure 7. Completed CDOT Barrier Wall from Neighborhood Side

- ▶ Approximately 2.5 feet of barrier “free board” was present above the sound meter during the measurement and was affected by the amount of noise refraction over the top of the barrier.
- ▶ The Tire-Ties™ were intentionally stacked loosely on top of each other within the vertical I-beam supports for this project. Though the faces of the stacked Tire-Ties™ did fit together well, not all of the joints mated perfectly, so occasional small gaps between Tire-Ties™ were present. This was a minor effect, but sound can pass through these gaps. Such gaps could be closed, such as with caulking between ties.

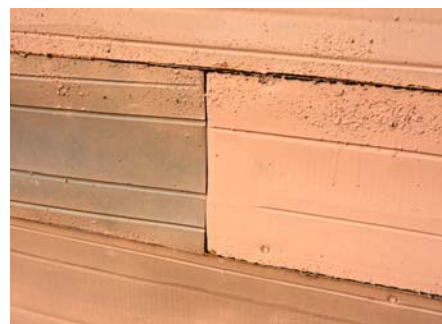
The Tire-Ties™ were manufactured with steel and rust appeared on some of the exposed steel (Figure 8). This will be primarily an aesthetic issue. The rust was similar in color to the finish stain, but it is visible. It is unknown how this will progress over the life of the wall.

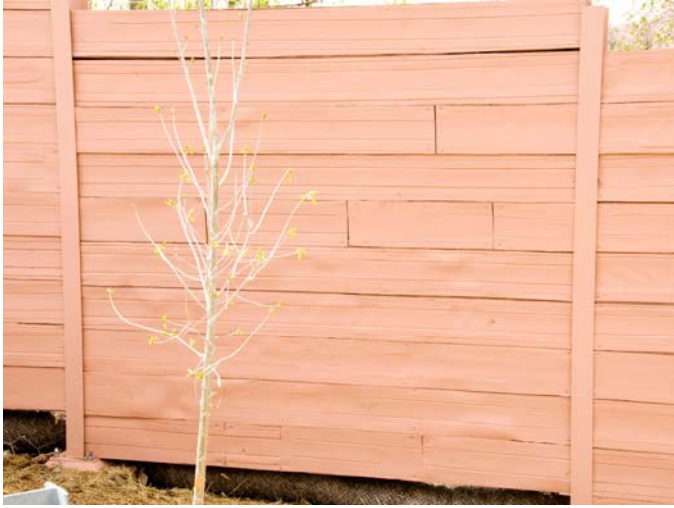
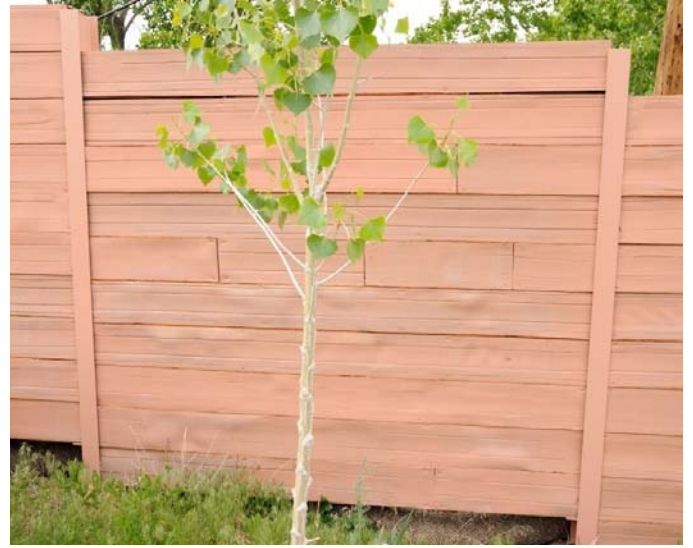
Wall Panel 2

May 2010

May 2011

Figure 8. Photographs of Wall Panels Selected for Close Monitoring

Several qualitative aspects of the barrier material (Section 5) were monitored during the first year after construction. Two wall panels (Panel 2 and 17) were selected as proxies for the rest of the barrier for closer monitoring (Figure 8). The intention was to observe and document real-world performance of the wall design, materials and finishes.

The Tire-Ties™ were not designed to be a visually refined product to fulfill their primary purpose with the railroads. Consequently, the manufacturing tolerances allowed for imperfections that were visible when the ties are used in a noise wall. For instance, some of the surficial tire treads contained “bubbles” (photo at right) and other visual breaks. This was an aesthetic consideration that did not affect the integrity of the wall and did not change noticeably during monitoring.

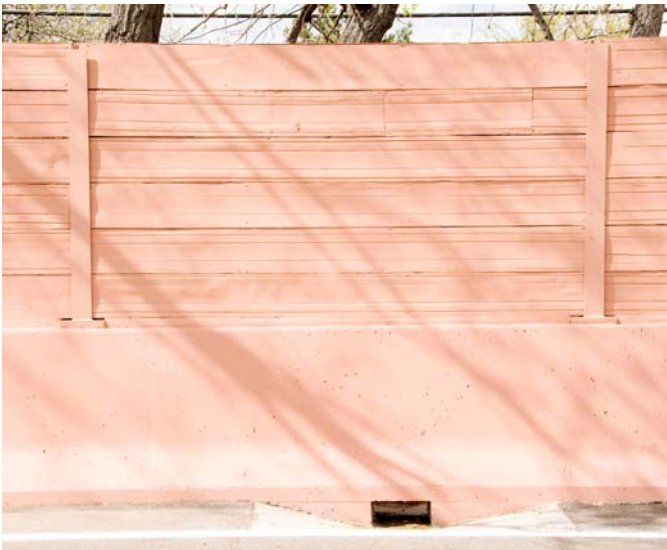
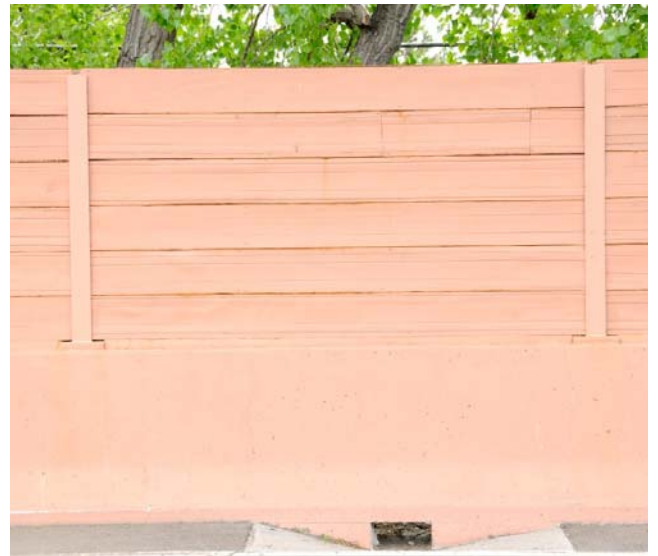
Wall Panel 17

May 2010

May 2011

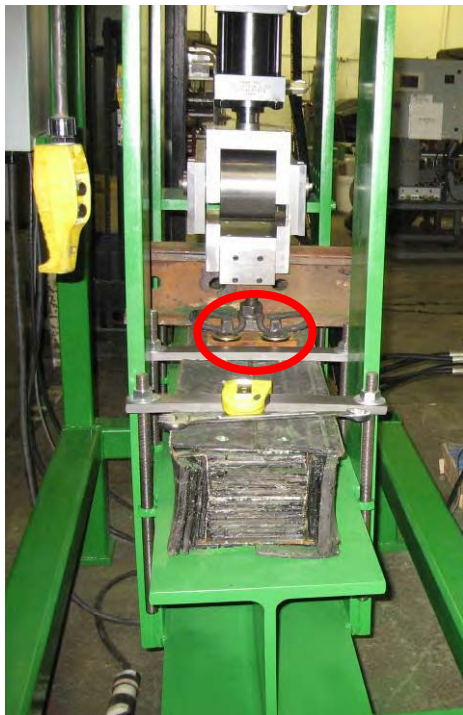
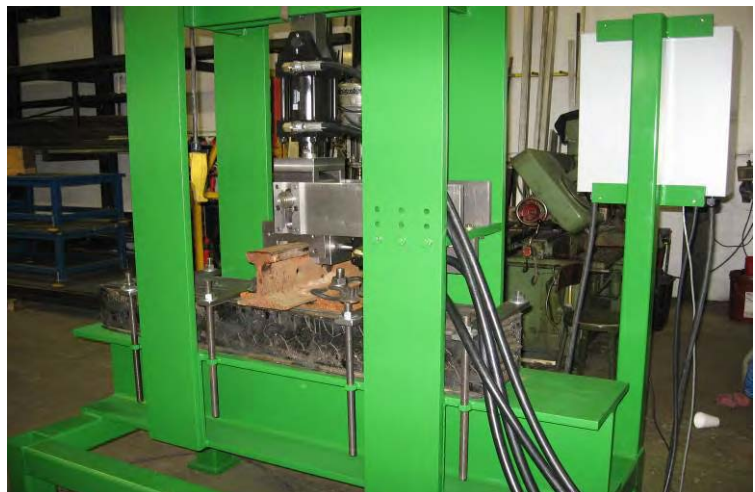
Figure 1: NP&G TireTie™ Lateral and 3-Point Bend Fixture

This fixture with simple modifications also can apply a load to the center of the cross tie in a 3-pt bend configuration.

The 3 point bend test was performed on the NP&G cross tie test fixture depicted in figure 1. The crosstie under test was supported by two plastic blocks 60 inches apart with a vertical load applied centered between the two blocks. Figure 4 below shows the support and loading configuration.

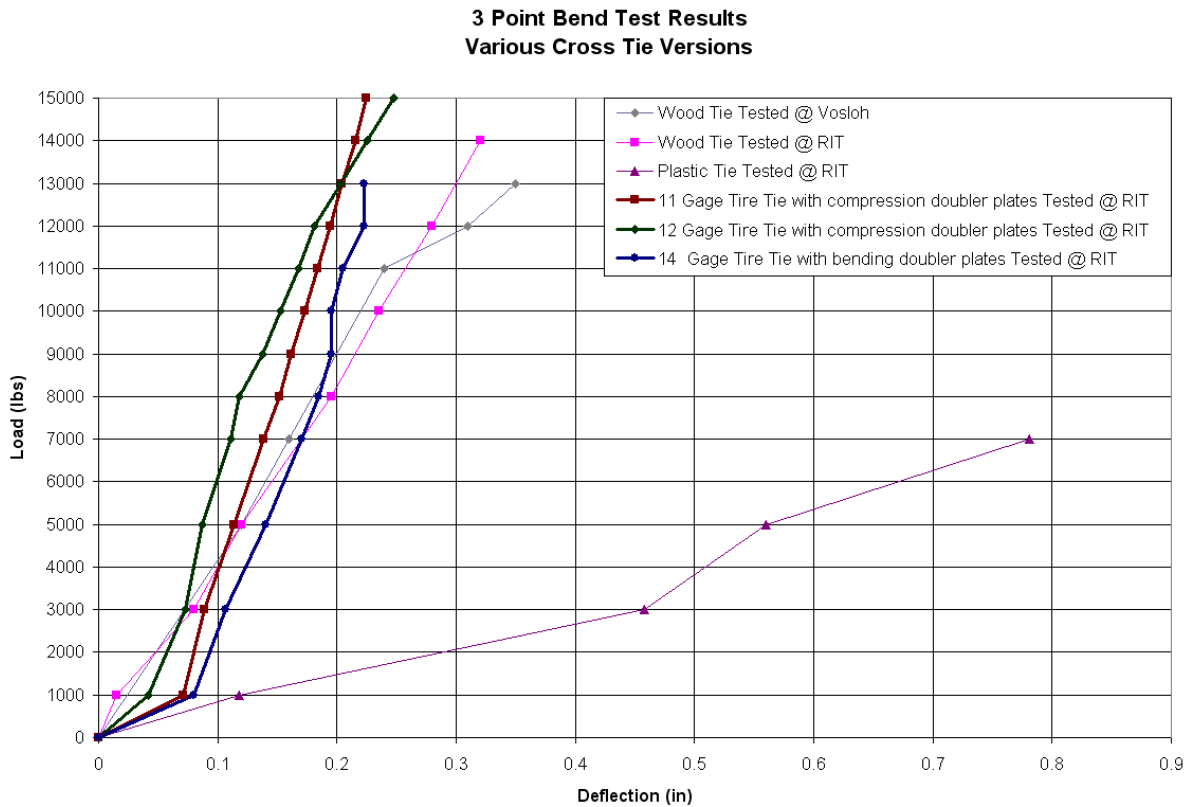
Figure 5: Three Point Bend Results all deflections in inches.

Figure 5 also shows that the NP&G cross ties had the least deflection per given load and the plastic tie had the most deflection. The 3-point bend test performed on the plastic tie was stopped after deflecting 0.78" at a loading of 7000lbs.

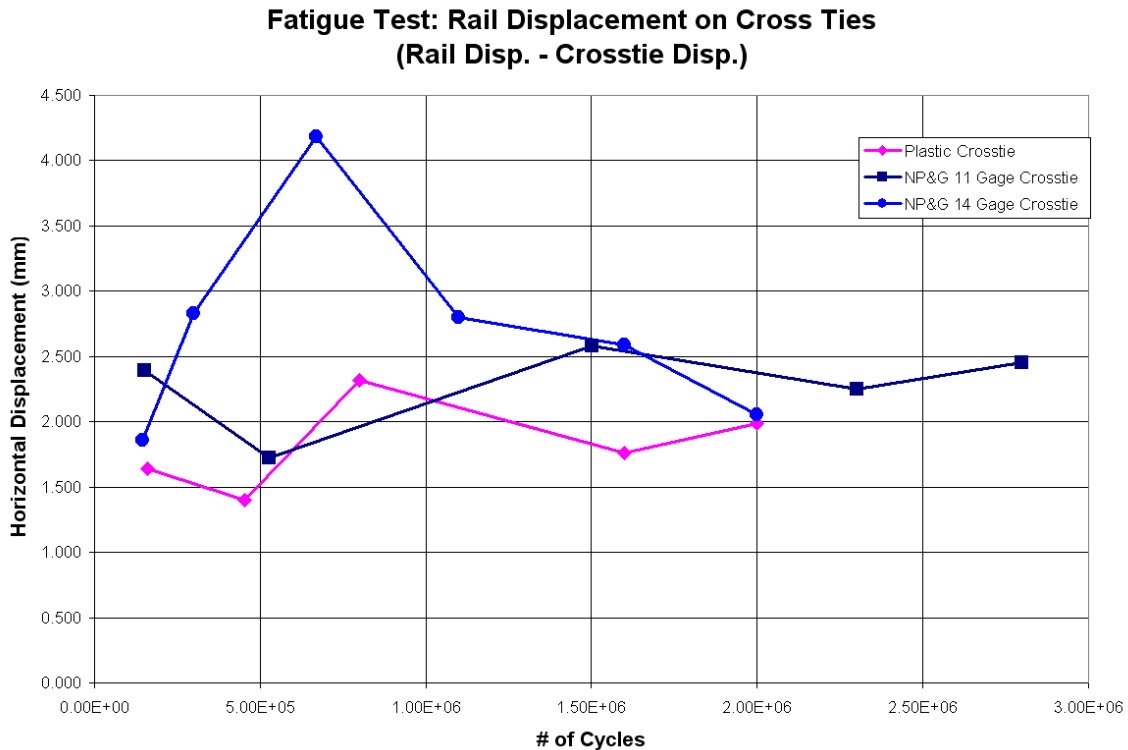
Figure 9: Fatigue test results (deflection of top of rail – deflection fo the cross tie top surface) for the two configurations of the NP&G composite cross tie and the plastic cross tie.

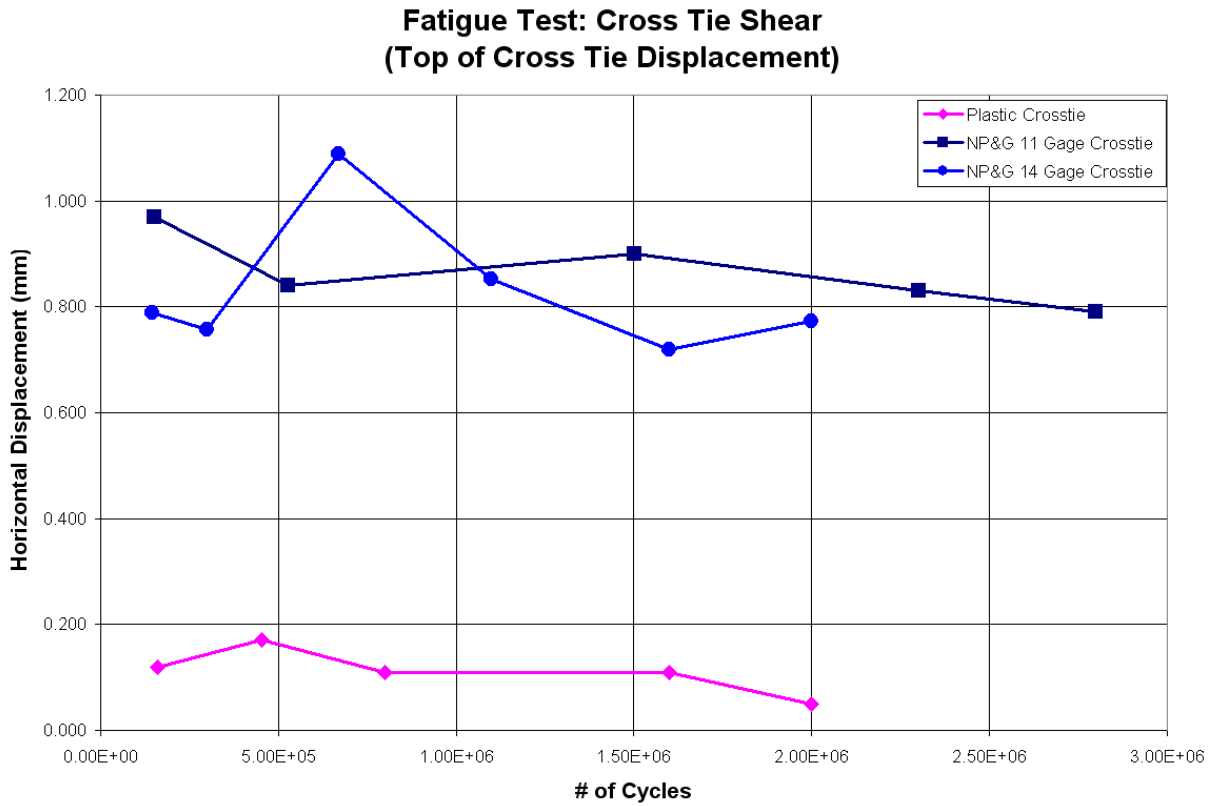
Figure 11: Fatigue test results (cross tie surface deflection) for the two configurations of the NP&G composite cross tie and the plastic cross tie.

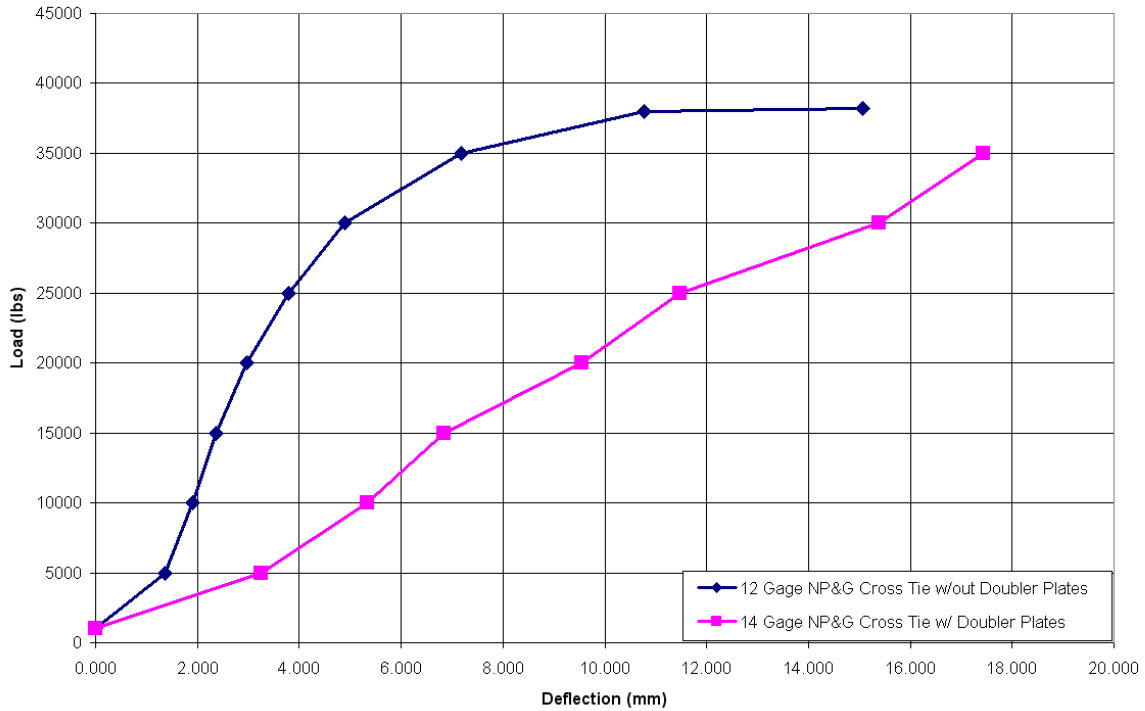
Figure 15: MOR test results for the NP&G 12 and 14 gage composite cross ties.
