1. Report No. TX-00/3983-1		2. Government Accession No.		3. Recipient's Catalog No.	
4. Title and Subtitle WORK ZONE LANE CLOSURE WARNING LIGHT SYSTEM				5. Report Date September 1999

# **WORK ZONE LANE CLOSURE WARNING LIGHT SYSTEM**

Report 3983-1

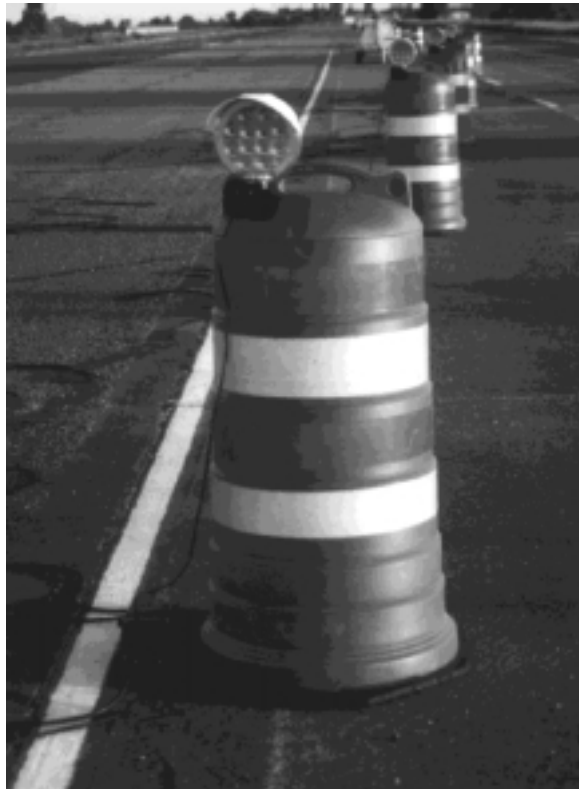
**Figure 2. Individual Flashing Warning Light Connection.**

The flash rate of each individual flashing warning light, which in turn controls the number of times the “moving” light sequences down the taper in a given period of time, is controlled by a starter box located at the beginning of the taper (Figure 3). A knob on the starter box allows for

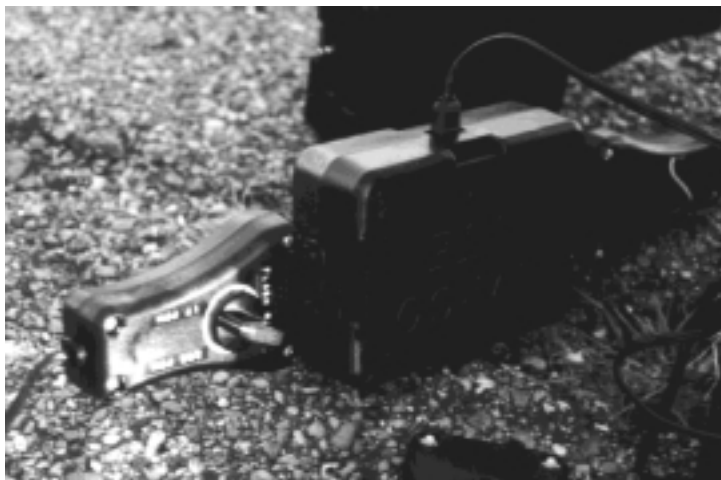
**Figure 3. Starter Box.**

the flash rate to be adjusted from 17 flashes per minute (fpm) to 265 fpm. It should be noted that the speed of the “moving” light down the taper is not affected when the flash rate is changed.
