# Performance Evaluation of Hot and Cold Pour Crack Sealing Treatments on Asphalt Surfaced Pavements

Research Report 4061-2

Research Project 0-4061  
*Comparison of Hot Poured Crack Sealant to Emulsified Asphalt Crack Sealant*

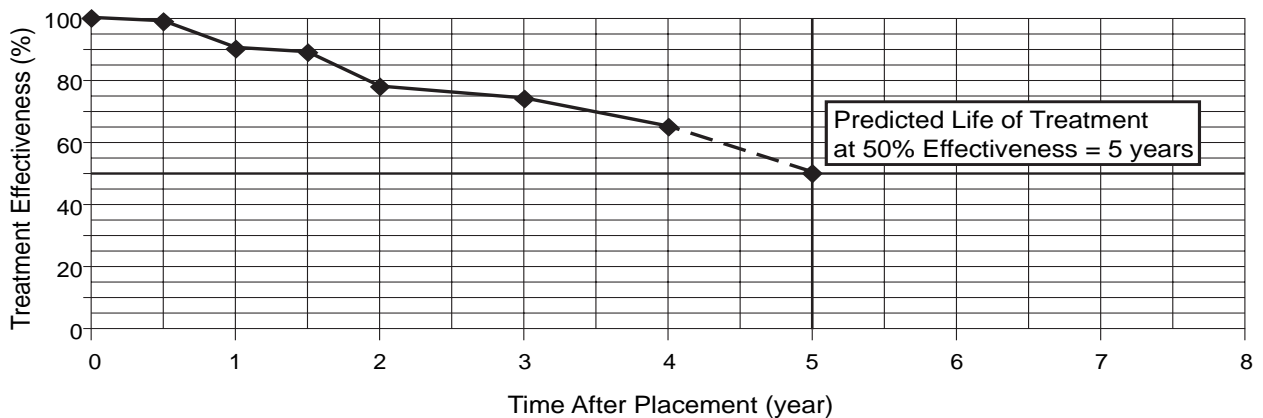
As shown in Figure 3.1, the main product of this evaluation procedure is a chart depicting effectiveness (in percentage) with respect to time of measurement. A minimum of one evaluation measurement each year is needed to provide an estimation of the performance of the crack treatment. For the most effective evaluation, measurements should be conducted during the mid-winter period when the crack is subjected to maximum opening. It is suggested that the first inspection be made during the first winter, while another can be done after winter to assess winter damage. Along with the traffic control devices, the basic apparatus needed is a distance measurement device like a measuring wheel.

Figure 3.1 Example graph of treatment effectiveness versus time

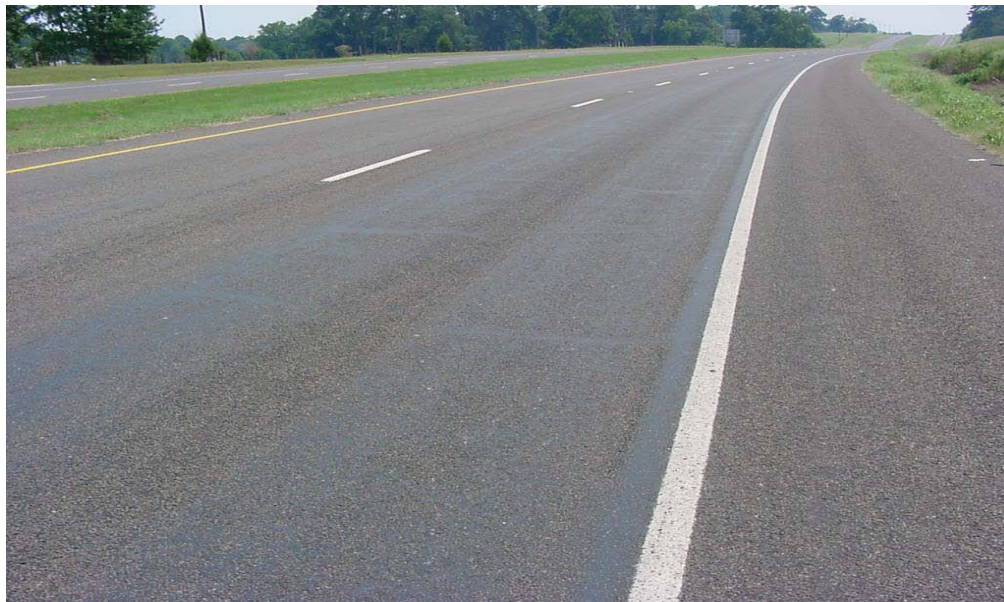
In Atlanta, crack seal was applied on January 31, 2001, and chip seal was applied on June 20, 2001, to Loop 281 in Harrison County in the southbound, outside lane. An evaluation was made after two months and the results are mentioned in Chapter 2. This section was evaluated again on August 8, 2002.

*Figure 4.6 Atlanta, H1-covered test section during the August 8, 2002 investigation visit*

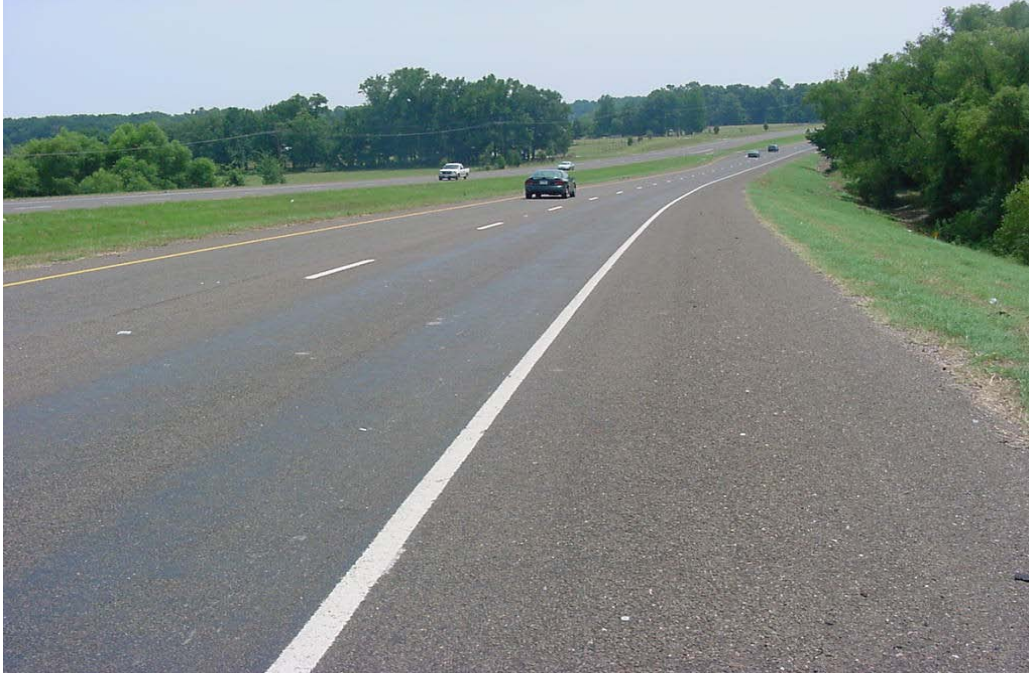
*Figure 4.7 Atlanta, C2-covered test section during the August 8, 2002 investigation visit*

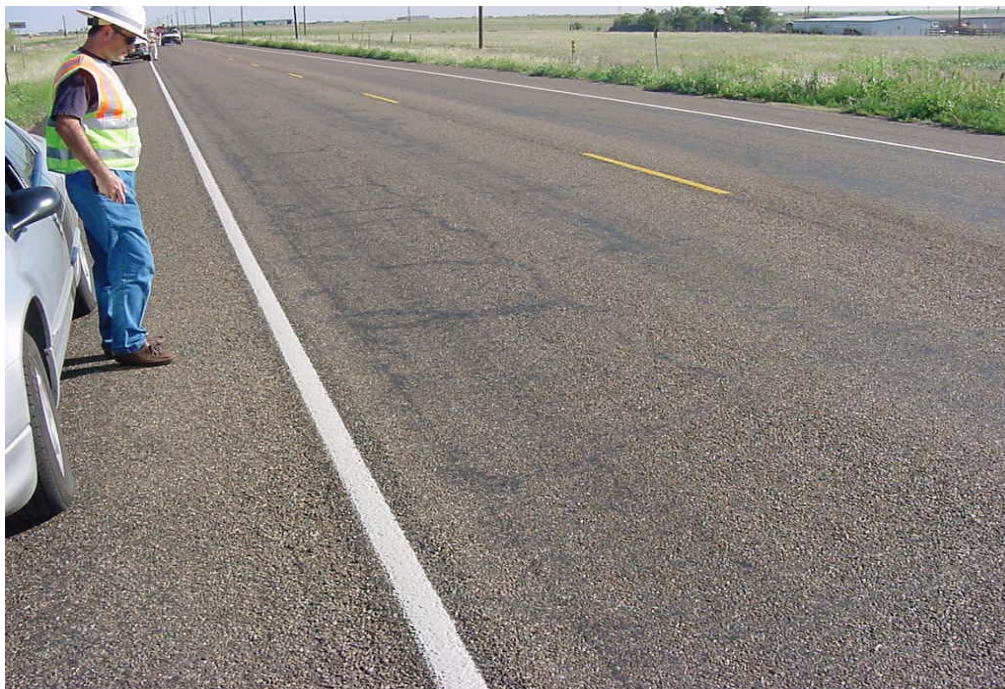
This test section, located in Randall County on FM 1541 in the Southbound, Outside Lane, was crack sealed on February 20, 2001 and was chip sealed and visited for evaluation two months after the chip seal. Cold pour sealant C1 and hot pour sealant H3 were used for crack treatment before the chip seal was applied on August 17, 2001. Then, the test sections were investigated again on August 15, 2002. Once more, the hot pour sealant seemed to engender a bleeding problem. However, the severity of the bleeding was very low. Figure 4.8 shows the H3-covered section in Amarillo during the August 15, 2002 investigation visit. On the other hand, the test section that was treated with C1 did not show any bleeding problems. Figure 4.9 shows the C1-covered section in Amarillo during the August 15, 2002 investigation visit.

*Figure 4.8 Amarillo, H3-covered test section during the August 15, 2002 investigation visit*

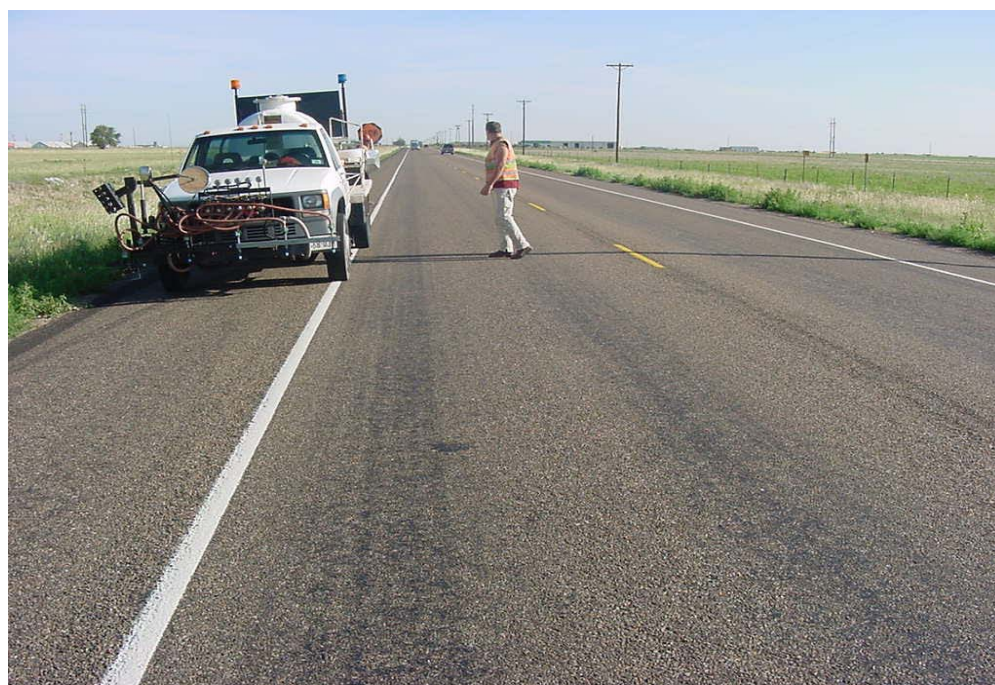
*Figure 4.9 Amarillo, C1-covered test section during the August 15, 2002 investigation visit*

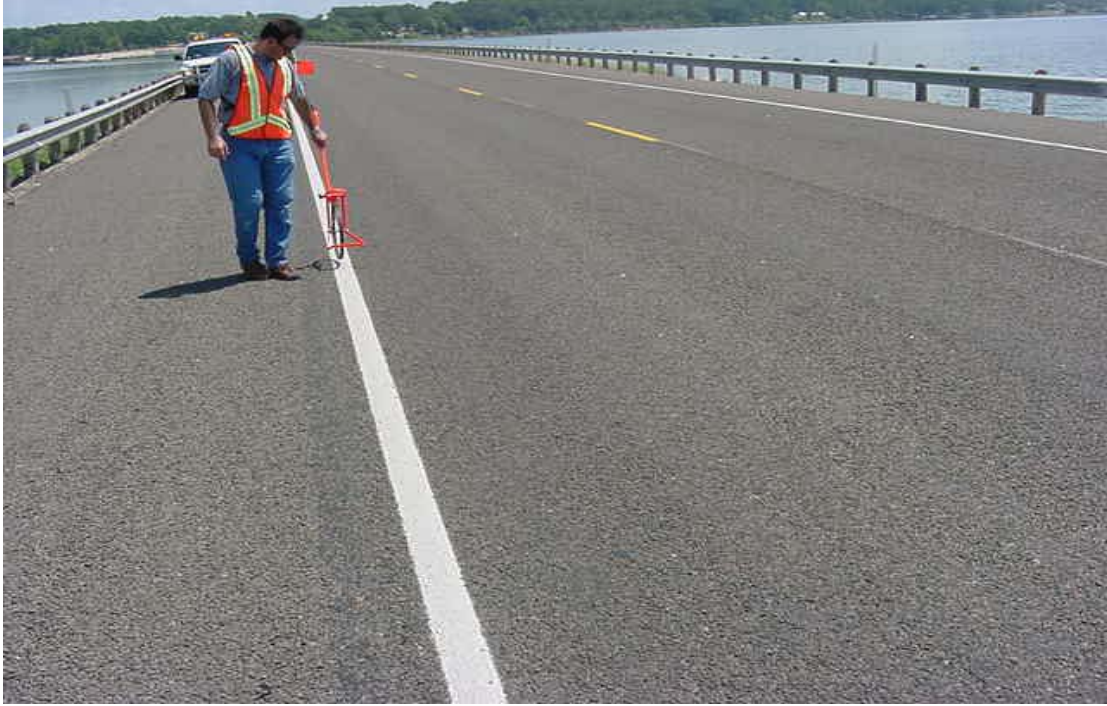
This test section, located in Polk county on US 190 in the Westbound, Outside lan, was chip sealed on June 25, 2002, and then crack seal was applied on February 7 and 8, 2001. It was investigated once only on August 20, 2002. Two cold pour sealants (C1 and C2) and two hot pour sealants (H1 and H3) were used for crack treatment of this test section. As expected, bleeding was observed during the investigation of hot pour treated sections. However, its severity was very low. Bleeding portion lengths were 214 ft (65.2 m) and 150 ft (45.7 m) for H1 and H3 respectively. In the case of cold pour sealants, no signs of bleeding were observed. Figures 4.10 through 4.13 show the covered sections in Lufkin that are treated with C1, C3, H1, and H3 respectively.

*Figure 4.10 Lufkin, C1-covered test section during the August 20, 2002 investigation visit*

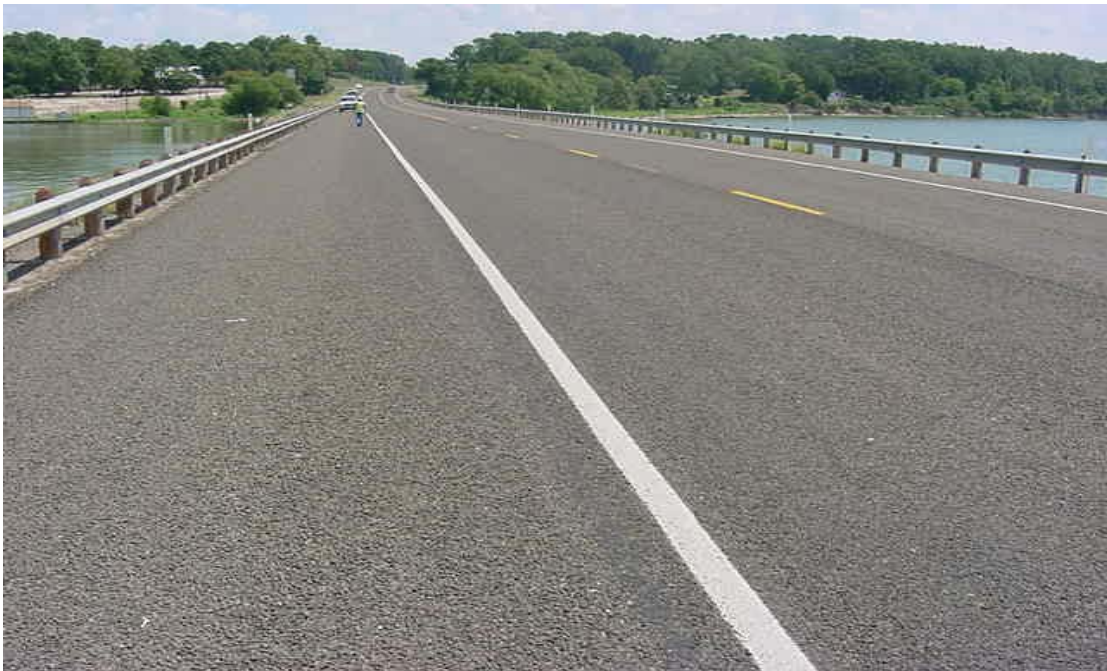
*Figure 4.11 Lufkin, C2-covered test section during the August 20, 2002 investigation visit*

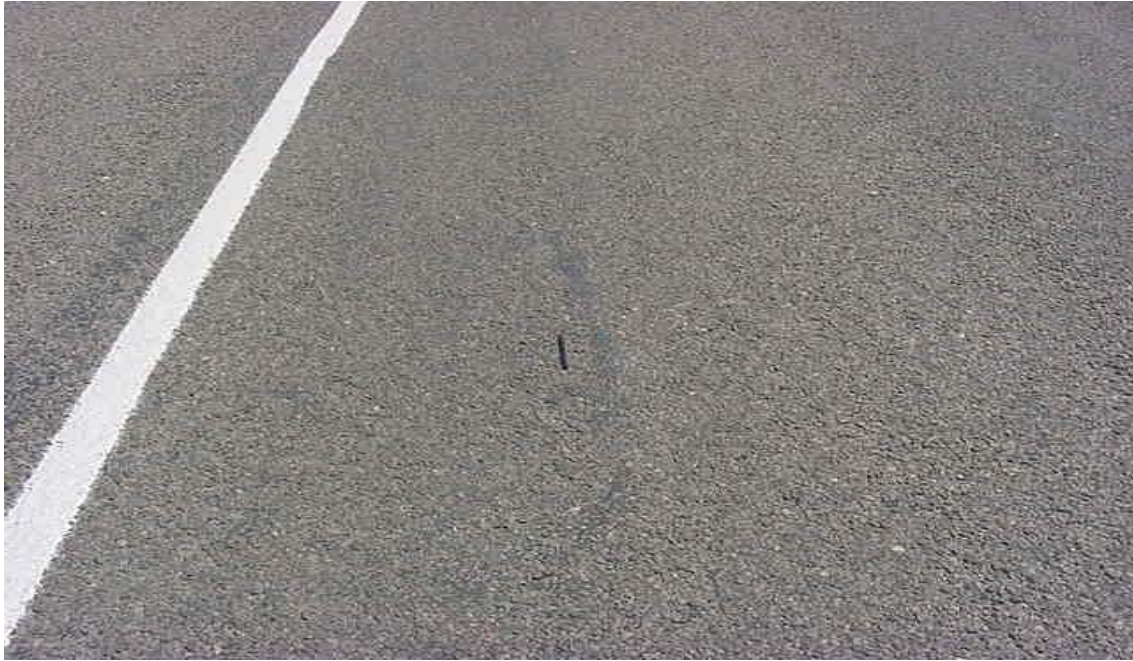
*Figure 4.12 Lufkin, H1-covered test section during the August 20, 2002 investigation visit*

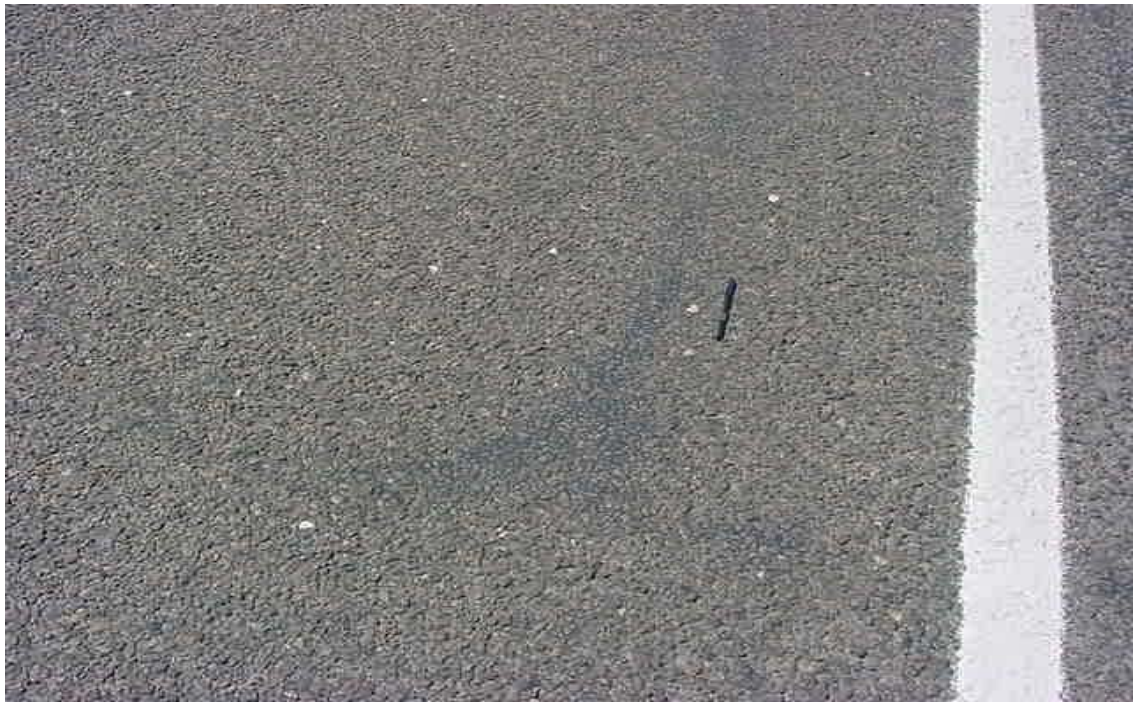
*Figure 4.13 Lufkin, H3-covered test section during the August 20, 2002 investigation visit*

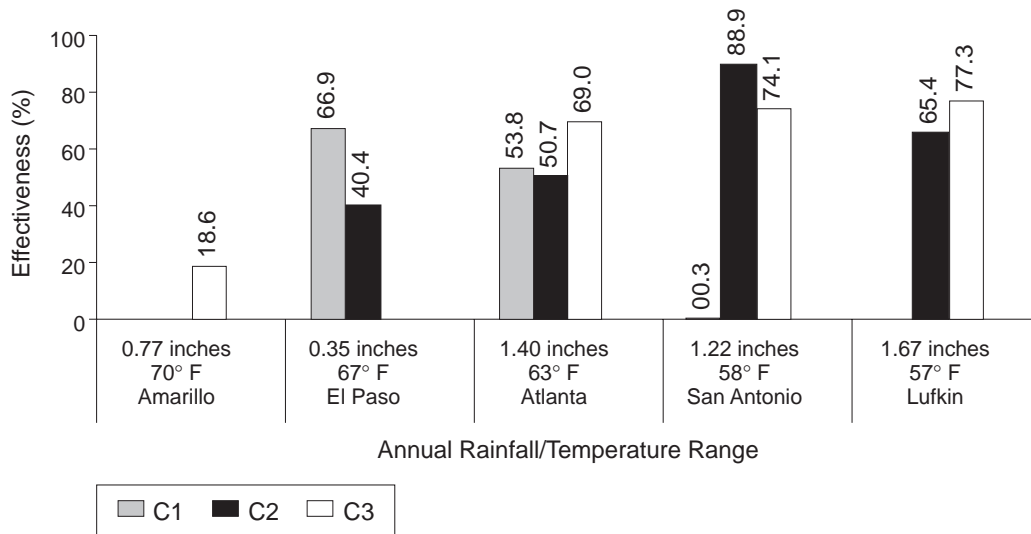
Figure 5.3 Performance trends of cold pour sealants with respect to temperature range after the winter 2002 investigation

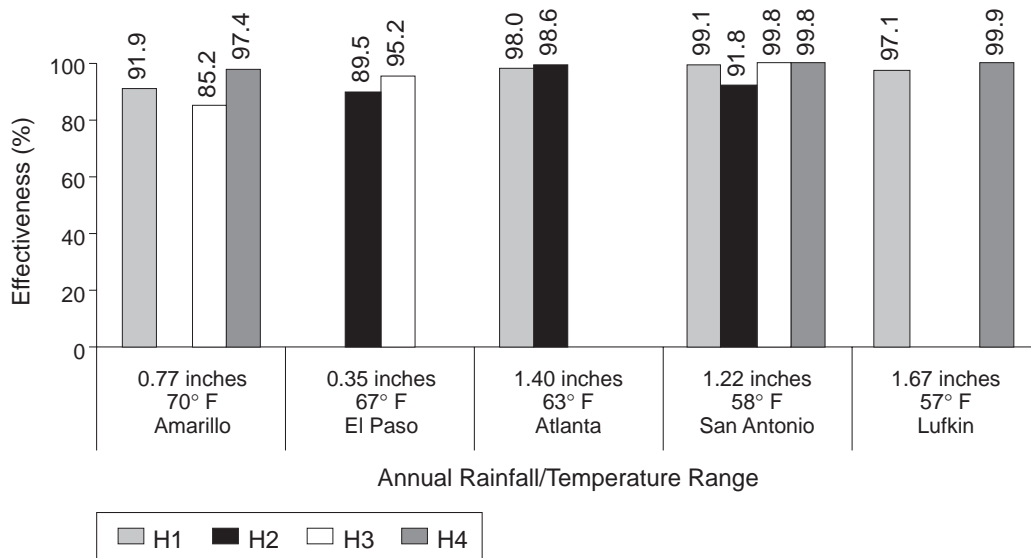
For the hot pour sealants, there is a pattern of increase in performance with the decrease of annual temperature range. This pattern can be clearly seen in the performance trend of H3 and H4 where their performance continues to increase as we go from Amarillo to Lufkin. This trend also occurs generally in the performance of H1 and H2.

Figure 5.4 Performance trends of hot pour sealants with respect to temperature range after the summer 2002 investigation

Similarly, performance trends of both hot and cold pour sealants with respect to environmental factors after the summer 2002 investigation are shown in Figures 5.4 and 5.5 respectively.

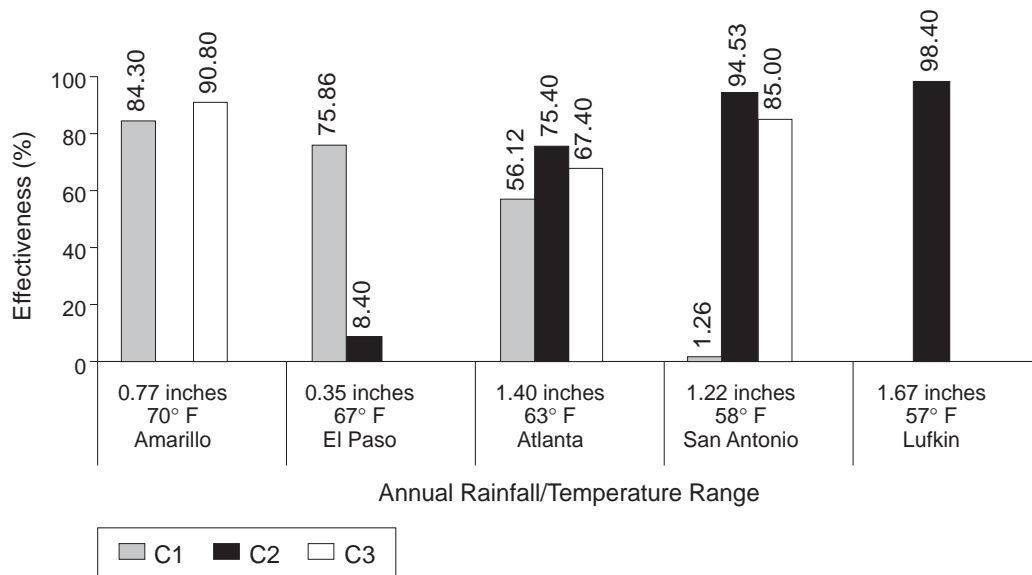
For the cold pour sealants, on the other hand, two different patterns can be extracted. The first pattern is that of C1 (highest softening point, 202° F, among the cold pour sealants) where the effectiveness exhibits a continuous drop with the decrease of annual temperature range. The opposite pattern is exhibited by C2 (lowest softening point, 158° F among the cold pour sealants) in which the effectiveness increases with the decrease of annual temperature range.

*Figure 5.5 Performance trends of cold pour sealants with respect to temperature range after the summer 2002 investigation*

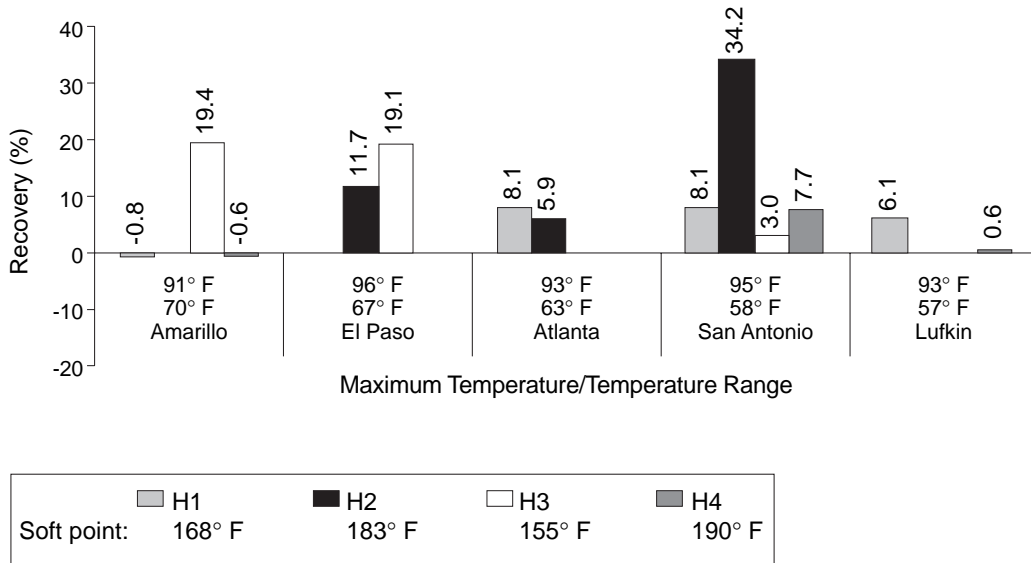
The increase in the percent effectiveness in the summer seems to have a correlation with the maximum annual temperature. This phenomenon is largely based on the temperature range and the natural process of cracks opening in the winter and closing in the summer, plus other pavement, soil, and rain conditions. This was expected given the configuration of the hot pour sealing material in the crack. The recovery of hot pour sealants at different districts is shown in Figure 5.6.

Figure 5.6 Recovery rate of hot pour sealants in different districts

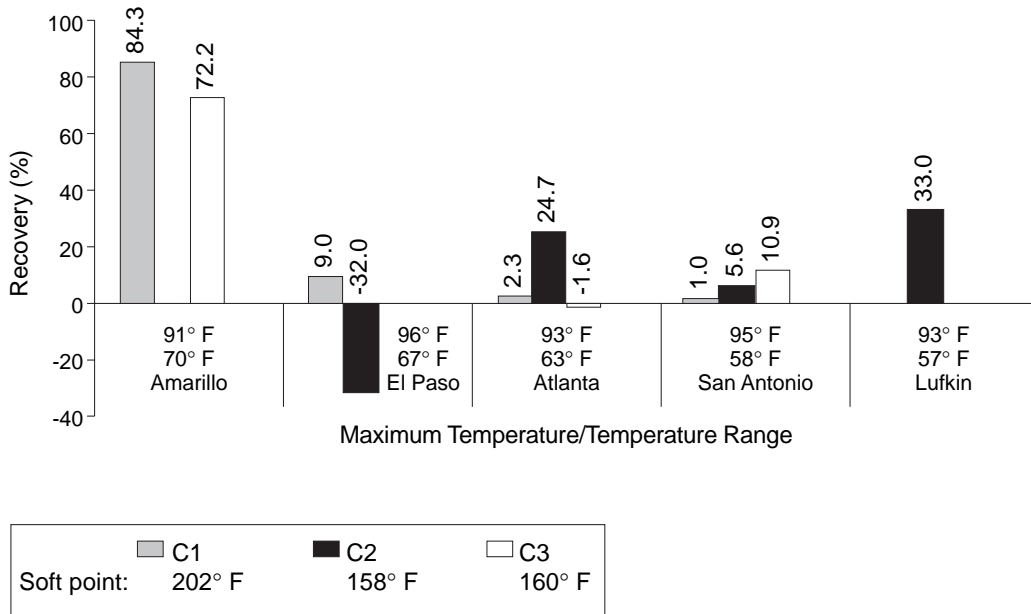
The recovery rate for the cold pour sealants seems to respond contrarily. Higher rates of recovery were exhibited in districts with lower annual maximum temperatures, such as Amarillo. Figure 5.7 shows the cold pour sealants' recovery rate in different districts.

Figure 5.7 Recovery rate of cold pour sealants in different districts
