Metro Gold Line Eastside Extension  
Four Quadrant Gate Feasibility Study

September 2009

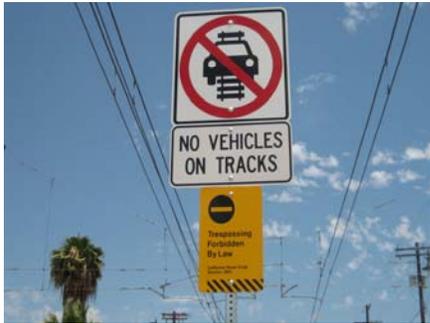
Figure 1 – No Trespass and No Vehicle Signs

Signs have been placed within the 1<sup>st</sup> Street and 3<sup>rd</sup> Street trainways to warn pedestrians of trespass and motorists that vehicles are not permitted on the tracks. These signs are appropriate. However, the No Trespass sign size and lettering appear to be too small. The team was not able to easily read the sign until they were in the trainway itself, defeating the purpose of the sign. On the other hand the “No Vehicle on Tracks” sign and “No Vehicles” symbol sign, appear to be appropriately sized. See Figure 1

Recommendation 1 – No Trespass Signs

Recommendation 2 – Sign Clutter

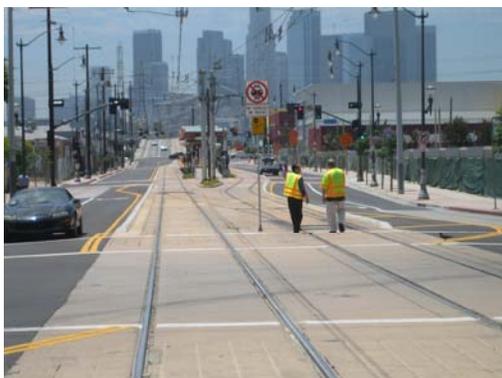
vehicle traffic and to define the dynamic envelope of the train. The latter is particularly important for those segments where trains mix with vehicular traffic, such as in roadway intersections. Typical means to delineate the trainway are by striping, curbs (including mountable curbs), raised buttons or other tactile treatment. Along 1<sup>st</sup> Street and 3<sup>rd</sup> Street, the trainway is delineated by a 6-inch mountable curb, colored stamped concrete, and in some

locations reflective paddles atop the curbs. The panel found the stamped concrete to be noticeable during daylight hours. During hours

of darkness, the color contrast of the stamped concrete area with the roadway was much less discernable. This is a concern as a motorist negotiating a turn may mistake the trainway for the roadway, and as a consequence, enter the trainway. Additional treatment is needed to more clearly indicate that the trainway is not a roadway and that motorists are not to enter it. See Figure 2.

**Recommendation 4 – Trainway Delineation**

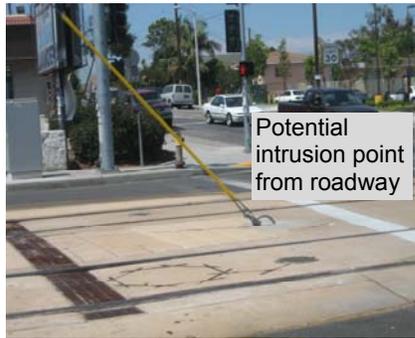
Figure 3 – Unprotected Guy Wire

At several locations, catenary poles and catenary guy wires are located at the intrusion entry point of the trainway. The poles and guy wires need to be protected from errant vehicles. An option is to protect the poles and guys with bollards striped with retro-reflective tape. See Figure 3.

**Recommendation 3 – Catenary Pole/Guy Wire Protection**

*Place bollards or other devices to protect the catenary poles and guy wires from being accidentally struck and damaged by an errant motor vehicle.*

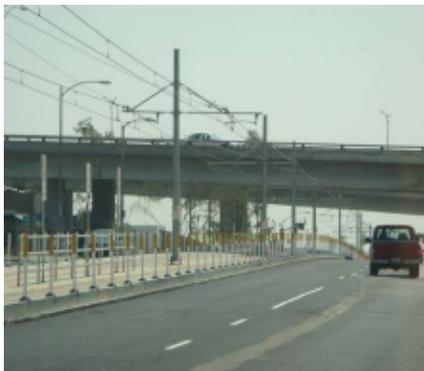
Figure 4 – Reflective Paddle Delineators

The reflective paddles along 3<sup>rd</sup> Street visibly outline the trainway. However, the paddles are likely to become a maintenance issue as they are easily damaged. Several damaged paddles were seen during site visits. There are several other treatments that can achieve the same effect. One option is to place yellow raised buttons on the curbs with reflective pavement markers place every third one or so. Another option is to simply place reflective pavement markers on the curb. If on the other hand paddles are to be retained, they should be placed at approximately 15-foot intervals.

**Recommendation 5 – Trainway Delineators**

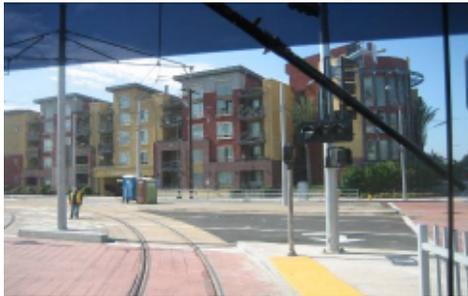
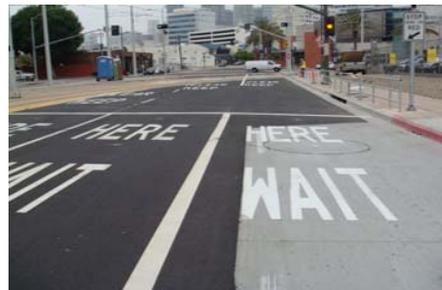
### **1<sup>st</sup> Street and Alameda Avenue**

Eastbound train moves from Little Tokyo Station through 1<sup>st</sup> Street and Alameda Avenue require operators to negotiate the move at 10 mph due to the sharp curve.

Trains moving through this crossing frequently encounter motor vehicles encroaching in the designated “Clear Zone”. The encroachment may be due to motorist confusion as to where to stop, as the “Wait Here” and “Keep Clear” zones appear to blend together. The encroachment creates two problems. First, it may impede train movements. Second, a train moving through the crossing may collide with the stopped vehicle, as it may not always be evident to the operator that there is insufficient clearance. The use of markers to define the dynamic envelope will assist the operator in knowing whether it is safe to proceed through the curve. Train clearance markers have an added benefit. They provide a visual queue to the operator where the end of the train is in relation to the curve and when it is safe to accelerate.

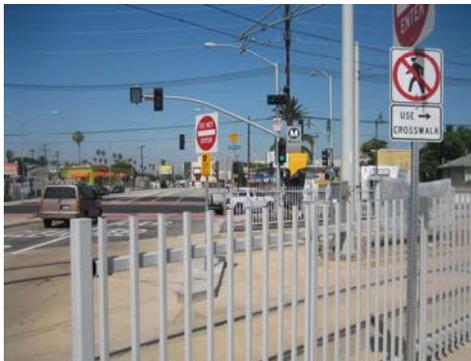
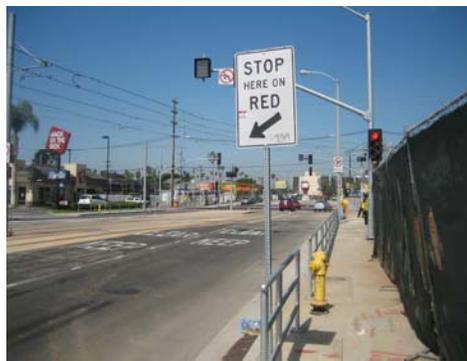
### **3<sup>rd</sup> Street and Indiana Avenue**

The photographs above show a view on 3<sup>rd</sup> street looking west at Indiana Avenue. The light rail station is just to the right in each photograph. Pedestrians approaching Indiana Avenue from the west (northwest quadrant of the intersection) are directed across

Indiana (toward the northeast quadrant) and onto what appears to be a pedestrian island. The area is not a pedestrian island, but in fact the northeast corner of the intersection. After reaching the corner, pedestrians are to proceed to the pedestrian crossing located on the south end of the 3<sup>rd</sup> and Indiana Station, if they wish to continue east along 3<sup>rd</sup> Street. Pedestrians are not to continue across the tracks as it places them into the roadway with no safe refuge, such as a sidewalk.

*Consideration should be given to extending the picket fence on the island to discourage pedestrians from continuing straight across the light rail tracks. A sign stating that pedestrian are prohibited from crossing the tracks at this location should be placed on the fence, as well.*

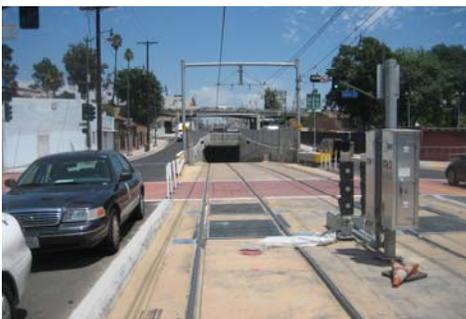
**1<sup>st</sup> Street and Gless Avenue**

1<sup>st</sup> Street and Gless Avenue is the locality of the west end of the tunnel. Prior to the construction of the tunnel portal, vehicular traffic was permitted to cross 1<sup>st</sup> Street at this location. Now, high curbs with large reflective paddles on top have been put in place as a crossing barrier. A number of active and passive signs were also in place, informing motorists that they must not turn and proceed straight ahead. Although no damage to the barrier was found, the signage at this location

was cluttered and may be confusing. There were “No U Turn” and “No Left Turn” signs on Gless Street (only right turns are permitted). Signage at this location should be evaluated.

**Recommendation 24 – Reevaluate Signage**

*Reevaluate the signage on Gless Avenue, as many of the signs are no longer applicable.*

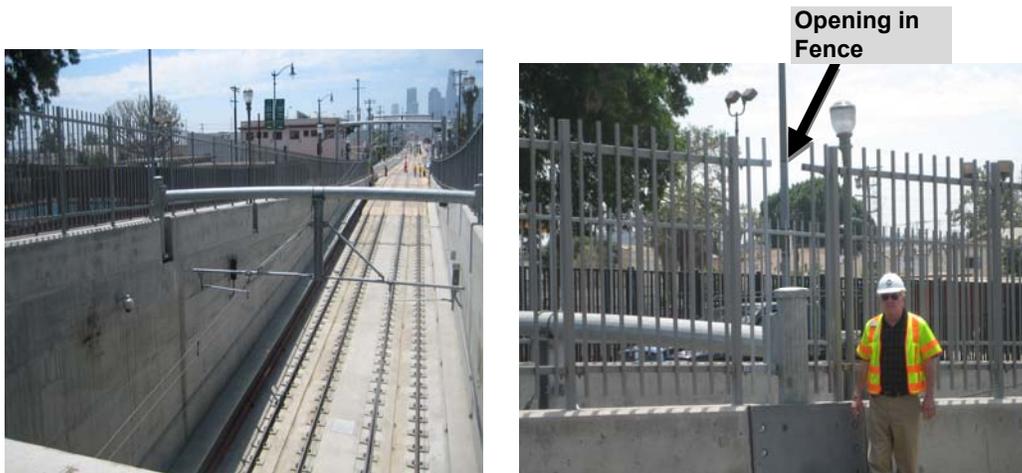
A significant safety issue was identified at the west portal (above photographs). The pickets on the perimeter of the portal walls are spaced far enough apart to permit objects from being pushed through and landing on the trainway, making contact with the catenary, or being dropped in front of an approaching train. Additionally, there is a large opening (see photograph on the right) that allows a person to climb on to the pipe spanning the tracks. Tight wire mesh or other tightly woven fabric should be placed on the pickets to prevent objects from being pushed through. Additionally, the large openings on each side of the pipe span should be closed.

**Recommendation 25 – Picket Fence**

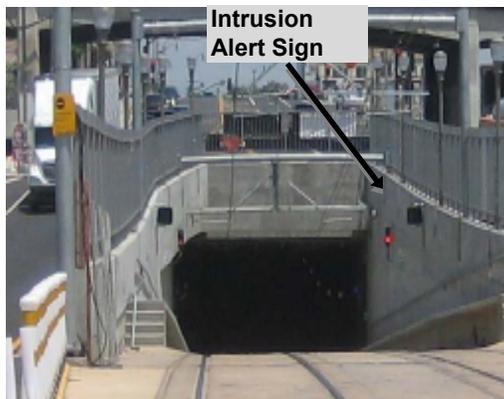
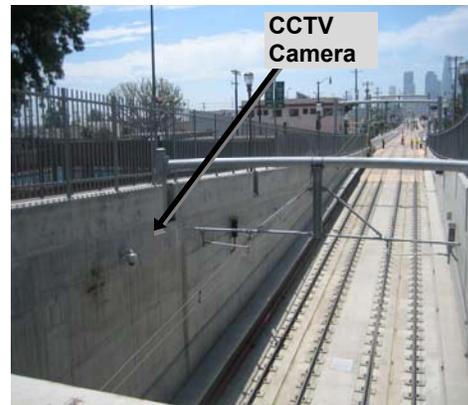
A tunnel intrusion detection system has been installed to detect unauthorized persons and vehicles in the tunnel. Upon detection, an alert is sent to the ROC. A CCTV camera, mounted on the portal wall (see lower right photograph below) permits ROC personnel to view the intrusion. Additionally, a visual alert is displayed at the portal (see lower left photograph below) to notify train operators that an intruder is in the tunnel.

At each underground station there is an intrusion detection system that will be coupled to the platform end gates. Intruders entering the tunnel through the gate are immediately detected; sending an alarm to the ROC and are viewed through a CCTV system. Intrusions by stepping off the platform and into the trainway; however, would go undetected, as the detection device is only on the gate. Moreover, the platform detection system and the portal detection system are not integrated. Consequently, an intrusion from the portal would not automatically and immediately alert train operators already in the bores (the ROC Controller would have to notify these operators of the intrusion via radio communications). Conversely, trains entering the tunnel would not know of an intrusion from one of the stations unless notified by the Controller. Similarly, a train that has passed any one of the visual alerts would not know of an intrusion. For example, an eastbound train leaving the Boyle Heights Station would not know of an intrusion from the east portal. For safety and security reasons, it is vitally important that all trains be immediately informed of an intrusion. All of the detection systems should be fully integrated; sending visual alerts to all signs. Furthermore, an audible and visual alert should be annunciated locally to inform the intruder that they have been detected and they are to leave immediately.

### **Recommendation 32 – Detection System Integration**

*Integrate the platform and portal intrusion systems so that detection at any location will send an alert to all locations.*

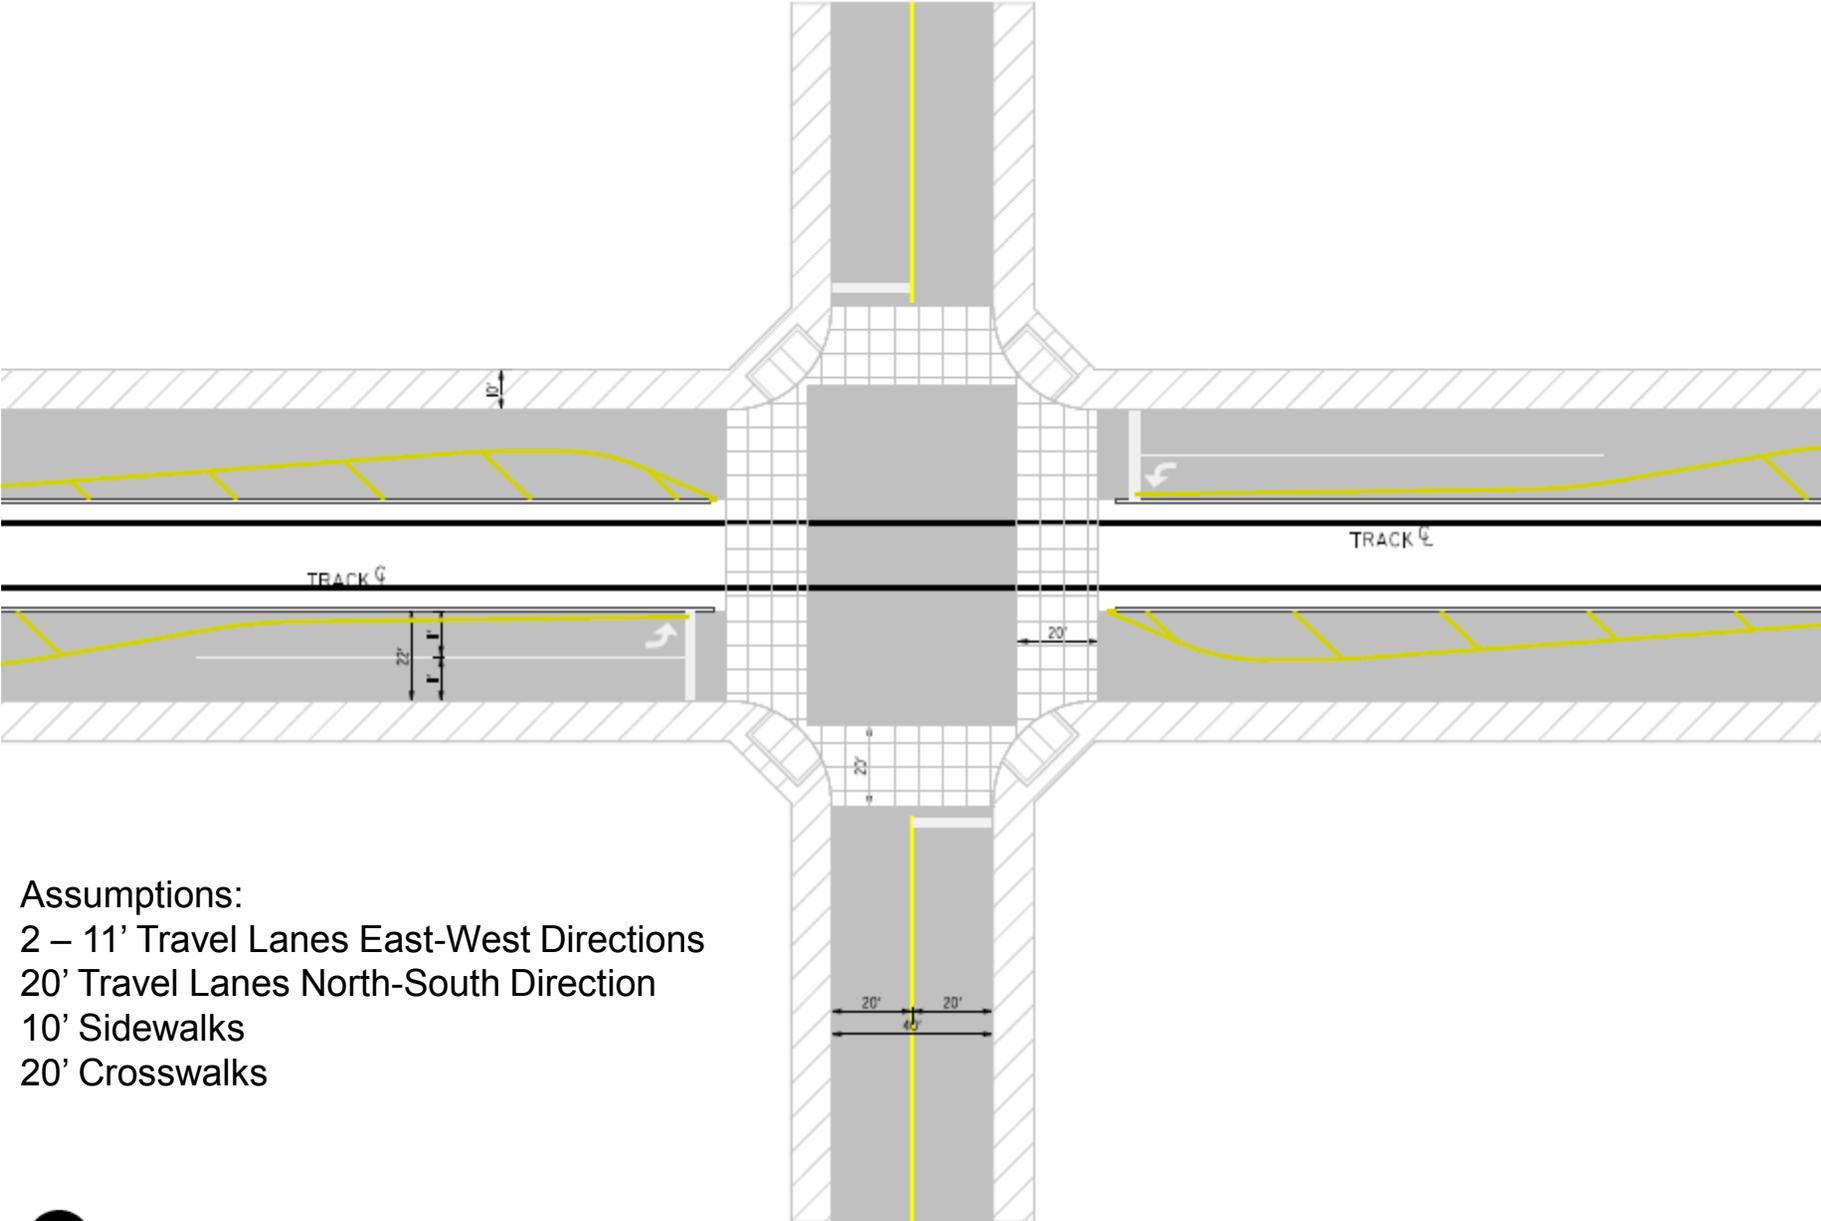
# Standard Ideal Intersection

- Assumptions:
- 2 – 11' Travel Lanes East-West Directions
  - 20' Travel Lanes North-South Direction
  - 10' Sidewalks
  - 20' Crosswalks

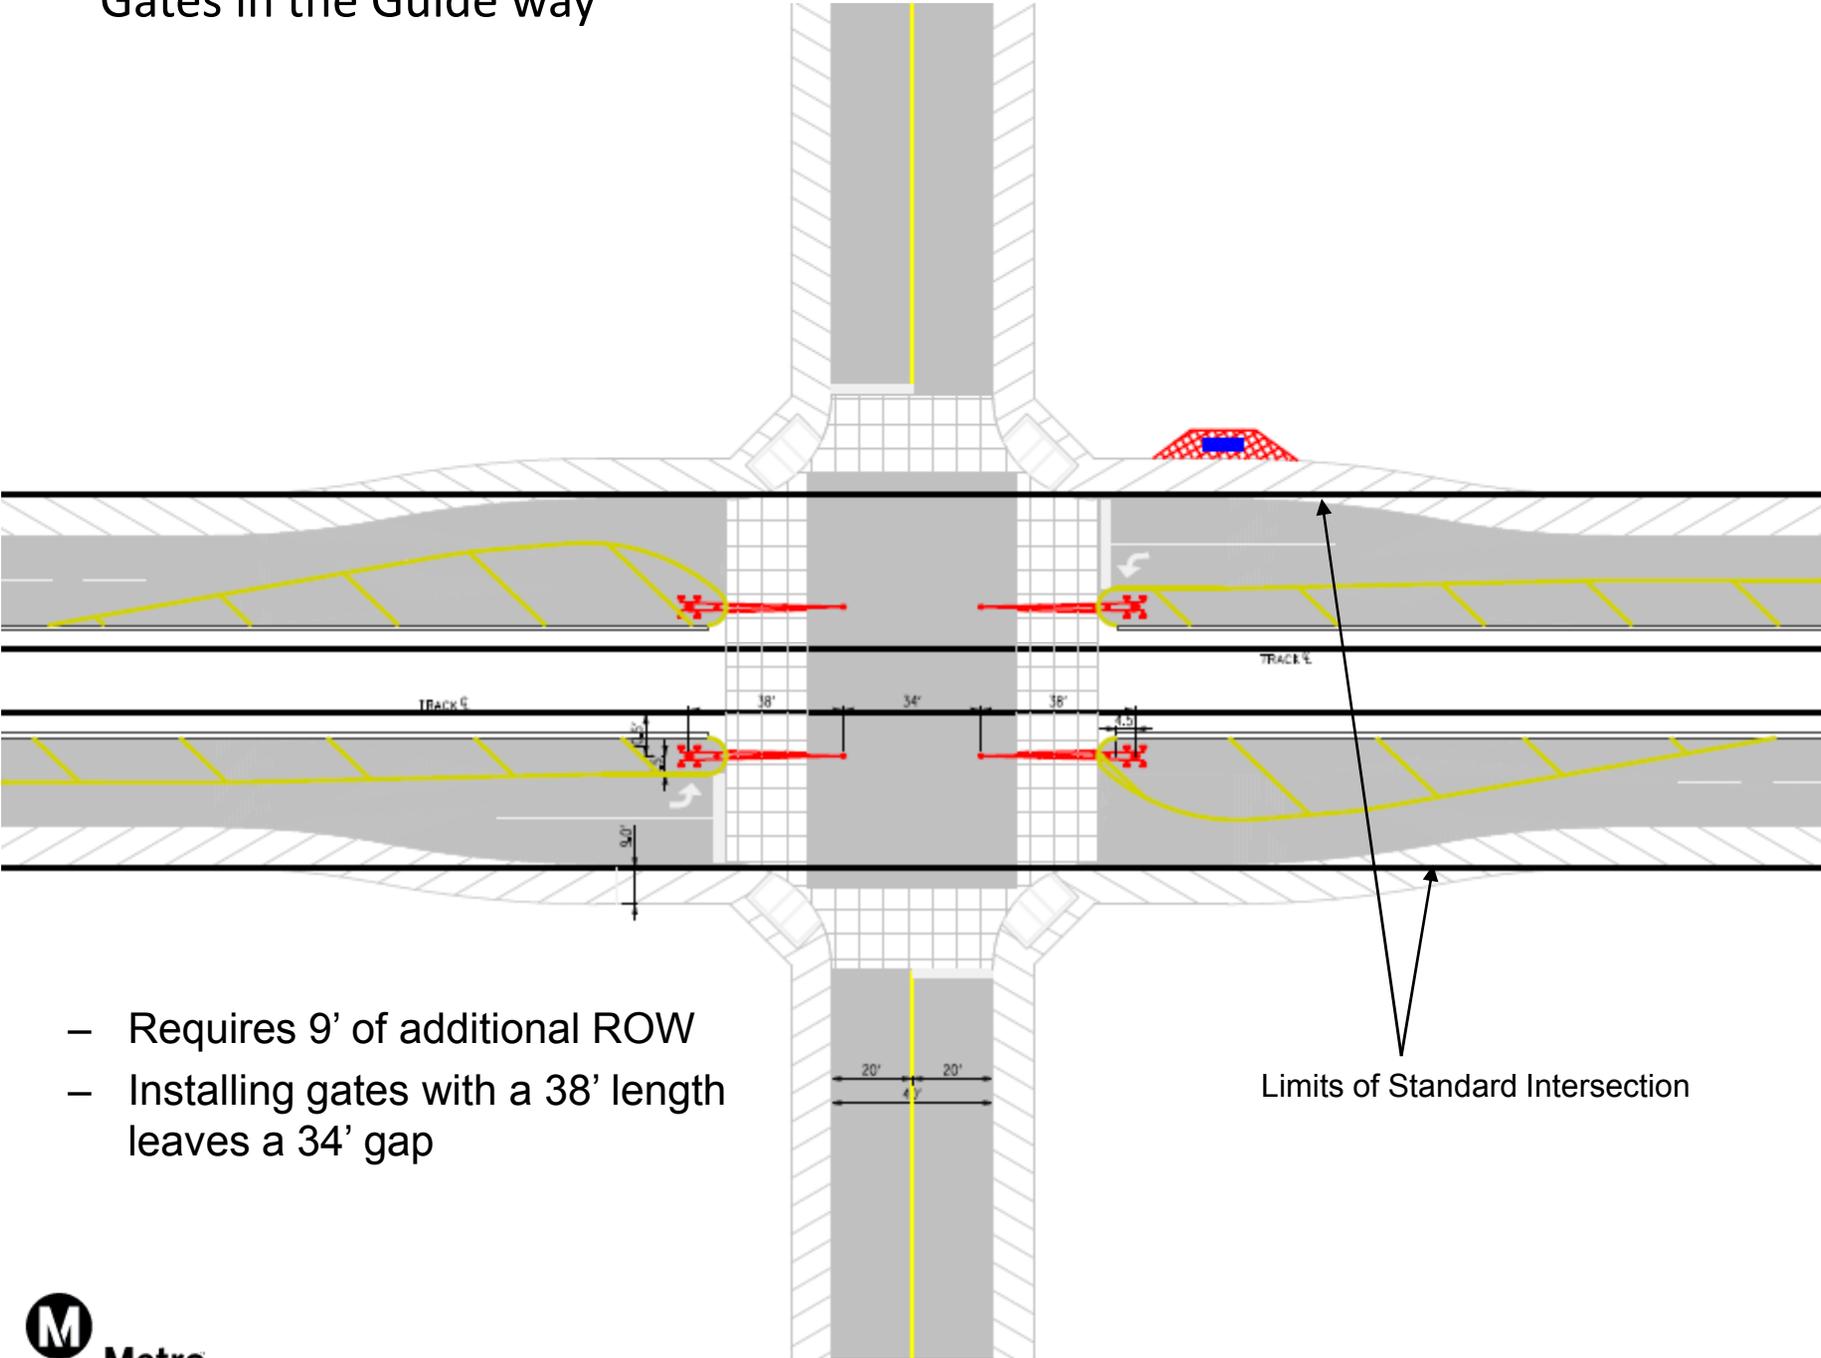
# Gates in the Guide way

- Requires 9' of additional ROW
- Installing gates with a 38' length leaves a 34' gap

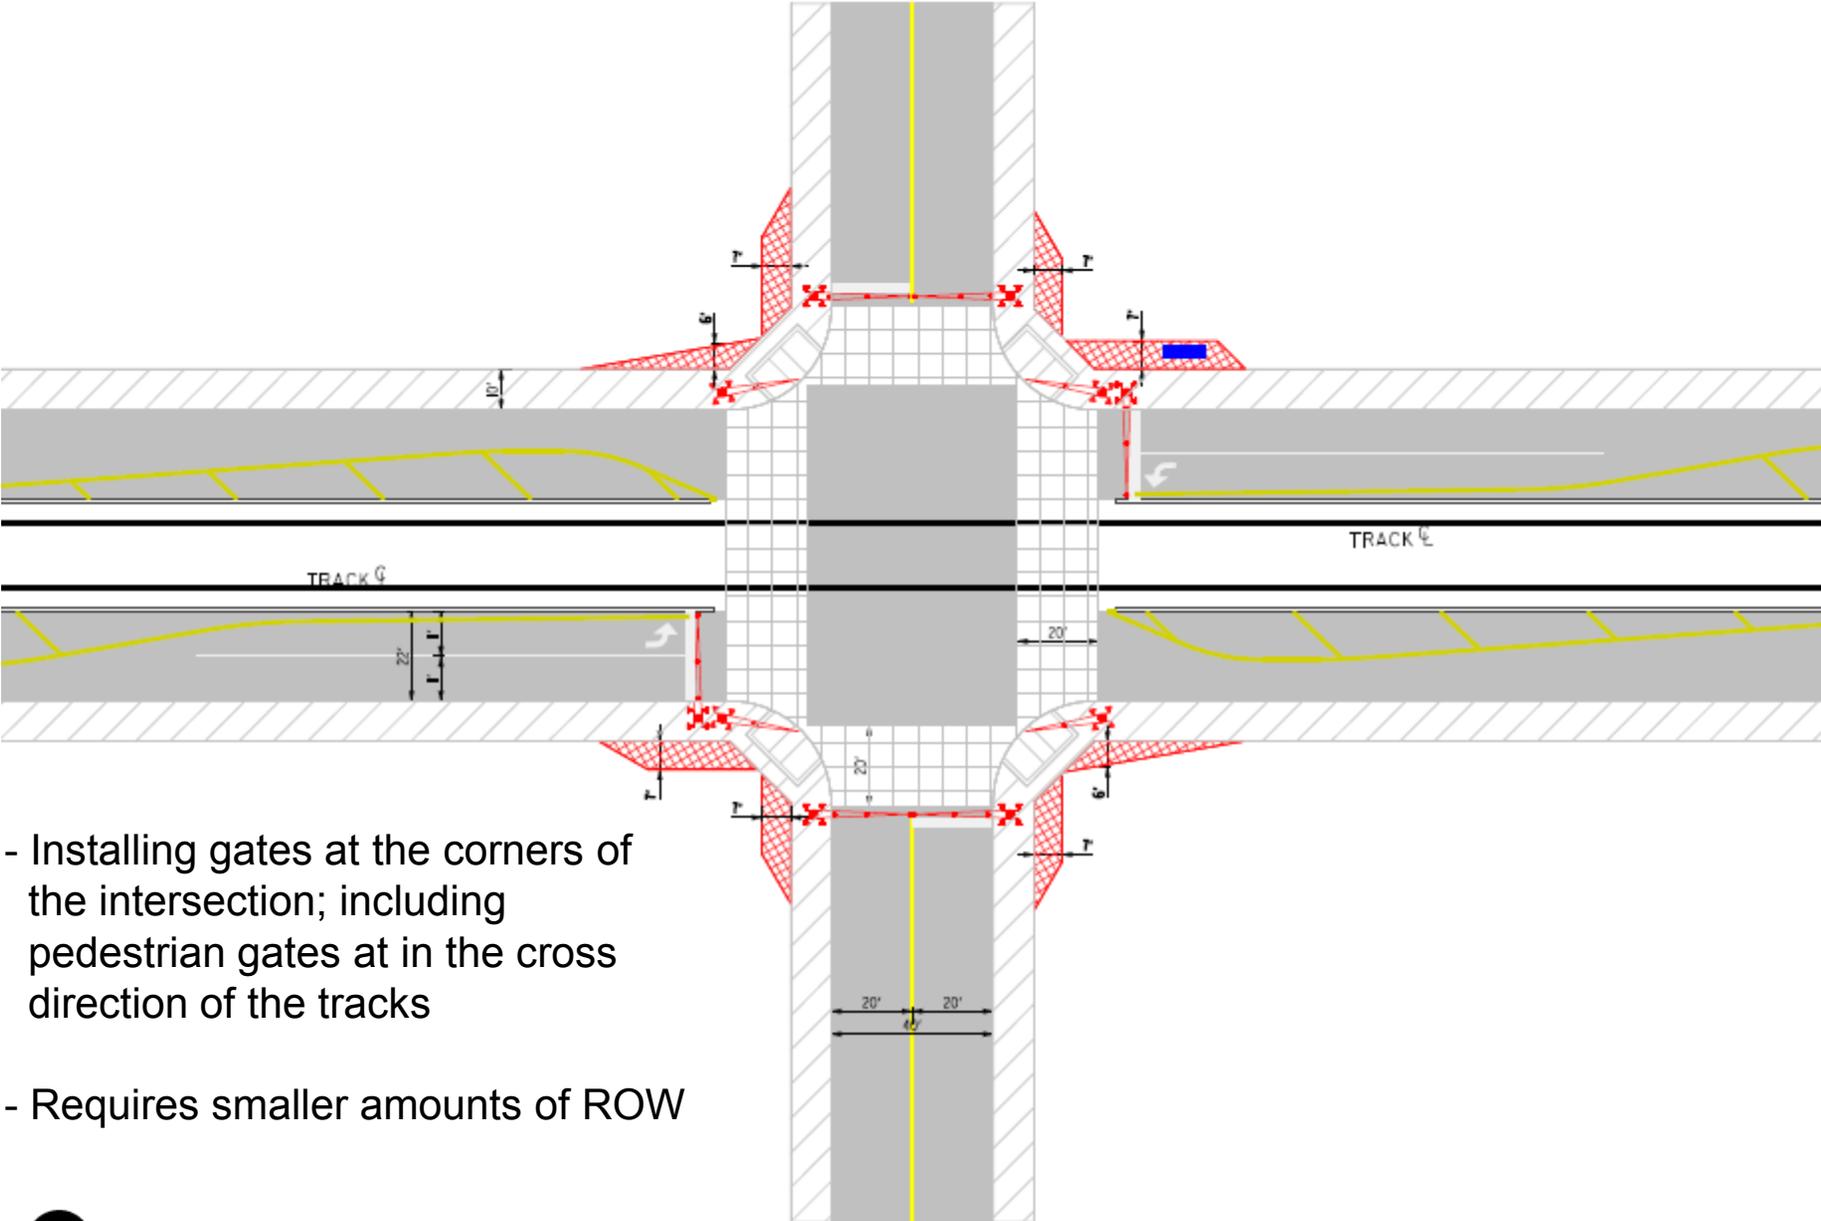
# Gates Closing the Intersection

- Installing gates at the corners of the intersection; including pedestrian gates at in the cross direction of the tracks
- Requires smaller amounts of ROW
