URBAN TRAFFIC CONTROL AND BUS PRIORITY SYSTEM OPERATIONS AND MAINTENANCE

June 1976
Final Report

An Urban Traffic Control and Bus Priority System has been implemented in the District of Columbia by Sperry Systems Management under Federal Highway Administration Contract No. FH-11-7605, Advanced Control Technology in Urban Traffic Control Systems - Installation. The system includes on-street surveillance and control elements and a central office data processing facility. This report relates the overall experience gained in the daily operation and maintenance of the system.

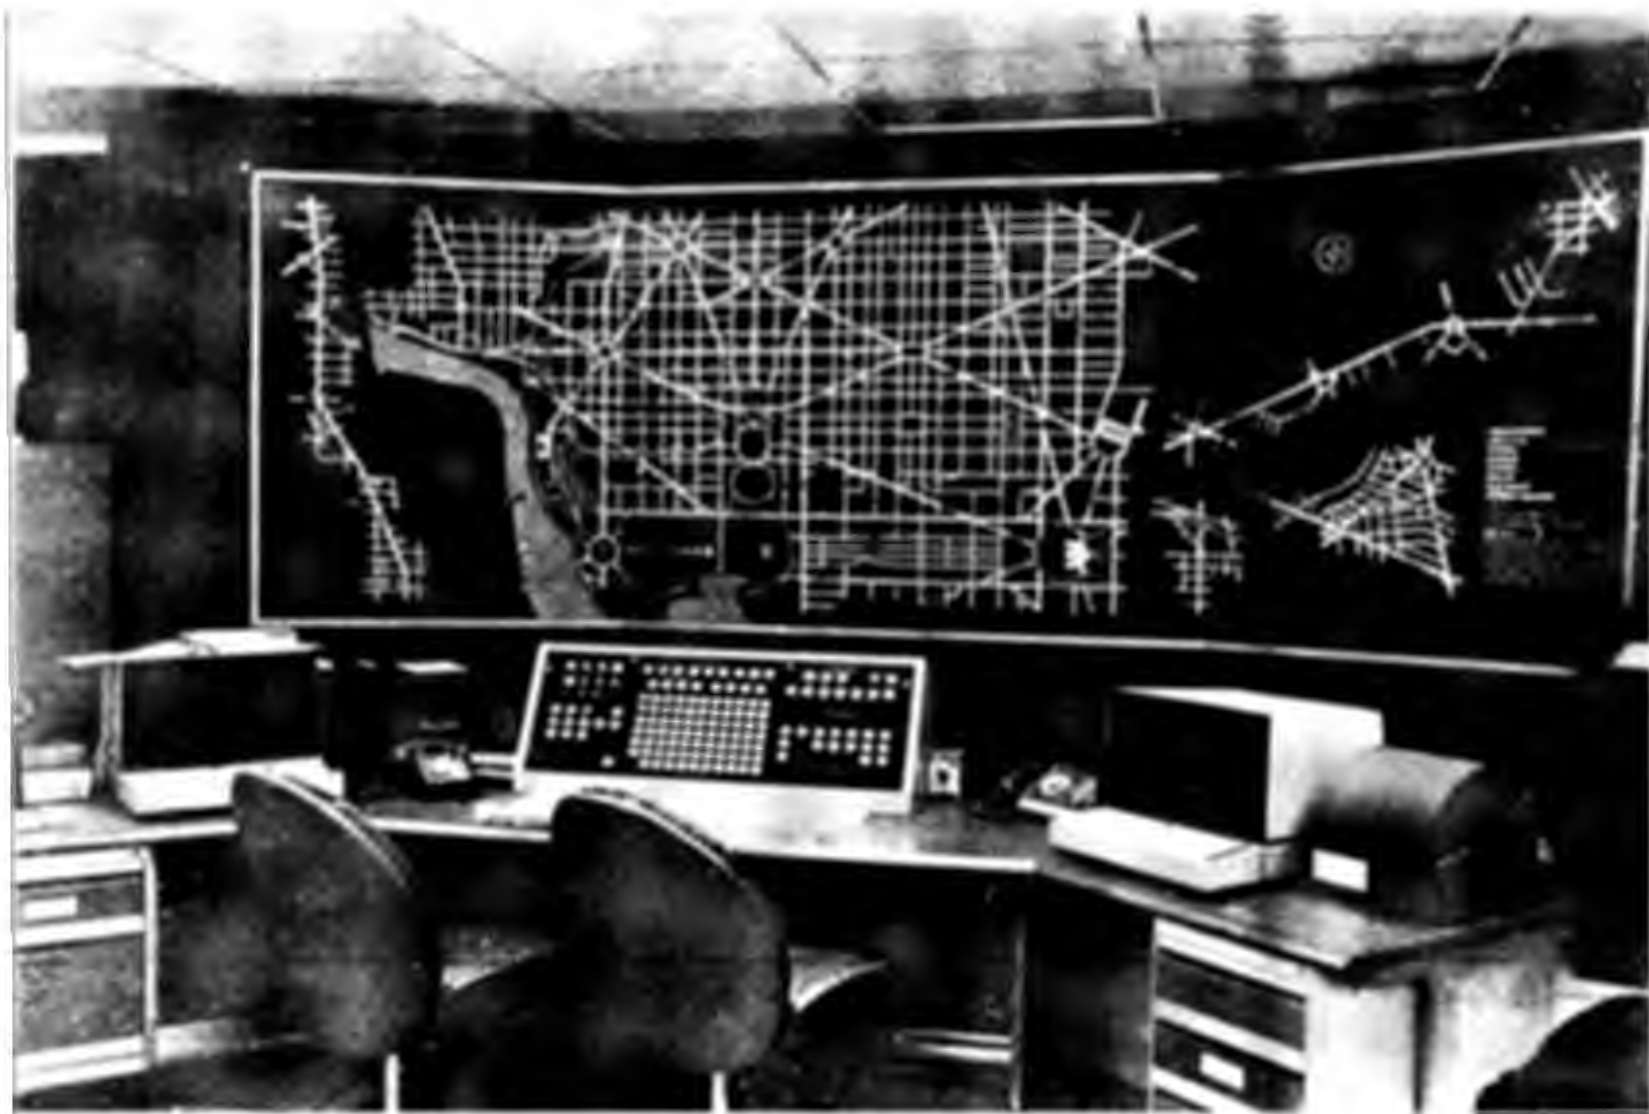
Figure 3. Systems Operator's Console Showing Map Display, CRTs, and Control Panel

The control panel is composed of four sections: system control, map display control, CRT displays control, and malfunction indicators. These can be seen in Figure 4. The system control section was used by the operator to activate and deactivate the traffic control system, to establish the mode of operation for each of the system's sections, to make individual signal parameter changes, and to reactivate field equipment which had been perceived as failed. During system evaluations, parameter and operation mode changes were not performed so that the system could be evaluated in its totally automatic state. At other times, however, the operator was able to exercise the system and attempt to improve flow.

The map (4) and CRT display (5) controls were used by the operator to obtain a variety of information regarding system status. With such information, he could monitor the performance of the system. Monitoring performance involved watching for occasional field equipment failures, congestion build-ups, and proper functioning of bus priority and critical intersection control systems when active. When field equipment failures were recognized, the operator typically repaired them from the control panel on their first and second occurrence. If a failure continued to recur, it was considered a "hard failure", and troubleshooting procedures were begun. Nonrecurrent failures of vehicle detectors frequently occurred and were attributed to such temporary problems as obstructed traffic lanes.

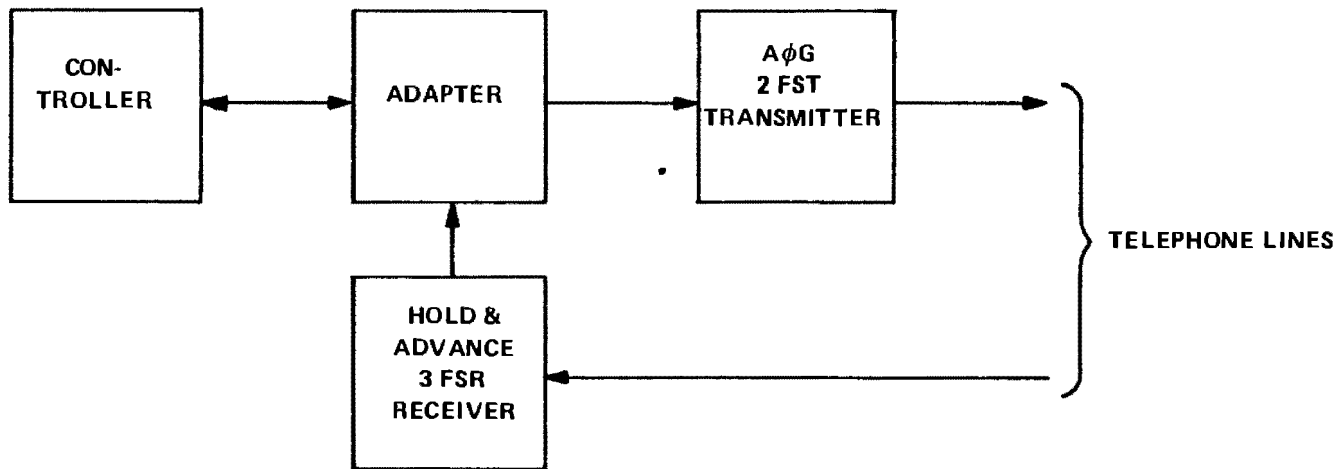
Figure 15. Controller Subsystem

From Table 2 (using the proportions described in paragraph A in the case of the 2FSTs, the number of failures in each category during the period 11/1/72 to 7/1/75 is:

Controller* : 15 failures (total complement = 111)

Adapter : 13 failures (total complement = 111)

AØG 2FTs : $\frac{111}{608} \times 50 = 9 \text{ failures}$ } (AØG complement = 111)
total complement = 608

H/A 3FRs : 8 failures (total complement = 111)

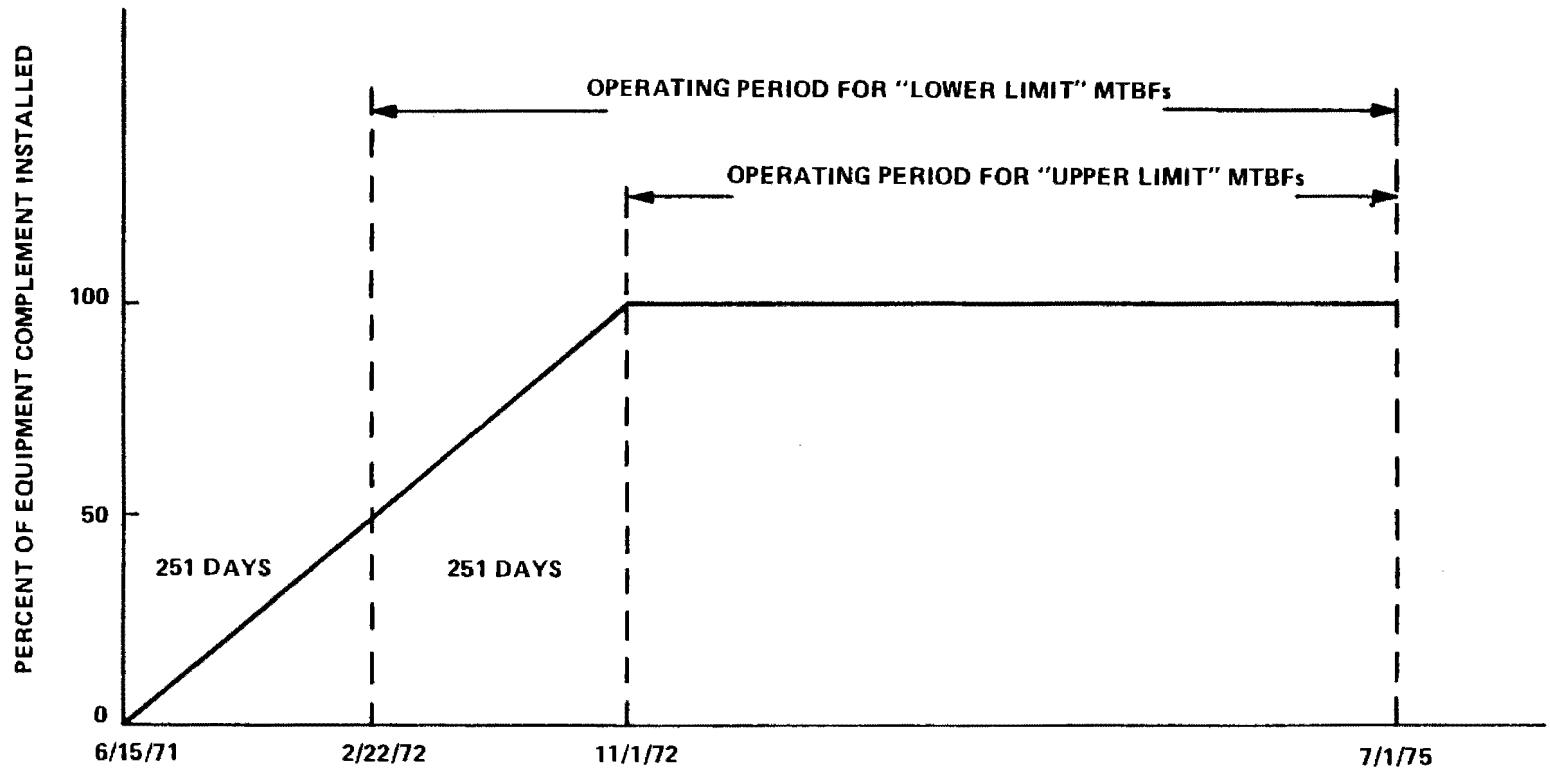
Figure 18. Assumed Installation Rate for Calculation of Lower Limit MTBFs

Assuming an operating period extending from February 22, 1972 to July 1, 1975 (972 + 251 = 1223 days), the detector subsystem failures are as follows:

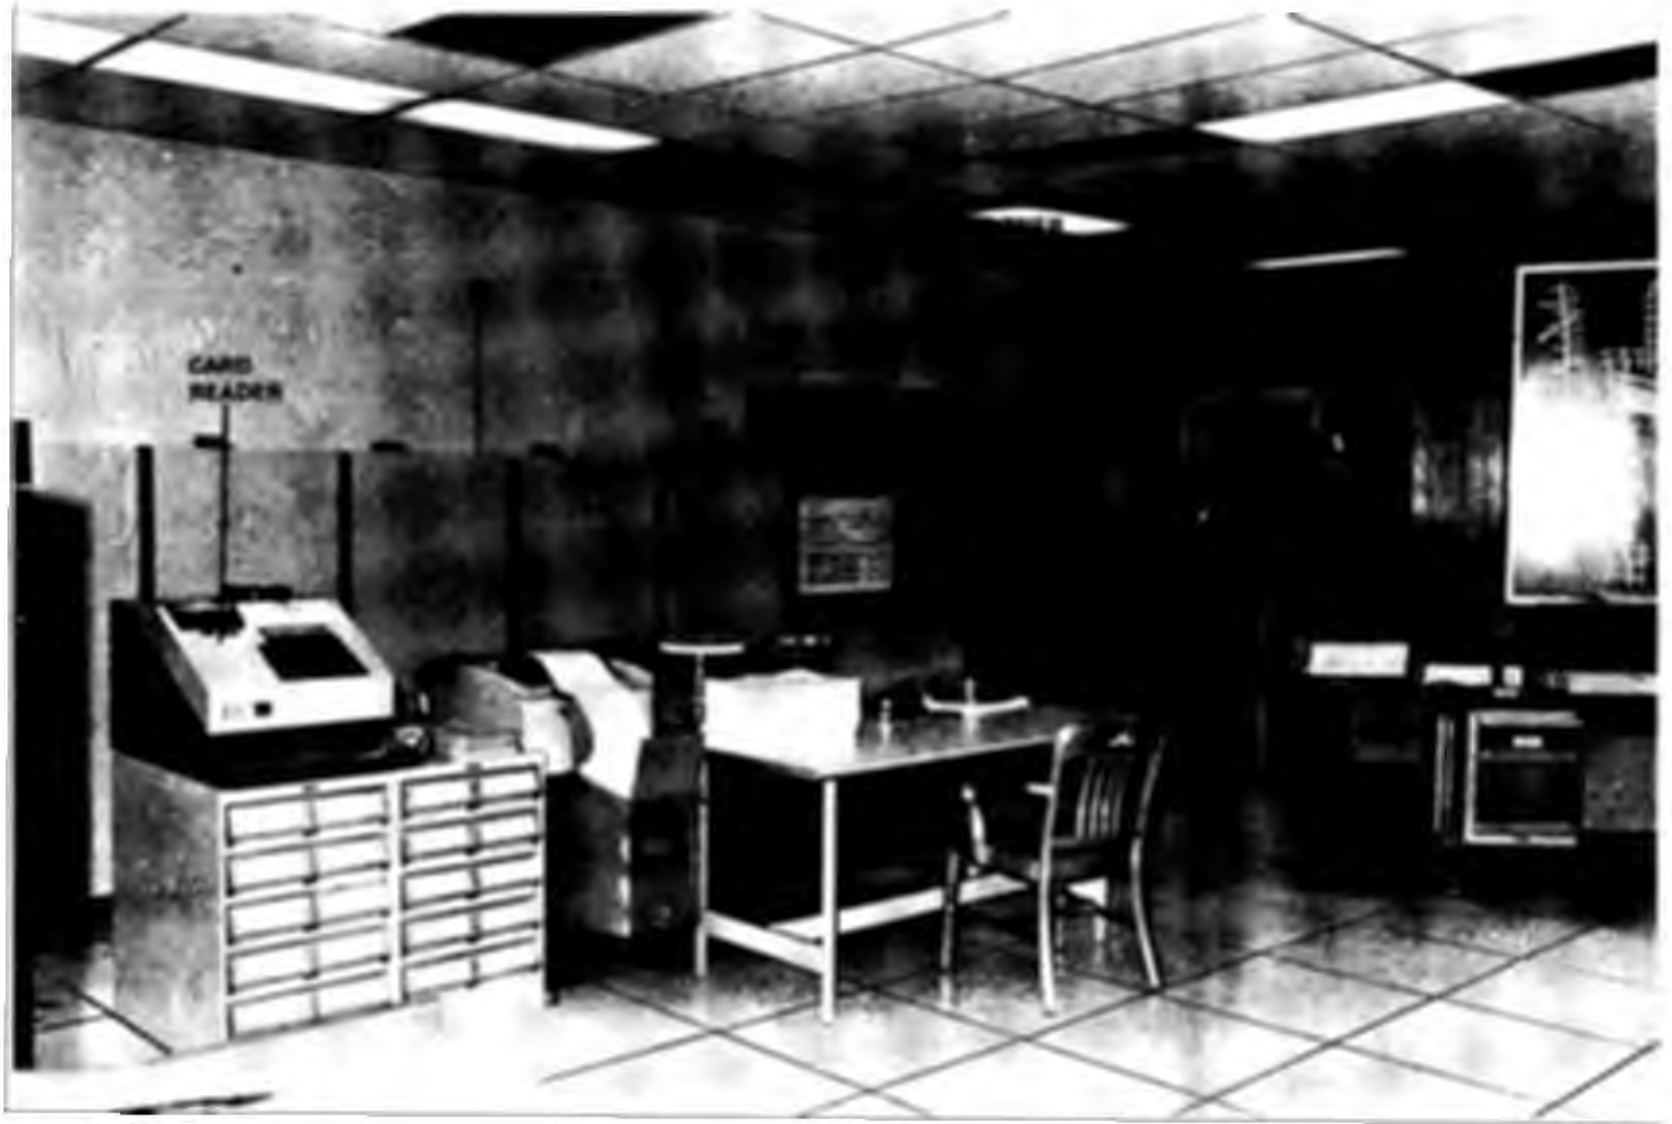
Figures 25 and 26 show all the UTCS/BPS control center equipment.

Figure 25. View of Control Center from Rear of Control Console (front of room)

Figure 26. View of Control Center from Rear of Room

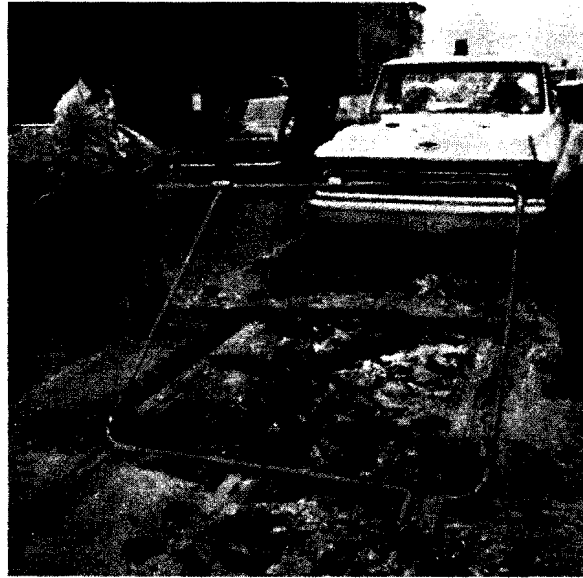
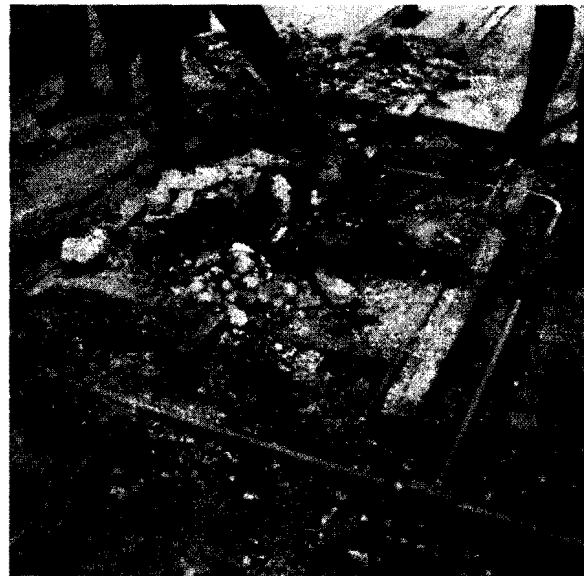
The vehicle detector electronics was tuned without the trolley tracks having any effect on its operation. To date, the installation has been highly successful, relatively inexpensive compared to other alternatives, and provided a means for placing a loop in an otherwise inaccessible location.

Figure 36. Enclosed Loop Configuration

Figure 37. Enclosed Loop Installation
