# AN EVALUATION OF PERFORMANCE REQUIREMENTS FOR CROSS TIES AND FASTENERS

INTERIM REPORT

1. Report No. FRA/ORD-78/37		2. Government Accession No.		3. Recipient's Catalog No.	
4. Title and Subtitle AN EVALUATION OF PERFORMANCE REQUIREMENTS FOR CROSS TIES AND FASTENERS				5. Report Date December, 1978

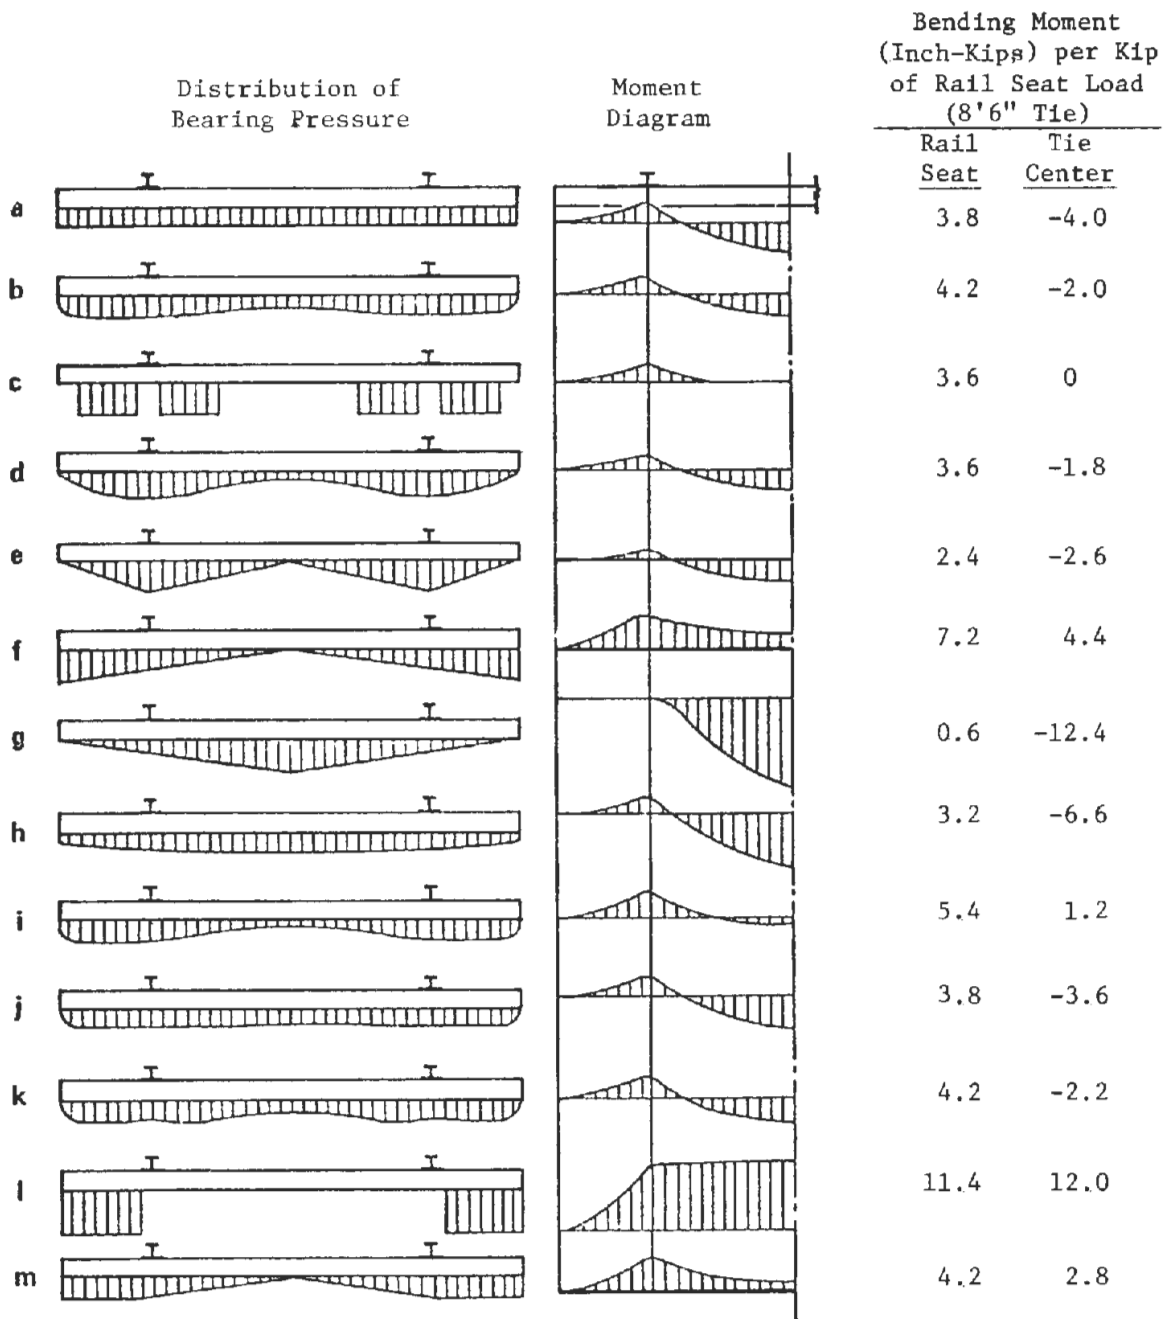
TABLE 4-2. HYPOTHETICAL DISTRIBUTIONS OF BEARING PRESSURE AND CORRESPONDING MOMENT DIAGRAMS FOR TIE [4-1]

Local stresses from the rail seat load can cause a significant difference in the strain distribution from what would be expected for pure bending. The center-binding support condition shows the greatest variation because the bending strain in the rail seat region is quite small relative to the local strain. Strain gages located near the top surface of the tie should not be used to estimate tie bending moments. Gages located near the bottom of the tie are less influenced by the local contact stresses on the rail seat and the effect of the support reaction on the bottom gages is also small. Strains predicted by the finite-element model ranged from 85 to 100 percent of beam theory, except for Load Case 3 (center-binding) where the predicted strains were about 60 percent. This reduction in tensile strain near the tie bottom will cause bending moments estimated from field strain data to be under-estimated using linear beam theory or calibration factors from pure bending tests.

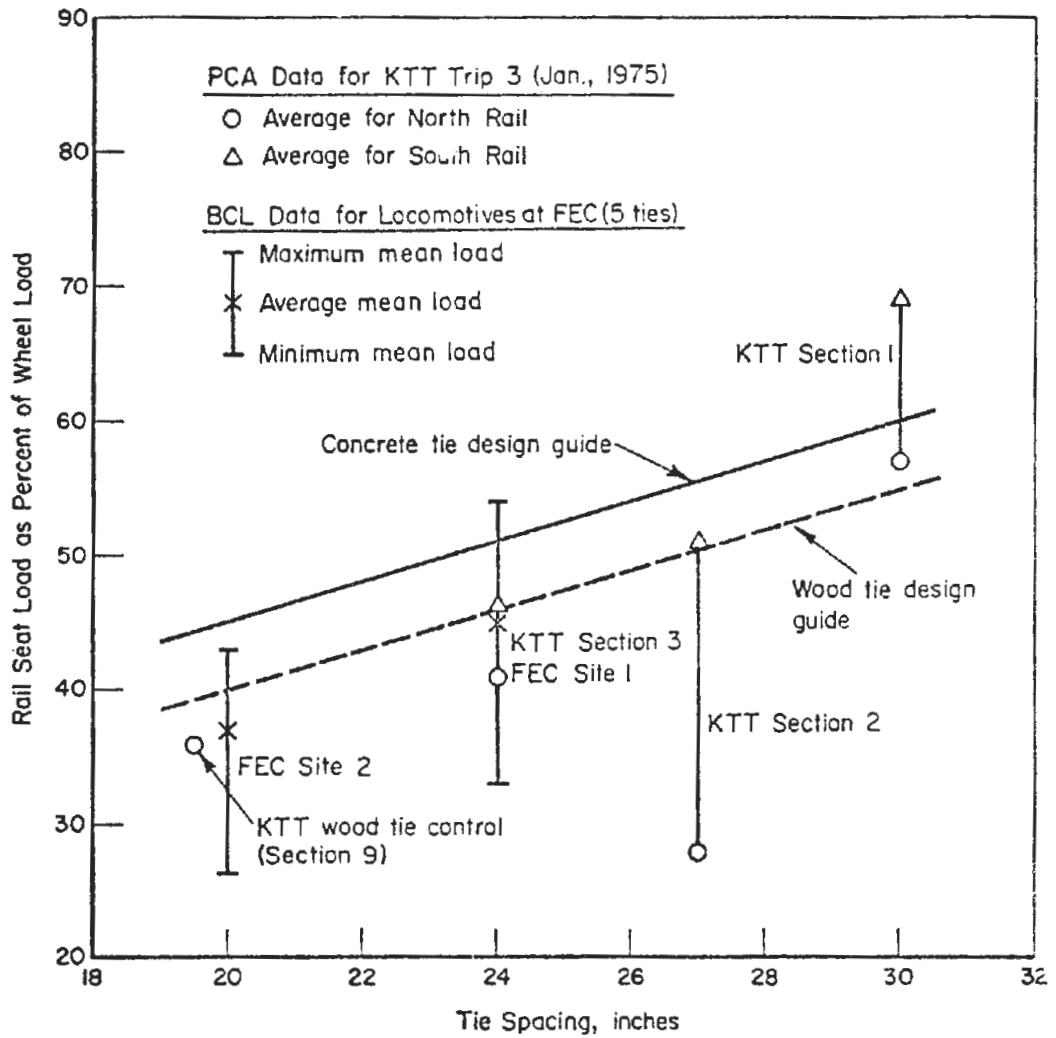
FIGURE 5-1. EFFECT OF TIE SPACING ON MEAN RAIL SEAT LOADS FOR LOCOMOTIVES [5-4]

The impact factor is intended to estimate the dynamic effect of wheel and rail irregularities in increasing actual track loads above maximum static wheel loads. Table 5-1 shows the rail seat load estimates used in the original and current AREA specifications. Current specifications are based on IF = 150 percent, whereas the original specifications used IF = 50 percent based on

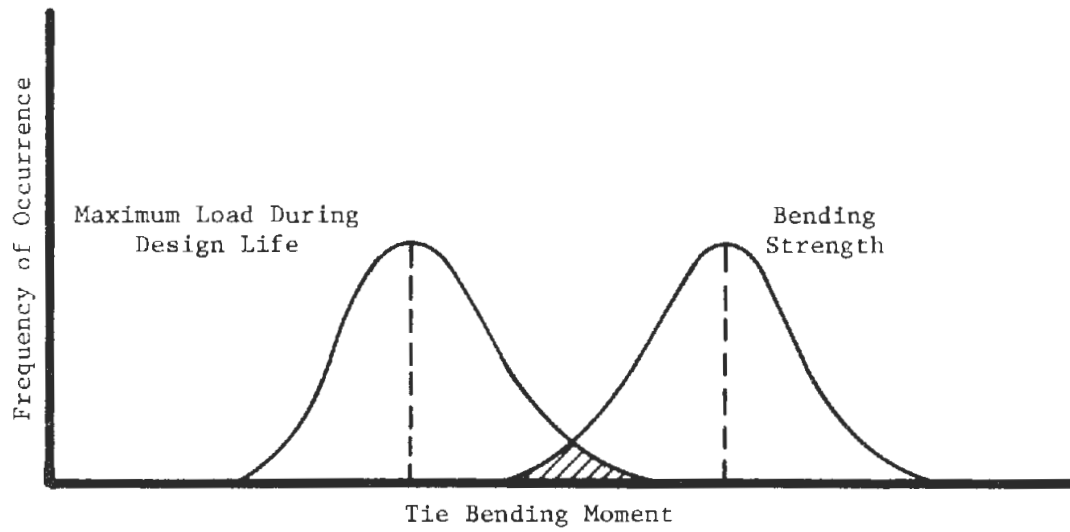
FIGURE 5-2. INTERFERENCE OF TIE LOAD AND STRENGTH DISTRIBUTIONS

Reliability with regard to a fracture failure where the applied load exceeds the tie design strength is evaluated conceptually as shown in Figure 5-2. Tie bending strength in terms of initial cracking moment varies from tie to tie due to manufacturing tolerances in geometry, prestress, and material properties. Table 3-4, for example, lists initial cracking moment data for both rail seats of six ties. These ties show a mean strength of 332 in.-kips and a standard deviation of 22 in.-kips.

Deriving statistical tie load data suitable for a reliability analysis is more complex than the strength data. Bending moments on each tie show statistical distributions from the train traffic, but these loads change during the tie's life due to variations in support conditions. Spatial variations in roadbed conditions and track layout (curves, spirals, grades, etc.) will also cause additional tie-to-tie loading variations. The load distribution which is needed for a failure analysis must be presented in terms of the number of ties (frequency of occurrence) which are subjected to one occurrence of a given maximum bending moment during a selected design life. When this is compared to the strength distribution in terms of number of ties (frequency of occurrence) having a given strength, the cross-hatched interference region where the maximum

load exceeds the tie strength represents the number of ties which will be cracked during the design life. If failure is caused by fatigue rather than fracture from a single load, the interference analysis requires a comparison between fatigue strength data for a specified life (number of cycles) and load data in the form of number of ties versus "equivalent fatigue load". The equivalent fatigue load represents a bending moment of constant amplitude that would cause tie failure at the same life obtained by applying the actual service load spectrum. This requires the use of fatigue data and a cumulative damage criteria such as Miner's rule.

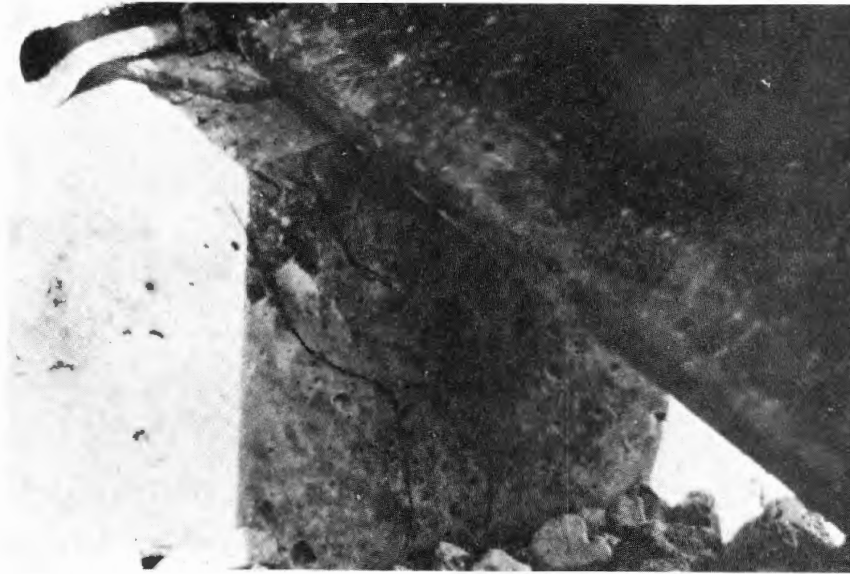
Photo #1 - Rail Seat Crack - completely through tie showing typical "Y" configuration (outlined in black) (1)\*

Of the tie failures observed, the most common appears to be rail seat cracking. In general these cracks initiate at the bottom of the tie directly under the rail. The cracks progress vertically upward to about the center of the rail seat side face where they generally split into a "Y" configuration and proceed to the top surface. Although probably varying with tie design, the point at which the vertical crack divides appears to coincide with the location of the top layer of prestressing tendons.

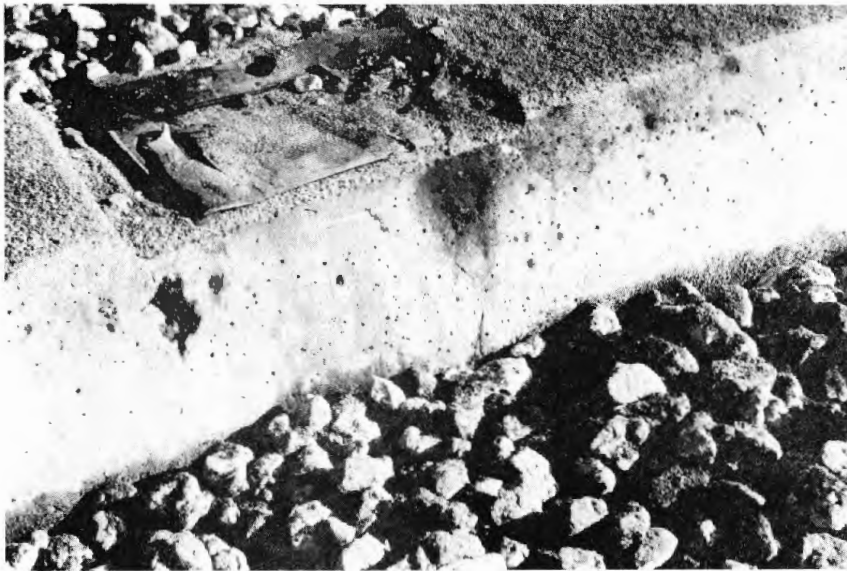
Photo #3 - Rail Seat Crack - also showing bolt failures, tie pad deterioration and fines from ballast degradation. Tie removed from track during ballast replacement operation (2)

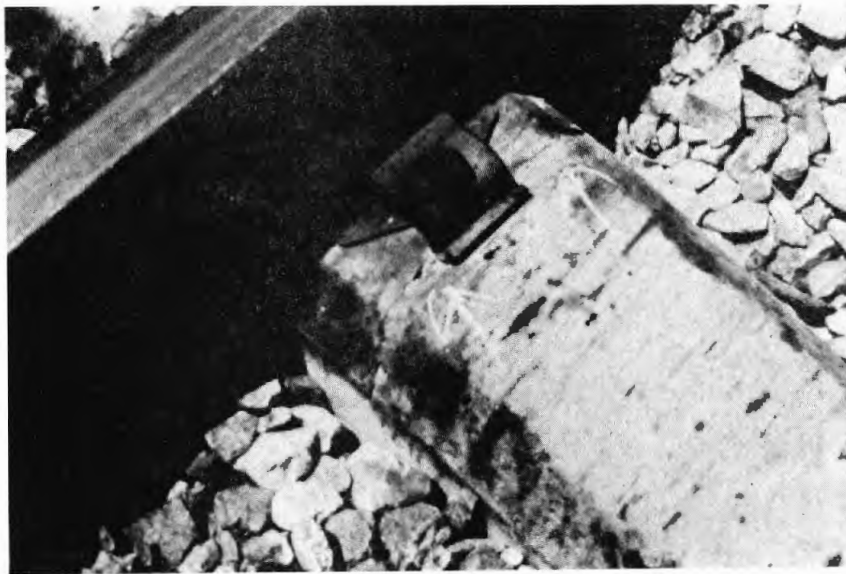
Photo #4 - Rail Seat Crack - through rail fastener bearing surface (1)

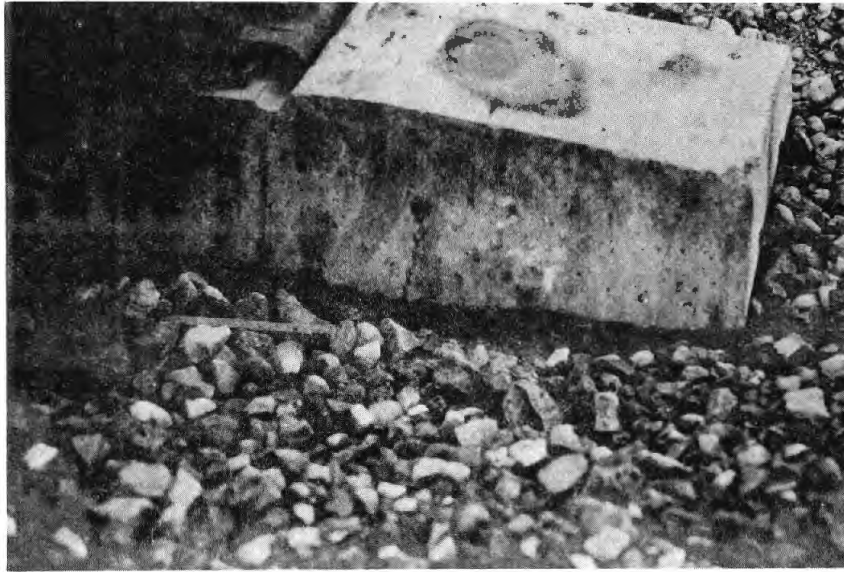
Photo #15 - Typical shape and size of ballast as installed in track. (2)

Photos #15 thru #19 show process of ballast deterioration in the same section of track.

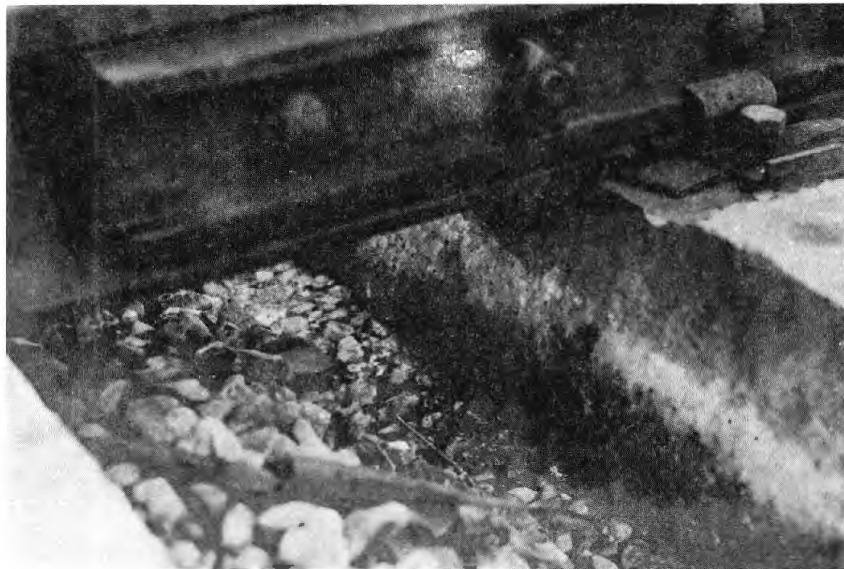
Photo #16 - Tie shifted by tie spacing machine to show well tamped ballast under rail seat. No deterioration. (2)

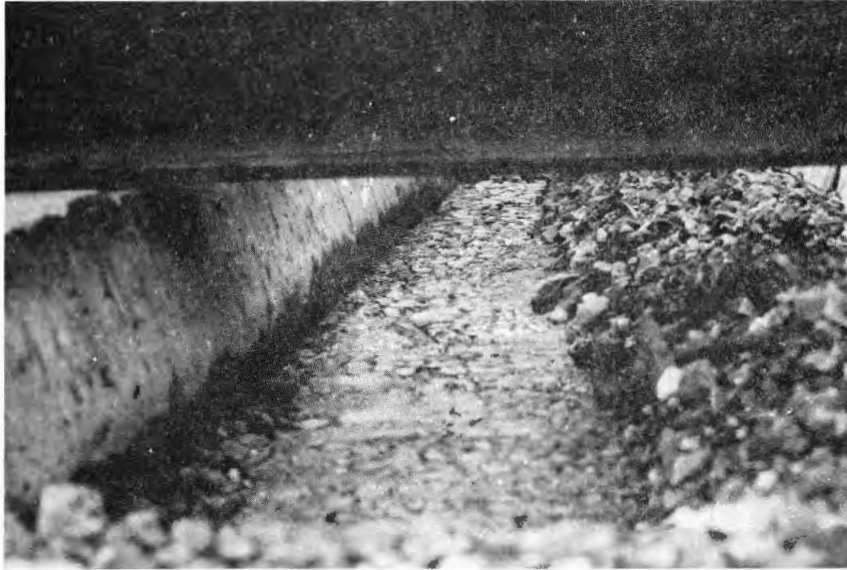
Photo #17 - Tie shifted by tie spacer showing beginning of ballast deterioration under rail seat. Note fines in ballast surface not present in previous photo. (2)

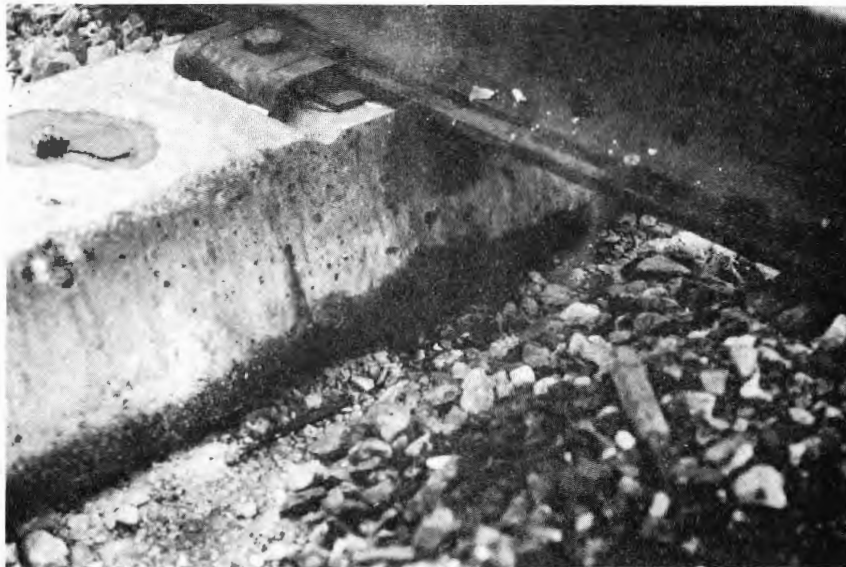
Photo #18 - Tie shifted by tie spacer. Note large amount of fines being generated under tie. (2)

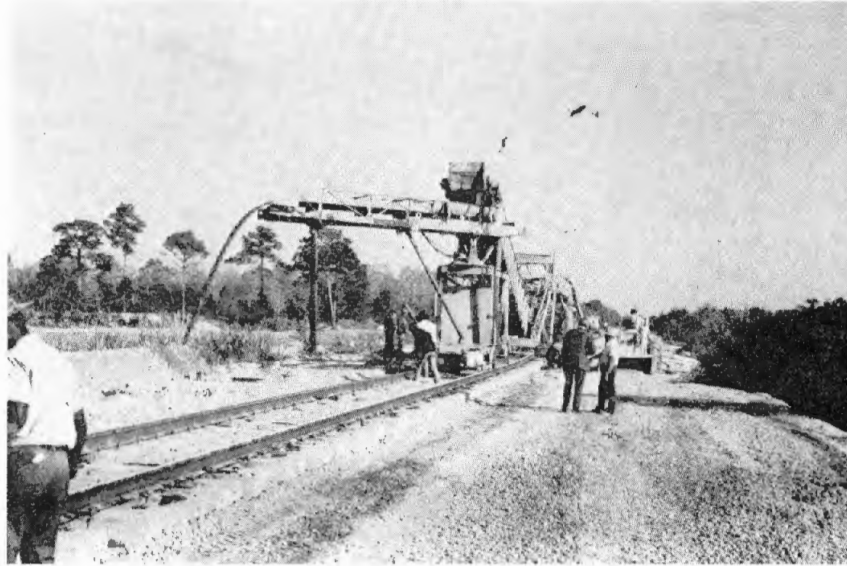
Photo #21 - Replacement of soft and degraded ballast on one U.S. railroad. (2)

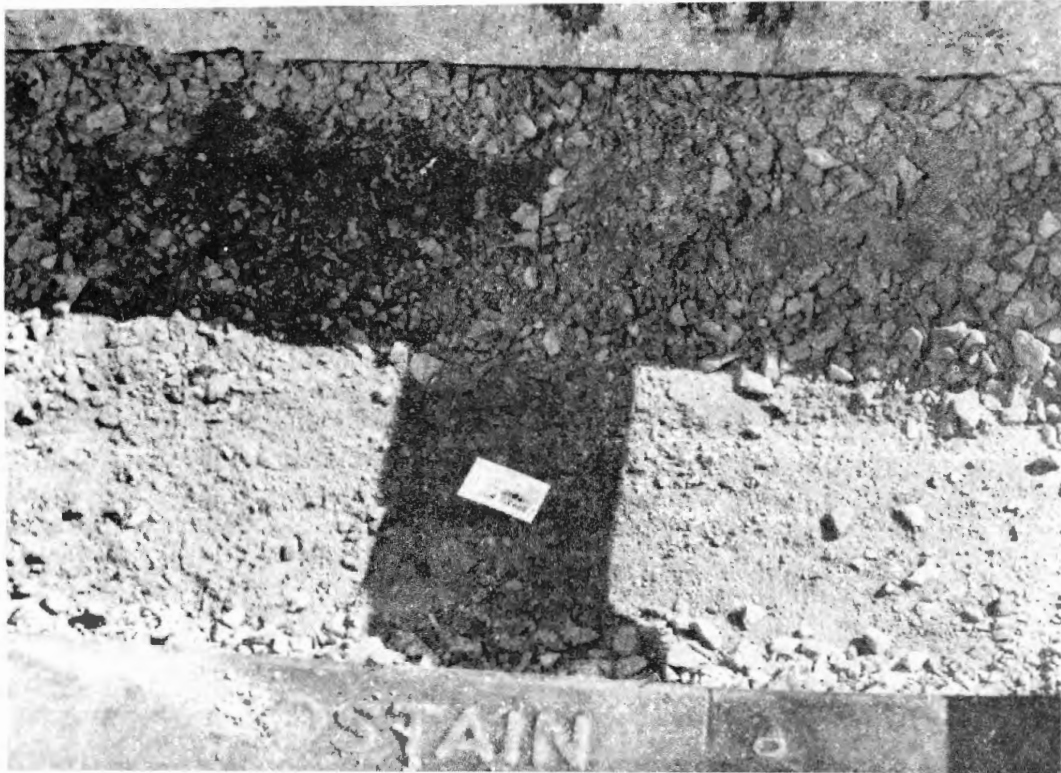
Photo #23.- Migration of Subgrade Fines Into Ballast,  
Concrete-Tie Subsection E (3)
