Southern California Rapid Transit District  
Metro Rail Project

Analysis of  
Fireproofing Repairs  
to Main Shop Building  
Contract A112  
November 14, 1989

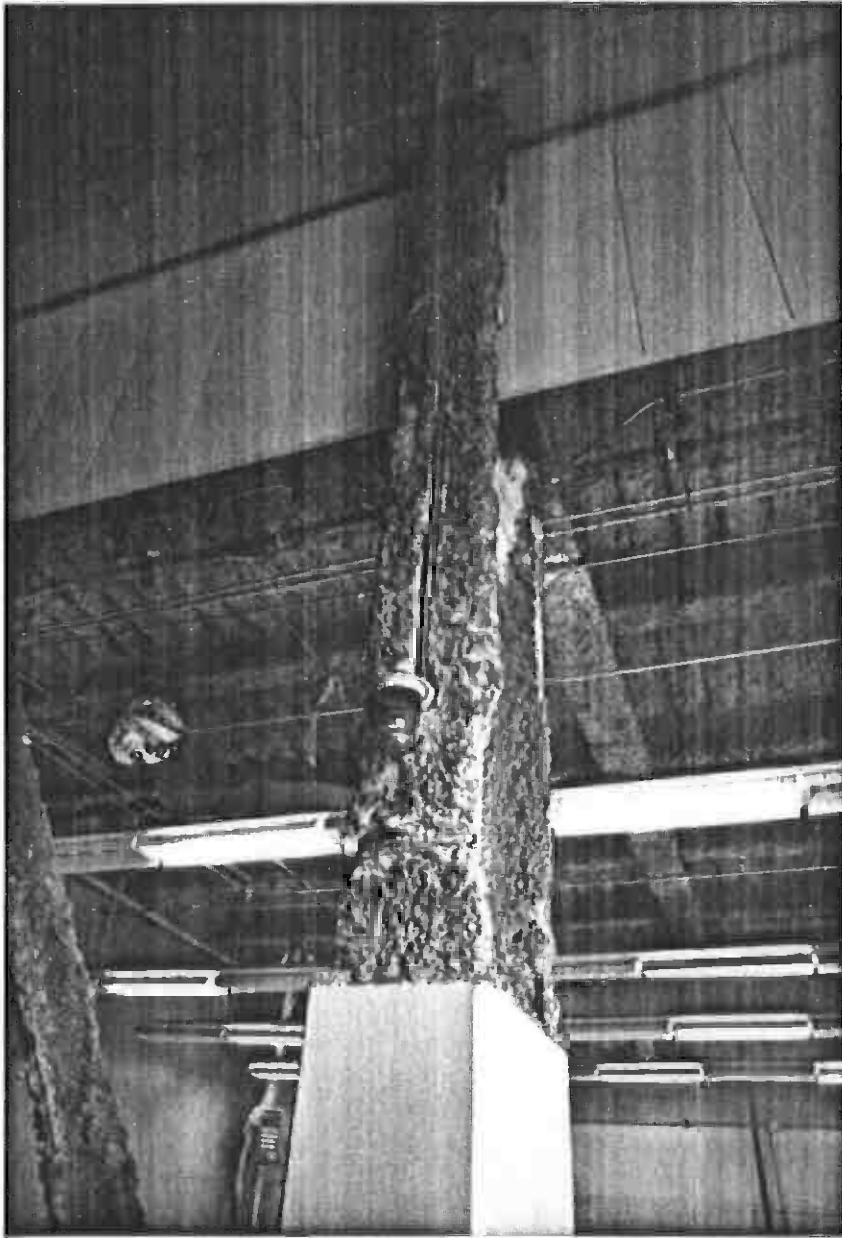
RM. 124- COL F-6 W/ TYP. SURF. MNTD. LT.

The K-braces on gridlines D and F in the Heavy Repair Shop shall receive the gypsum board finish extending to 8'0" above finish floor. (Repair Type III. Photos Nos. 24, 25, 26, 27, 28, 29, 30, and 31.)

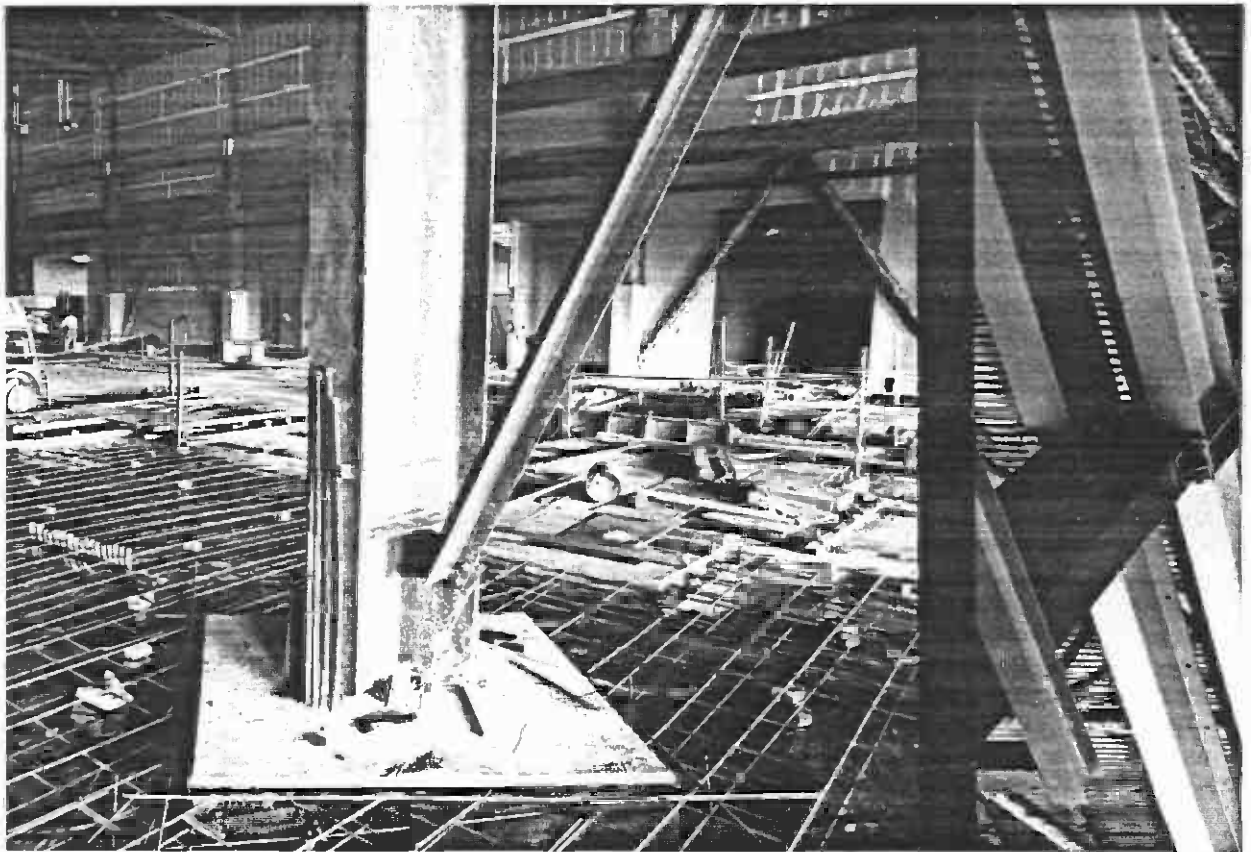
RM. 124- COLUMN E-17.

At gridline E in the Heavy Repair Shop, the columns and K-braces must be stripped of the existing fireproofing and resprayed with a cementitious-type fireproofing. The columns shall be sprayed from above the concrete encasement to the roof deck, and the K-bracing from finish floor to the bottom chord of the roof trusses. A compatible hard surface coating shall be applied over the fireproofing to provide further resistance to impact damage. This coating shall cover all fireproofing at gridline E from its lowest point of application to the height of the crane rail above. Surface mounted light fixtures, electrical outlets and fire hose cabinets and these will have to be relocated to the surface of the new finish. (Photos Nos. 32, 33, 34.)

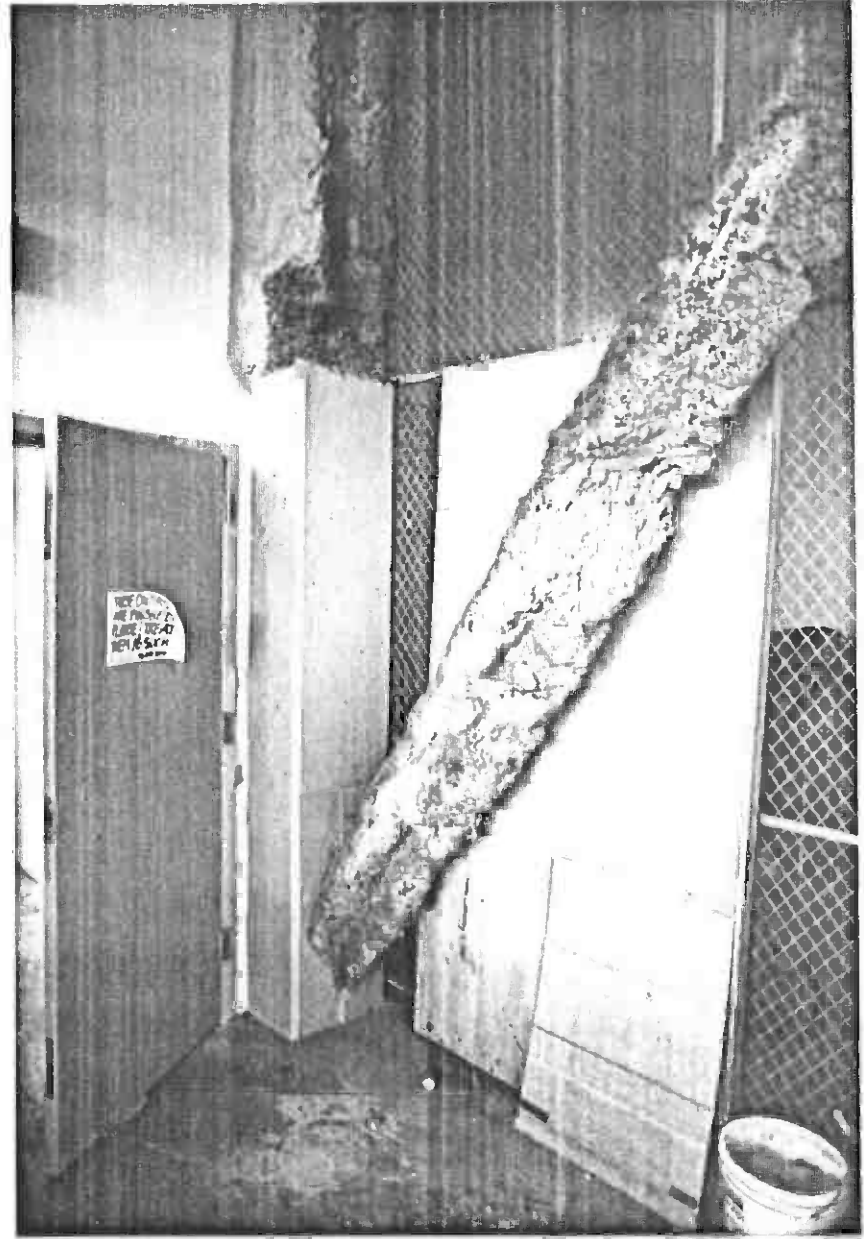
RM 134- COL F.6-14 W/ K-BRACING

above concrete encasements to steel deck above. (Repair Type IV.) (Photos Nos. 54, 55, 56, 57, 58, 65, 66, 67, 68, 69, 70, 71.)

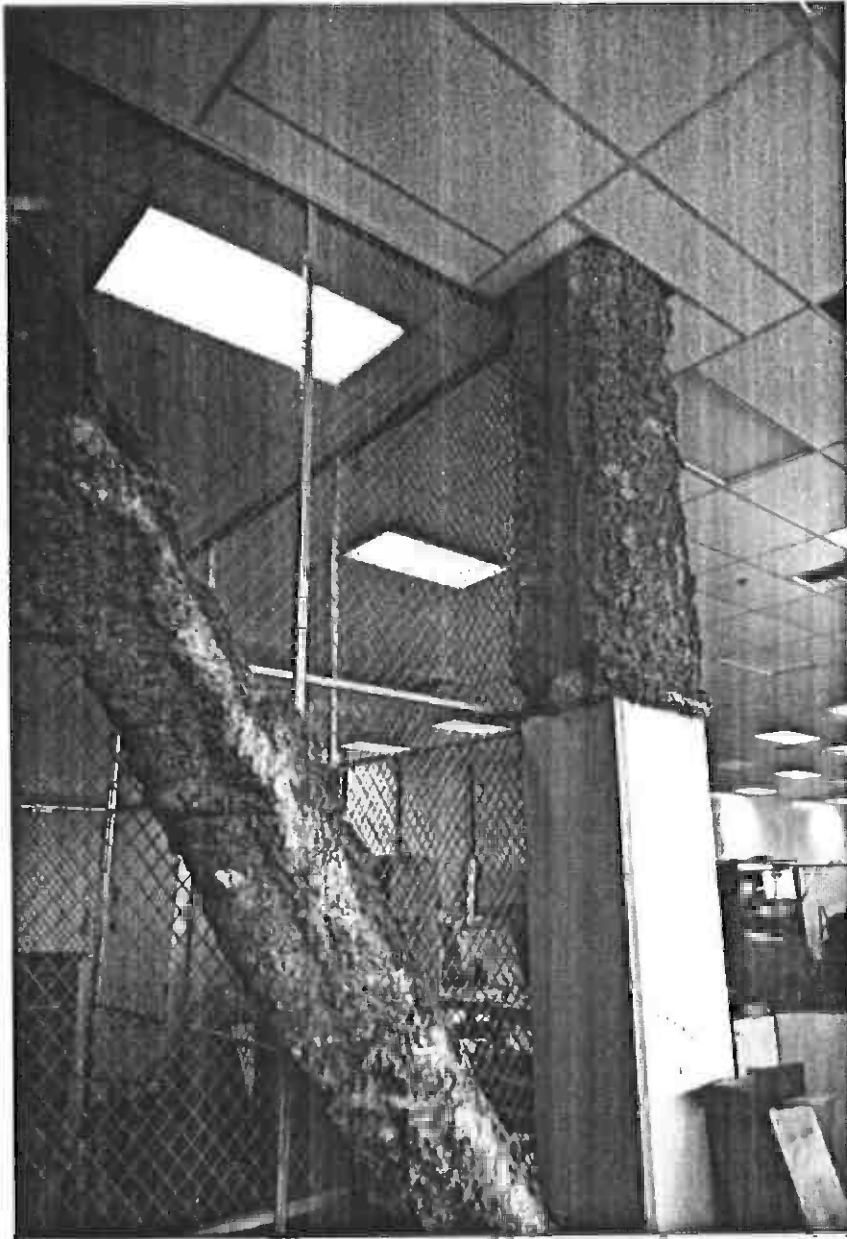
RM. 134- COL. F.6-15 W/ K-BRACING

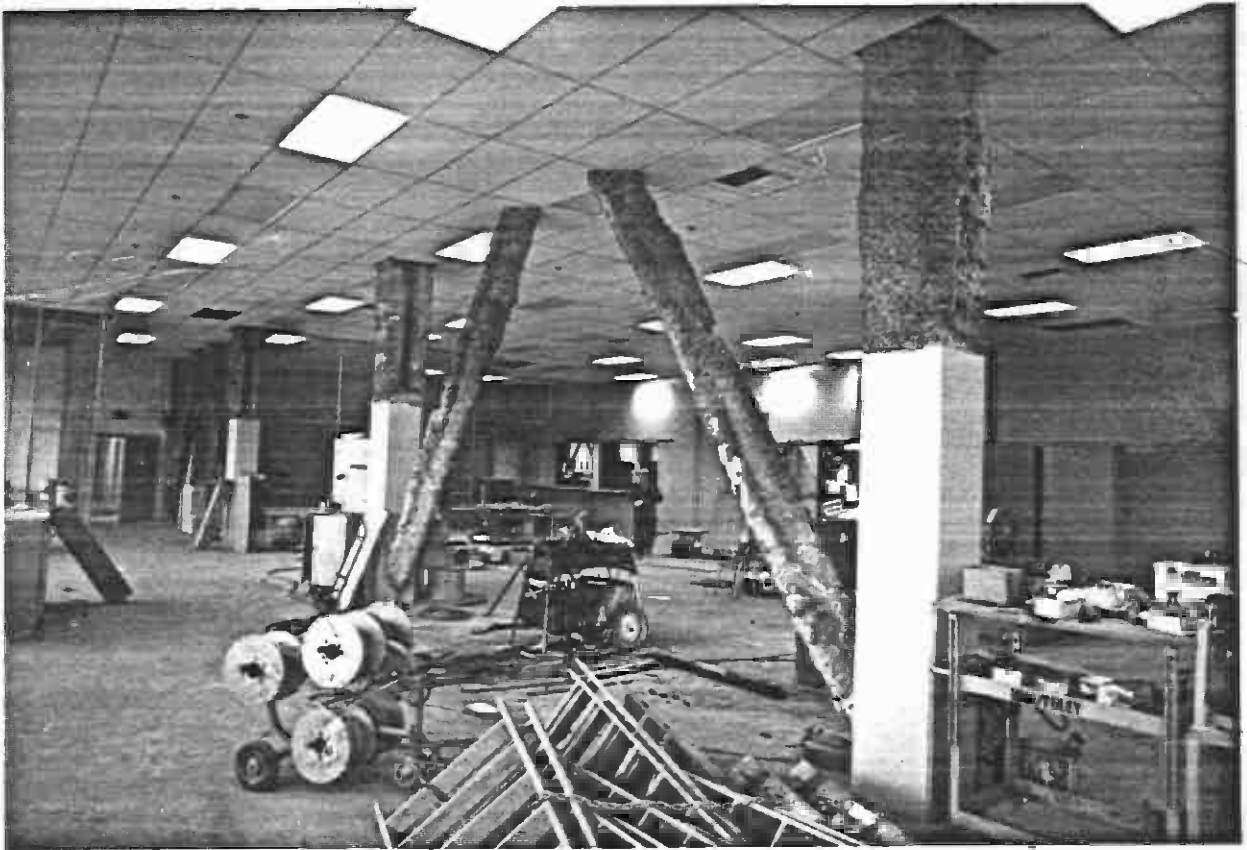
RM. 134- GRIDLINE F.6.
