## PROPERTY CONDITION ASSESSMENT

# PROJECT SANTA FE LOS ANGELES UNION STATION

800 North Alameda Street  
Los Angeles, California

Draft: November 12, 2010

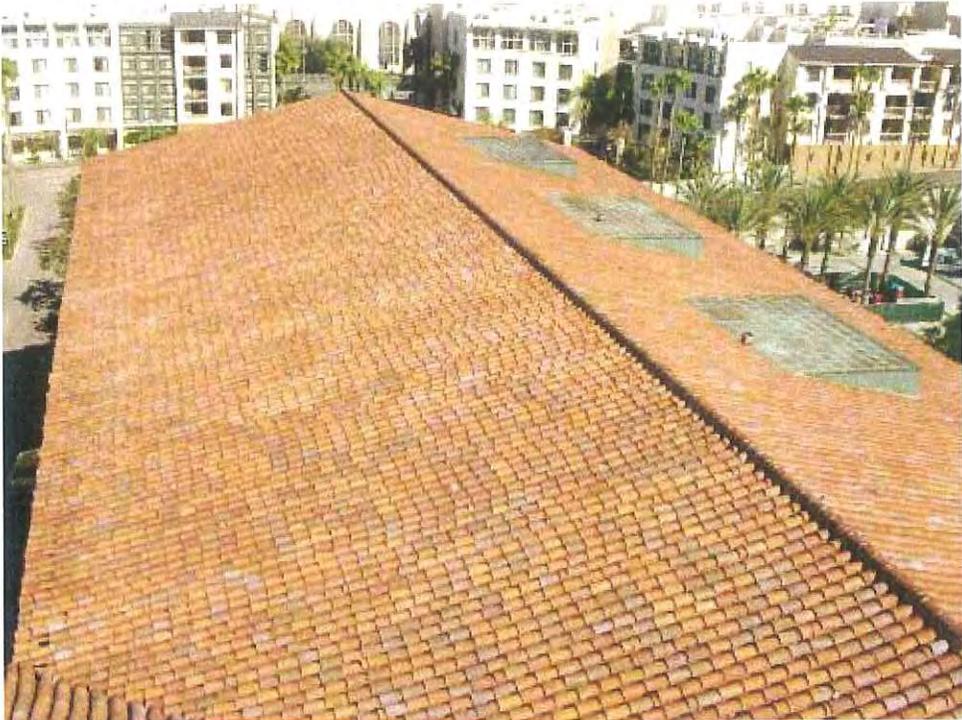
Photo #1 – General overview of North roof area.

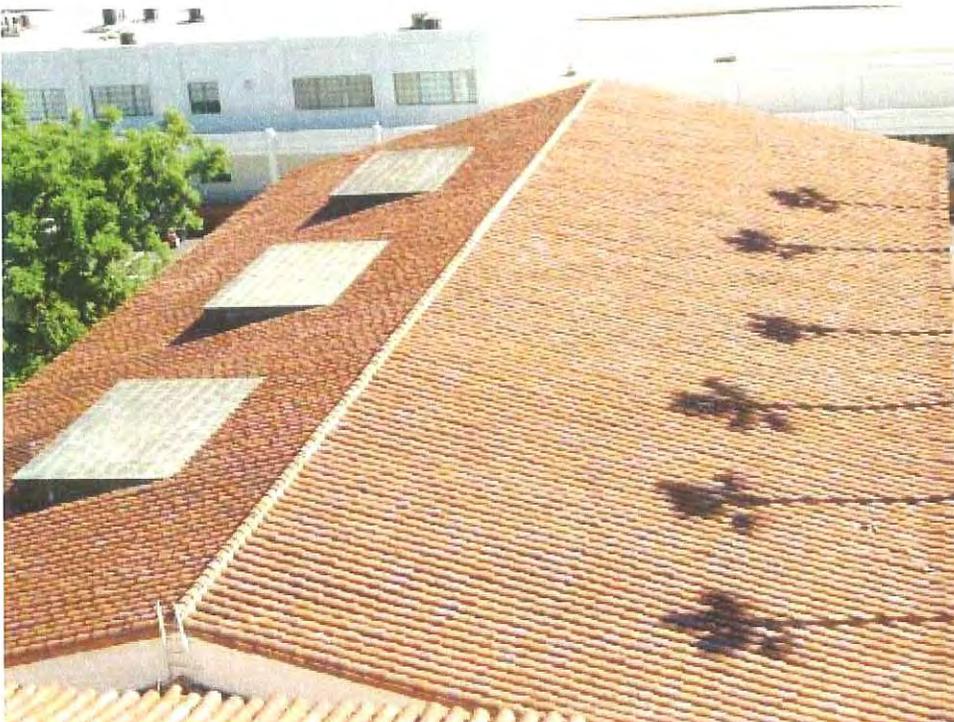
Photo #3 – General overview of East roof area.

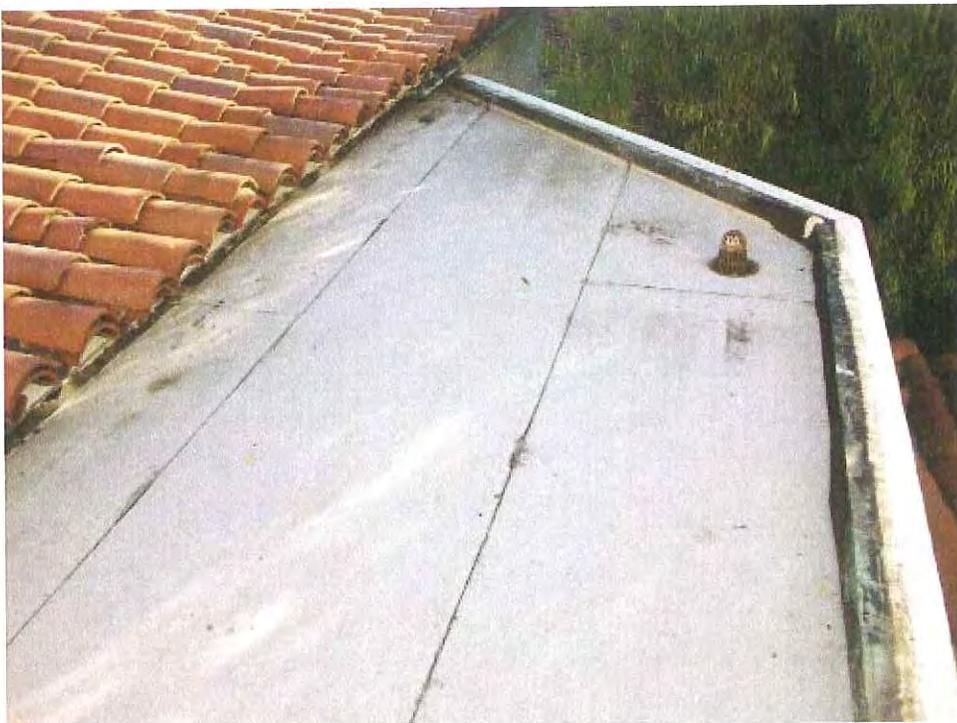
The small Southeast roof was recently replaced and is in good condition. No deficiencies were noted that are in need of repair at this time.

Photo #8 – General overview of Southeast APP modified roof area.

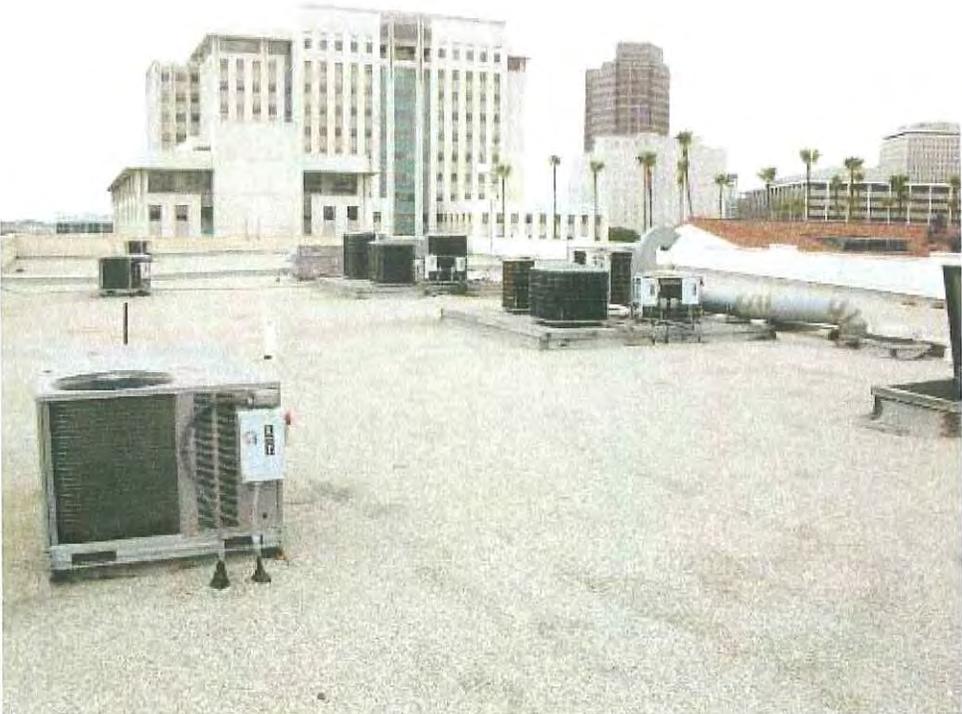
The overall condition of this roof is fair. The test cut showed brittle interply asphalt with fair adhesion. The only deficiency noted that is in need of repair at this time is loose and exposed top of base flashing at the roof access hatch. However, a few stucco cracks above the counterflashing were also noted that should be monitored and repaired if necessary to eliminate unnecessary roof leaks and possible structural damage.

Photo #1 – General overview of roof.

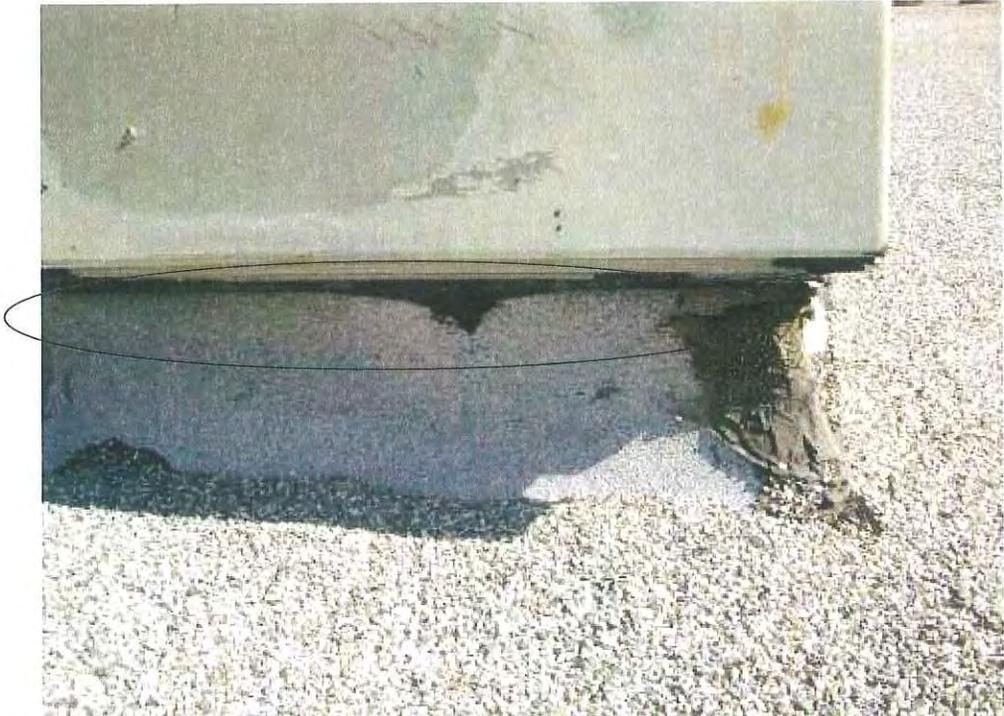
**Deficiency:** Top of base flashing is loose and exposed at roof access hatch.

Photo #2 – Top of base flashing exposed.

**Recommendation:** Install extended 4" metal counterflashing over exposed base flashing and secure with appropriate screws through steel/neoprene washers spaced at 12" on center.

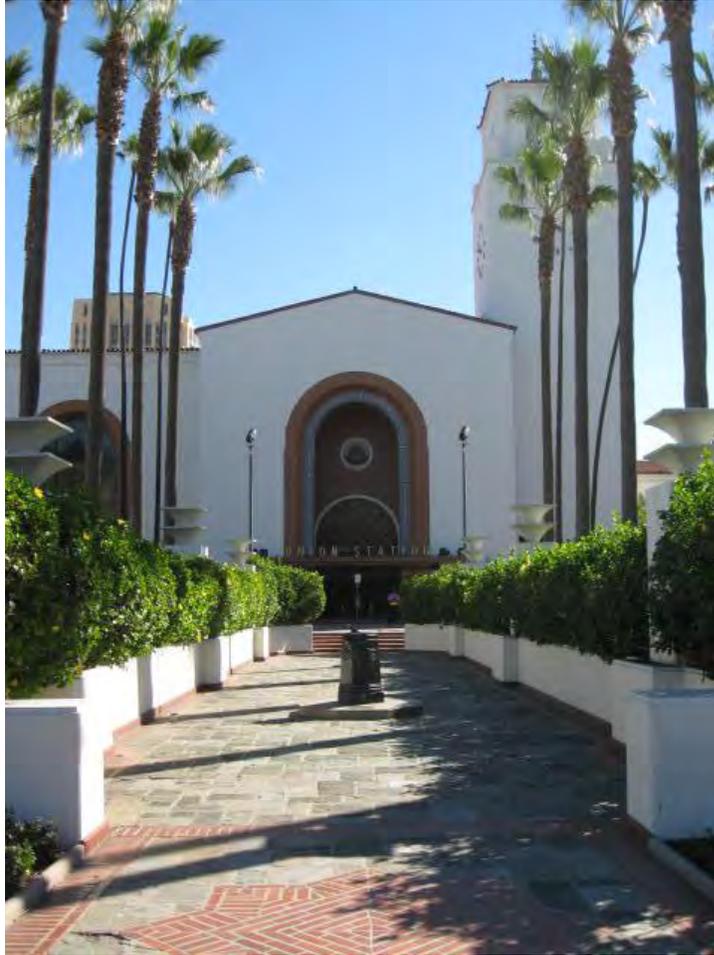
Photograph #1

View of the entry courtyard.

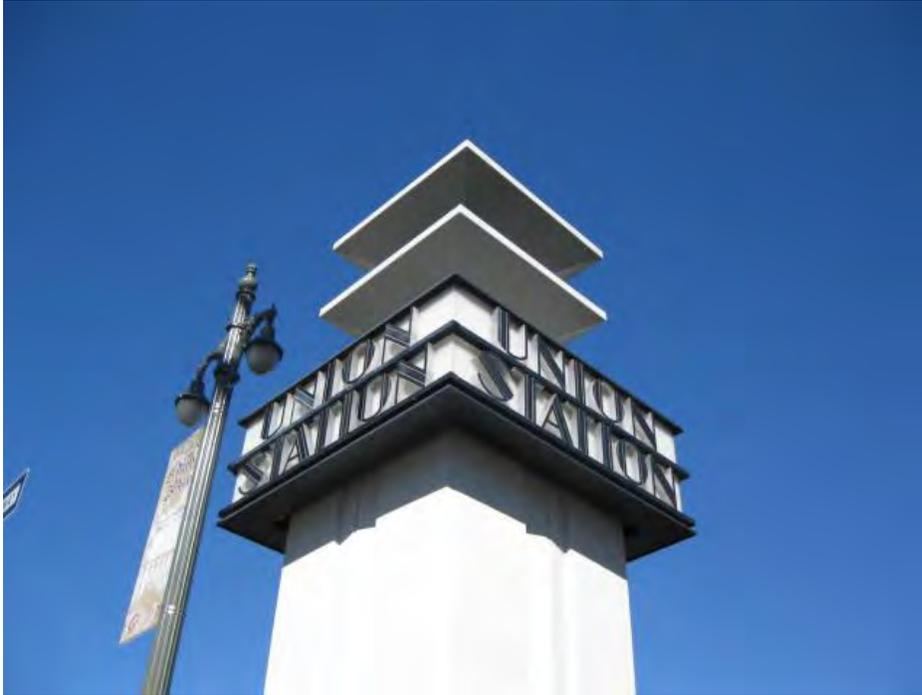
Photograph #3

Monument signage  
along the Alameda  
Street.

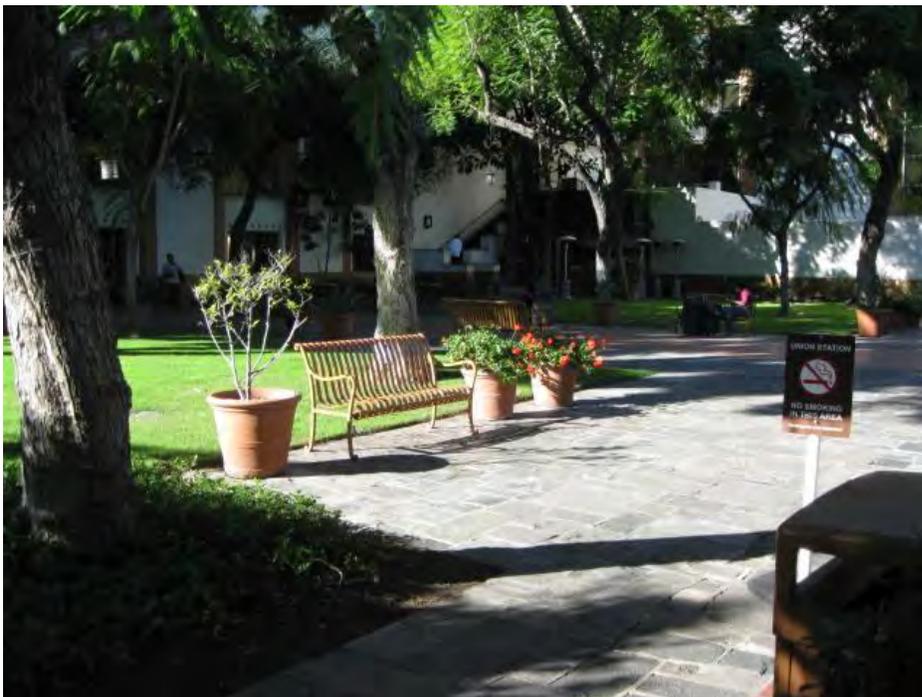
Photograph #4

Overall view of the  
north courtyard.

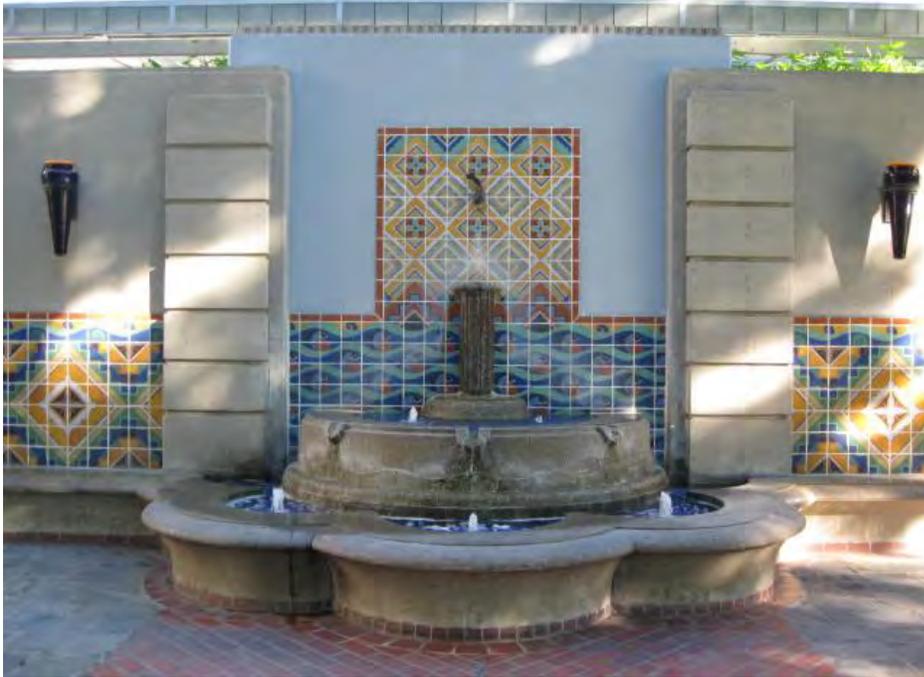
Photograph #5

View of the water feature at the north courtyard.

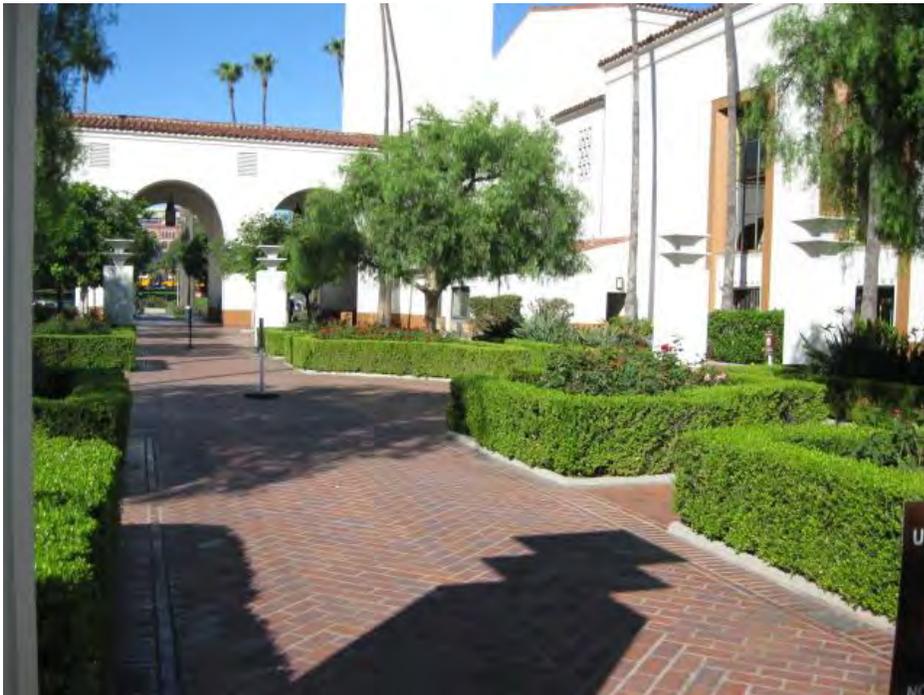
Photograph #6

Overall view of the south courtyard.

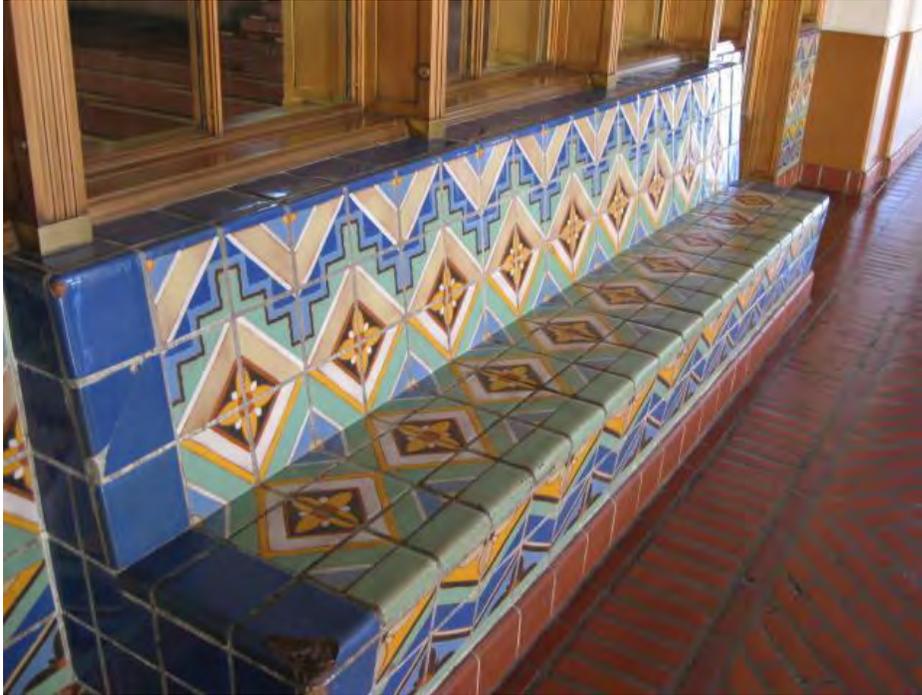
Photograph #7

Typical tiled site bench.

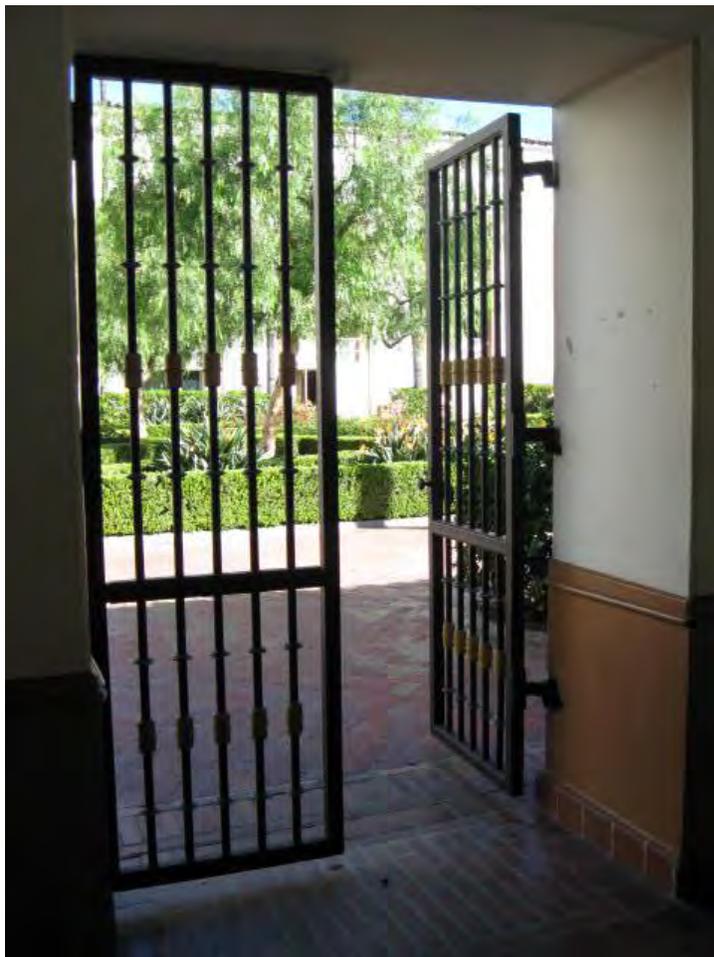
Photograph #8

Typical decorative site iron gates.

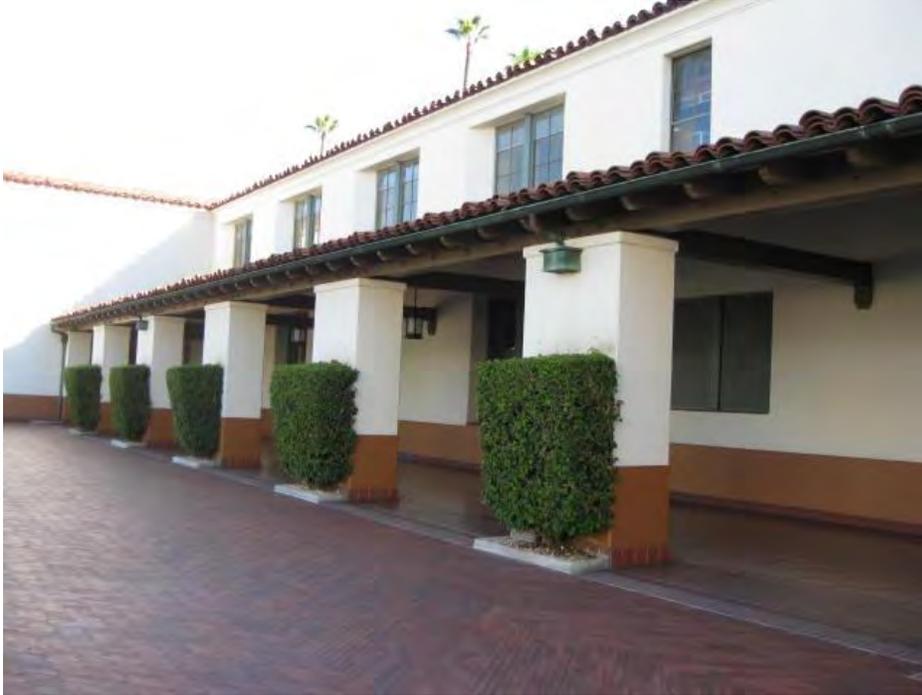
Photograph #9

Typical brick pavers  
and vine pockets.

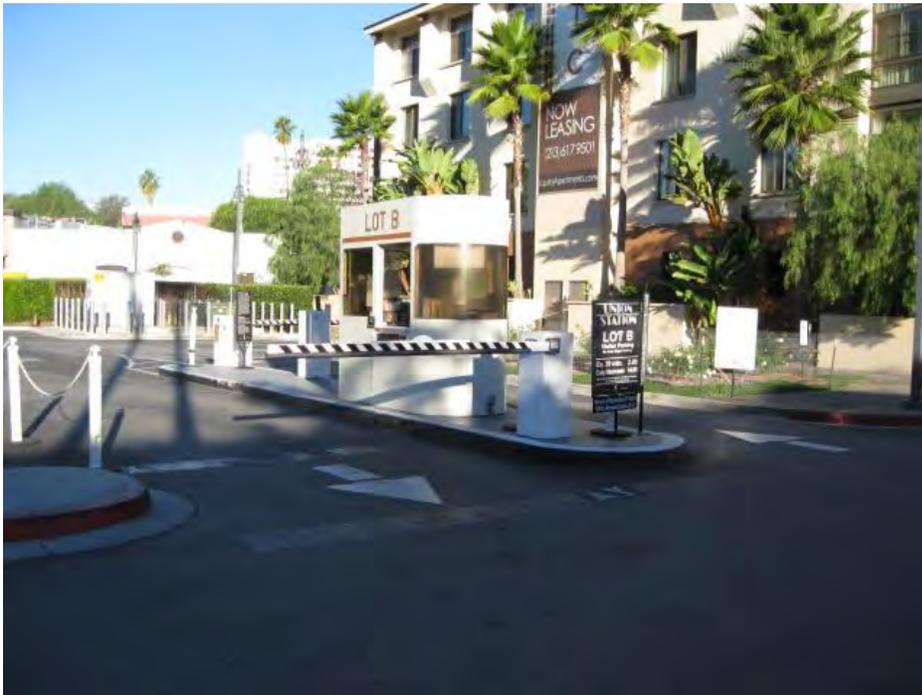
Photograph #10

Typical parking lot  
controlled access  
point and booth.

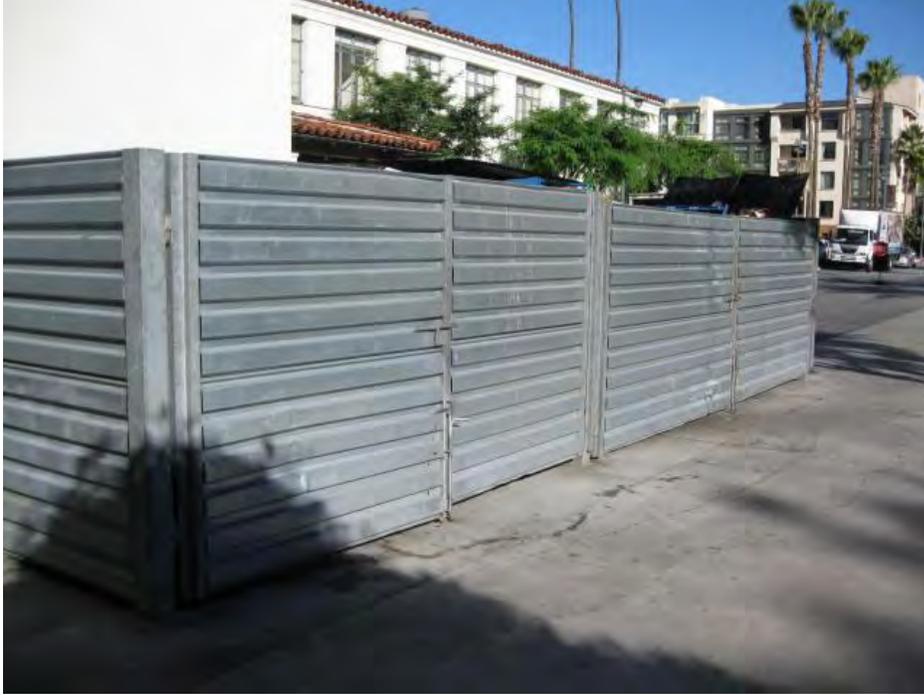
Photograph #13

Trash enclosures near the Amtrak bus lot.

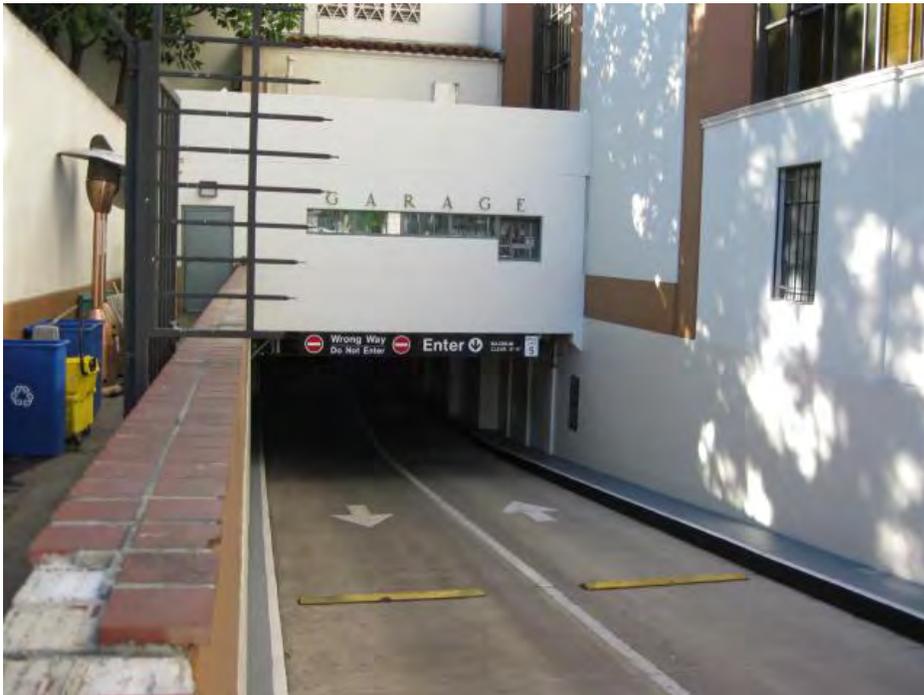
Photograph #14

Vehicular access to the garage.

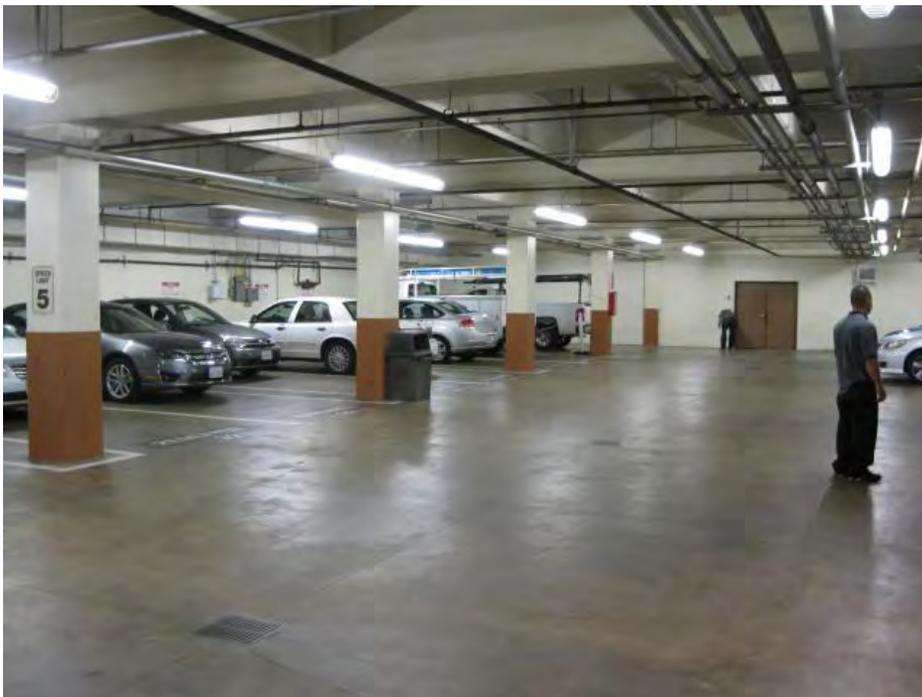
Photograph #16

Overall view of the  
garage.

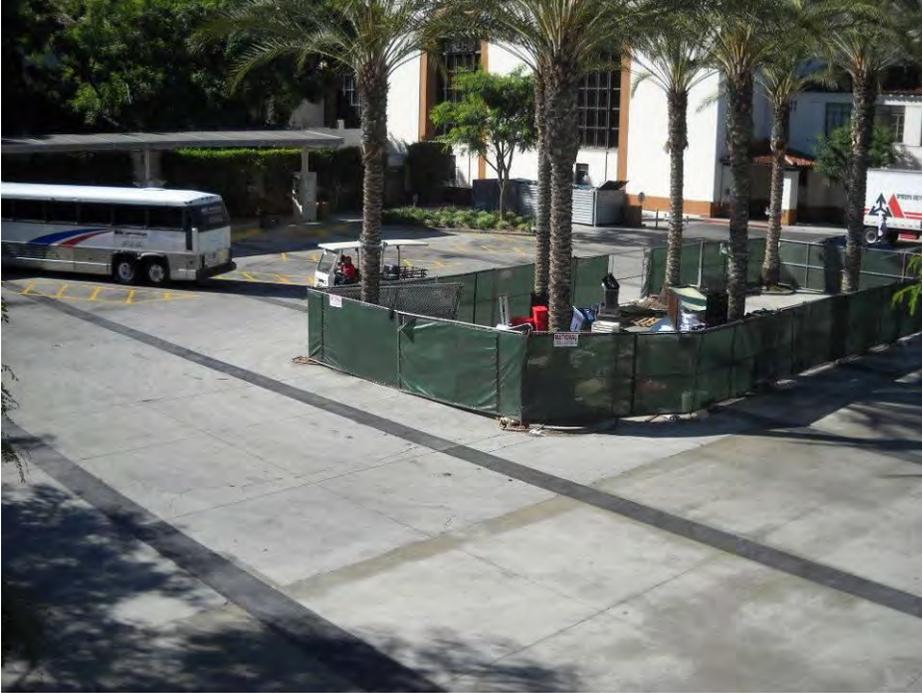
Photograph #23

A portion of the parking lot is closed for construction.

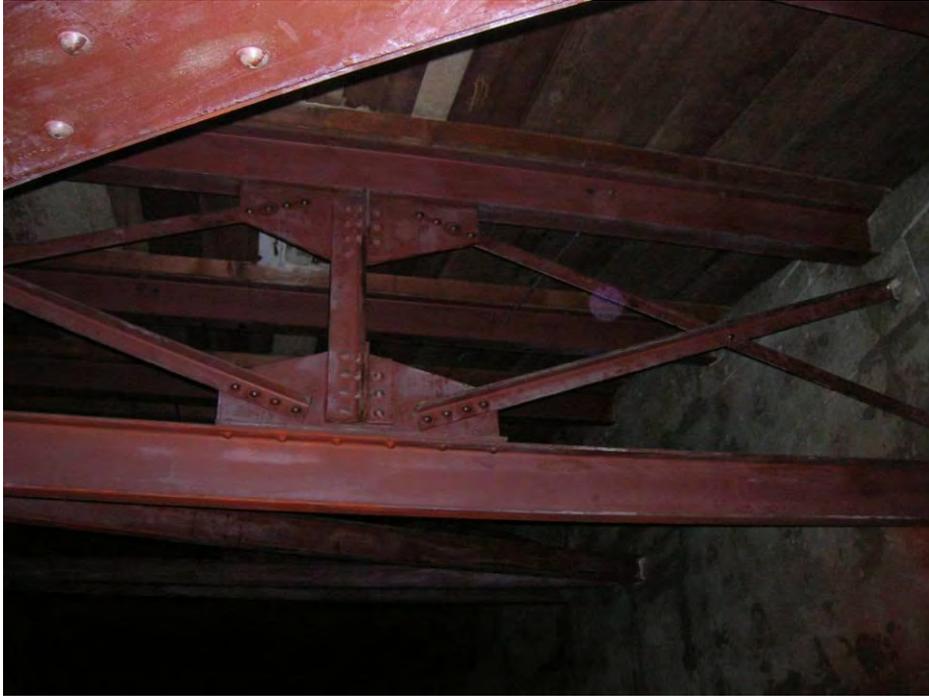
Photograph #31

Steel framing as seen in tower adjacent to Waiting Hall.

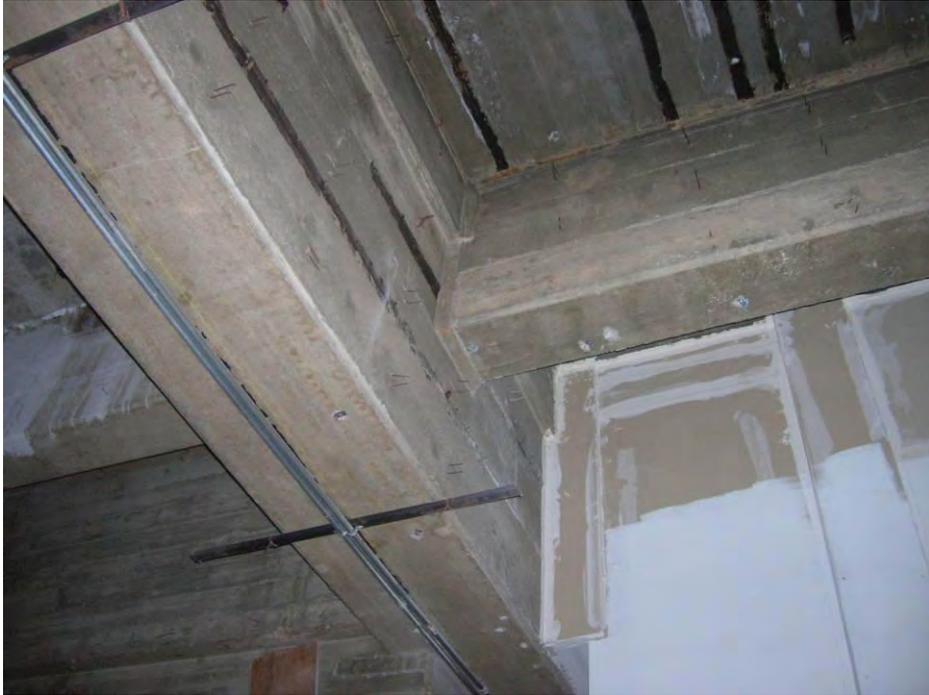
Photograph #33

Ground floor framing at Amtrak building (future Starbucks Coffee space).

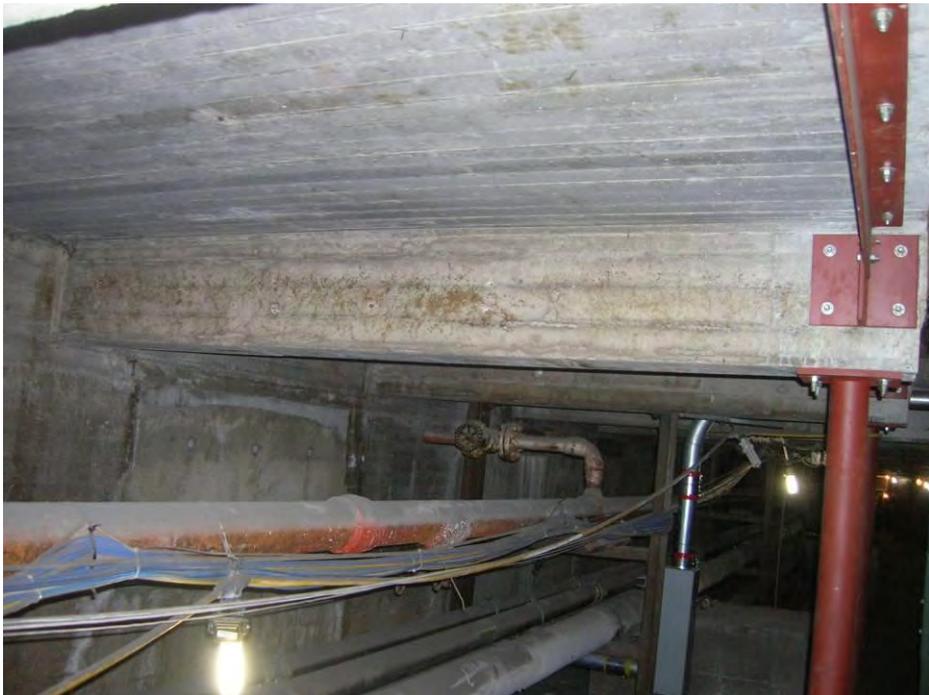
Photograph #34

Ground floor framing at Amtrak building.

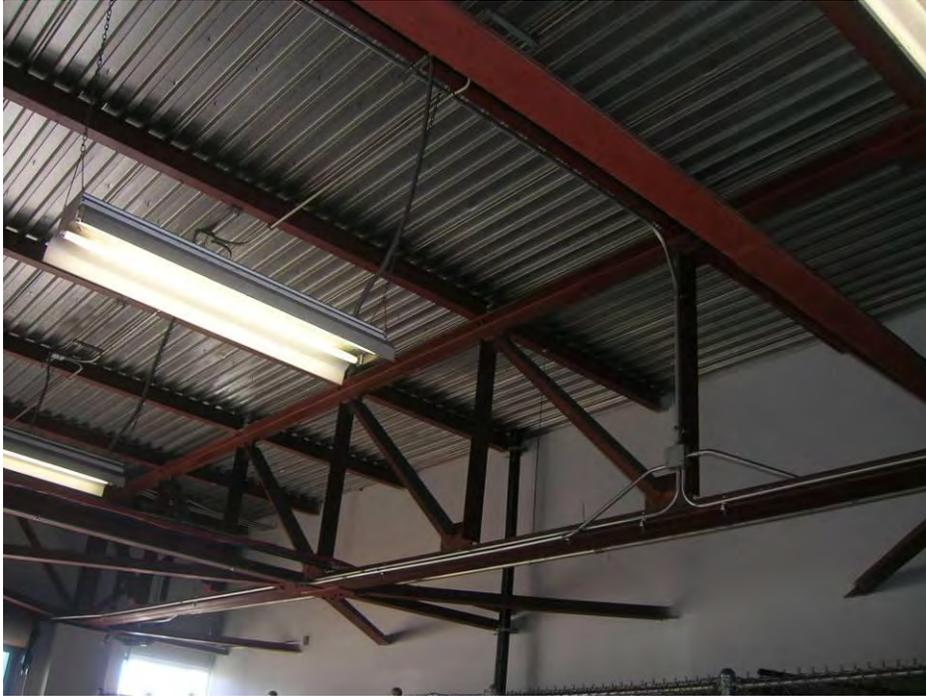
Photograph #35

Second floor  
framing at Amtrak  
building.

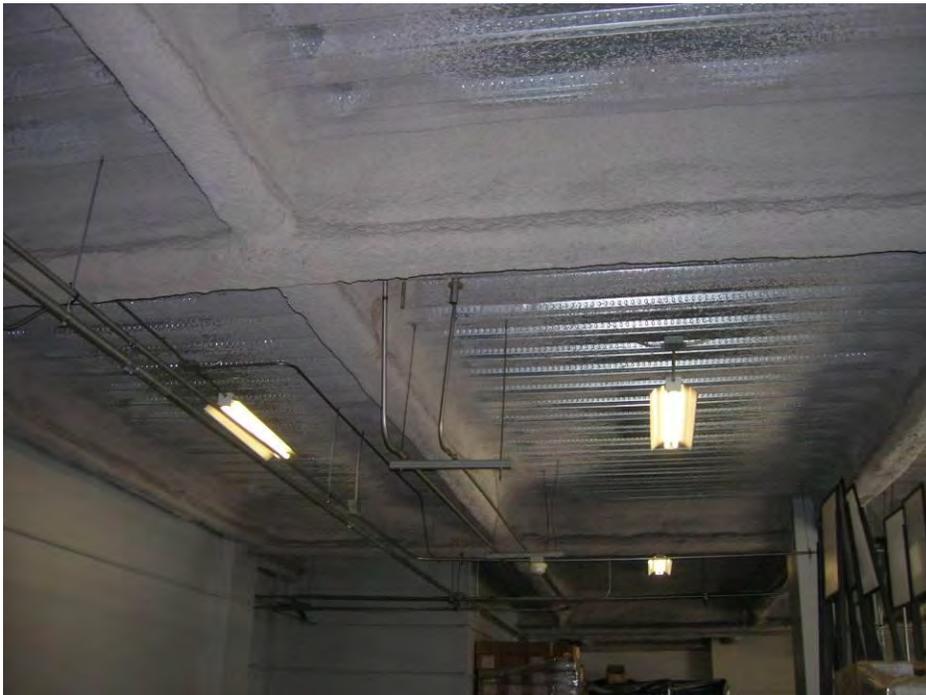
Photograph #36

Second floor  
framing at Amtrak  
building.

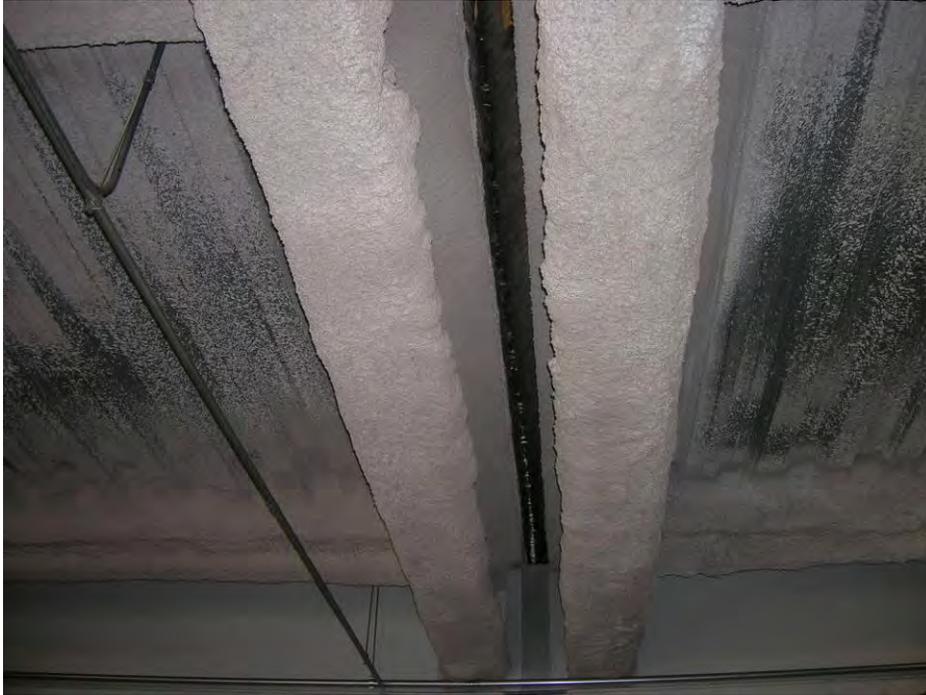
Photograph #37

Seismic separation  
between structures  
at Amtrak building.

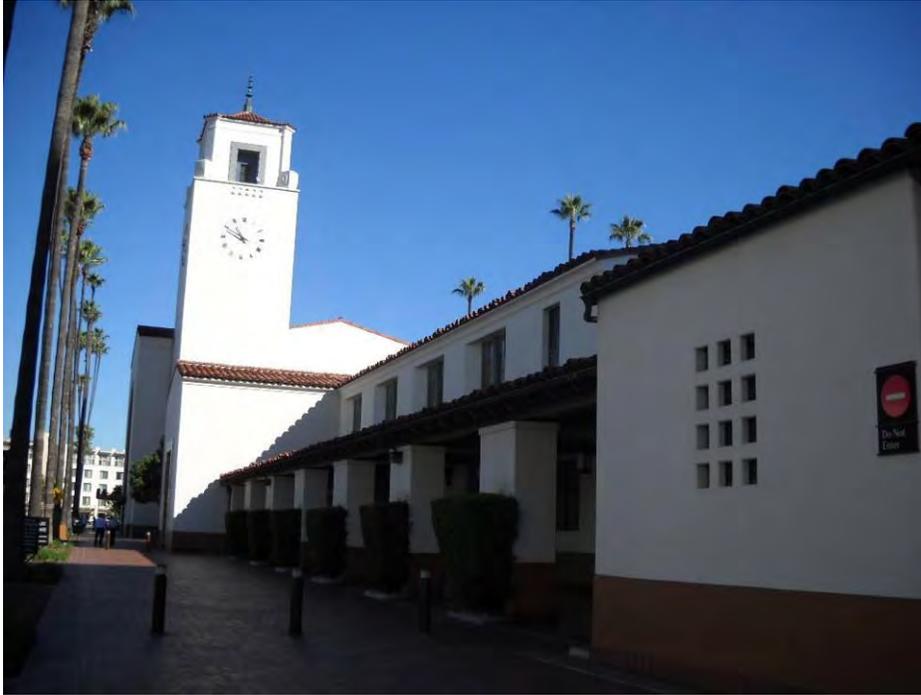
Photograph #41

Overview of the front elevation.

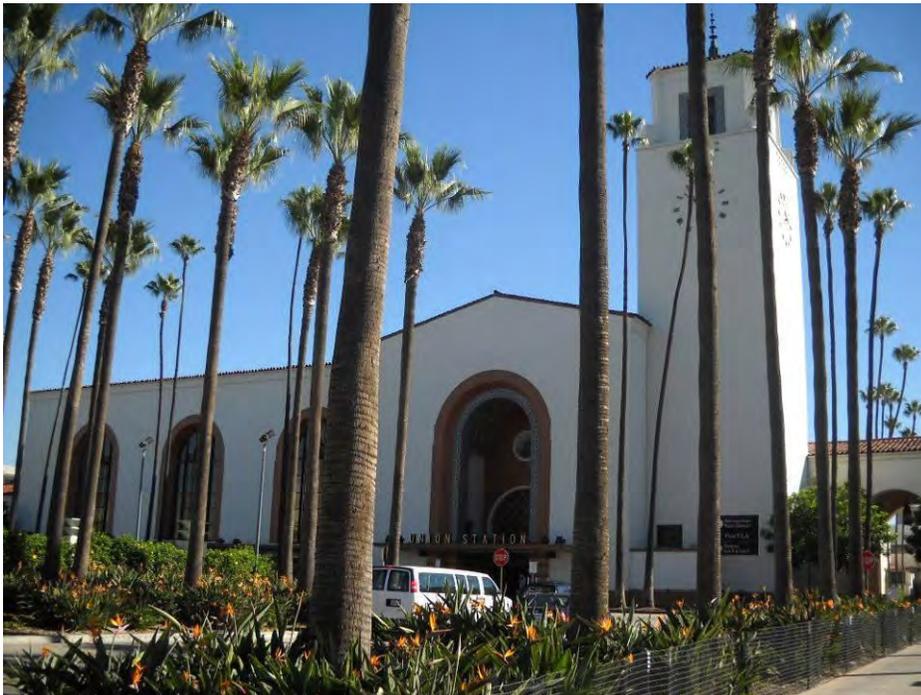
Photograph #42

View of the clock tower and the main concourse.

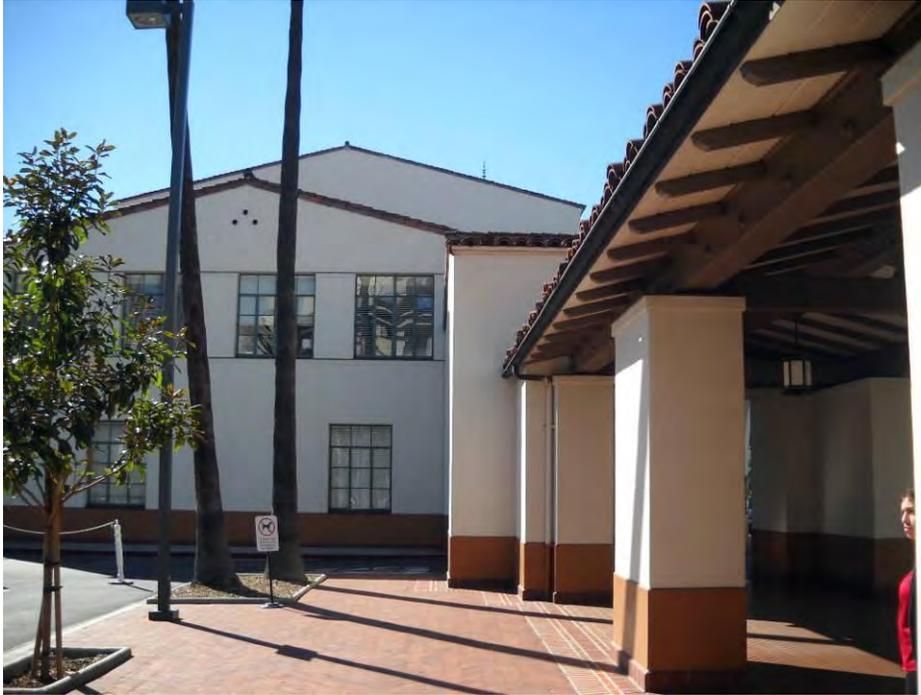
Photograph #43

View of the Catellus  
offices on the north.

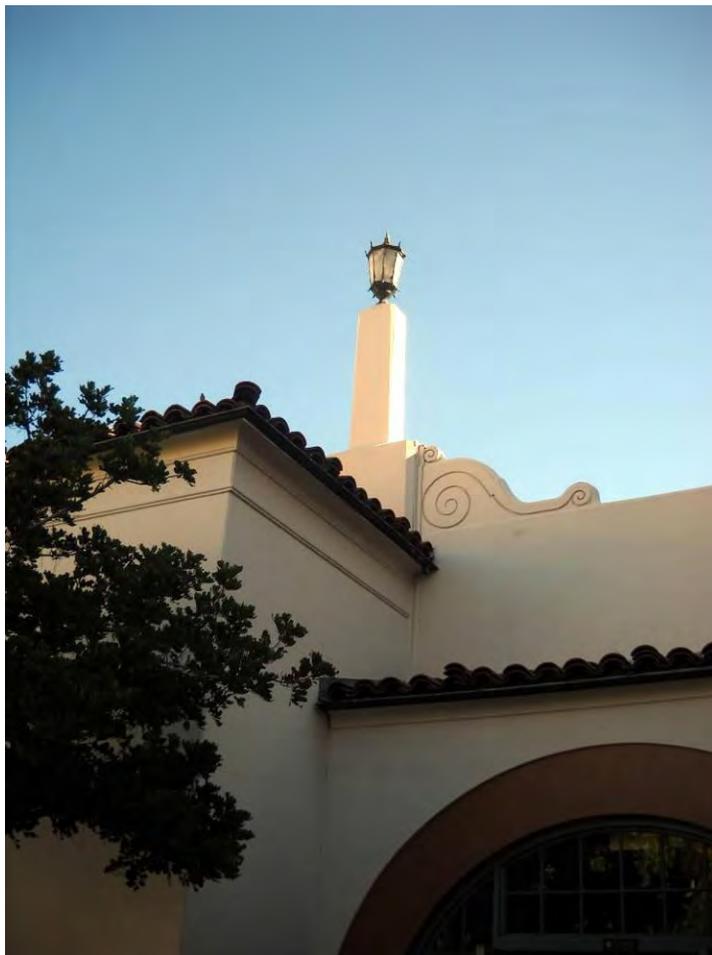
Photograph #44

Typical mission  
revival details.

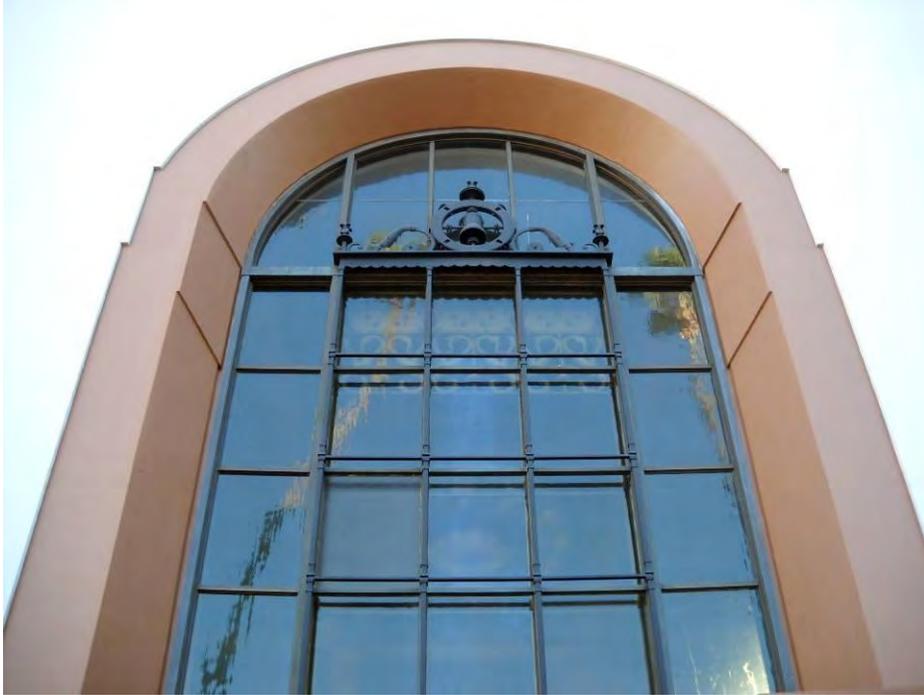
Photograph #45

Large arched windows with decorative forged iron grill and mullions.

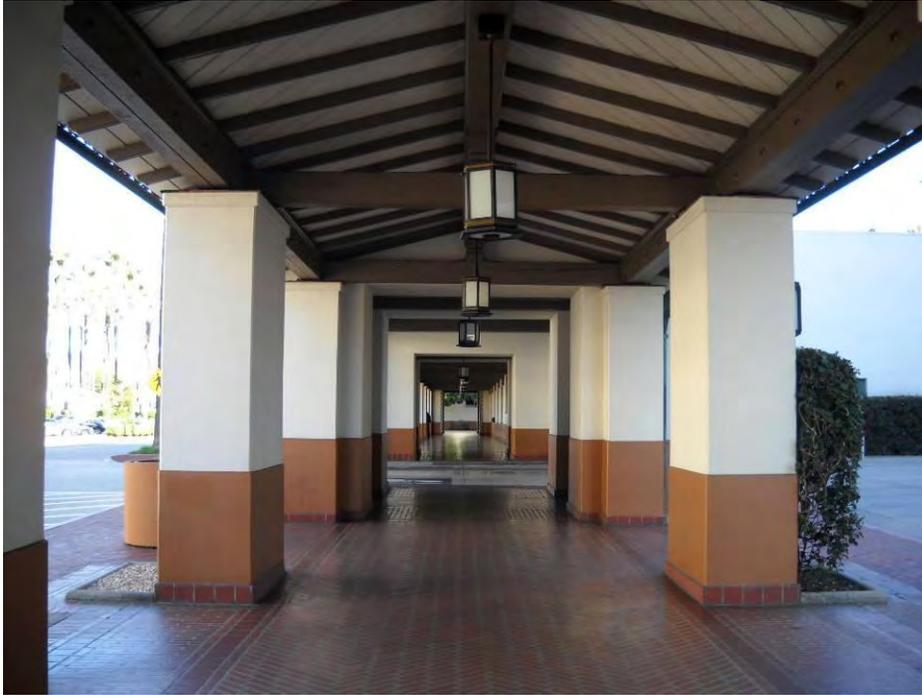
Photograph #46

View of the concourse area elevation.

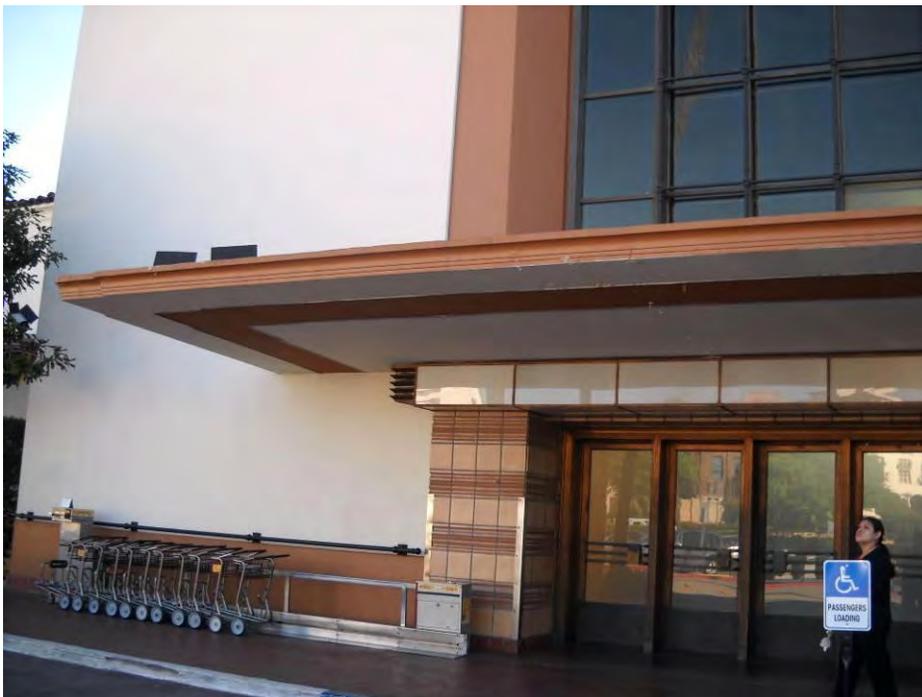
Photograph #47

Typical portico and breezeway extension to the south.

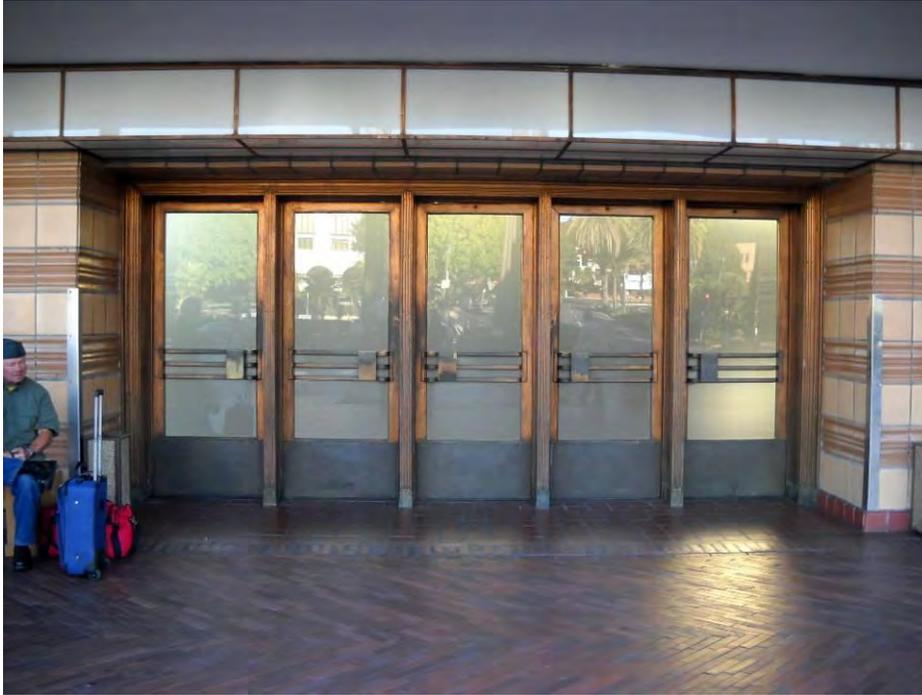
Photograph #53

Exterior metal clad  
entrance doors.

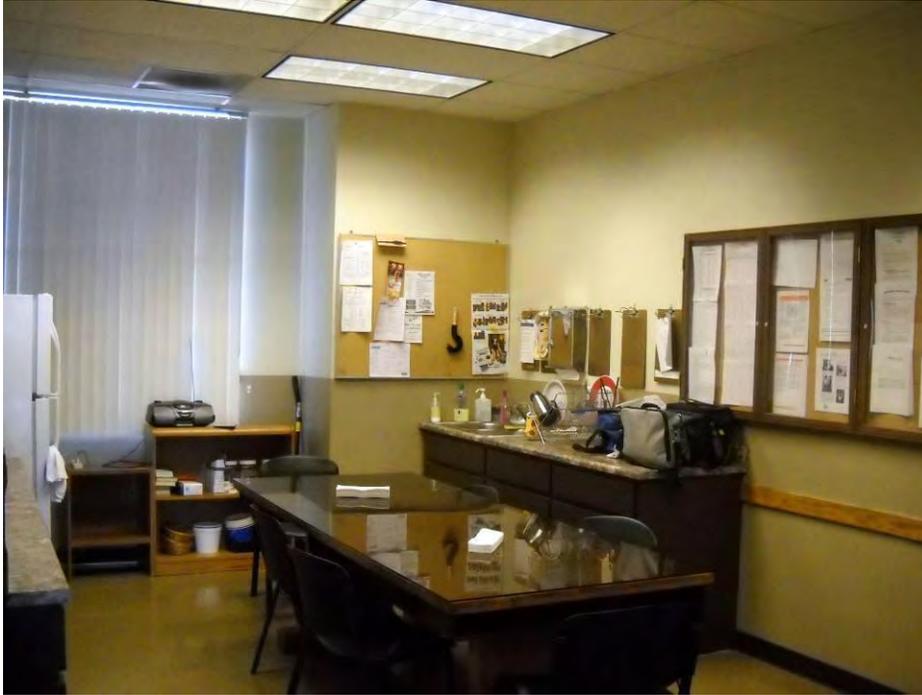
Photograph #55

View of the break room in the loading dock area.

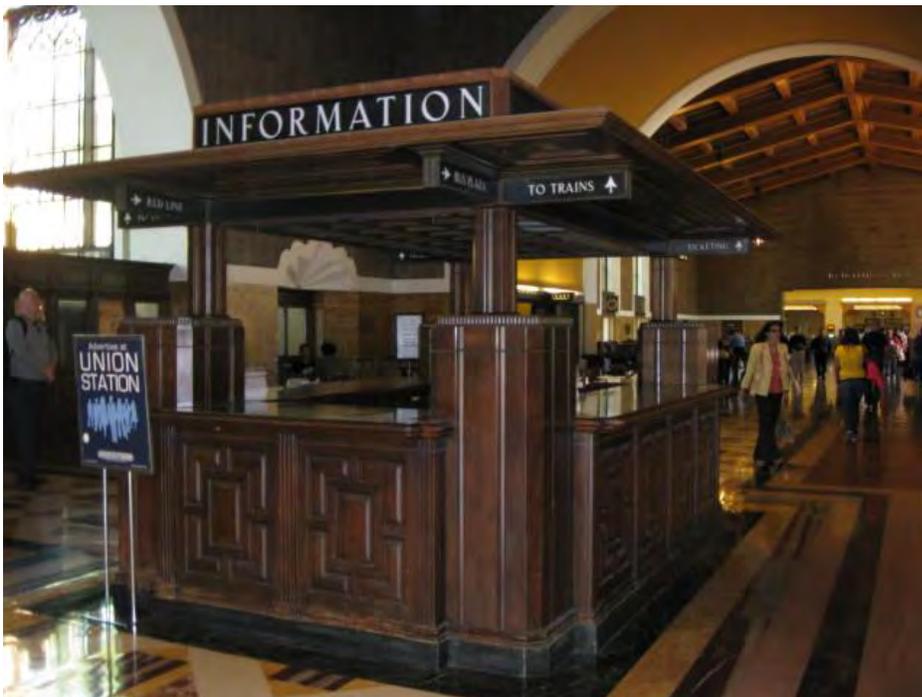
Photograph #56

View of the typical casework provided in the main entry.
