## PROPERTY CONDITION ASSESSMENT

# PROJECT SANTA FE LOS ANGELES UNION STATION

800 North Alameda Street  
Los Angeles, California

Draft: November 12, 2010

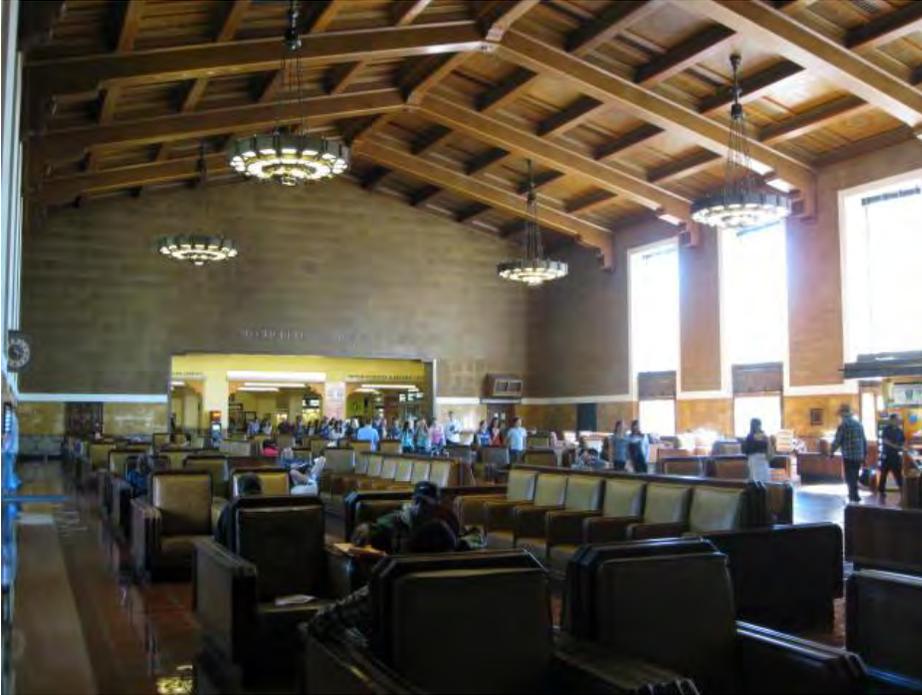
Photograph #57

Overall view of the  
main concourse  
area.

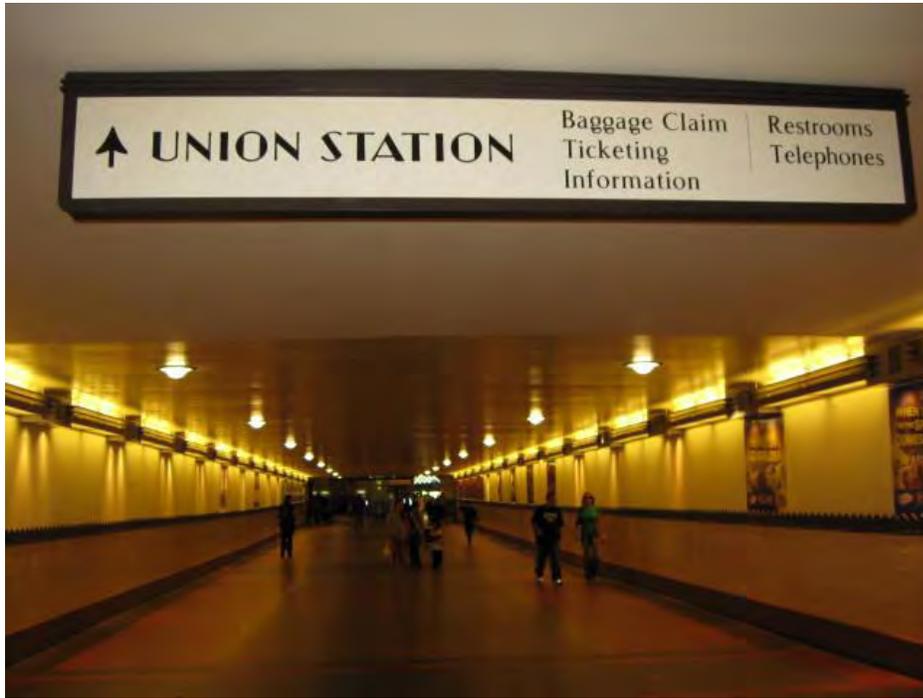
Photograph #59

Overall view of the main tunnel.

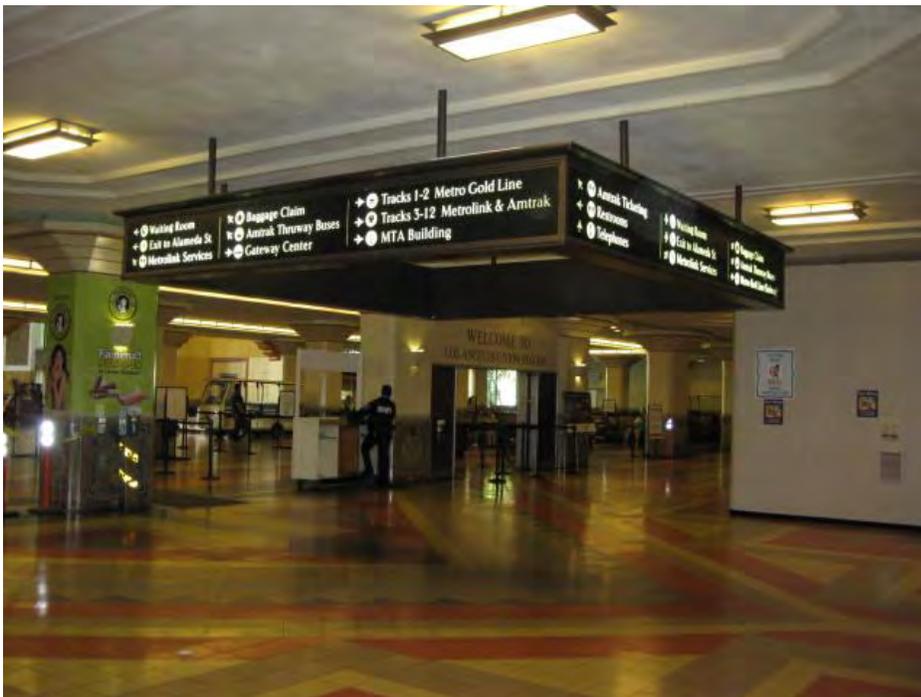
Photograph #64

Typical directional signage.

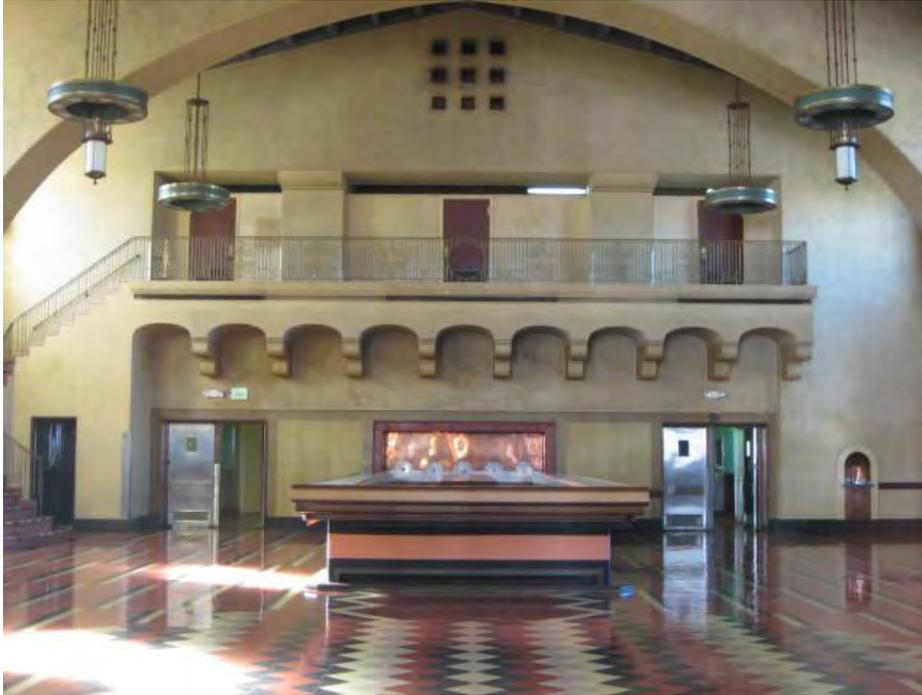
Photograph #65

Overall view of the vacant restaurant.

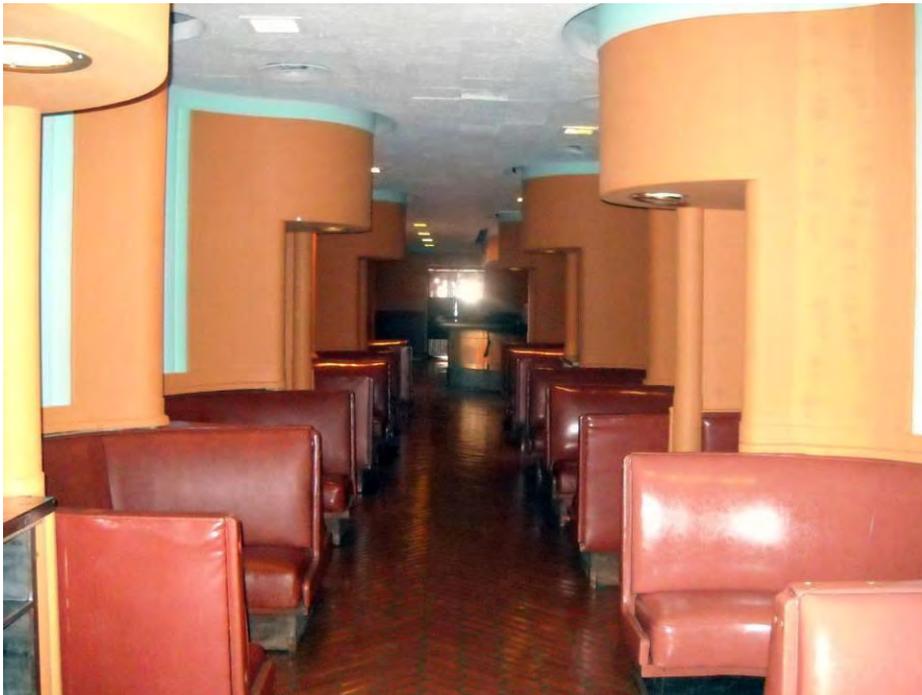
Photograph #68

View of the bar area seating at the Fred Harvey Restaurant.

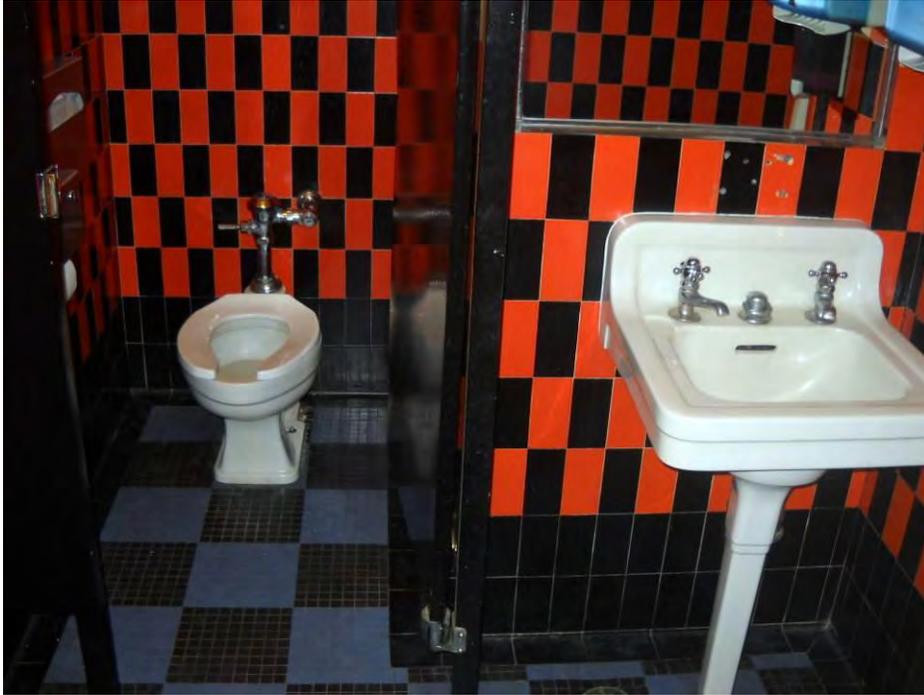
Photograph #69

Toilettrooms in the  
Fred Harvey  
Restaurant.

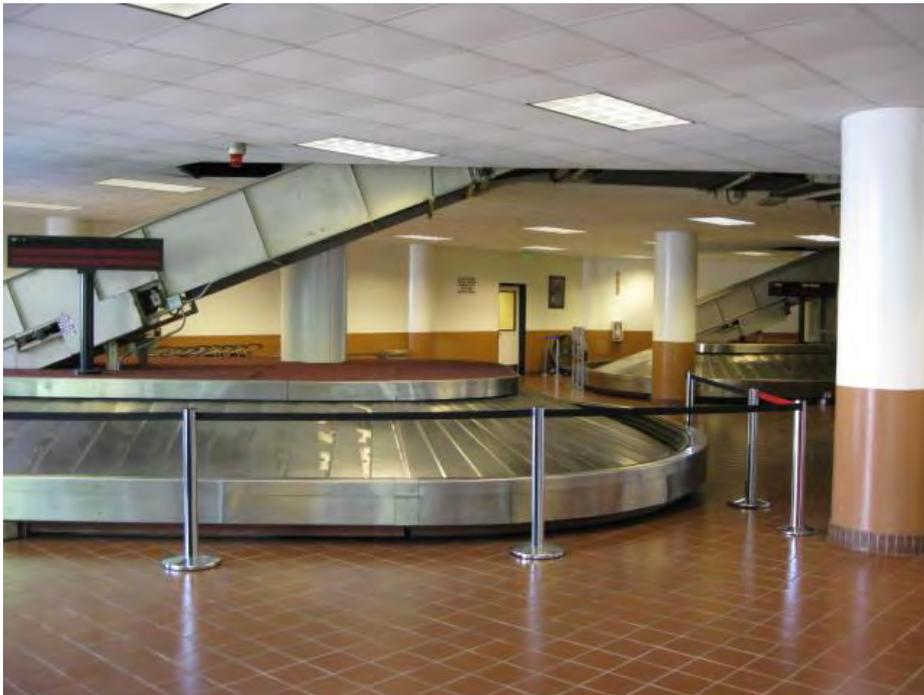
Photograph #70

View of the Amtrak  
baggage area.

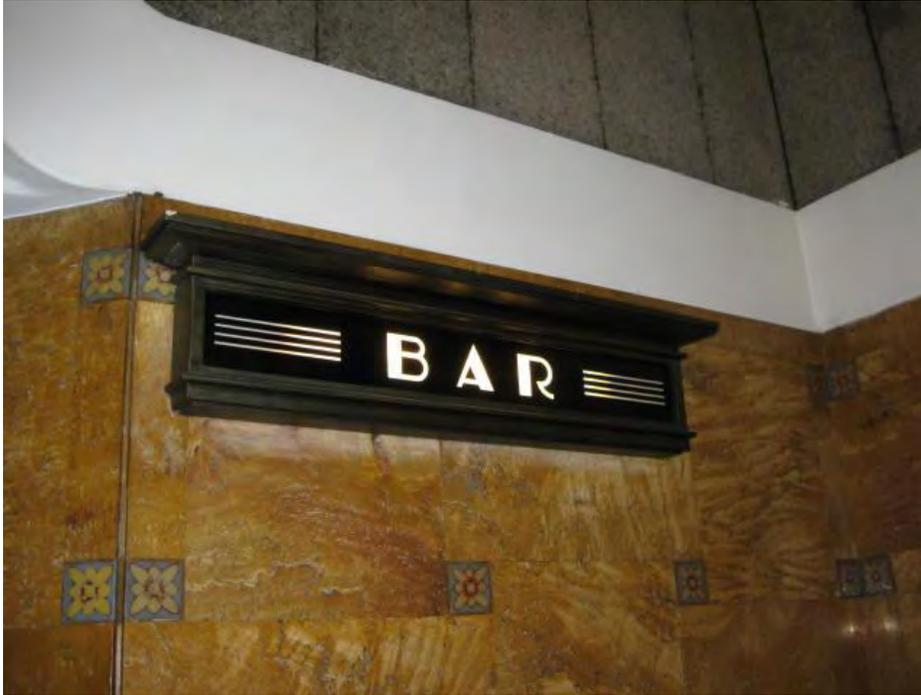
Photograph #71

View of a typical room signage throughout the concourse area.

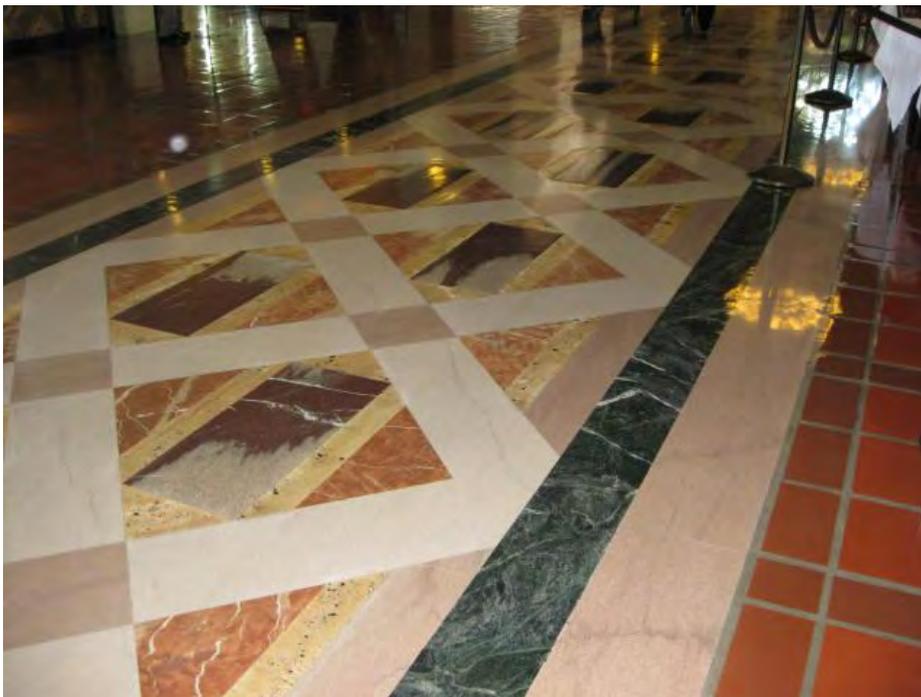
Photograph #72

View of the natural stone flooring provided throughout the main concourse area.

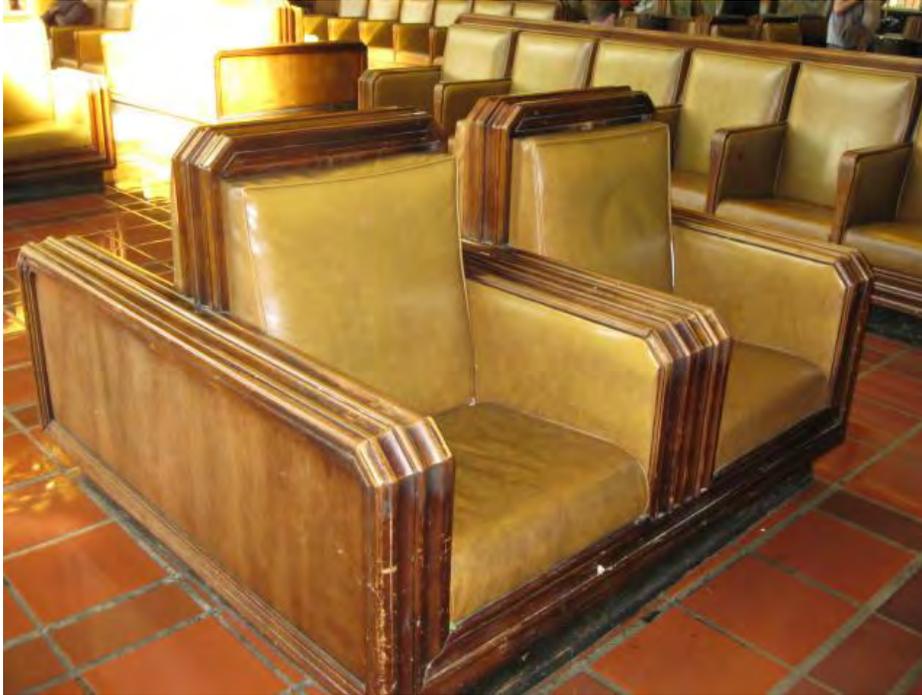
Photograph #73

Close-up view of the built-in seats in the main concourse area.

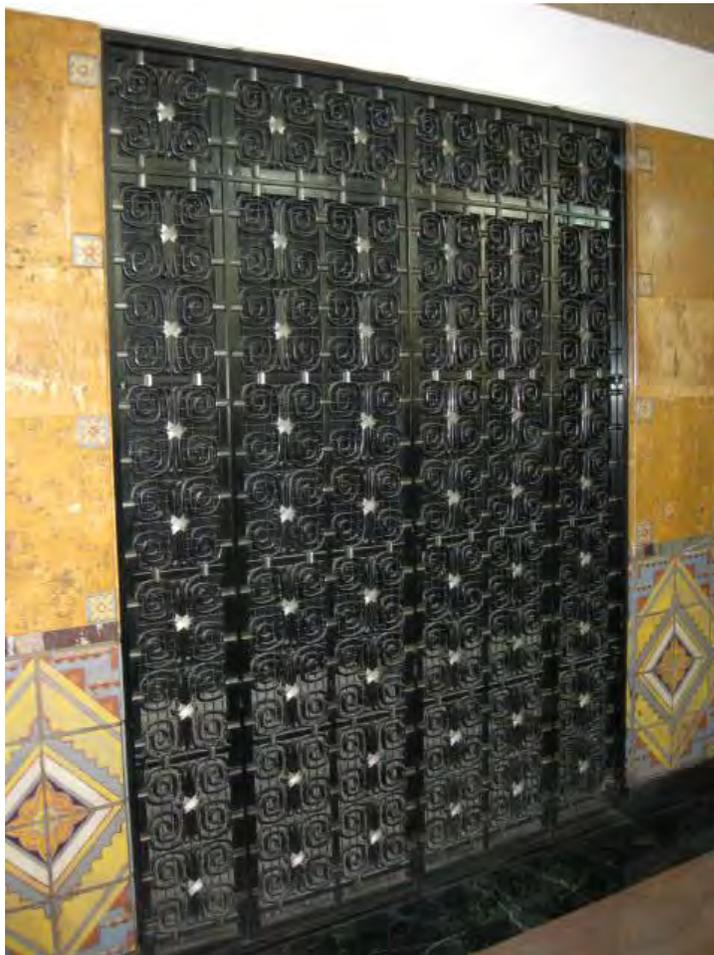
Photograph #82

Typical decorative iron gates provided in the concourse area.

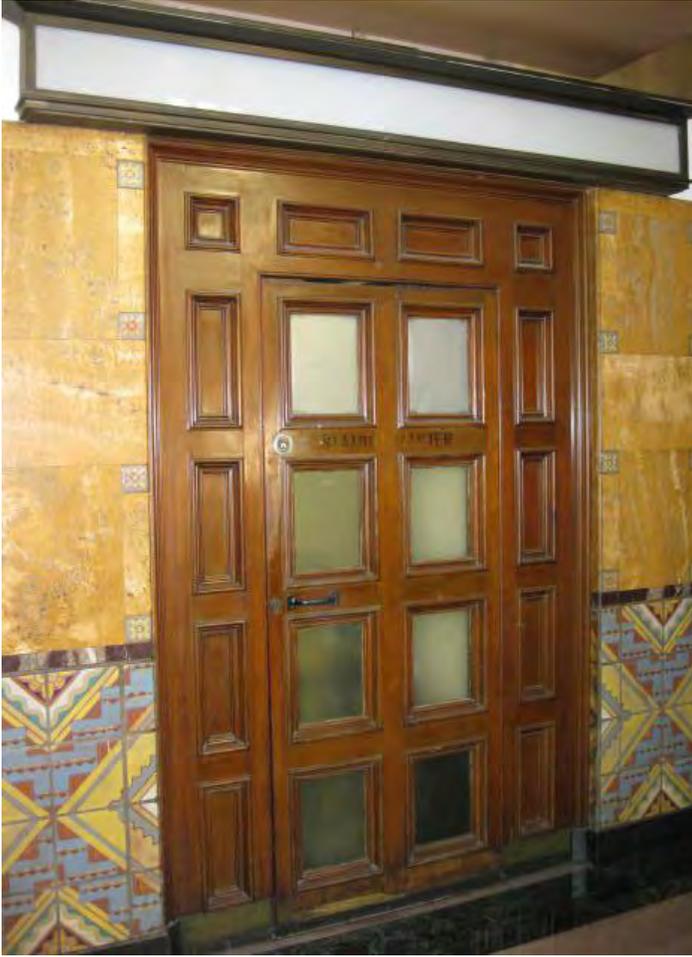
← Photograph #83

Typical view of an interior door and wall finishes in the main concourse area.

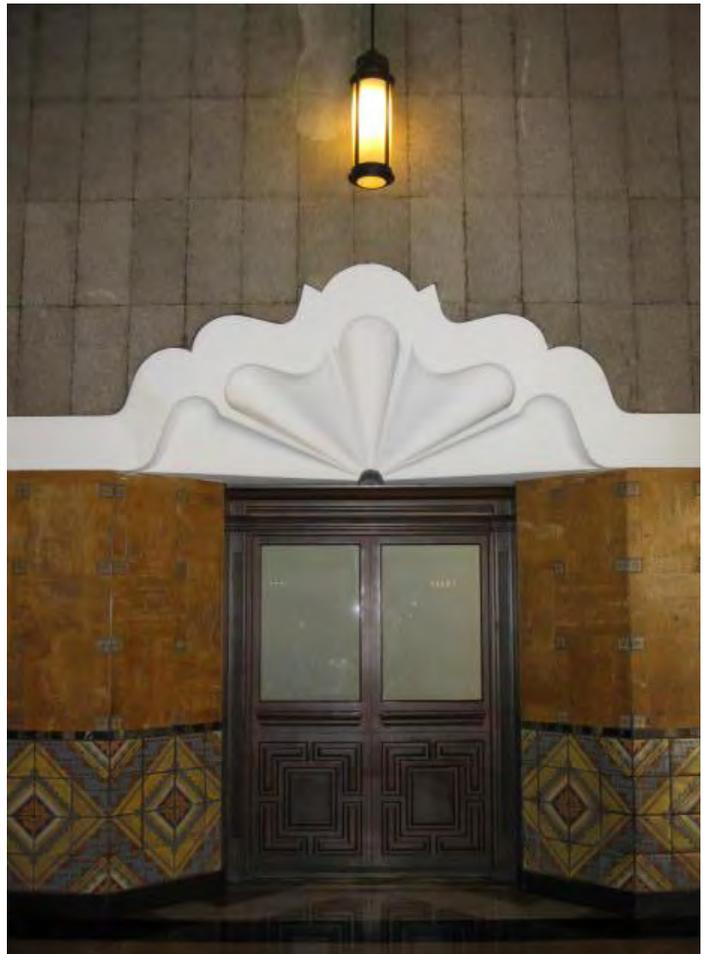
Typical lighting and wall finishes in the entry area.

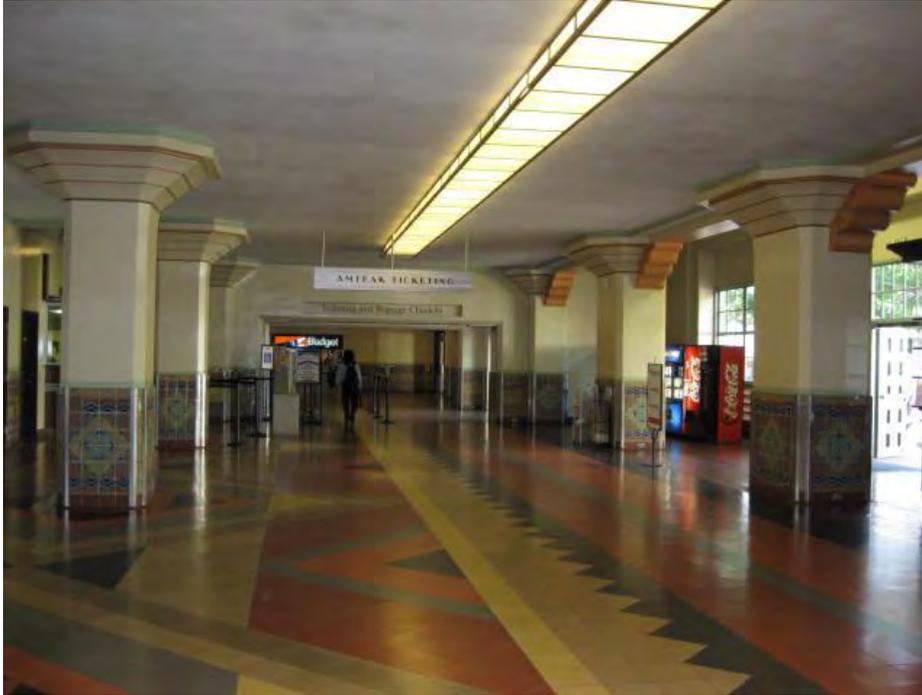
Photograph #85

Typical finishes at the ticketing area.

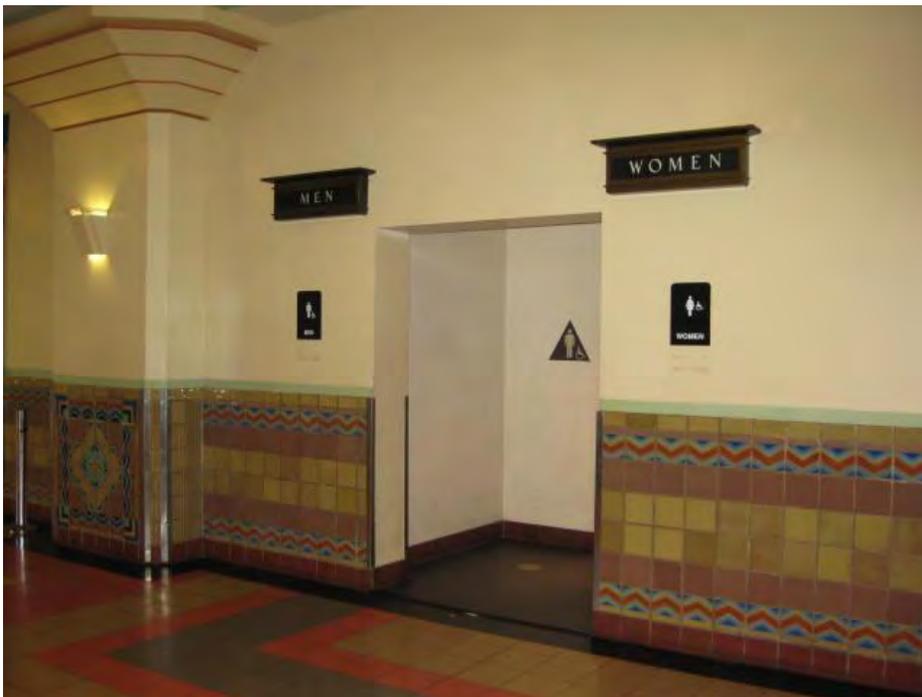
Photograph #86

Typical restroom entry alcove at the union station.

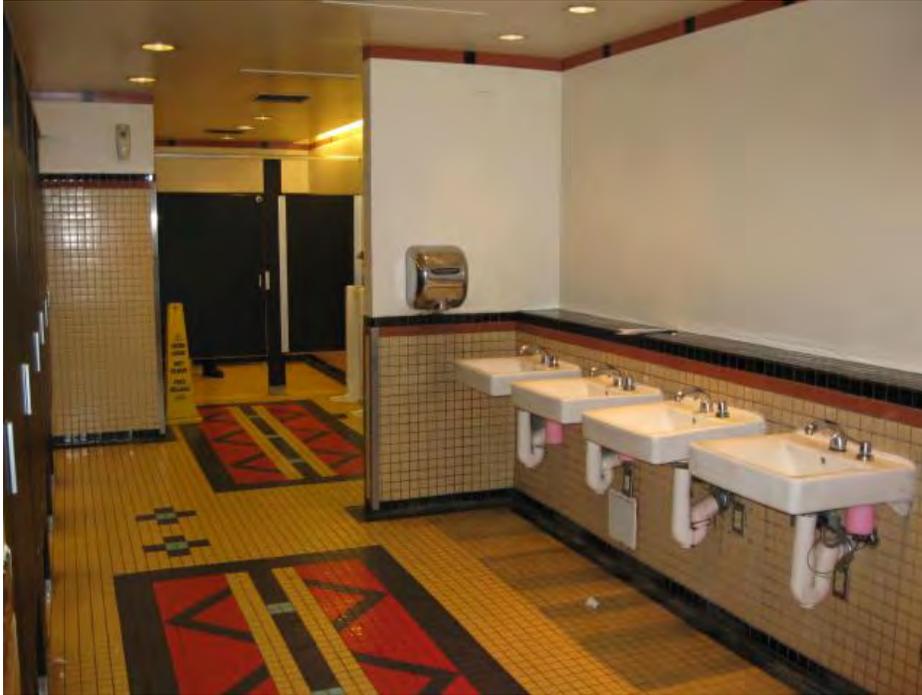
Photograph #87

Typical restroom finishes at the Union Station.

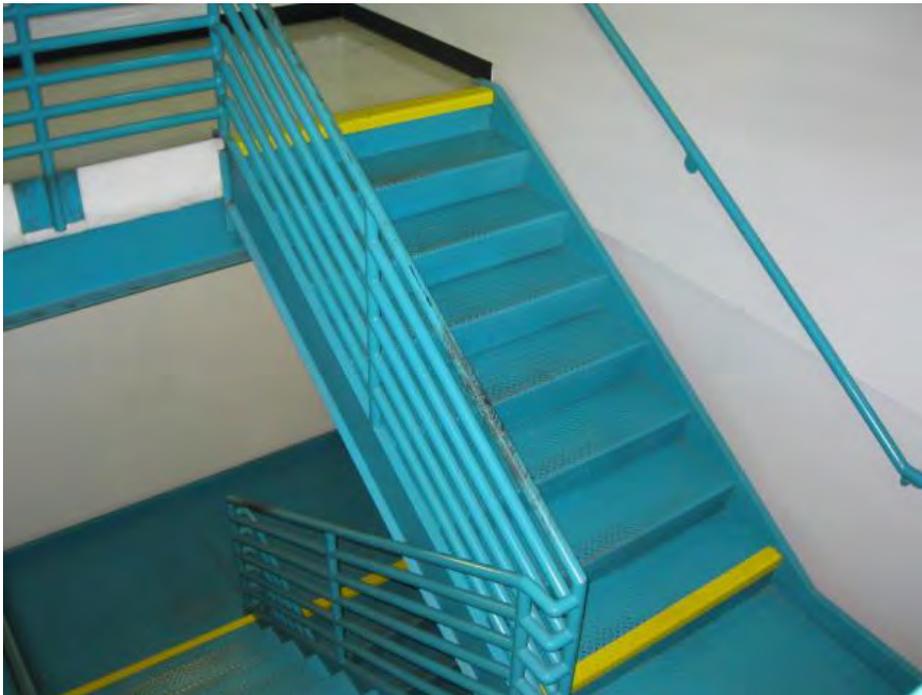
Photograph #88

Typical stairs at the Amtrak building.

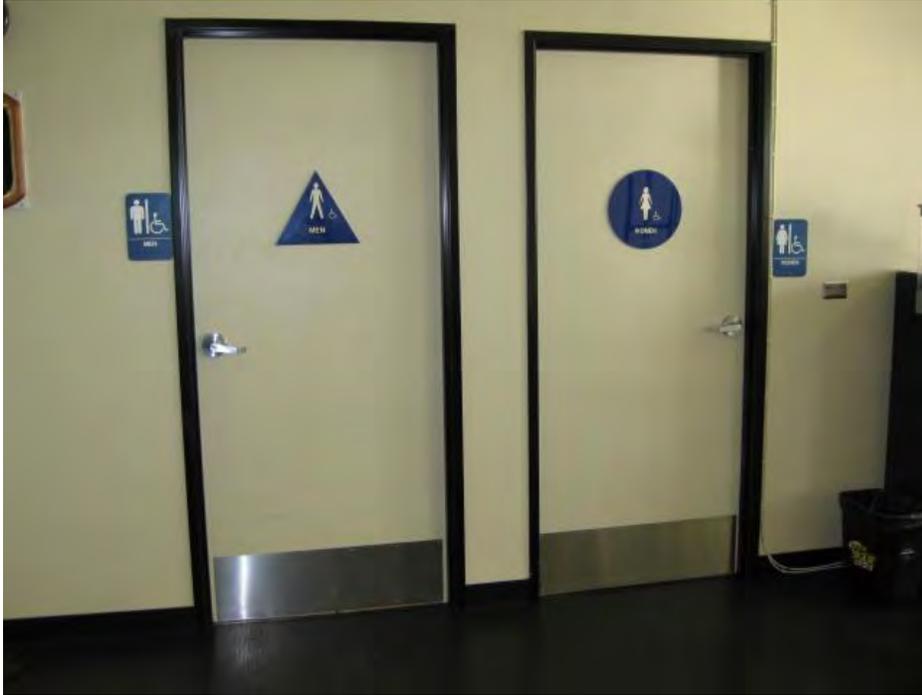
Photograph #89

Typical restroom entry doors at the Amtrak building.

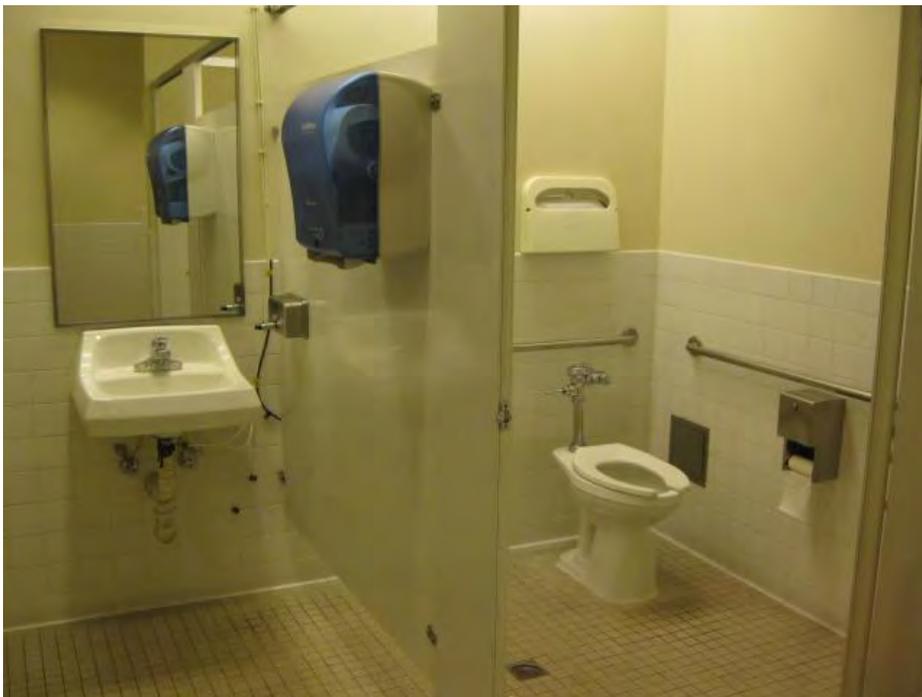
Photograph #90

Typical restroom finishes at the Amtrak building.

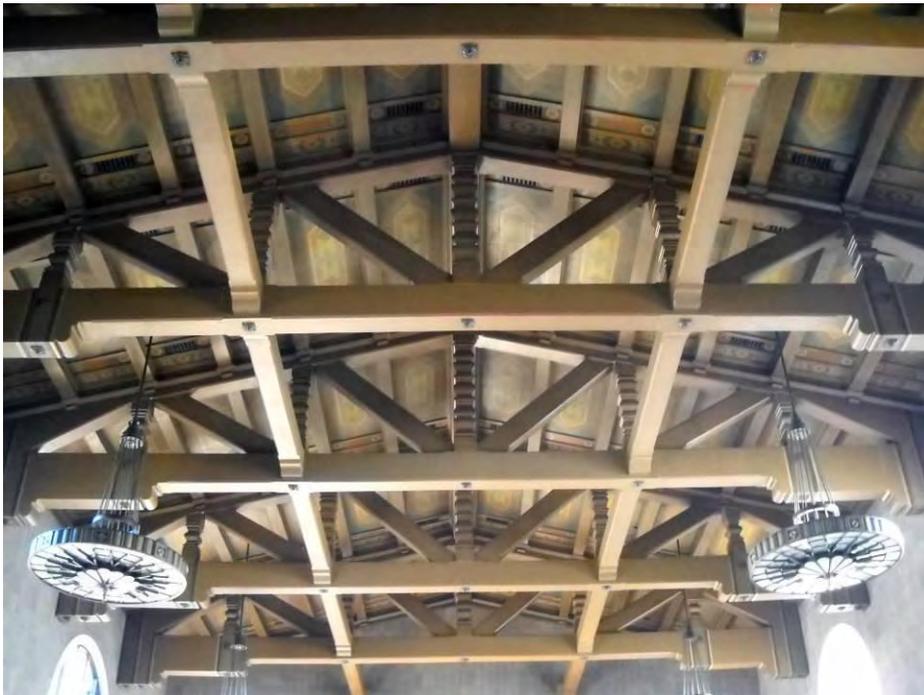
Photograph #92

View of the ornate cathedral ceiling at the main concourse.

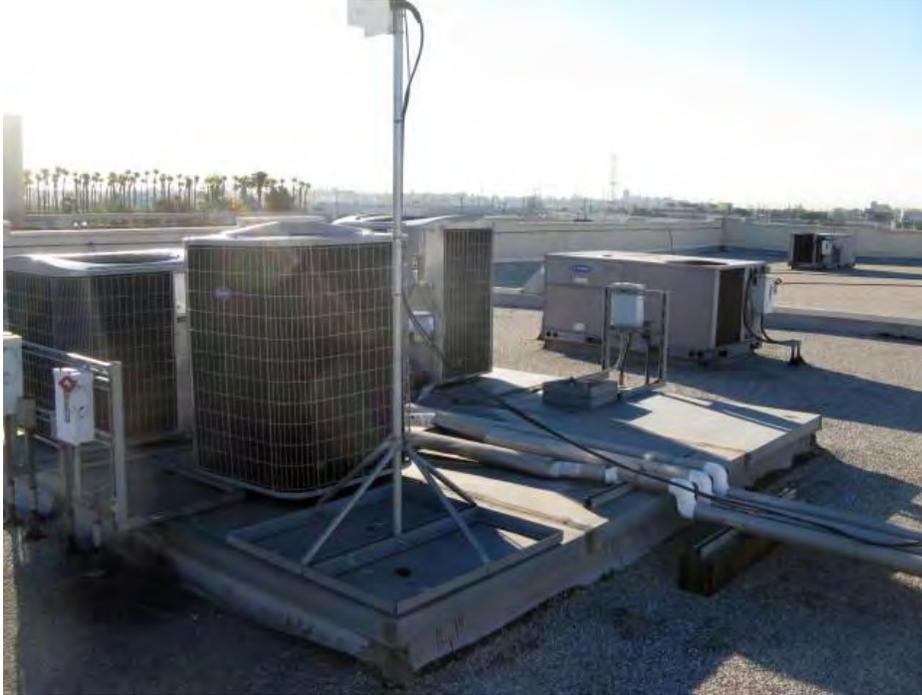
Photograph #95

Compressor/  
condensing units  
and package unit on  
the roof of the  
Amtrak building.

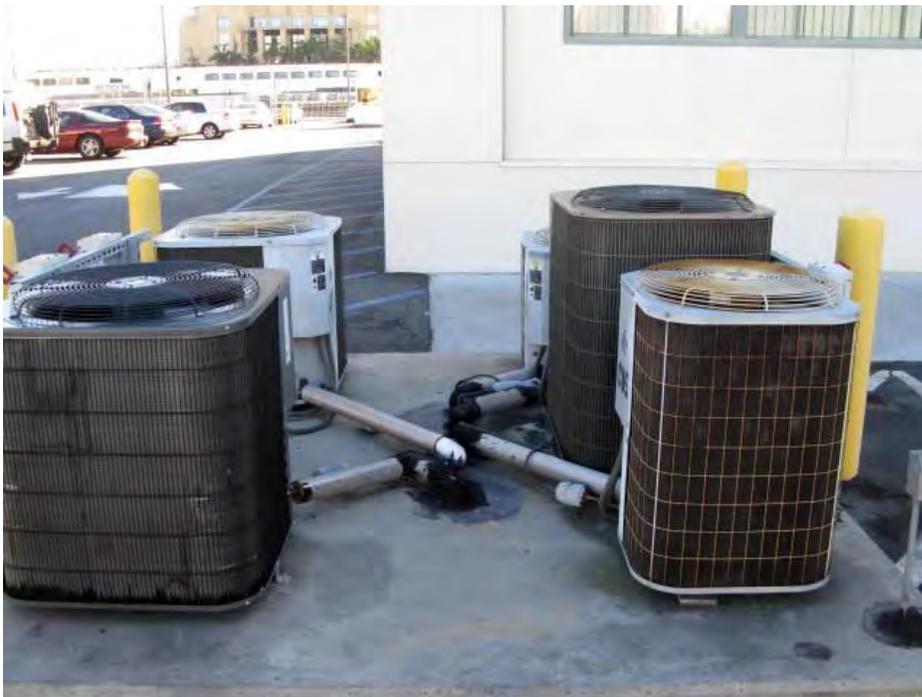
Photograph #96

Compressor/  
condensing units at  
northwest corner of  
Amtrak building at  
second level.

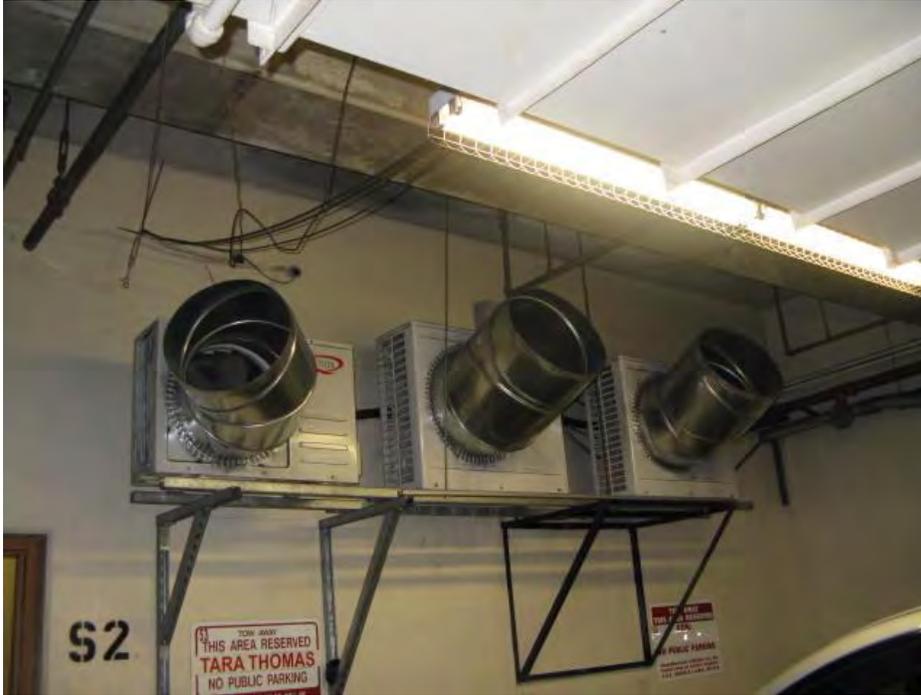
Photograph #97

Compressor/  
condensing units in  
basement parking  
level.

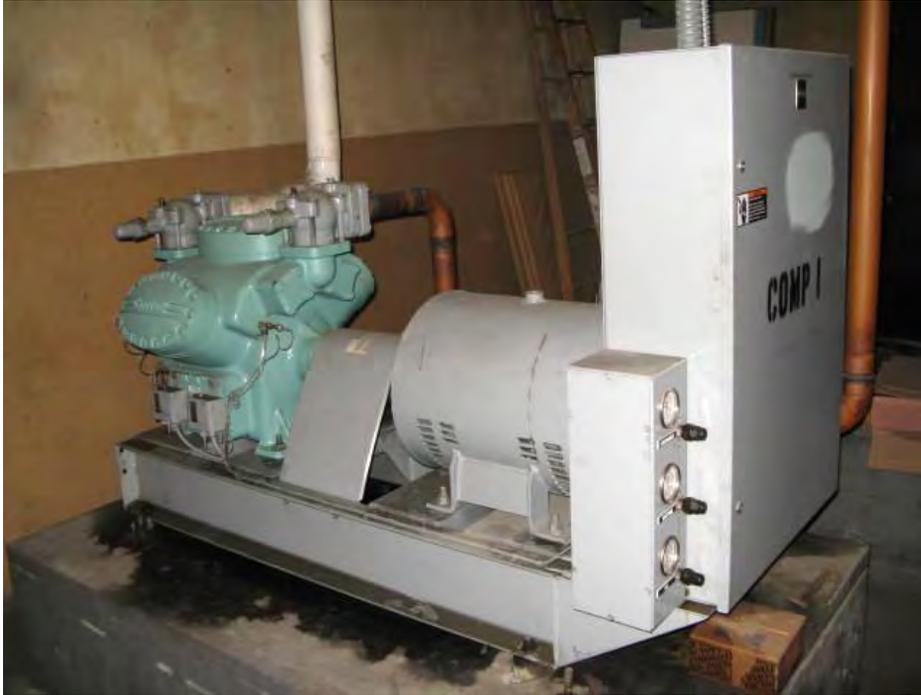
Photograph #99

Direct expansion  
compressor for  
main restaurant  
area.

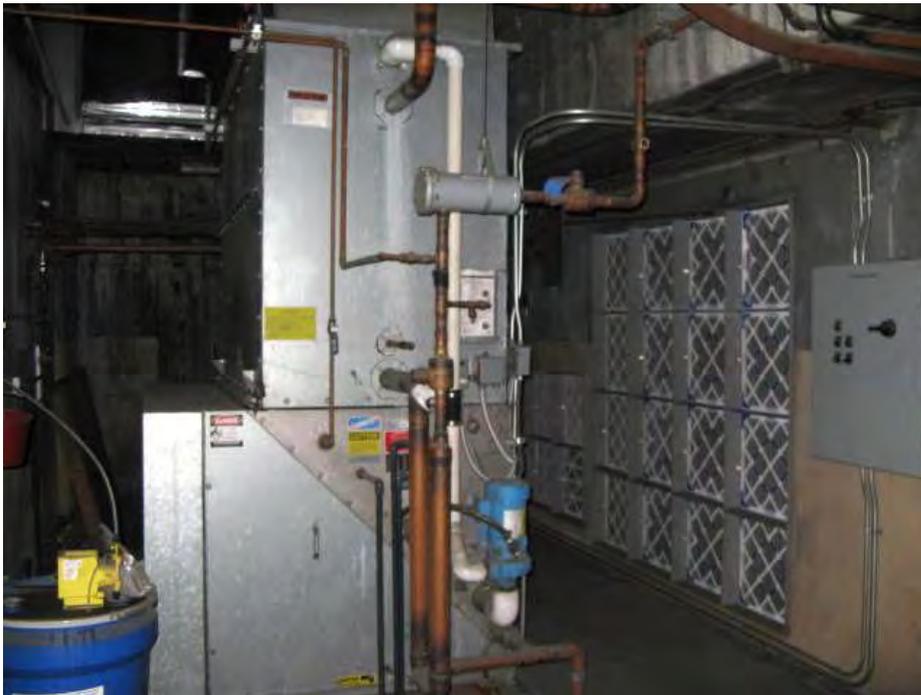
Photograph #100

Evaporative  
condenser for  
compressor for  
main restaurant  
area.

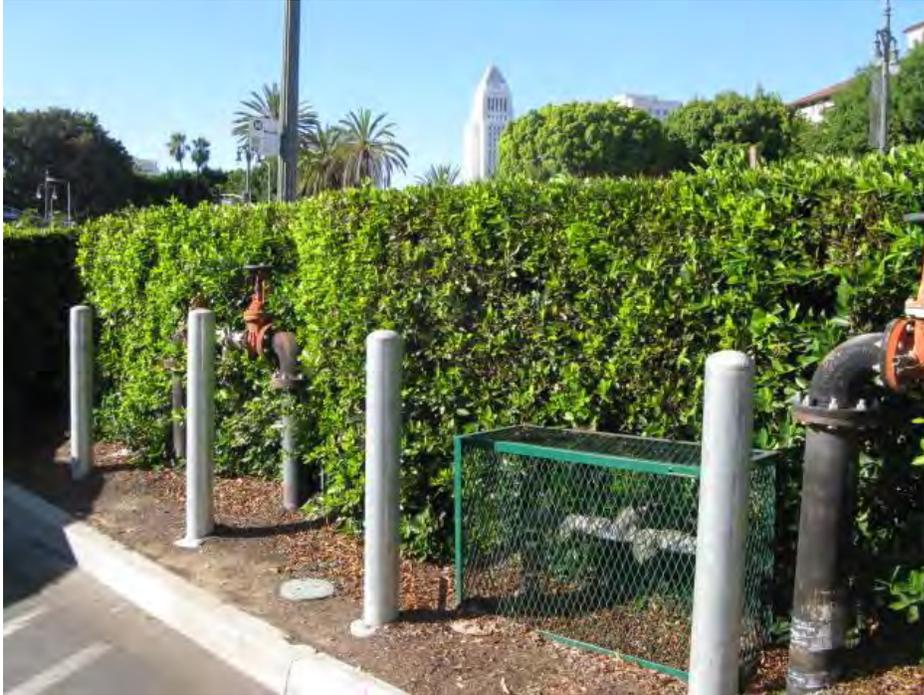
Photograph #101

Domestic water and irrigation services.

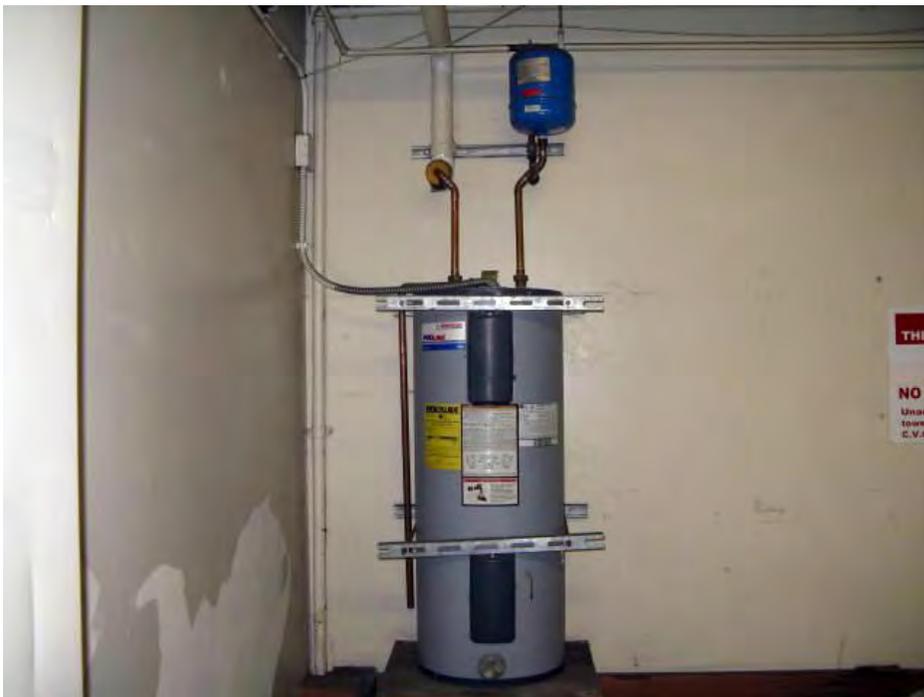
Photograph #102

Water heater in basement.

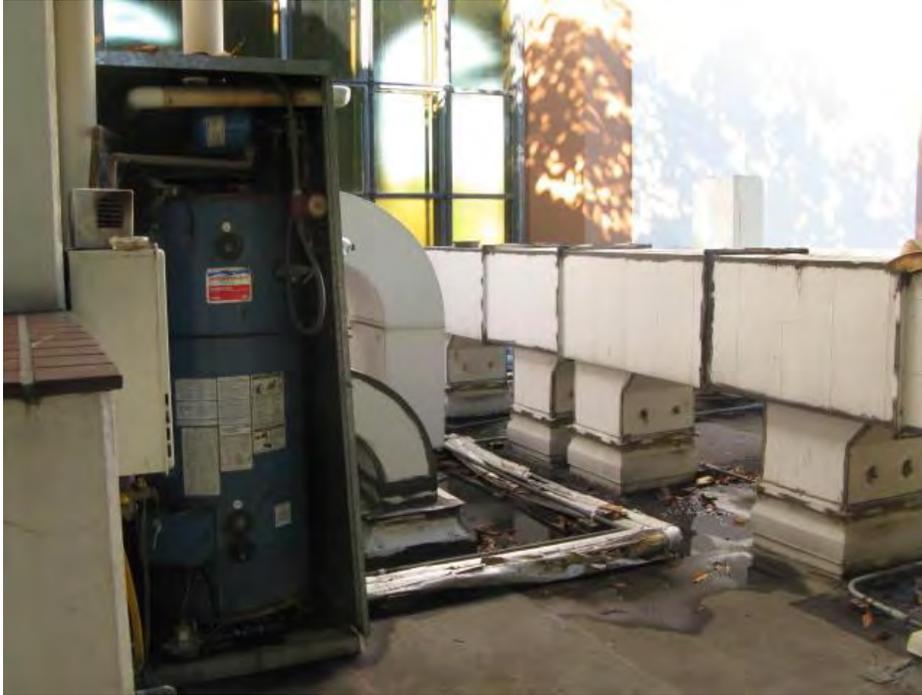
Photograph #103

Water heater and ductwork for Traxx restaurant.

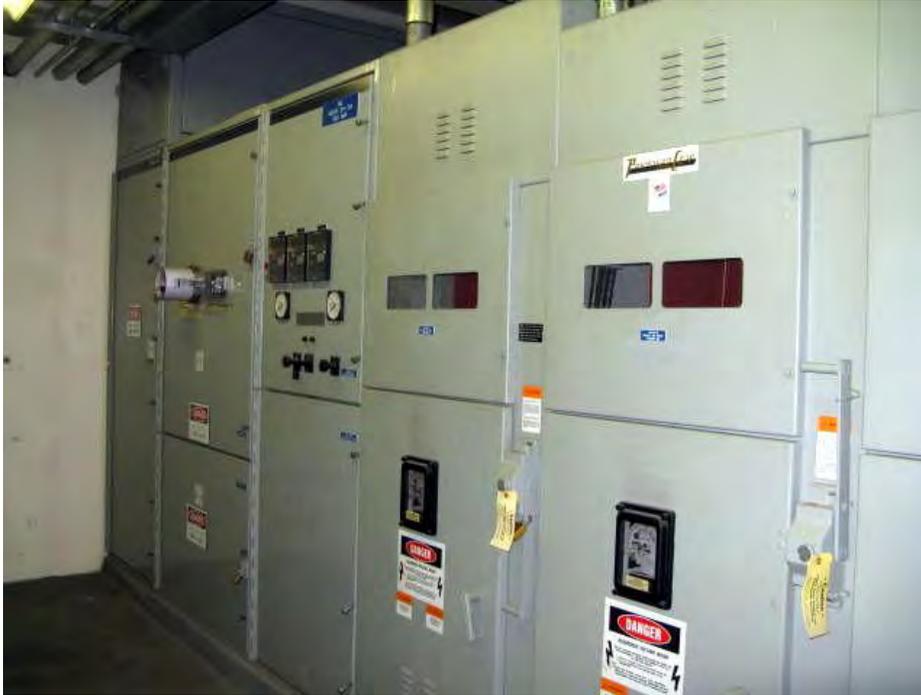
Photograph #104

Tenant natural gas service.

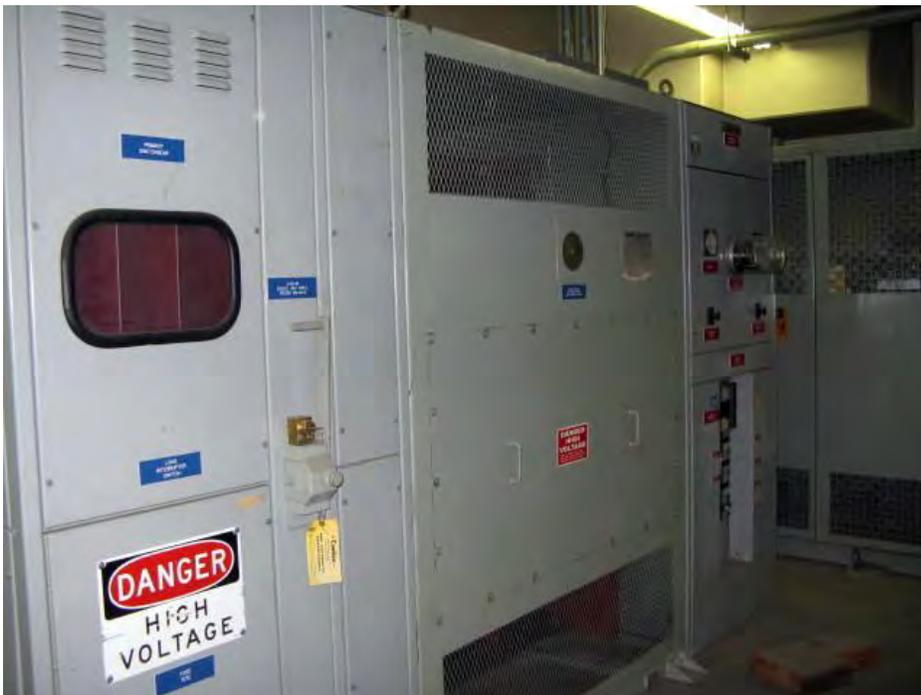
Photograph #105

High voltage electric  
service and  
distribution board.

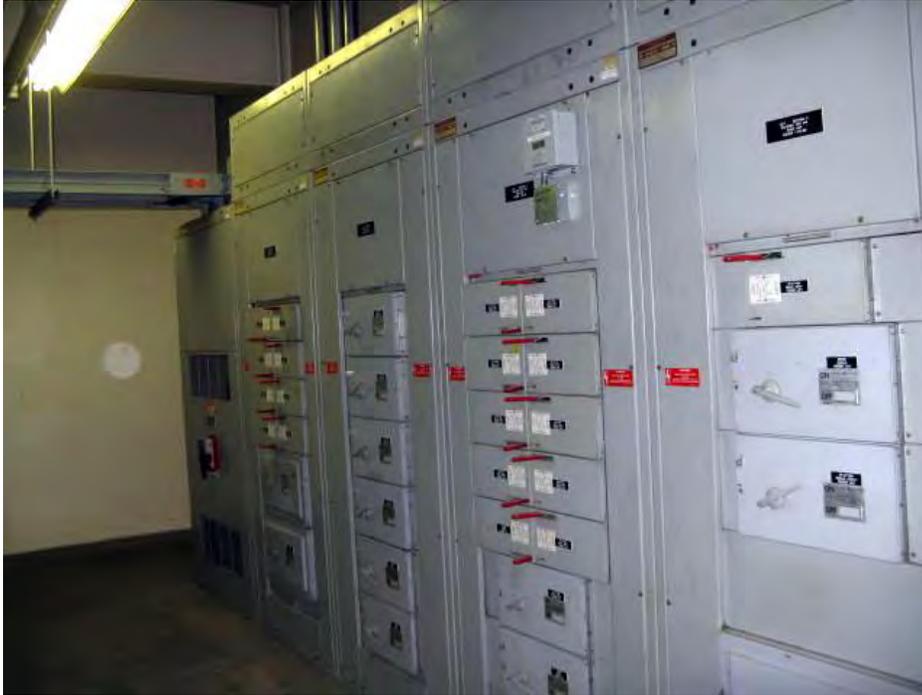
Photograph #106

Unit substation and  
480-volt  
distribution board.

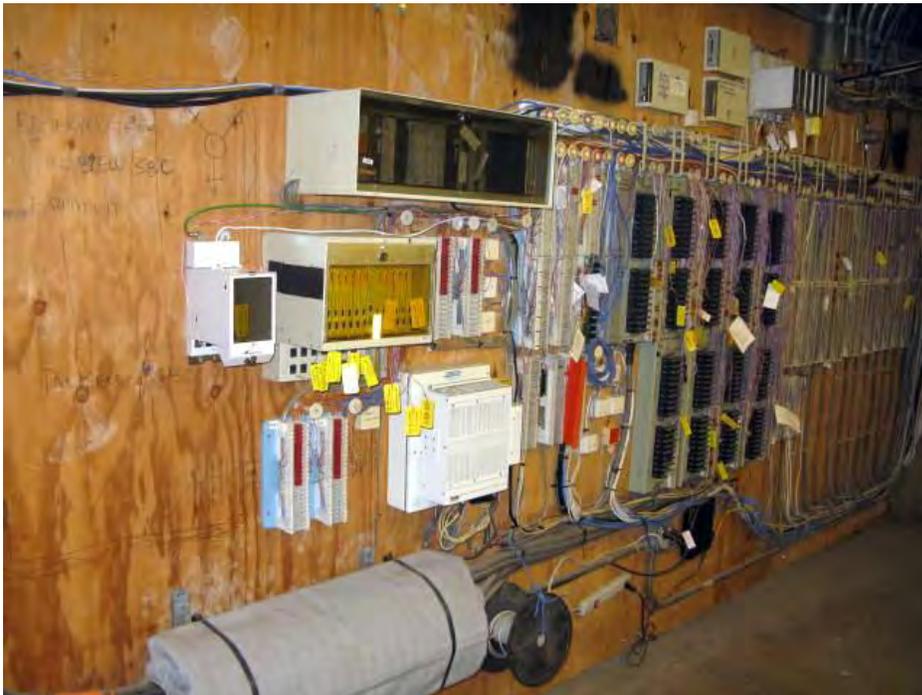
Photograph #107

120 -volt  
distribution board.

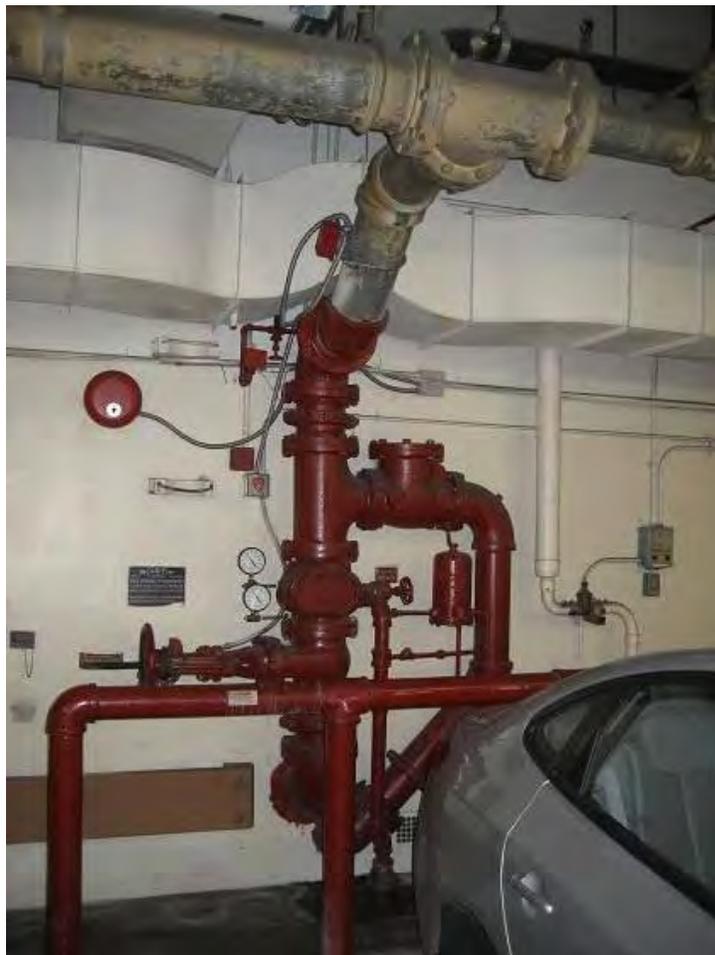
Photograph #110

Sprinkler riser in garage.

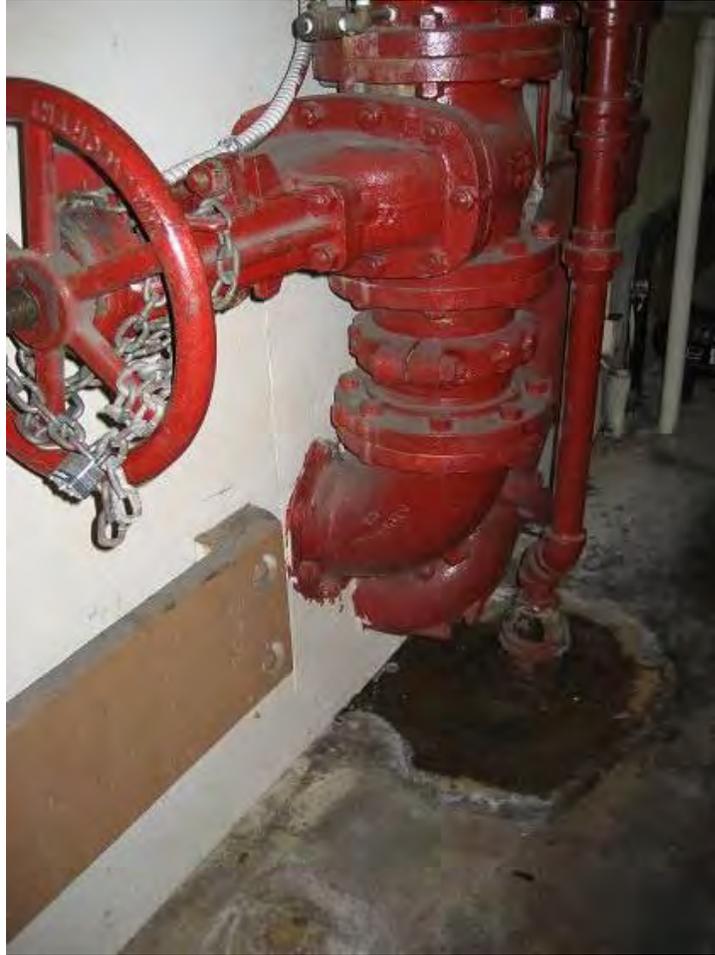
Photograph #111

Sprinkler system  
shut off valve.

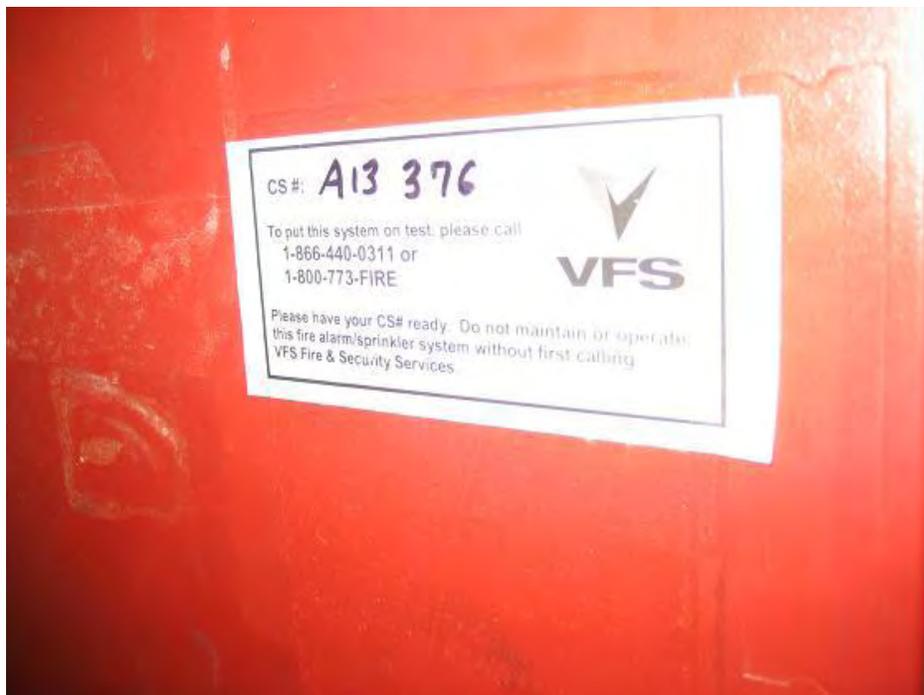
Photograph #112

Fire alarm panel for  
the garage sprinkler  
system.
