## PROPERTY CONDITION ASSESSMENT

# PROJECT SANTA FE LOS ANGELES UNION STATION

800 North Alameda Street  
Los Angeles, California

Draft: November 12, 2010

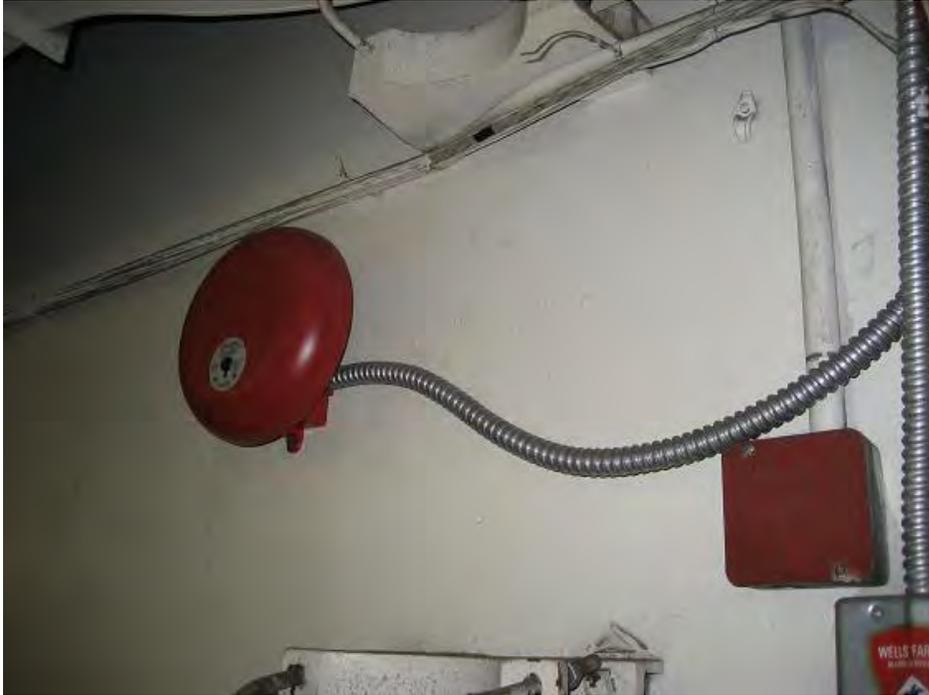
Photograph #113

Sprinkler system  
alarm bell.

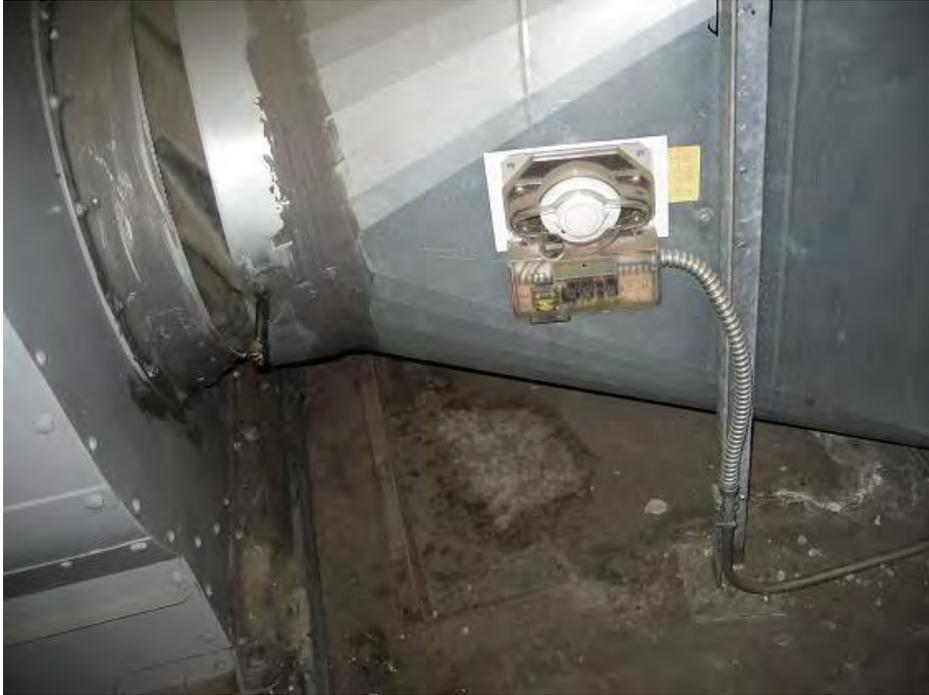
Photograph #115

Typical duct  
detector at AHU.

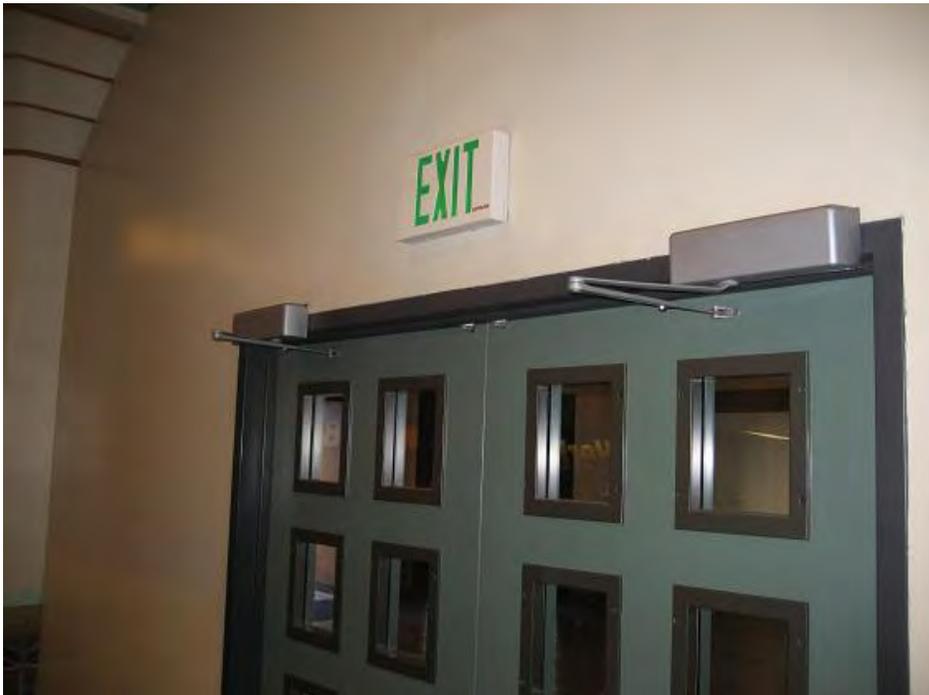
Photograph #116

Typical illuminated  
exit sign at  
concourse.

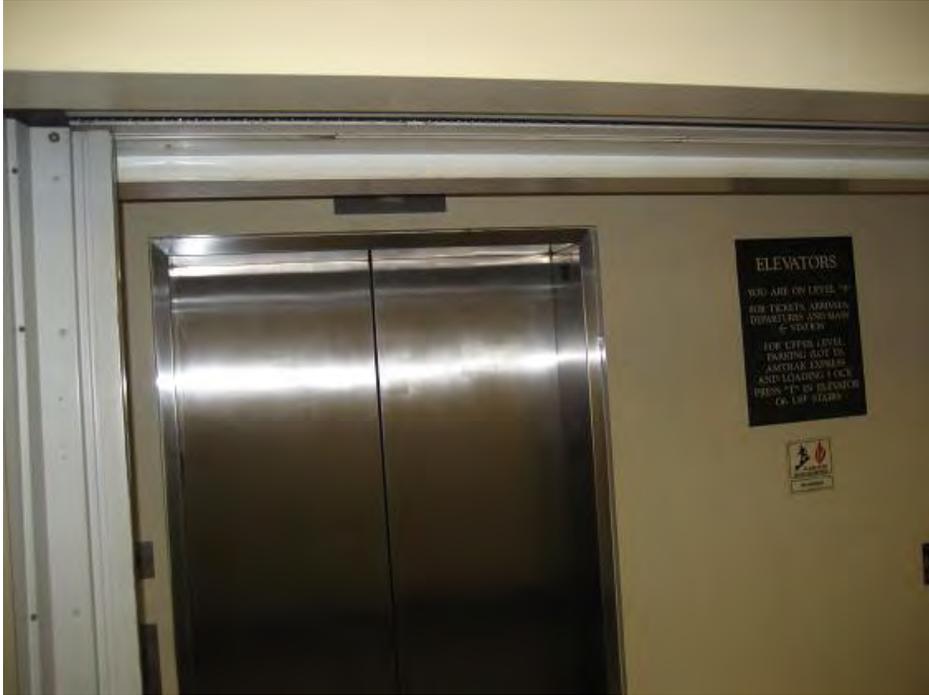
Photograph #117

Won-door at the first floor elevator lobby.

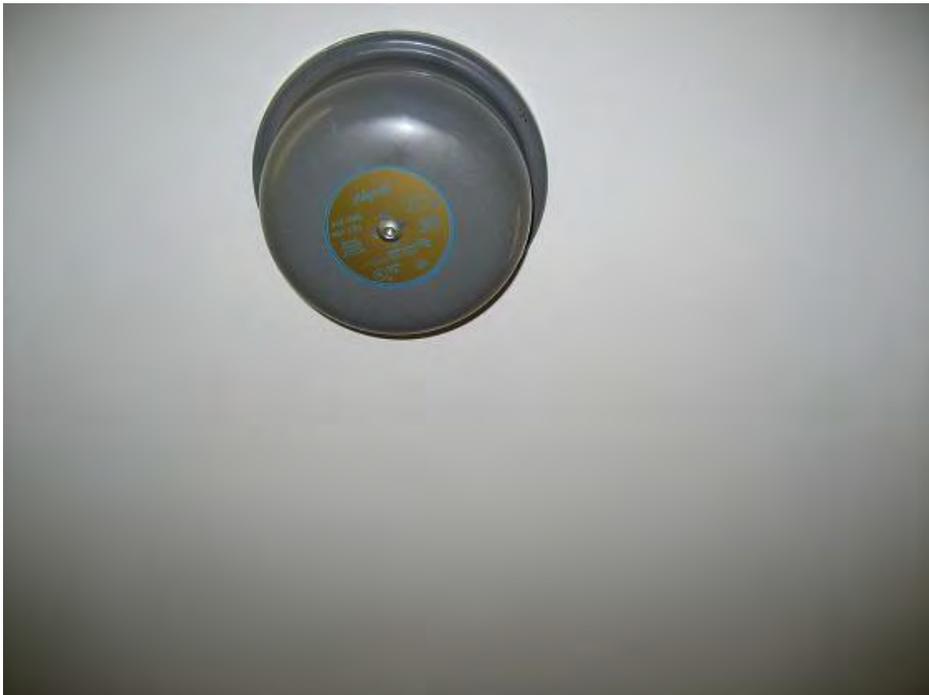
Photograph #118

Typical alarm bell in the Amtrak building.

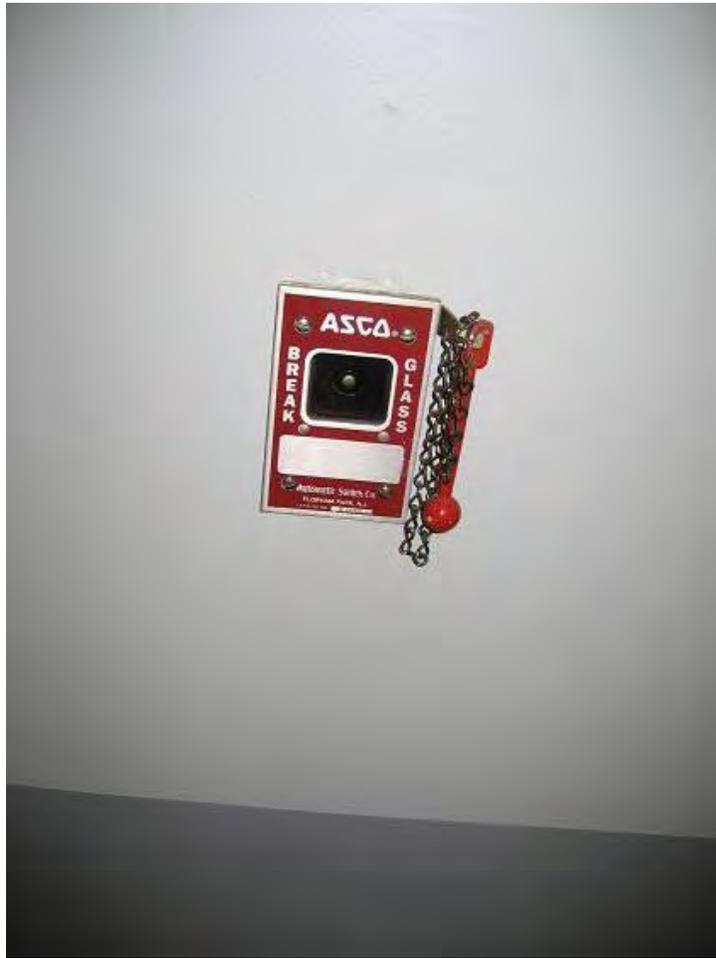
Photograph #119

Pull station in the Amtrak Building.

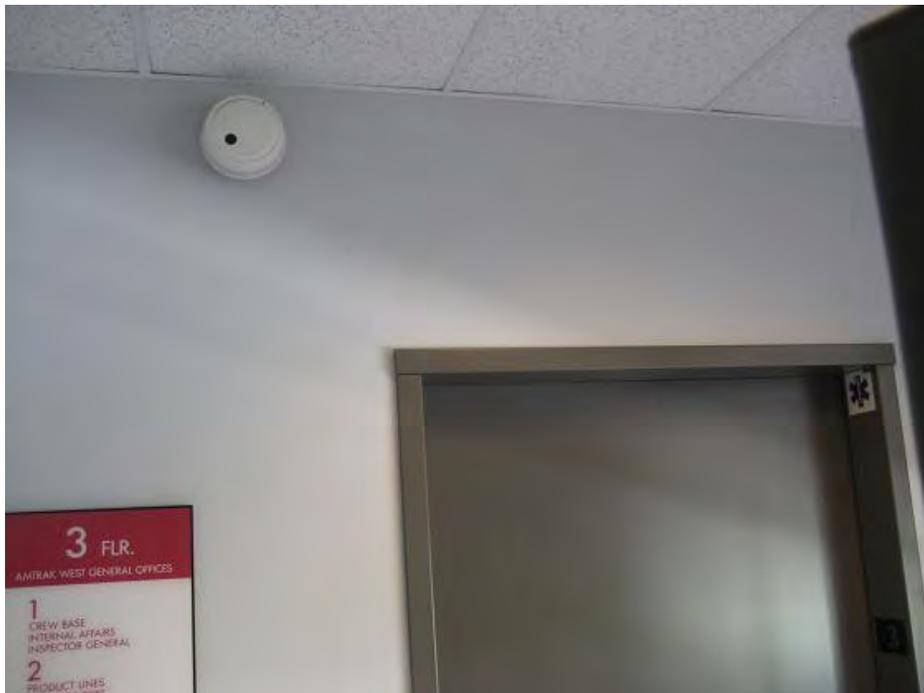
Photograph #120

Typical smoke detector in the Amtrak building.

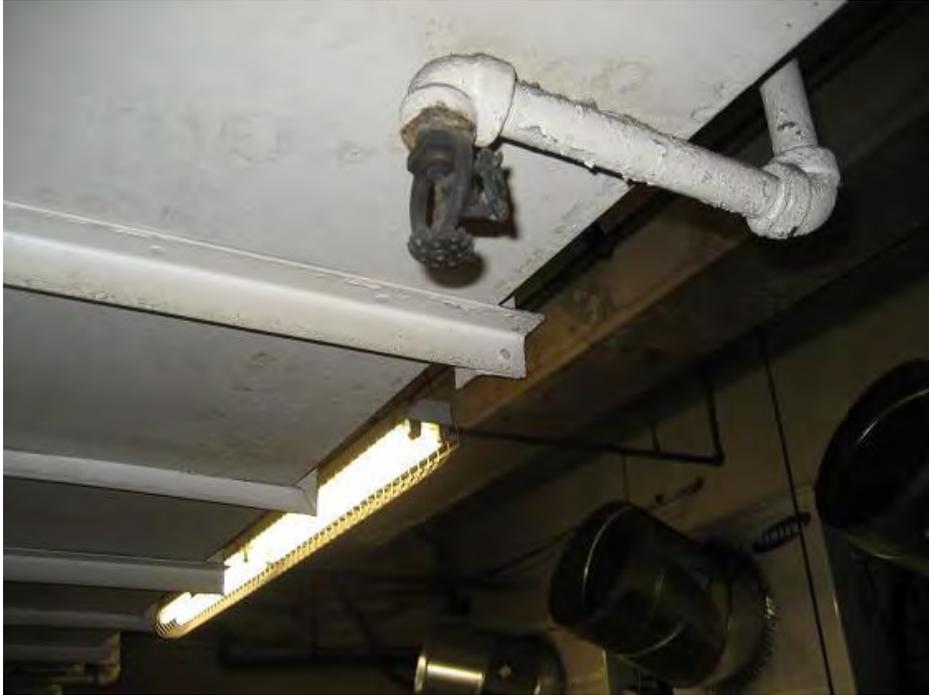
Photograph #121

Sprinkler under the ductwork in the garage.

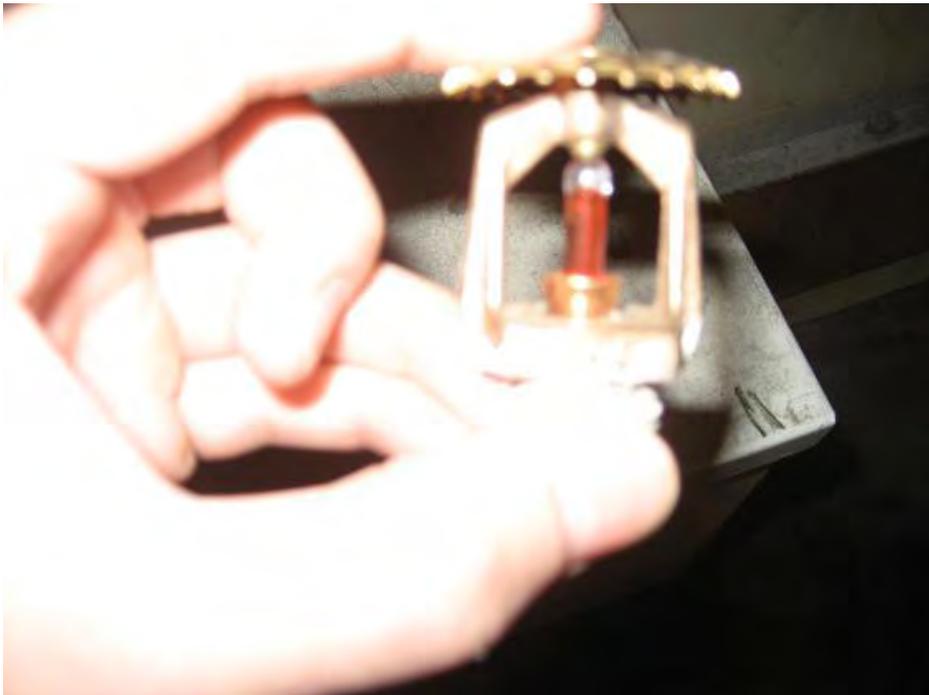
Photograph #122

Replacement sprinklers are provided in the cabinet at the garage.

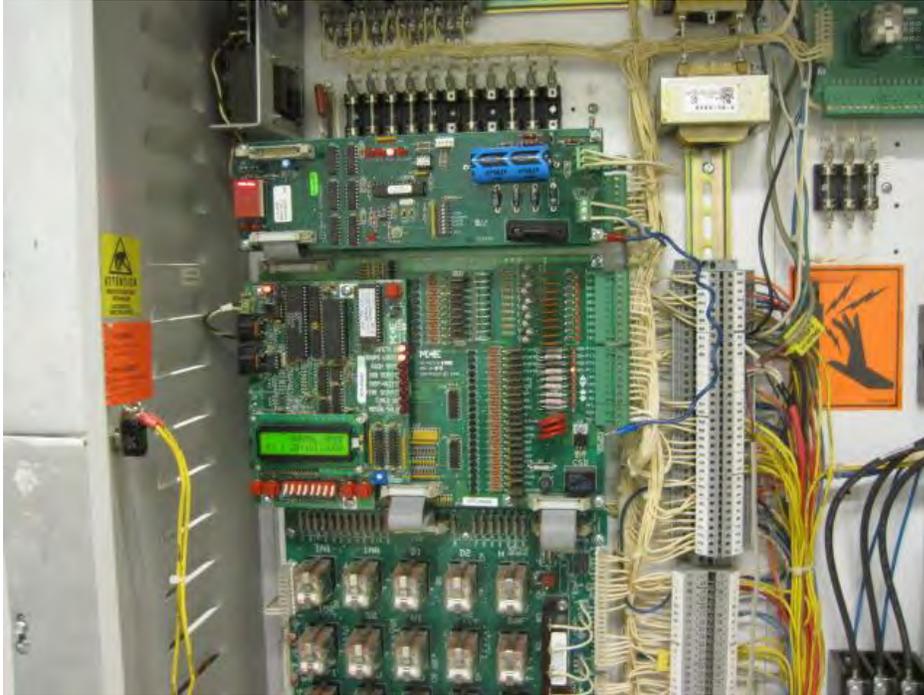
Photograph #123

New MCE  
microprocessor  
controller 2004 at  
Elevator 1 .

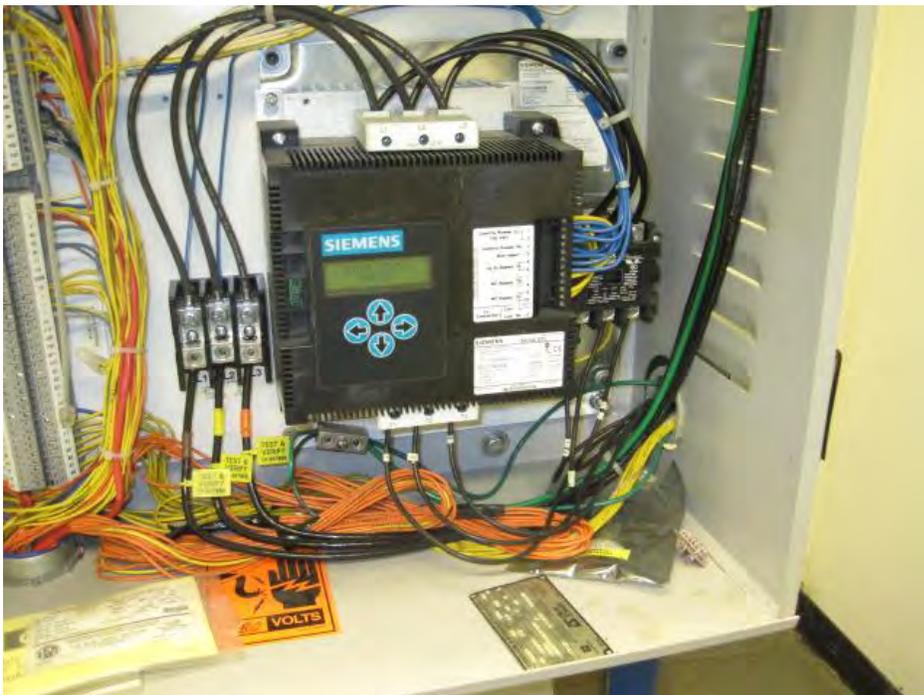
Photograph #124

New solid state  
motor control  
starter 2004 for  
Elevator 1 .

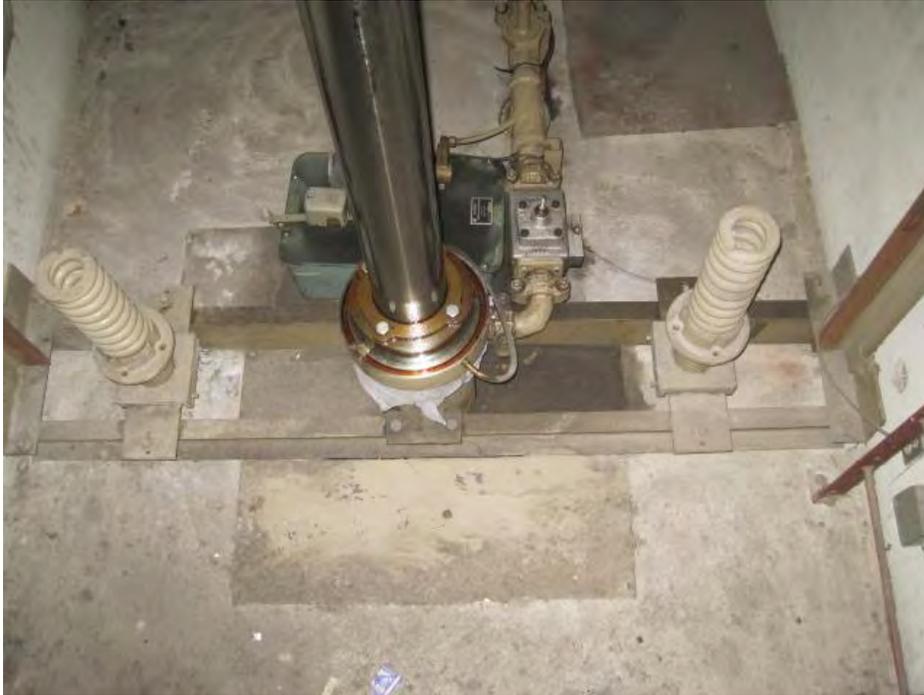
Photograph #125

Hydraulic cylinder with seismic valve at Elevator 1.

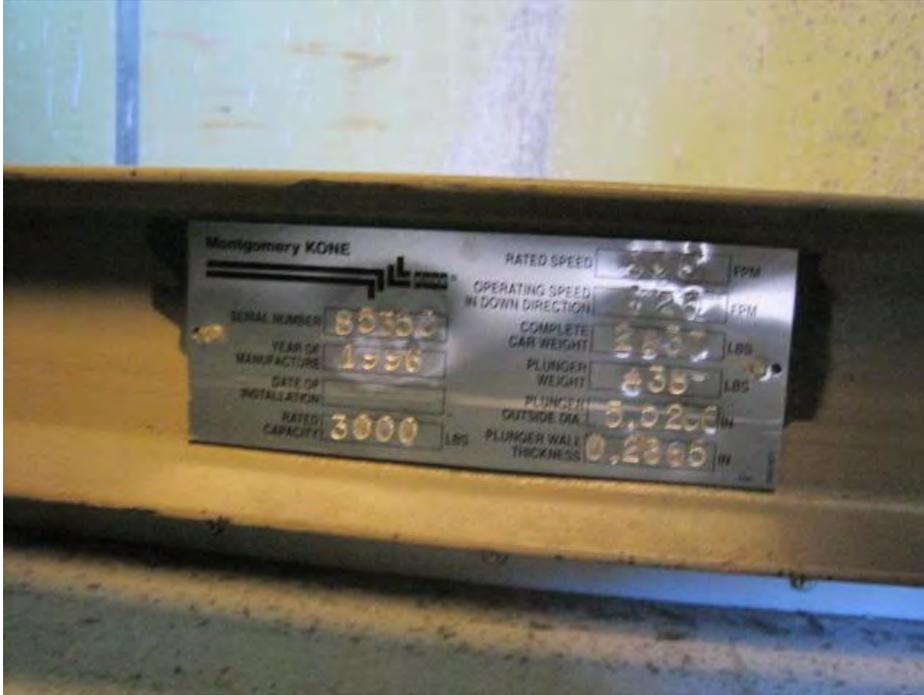
Photograph #127

Manufacturer's data tag at Elevator 1. 1996-3,000 pounds.

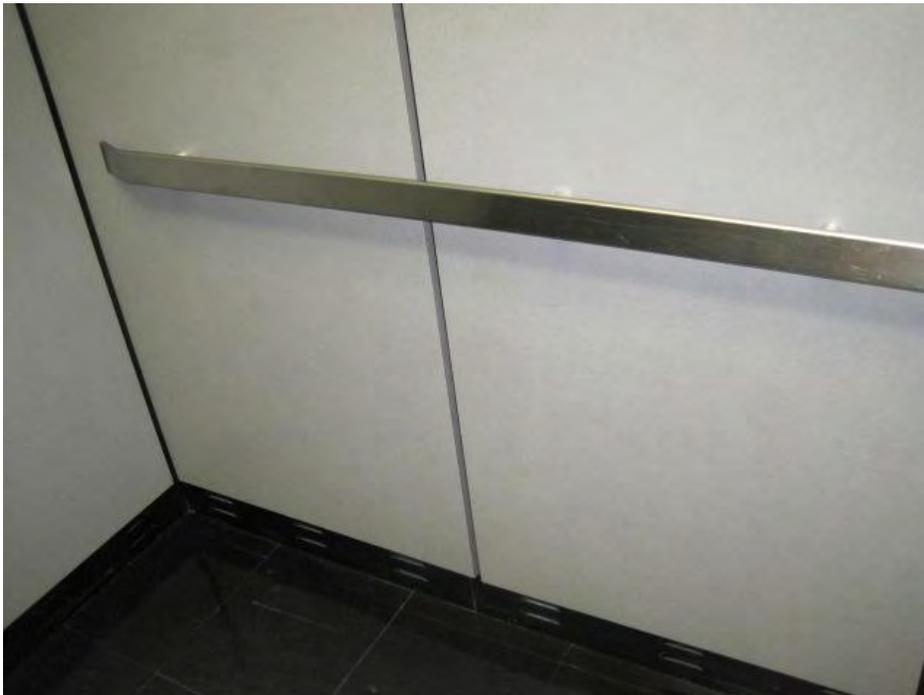
Photograph #128

Non-compliant ADA handrail at Elevator 1.

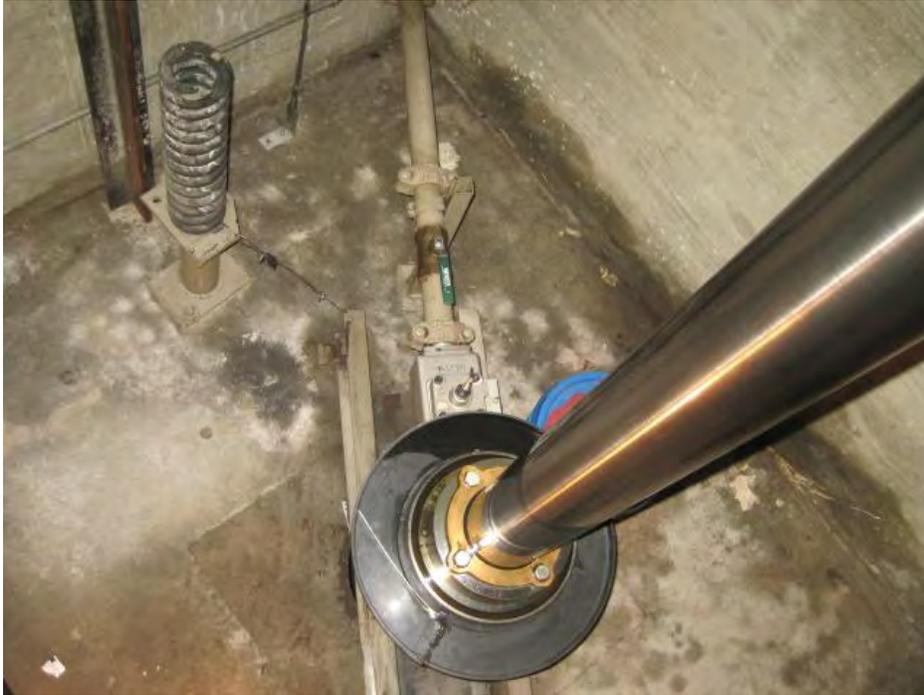
Photograph #131

Hydraulic cylinder and seismic valve at Elevator 2.

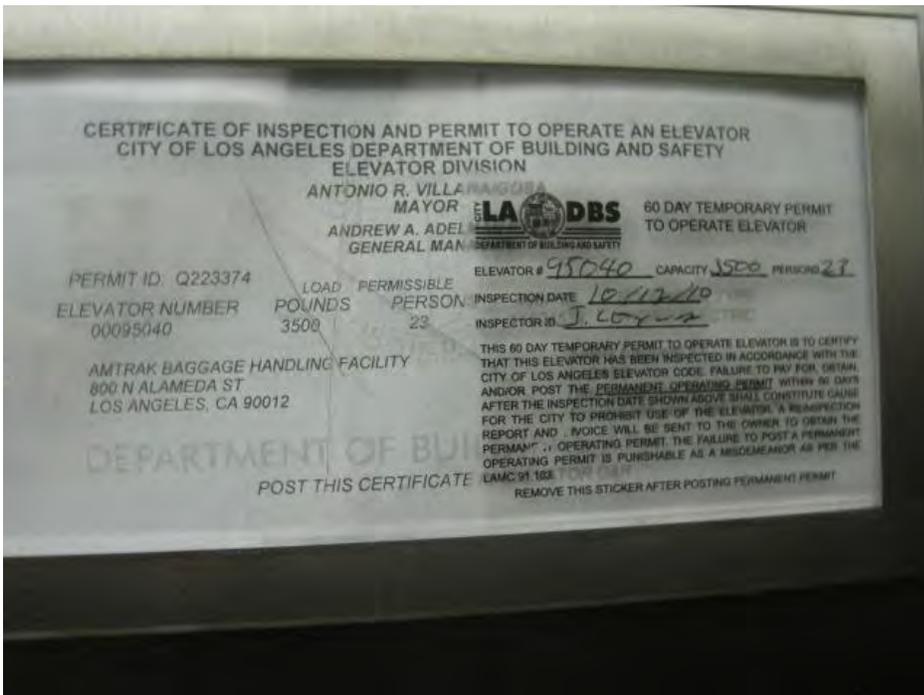
Photograph #132

Incorrect Permit No. 95040 and capacity at Elevator 2. Note that this number should be the same as the tag below. No. 95042 with capacity of 3,000 pounds.

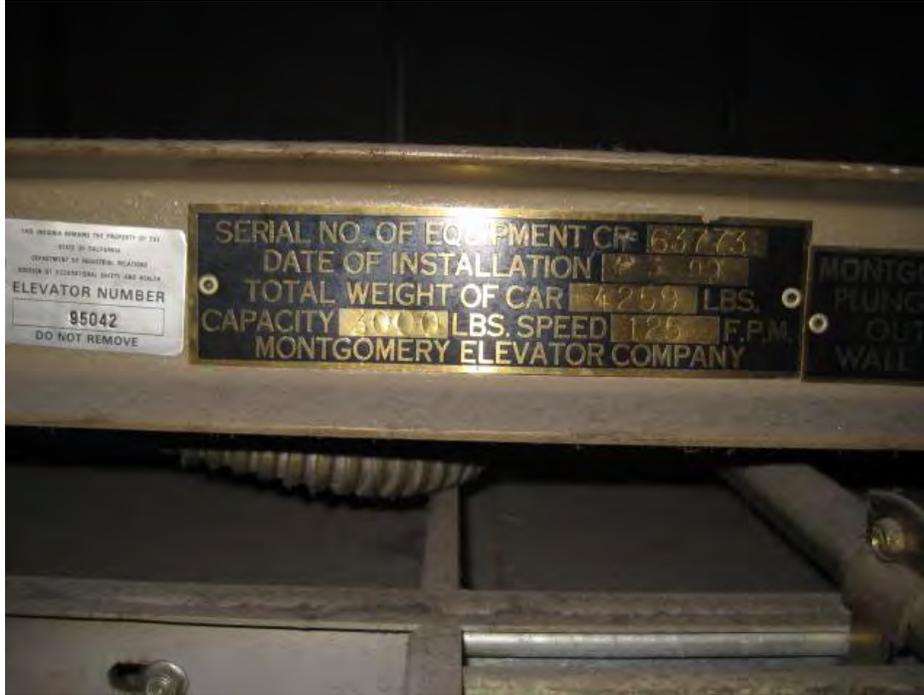
Photograph #133

Manufacturers data tag and California ID tag at Elevator 2.

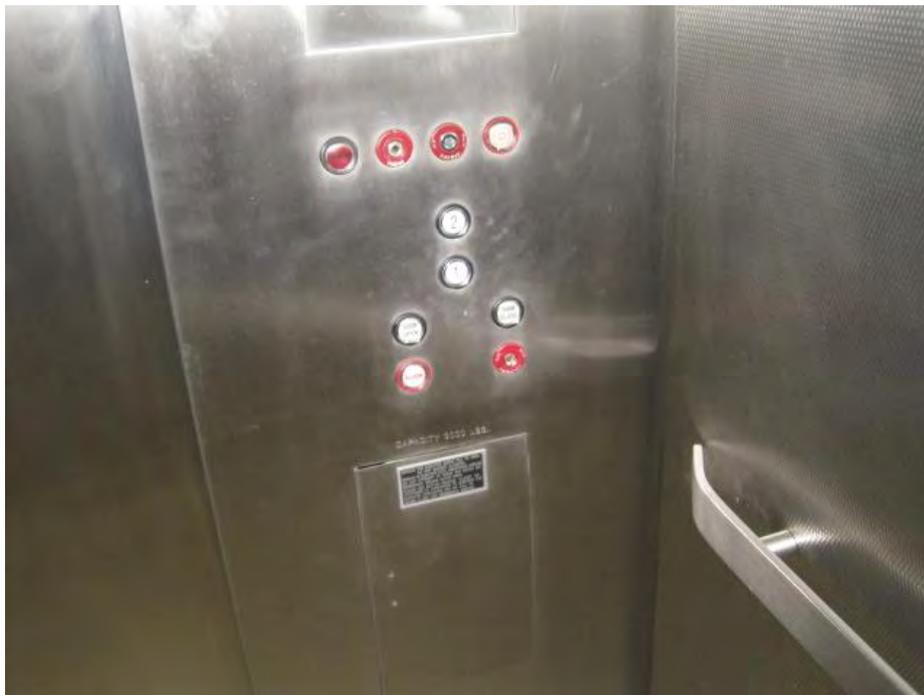
Photograph #134

Non-compliant ADA handrail and buttons.

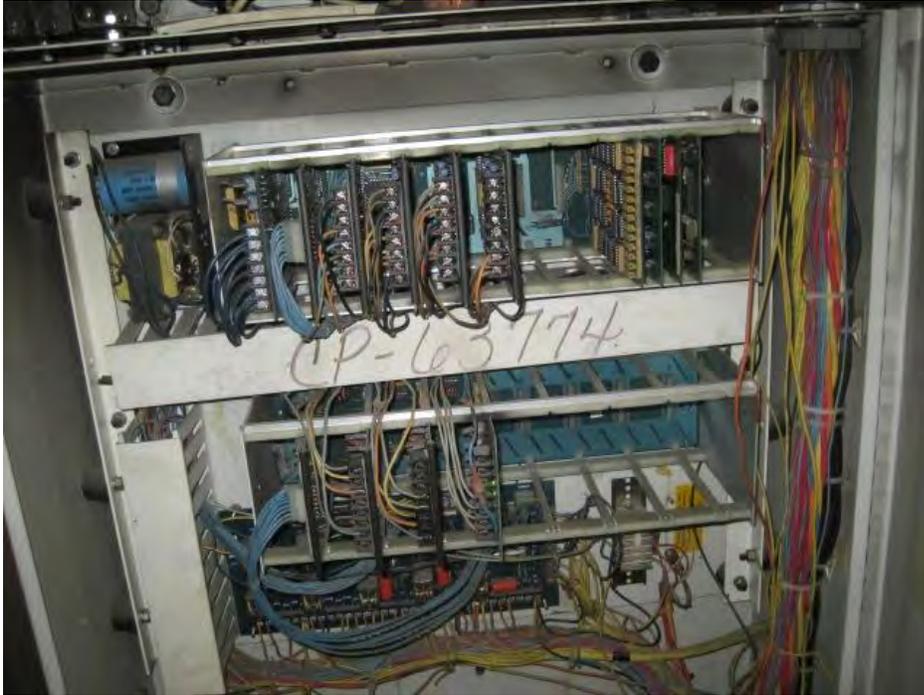
Photograph #135

Miprom half relay controller at Elevator 3, dated 1990.

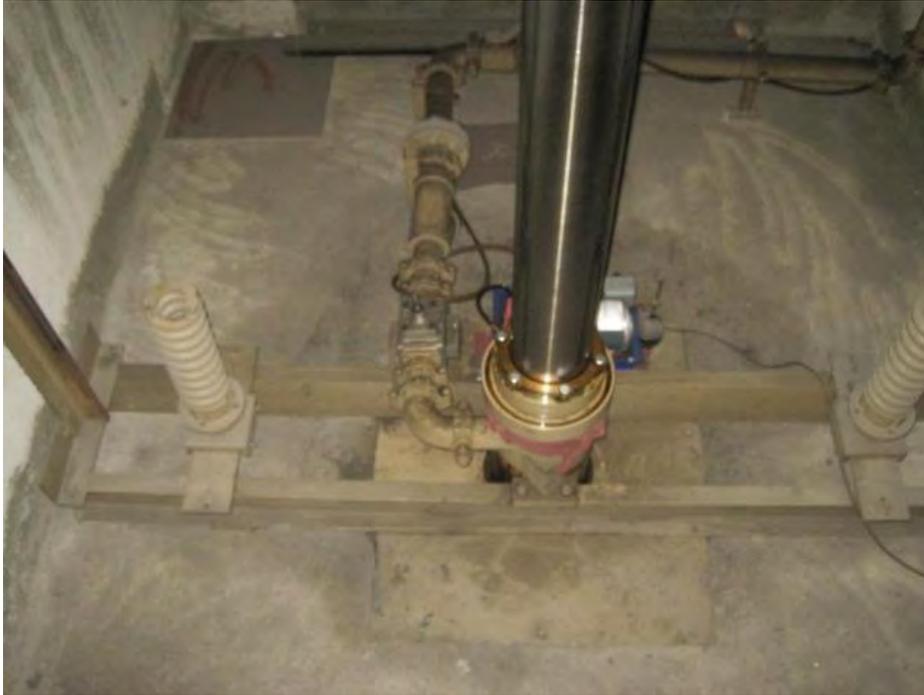
Photograph #137

Hydraulic cylinder  
and seismic valve at  
Elevator 3.

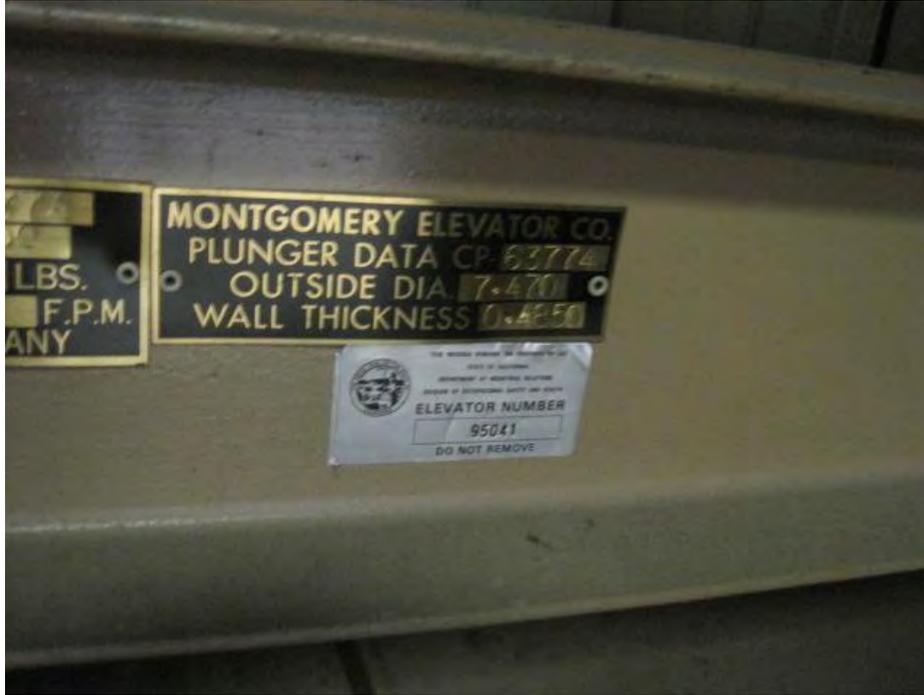
Photograph #139

Manufacturer's data tag and California ID for Elevator 3.

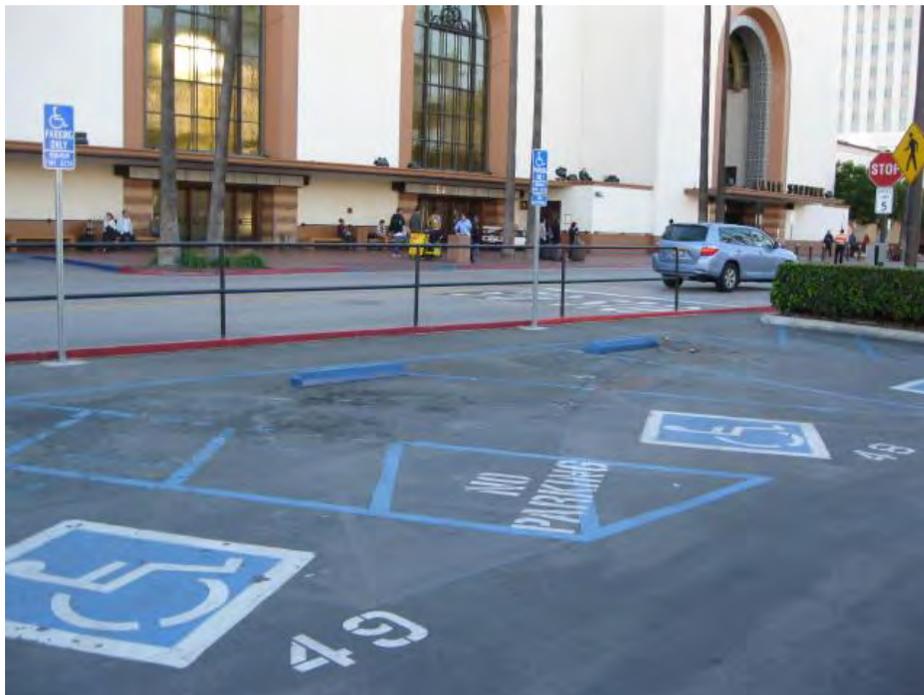
Photograph #140

Typical view of accessible parking.

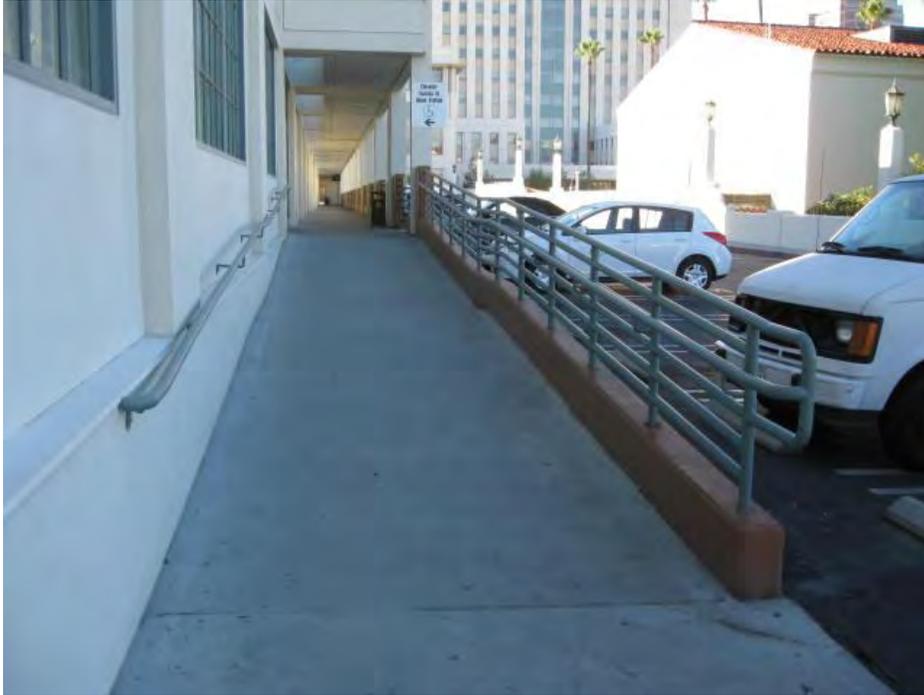
Photograph #141

Accessible ramp provided at the Amtrak building.

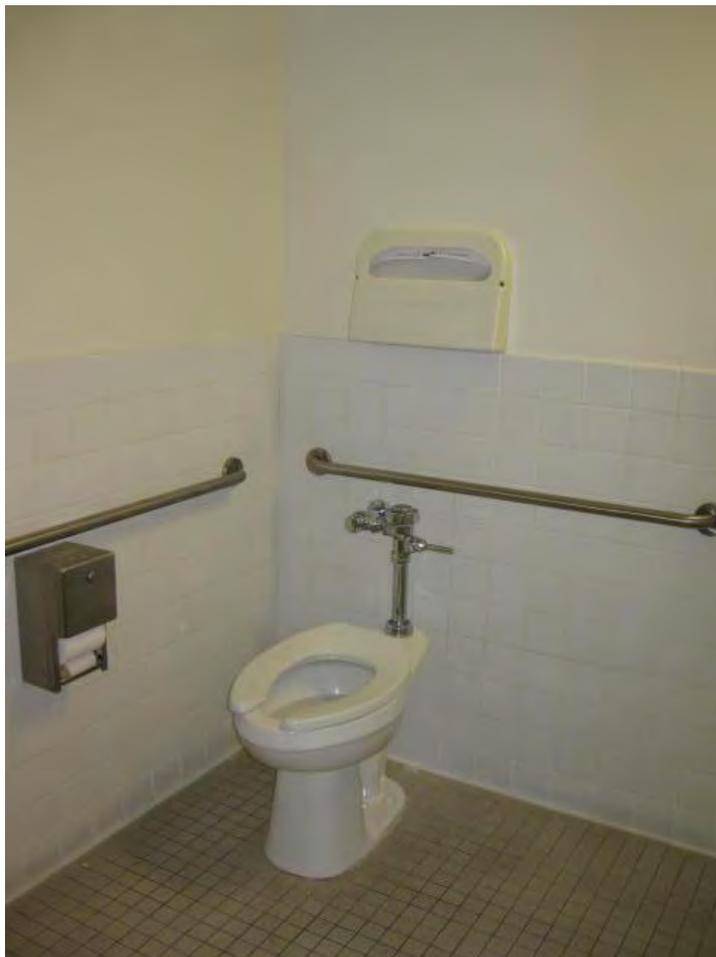
Photograph #142

Typical accessible toilet stall at the Amtrak building.

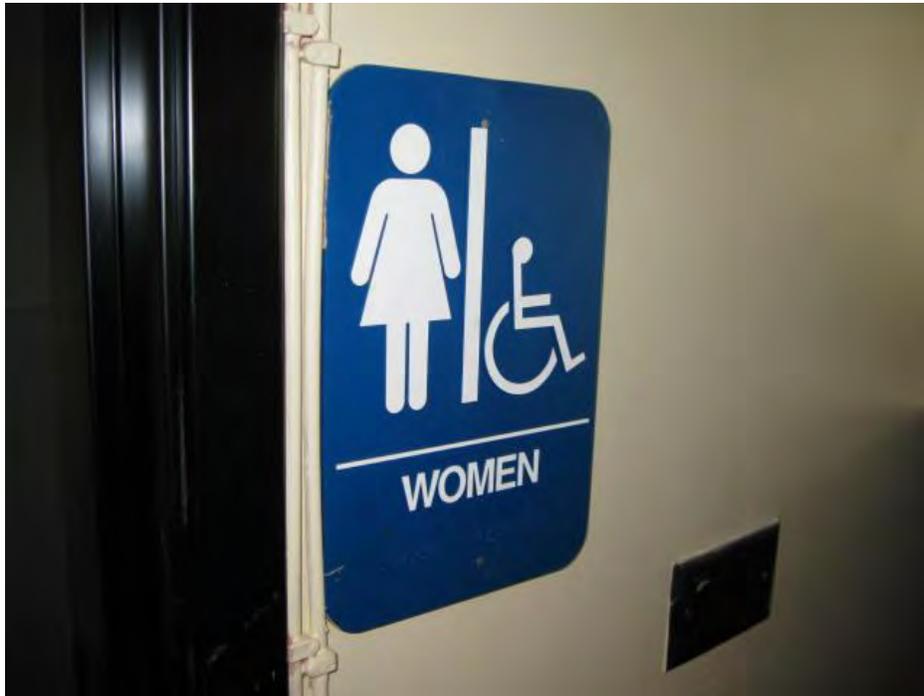
Photograph #143

Typical wall-mounted ADA signage.

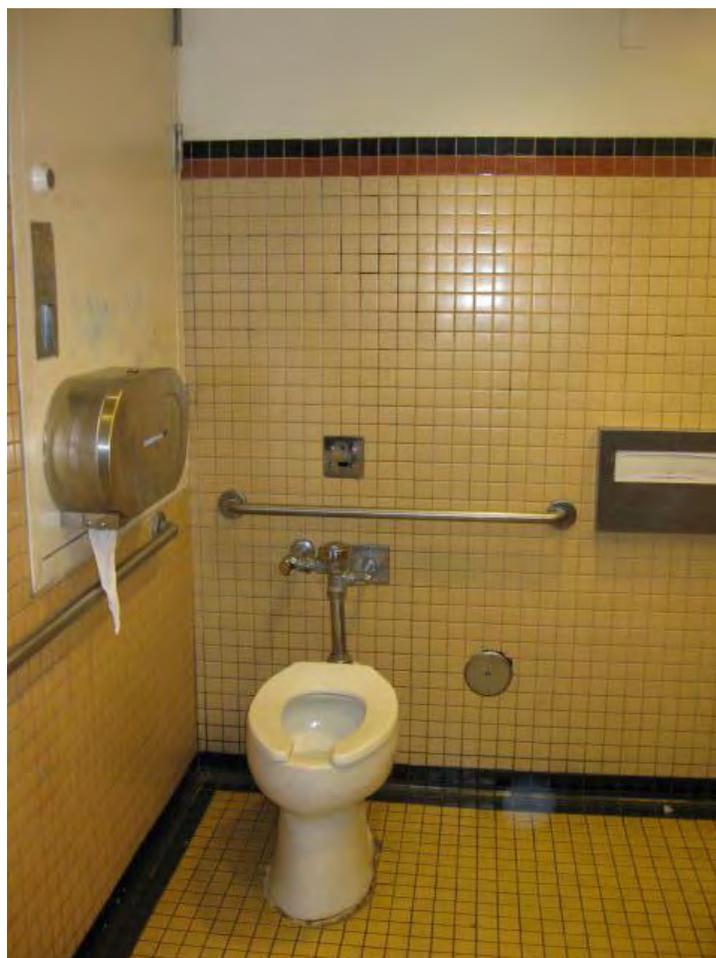
Photograph #144

Typical accessible toilet stall provided at the union station.

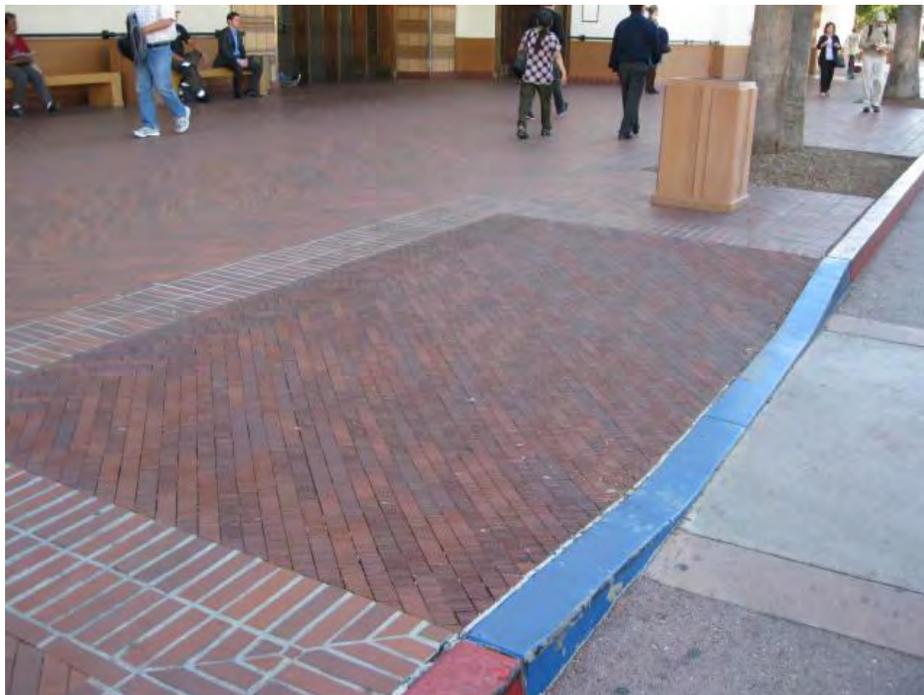
Photograph #146

Typical accessible ramps provided at Union Station.

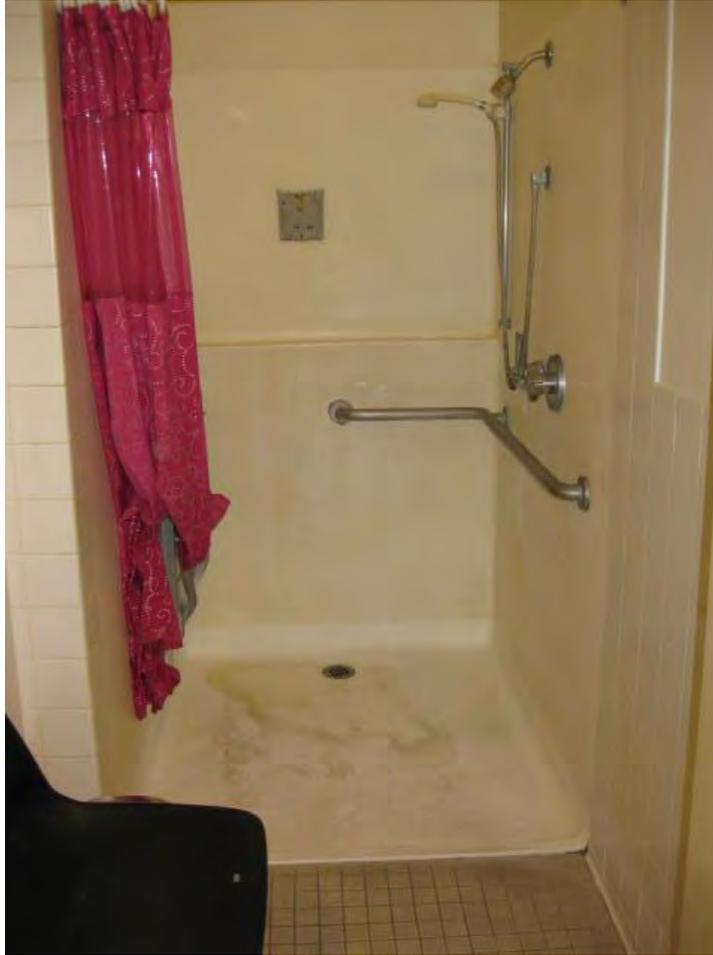
Photograph #147

Accessible shower stall provided at the Amtrak building for employees.
