CRENSHAW/LAX PHOTOGRAPHIC UPDATE

October 30, 2020

Crenshaw/LAX Transit Project

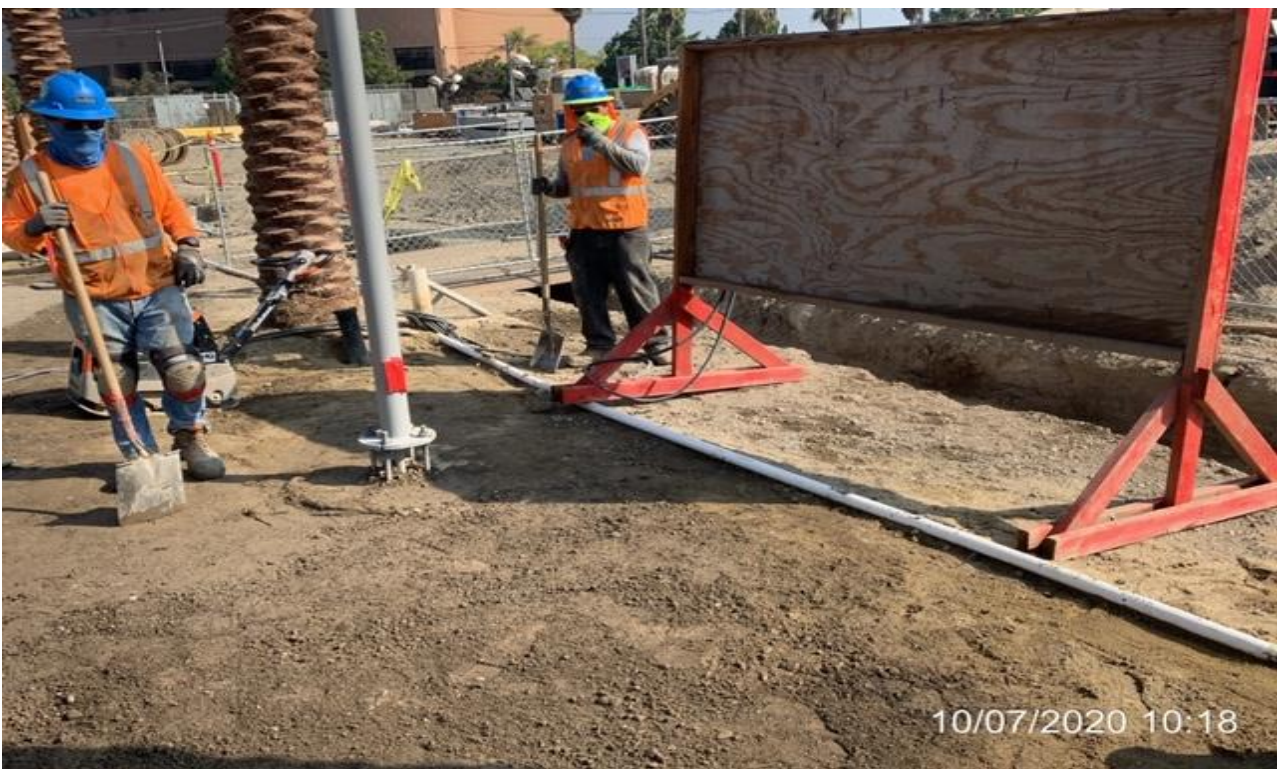
EXPO STATION – Continue rough grading/compacting throughout the plaza.
