# CRENSHAW/LAX PHOTOGRAPHIC UPDATE

Dec 30, 2020

## Crenshaw/LAX Transit Project

Overview of trackwork progress issues for 11/30/2020 – 12/15/2020  
(Please note the attached Trackwork Progress Tracking Report)

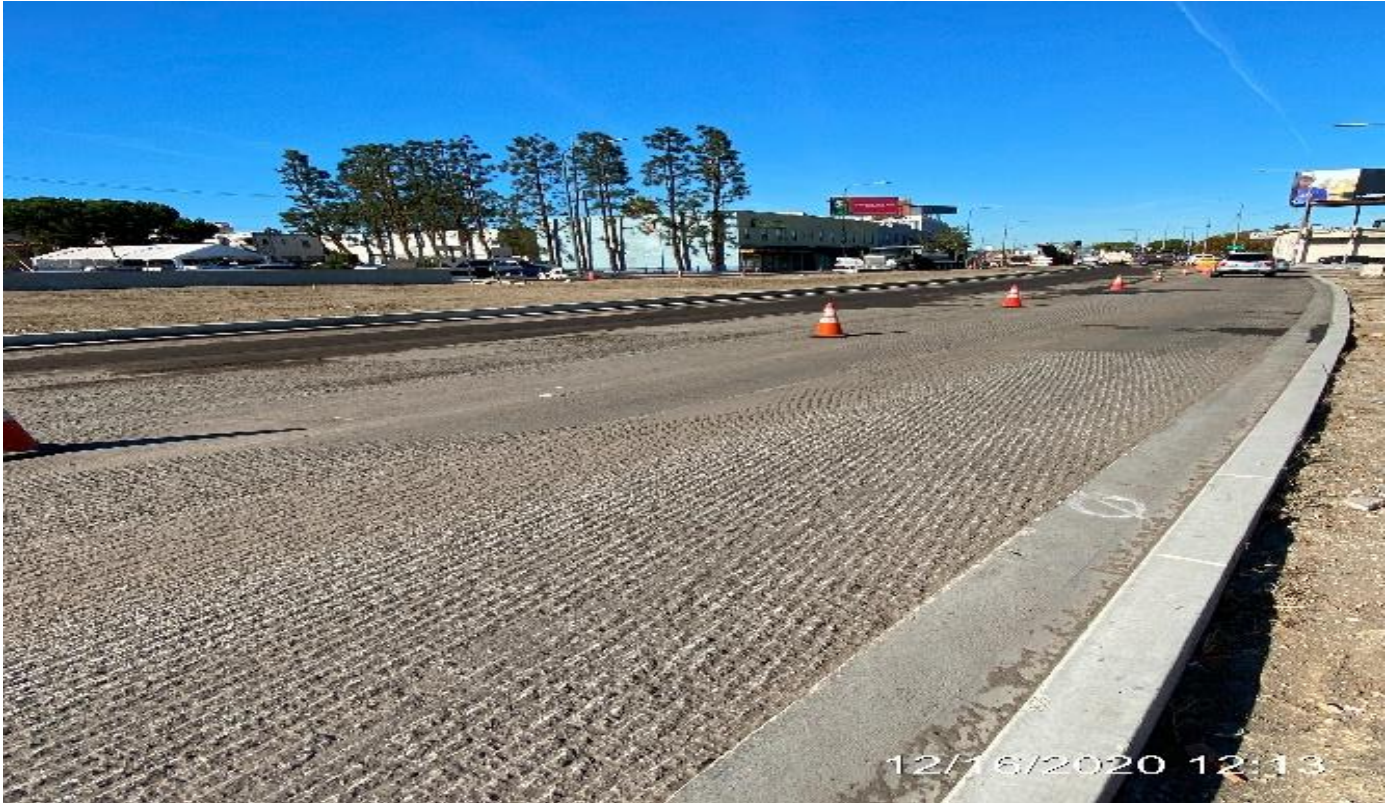
PARK MESA – Grinding in preparation for placement of asphalt concrete along northbound Crenshaw Blvd starting from 48th St and moving toward Homeland Dr.

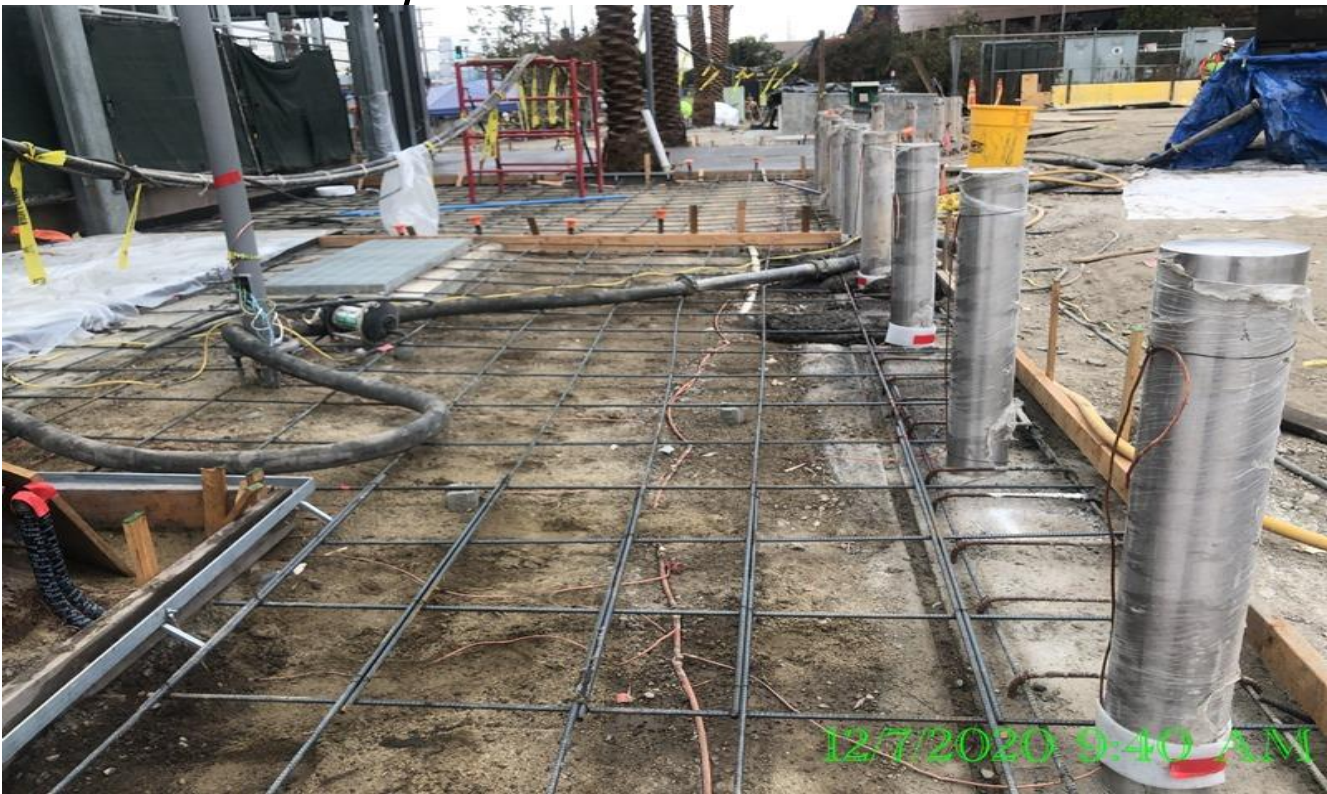
EXPO STATION – Continue ground grid system installation at the plaza.

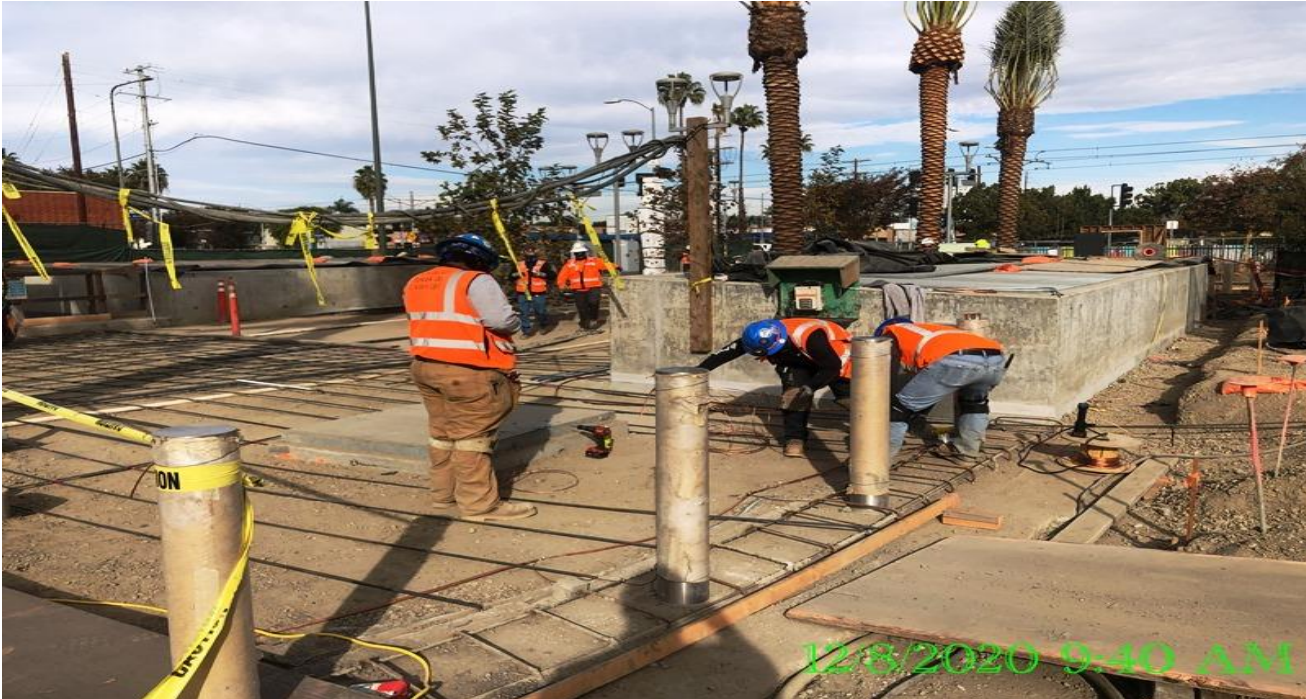
EXPO STATION – Continue ground grid system installation at the plaza.

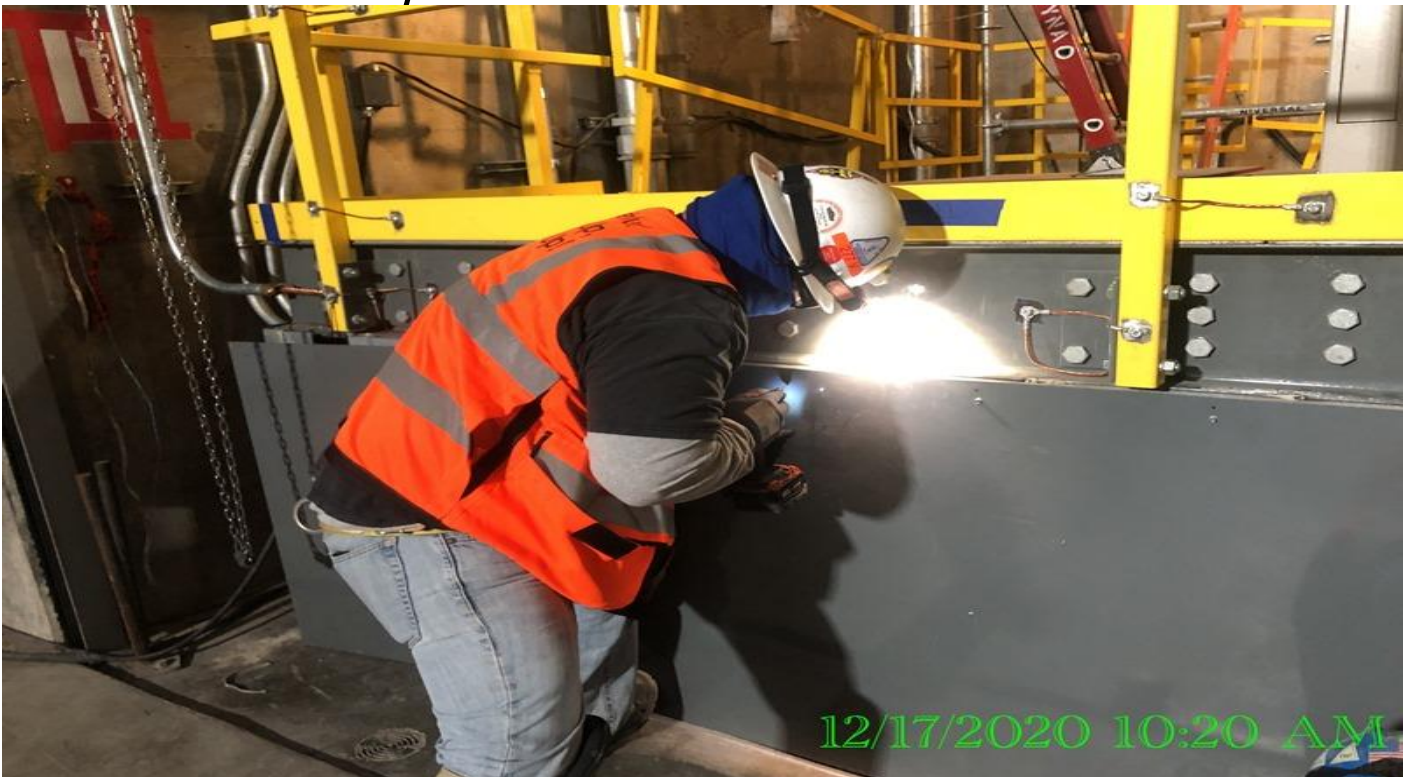
EXPO STATION – Continue welding steel support and installing skirt plates to the edge of the switchgear platform inside the TPSS #10 at invert.
