CRENSHAW/LAX PHOTOGRAPHIC UPDATE

March 17, 2020

Crenshaw/LAX Transit Project

- 8.5 miles Light Rail
- 8 Stations
- \$2,058.0 Million
(Board approved revised LOP)

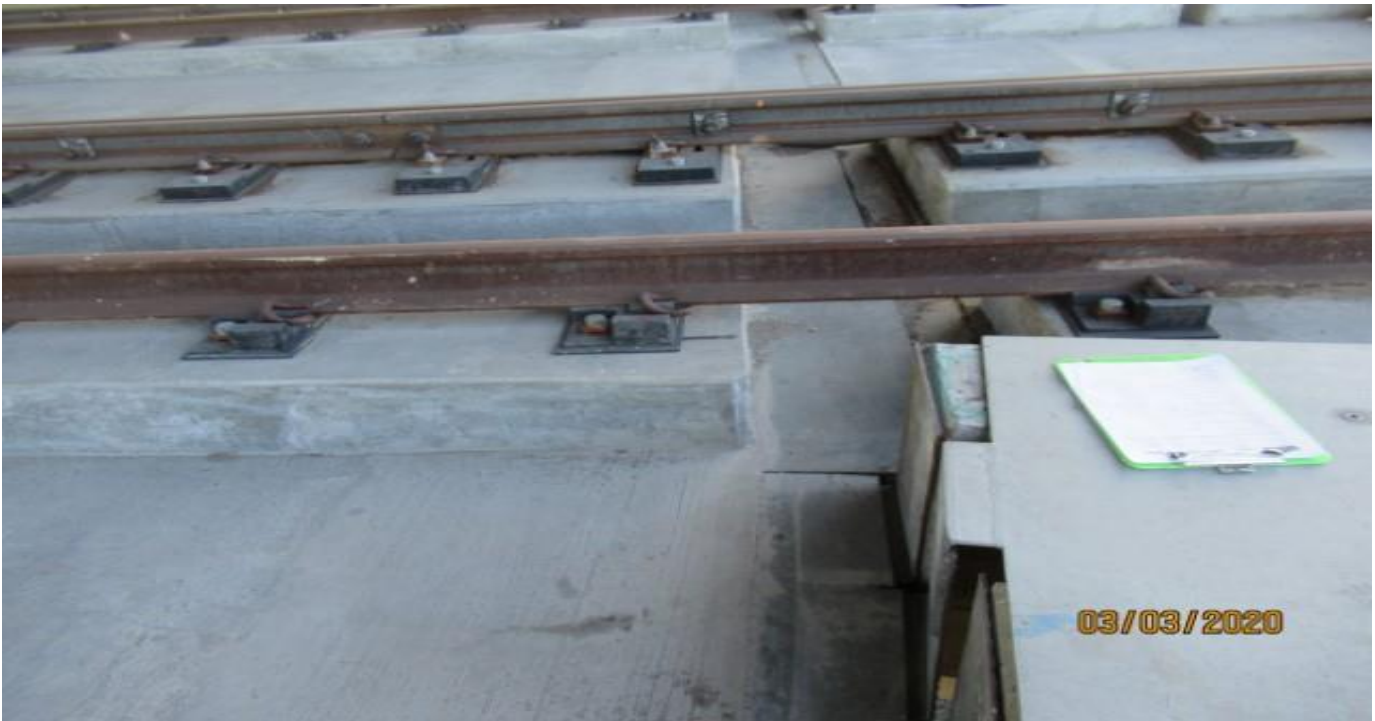
GUIDEWAY - Taper gauge under fastener plate east leg of wye.

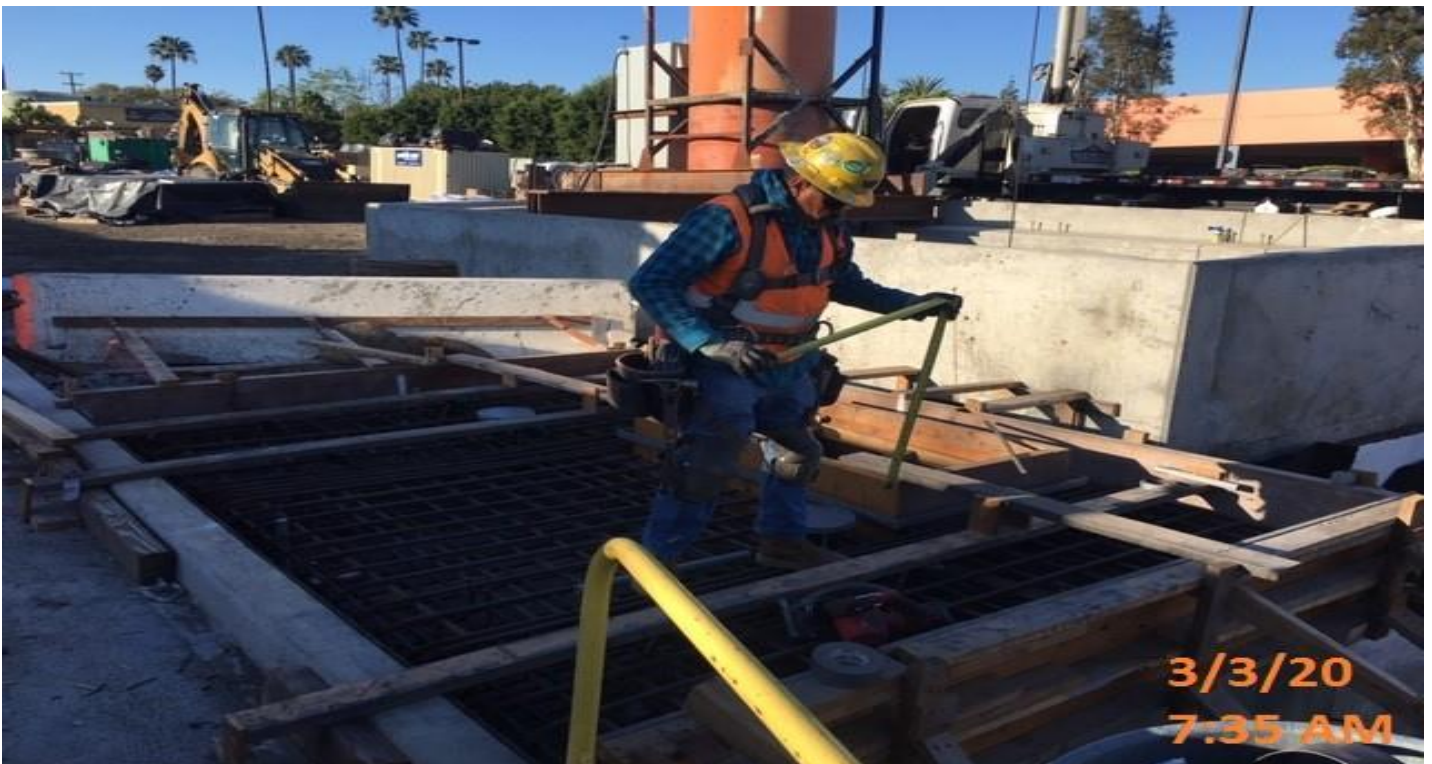
MLK STATION – WSCC crew setting rod embeds for concrete slab.

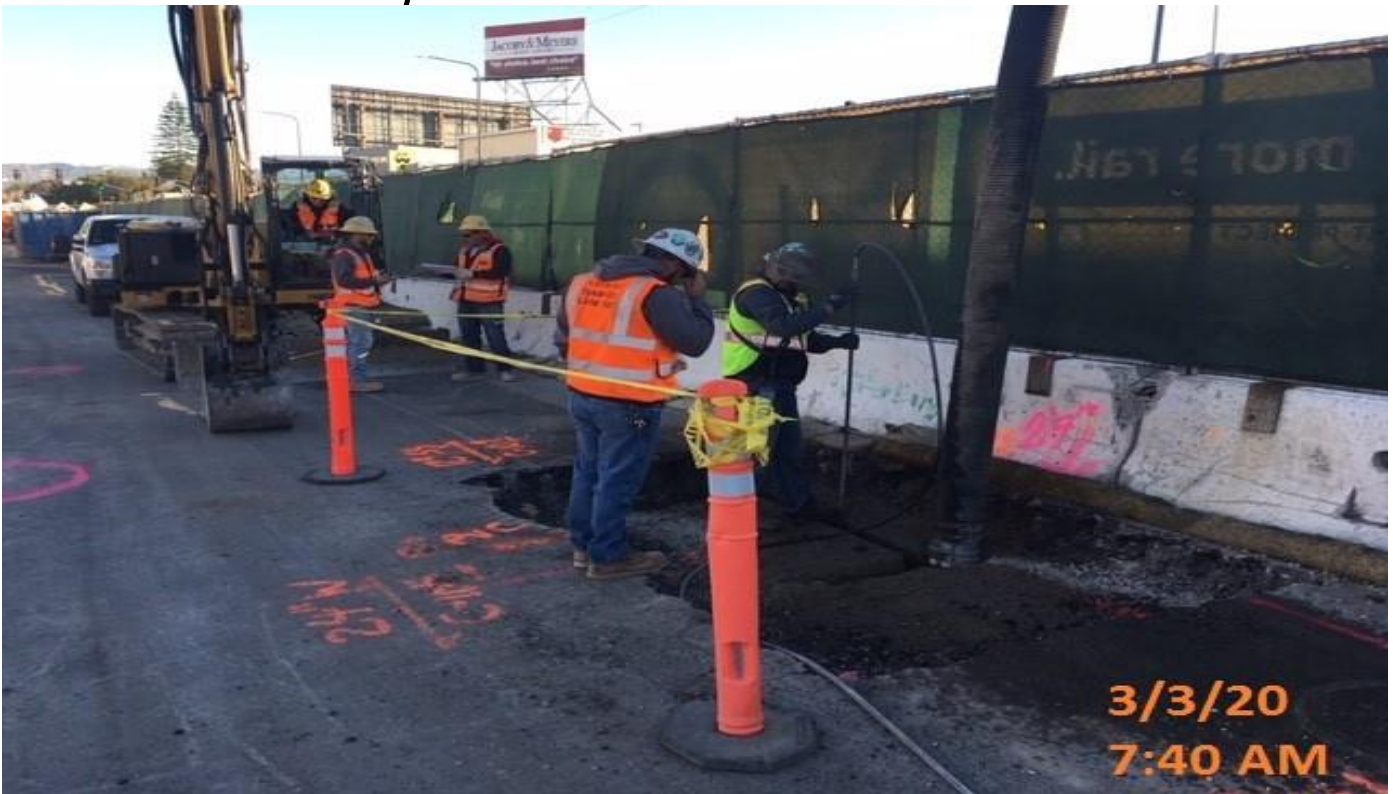
MLK STATION – WSCC crew and Norcal potholing in new area.
