#### CRENSHAW/LAX PHOTOGRAPHIC UPDATE April 15, 2020

#### Crenshaw/LAX Transit Project

Overview of trackwork progress issues for 4/15 - 4/30(Please note the attached Trackwork Progress Tracking Report)

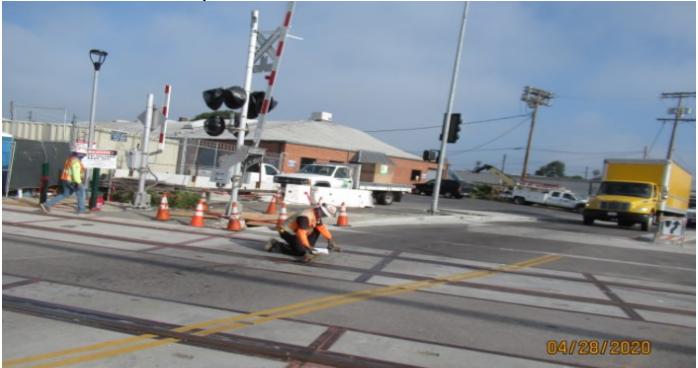
**Florence/Hindry** – WSCC QC track inspector verifying cross level on #3 NB track at Hindry grade crossing for BIM360 inturnal punch list updates (looking southeast)

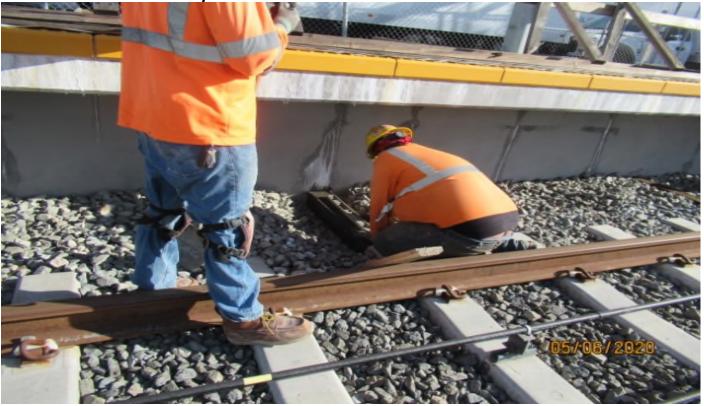
**HINDRY STATION-** WSCC leveling treaded timbers on SB #3 track, at Hindry station platform rework.

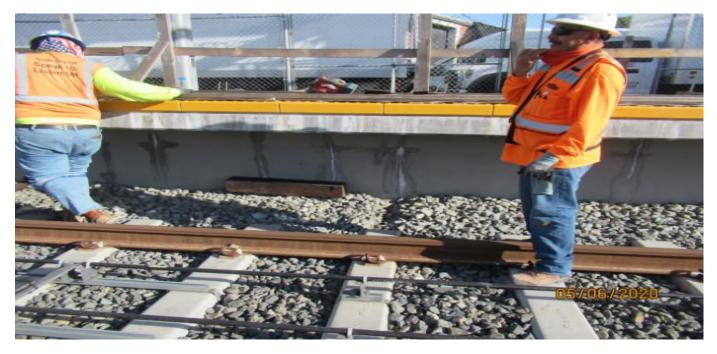
**HINDRY STATION-** WSCC removed ballast around treaded timber ties to level them equaling to Comon ties at Hindry station platform SB #3 track rework

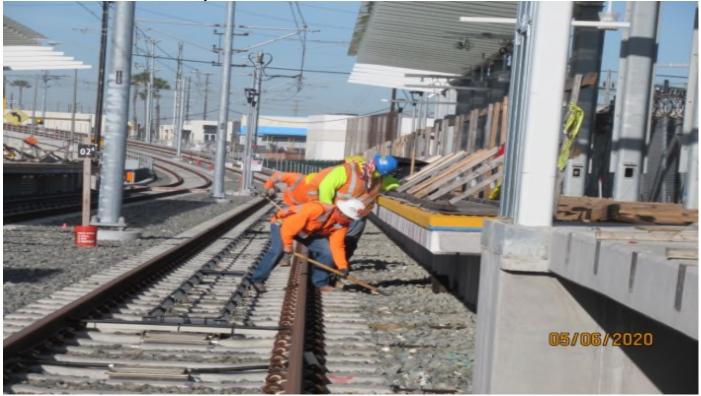
HINDRY STATION- WSCC hand dressing shoulder ballast & leveling treaded timbers on #3SB track throughout Hindry station platform (looking south) rework

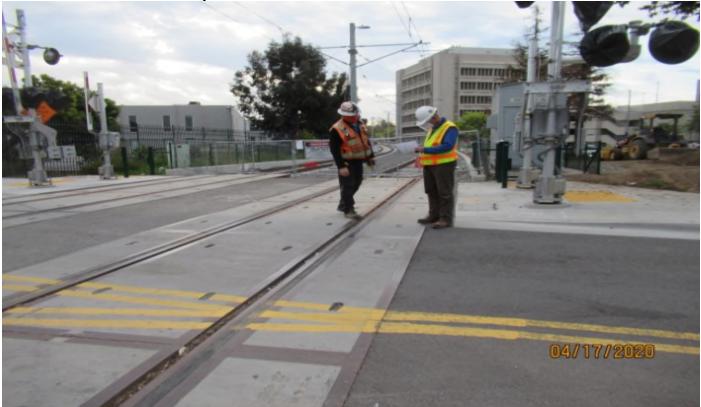
**Florence/Ivy** – WSCC & Metro inspector's gathering data for rail gouges at Ivy Ave grade crossing STA 189+00 (looking north)

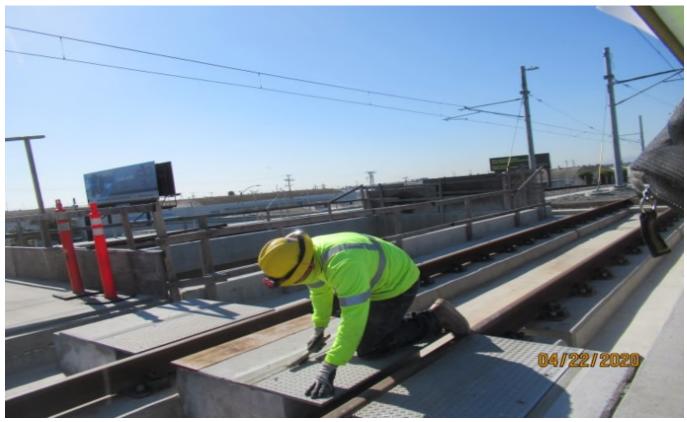
**Aviation/Century –** WSCC finalizing elevations on grout for emergency walkway crossing on SB #3 track STA 66+16 (looking southeast) Rework

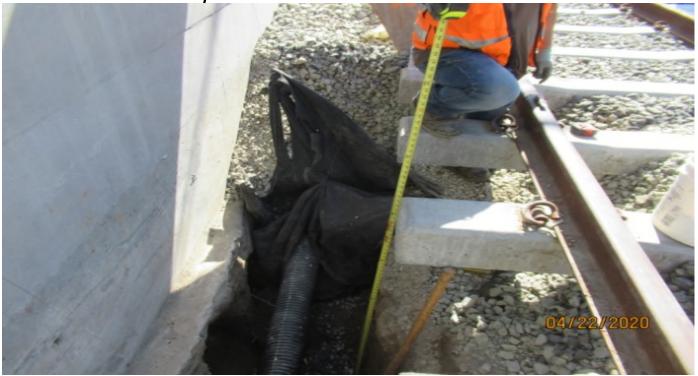
**Aviation/Century** – Measurement of 66+inches from bottom of excavation hole to top of tie on SB #3 track STA 178+00 Segment B1 (looking north) Rework, This will need to be retamped – century

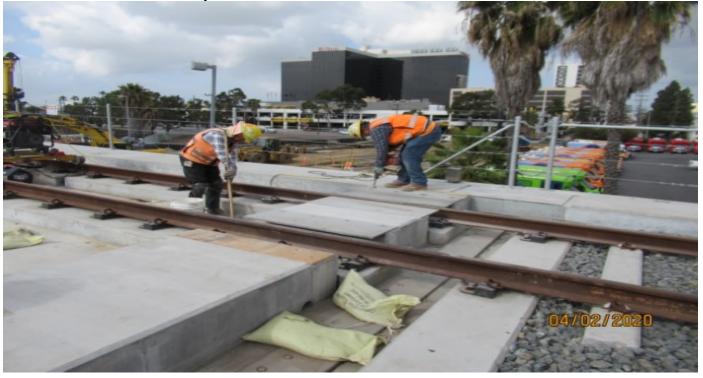
**Aviation/Century –** WSCC working on emergency walkway foundations Century-Aviation bridge SB #3 track STA 74+60 (looking west) Rework

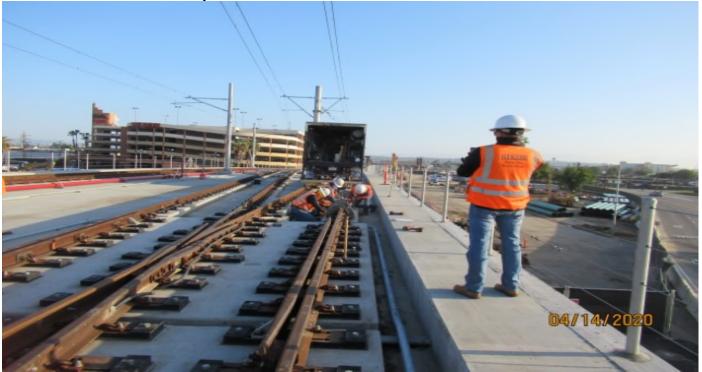
**Aviation/Century** – HCC, repairing cross levels on 10K1LH XO Century-Aviation Bridge NB # 4 track.

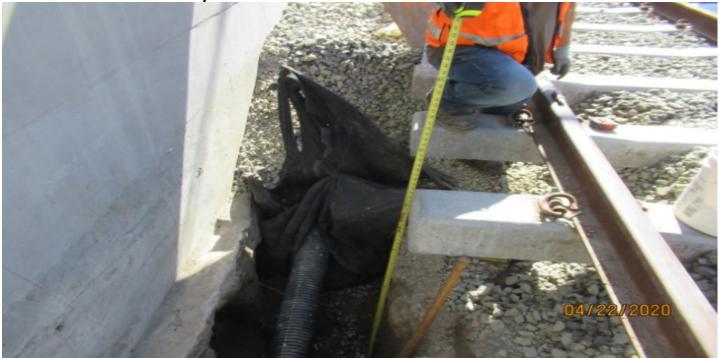
**AVIATION/CENTURY**- Mesurment of 66+inches from bottom of excavation hole to top of tie on SB #3 track STA 178+00 Segment B1 (looking north) Rework, This will need to be re-tamped – century

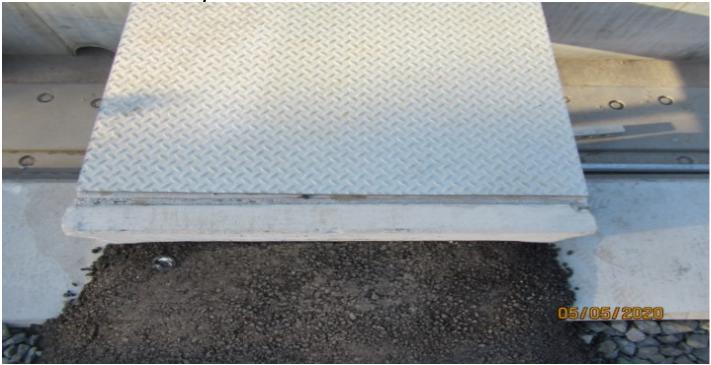
**AVIATION/CENTURY** - Emergency Walkway crossing at edge of DF track on Century/Aviation bridge STA 74+72.

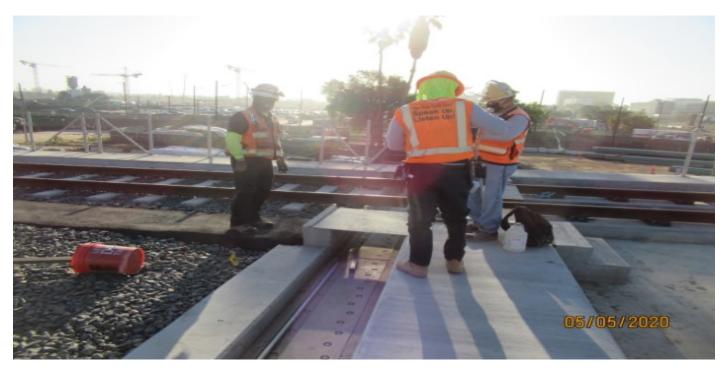
**AVIATION/CENTURY** - WSCC QC & concrete foreman going over open item punch list, Activity #1498 on Century/Aviation bridge (looking east)

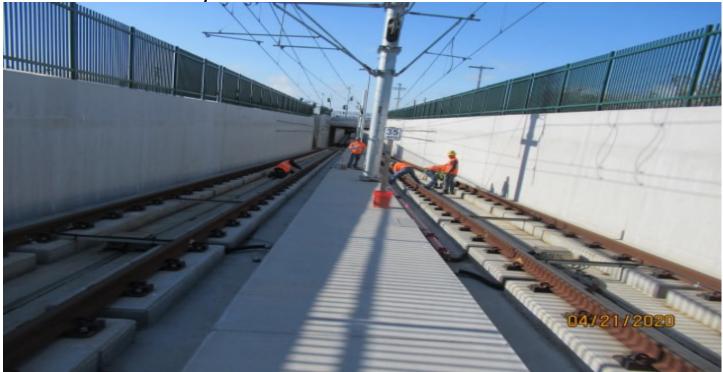
**UG - 1** – WSCC crew in UG1 both NB & SB tracks, for install of epoxy on expansion joints (looking south) out of sequence

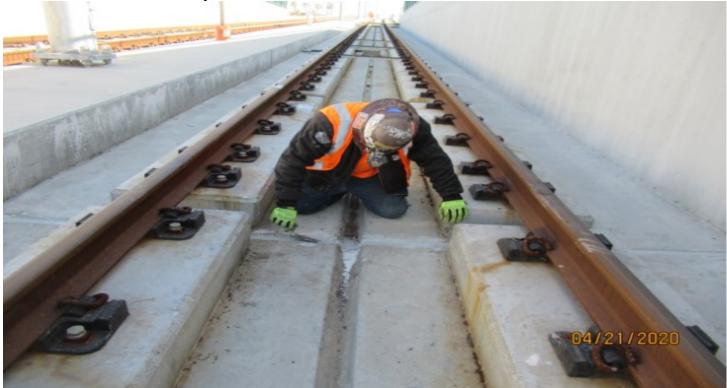
UG1 – WSCC placing epoxy on expansion joints in UG1 NB #4 track out of sequence work

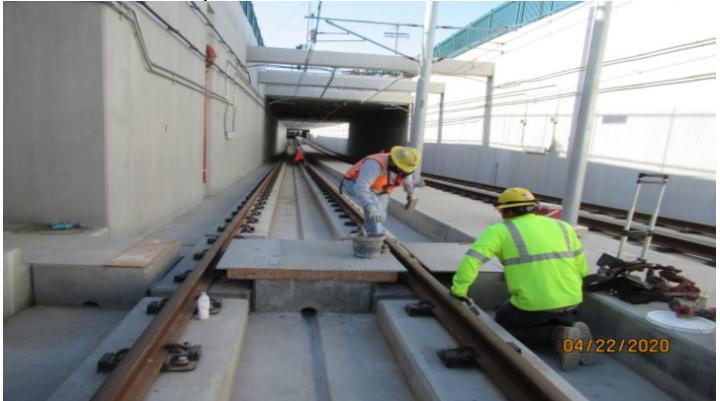
UG1 – WSCC repair work on emergency walkway crossing in UG1 SB #3 track STA 49+73

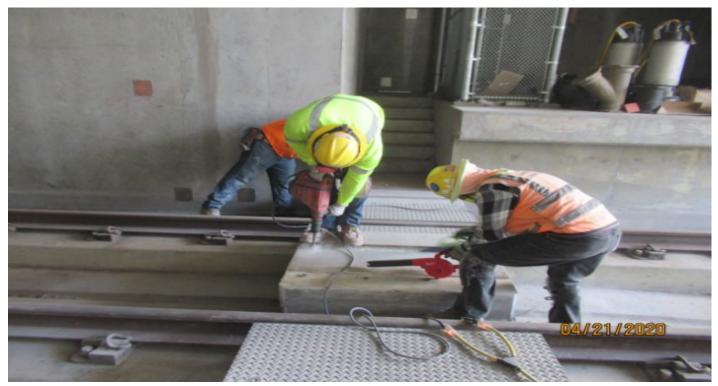
UG1 - WSCC repair work on emergency walkway crossing in UG1 SB #3 track STA 49+73.

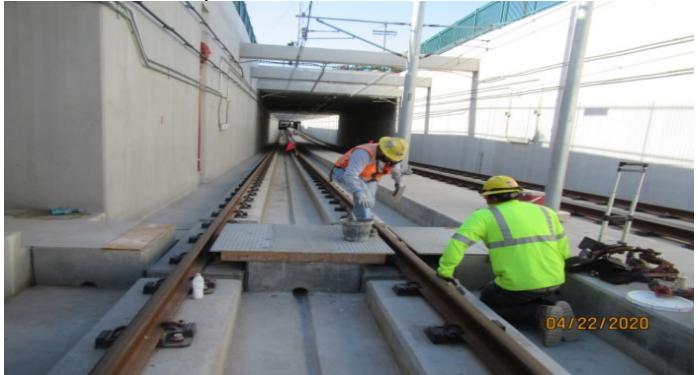
**UG1** - WSCC preforming repair work (grouting concrete foundations) on #4 track UG1 STA 56+50 (looking south) Rework.

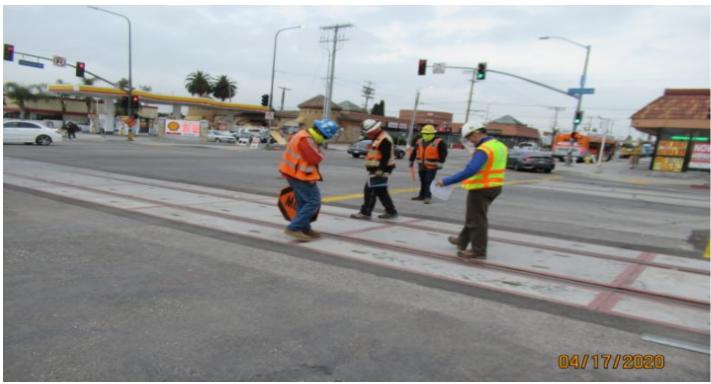
**Crenshaw / Slauson –** Slauson Ave grade crossing STA 323+88, Metro & WSCC inspectors verifying rail gouges on NB #4 track (looking northeast)

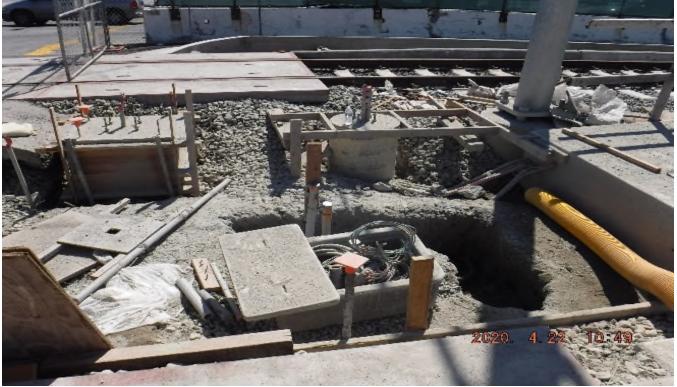
**Crenshaw / Slauson -** STA 323+00 TK#3/SB looking west – track structure disturbed (between tracks) north end of Slauson Station – PUNCH LIST

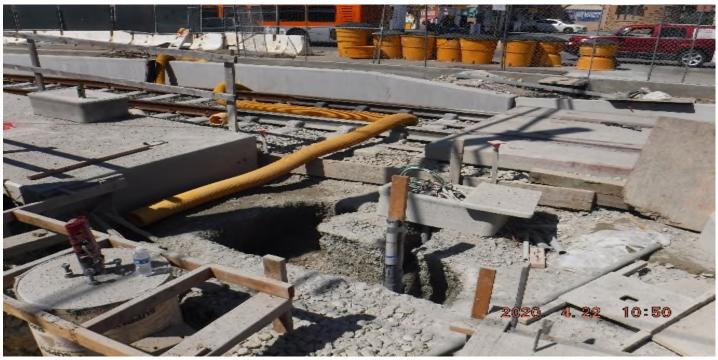
**Crenshaw / Slauson -** STA 323+00 TK#3/SB looking west – track structure disturbed (between tracks) north end of Slauson Station – PUNCH LIST

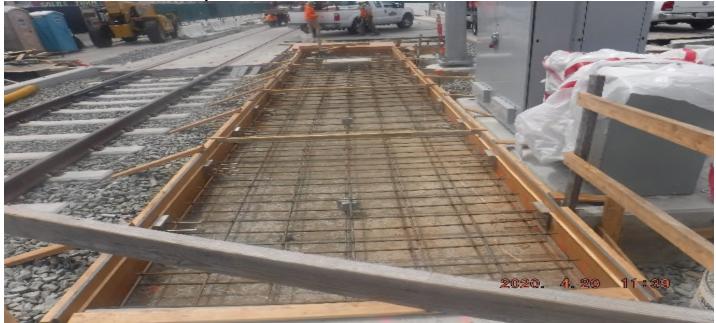
**Crenshaw / Slauson -** STA 323+00 TK#3/SB looking west – track structure disturbed (between tracks) north end of Slauson Station – PUNCH LIST

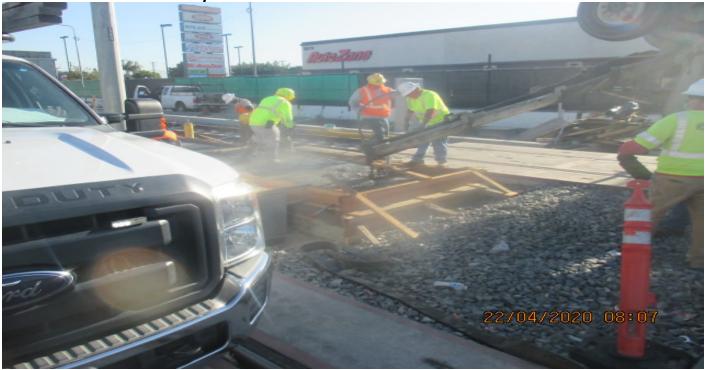
**Hyde Park Station** – Began formwork and rebar installation for the south end entrance ramp of the platform. 4/21/20

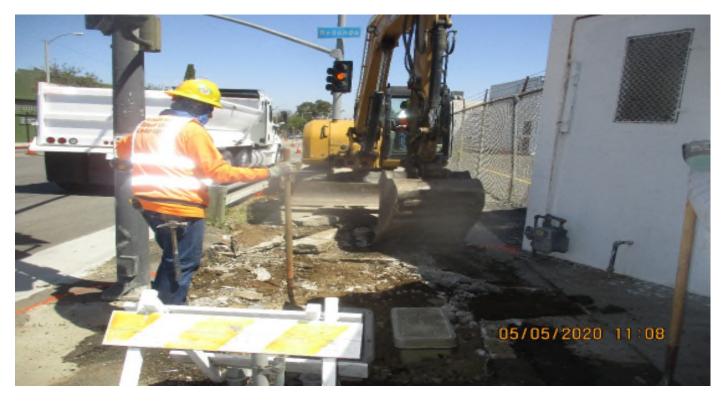
Florence/West – Select Electric Pull cable for all of Redondo/West intersection.

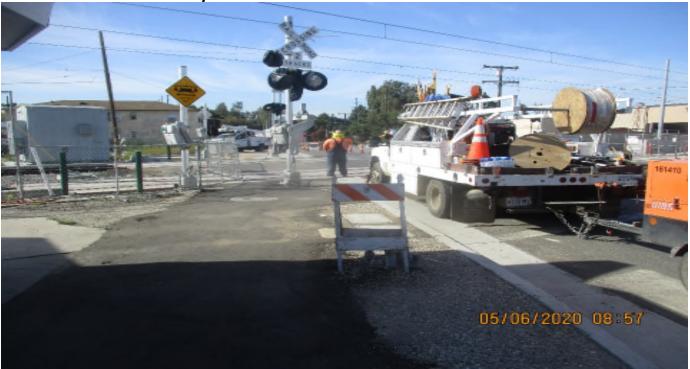
Florence/West – WSCC Start removals on N/B West St at crossing.

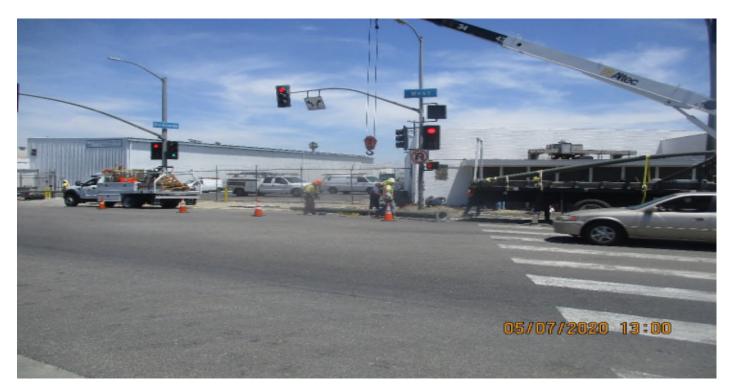
Florence/West – Select Electric Continue pulling wire and standing poles At 71St and West St.

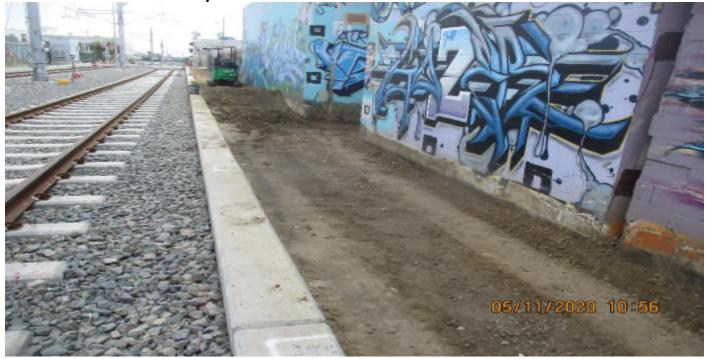
Florence/West – Select Electric Pulling wire and standing poles at Redondo and West St.

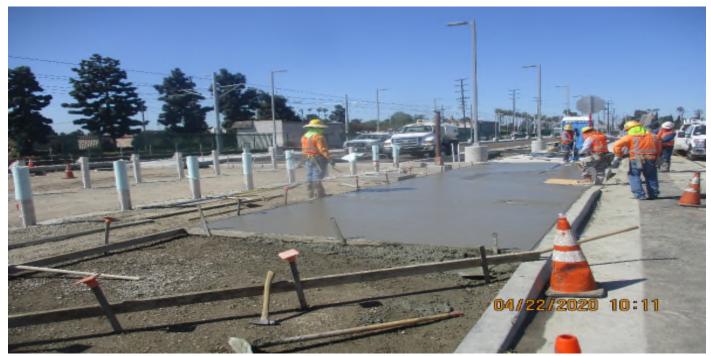
**Florence/West** – WSCC Placing concrete pace of generator pedestal at West Station parking lot.

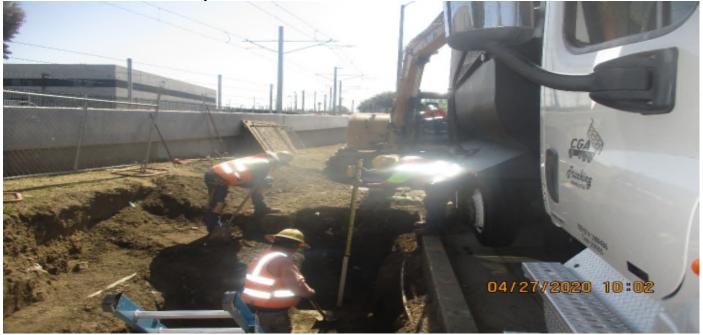
Florence/La Brea – WSCC Core hole in CB west of La Brea on W/B Florence.

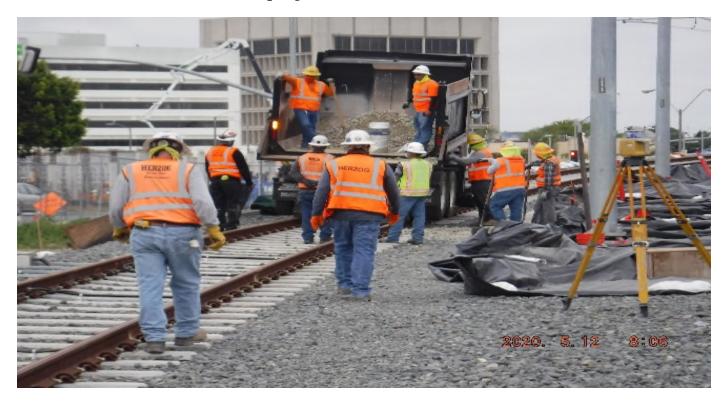
**Florence/Brea** - STA 208+00 TK#4/NB looking north – track geometry measurement south of La Brea Station before re-tamping

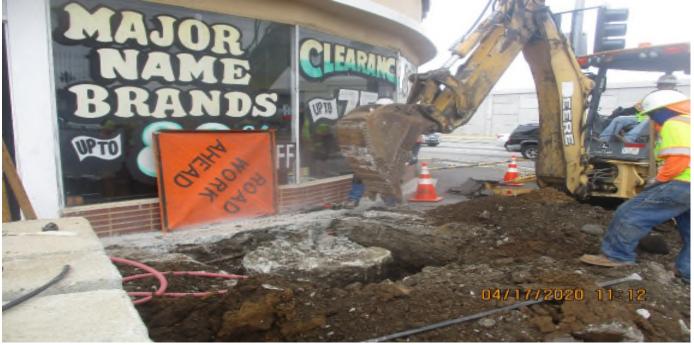
Florence/Brea - WSCC Grading behind SWK at La Brea and Florence S/E corner.

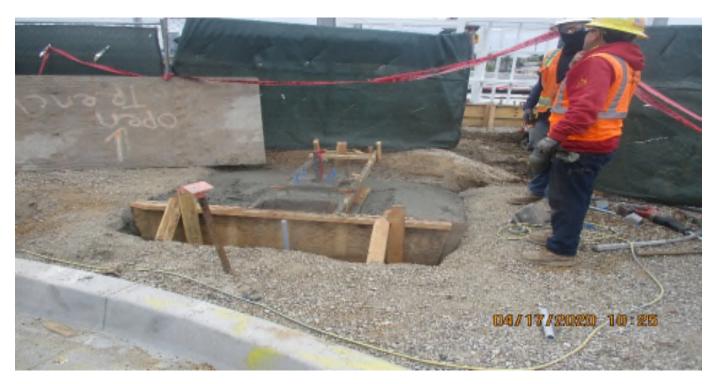
**Florence/Brea** – Select Electric Removed existing TS foundation at S/E corner of La Brea and Florence.

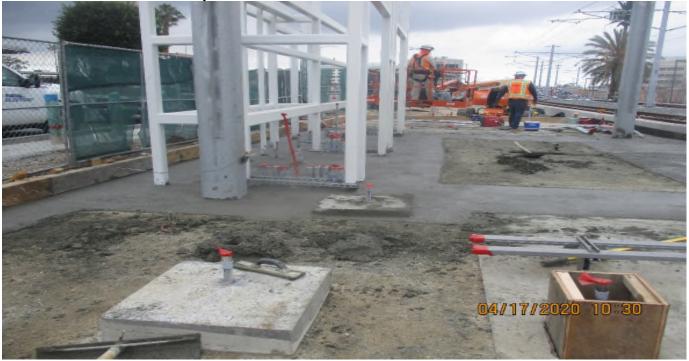
Florence/Brea – WSCC Placed concrete for pylons at W/B Florence at La Brea Station.

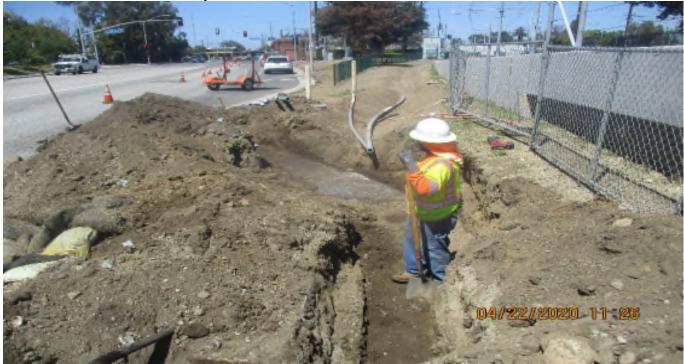
**Florence/High St. -** STA 257+30 TK#3/SB looking north – TC (system) work between High St (behind camera) and West Blvd.

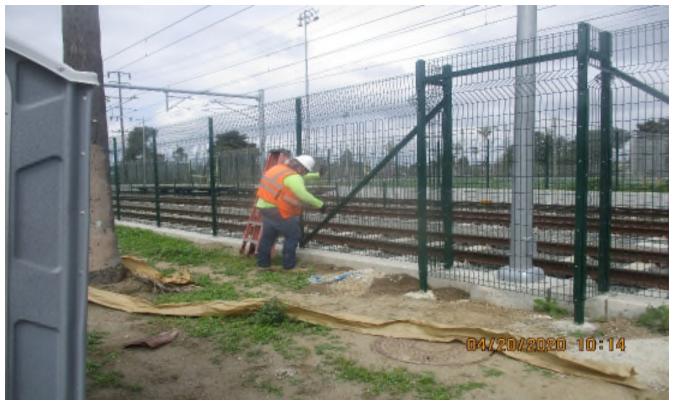
Florence/High St. - Select Electric Place TS conduit at E/B Florence and High St.

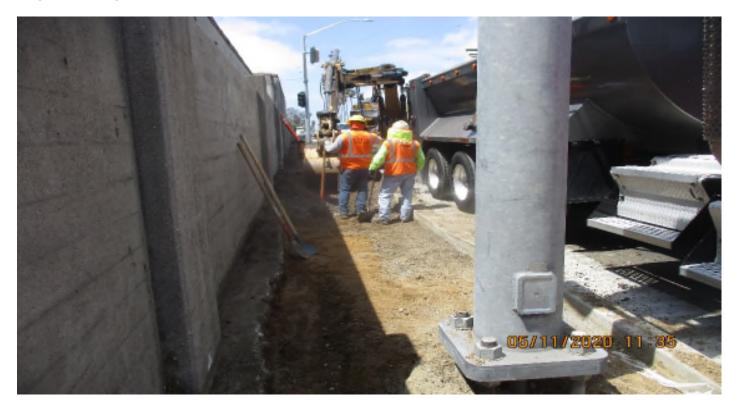
**Florence/High St**. - STA 257+25 TK#3/SB looking south – system work north end High St at grade Xing.

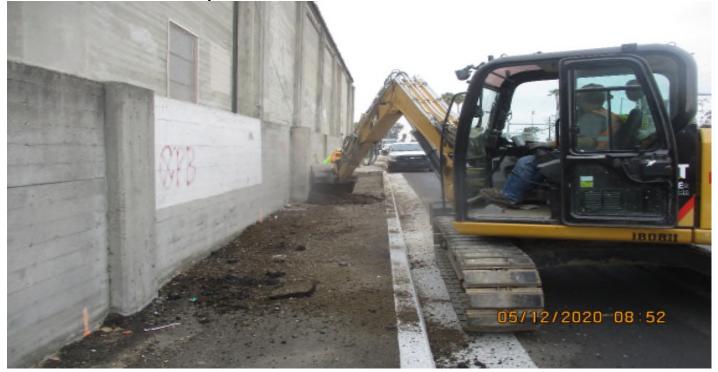
Florence/High St. - WSCC Cut and make grade for SWK pour at EB Florence and High St.

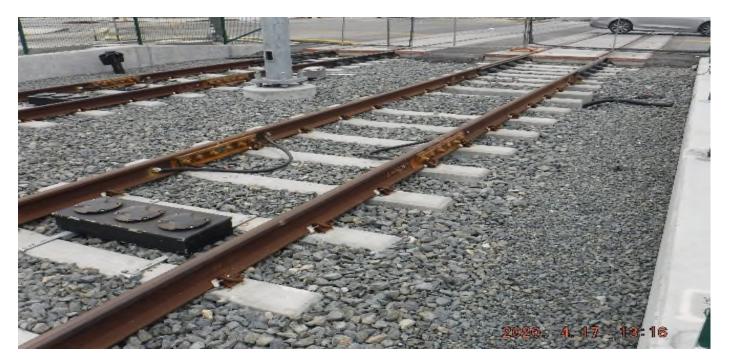
**57<sup>th</sup> Street** - STA 329+75 TK#4/NB looking north – track structure status as of 4.17.2020 south of 57th St – PUNCH LIST.

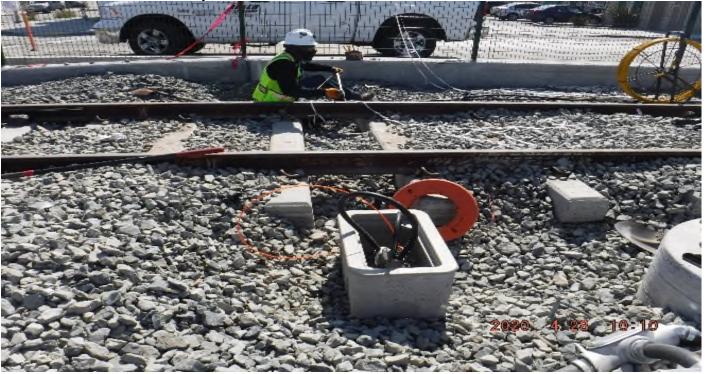
**57**th **Street** - STA 329+90 TK#4/NB looking east – system work with track structure disturbance south of 57th St – PUNCH LIST.

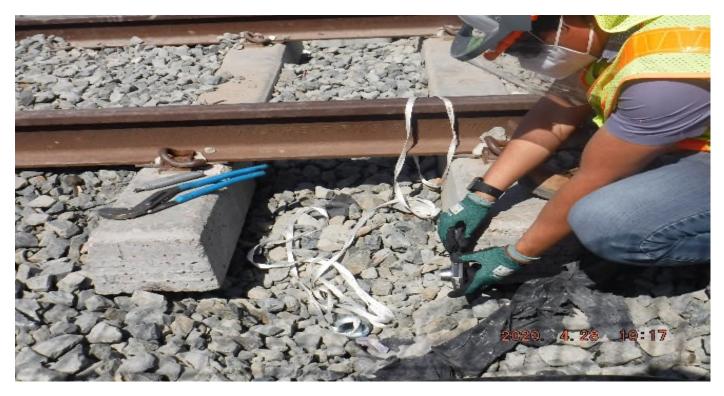
**57<sup>th</sup> Street** - STA 329+90 TK#4/NB looking west – checking depth of system conduit imbedded in track structure south of 57th St.

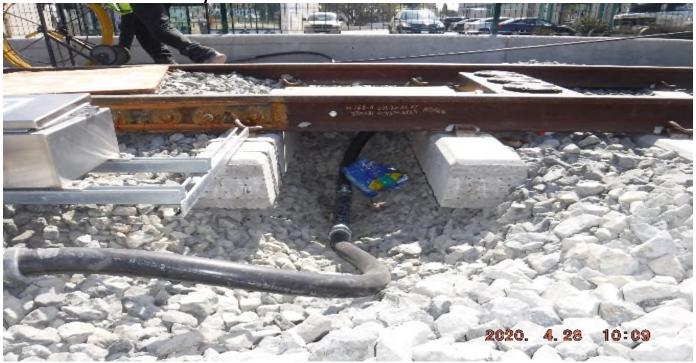
**57<sup>th</sup> Street** - STA 329+75 TK#4/NB looking east – checking depth of system conduit imbedded in track structure south of 57th St.

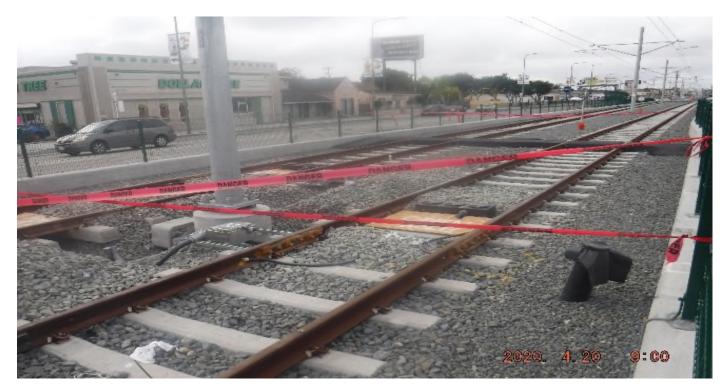
**57<sup>th</sup> Street** - STA 330+00 TK#3/SB looking south – system work with track structure disturbance south of 57th St around/next to OCS #1258 as of 4.20.2020 – PUNCH LIST

• Disturbed ballast due to systems electrical conduit relocations continues to be repaired and re-dressed.

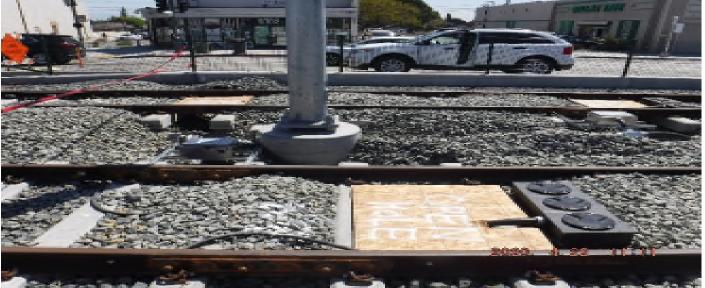
**57**th **Street** - STA 329+75 TK#3/SB looking east – system work with track structure disturbance south of 57th St around/next to OCS #1258 as of 4.22.2020 – PUNCH LIST

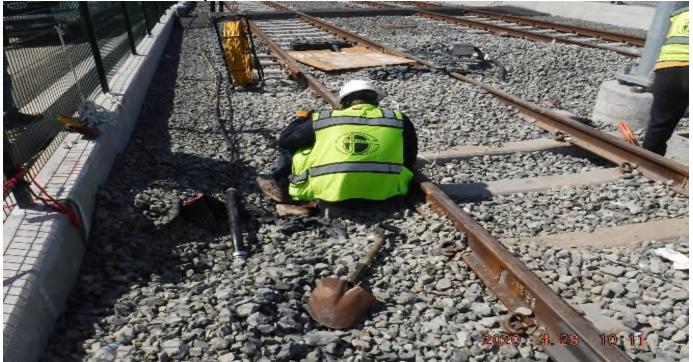
**57th STREET-** STA 330+00 TK#4.NB looking south right shoulder – system work with track structure disturbance south of 57th St – PUNCH LIST

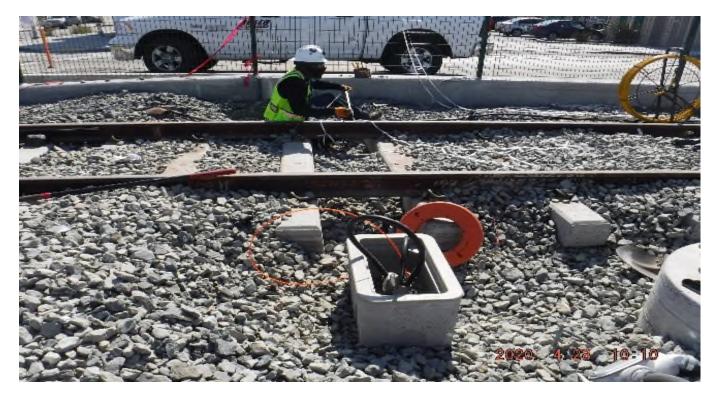
**57th STREET**- STA 329+90 TK#4 , NB looking east – system work with track structure disturbance south of 57th St – PUNCH LIST

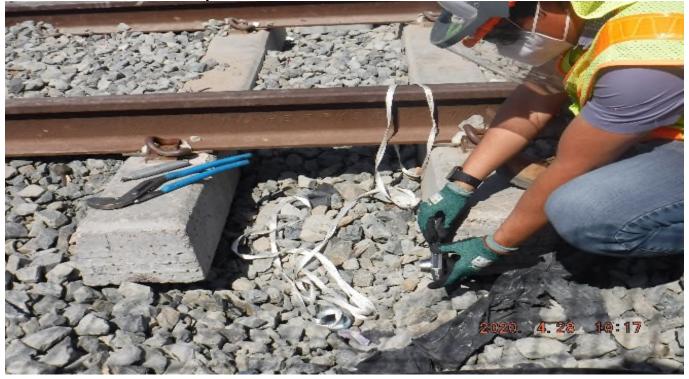
**57th STREET-** STA 329+90 TK#4, NB looking west – checking depth of system conduit imbedded in track structure south of 57th St – PUNCH LIST

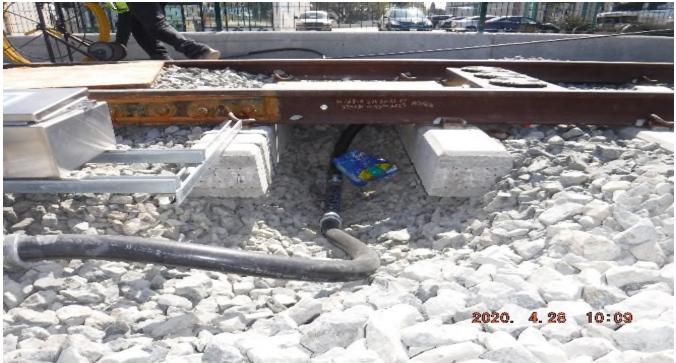
**57th STREET**- STA 329+75 TK#4 , NB looking east – checking depth of system conduit imbedded in track structure south of 57th St – PUNCH LIST

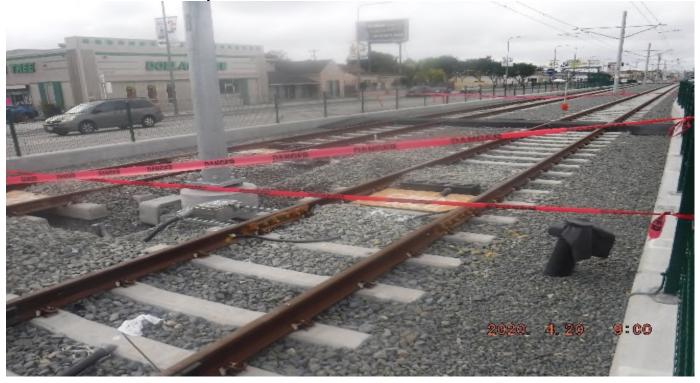
**57th STREET-** STA 330+00 TK#3 , SB looking south – system work with track structure disturbance south of 57th St around,next to OCS #1258 as of 4.20.2020 – PUNCH LIST

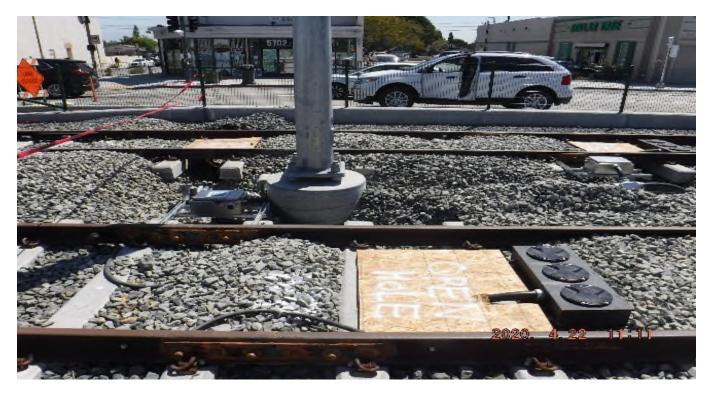
**57th STREET-** STA 329+75 TK#3,SB looking east – system work with track structure disturbance south of 57th St around,next to OCS #1258 as of 4.22.2020 – PUNCH LIST

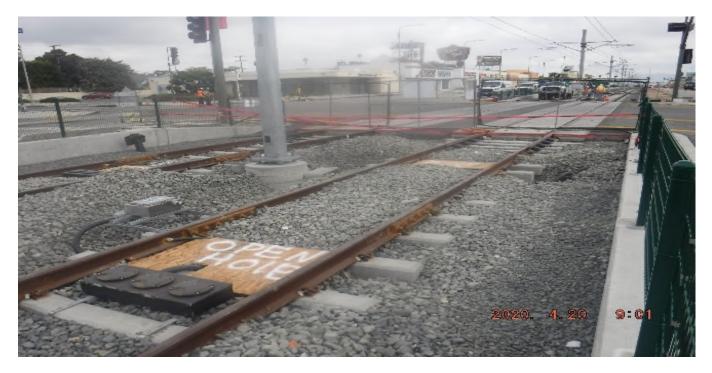
**57th STREET**-STA 329+40 TK#4,NB looking north – track status , track structure disturbance after weekend work NCR-B-089 (57th St) – PUNCH LIST

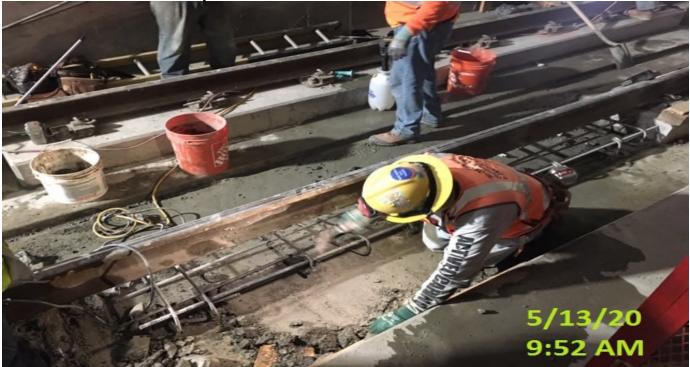
**Crenshaw/Expo** - EXPO – WSCC crew demoing sections of plinth that did not pass pull test.

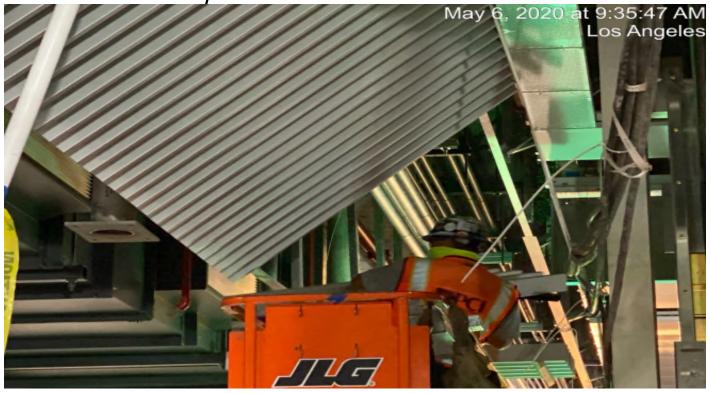
**Crenshaw/Vernon -** Vernon Concourse, TC&C Room C112, CTS Comm Rack, begin terminating fiber optic cable for A-train.

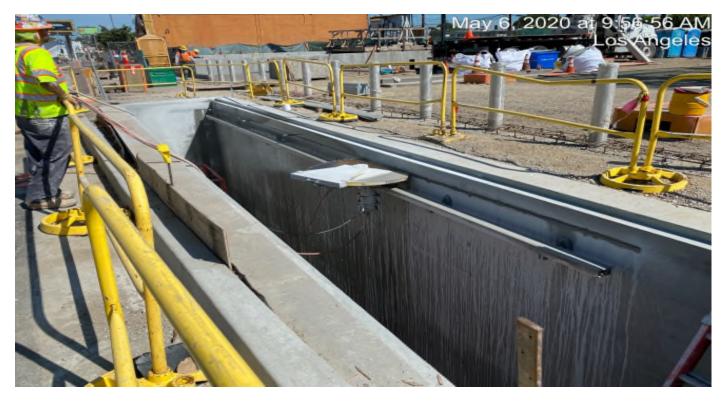
Crenshaw/Vernon - PCI Re-installing bar panels at Vernon.

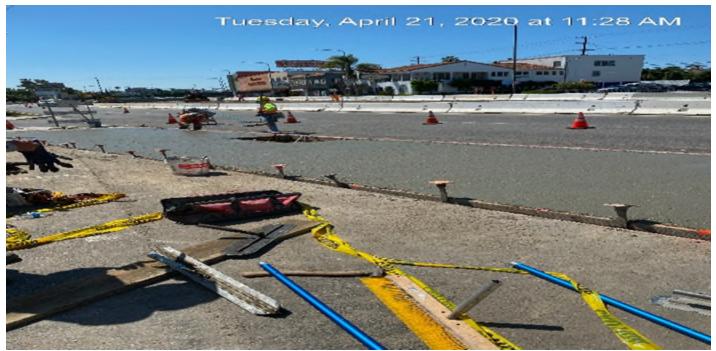
**LEIMERT PARK STATION** – Placing concrete for new sidewalk installation for the center "Pork Chop" median island on Crenshaw Blvd between 46th St and Leimert Blvd.

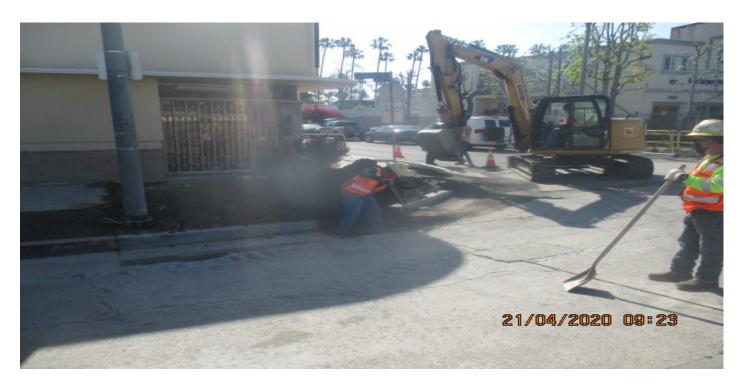
**LEIMERT PARK STATION** – Excavating for new sidewalk and ADA ramp installation on the northeast corner of 46th St and Leimert Blvd. 4/21/20

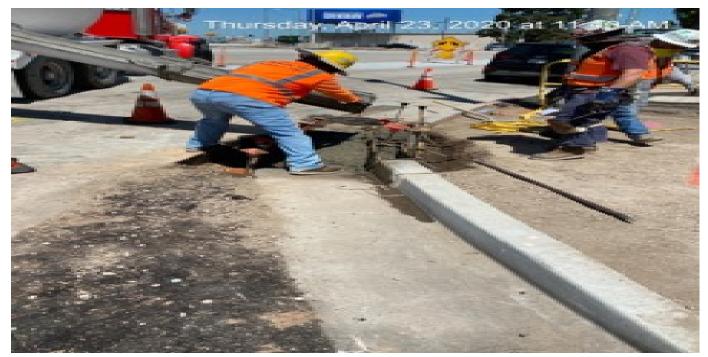
**LEIMERT PARK STATION** – Placing concrete for new curb/gutter on the south and northeast corners of 46th St and Crenshaw Blvd.

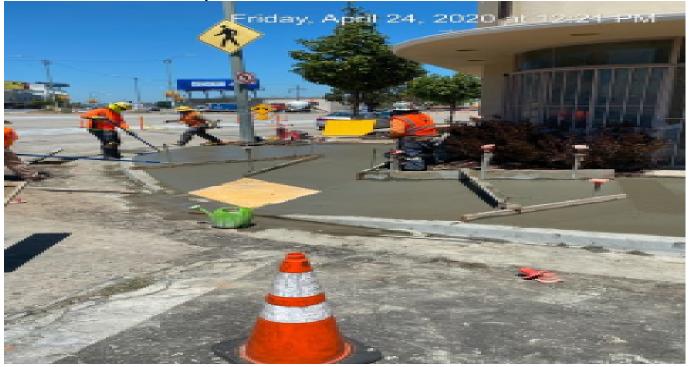
**LEIMERT PARK STATION** – Continued placing concrete for the new sidewalk and ADA ramp installation at the northeast corner of 46th St and Leimert Blvd.

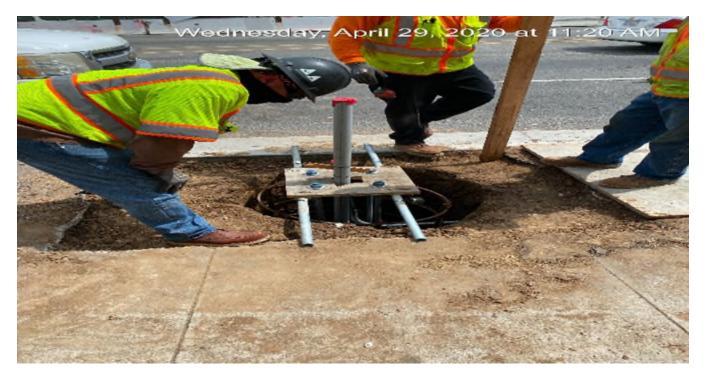
**LEIMERT PARK STATION** – Continue light pole foundation installation on the northeast corner of 43rd Pl and Crenshaw Blvd.

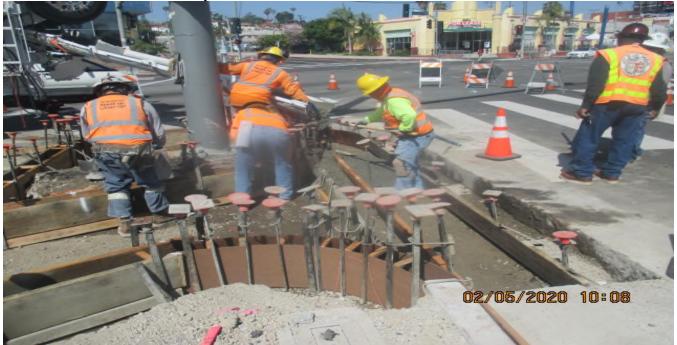
**LEIMERT PARK STATION** – Placing forms and concrete for new curb/gutter installation on the southeast corner island of Vernon Ave and Crenshaw Blvd. 5/2/20

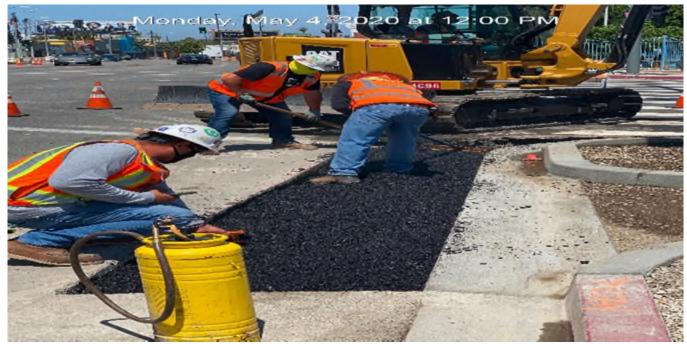
**LEIMERT PARK STATION** – Placing asphalt concrete around the curb/gutter on the southeast corner island of Vernon Ave and Crenshaw Blvd.

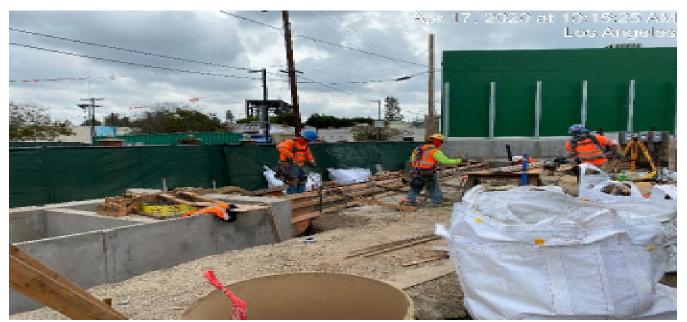
**LEIMERT PARK STATION** – Continue tunnel fan damper section installation for the sound attenuator for EVF-6-102 in the North Fan Room C – 142 of the concourse level.

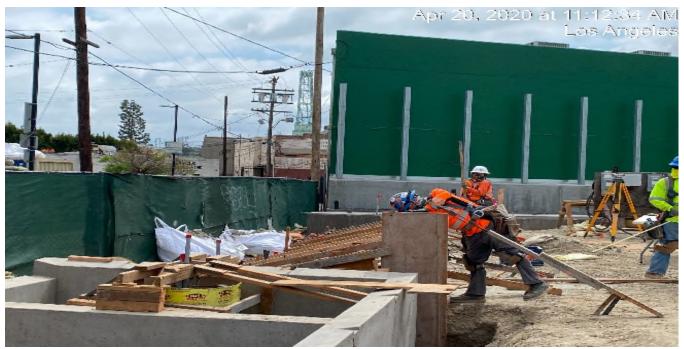
**LEIMERT PARK STATION** – Continue formwork for the planter stair risers on the northwest section of the plaza level.

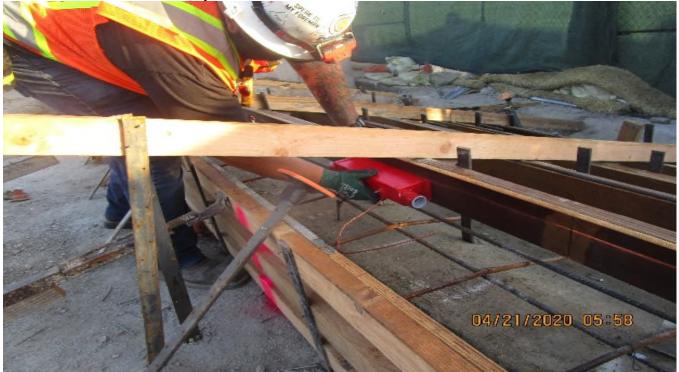
**LEIMERT PARK STATION** – Began layout of recessed lighting fixtures for planter stair risers on the northwest section of the plaza level.

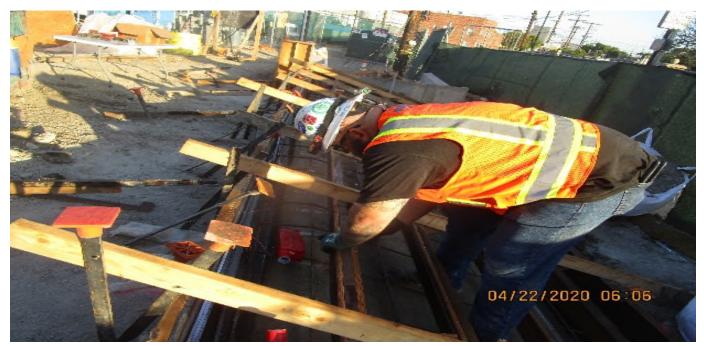
**LEIMERT PARK STATION** – Continue embedded and ramp lighting fixture installation for planter stair risers on the northwest section of the plaza level.

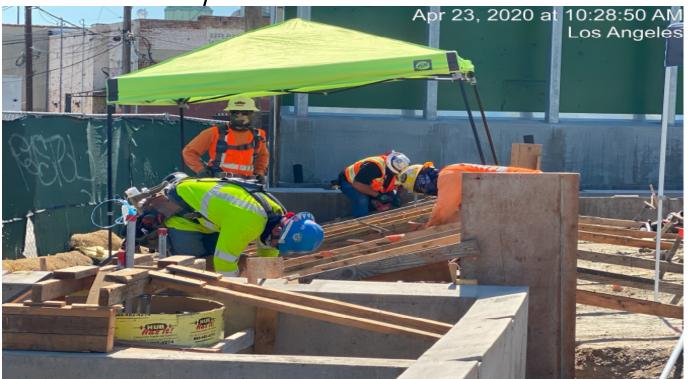
**LEIMERT PARK STATION** – Continue formwork for the planter stair risers on the northwest section of the plaza level.

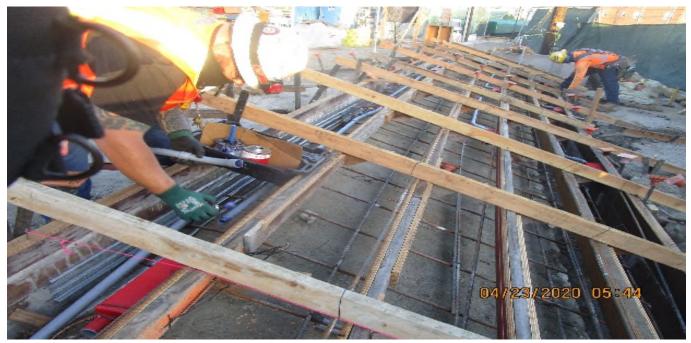
**LEIMERT PARK STATION** – Continue embedded and ramp lighting fixture installation for the planter stair risers on the northwest section of the plaza level.

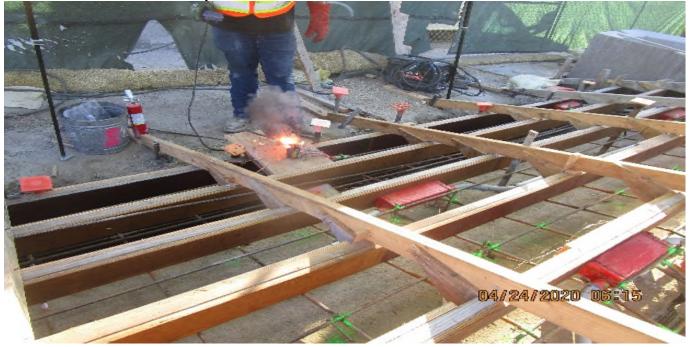
**LEIMERT PARK STATION** – Continue embedded and ramp lighting fixture installation for the planter stair risers on the northwest section of the plaza level.

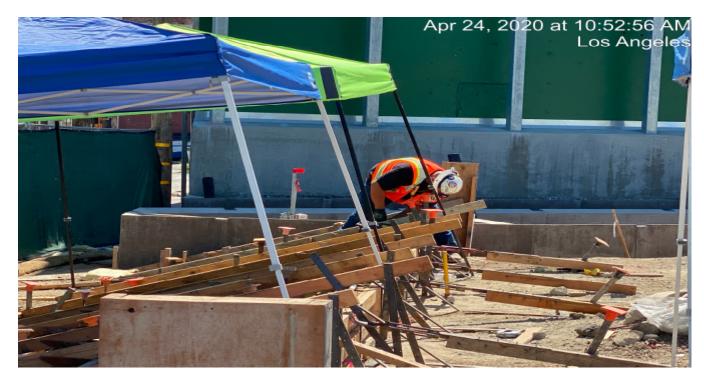
**LEIMERT PARK STATION** – Continue formwork for the planter stair risers on the northwest section of the plaza level.

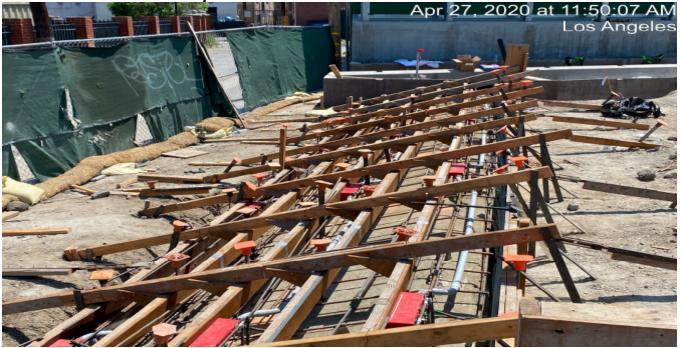
**LEIMERT PARK STATION** – Continue formwork for the planter stair risers on the northwest section of the plaza level.

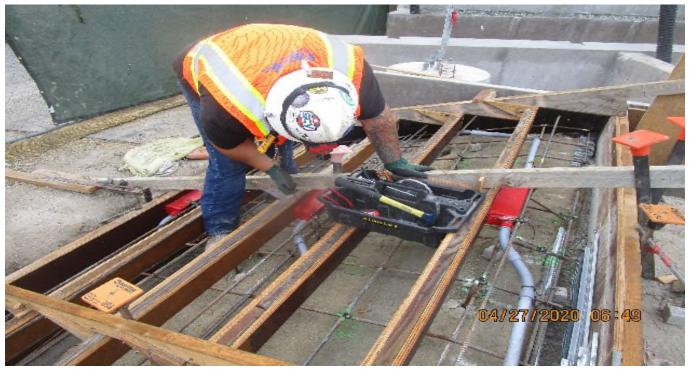
**LEIMERT PARK STATION** – Continue embedded and ramp lighting fixture installation for the planter stair risers on the northwest section of the plaza level.

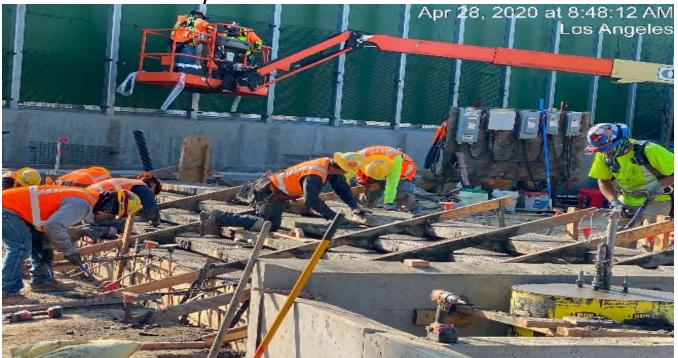
**LEIMERT PARK STATION** – Placed concrete and continue formwork for the planter stair risers on the northwest section of the plaza level.

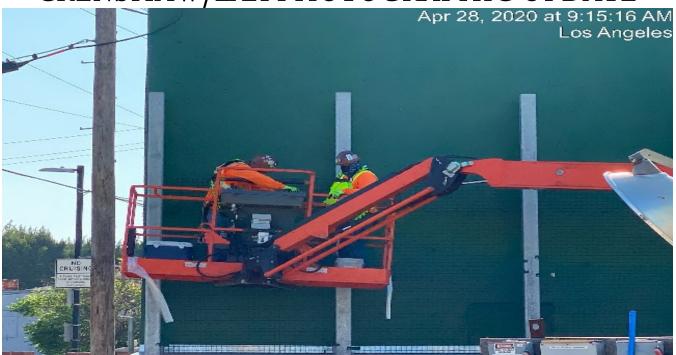
**LEIMERT PARK STATION** – Continue lattice installation for the green screen wall at the plaza level.

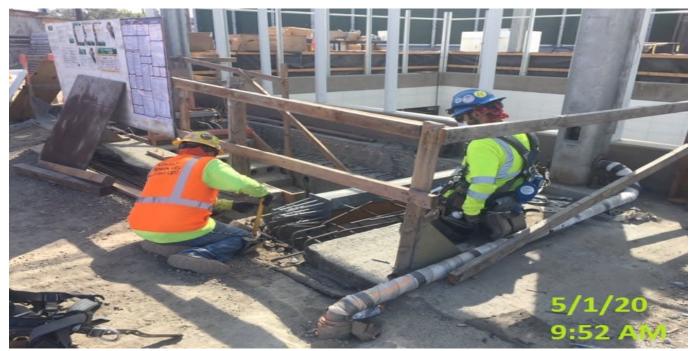
**LEIMERT PARK STATION** – Installing steel framing for the north emergency exit hatch doors at the plaza level.

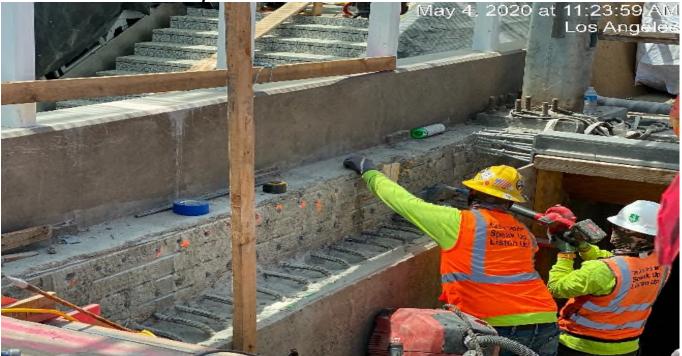
**LEIMERT PARK STATION** – Drilling and doweling for the north emergency exit hatch doors at the plaza level.

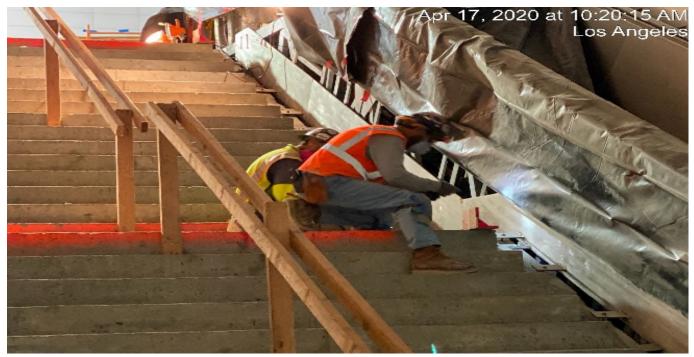
**LEIMERT PARK STATION** – Continue granite thread and riser installation at the main stair case landing of the plaza level.

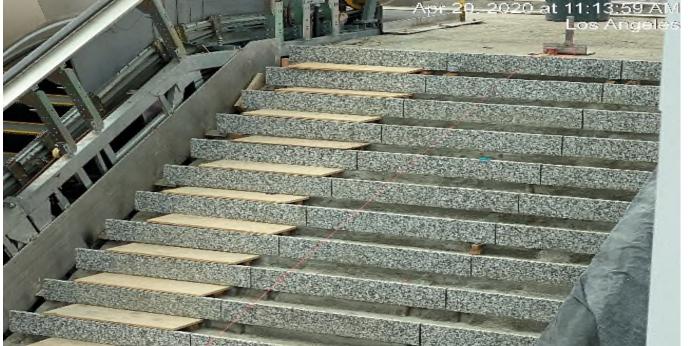
**LEIMERT PARK STATION** – Continue granite thread and riser installation at the main stair case landing of the plaza level.

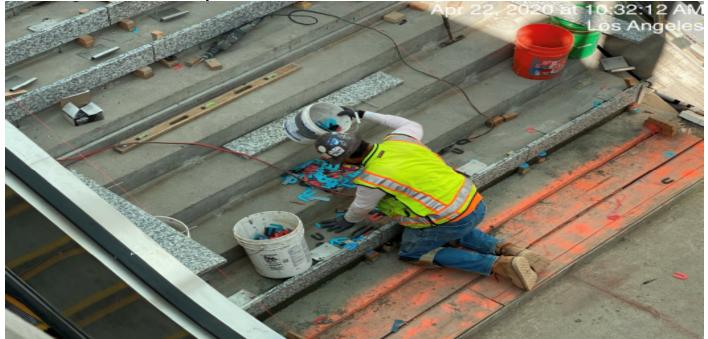
**LEIMERT PARK STATION** – Continue granite thread and riser installation at the main stair case landing of the plaza level.

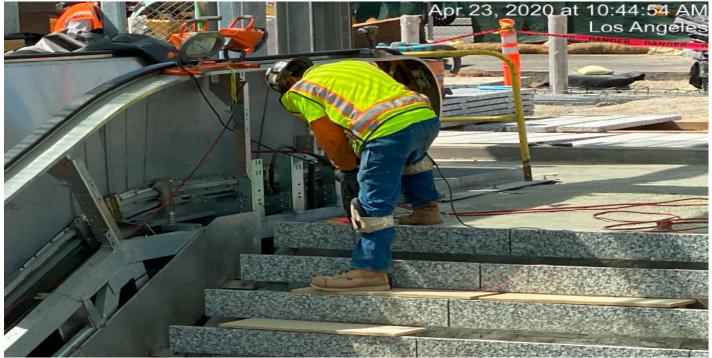
**LEIMERT PARK STATION** – Continue granite thread and riser installation at the main stair case landing of the plaza level.

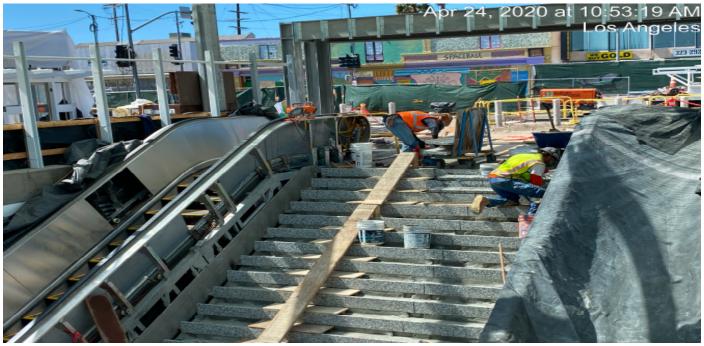
**LEIMERT PARK STATION** – Continue granite thread and riser installation at the main stair case landing of the plaza level.
