#### CRENSHAW/LAX PHOTOGRAPHIC UPDATE April 15, 2020

#### Crenshaw/LAX Transit Project

Overview of trackwork progress issues for 4/15 - 4/30(Please note the attached Trackwork Progress Tracking Report)

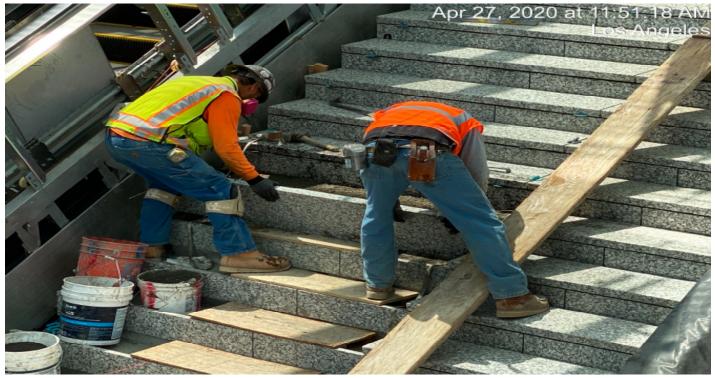
**LEIMERT PARK STATION** – Continue granite thread and riser installation at the main stair case landing of the plaza level.

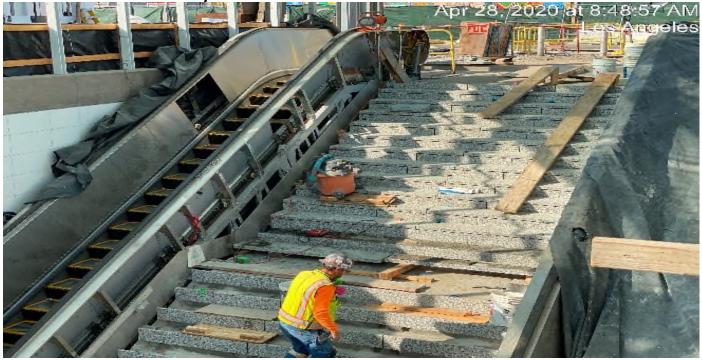
**LEIMERT PARK STATION** – Continue granite thread and riser installation at the main stair case landing of the plaza level.

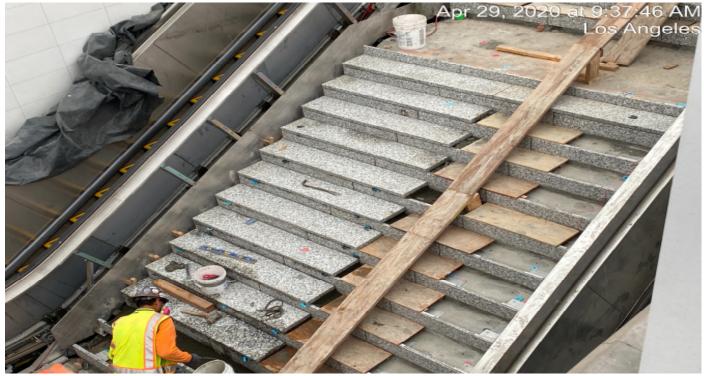
**LEIMERT PARK STATION** – Continue granite thread and riser installation at the main stair case landing of the plaza level.

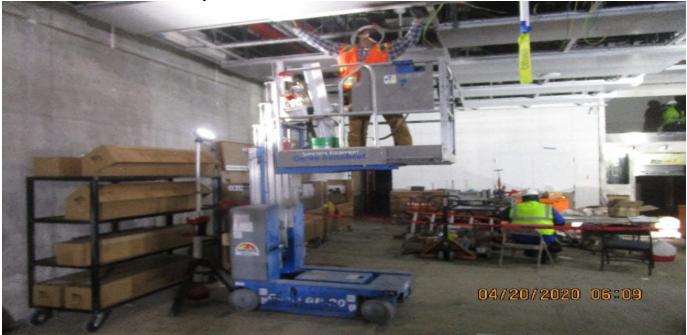
**LEIMERT PARK STATION** – Continue installing ceiling light fixtures at the concourse level.

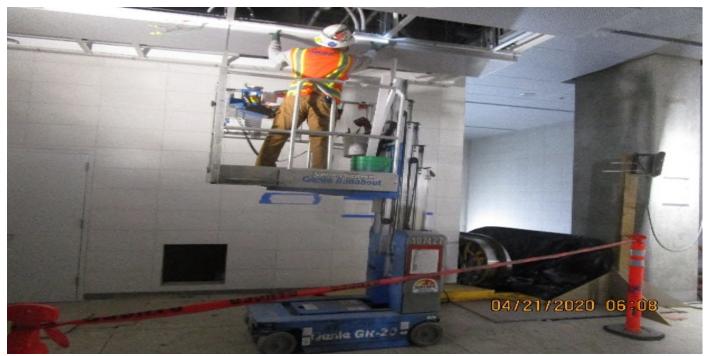
**LEIMERT PARK STATION** – Continue installing ceiling light fixtures at the concourse level.

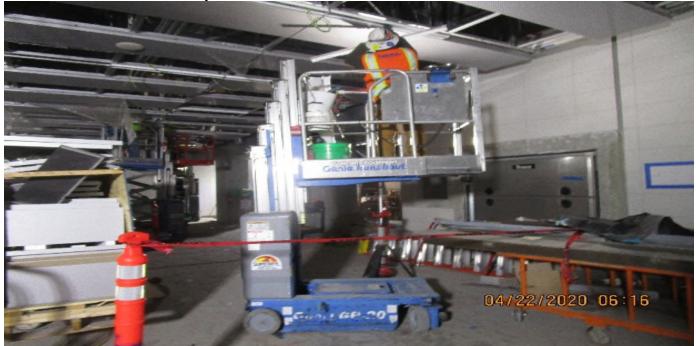
**LEIMERT PARK STATION** – Continue installing ceiling light fixtures at the concourse level.

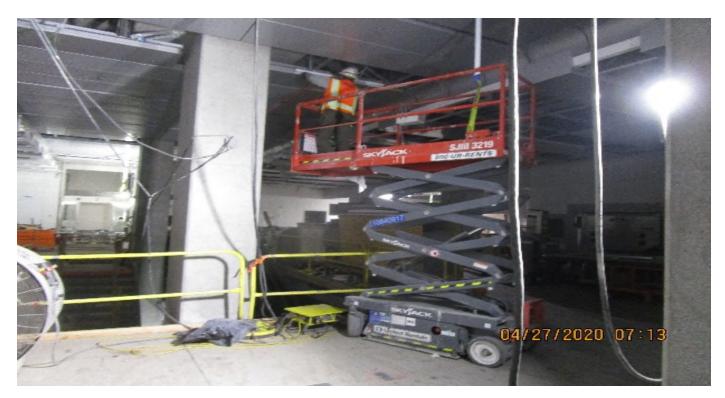
**LEIMERT PARK STATION** – Continue installing ceiling light fixtures at the concourse level.

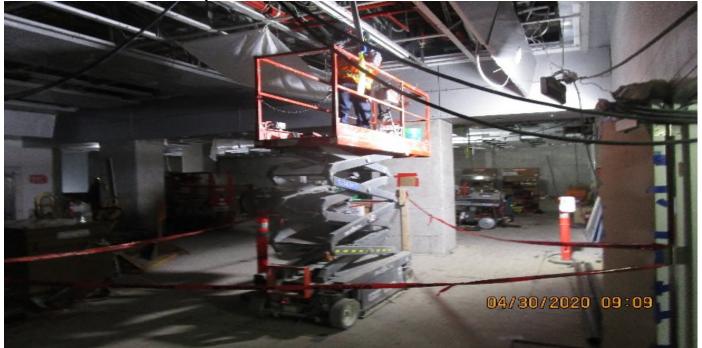
**LEIMERT PARK STATION** – Continue installing ceiling light fixtures at the concourse level.

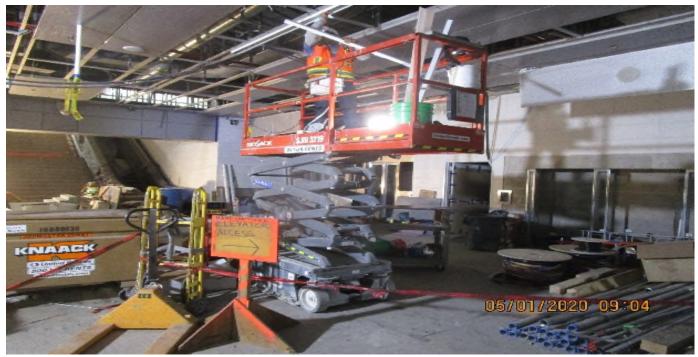
**LEIMERT PARK STATION** – Continue installing ceiling light fixtures at the concourse level.

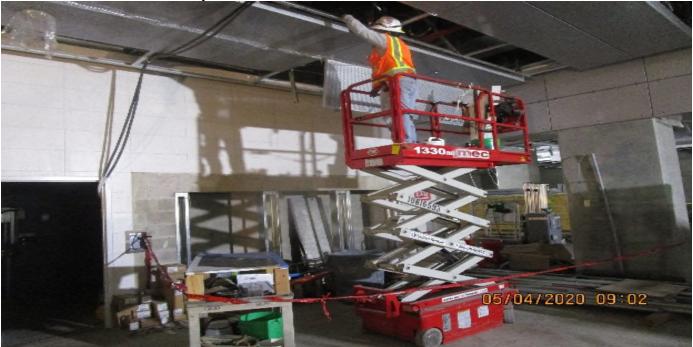
**LEIMERT PARK STATION** – Continue installing ceiling light fixtures at the concourse level.

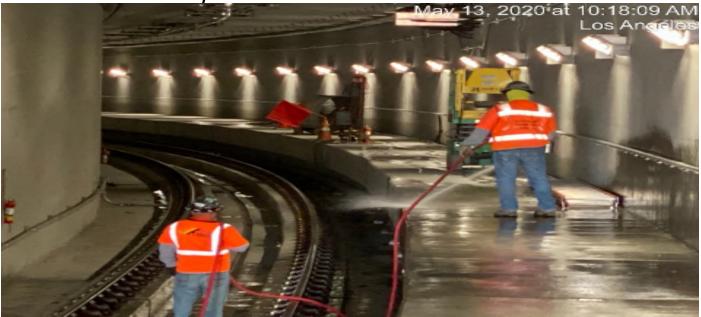
**UG-4-** STA 400+50 TK#4/NB looking south – minerals on UG4 invert between Vernon & MLK.

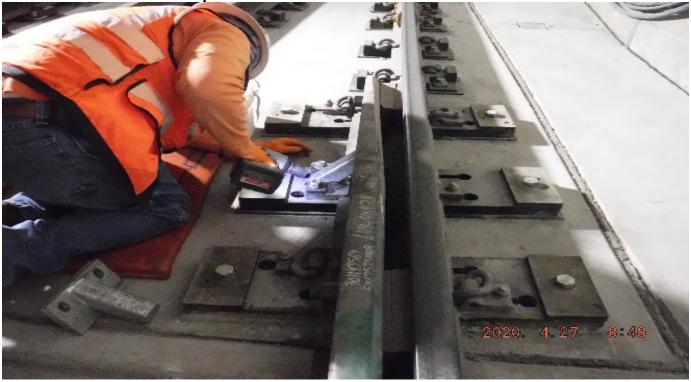
**UG-4-** STA 441+80 TK#4/NB looking south – torque DF fasteners 8W1LHXO – UG4 Exposition Station.

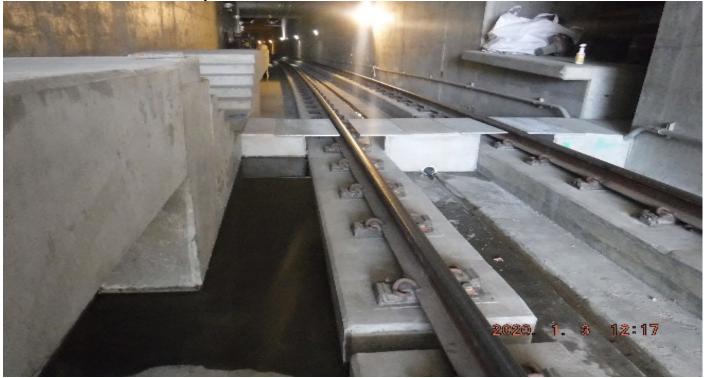
**UG-4-** STA 444+39 TK#3/SB looking south – torque DF fasteners between 8X1RHXO & 8W1LHXO – UG4 Exposition Station

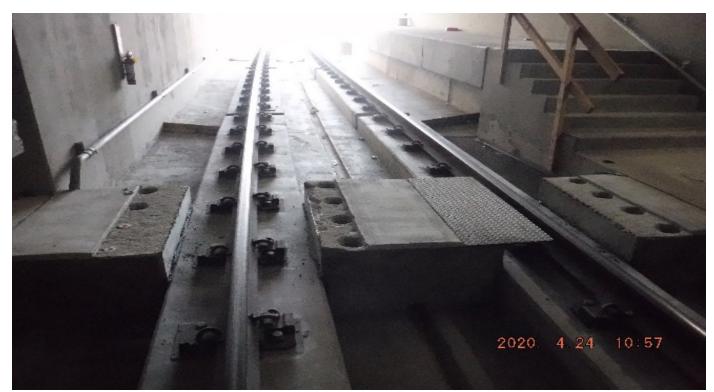
**UG-4-** STA 371+65 TK#4/NB looking north – steel plates set at crosswalk UG4 at the end of 2019 – PUNCH LIST
