CRENSHAW/LAX PHOTOGRAPHIC UPDATE

July 7, 2020

Crenshaw/LAX Transit Project

Overview of trackwork progress issues for 06-22-2020 – July 7, 2020
(Please note the attached Trackwork Progress Tracking Report)

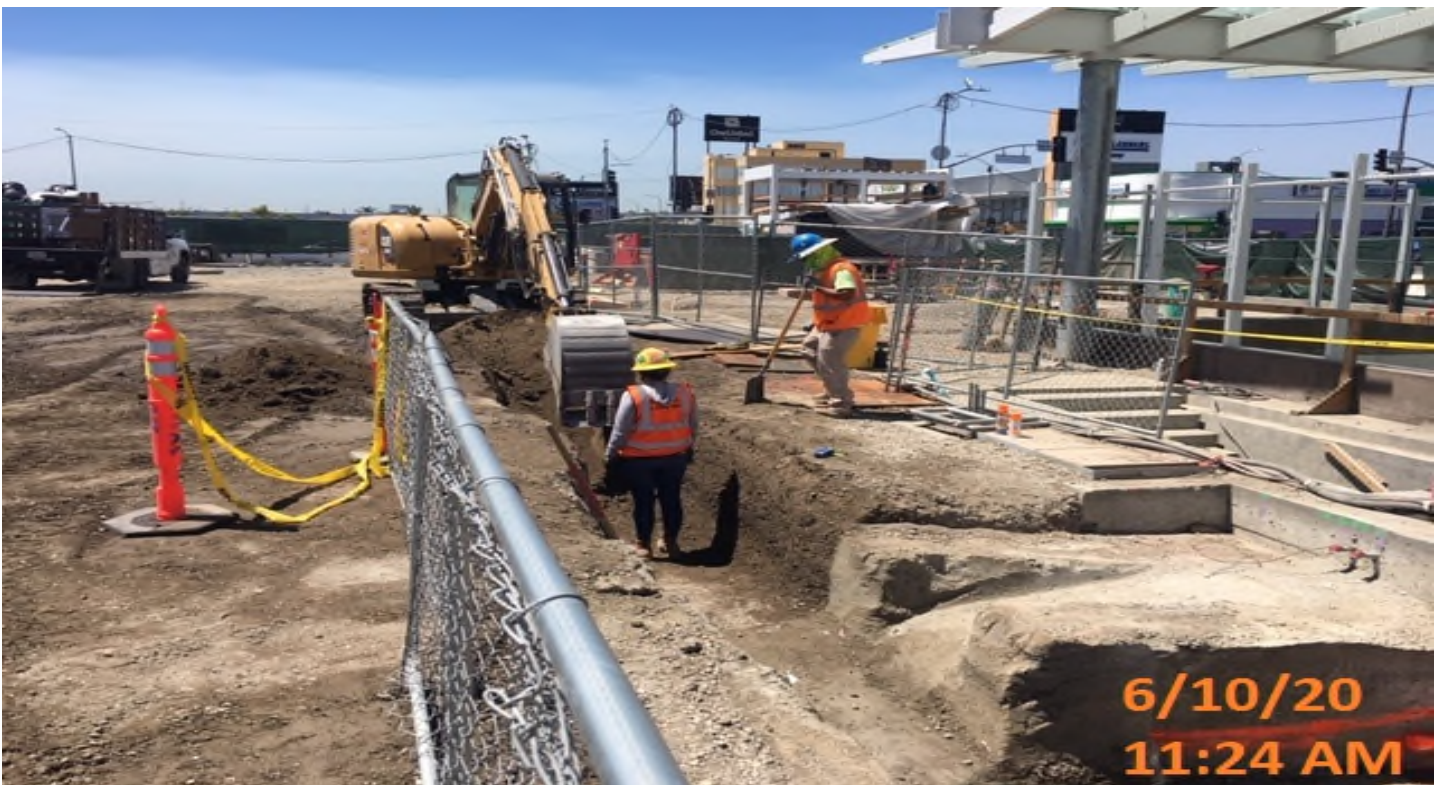
EXPO STATION- WSCC excavating trench for lighting conduit and irrigation.

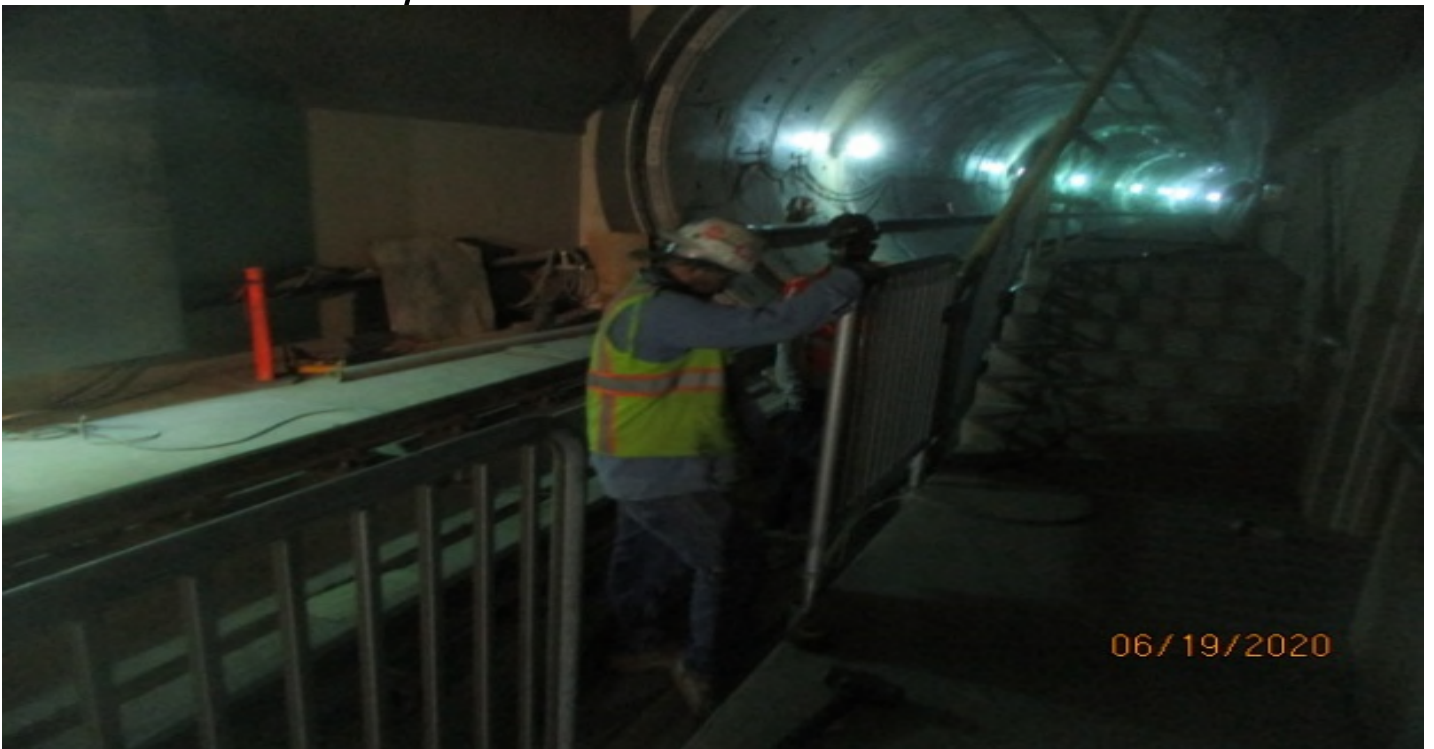
LEIMERT PARK STATION – Continue guardrail installation at the north and southbound walkways of the north end platform level.
