CRENSHAW/LAX PHOTOGRAPHIC UPDATE

Feb 12, 2021

Crenshaw/LAX Transit Project

Overview of trackwork progress issues for 1/30/2021- 2/15/2021
(Please note the attached Trackwork Progress Tracking Report)

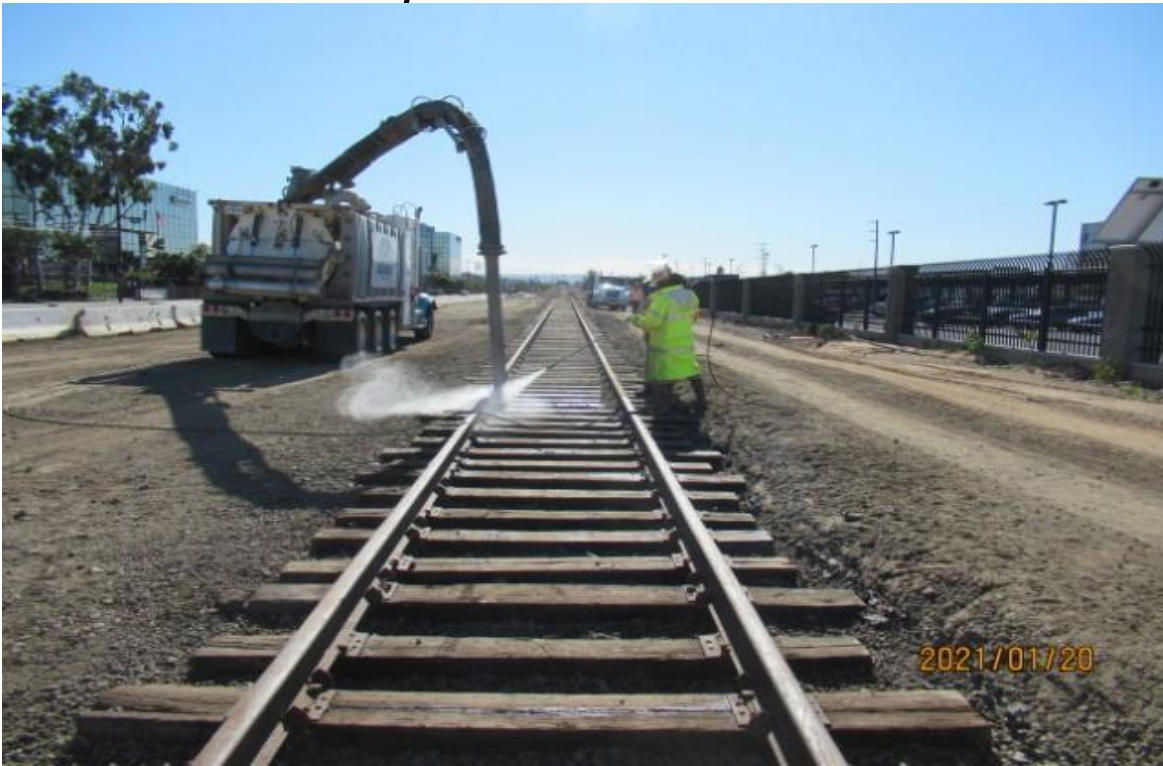
124th - WSCC Sub-contractor Badger Day lighting using vacuum truck & hi pressure water to remove contaminated ballast on BNSF track near 124th Street outside of CLAX project limits (looking south)

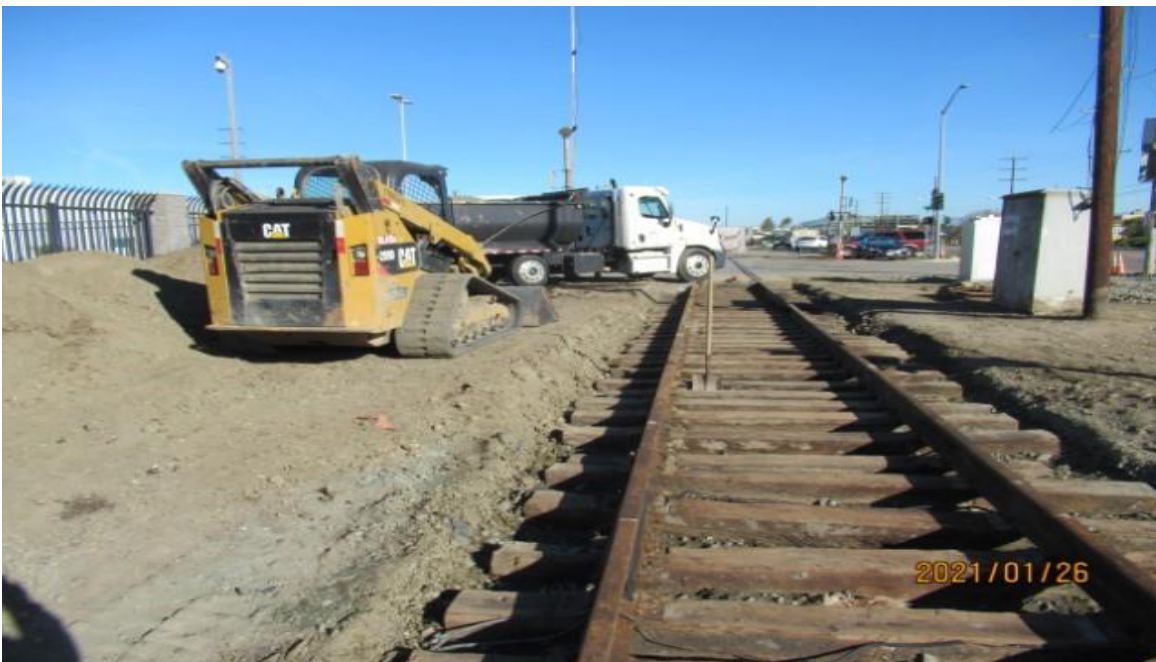
124th - WSCC at 124th Street BNSF track crossties skeletonized from removing contaminated ballast (looking north)
