The Northridge Earthquake

Post Earthquake Investigation Report

California Department of Transportation - Division of Structures

17 January 1994

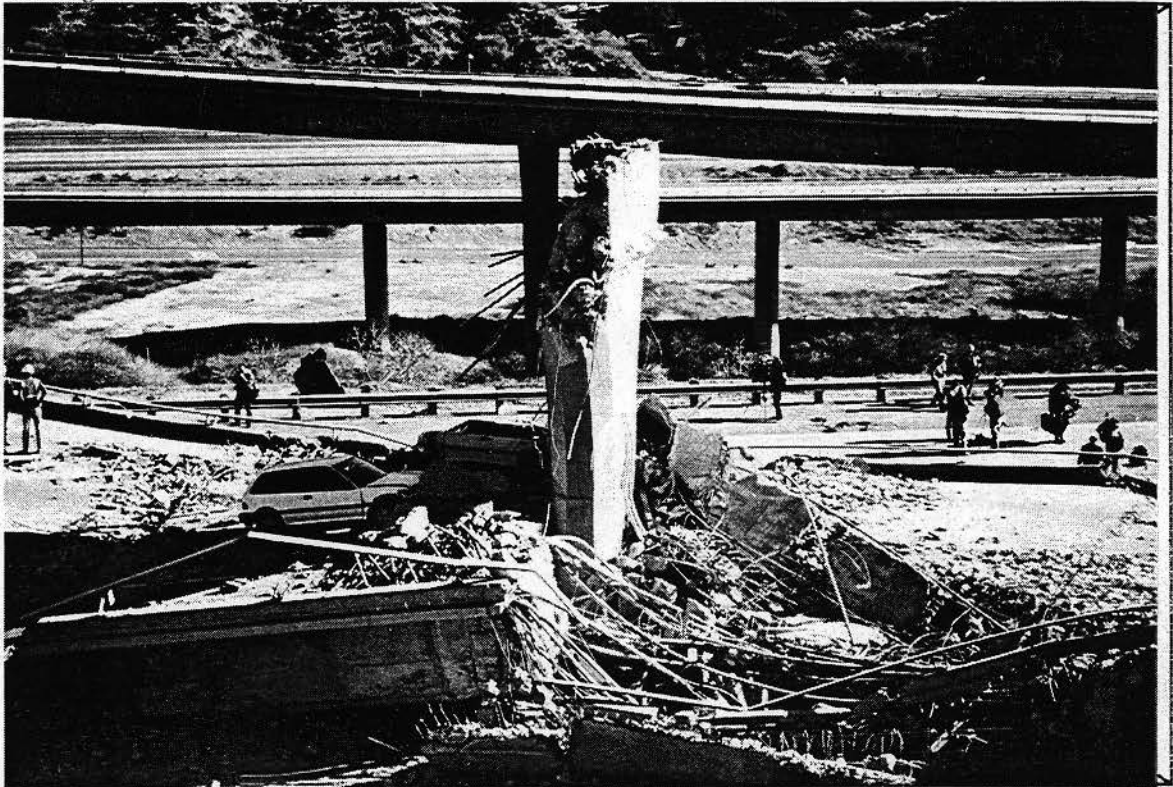
14/5 Conn. Sep. & OH
Bent 3 looking E.

Pier 3 remained standing. Pier 3 did not have cracking on the transverse face, while some vertical cracking ($\approx 3/8$ " wide) was evident on the longitudinal face (looking in elevation). The superstructure on both sides of the pier was on the ground. The main bent cap reinforcement at pier 3 was also on the ground. The #18 bars appeared undamaged and all the concrete was cleaned from the bars. The #5 stirrups in the bent cap had been ripped from the bent cap. Furthermore, there was no longitudinal, mild steel through the bent cap. When the prestressing was over-stressed and failed, the superstructure had almost no negative moment capacity.

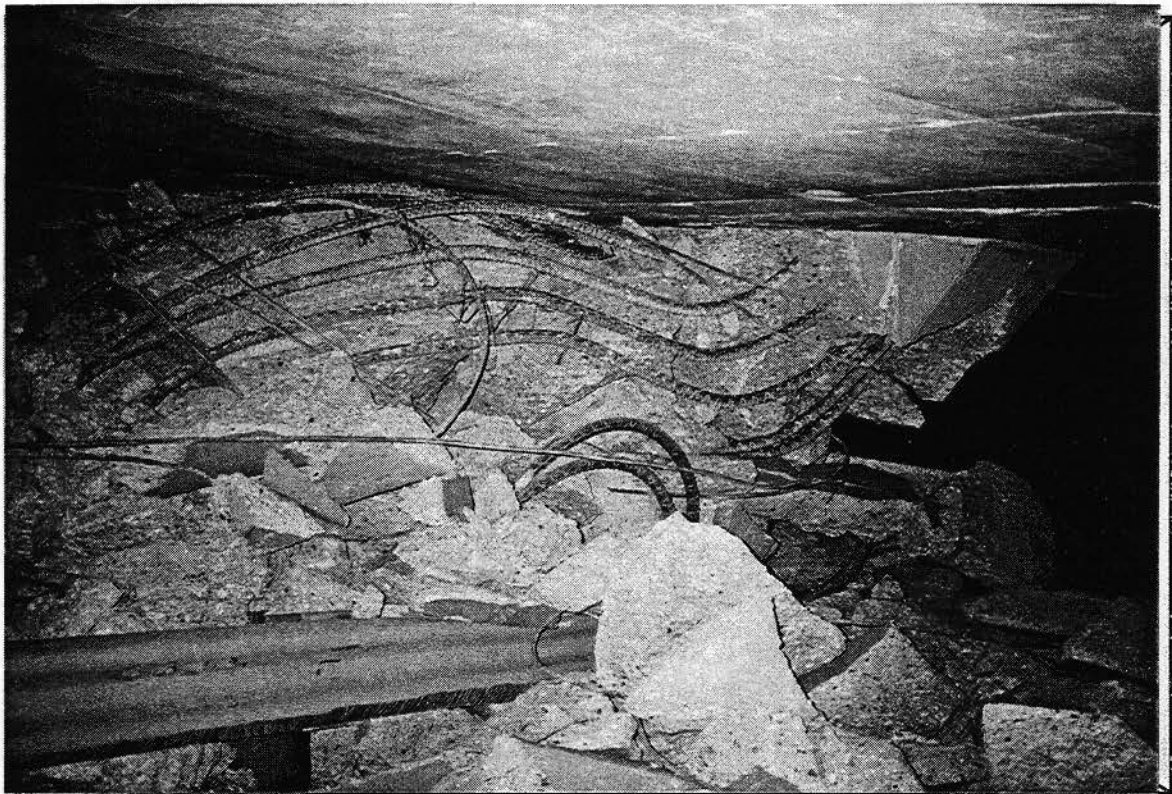
14/5 Conn. Sep. & OH
Looking W @ pier 2

At pier 2, the column failed completely. The main reinforcing steel in the column remained

attached to the bent cap. The top of the column at pier 2 had translated several feet ahead of the base of the column (along the centerline of the bridge) towards pier 3. The exterior girders on both sides of the bent cap had large vertical cracks at the face of the bent cap (looking in elevation).

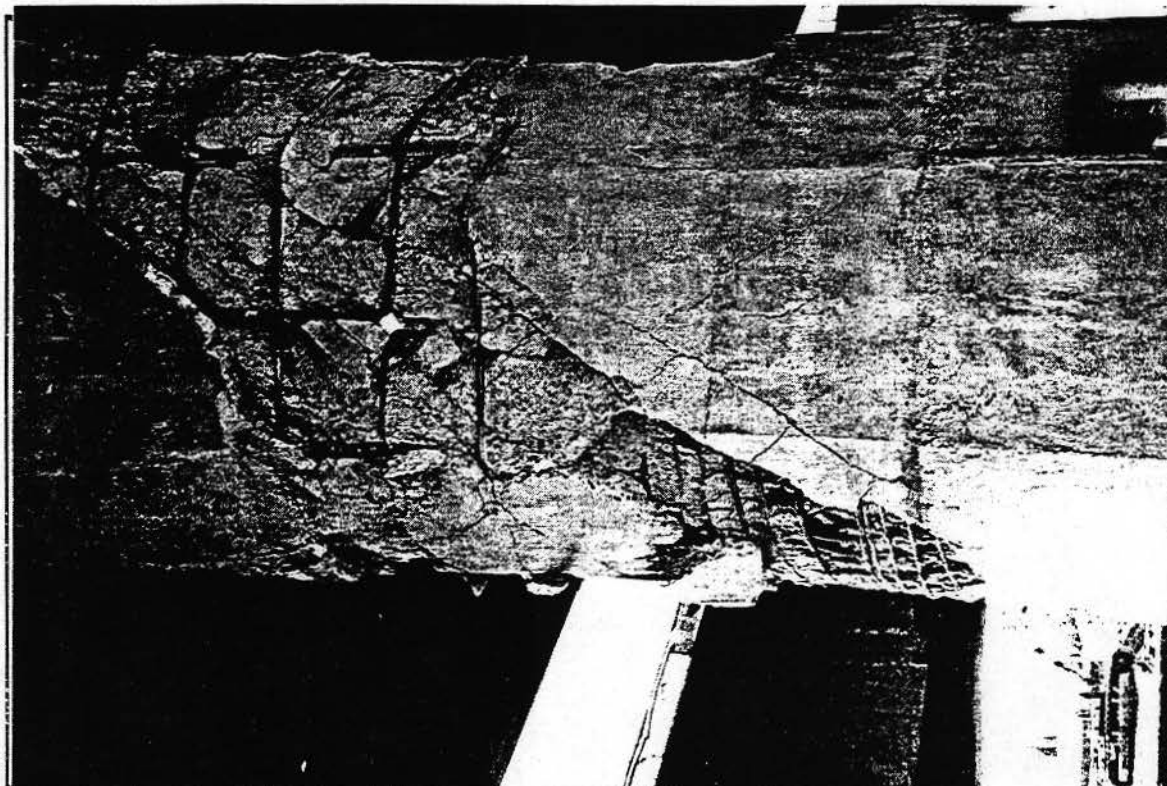
Bent 2L, right column, looking south.

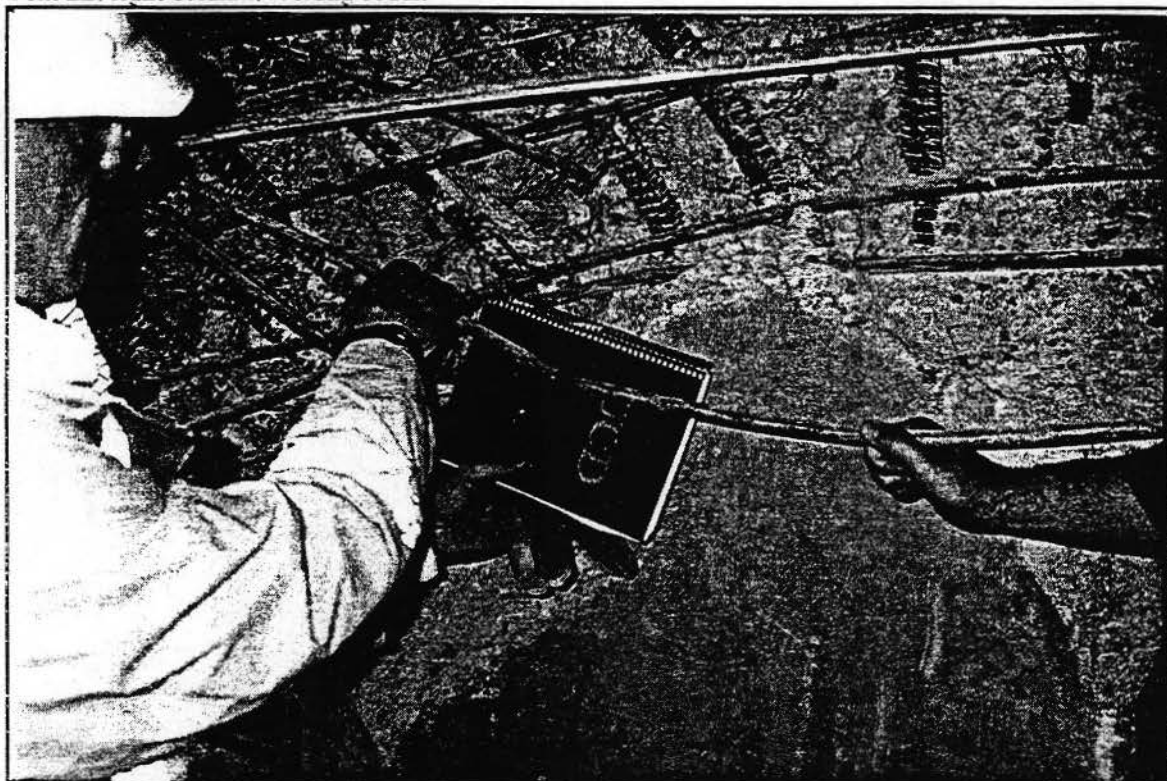
Closeup of #5 spiral necked down and ruptured in tension.

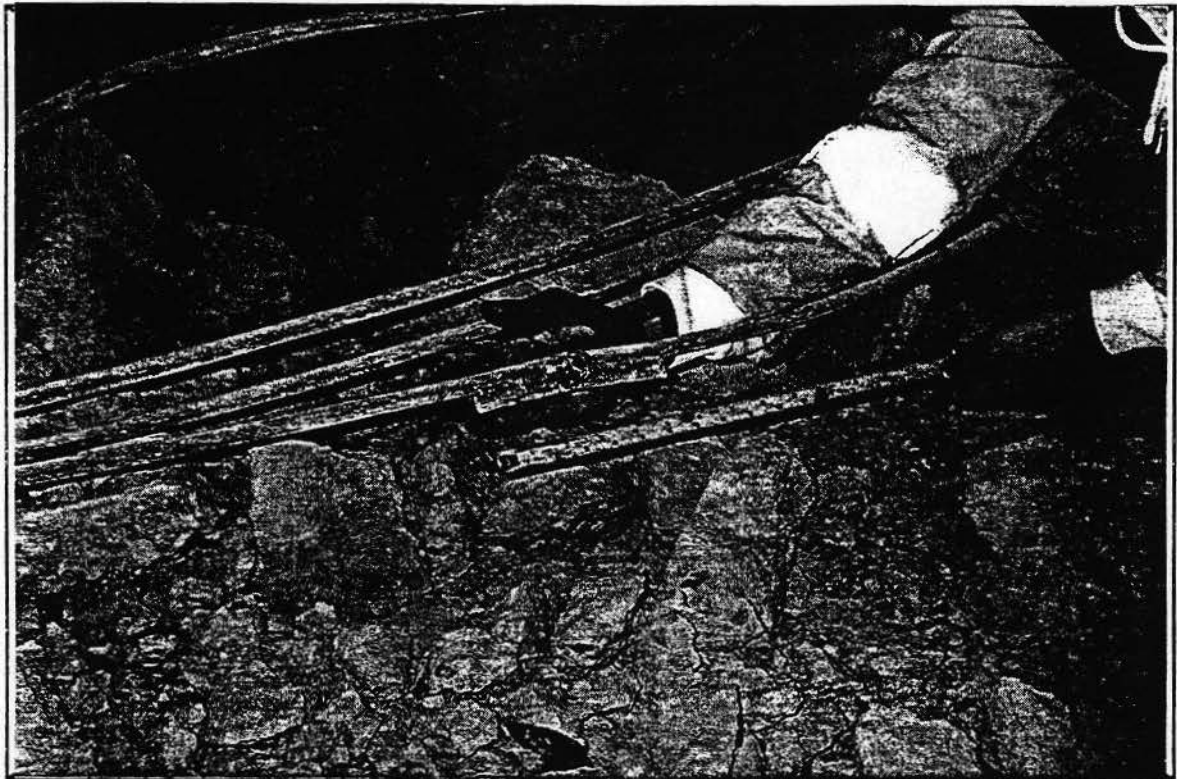
Closeup of spiral anchorage detail selected by contractor.

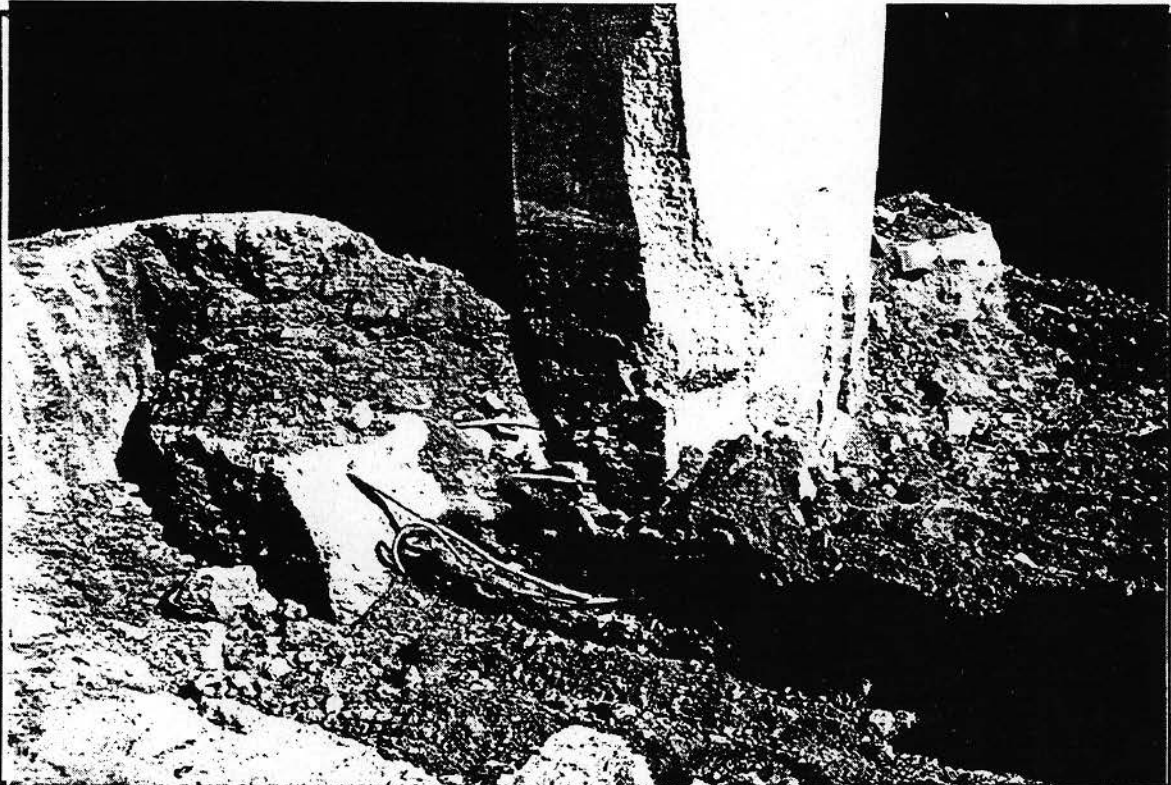
Bent 2R, right column excavated to show broken off collar, looking north.
